CULTURAL LANDSCAPE REPORT FOR
NATIONAL CENTER FOR PRESERVATION
TECHNOLOGY AND TRAINING

NORTHWESTERN STATE UNIVERSITY
NATCHITOCHES, LOUISIANA

Prepared by
Christopher Stevens, Olmsted Center for Landscape Preservation

National Park Service, Boston, Massachusetts, 2006

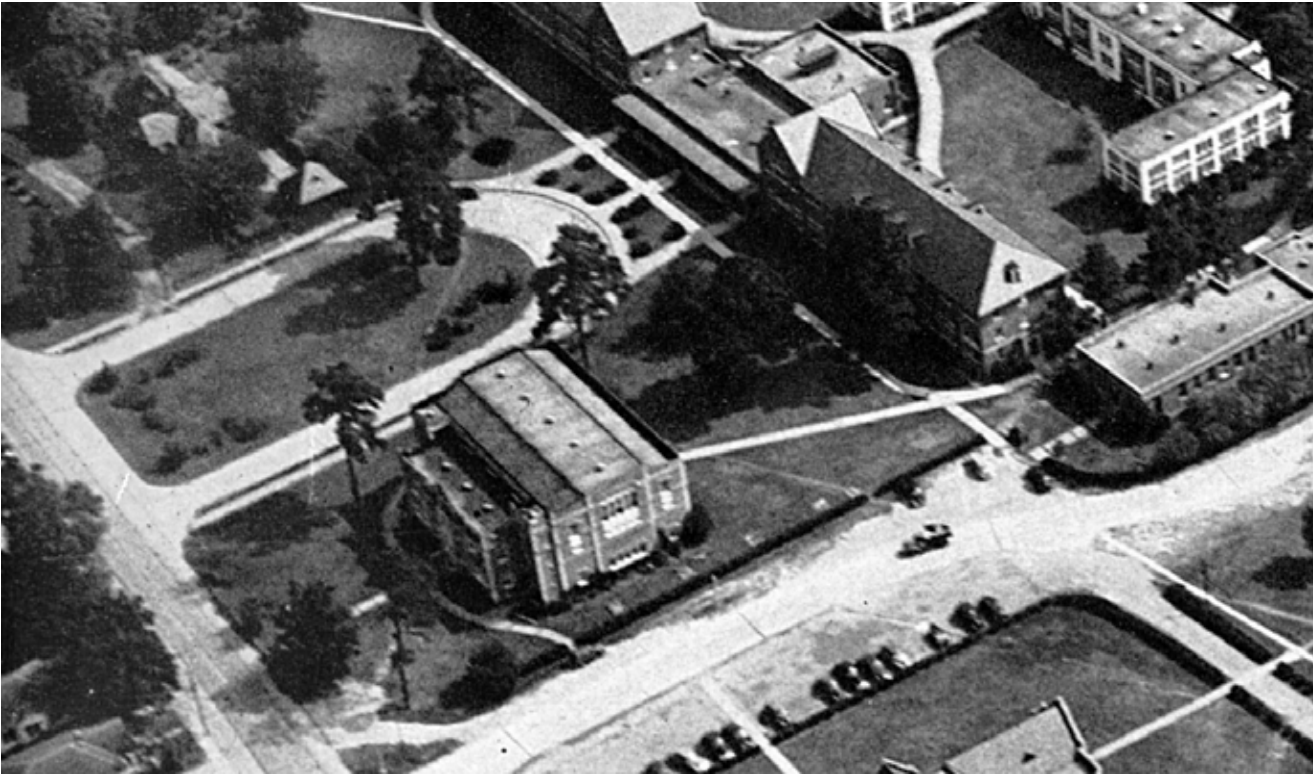
Figure 38. Aerial photograph showing from top left to bottom center, the President's Home, Horseshoe Drive, and the Women's Gymnasium, 1948. Note the extensive use of hedges on the campus including between Caspari Drive and the gym. All of the trees at the gym were pines. Varnado Hall is at the top with modern pergola-covered walkways behind (Northwestern State University, Watson Memorial Library, Cammie G. Henry Research Center (Potpourri Yearbook)).

A 1939 period plan (Figure 31) depicts the Women's Gymnasium landscape and its surroundings immediately prior to the construction of Varnado Hall and Horseshoe Drive. With the completion of these projects, the Women's Gymnasium landscape changed (Figures 32-38). The college realigned the walkways south of the Women's Gymnasium. The college removed the orthogonal walkway and pergola from the rear entrance of the gymnasium, and replaced it with a diagonal walkway that headed southwest to connect with Caspari Street and a new campus walkway along the front of Varnado Hall. By the 1940s, hedges still bordered College Avenue and Caspari Street, and the college had planted shrubs along the foundation of the gymnasium. The pine trees at the southwest corner of the gymnasium had disappeared. By 1941, the college had installed the lamp standards with concrete poles that still illuminate much of the campus today.

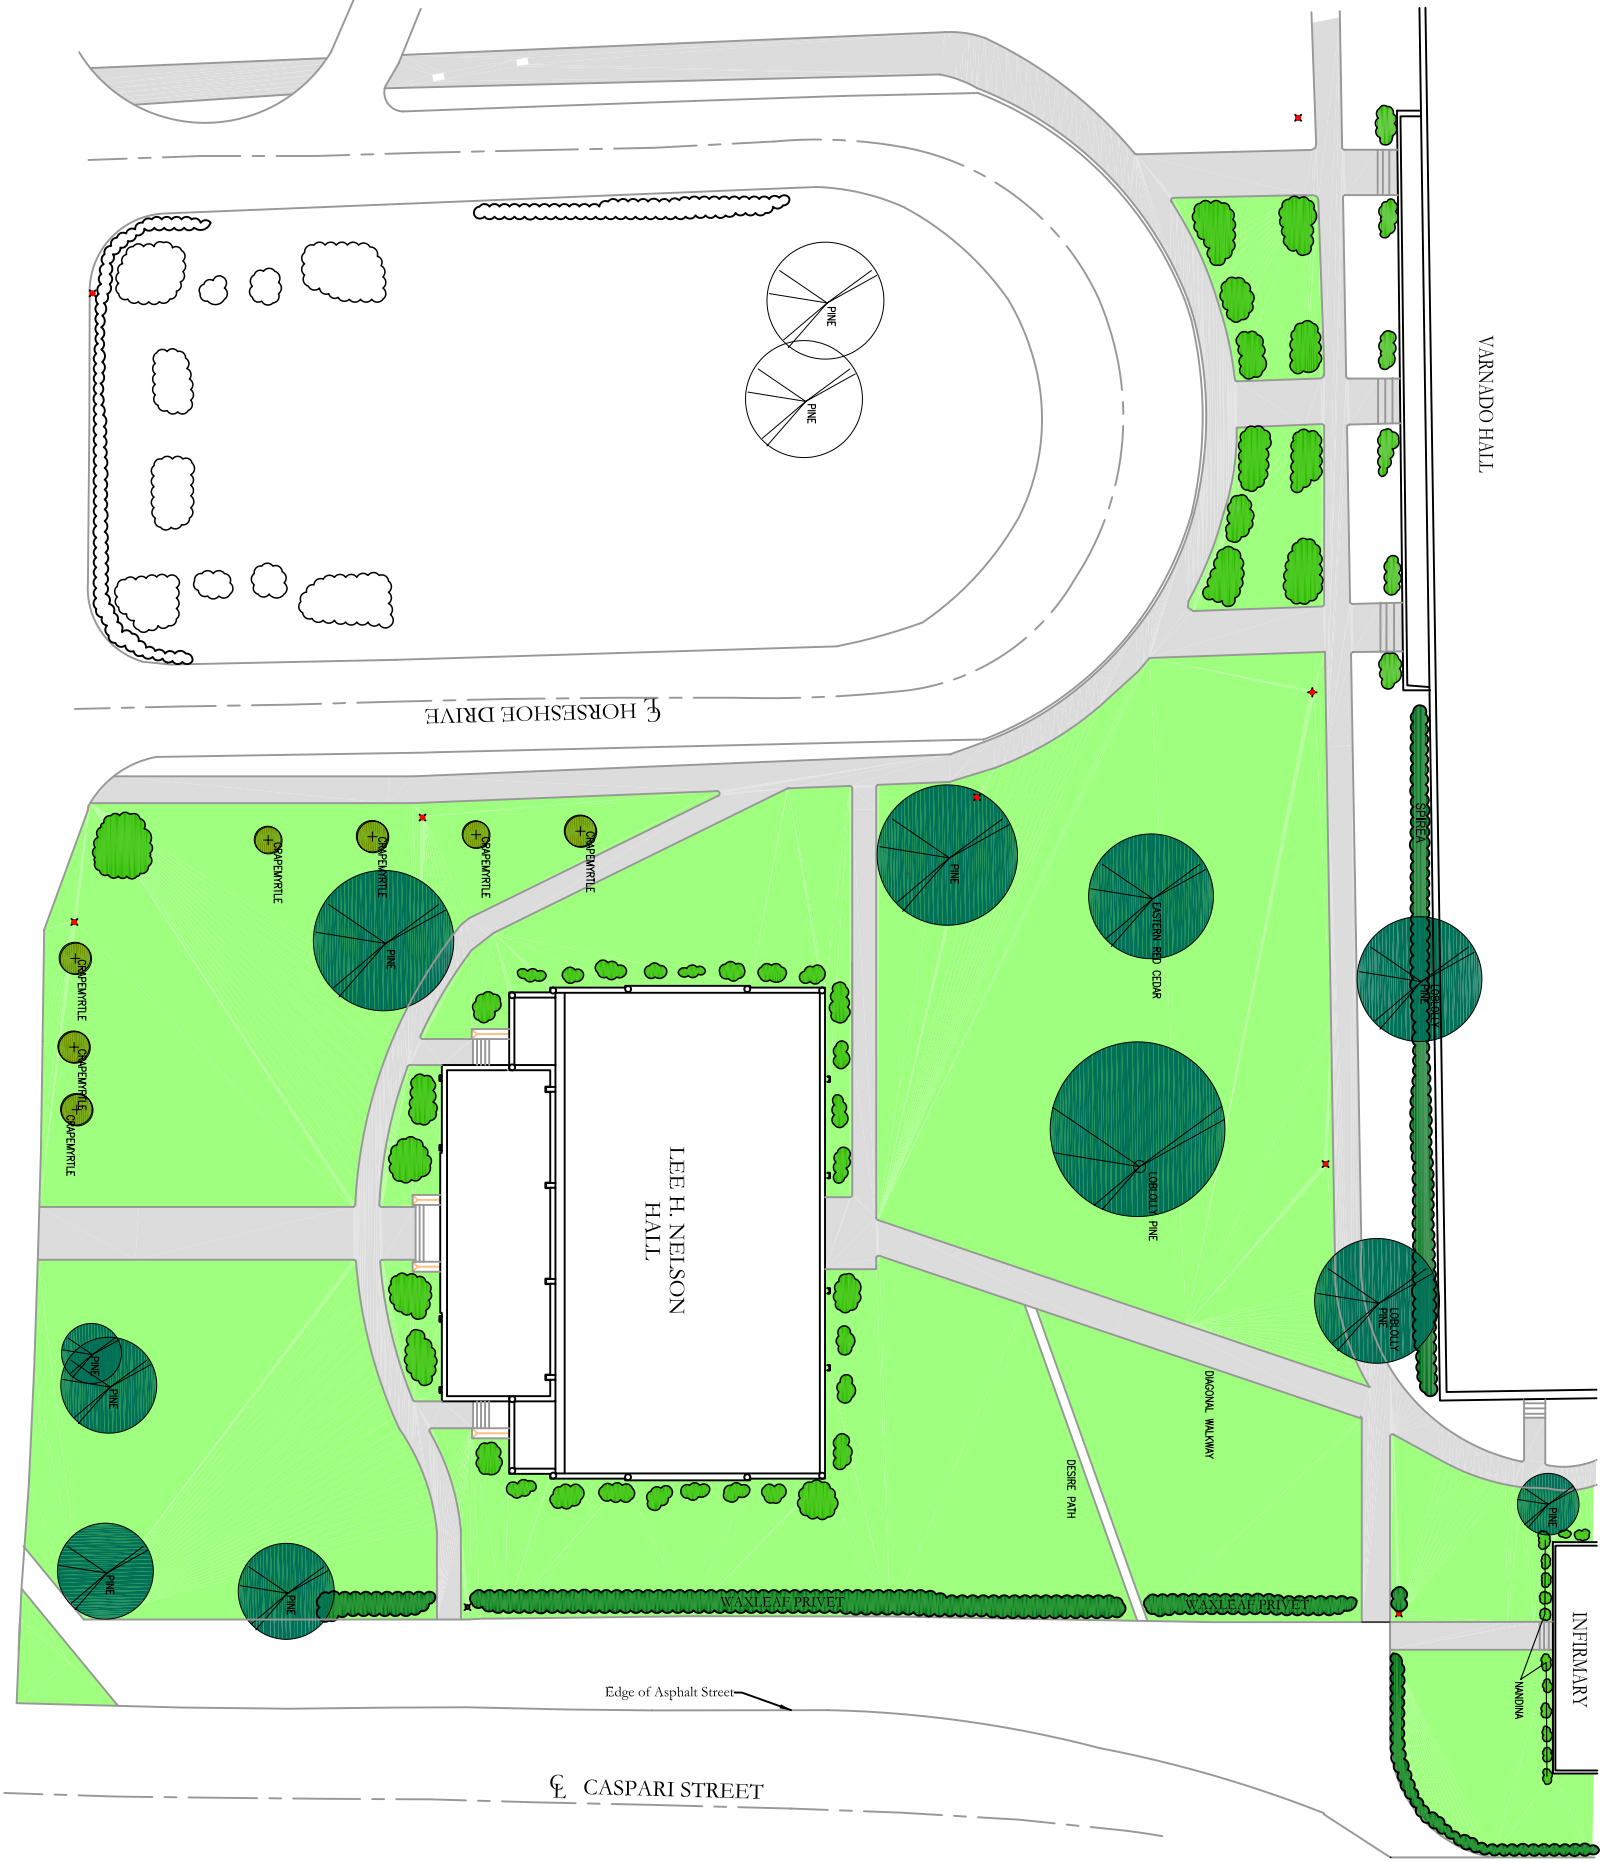
Figure 39.

PERIOD PLAN
c. 1950s - 1960s
Women's Gym
Landscape

The Women’s Gymnasium landscape changed little during the 1950s and 1960s (Figures 39-47). The sidewalks remained unchanged from the 1940s. Pine trees still graced the northwest corner of the Women’s Gymnasium as well as the end of the front walkway and the center of the south lawn, and earlier foundation plantings had matured. By the 1950s, the hedges at the Women’s Gymnasium had begun to decline with only remnants remaining along College Avenue, although the hedge along Caspari Drive remained robust. The college likely planted crapemyrtle trees along College Avenue in the front lawn during this time. Adjacent to the Women’s Gymnasium property, the college had planted more trees in the southern half of Horseshoe Drive’s lawn while the shrubs in the northern half had matured. Shrubs and some large pine trees still lined the foundation of Varnado Hall.

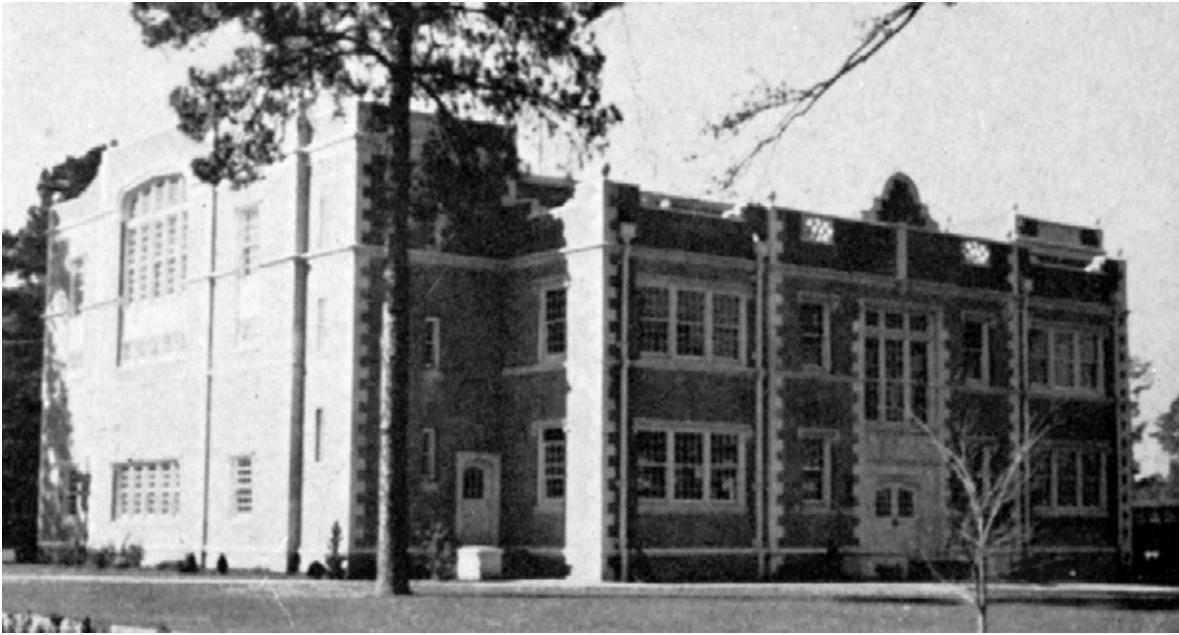
Figure 40. Eastern and northern (front) facades of the Women's Gymnasium, ca. 1950. Note the foundation plantings, the large pine tree, and the young tree in the foreground (perhaps a crapemyrtle) (Northwestern State University, Watson Memorial Library, Cammie G. Henry Research Center (Potpourri Yearbook)).

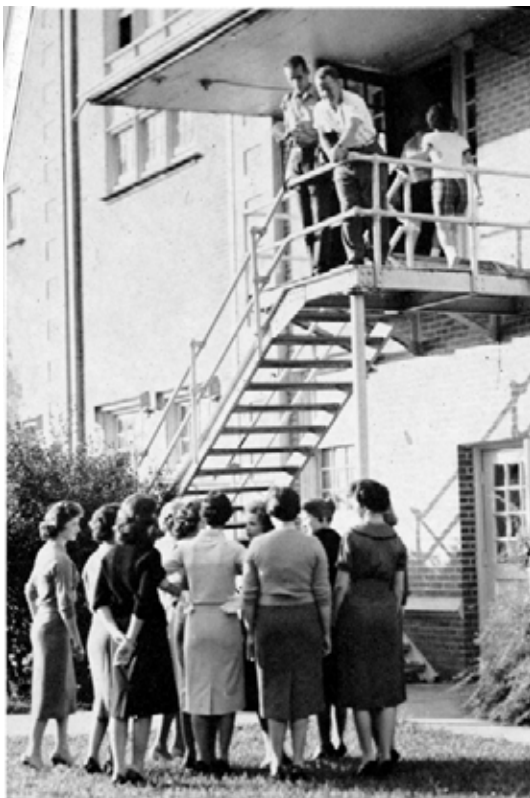
Figure 43. Rear (south) entrance of the Women's Gymnasium, 1961. Note the orthogonal walkway leading across the lawn and the large shrubs (Northwestern State University, Watson Memorial Library, Cammie G. Henry Research Center (Potpourri Yearbook)).

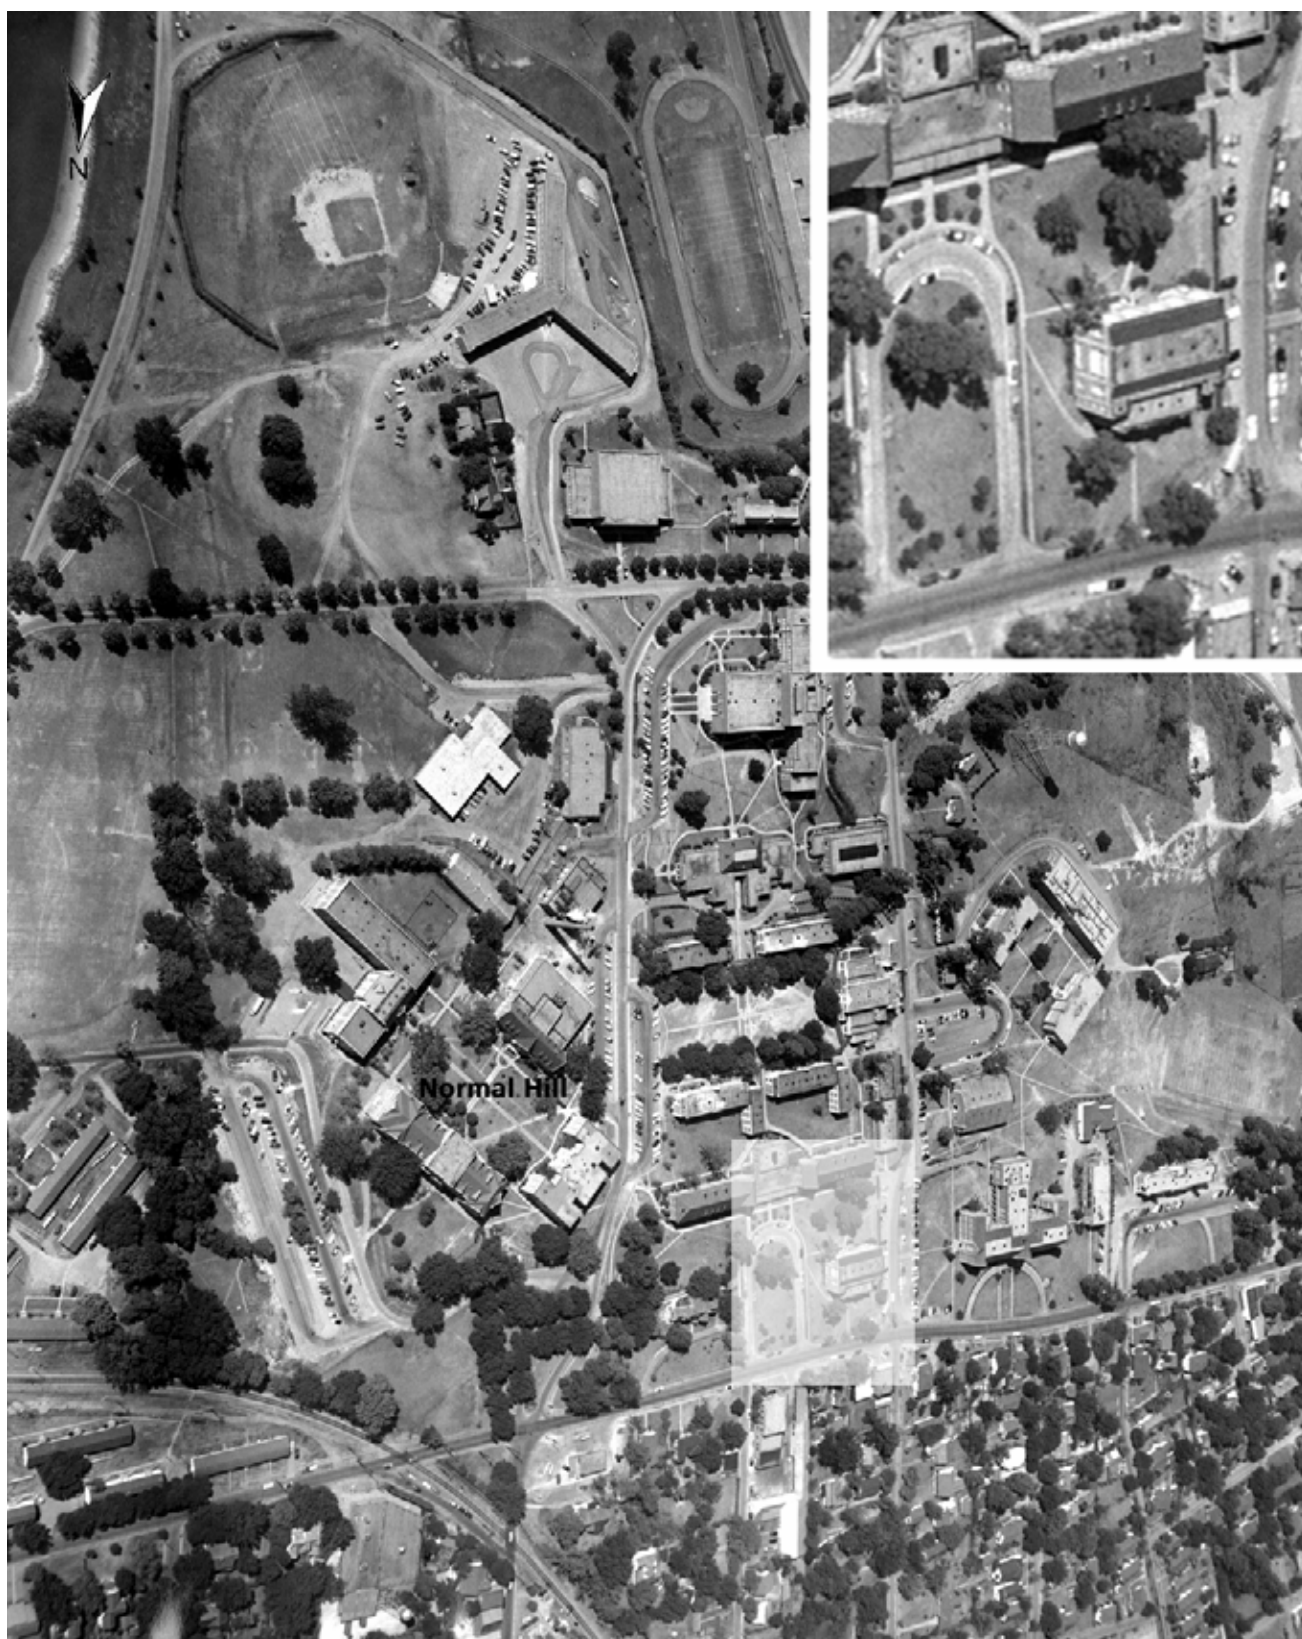
Figure 44. Aerial photograph of NSU, 1961. The Women's Gymnasium area is highlighted and magnified in the inset, upper right. Note the Pergola-covered walkways behind Varnado Hall (Northwestern State University, Watson Memorial Library, Cammie G. Henry Research Center).

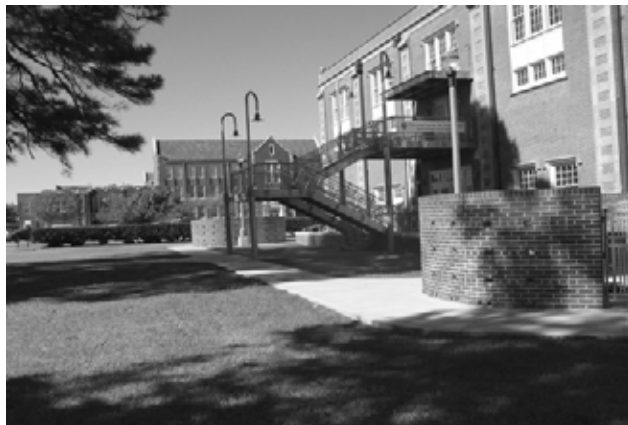
Figure 59. The steel staircase flanked by two brick utility pods along the south façade of Nelson Hall (OCLP, 2004).

egress (Figures 59 and 60). In addition, three brick pods were constructed in the landscape to conceal utilities such as HVAC equipment (Figures 59 and 60). These utility pods are about six feet tall and can be accessed through a lockable gate.

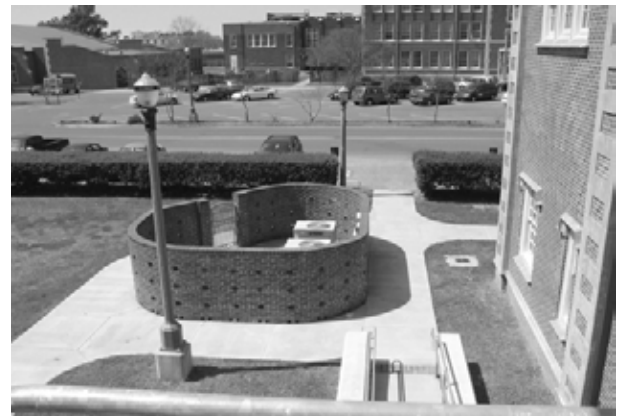
Figure 60. The southwest brick utility pod and part of the ADA-compliant ramp as seen from the steel staircase (OCLP, 2004).

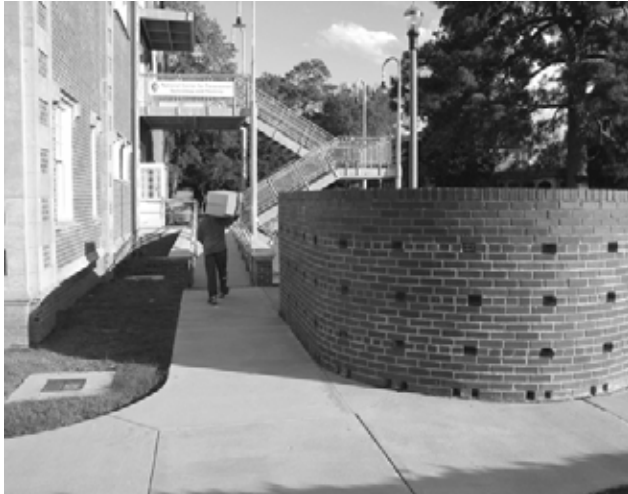
Figure 63. Walkway from Caspari Street parking area to Nelson Hall's current main entrance pinched between the building's south façade and a brick utility pod (OCLP, 2004).

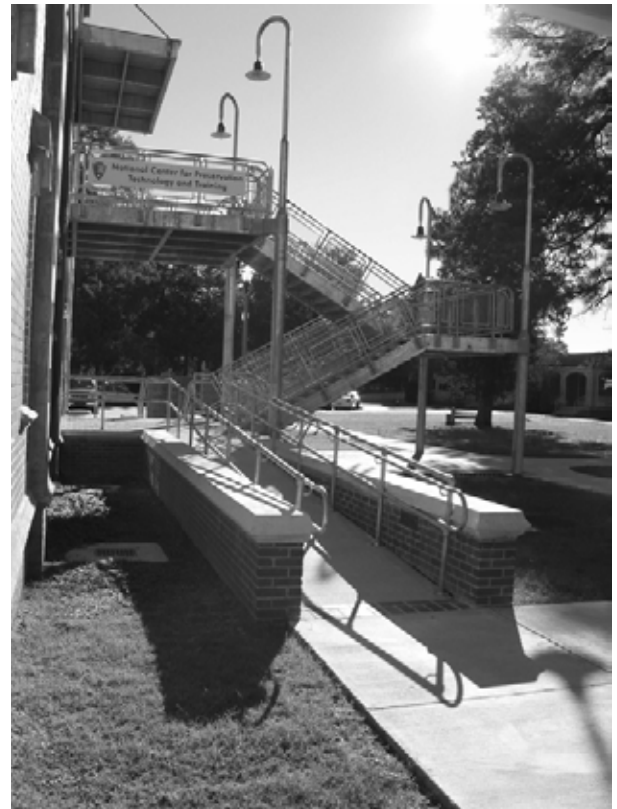
Figure 64. Accessibility ramp leading to Nelson Hall's main (south) entrance landing beneath the steel staircase (OCLP, 2004).

elaborate and symmetrical walkway system mainly links the parking areas to the building. One uncompleted concrete spur leads from the south entrance to the middle of the south lawn (the c. 2000 landscape plans were only partially installed). The signage and views primarily lead visitors to the rear (south) door of Nelson Hall which currently serves as the main entrance. The most direct route from the two parking areas is uncomfortably pinched between the two brick utility pods and the building's south façade and leads underneath the building's rear steel staircase (Figure 63). Stairs lead to the brick entrance landing from the east and an ADA-compliant ramp leads from the west (Figure 64). The steel staircase overhead provides egress from the second floor (Figure 65).

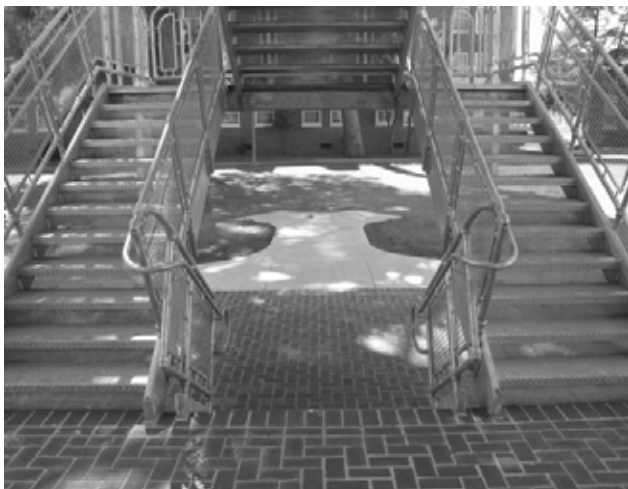
Figure 65. Brick landing by main (south) entrance to Nelson Hall looking south beneath the steel staircase along the uncompleted walkway toward Varnado Hall (OCLP, 2004)

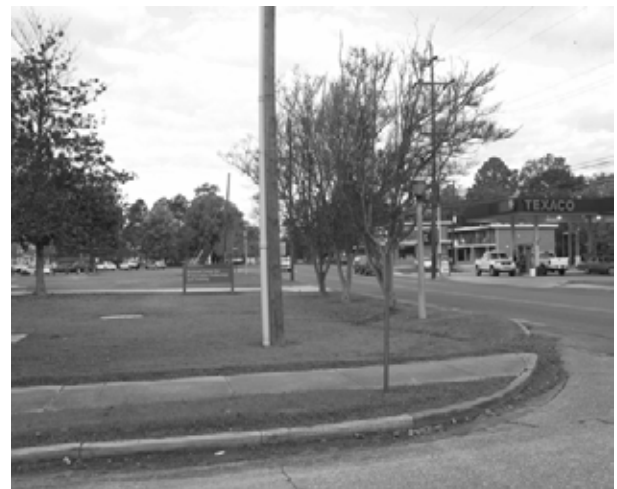
Figure 66. The two concrete walkways that lead to College Avenue. Note the absence of a sidewalk along College Avenue, joining the two walkways (OCLP, 2004).

Walkways lead to College Avenue from the front (north) door of Nelson Hall and from the Horseshoe Drive parking area (Figure 66). Many students follow Caspari Drive to the NCPTT property where they cut across the front lawn and cross College Avenue to get to the businesses on the other side. There are no walkways along College Avenue or adequate crosswalks to safely convey these pedestrians.

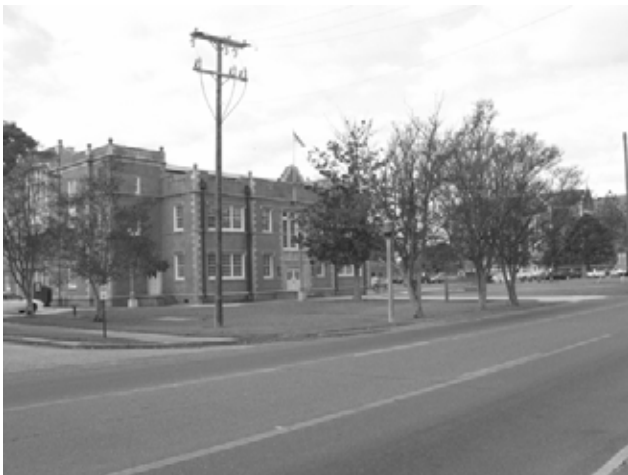
Figure 67. Crapemyrtle trees along College Avenue and Horseshoe Drive and the southern magnolia near the front door of Nelson Hall (OCLP, 2004).

A large portion of the NCPTT property is covered with lawn, including the intricate spaces created by the elaborate sidewalk system surrounding Nelson Hall. The north lawn is devoid of any other vegetation northwest of Nelson Hall. The northeastern section of the north lawn has three old crapemyrtle trees growing along College Avenue and two additional crapemyrtle trees along Horseshoe Drive. A large southern magnolia tree grows northeast of the front door and is in a declining state of health (Figure 67).

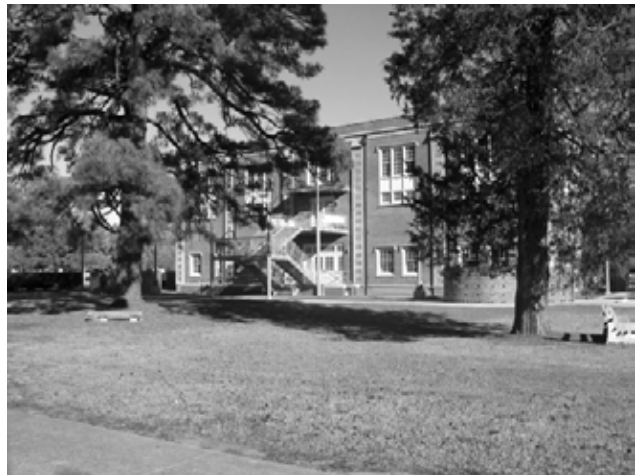
Figure 68. Loblolly pine tree (left) and eastern red cedar tree (right) in the south lawn (OCLP, 2004).

The south lawn supports two trees in the middle of the southeastern section, an eastern red cedar and a large loblolly pine tree (Figure 68). The loblolly pine tree's

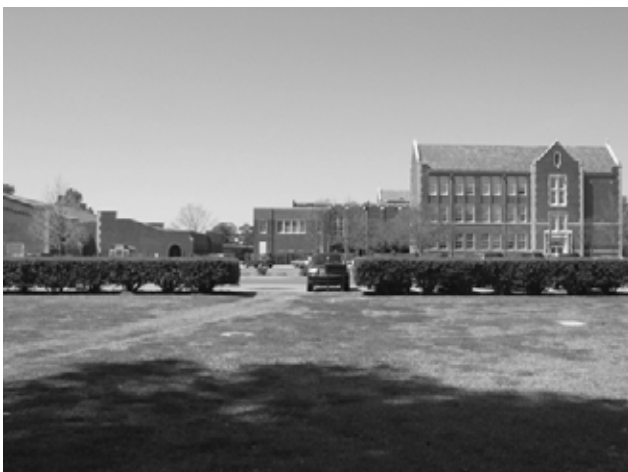
Figure 69. Waxleaf privet hedge between south lawn and Caspari Street parking area with gap in the center (OCLP, 2004).

canopy is not centered on the trunk but rather stretches easterly. A waxleaf privet hedge borders the south lawn to the west (Figure 69). The hedge is perforated with sidewalks at its northern and southern ends and has a gap near the center (Figure 70).

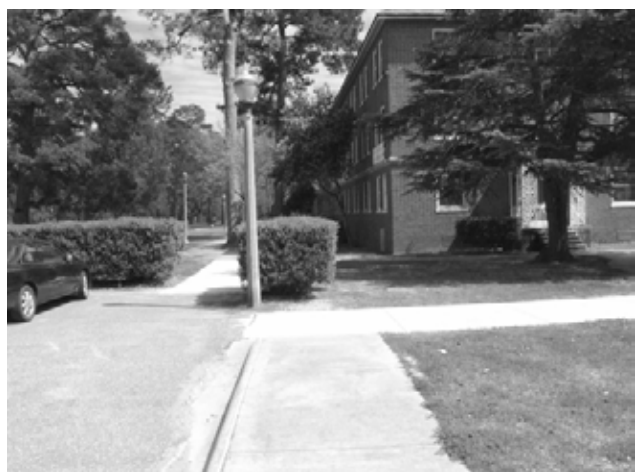
Figure 70. Sidewalk passing through waxleaf privet hedge along Varnado Hall's foundation trees and shrubs (OCLP, 2004).

Eastern Views include the trees and shrubs growing inside Horseshoe Drive with the former President's Home and the walkway to Normal Hill just beyond. This walk is poorly aligned from the west side of the property to the west side of Caspari Drive (Figure 70). The poor alignment blocks the visual connection that could link the two segments of this major walkway across campus. The three utility pods on the property are about six feet tall and block many pedestrian views across the landscape.

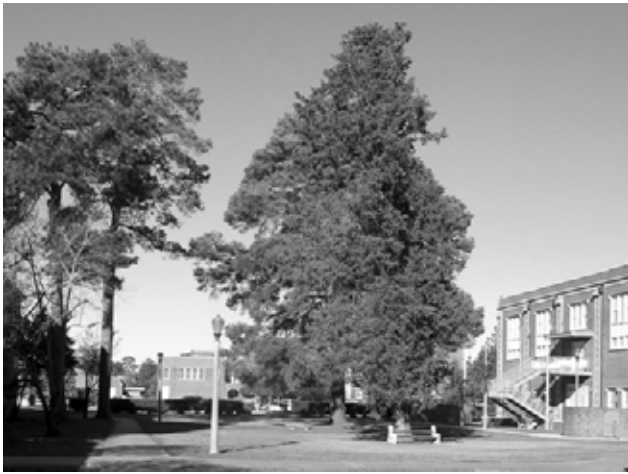
Figure 73. From left to right: c. 1940 lamppost standards and both benches (OCLP, 2004).

along the front of Varnado Hall, the area within Horseshoe Drive, and the north lawn along College Avenue (Figures 70). Taller, c. 2000 lamppost standards illuminate the areas immediately surrounding Nelson Hall (Figures 60 and 73). Steel, shepherd’s crook lampposts illuminate the steel staircase on Nelson Hall’s south façade (Figure 64). Two benches provide respite on the south lawn - one a concrete slab resting on two concrete footers beneath the loblolly pine tree and the other consisting of two concrete side supports with brown wooden slats beneath the eastern red cedar tree (Figure 73). The latter bench is in poor condition with the top slat missing and the remaining wooden slats rotting and chipping. Numerous concrete slabs mark utilities throughout the north and south lawns, and drainage grates cover the numerous drains in the lawns and along the building (Figure 74).

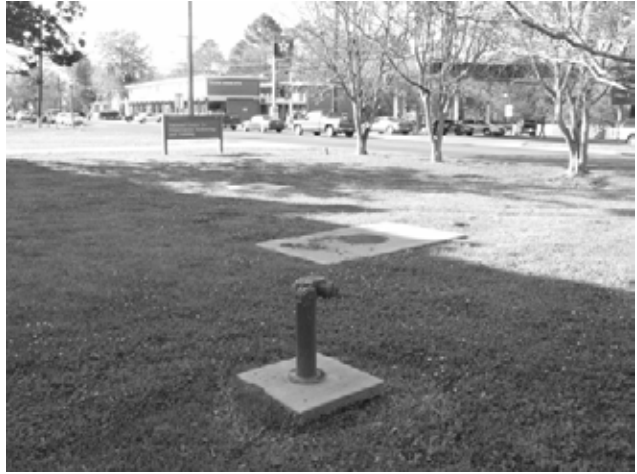
Figure 74. Concrete utility covers in the north lawn with the main NCPTT sign in the background (OCLP, 2004).

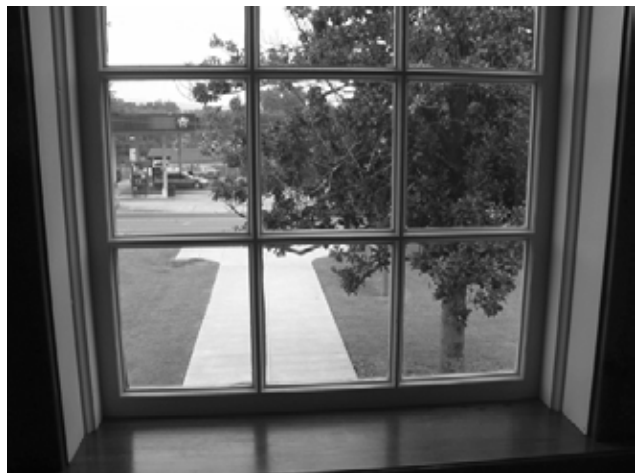
Figure 76. Northern view from the landing just before the second floor gym through the declining southern magnolia tree to College Avenue (OCLP, 2004).

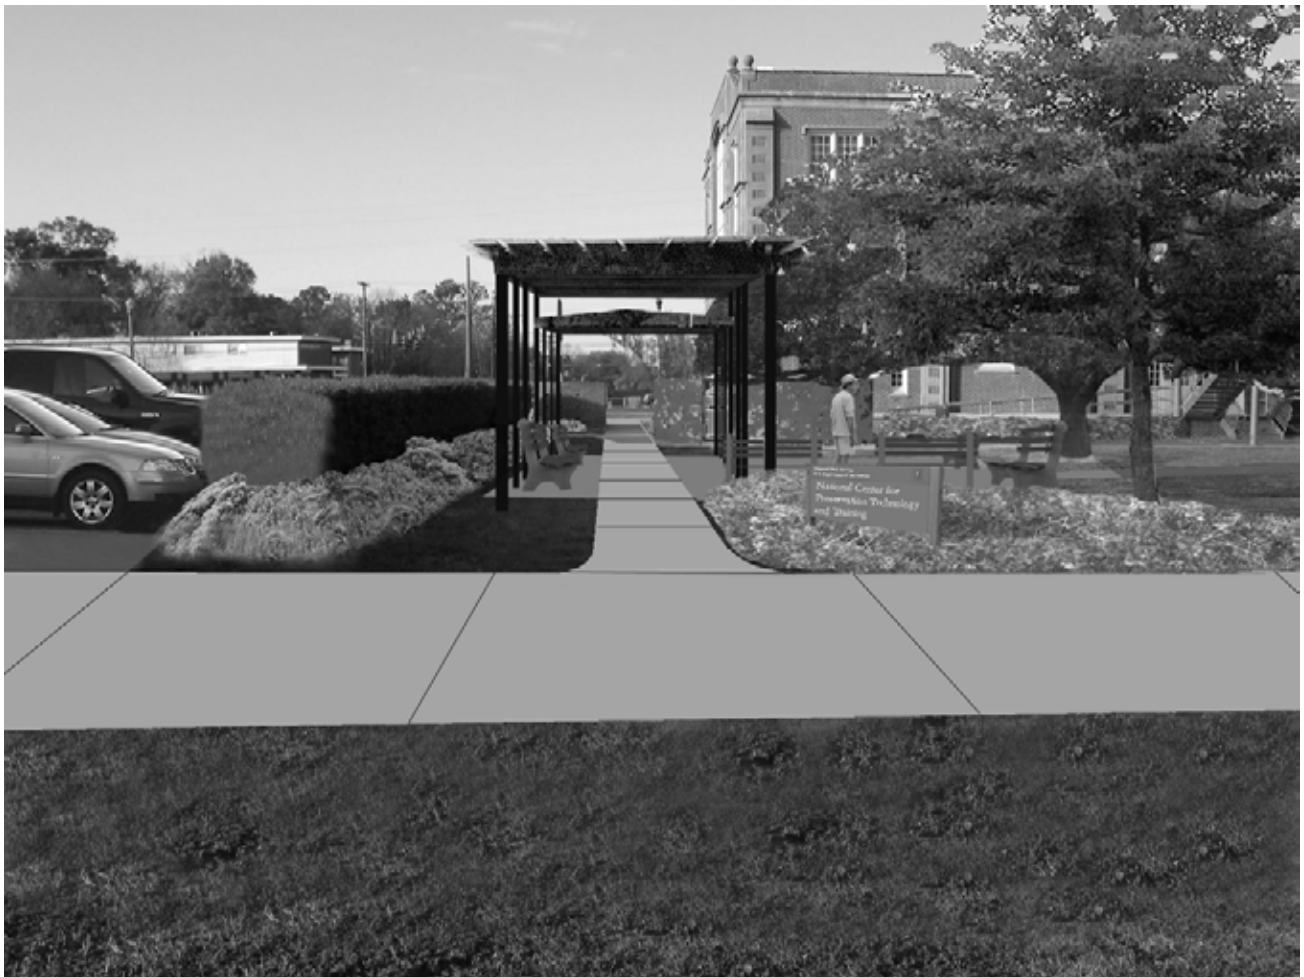
Proposed Pergola Garden Room for the southwest corner of the NCPTT property at Northwestern State University, Natchitoches, LA, 2004 (Olmsted Center for Landscape Preservation).

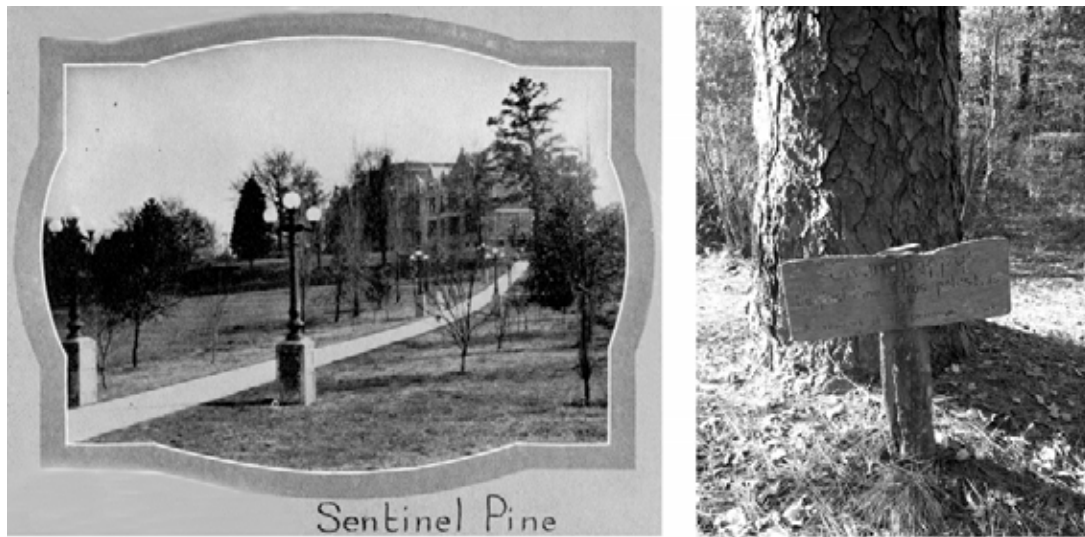
Figure 79. NSU's "Sentinel Pine," 1928, and the Caroline Dormon Nature Preserve's "Grandpapy Pine," 2003 (Northwestern State University, Watson Memorial Library, Cammie G. Henry Research Center (Potpourri Yearbook) and OCLP).

The magnificent loblolly pine will dominate the area for many years while the new plantings mature. The “Sentinel Pine” once graced Normal Hill and was captured in many historic photographs. “Grandpappy” pine presides over the Caroline Dormon Nature Preserve as a remnant of a primeval forest (Figure 79). Perhaps NCPTT could name their existing large pine for future generations to enjoy, much like the tradition of the “Ghost of Normal Hill” who now resides in the building.

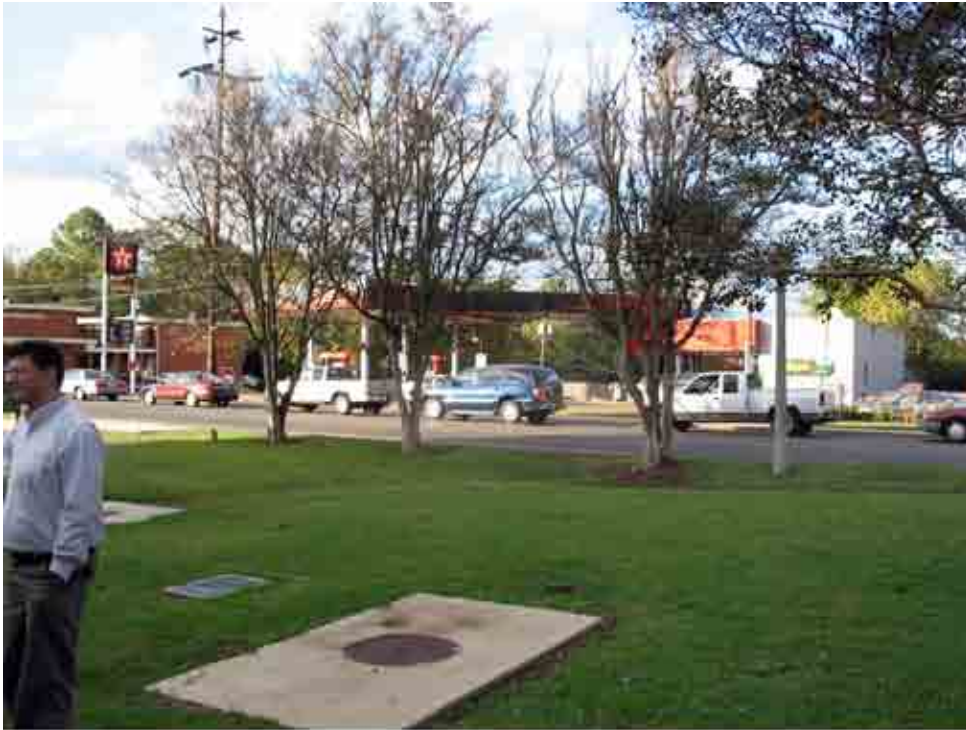
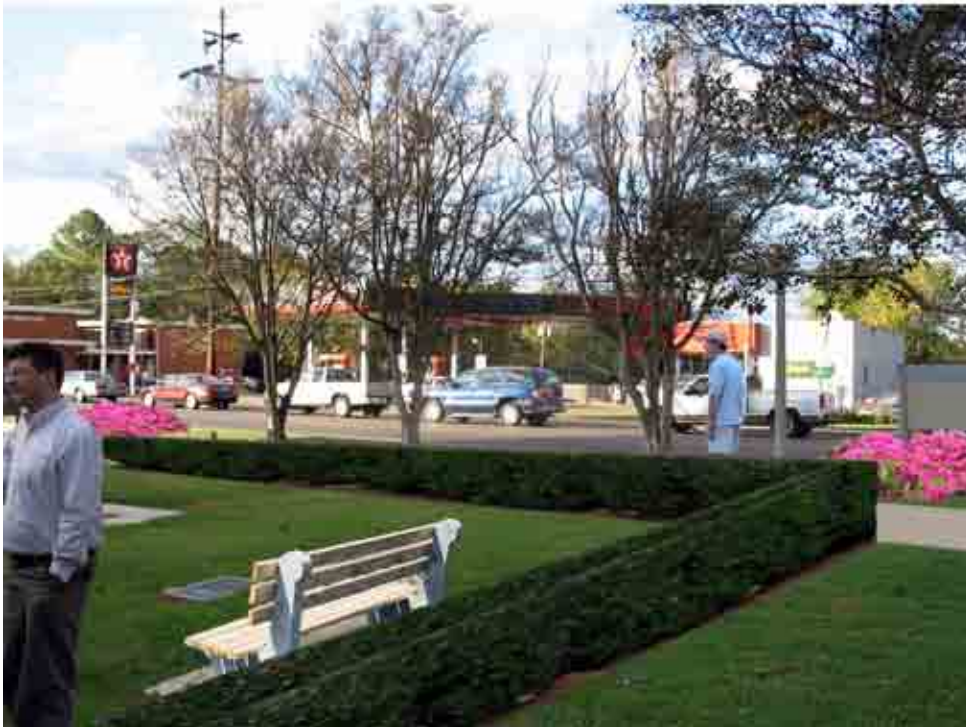
Figure 80. Top: NCPPT's existing north (front) lawn and crapemyrtles with view of College Avenue, 2003 (OCLP). Bottom: Proposed hedge row and shrub planting provides spatial definition and softens view, 2004. (OCLP).

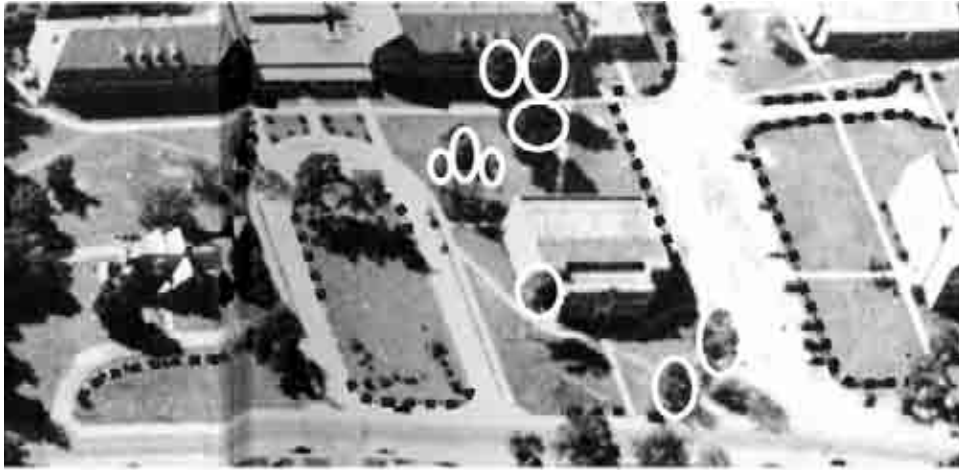
Figure 81. 1948 aerial photo (top) and 1951 aerial photo (bottom) showing hedges (dashed lines) and pine trees (circled) at and near the Women's Gymnasium (Northwestern State University, Watson Memorial Library, Cammie G. Henry Research Center (Potpourri Yearbook)).

A proposed hedge will further frame three sides of the north lawn and selectively screen views of the avenue and Caspari Street. It will begin near the northern edge of the Caspari Street parking area and continue the line of the waxleaf privet hedge. The evergreen, low-maintenance and ornamental shrub, sasanqua camellia (*Camellia sasanqua* 'Shi-Shi Gashira') has been specified. The camellia hedge will produce large pink flowers, and will be lined with pink Encore Azaleas® along the western edge of the north lawn. This hedge row is inspired by a former one that dated to the 1920s (Figure 81). The hedge

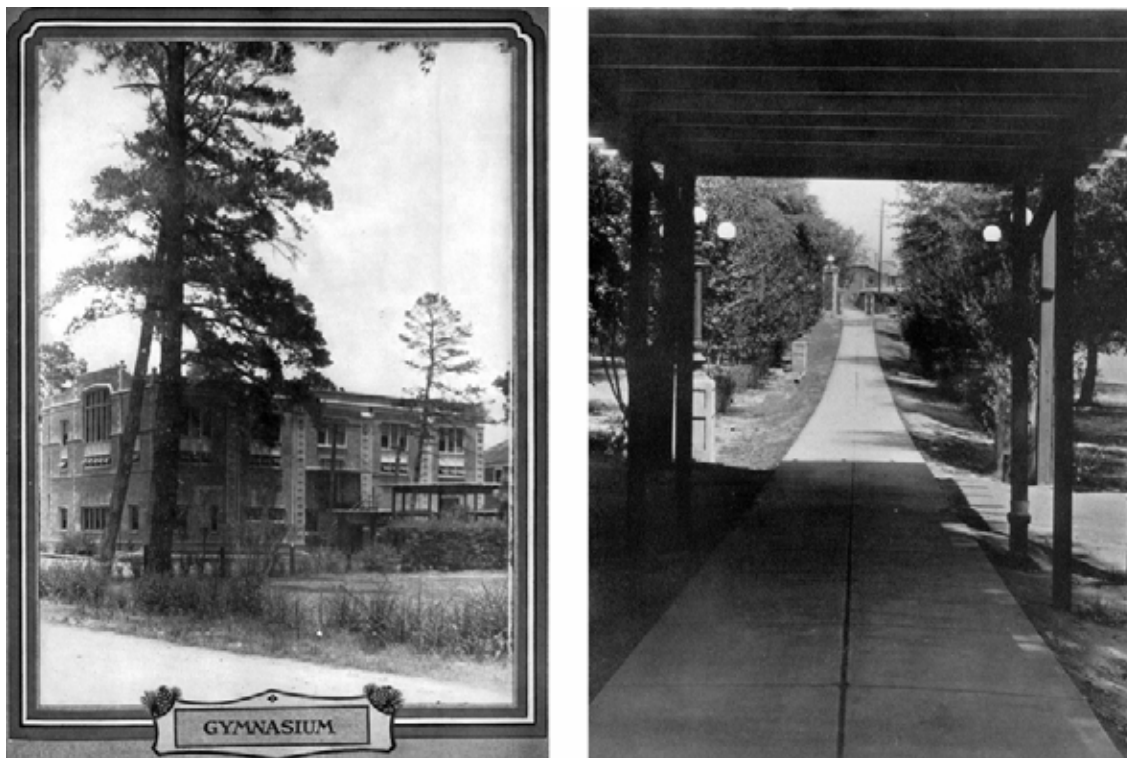
Figure 82. Left: 1926 photo showing tiered pergola covering the walkway behind the Women’s Gymnasium. Right: 1932 photo showing walkway passing through one of the campus’ many pergolas (Northwestern State University, Watson Memorial Library, Cammie G. Henry Research Center (Potpourri Yearbook)).

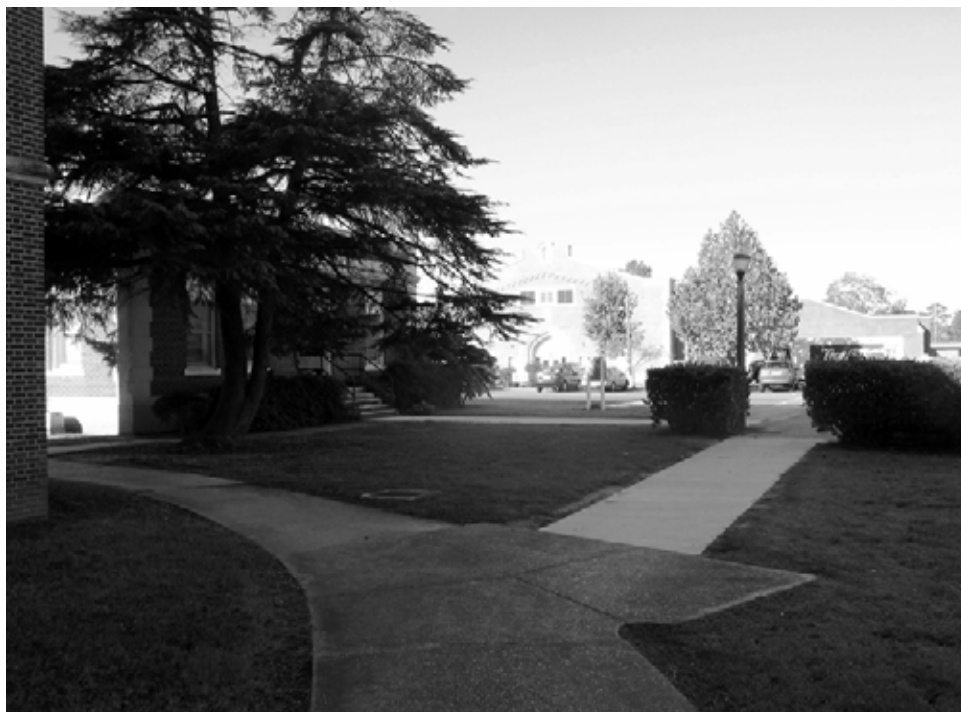
Figure 83. Existing “Demon Crossroads” southwest of the NCPTT building beside the University Health/Police building, 2003. Note the noncontiguous walkways (OCLP).

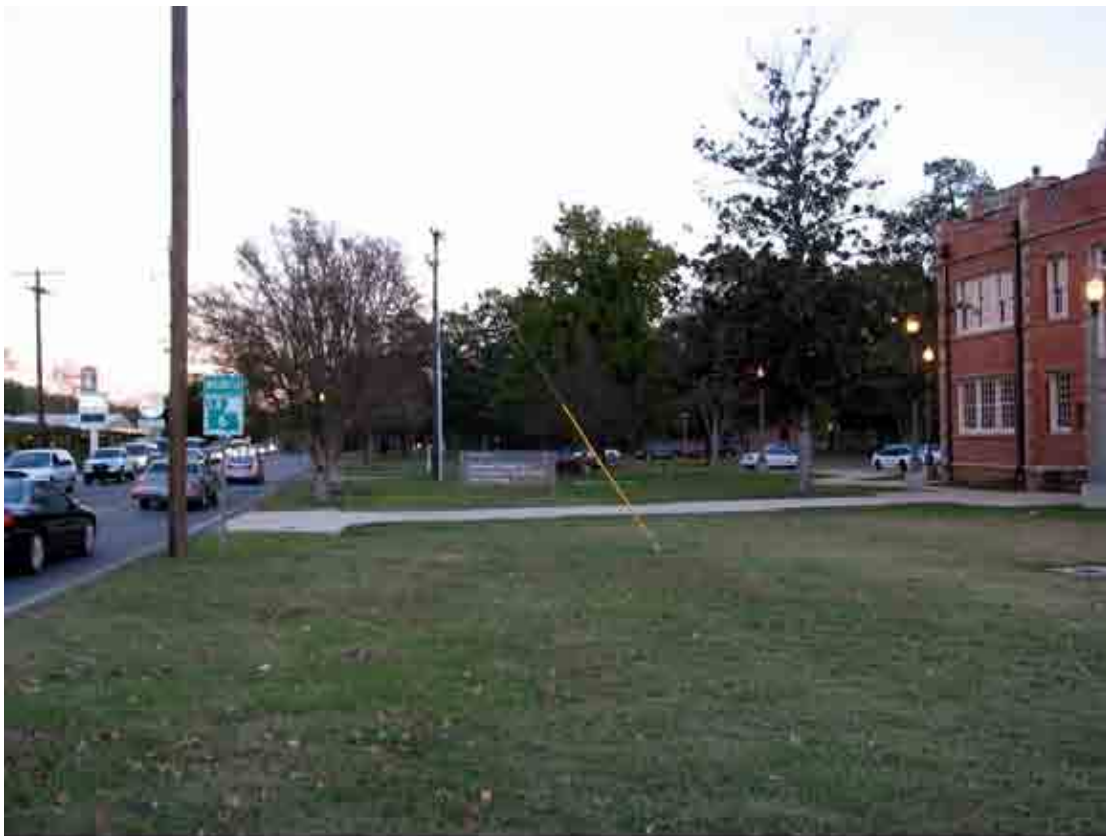
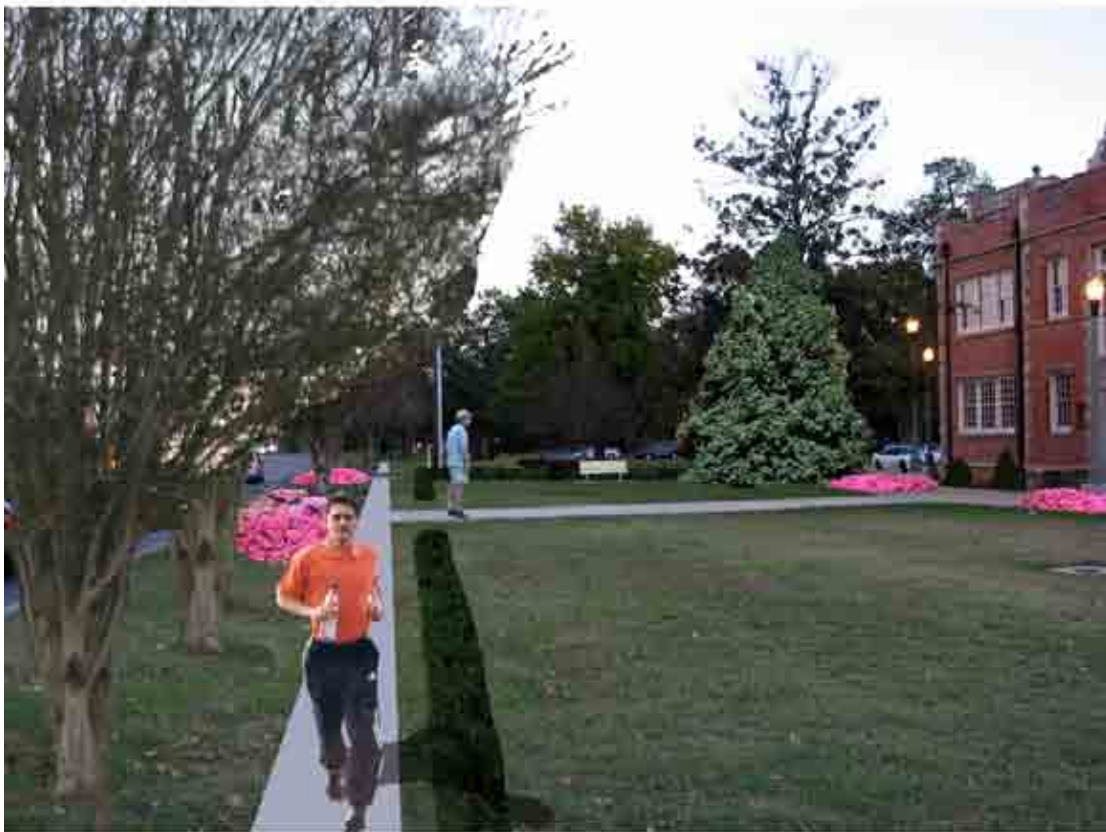
Figure 84. Top: NCPTT's existing north (front) lawn, barren with a dying magnolia tree, 2003 (OCLP). Bottom: Proposed College Avenue campus walkway, supplemental crapemyrtle trees, flowerbeds, hedge row, and American holly, 2004 (OCLP).
