CULTURAL LANDSCAPE REPORT FOR
NATIONAL CENTER FOR PRESERVATION
TECHNOLOGY AND TRAINING

NORTHWESTERN STATE UNIVERSITY
NATCHITOCHES, LOUISIANA

Prepared by
Christopher Stevens, Olmsted Center for Landscape Preservation

National Park Service, Boston, Massachusetts, 2006

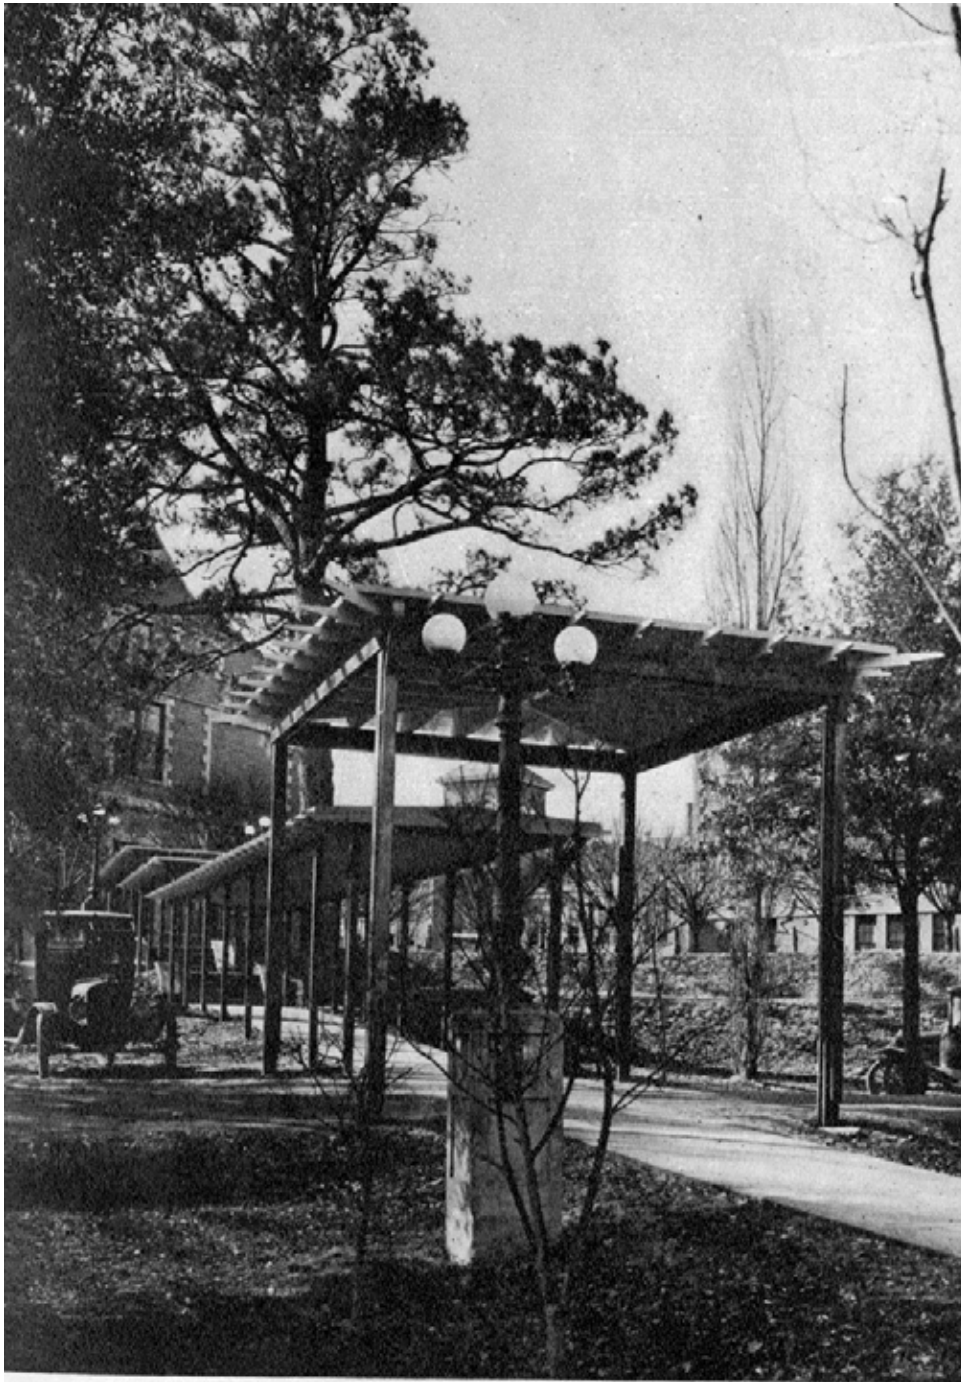
PERGOLAS AT THE MAIN ENTRANCE

Figure 85. Tiered pergolas along the campus' main walkway in 1924. Note the craftsmen inspired exposed rafters (Northwestern State University, Watson Memorial Library, Cammie G. Henry Research Center (Potpourri Yearbook)).

The proposed "Pergola Garden Room" will incorporate the pergola covered portion of the new walkway southwest of the NCPTT building (Figures 85 & 86). A brick plaza will adjoin the proposed concrete walkway under the shade and protection of the structure. The forty plus-foot long pergola will be tiered with the southern third taller than the northern two thirds like the historic examples. The roof will be solid for maximum shade and rain shelter as they were historically on campus. It will be constructed of tube steel and pressure treated lumber painted and/or stained black. The historic hedge row and new low shrub beds will border the plaza, and a live oak, Florida sugar maple, and Carolina silver bell tree will provide additional shade and interest. The plaza will include six benches. This mixed-use area will encourage interaction between passing students and NCPTT functions. The pergola will be discretely lit from within and two electroliers will light the plaza from its eastern edge. Underground electrical conduit should be run to the locations of all three new NCPTT signs, to both electroliers, and to the pergola early during the landscape installation.

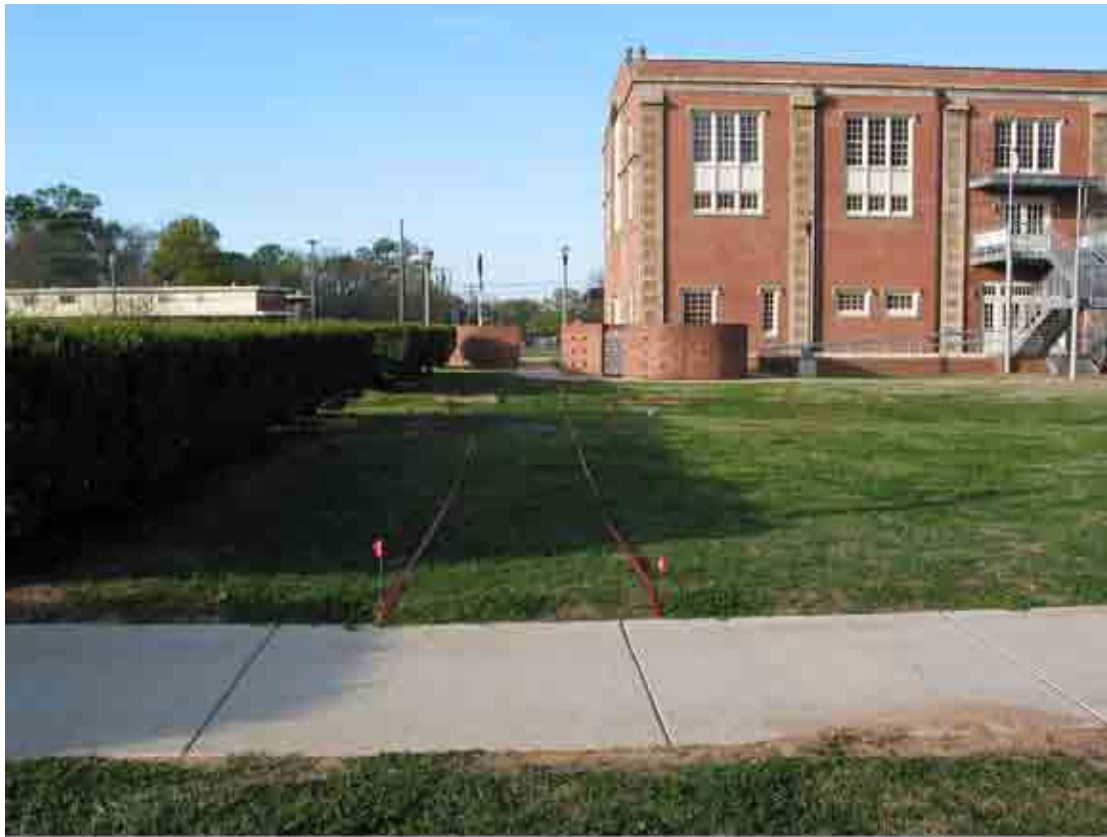
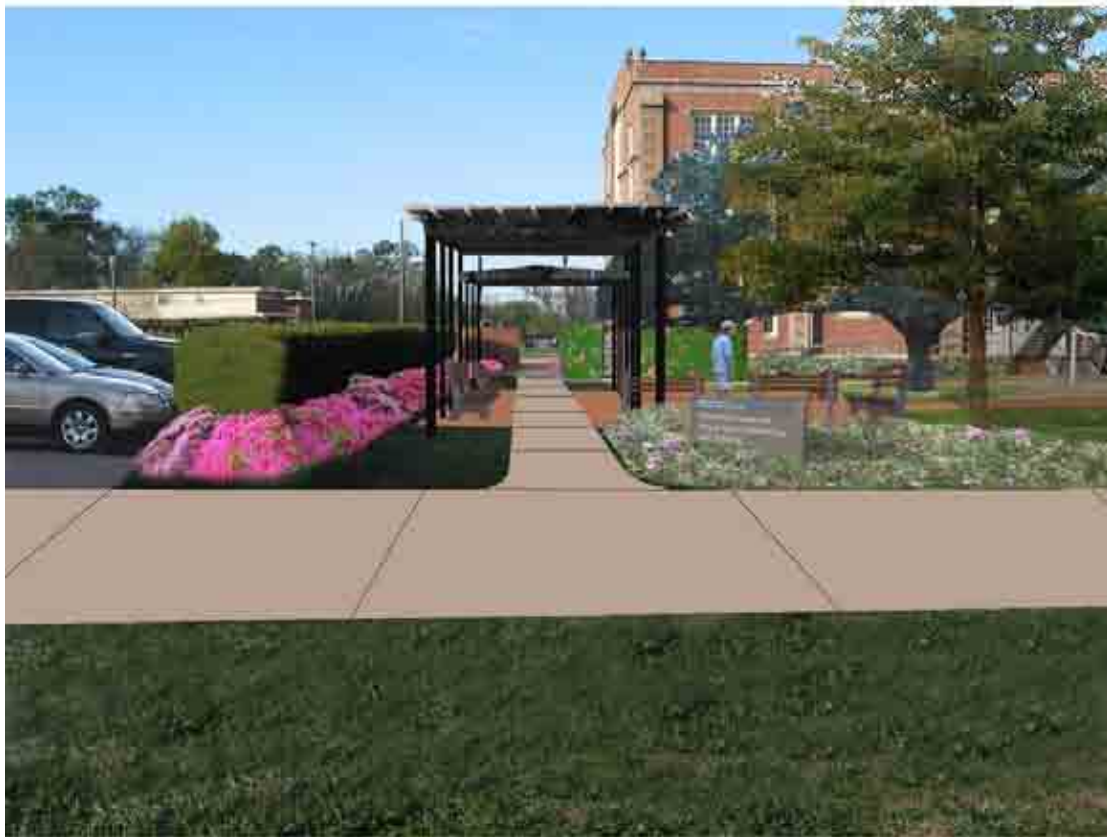
Figure 86. Top: NCPTT's existing south lawn, waxleaf privet hedge, and parking area, 2004 (OCLP). Bottom: Proposed new walkway to College Avenue lined by azaleas, Pergola Garden Room, and shade trees, 2004 (OCLP).

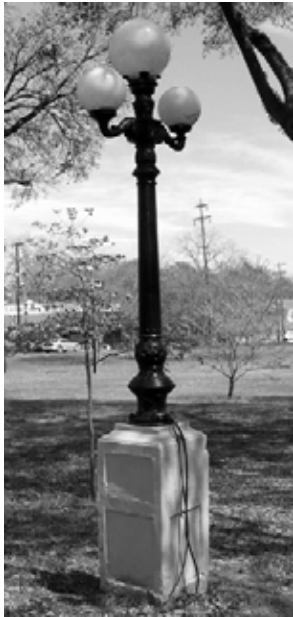
Select electroliers that match the existing historical (c. 1919) examples that remain near Northwestern State University's main gate. Quantity needed - 2

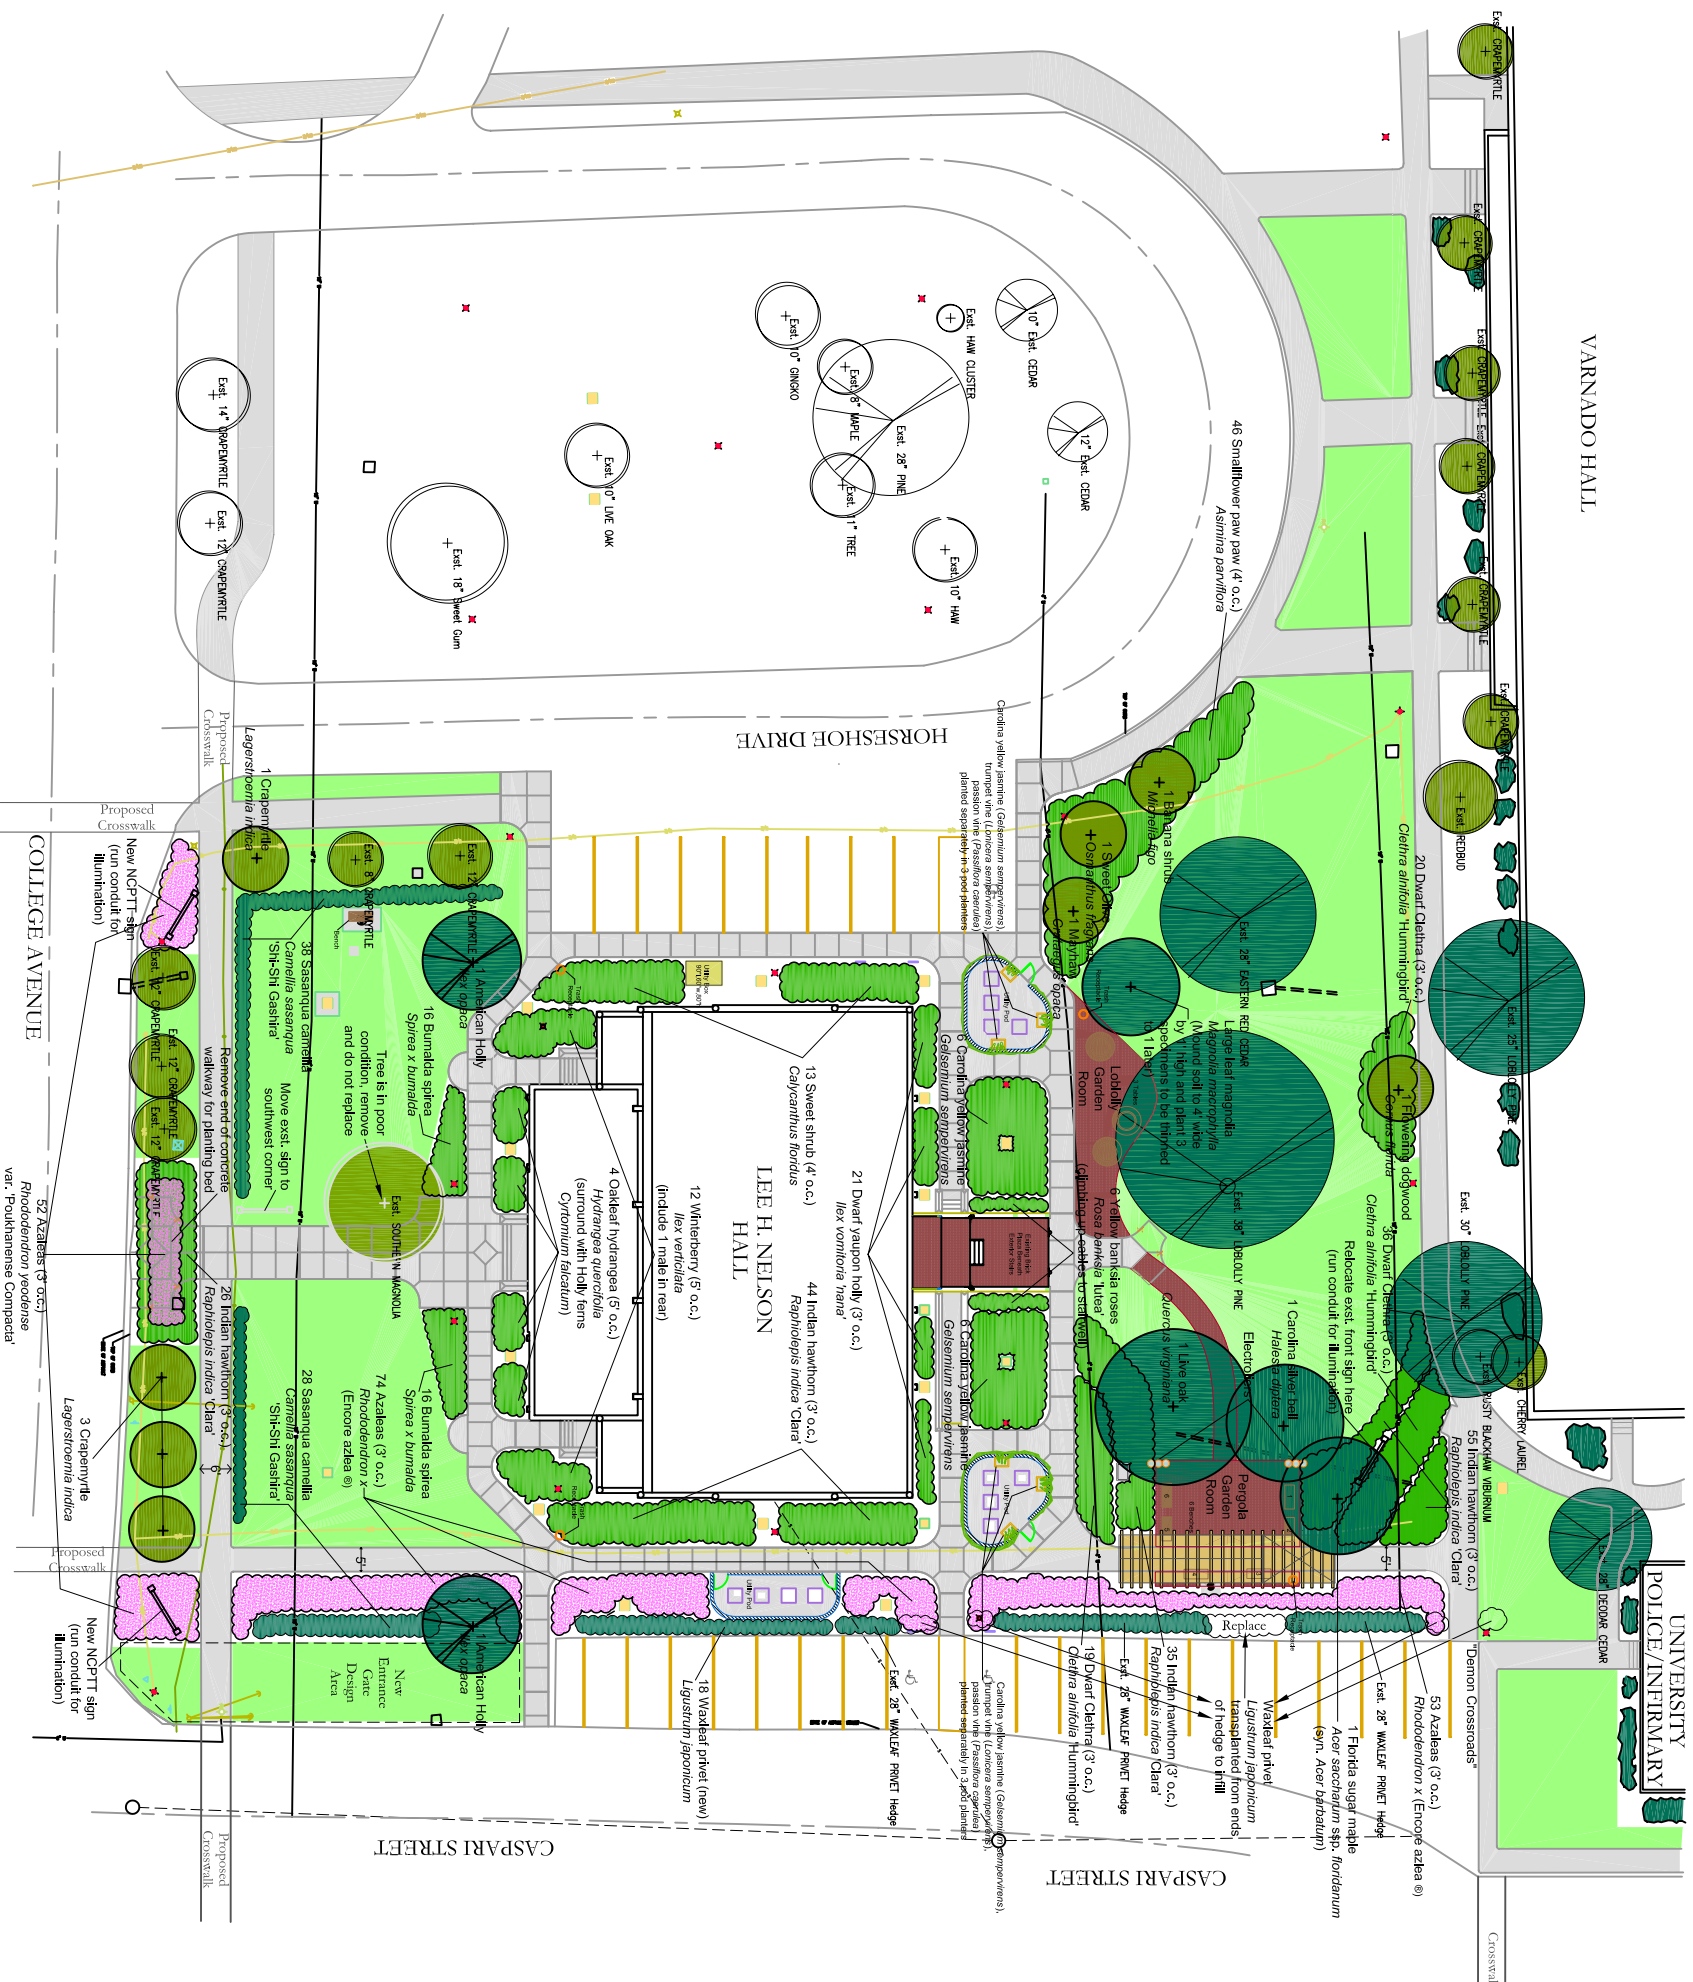
1. People design inspired by photographs of historic examples at NSU. To be constructed of tube steel and pressure treated lumber painted and/or stained black. Southern 1/3 portion will be slightly taller than the northern 2/3 like the historic examples.

7. Existing southern magnolia in front is not historic and is in poor condition. It should be removed without replacement.
8. According to 3 soil samples, the pH of the soil surrounding Nelson Hall averages 7.47 (slightly alkaline or basic). Most ornamental plants of Louisiana prefer a slightly acidic pH of 6.0 with azaleas preferring a range of 4.5 - 6.0. In general add 1.5 lbs. of ground elemental sulfur per 100 sq. ft. of garden space to lower the pH by 1/2 point, so in total add 4.5 pounds of ground sulfur per 100 square feet to lower the pH from 7.47 to 6.0.

The treatment plan is synthesized from the chronological site history, the existing conditions, and the evaluation of the significance and integrity of the landscape presented within this report. Four sheets are presented (Figures 88-91). The plan is not a construction document, but rather a detailed, planting plan. NCPTT will have construction drawings prepared by a licensed architect and will contract out construction including the irrigation system.
