Third International Symposium of Historic Preservation on Puerto Rico and the Caribbean

May 9-13, 1994
San Juan, Puerto Rico

LECTURES

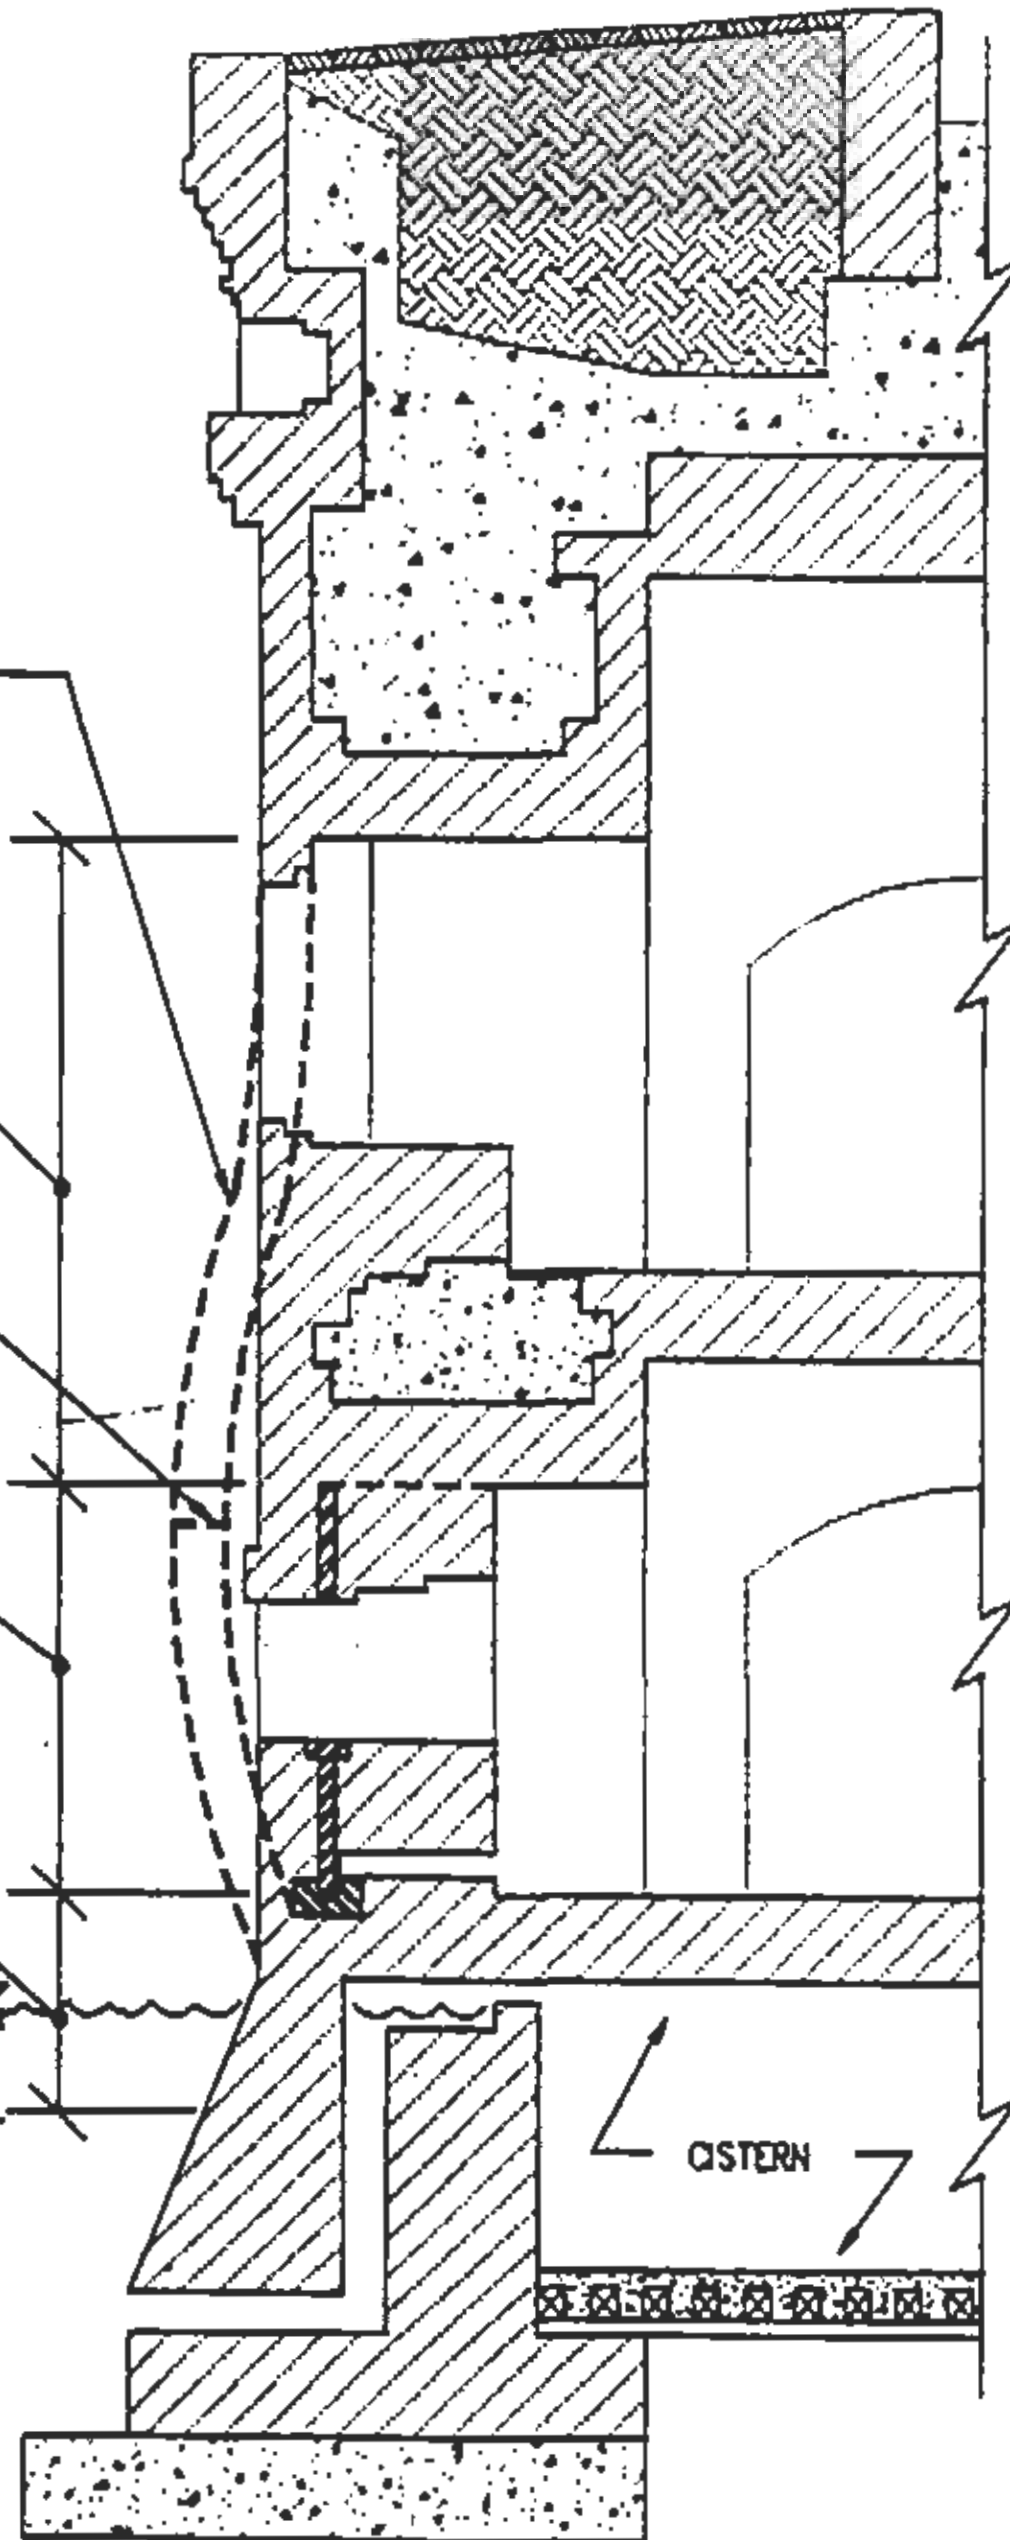
**SCHEMATIC SECTION THROUGH SCARP WALL
① EMBRASURE OPENING CATEGORIES 1 TO 3**

OPEN HORIZONTAL JOINT
WHICH PRECEDES FAILURE,
PRESENT AT CATEGORY 1
EMBRASURES.

ZONE OF EMBRASURE IRON
EXPANSION. LOCALIZED
FAILURE OF BRICK • SHUTTER
ANCHORAGE. EXPANSIVE FORCE
OF IRON PUSHES OUT FACE
BRICK. BULGING SPREADS
BEYOND OPENINGS, VERTICALLY
& HORIZONTALLY.

TIDAL ZONE OF SEVERE MORTAR
LOSS & BRICK DETERIORATION.
BRICKS TEND TO ROTATE
OUTWARD DUE TO MORTAR LOSS,
INDEPENDENT OF EMBRASURE
IRON CONDITION.

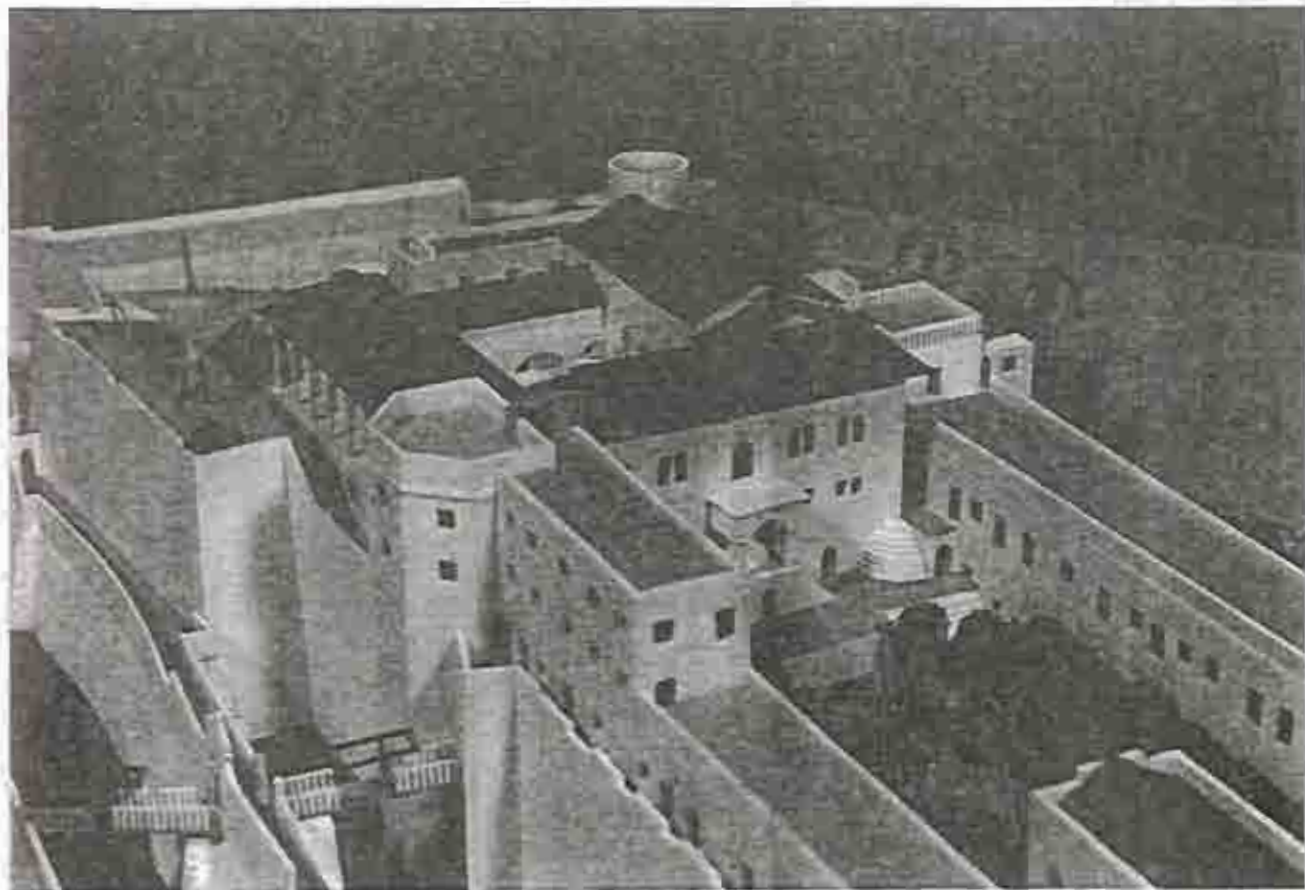
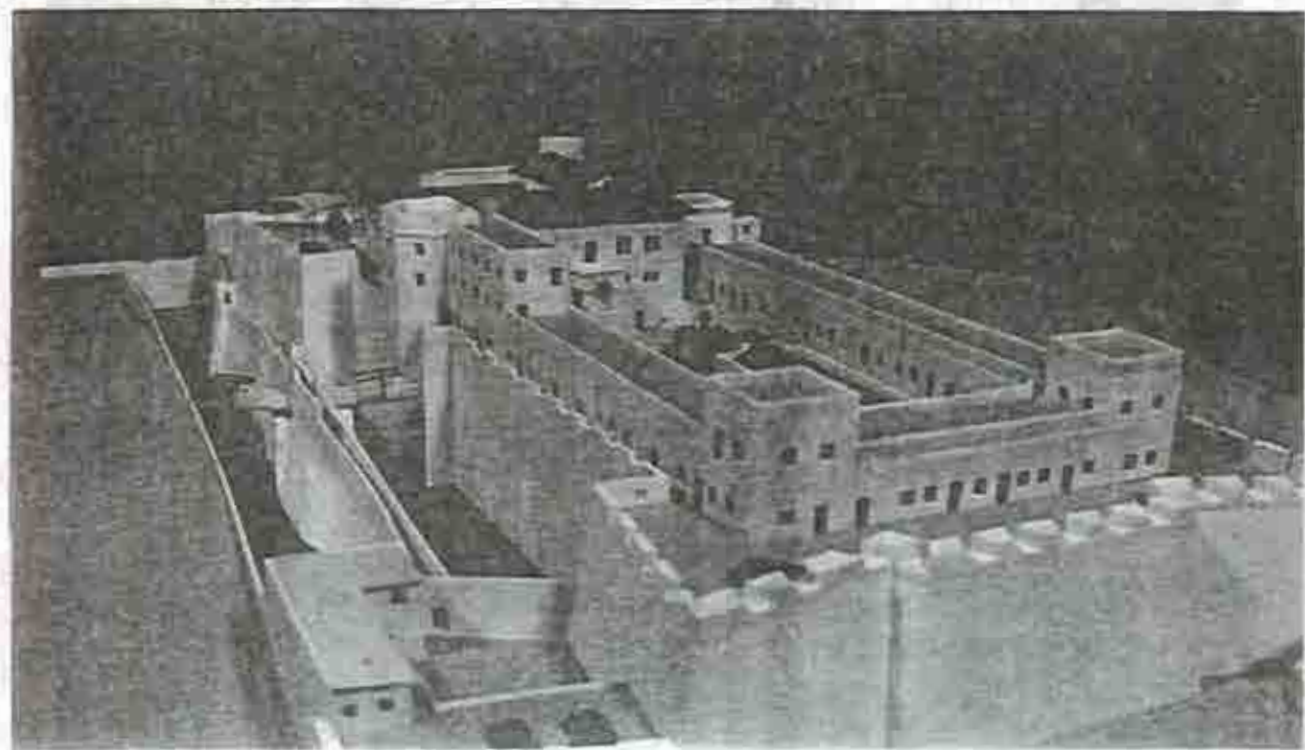
Castle St George d'Elmina

Restoration-proposal by A.K. Joustra & D.L. Six, 1989

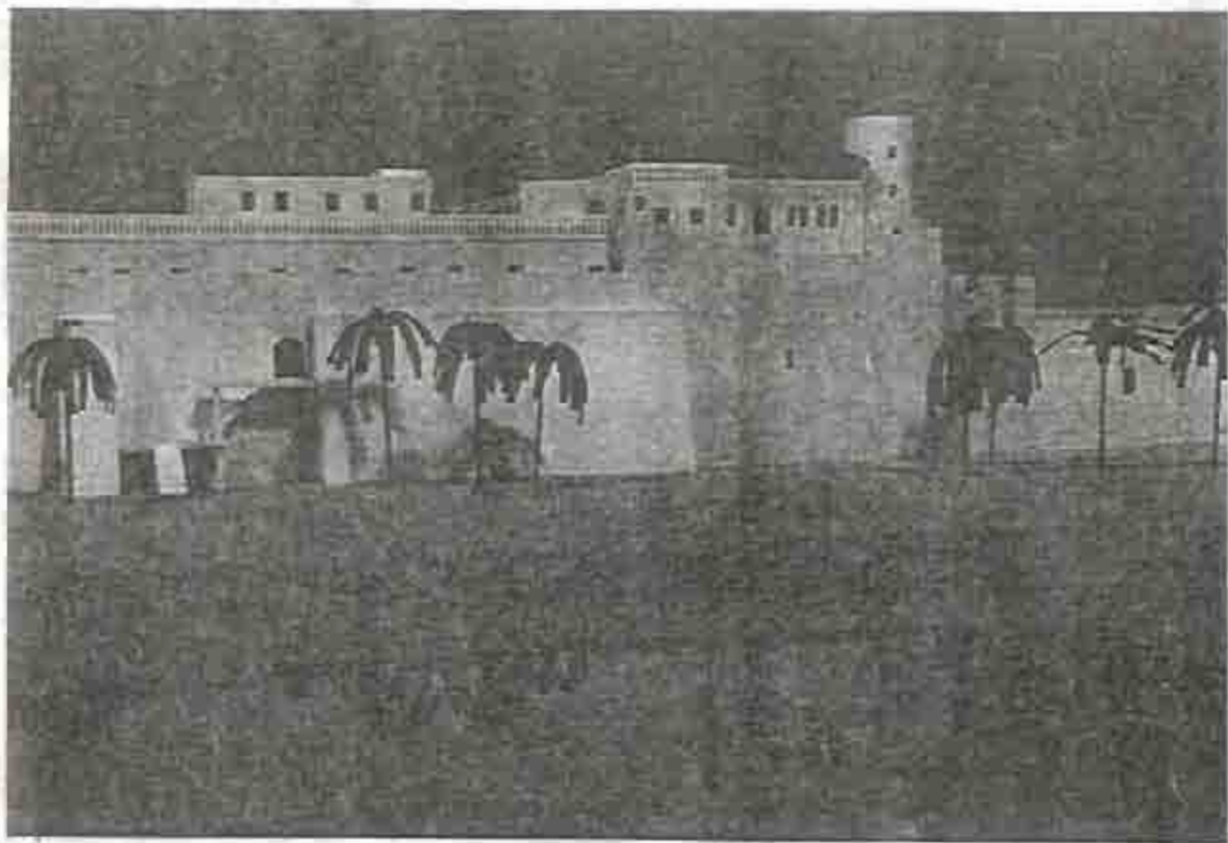
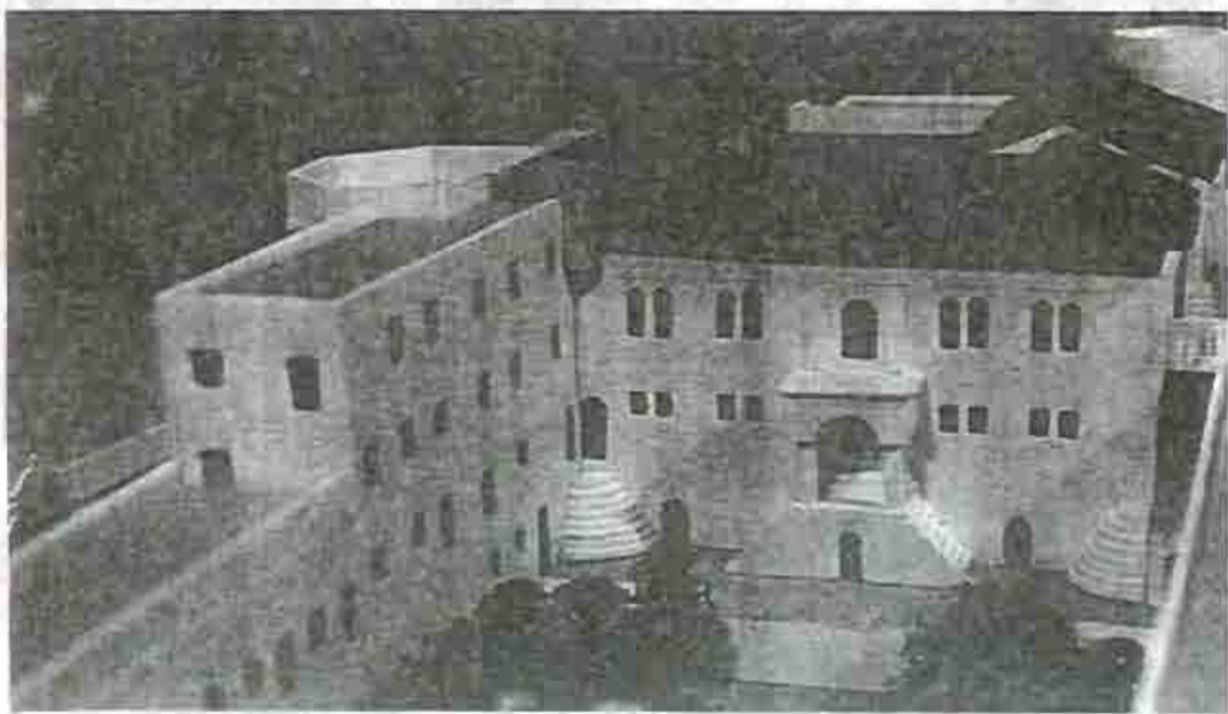
Castle St George d'Elmina

Restauration-proposal by A.K. Joustra & D.L. Six, 1989

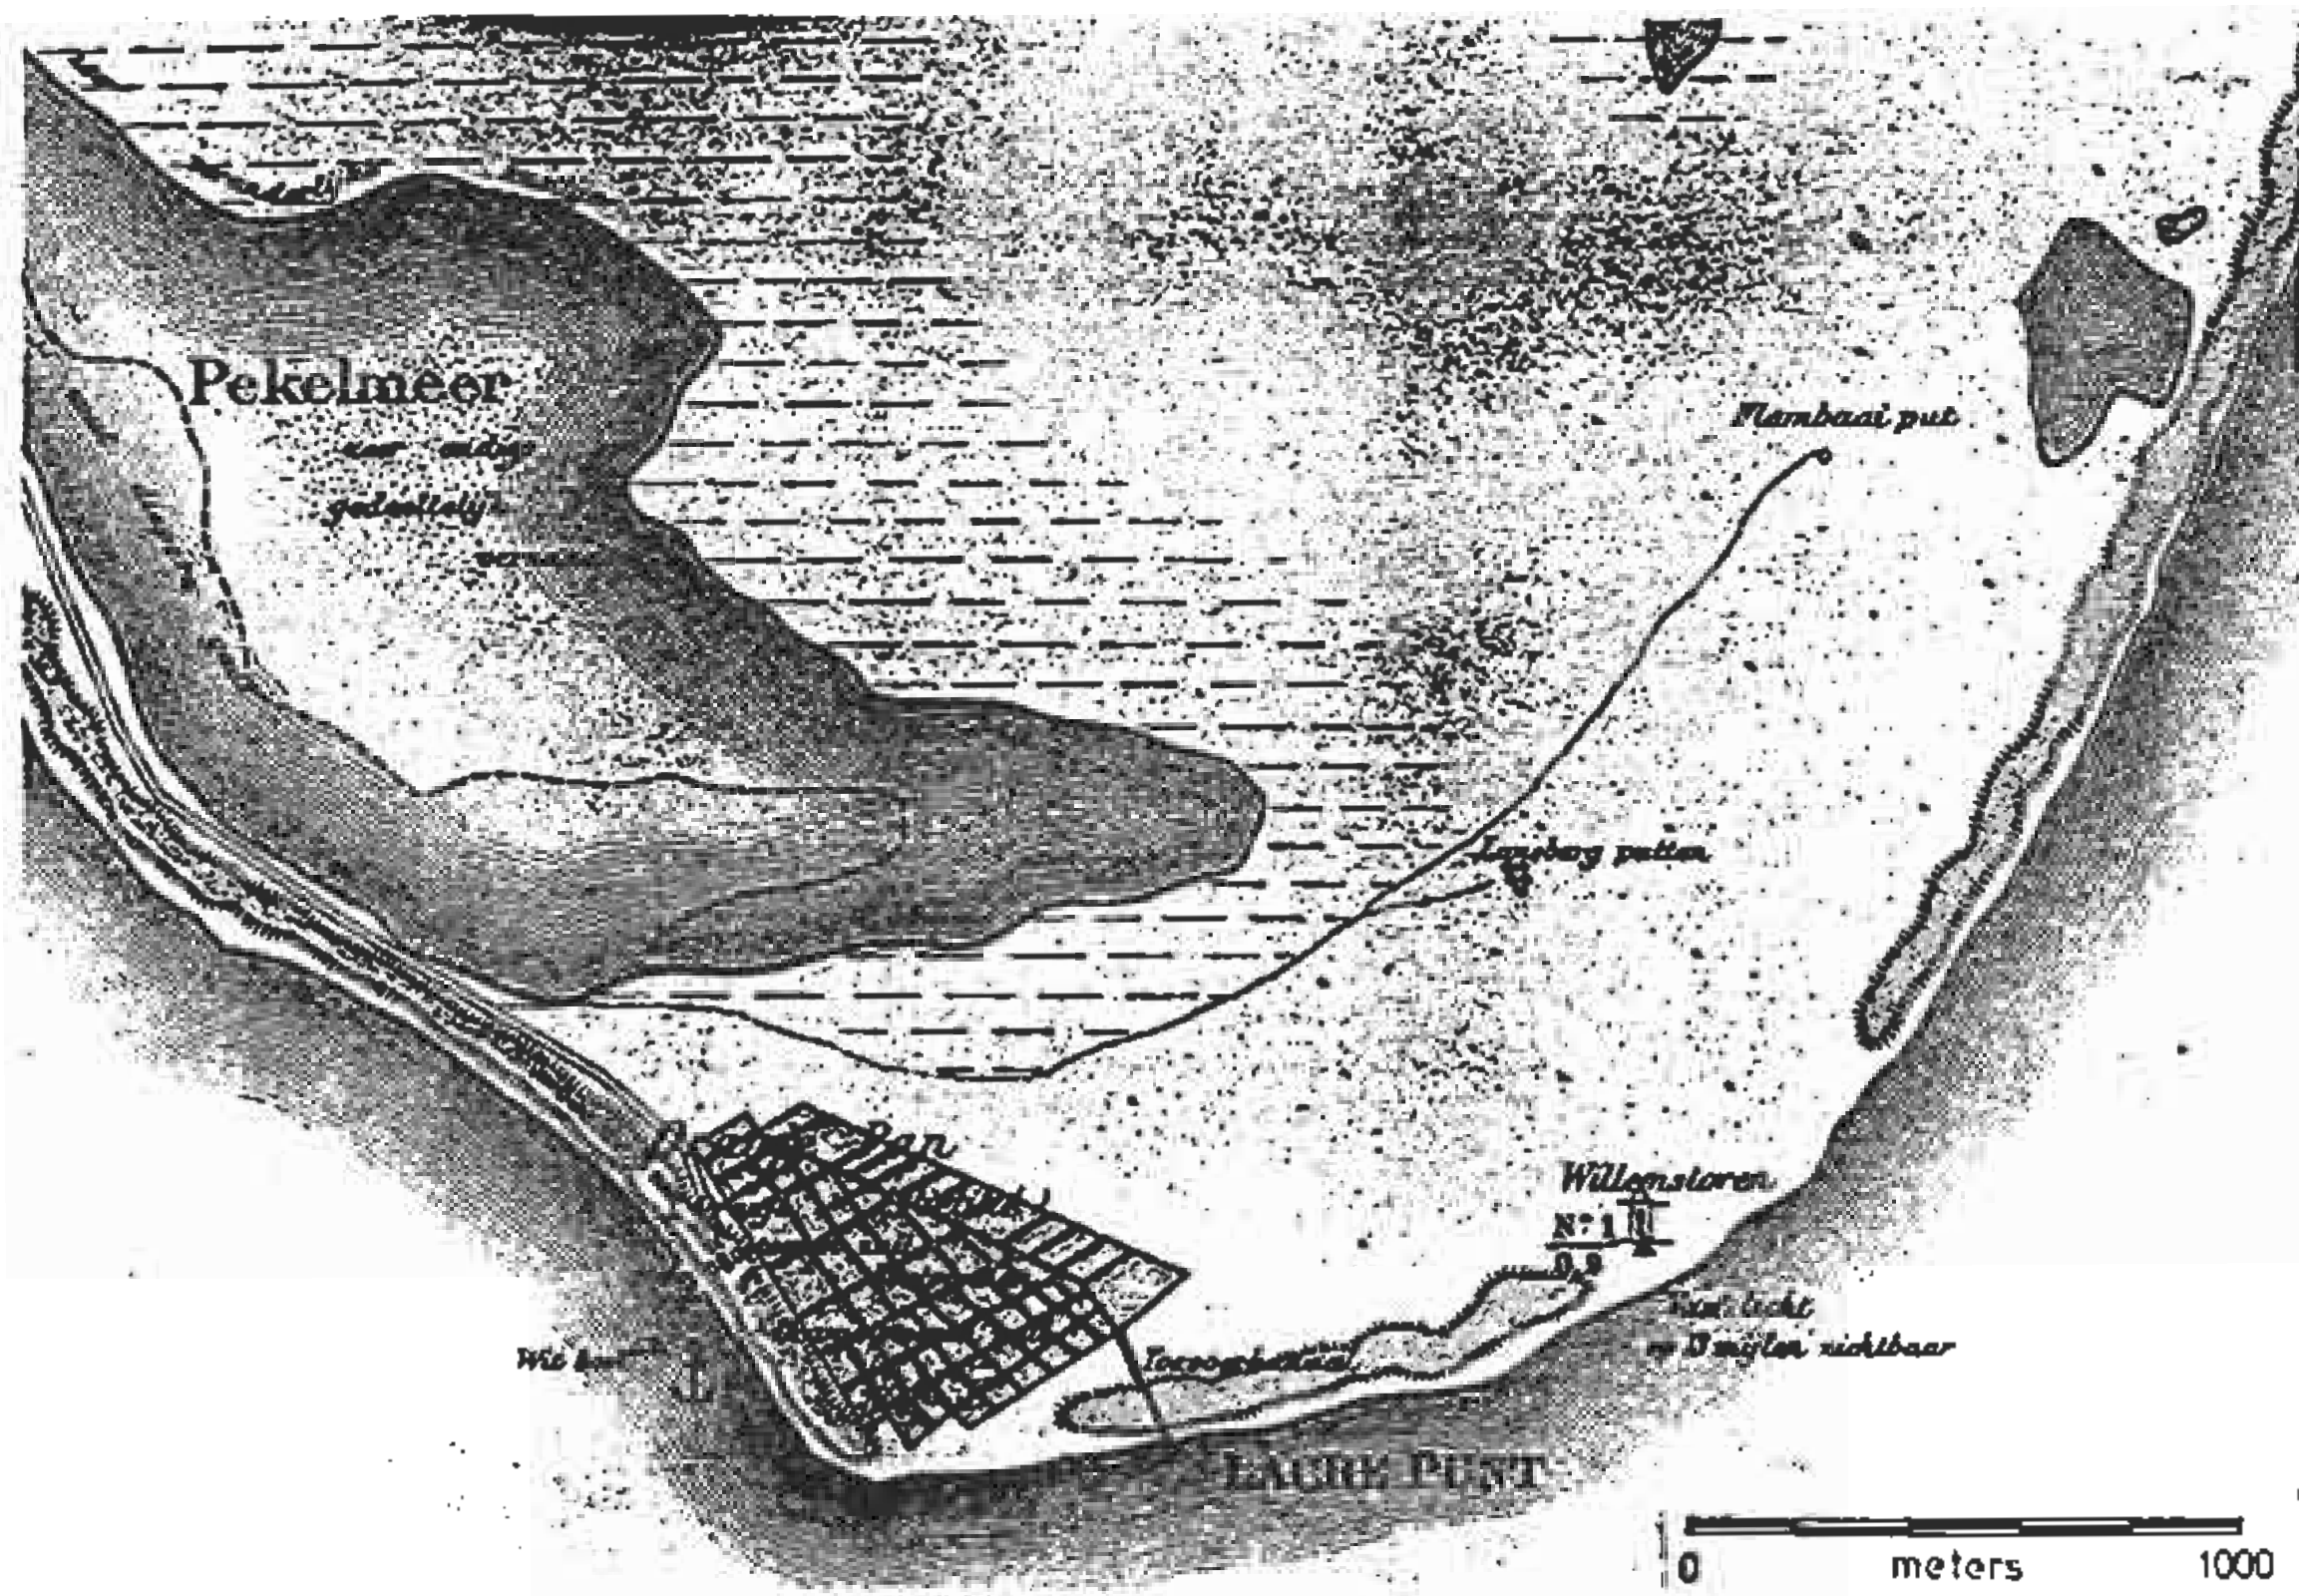
5

Model
van den opterigten Vuur-toren
op de Zuid-Oost punt van
het Eiland
Bonaire.

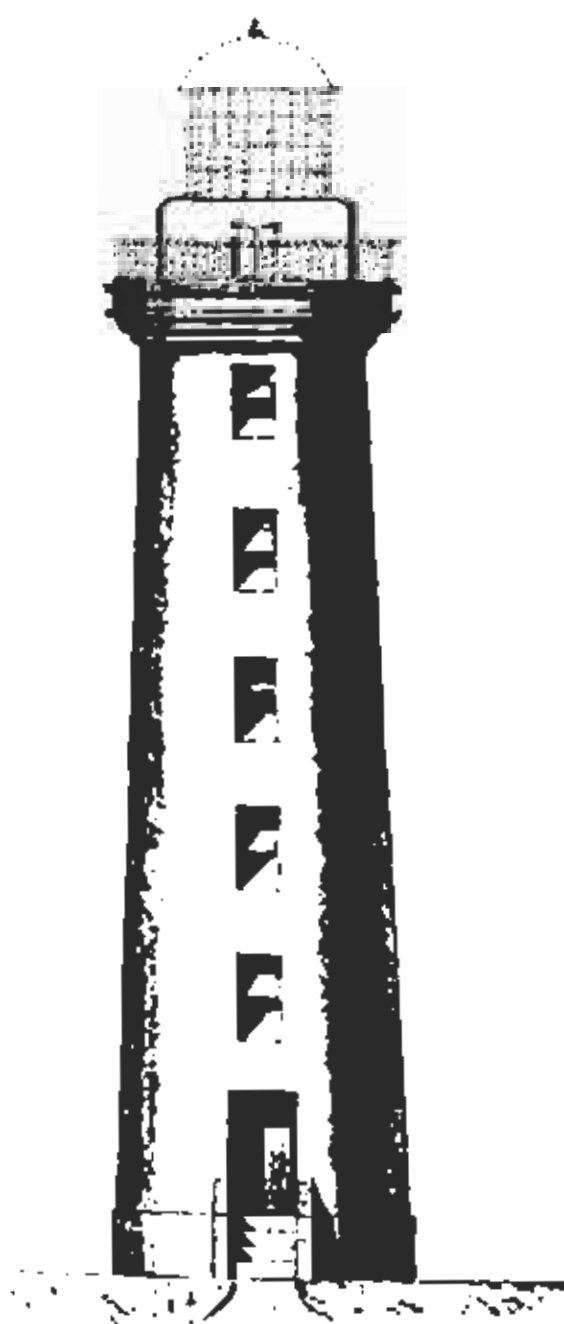
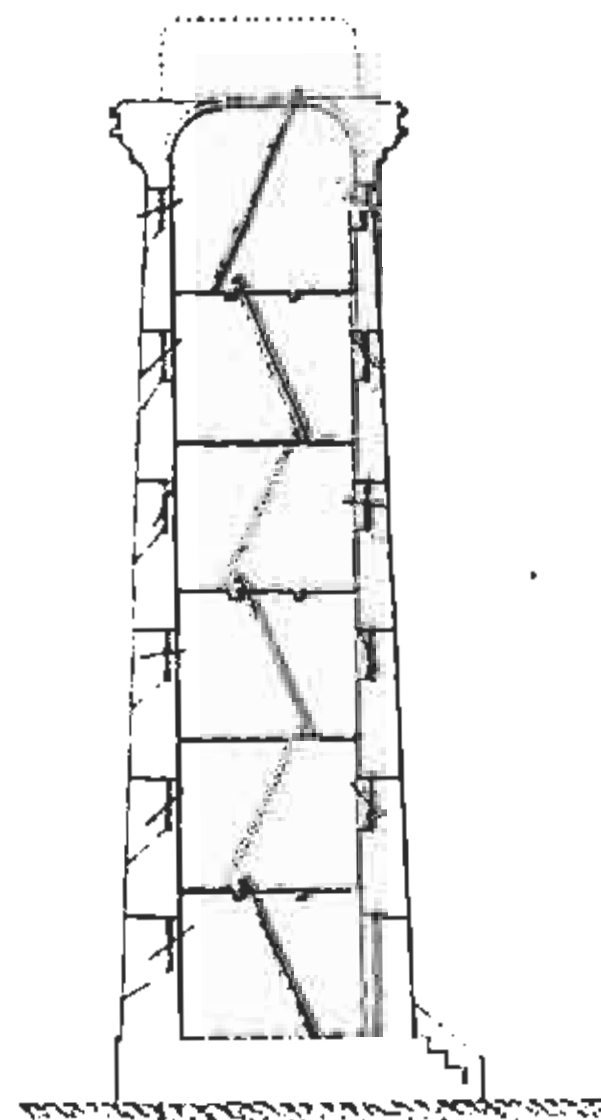
6

Model van een vuurtoren
op den Zuid-Oostpunt van
het Eiland Bonaire.

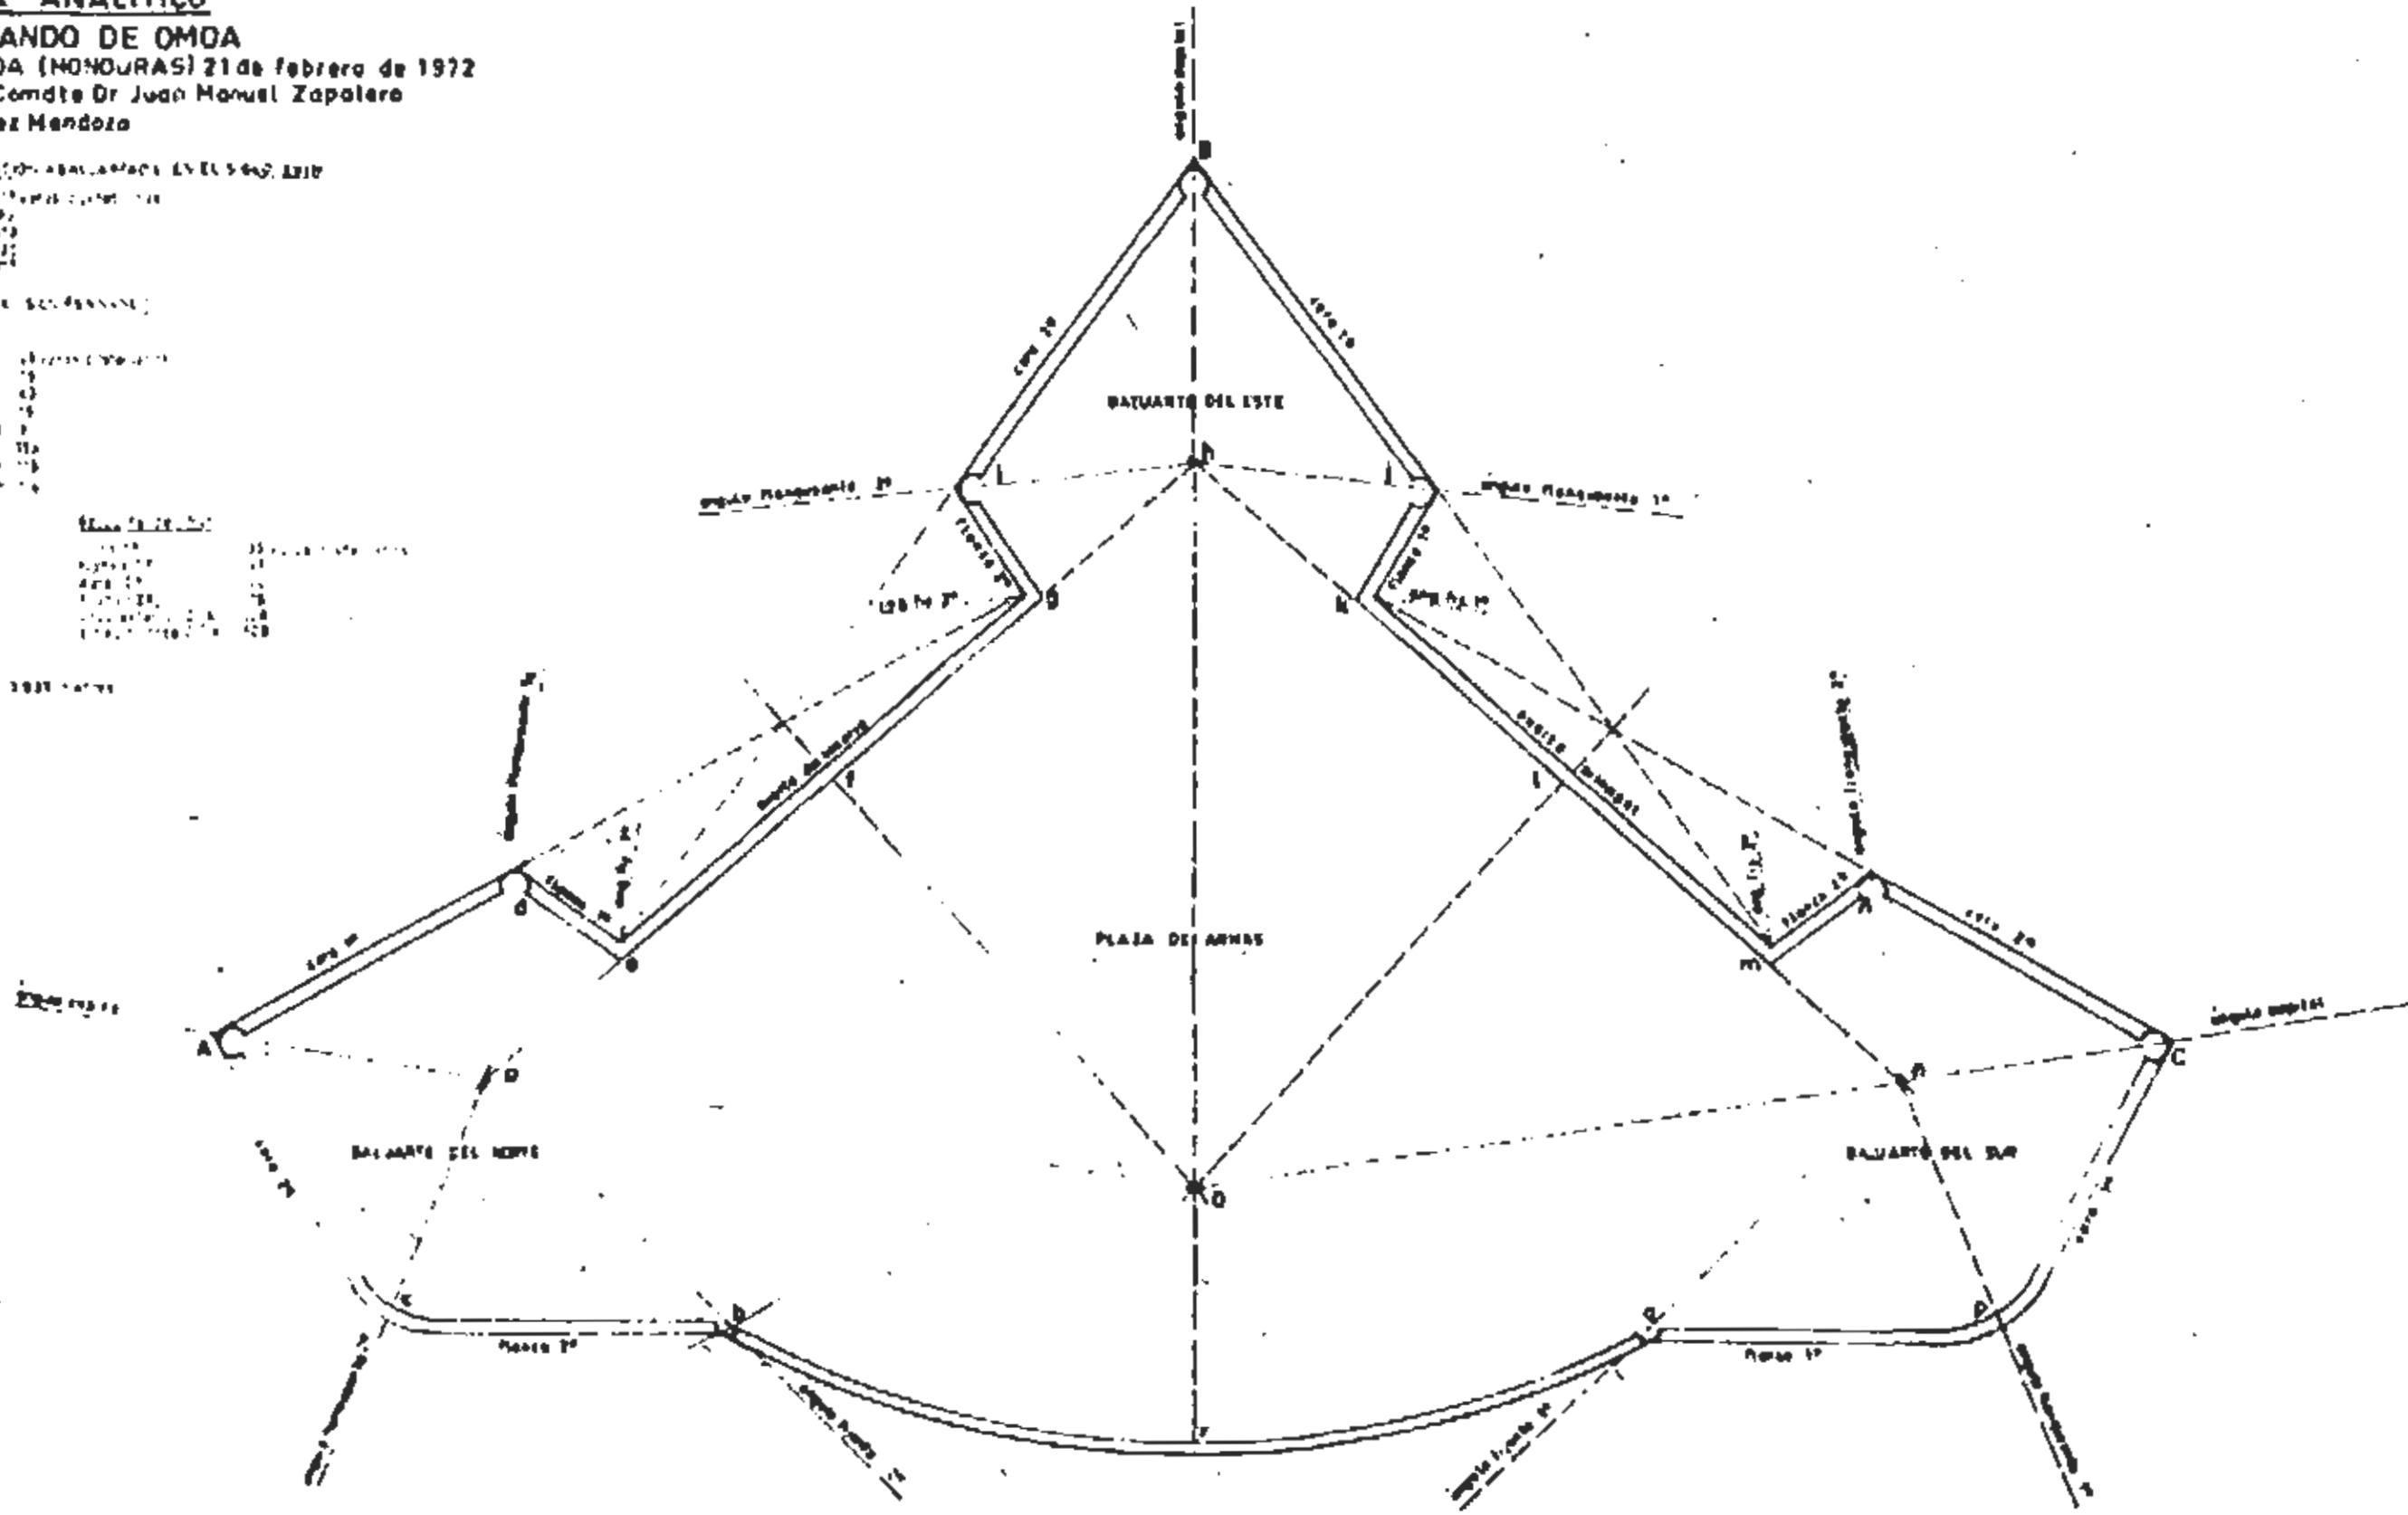
PLANO RECTOR 1,2
FUERTE SAN FERNANDO DE OMOA

PLANTA SUPERIOR
 SAN FERNANDO DE OMOA (HONDURAS) 21 de febrero de 1972
 Asesor Histórico Militar, Comdte Dr Juan Manuel Zapalero
 Delimitante José Domínguez Mendoza

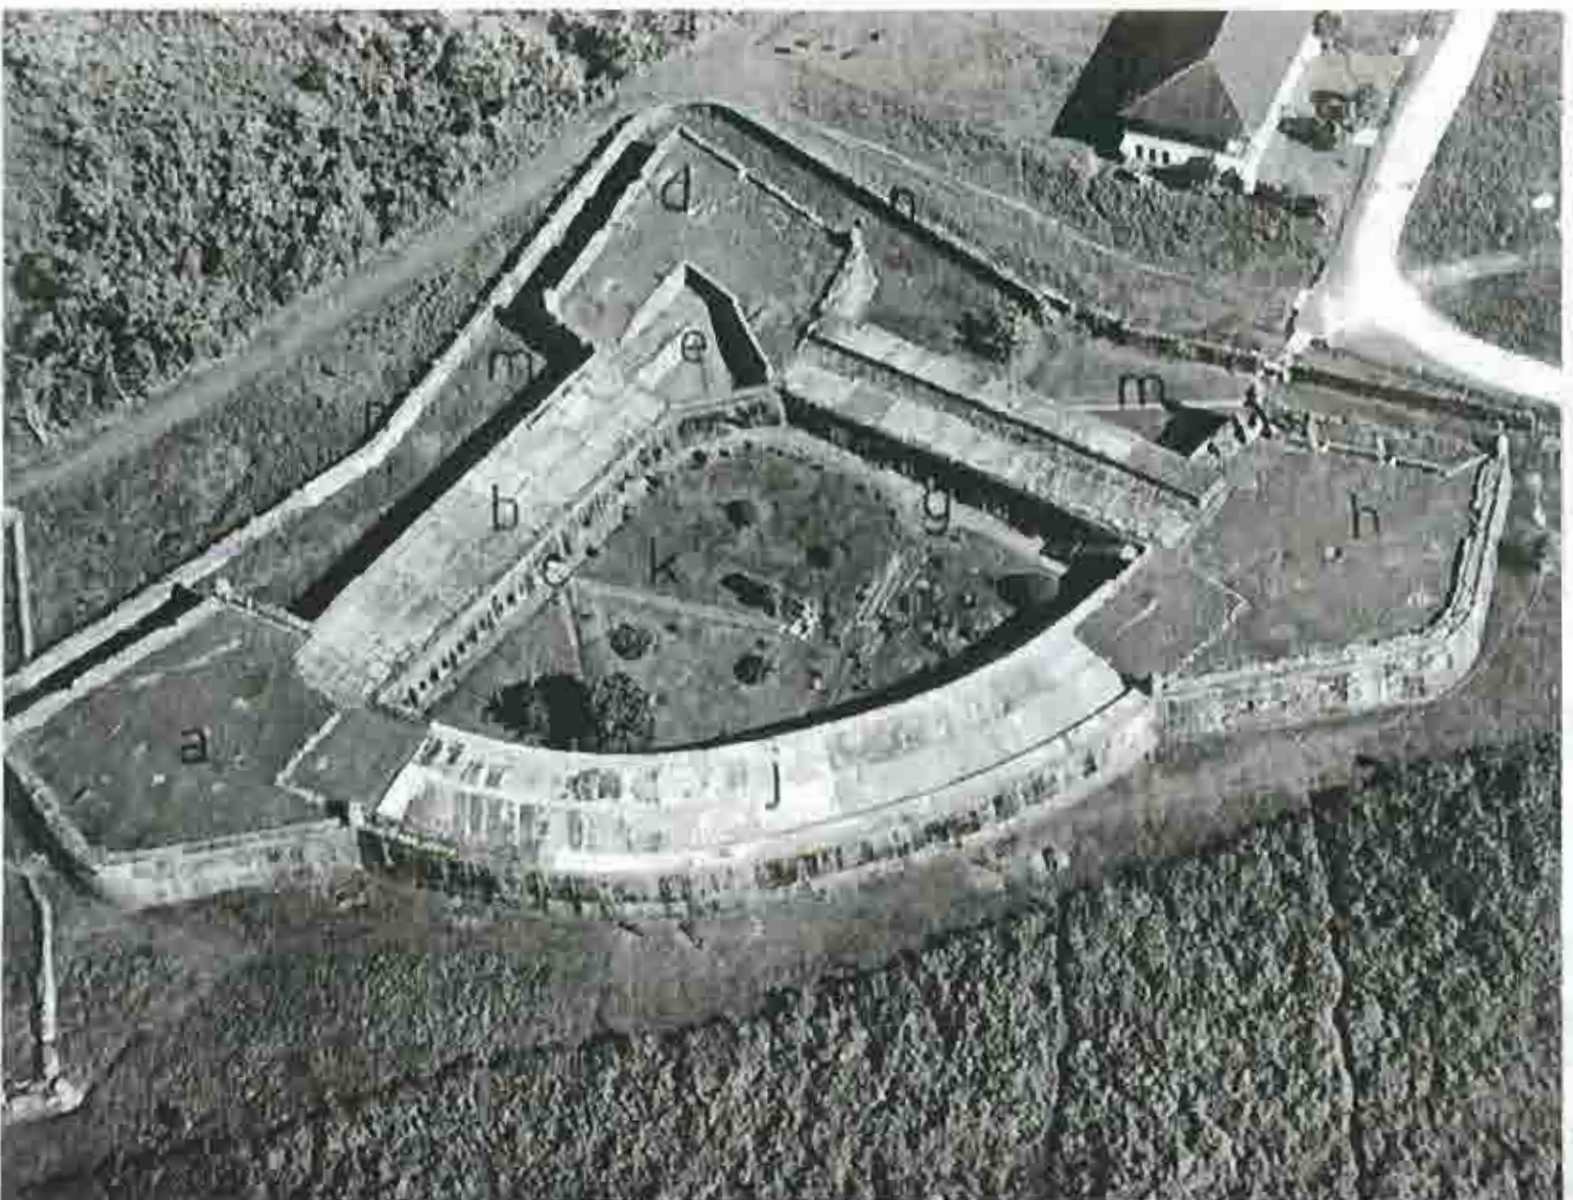
"ESCENOGRAFIA"

"Escenografía" del Fuerte San Ferrnando de Ormo (Honduras), construido segn el proyecto 15 Diciembre de 1756. La vista fue tomada por J. R. Schauer, San Pedro de Sula, durante los "Reconocimientos" y "Estudio Asesor para la Restauración", hechos por el autor de esta Comunicacin.
