Seacoast Fortifications Preservation Manual

Golden Gate National Recreation Area
San Francisco, California

National Park Service and KEA Environmental
Golden Gate National Recreation Area
San Francisco, California

July 1999

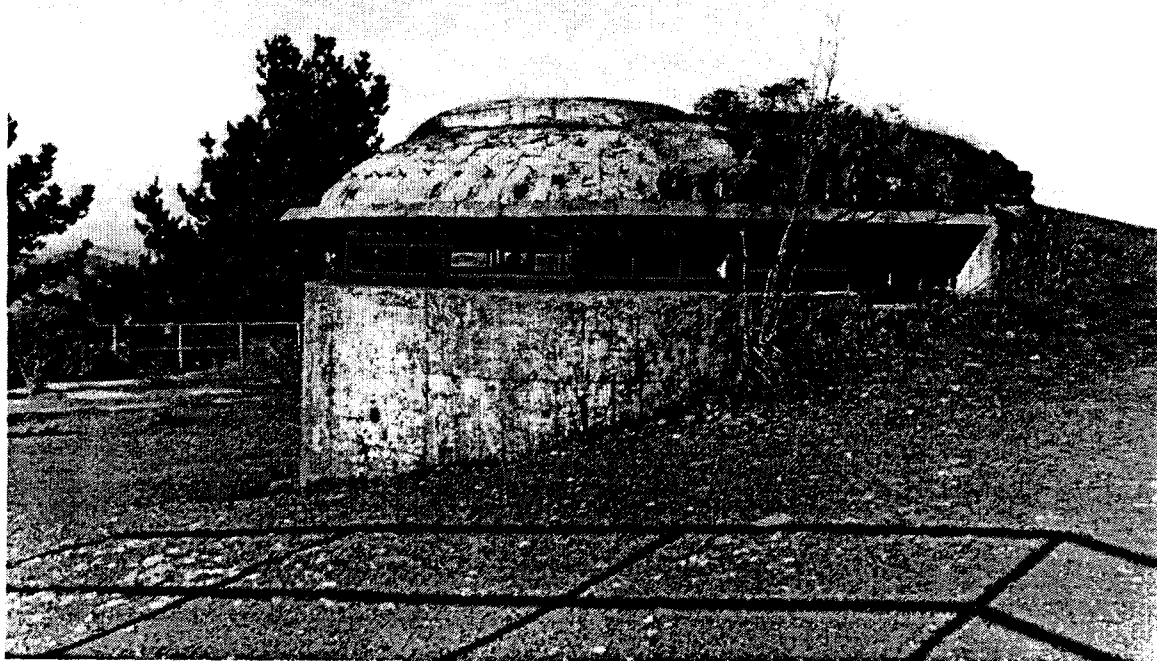
Plate 3. BC Station, Battery Construction #129, Fort Barry, constructed 1942-1944. Looking east.

Explorations in the immediate proximity of a battery can yield not just a better understanding of the primary structure, but also of its important ancillaries. For World War II Battery Construction #129 within Fort Baker, a battery commander's station gives a clear sense of the role of the observation post, half-buried, with its viewshed framed by a bunker-like horizontal, panoramic opening. And when one comes upon Battery Wallace, one is stopped, as one is always stopped, by the graphic announcement of a formal name and date of construction: *Battery Wallace 1942*. As is often true when we confront the painted signage and imagery added to the equipment of war, from aircraft to the command blockhouses controlling missiles, we are pulled back into the past through specificity (Plates 3 and 4). We preserve coast defenses, then, so that we may allow future generations to see and touch the past.

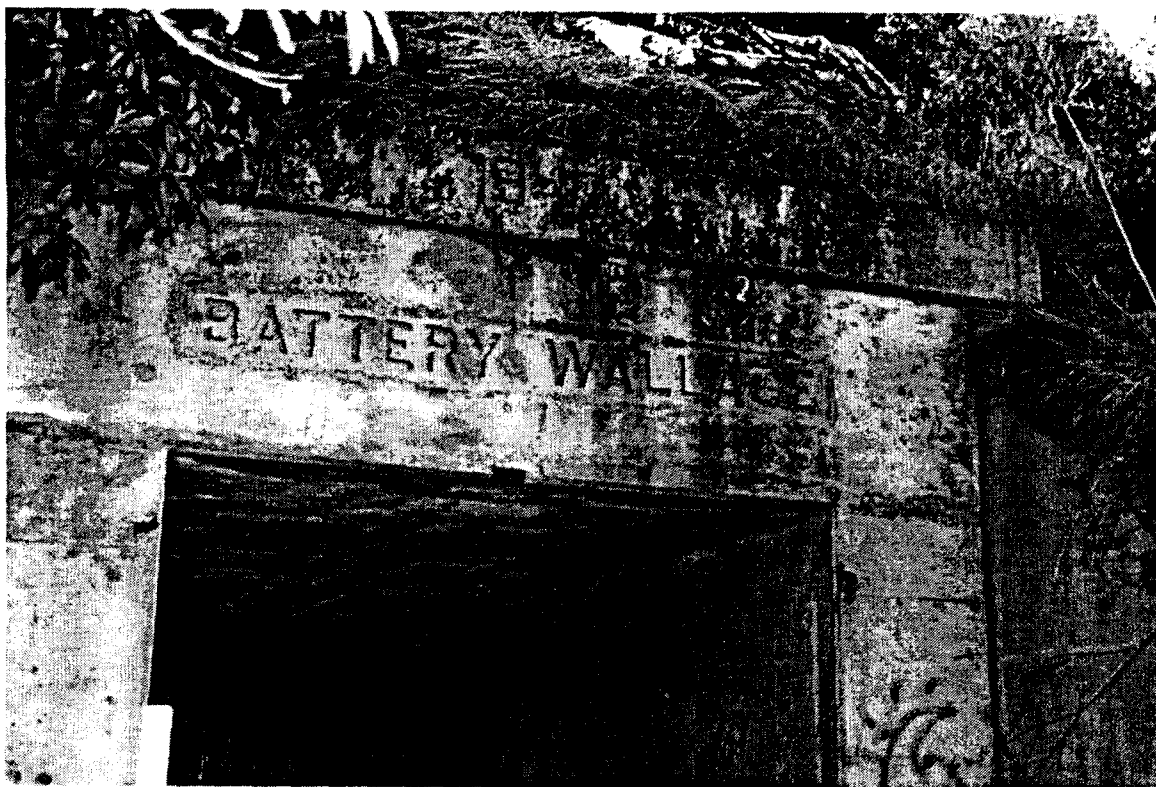
Plate 4. Battery Wallace, Fort Barry, constructed 1917-1921. With casemating of its two guns in 1942-1943. Emplacement entry.

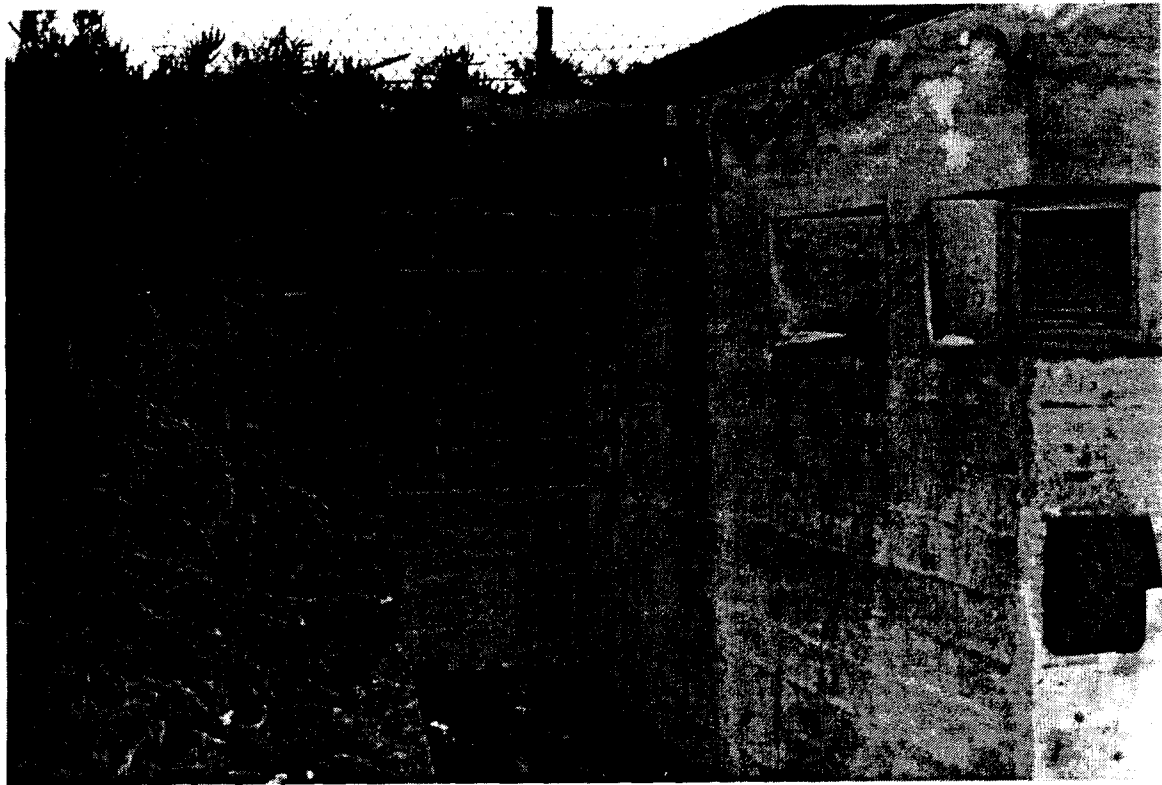
Plate 7. Battery Stotsenburg-McKinnon, Fort Winfield Scott, constructed 1897-1898. Blackboard racks at data booth.

Mr. Hansen noted, like civil engineers of the early twentieth century, that batteries were much like ships—they really were never finished, demanding continuous maintenance and improvements. The earthen embankments immediate to the batteries protected the fortifications, deflecting projectiles away from the installations. As cannon adapted to the disappearing carriage, Army engineers developed mechanisms to load the guns behind walls and then raise them to fire. The resulting batteries had two stories, the upper area open behind walls, and the lower fully enclosed as rooms. Such a design also required hoisting heavy and dangerous ammunition from a low point upwards, making clear just how the physical form of the battery would always be subservient to ordnance. In other cases, barbette carriages did not require the crested upper wall design, and thus also affected experimentation with placement of the ammunition magazines on a more nearly equal level to the guns. Over time batteries tended to become larger, with individual emplacements separated within single installations and with batteries increasingly spread out across the coastal terrain. Less dramatic, engineering efforts also attacked problems of water percolation through the porous concrete; varieties of deliberate plantings immediate to the installations; and, methods of blending the batteries into their hosting land forms. And in all cases, Army procedure dictated how the post would be commanded. Such procedure also changed over the decades and is reflected today in the nearly archeological remnants of items like the turn of the century blackboard racks in the data booth at Battery Stotsenburg-McKinnon (Plate 7).

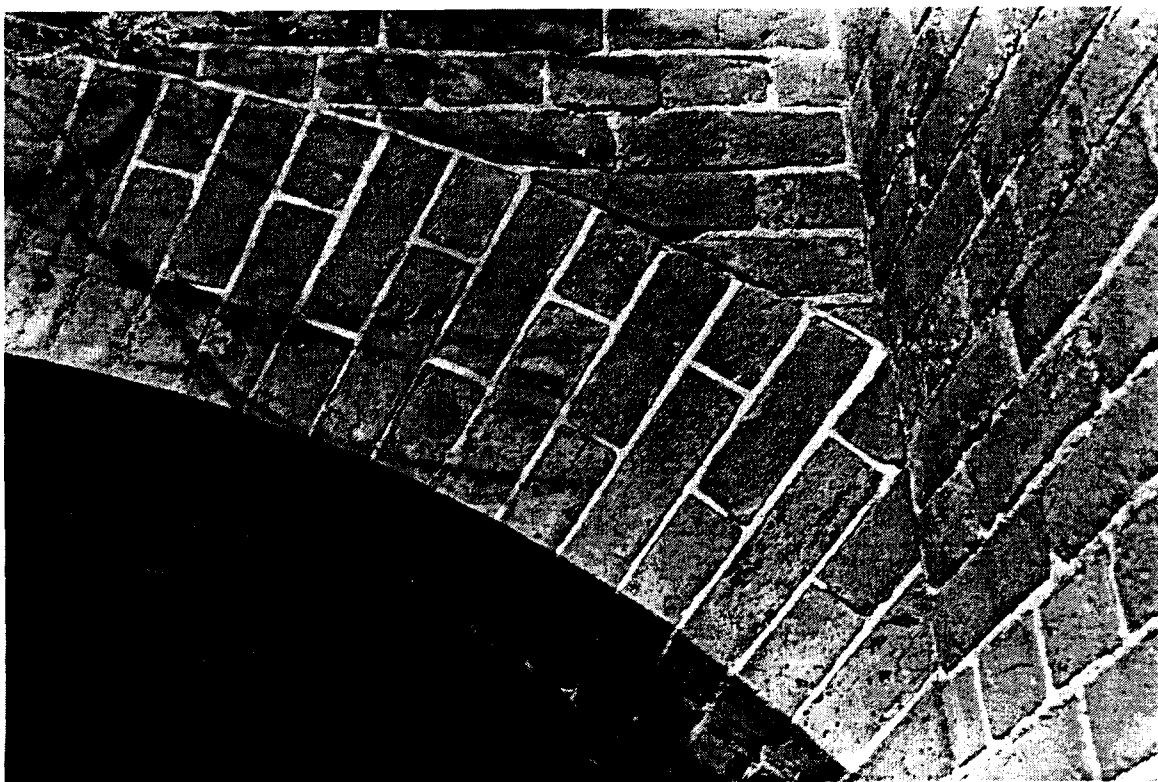
Plate 11. The quality of brickwork in the surviving elements of the 1870s is very high, reflecting both the careful selection of materials as well as the skill of the masons. Cavallo Battery.

The brickwork in this period formed the round-arched passageways that connected different portions of the defenses. Exposed arch faces were made of common brick that was not sanded to shape; mortar joints were tapered instead. The craftsmanship was at a level equal to other well-built masonry structures, and it has contributed to the generally excellent condition still apparent today (Plate 11). There was little stone. At Cavallo Battery, lintels and sills were of cut granite set into the brick walls. East Battery contains an indicator of things to come. The groin formed by the intersection of two galleries is rendered in concrete, not brick. It is a limited application of the material, and early evidence that concrete was considered simple to fashion into complex shapes, more economical than brick and requiring less skill.

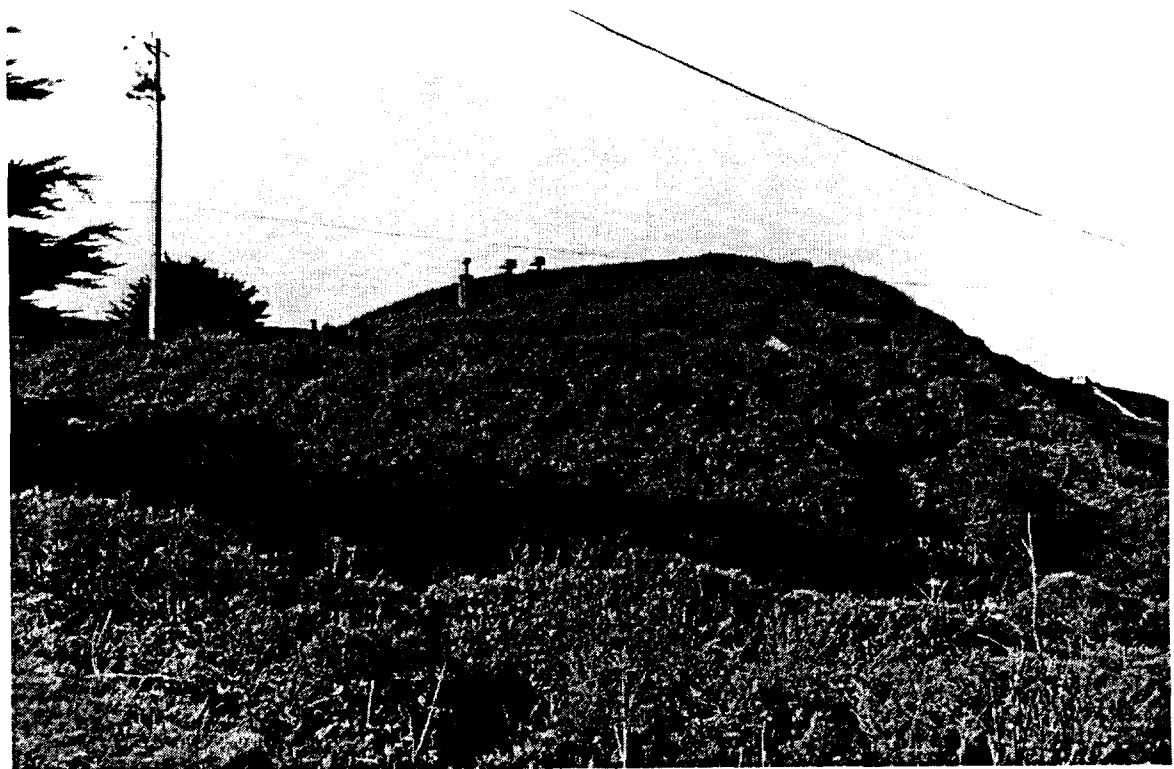
Plate 13. Earth remained a constant in the fortifications built after the Civil War. Here at the Fort Barry mine casemate, it covered a modern structure of reinforced concrete, rendering that structure invisible to eyes that might view it from the sea or the air.

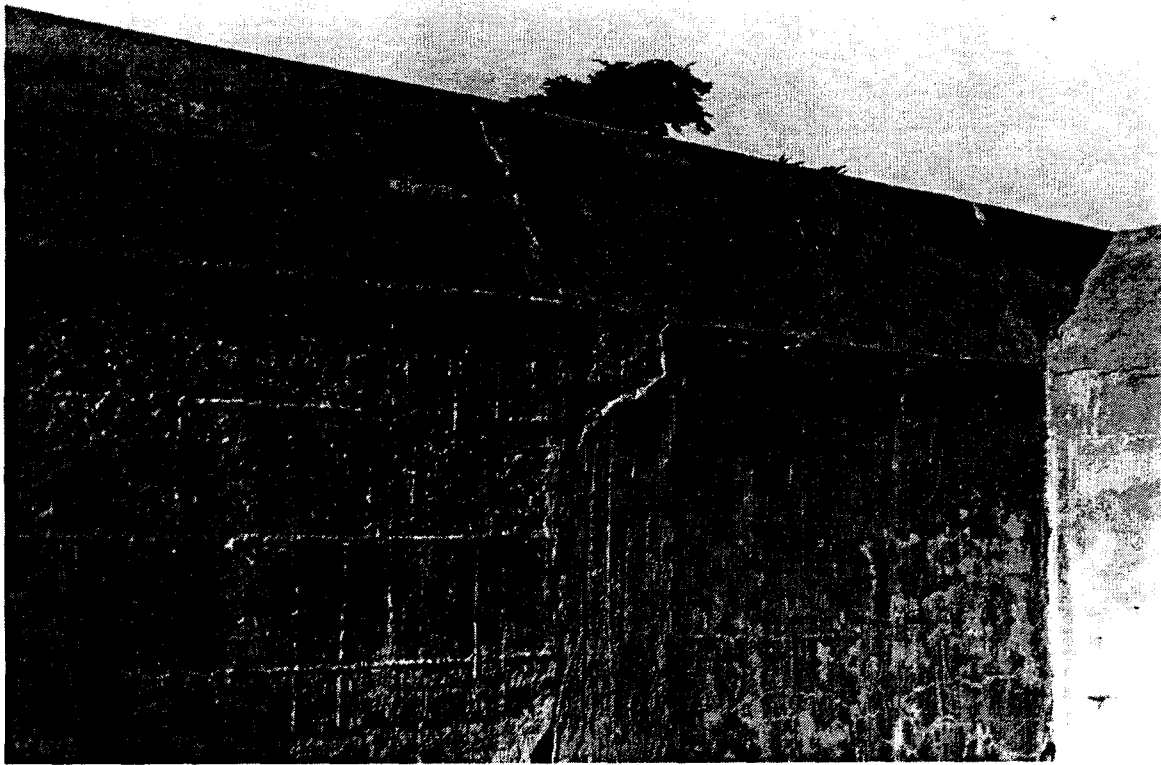
Plate 14. Concrete often retains evidence of how it was placed and finished. Different methods can still be seen today, and are expressions of building history. Battery Marcus Miller.

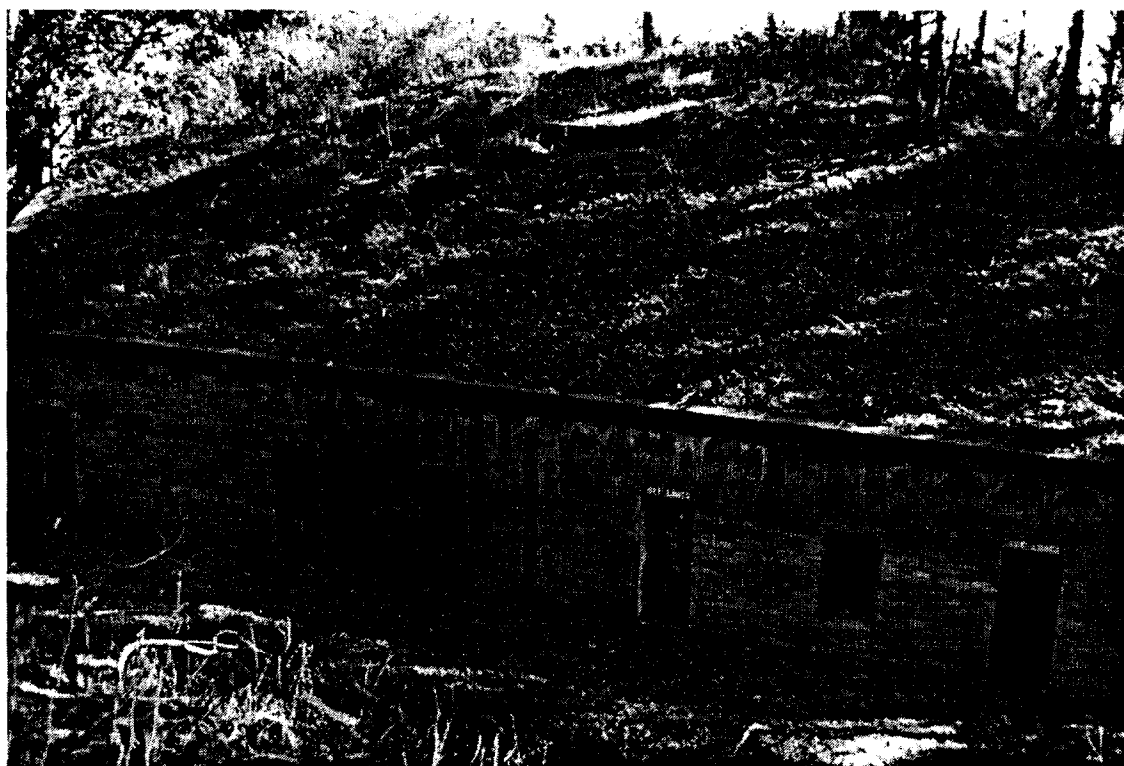
Plate 26. Battery Duncan. Rear of traverse showing fenestration, ladder to BC station, and BC station (overgrown at top of elevation).

quick appearance of hairline cracking. Workers created a smooth concrete surface by using tongue-and-groove flooring boards as the final exterior formwork. They then troweled on a two-inch thick layer of concrete mixed with fine gravel and sand. The surface gravel-concrete layer replaced plasterwork, and was finished with a cement wash tinted with lampblack to dull and darken concrete's generic lightness against the landscape.¹⁶ At Battery Duncan, set high on an isolated red-rock knoll at Fort Baker, the Army went to further extremes to blend the installation with the surrounding land form. Here the walls were visible at a distance, and were deliberately tinted red.¹⁷ (Plate 26)

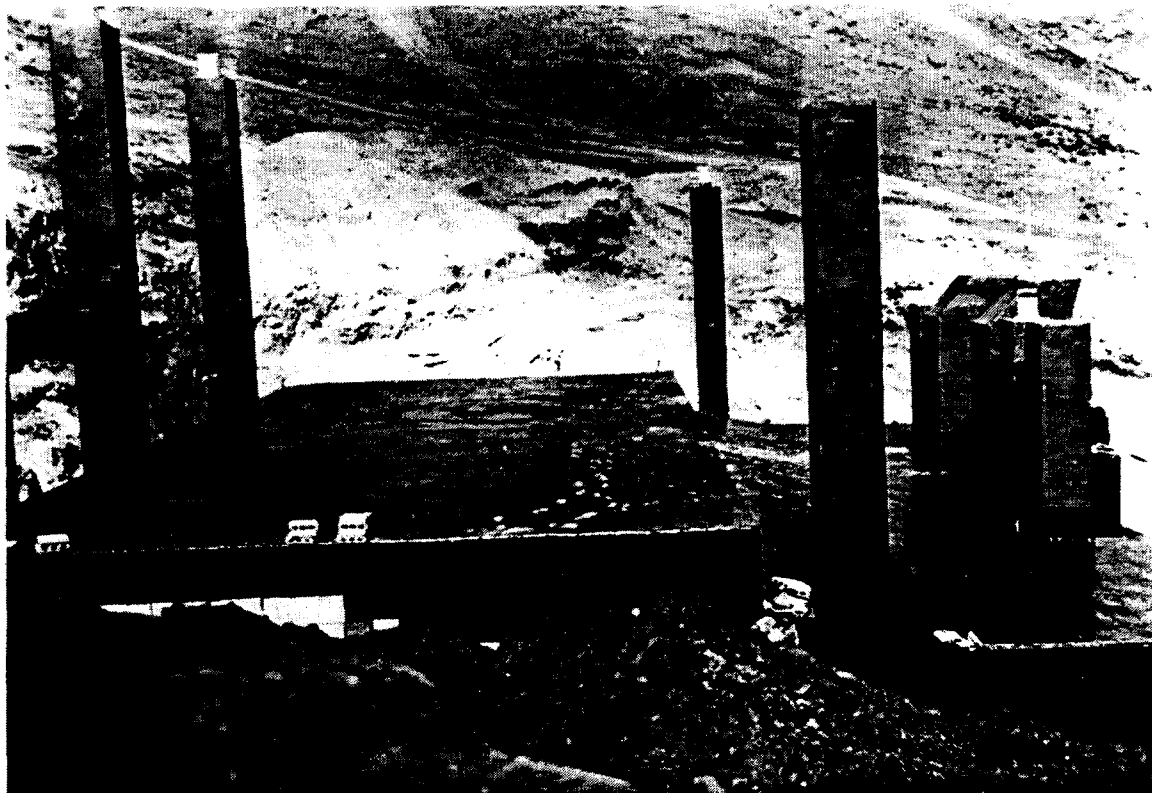
Plate 33. Battery Townsley, Fort Cronkhite, 1938-1940. Under construction, showing damp-proof membrane. Courtesy of the Park Archives of the Golden Gate National Recreation Area.

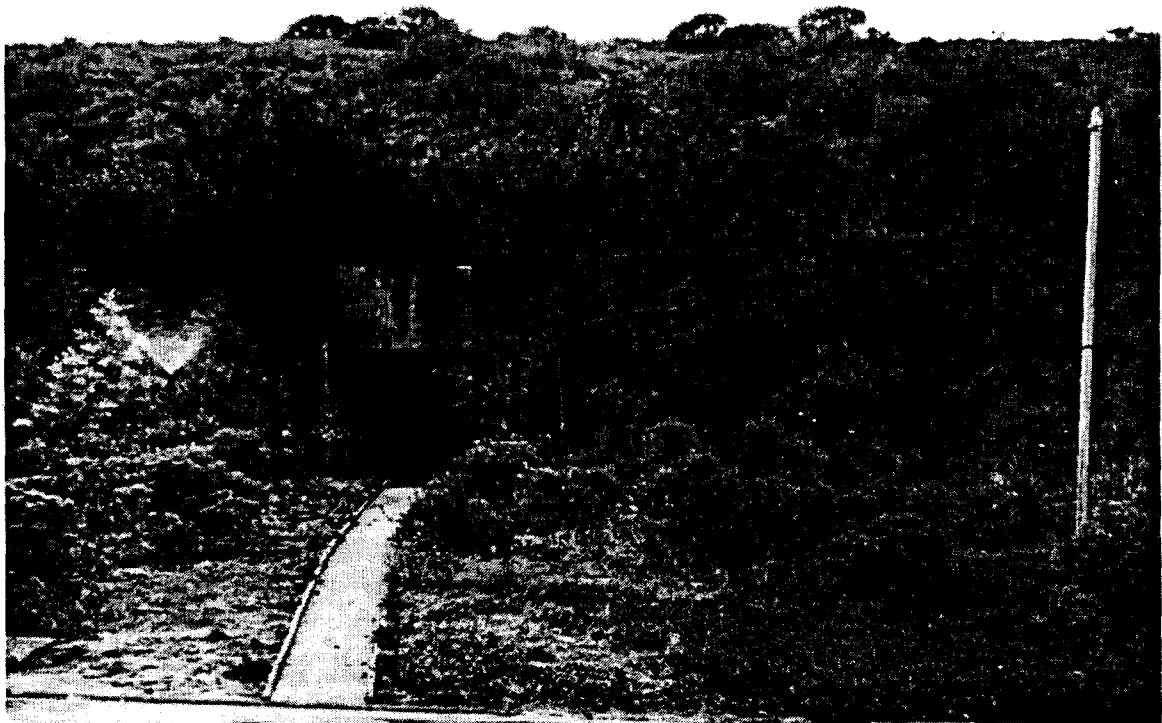
Plate 36. Battery Davis. Landscape camouflage at the power room entrance. View immediately post construction, September 1940. Courtesy of the Park Archives of the Golden Gate National Recreation Area.

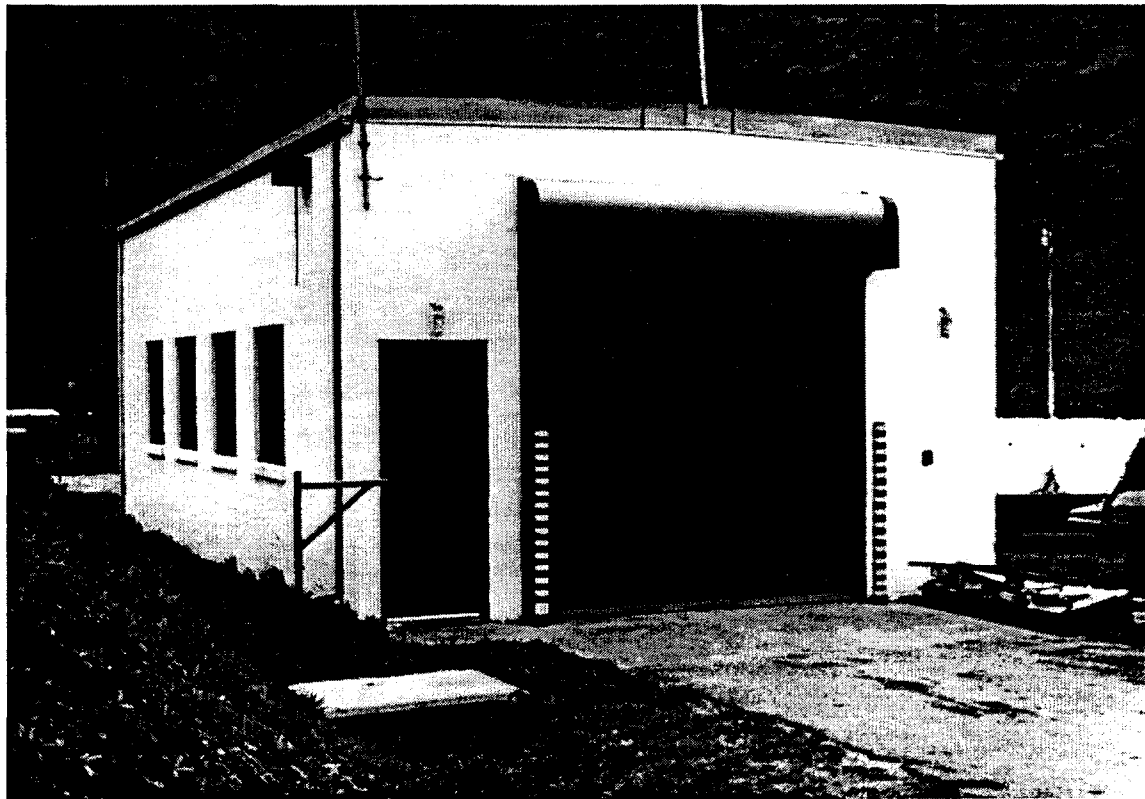
Plate 37. Nike Hercules Warhead Building, Nike Site SF-88L, Fort Barry, 1959. Courtesy of the Park Archives of the Golden Gate National Recreation Area.

The Nike site SF-88L, now restored at Fort Barry, was under construction as of 1953-1954, with "Type B" underground missile storage structures. Although not researched here, it is likely that the engineering firm responsible for the Type B storage structure was Black & Veatch of Kansas City. Sandia had hired Black & Veatch in 1946 to design the very first atomic weapons storage facilities in New Mexico, and by the early 1950s the firm consistently designed all such structures for the U.S. military. The Type B structure closely followed in name and typology Black & Veatch's Plant B for the nuclear weapons stockpile and operational storage sites, known as Q Areas (due to their restricted Atomic Energy Commission clearance status). Q Areas were associated with thirteen U.S. Air Force and Army installations, with selected additional facilities built in French Morocco for use by Strategic Air Command. Black & Veatch also typically designed missile assembly buildings for the Air Force over generations of nuclear missiles, and often undertook the associated design of heightened security systems. At SF-88L, the Army made early reuse of existing batteries for the aboveground needs in an ad hoc manner, even continuing this approach in its long use of assembly vans and a Butler building as the final missile assembly building in 1962. (See Plate 6, chapter 1.) Yet, such sustained improvised solutions were common during the Cold War, often running in tandem with permanent infrastructure. By the erection of the cinderblock warhead building in 1959 for Nike Hercules, it was understood that all aboveground structures would not survive the increased destructive power of thermonuclear warheads. Nonetheless, the structure remains cinderblock. The Air Force typically built such structures in reinforced concrete, windowless and with identical loading doors, for its missiles at Vandenberg and elsewhere. The choice of a Butler structure for the missile assembly building at SF-88L may also be an alternate use of the Butler Type III launch shelter for Bomarc, designed in 1958-1959 (Plate 37).

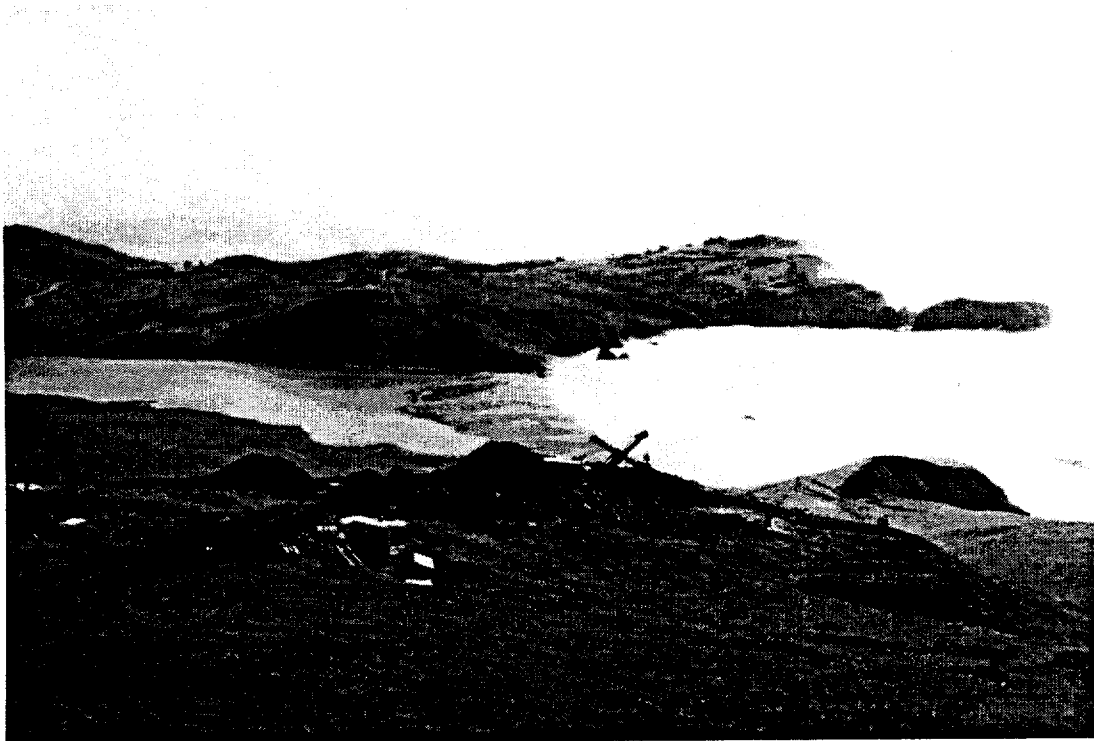
Plate 41. Battery Townsley. Initial construction, January 1938. Courtesy of the Park Archives of the Golden Gate National Recreation Area.

By the time of the World War II batteries, soil-cement stabilization around reinforced concrete foundations was standard, drawing upon lessons learned from both the engineering of concrete dams and soil-cement highways. Nonetheless, virgin battery sites still required massive amounts of excavation and backfilling, with completed installations literally implanted into the land (Plates 41 and 42).

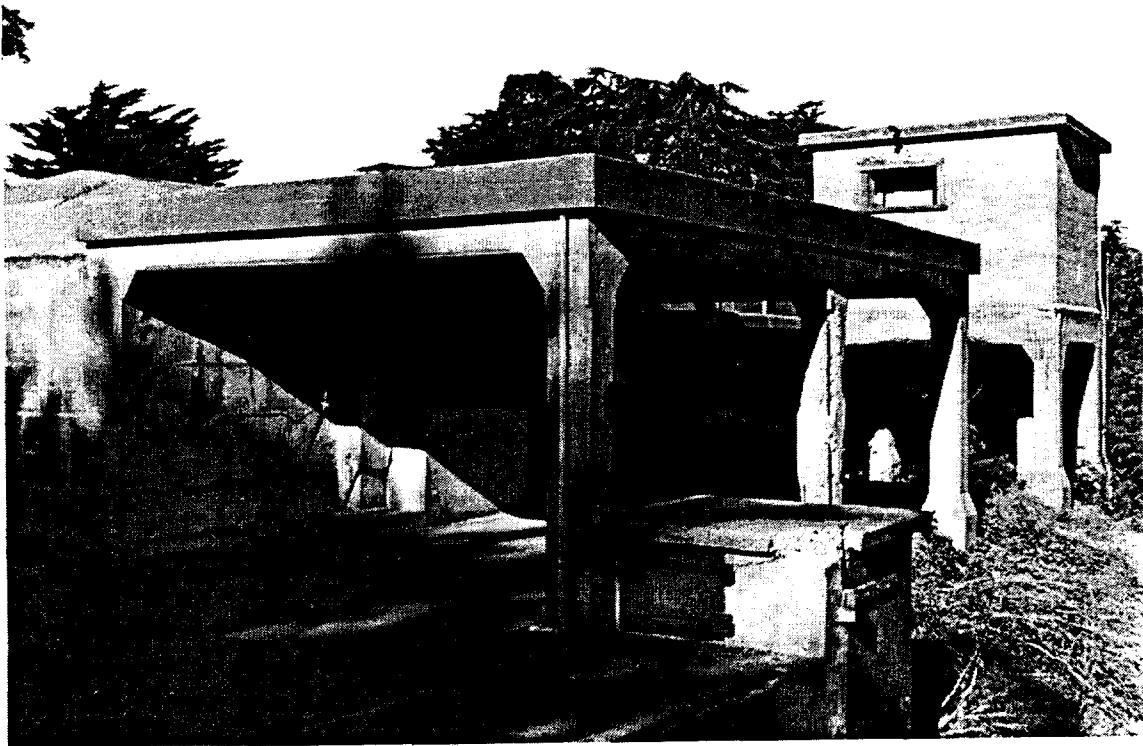
Plate 43. Even after the structures of the Endicott and Taft periods were completed, there was a pattern of improvements that also incorporated advances in concrete construction. The telautograph booth, ammunition hoist and splinterproof, and battery commander's station, shown here, were built between 1904 and 1912. These additions at Battery Marcus Miller were among the first attempts to use reinforced concrete in the fortifications.

Previous research, notably the work accomplished beginning in the late 1960s by historians of the National Park Service as well as other scholars, identified some of the principals and the chronology of their work. As a result, we know some about the construction of the 1870s, a great deal more about what took place in the Endicott and Taft years, but almost nothing about the designs of the 1940s. There are several reasons for the gap in the most recent period, however the lack of specific knowledge has little impact on what we know about the building of fortifications out of concrete. The use of concrete for defensive purposes was explored thoroughly in the years before World War I, and it is that period of innovation that is the most instructive. However, to fully comprehend the marks that fortifications have made on the landscape, our vision must extend beyond the material of construction itself. We must look at American military experience, the impressions made or not made by other nations on the American military, and a native engineering contribution to a distinctly American form of coast defense (Plate 43).

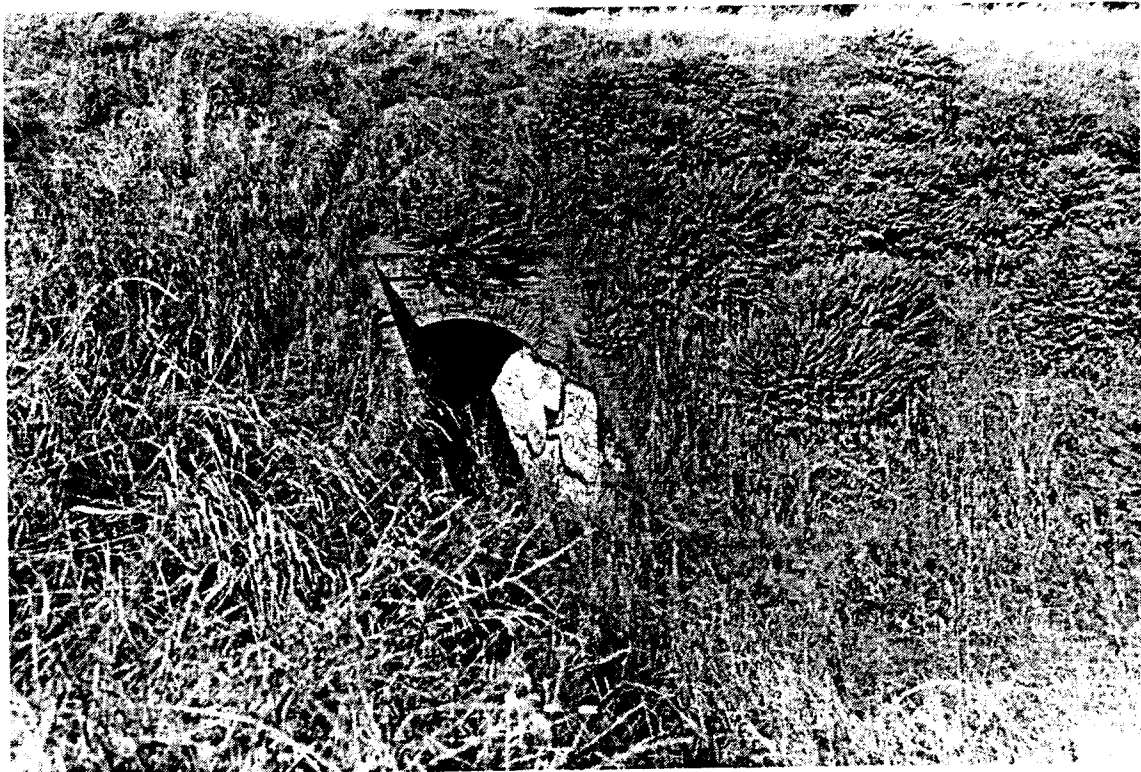
Plate 44. The design of Cavallo Battery called for the work to be accomplished in earth, and rendered in regular outlines. Those crisp outlines have been obscured by a century of plant growth.

The utilitarian and rhythmic emplacement-and-magazine plan of the 1870s batteries at Fort Scott owes its heritage to the Civil War, and there is little to separate them from similar fortifications of that conflict. Yet Cavallo Battery is a distinguished design and it has no surviving counterparts. Its seaward face is well understood, but its general trace and rear parapet suggest some similarities with French fortifications erected in the Franco-Prussian War, especially in regard to the positions for land defense armament at the extremities of the plan. American officers regularly toured the battlefields, arsenals, and fortifications of European nations, and did so even until the late 1930s, and what others were doing became part of the base of ideas that contributed to the defenses² (Plate 44).

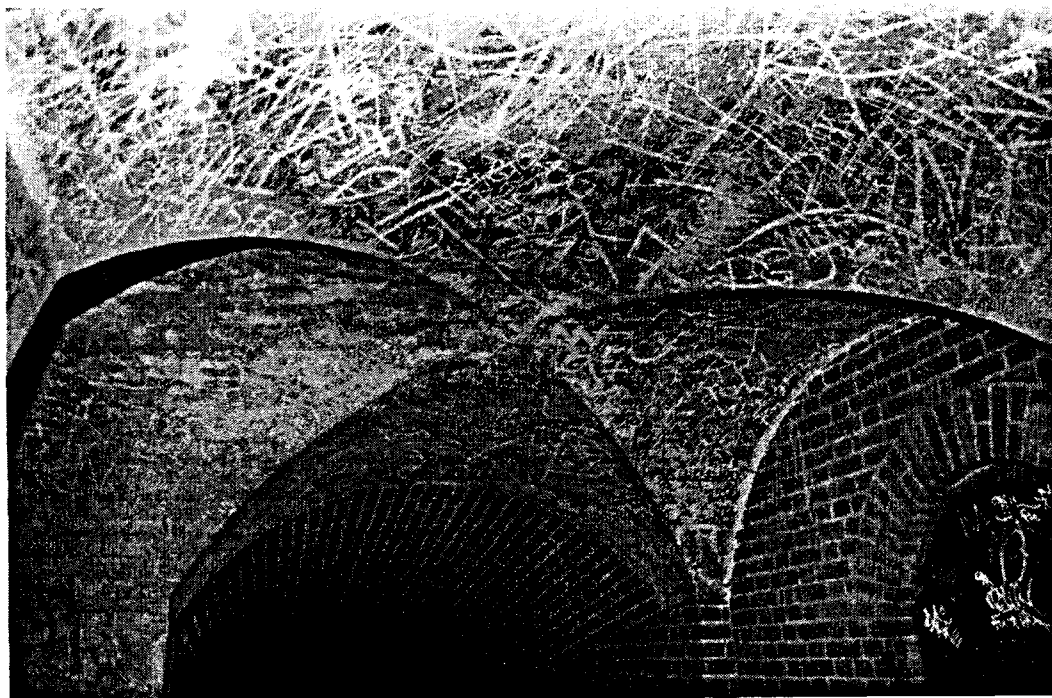
Plate 45. Although the batteries of the 1870s were built of earth and brick, concrete played an important role as well. Here a groin formed by the intersection of vaults in East Battery is made of concrete, displacing more expensive brickwork.

The selection of a disappearing carriage, either Buffington's or any other competitor for the design, meant that the batteries mounting it would have to be big—at least as tall as the machinery that would move the cannon above the parapet—and would have to be scaled in two stories. The first or lower story would contain the magazines for the projectiles and powder, and the upper story would provide a platform for the gun. Those requirements meant that earth was gone as a basic building material. Stone was an alternative, but it could only be worked by skilled craftsmen, while another material would be just as good and less expensive as well. It was concrete, and the adaptability of the material propelled it into the forefront of choice (Plate 45).

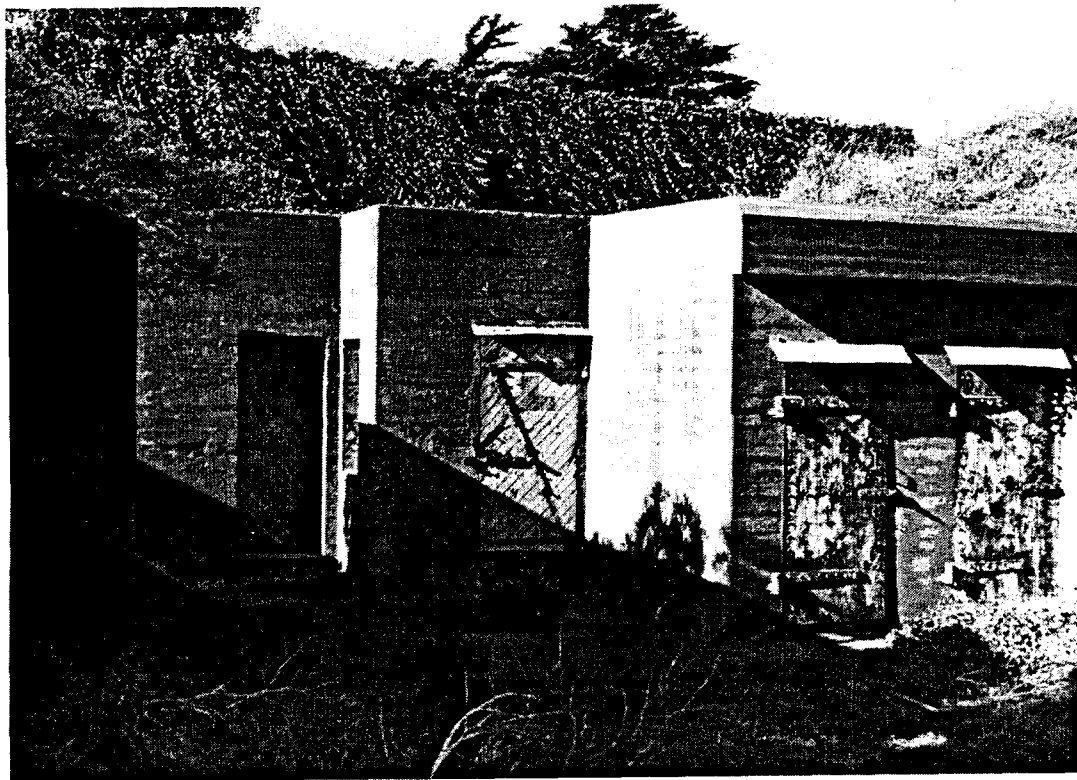
Plate 46. The designs for the earliest batteries did not anticipate the need for latrines, power plants, plotting rooms, and storage spaces. As a result, later building tacked on these components to fortifications completed only a few years before. These additions at Battery Godfrey are an example of the practice; they also portray the preference for steel doors in later construction.

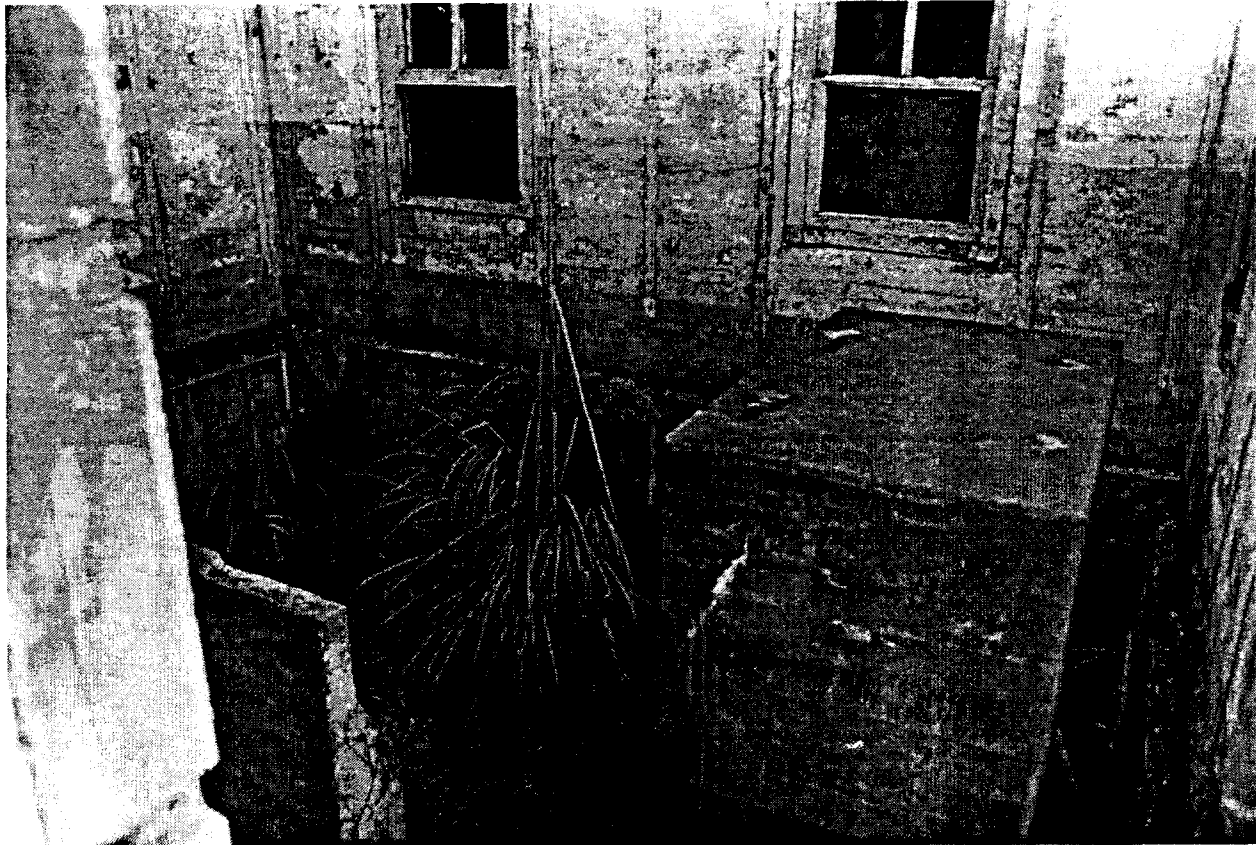
Plate 50. Absence of flooring, at the entrance to the switchboard room, mine casemate, Fort Barry.

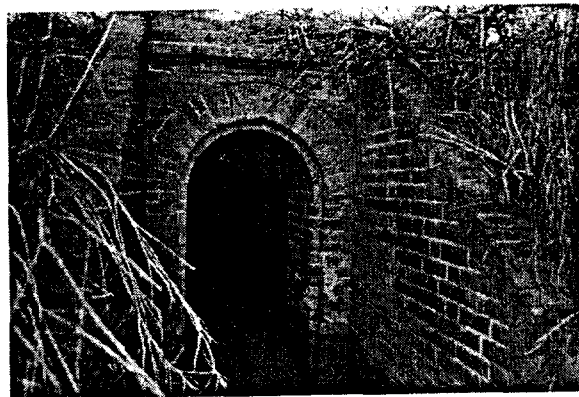
East Battery. Flooded magazine entry.

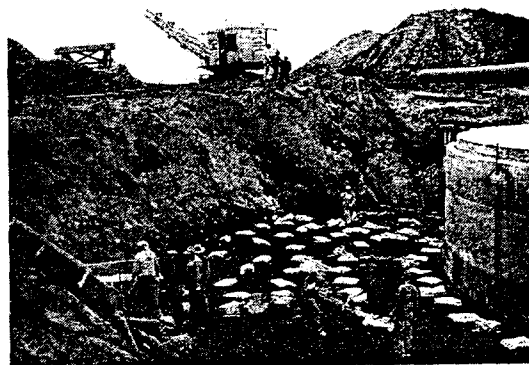
Battery Davis. Cement-soil stabilization, second operation, April 1938.

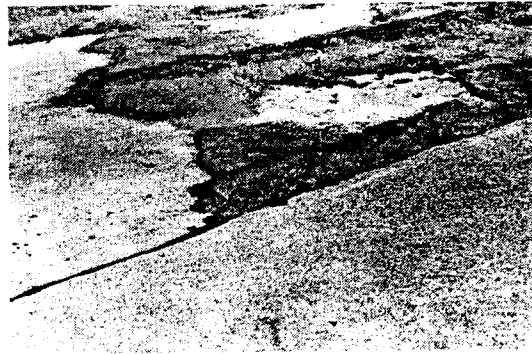
Battery Godfrey. Surface drainage system on blast apron composed of pipe, earth fill, and asphalt or oil-saturated earth.

Individual site inspections coordinated with the use of original drawings should locate visible and suspected drainage lines. Selective excavation may determine actual locations, depths, and slopes. Testing with high pressure water may help to locate lines and leaks.

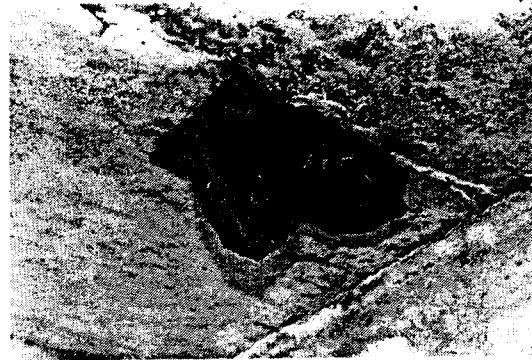
Battery Marcus Miller. Counterweight cable pulley for ammunition hoist doors.

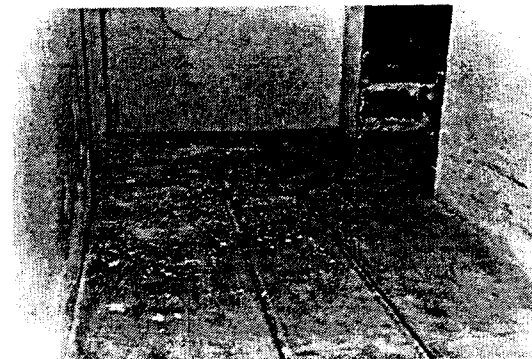
Battery Stotsenburg-McKinnon. Ammunition supply tramway and turntable in central corridor between pits.

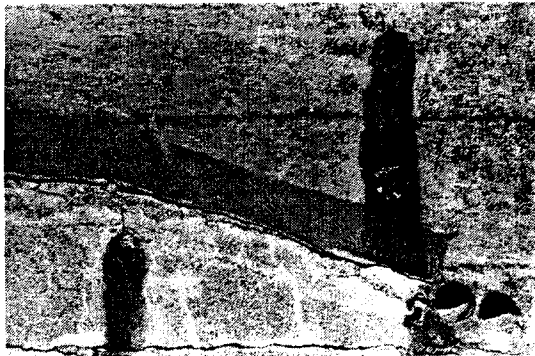
Battery Godfrey. Cold joint displaying sheet lead as waterproof layer. Stained concrete from imbedded metal elements.

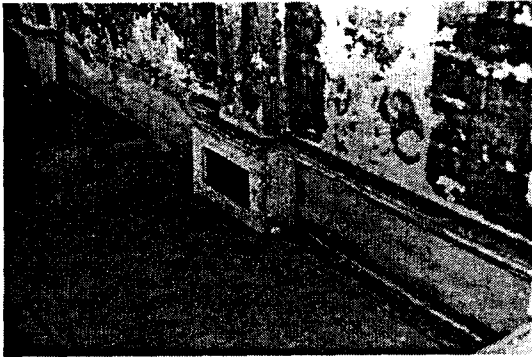
Battery Mendell. Remnants of wall finish and wooden wiring chase.

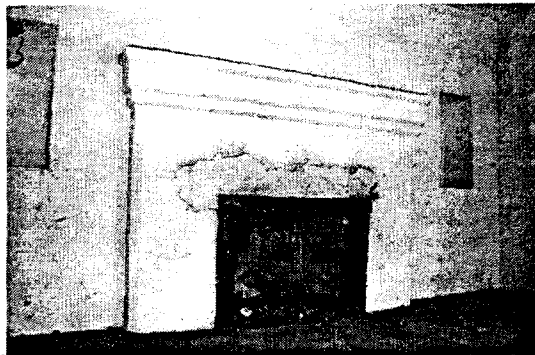
Battery Spencer. Finishwork for the fireplace in the commanding officer's room. Dependent structure.

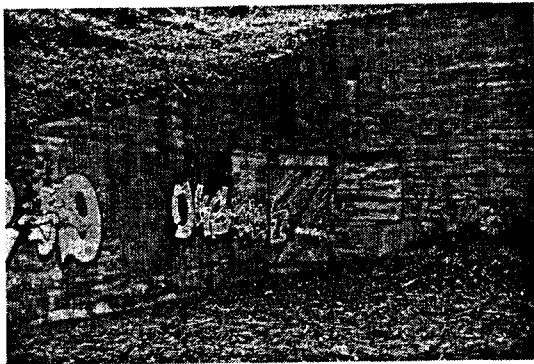
Battery Dynamite, emplacement three. Graffiti at rear corner, showing entry to cross-gallery. Also note debris accumulation and unique profile of sidewall.

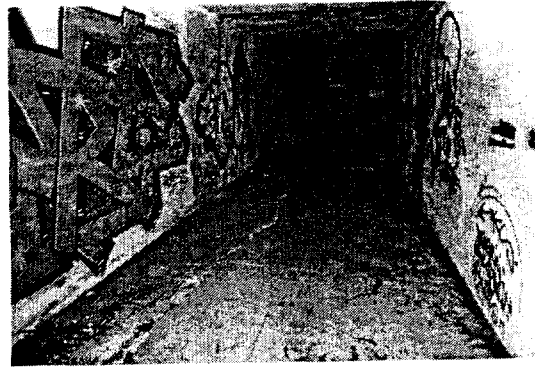
Battery Dynamite. Graffiti in cross-gallery, looking toward entry doors for emplacement one. Also showing significant floor deflection as a result of seismic action.

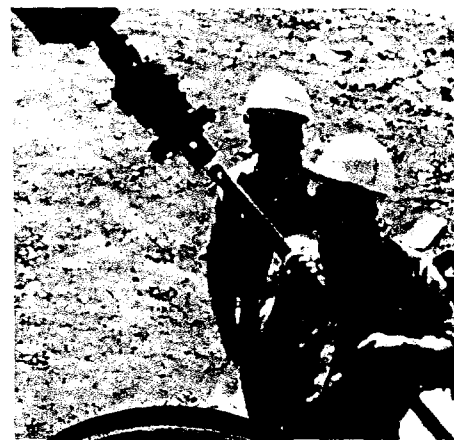
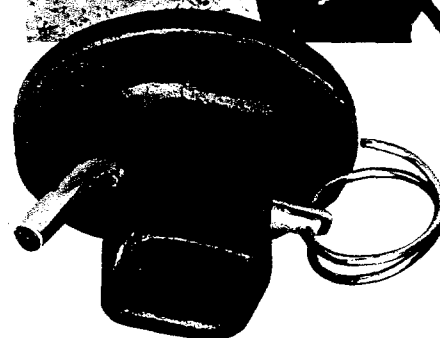
For attachment to a torque-output source directly or via a torque-indicating device, SS anchor drive tool sizes are of the same basic design.

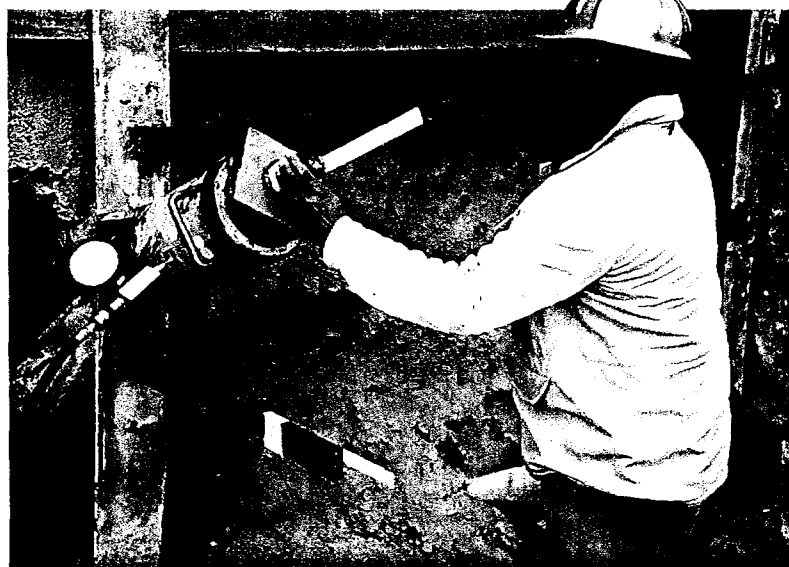
Screw anchors are compatible with various threadbars that are used in tieback construction. Round-cornered square-shaft extensions are used to install screw anchors to depths required. Then, the threadbar is coupled to the anchor by means of an adapter with an internal thread for the appropriate threadbar design.

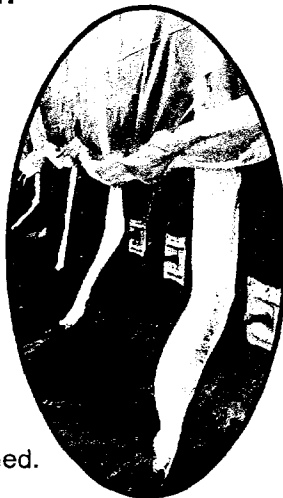
Terminations fit threadbar or provide a threaded stud to work with prefabricated or site-made lock-off devices. Other termination fittings also are available.

In some cases, the through-hole at the shaft end may be simply crossspinned.

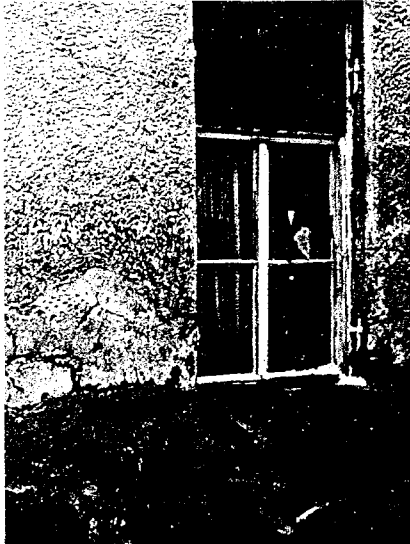
Rising damp in the underlying masonry caused this extensive surface coating damage.

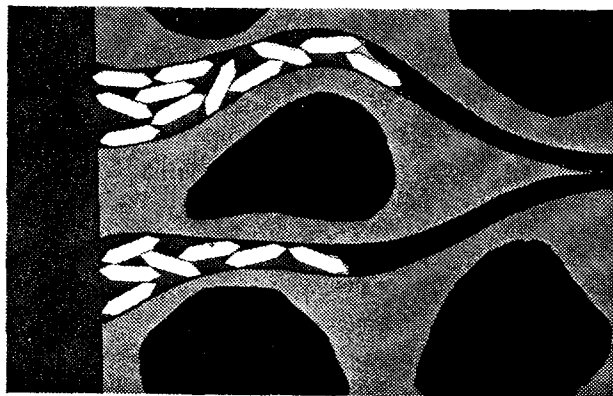
When mixed with water and applied as a cementitious coating, the active chemicals in XYPEX cause a catalytic reaction which generates a non-soluble crystalline formation of dendritic . . .

. . . fibres within the pores and capillary tracts of concrete. Thus the concrete becomes permanently sealed against the penetration of water or liquids from any direction
