# **THE FURNACE GROUP**

## **HISTORIC STRUCTURE REPORT**

**Hopewell Furnace National Historic Site  
Elverson, Pennsylvania**

**Historic Architecture Program, Northeast Region  
National Park Service  
Lowell, Massachusetts**

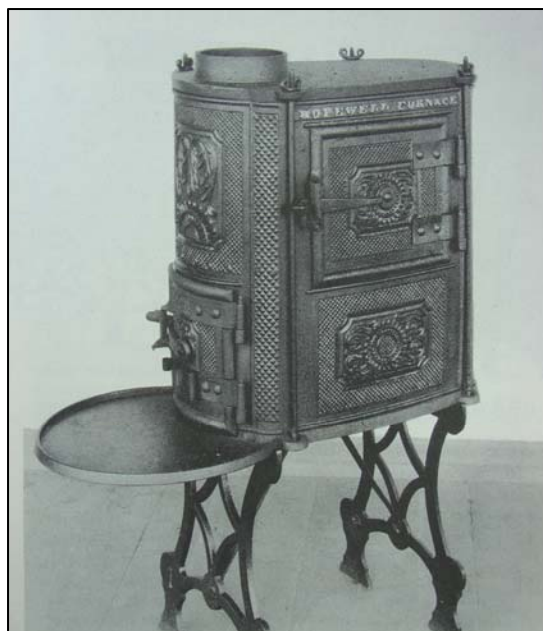
**Figure 3.** Ten- plate stove made at Hopewell Furnace, circa 1827- 44.

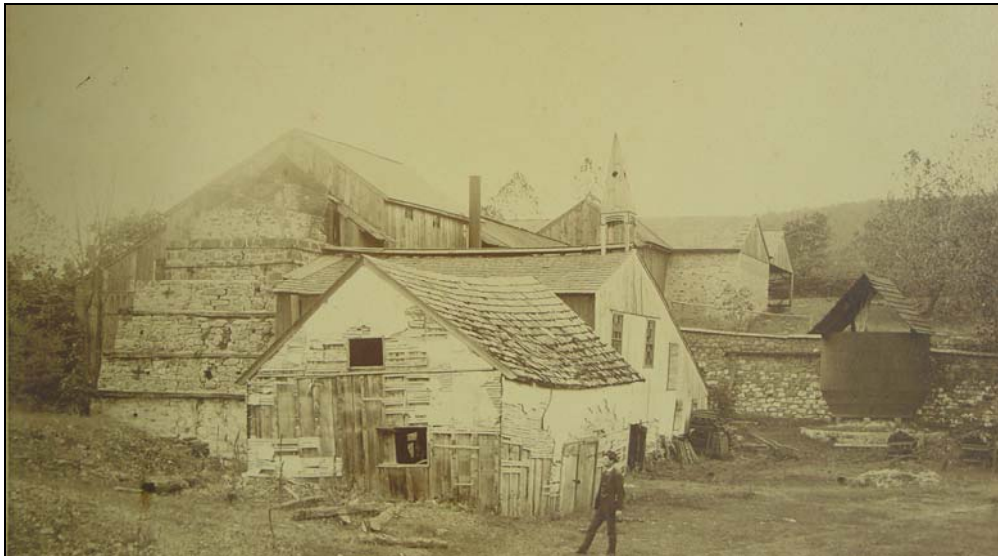
Figure 7. Earliest known photograph of Hopewell Furnace, October 10, 1887.

Deterioration of the furnace structures had already commenced when the first known photograph of the works was taken in 1887 (figs. 7 and 17), and had accelerated considerably by 1896 (figs. 18a and 18b). The water wheel and blast machinery were recorded and removed to on- site storage by the Franklin Institute of Philadelphia in 1931. Only the stone furnace stack and charcoal house remained standing in 1935, along with the Ironmaster’s House and some tenant houses, when the furnace property was sold by A. Louise Brooke to the federal government. Development of the newly created “French Creek Recreational Demonstration Area” used the labor of both the Civilian Conservation Corps (CCC) and the Works Progress Administration (WPA), under the supervision of the National Park Service. Their work included clearing and drainage of the furnace site, stabilization of the furnace stack (1936- 41), and partial restoration of the east head race (1938- 39). The historical importance of the old furnace was also recognized at this time by CCC Architect Gustavus Mang and NPS Historian Roy Appleman, who advocated restoration and reconstruction similar to John Rockefeller’s Colonial Williamsburg and Henry Ford’s Greenfield Village.

The earliest-known photograph of Hopewell Furnace was taken in 1887, four years after the furnace fired its last blast in 1883 (figs. 7 and 17). This view has come to be known as the “Stokes” photograph because it is in the Stokes collection at Hopewell Furnace NHS. The collection was probably obtained from the family of Mary Brooke Stokes, daughter of A. Louise Brooke and wife of Edward L. Stokes. The photograph may have been one of several described in 1935 by NPS Historian Roy Appleman as having been taken “several years ago when the furnace was pretty largely intact,” then in the possession of the E. & G. Brooke’s Iron Company of Birdsboro, PA.<sup>70</sup> Knowledge of the photograph appears to have been lost for the next 20 years until 1955, when it was said to have “first” come to the attention of NPS researchers.<sup>71</sup> It is a paper-printed copy mounted on cardboard, with the following handwritten notation on the back side: “Hopewell Furnace, Chester [sic: Berks] Co., Pennsylvania, Oct. 10<sup>th</sup>, 1887, Edward B. Hardin, Photo[grapher].” The view, looking towards the northwest, features an unidentified man standing next to a small gable building in front of an assemblage of structures of the former Hopewell Furnace.

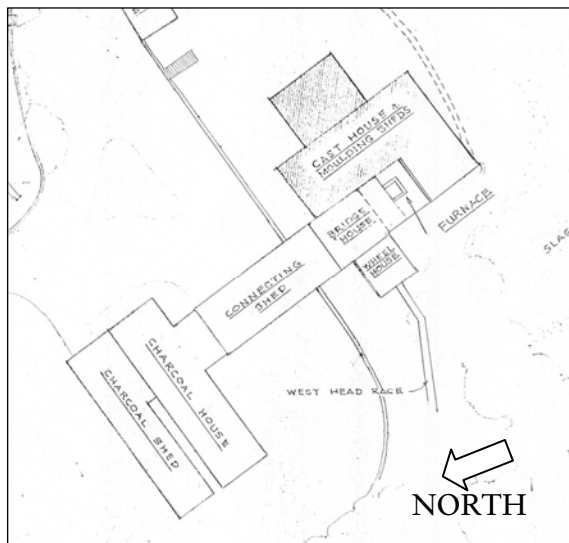
**Figure 8.** Plan showing the various components of the Furnace Group, 1964. Although the actual structures may have differed in earlier years, their operational and physical relationships are thought to have remained unchanged.

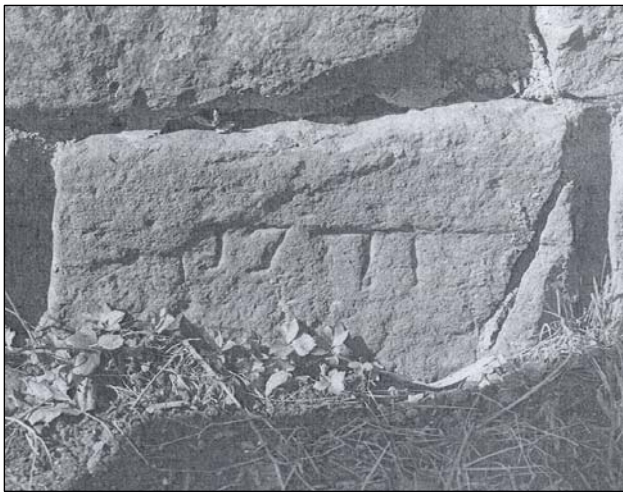
**Figure 9.** Stone carved with “1771” in the east face of the furnace, south of the cast arch. Photograph taken in 1962- 63.

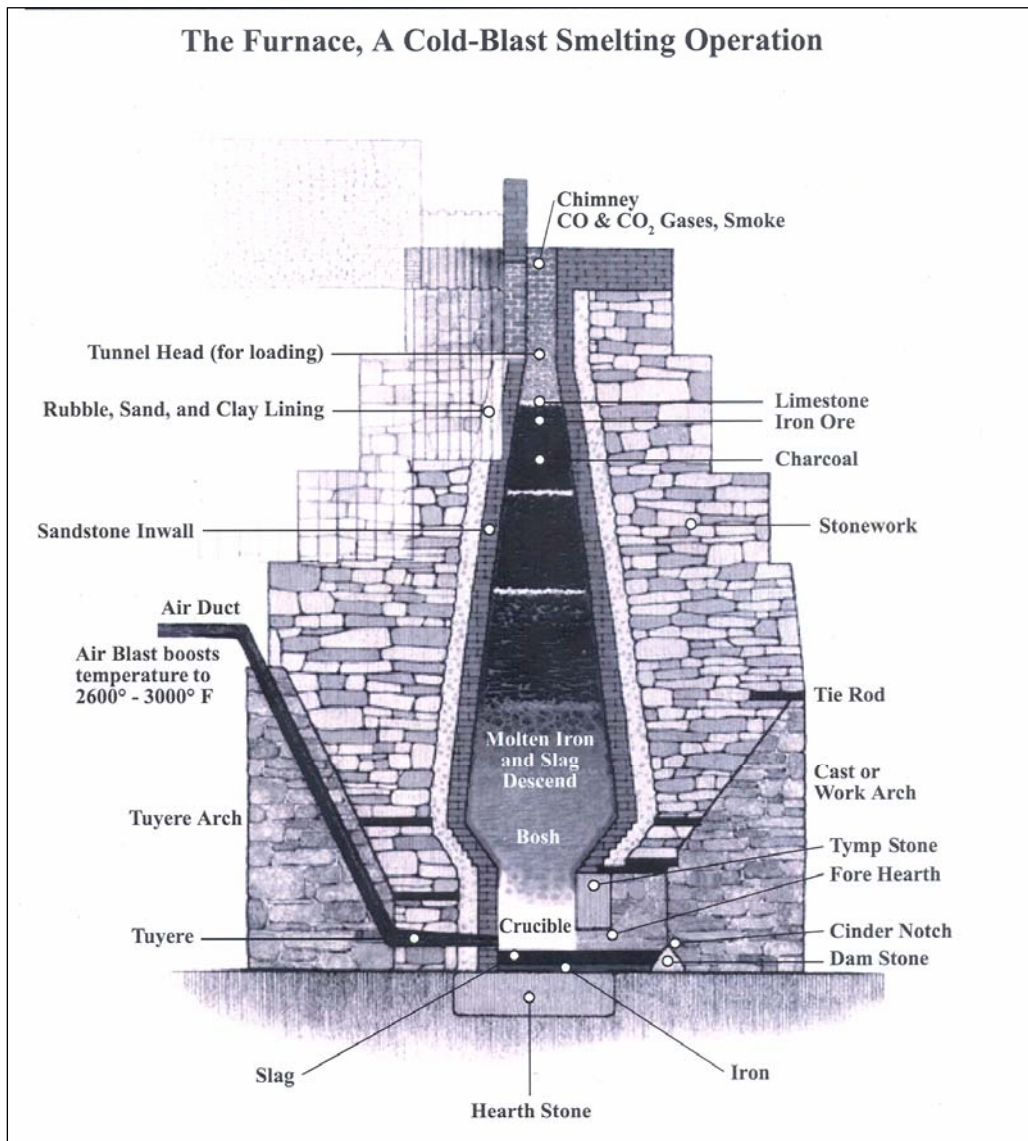
Figure 10. Annotated cross- section of a furnace similar to the one at Hopewell Furnace.

served as supports for wooden girders that were joined at the corners to lend additional support to the walls.<sup>3</sup> An opening on the upper north side of the furnace, called the tunnel head, is where the charge (iron ore, limestone, and charcoal) was loaded from the bridge. From here, the charge descended into the interior bosh where the ore was heated and smelted. The bosh was lined with sandstone (later with firebricks) and insulated with sand in the space between the bosh and the exterior stonework. Blasts of air channeled through a tuyere pipe and nozzle on the lower north side of the furnace, at the tuyere arch, caused the charge to burn hotter. Molten ore and lighter slag next descended to the hearth at the bottom of the furnace and collected in a stone-lined cylindrical reservoir called the crucible. These were tapped at the casting arch on the lower east side of the furnace (see fig. 10.)

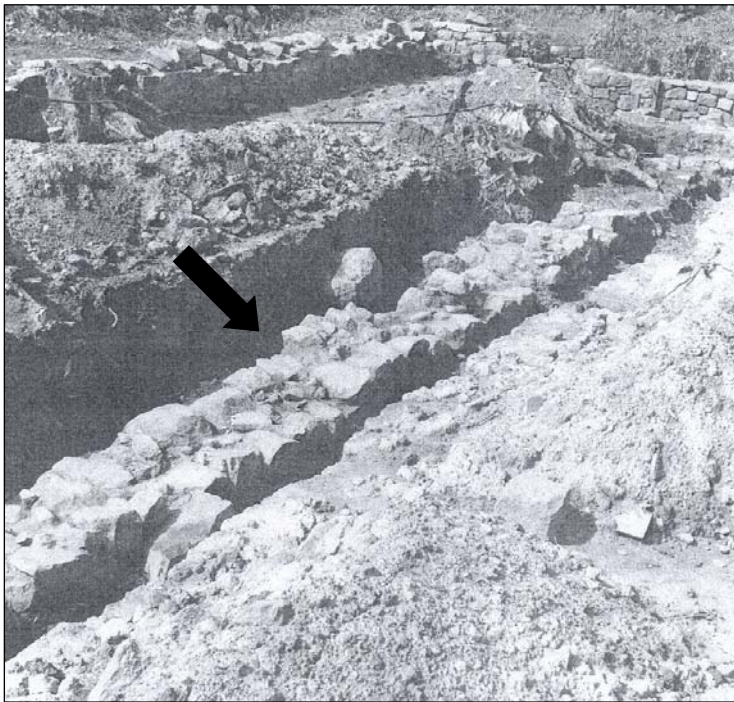
**Figure 12.** Original south foundation of the cast house (at arrow), excavated in 1962- 63. View is looking southwest.

because it had been covered by a later stone wall. This early foundation was described as a “crude masonry wall ... probably dating from 1771.”<sup>16</sup>

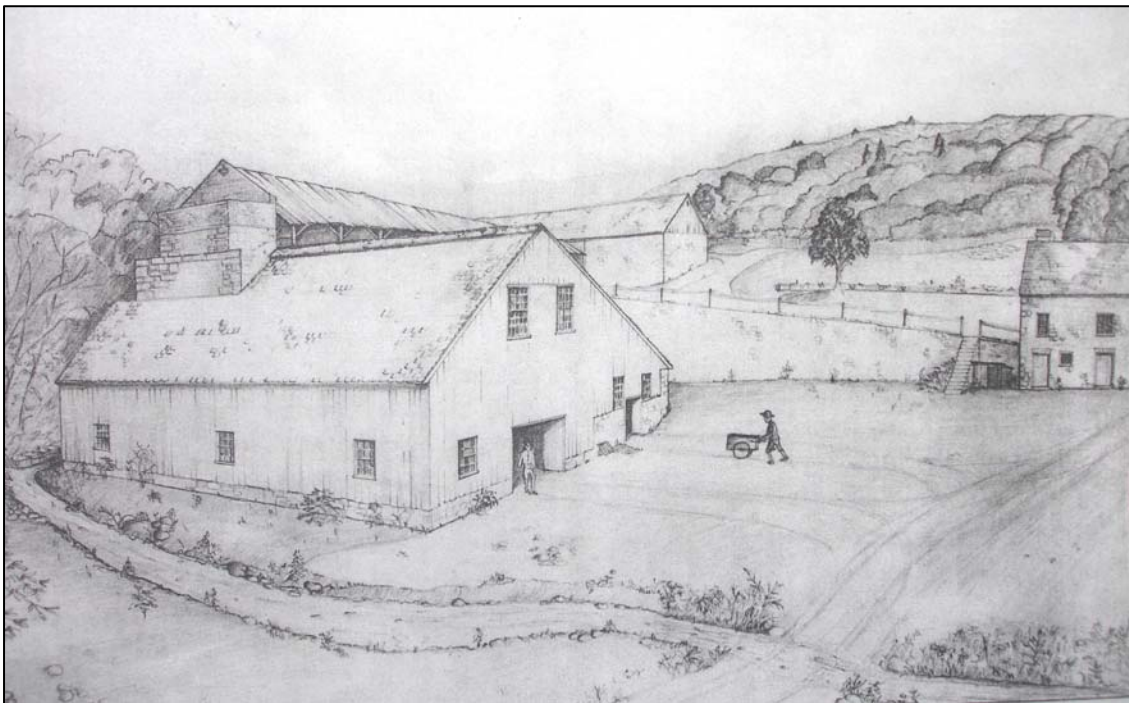
Figure 13. Conjectural sketch of Hopewell Furnace as it may have looked about 1800.

The sketch of the furnace stack as it may have looked about 1800 shows a stepped structure mostly enclosed by a wood- framed building that is assumed to be the cast house. Beyond the cast house can be seen the long bridge house with gable roof and open sides that connected with a stone charcoal house on the furnace bank; the cooling shed had not yet been constructed. Hidden from view by the cast house were the early north- south water wheel and bellows that provided a cold blast of air to the furnace.

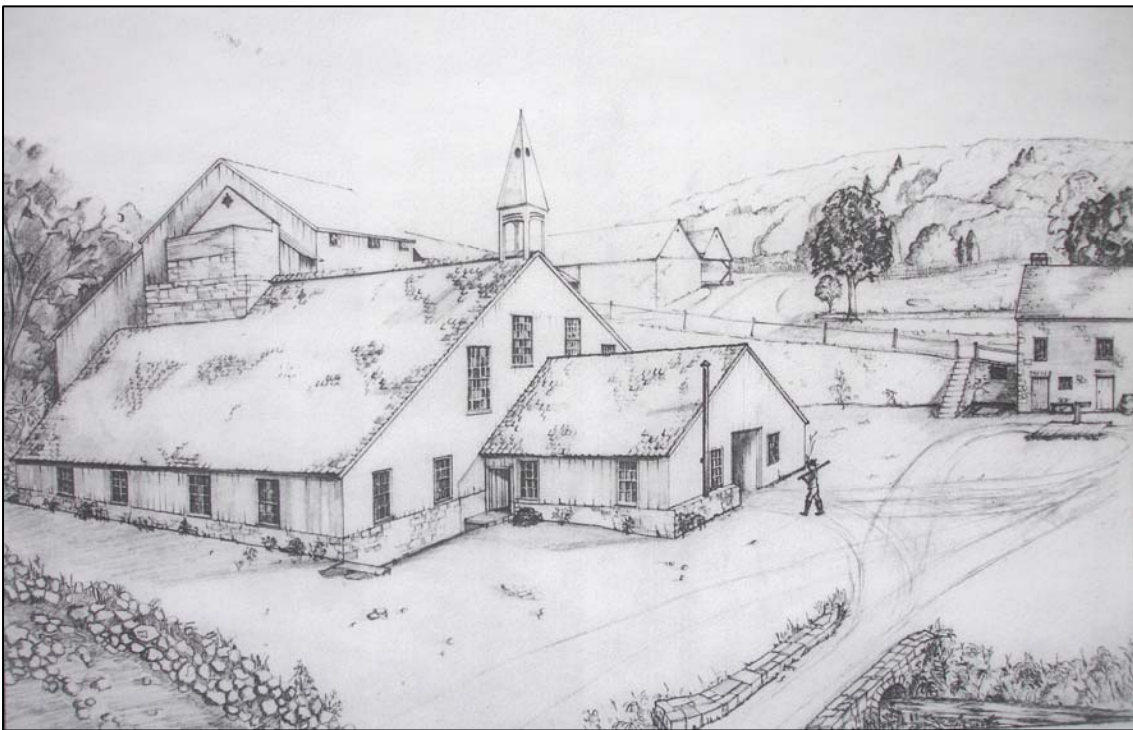
Figure 14. Conjectural sketch of Hopewell Furnace as it may have looked about 1840.

Norman Souder's conjectural sketch of circa 1840 shows several changes to the Furnace Group since 1800 (compare figs. 13 and 14). These include an enlarged cast house with a new belfry and east annex, a roofed enclosure over the water wheel, a remodeled bridge house, and a new charcoal-cooling shed north of the charcoal house. While helpful in envisioning the general physical appearance of the furnace about this time, several details merit discussion. First, Archeologist Leland Abel concluded in 1964 that the cast house had been completely rebuilt around 1816. Souder, on the other hand, depicts the building as an existing structure with newly added south extension, east annex, and belfry. Second, the roof of the wheel house is shown as continuous with the roof of the bridge house – a change that did not occur until 1879, according to Harker Long. Third, the enclosed portion of the bridge house nearest the furnace resembles that shown in the earliest known photograph dated 1887. This is more likely the configuration of the bridge house after extensive work was undertaken in 1847- 48, and is therefore not a true representation of its earlier 1840 appearance. Finally, it is possible, but not certain, that the cooling shed existed by 1840.

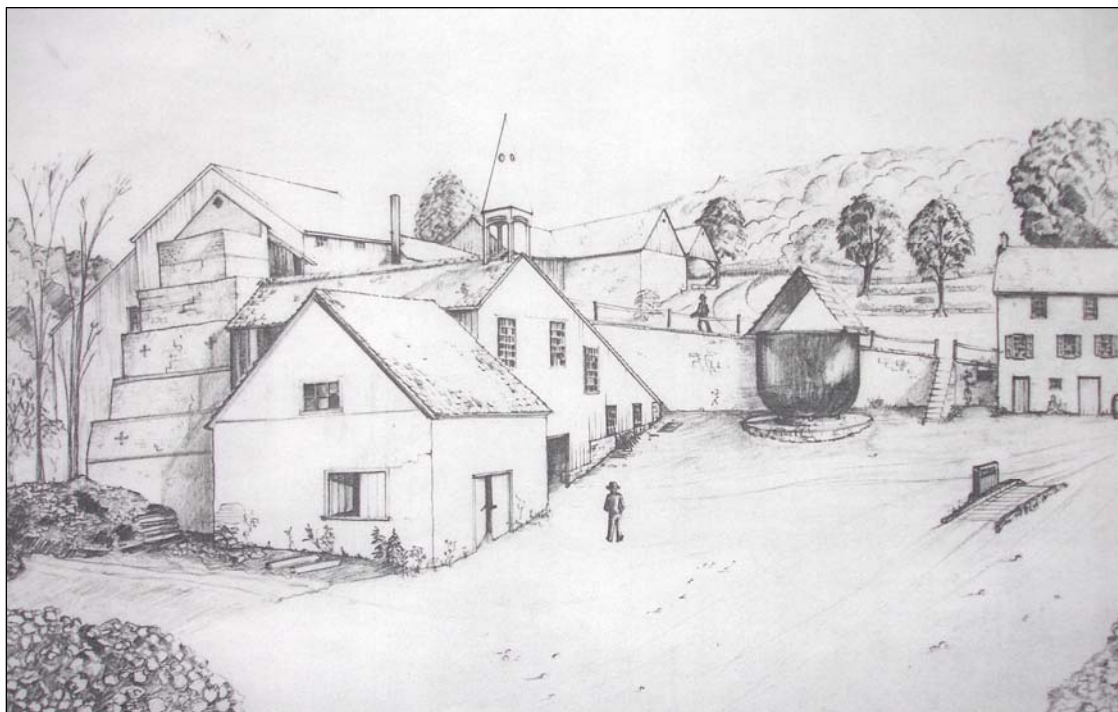
**Figure 15.** Conjectural sketch of Hopewell Furnace as it may have looked about 1880.

A conjectural sketch of Hopewell Furnace for the year 1880 was prepared by Architect Norman Souder around 1964 (fig. 15). This view was based primarily on the earliest known photograph of Hopewell dated 1887, four years after its last blast in 1883 (figs. 7 and 17). The primary difference between the sketch and the photograph is that the structures of the furnace were depicted by Souder in less- decrepit condition. The south portion of the cast house and its east annex had both been removed by 1867, and therefore do not appear in either the sketch or photograph.<sup>59</sup> A small gable- roofed structure south of the cast house is believed to have been the structure described by Harker Long as the “wheelwright- carpenter shop.”<sup>60</sup> The south extension of the charcoal house had been completed by this time, as had the east portion of the cooling shed, both constructed in 1880. Two inaccuracies postdating 1880 are a chimney for a later steam boiler, and an ore roaster situated east of the cast house.

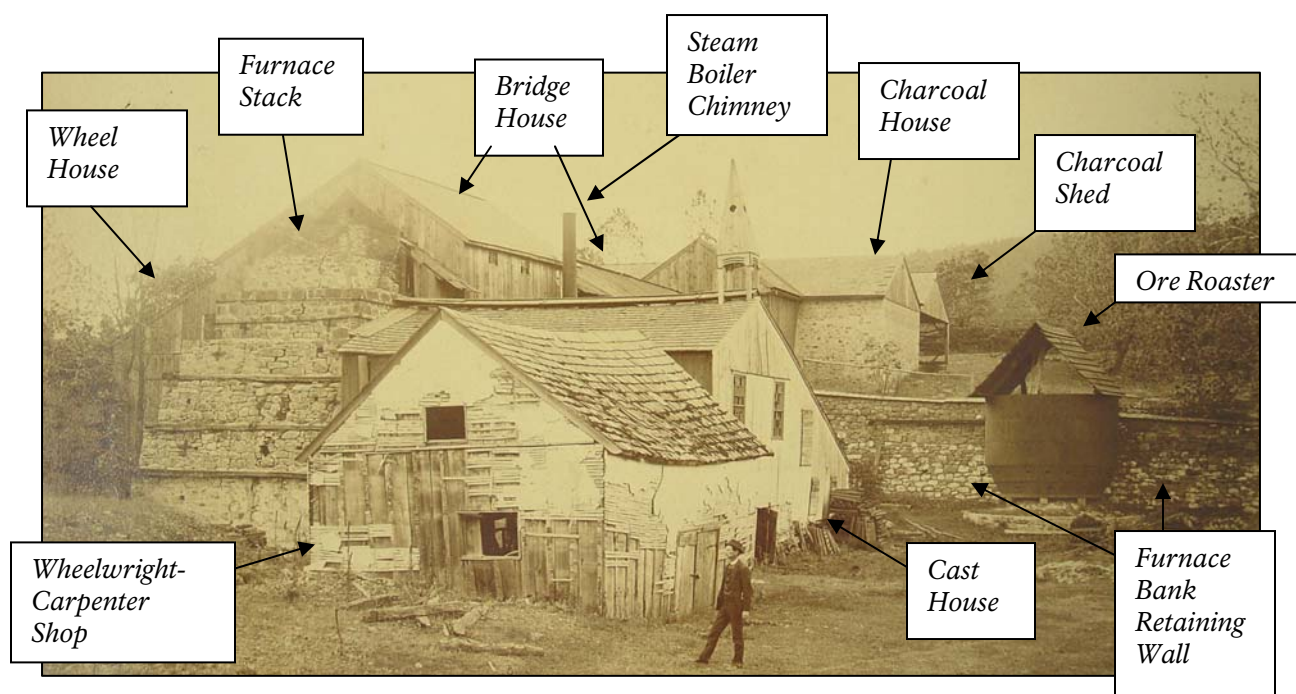
Figure 17. Annotated photograph of the Furnace Group, looking northwest, 1887.

The earliest-known photograph of Hopewell Furnace was taken by photographer Edward B. Hardin on October 10, 1887, four years after the furnace fired its last blast in 1883 (figs. 7 and 17).<sup>63</sup> The assemblage of structures captured by Hardin were those making up the Furnace Group, except for a small gable building in the foreground, identified as a wheelwright-carpenter shop, and a kettle-shaped ore roaster adjacent to the furnace bank. The south portion of the cast house had been removed by this time, as had the east annex. Deterioration of the remaining structures is evident by the wide masonry cracks in the furnace stack, missing siding, cracked windows, and patched roofing.

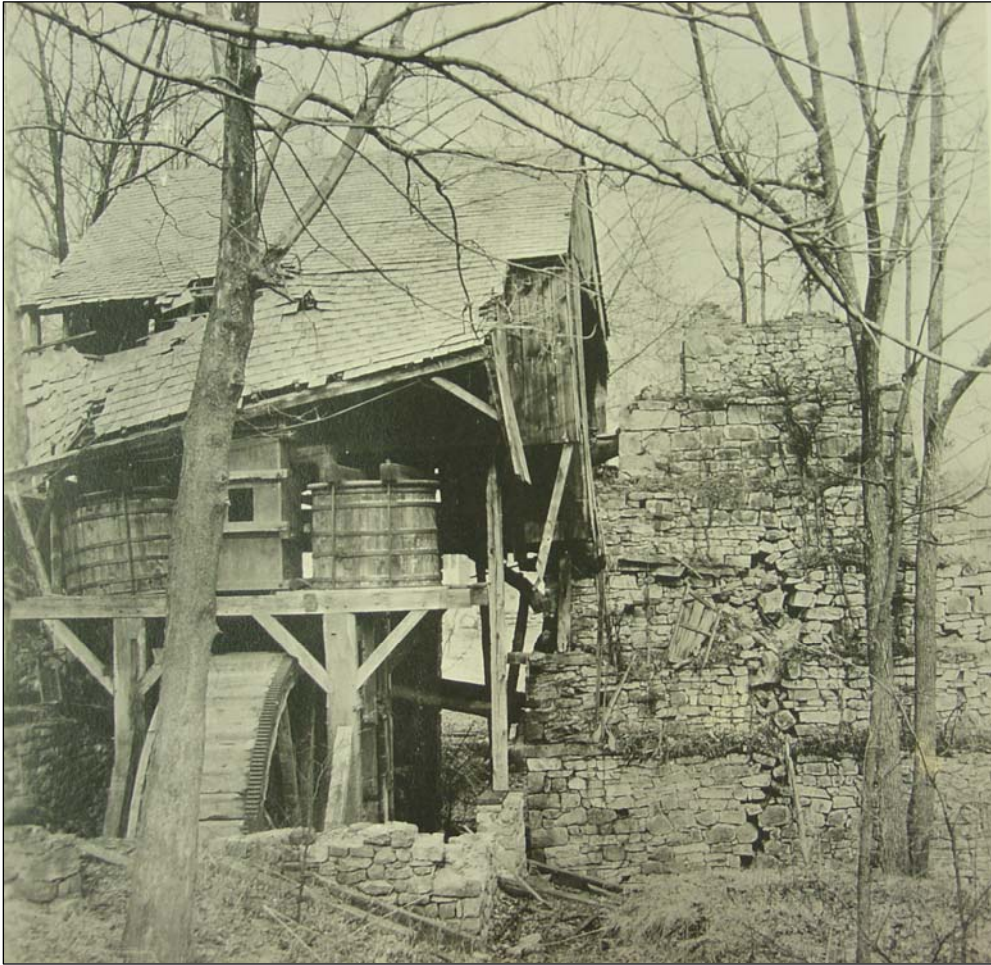
**Figure 22.** The wheel house and west elevation of the furnace, circa 1925.

An undated photograph taken sometime after Stauffer's views in 1920, roughly dated "circa 1925" by this report, captures the initial collapse of the wheel- house roof (fig. 22). It also provides the first clear view of the intact water wheel and the platform above it supporting the blast machinery. In a similar state of disrepair is the adjacent furnace stack, which has assumed the appearance of a crumbling mass of stones with a progressively widening vertical crack. By 1926, the roof of the wheel house had completely collapsed, leaving the water wheel and blast machinery exposed to the weather (fig. 23). It remained in this precarious state until the early 1930s.

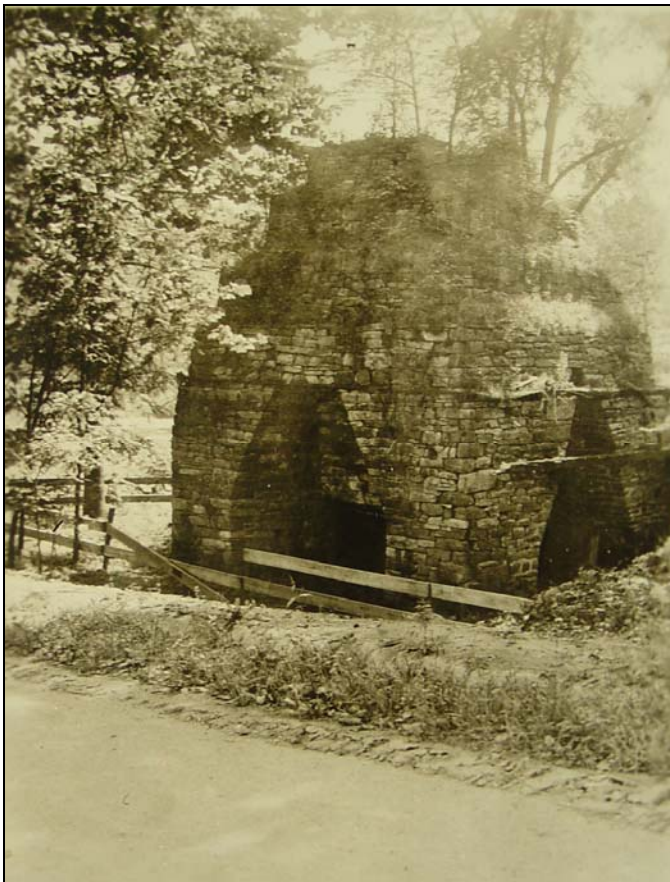
**Figure 26.** Northeast view of the furnace stack, taken sometime after the old Birdsboro- Warwick road was realigned in 1932, but before the start of furnace stabilization work in 1936.

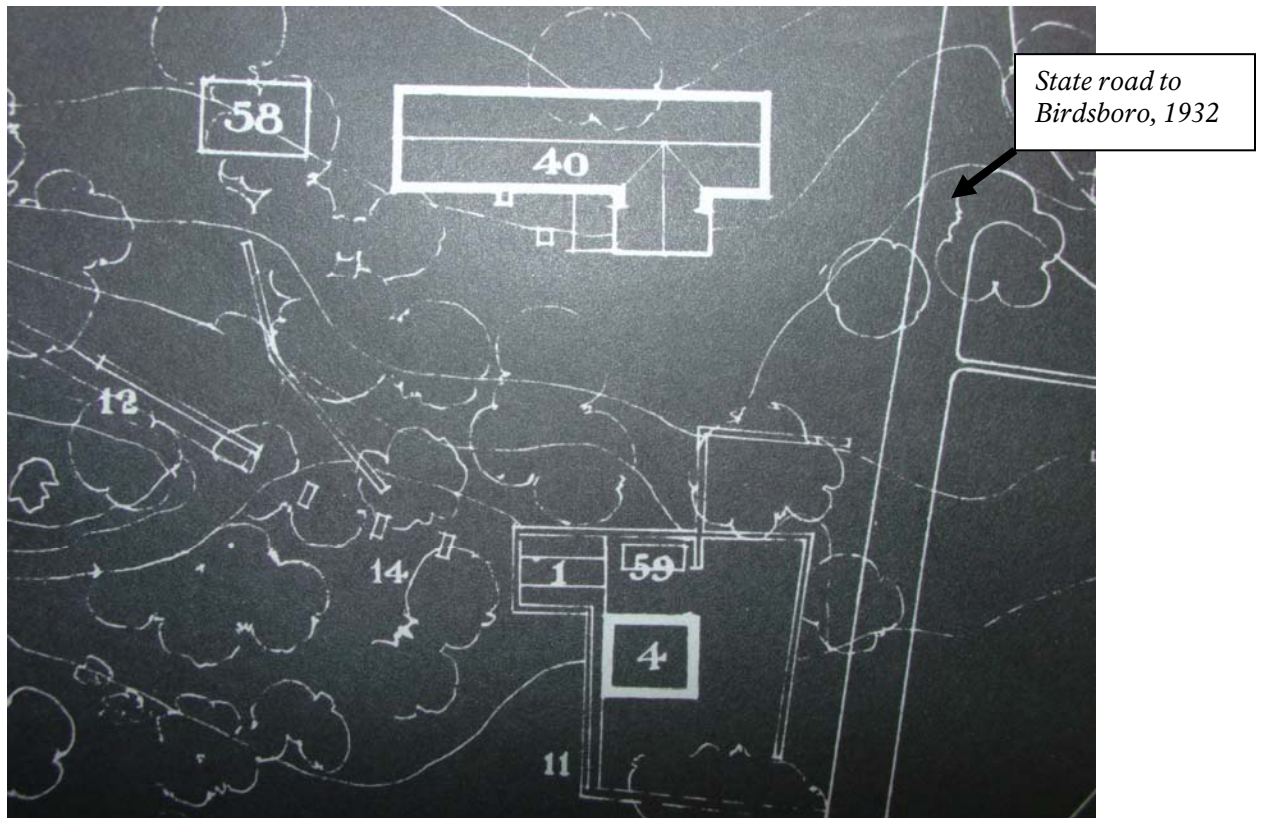
**Figure 27.** Detail of “Hopewell Village & Ruins” map, December 31, 1935, showing the remnants of the Furnace Group, including the water wheel pit (1), furnace (4), tail race (11), west head race retaining wall (12), forebay piers (14), charcoal house (40), and boiler (59). Located west of the charcoal house was a “temporary blacksmith shop” used by the CCC (58). Not shown in this detail are the “ruins of East Head Race” (50).

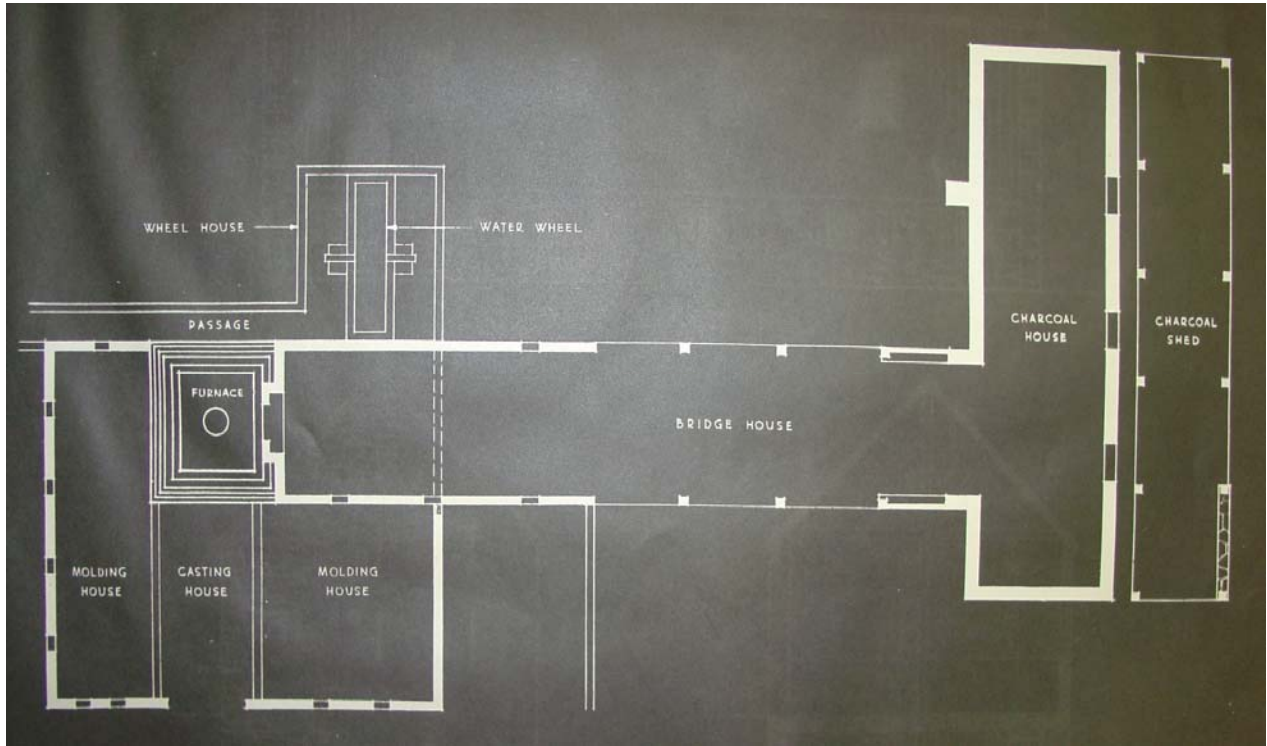
Figure 28a. Conjectural plan of the Furnace Group and cast house, December 31, 1935.

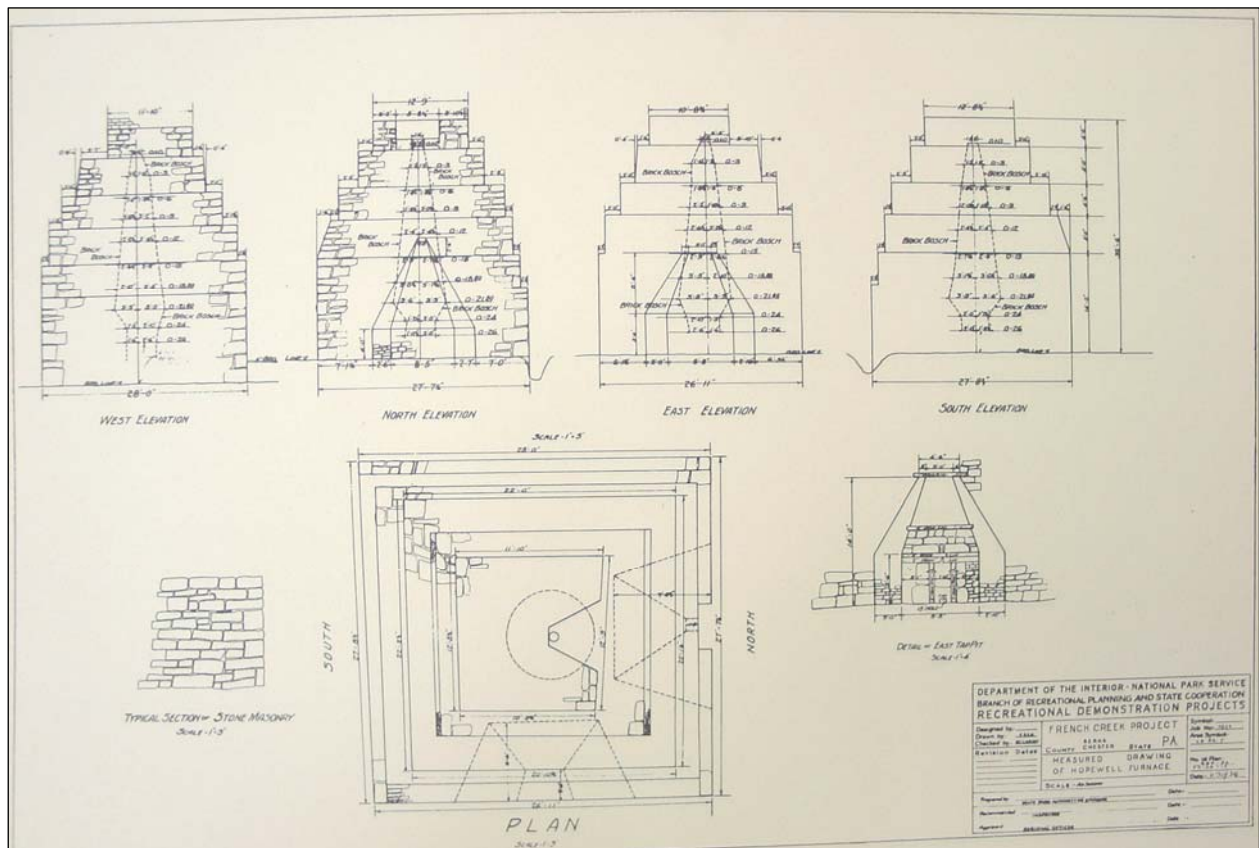
Figure 29. “Measured Drawing of Hopewell Furnace,” documenting the existing exterior and interior dimensions of the furnace, November 30, 1936.

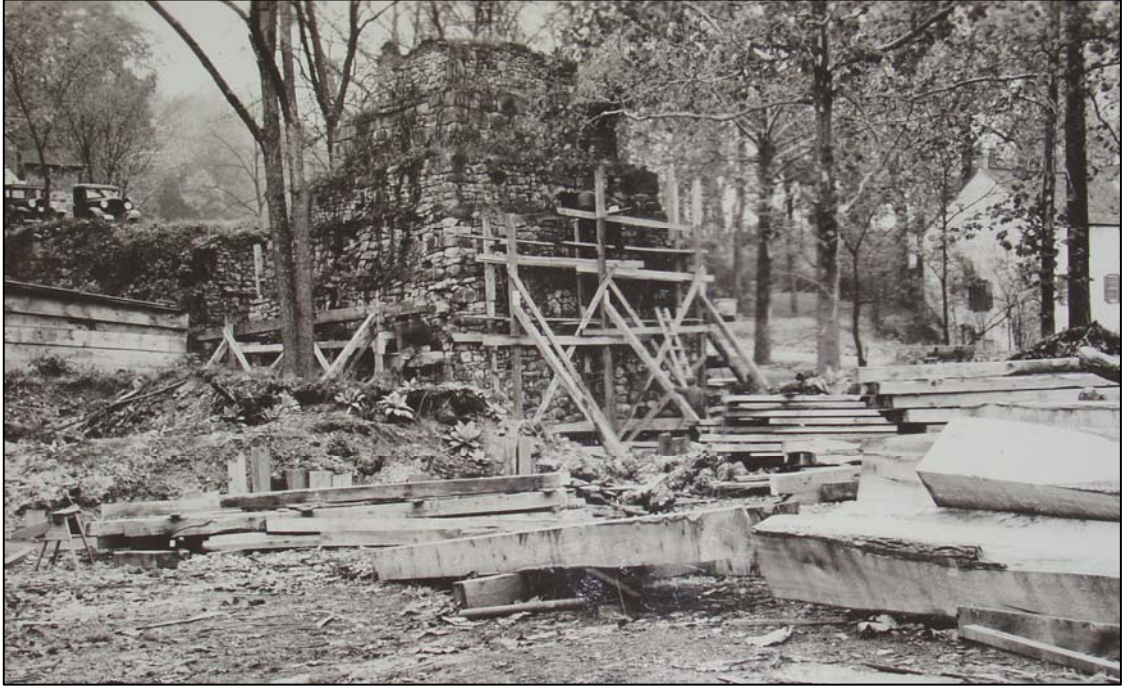
**Figure 30.** Installation of shoring on the south and west elevations of the furnace stack, October 1936.

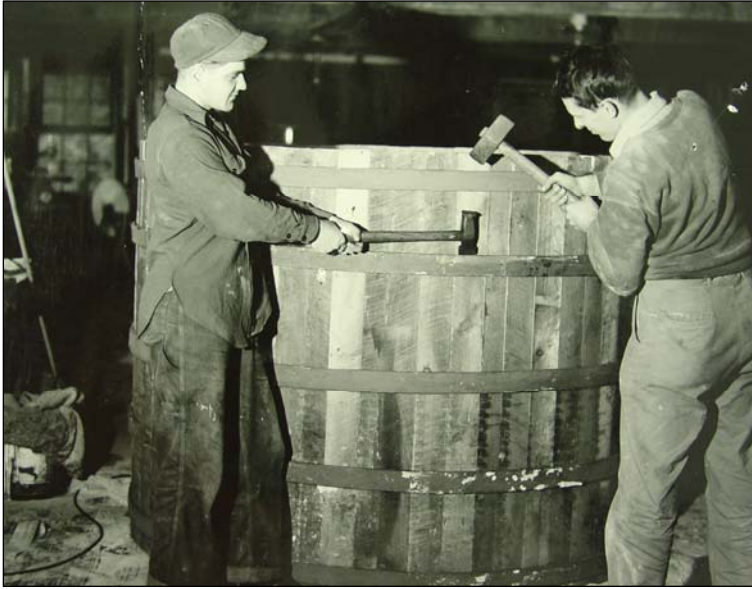
**Figure 42.** Workers installing iron bands around repaired blast tub, September 22, 1950.

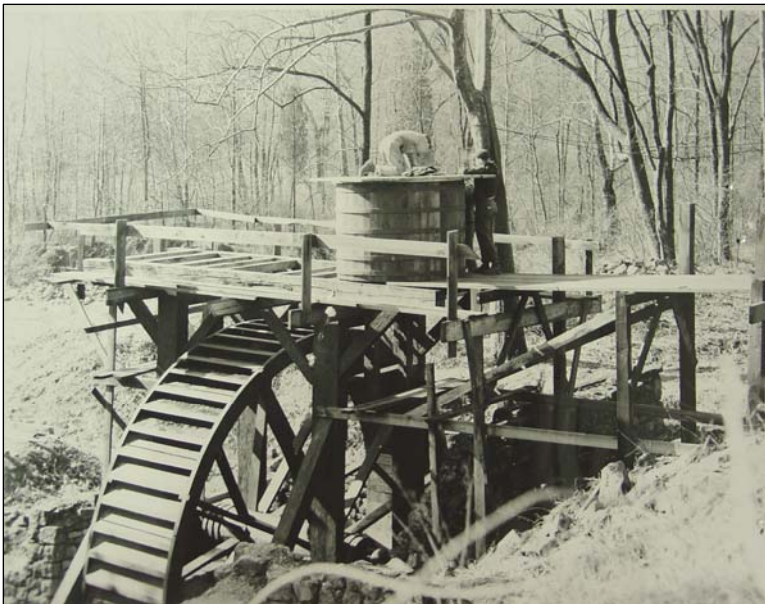
**Figure 43.** Water wheel and one blast tub installed on new platform, March 5, 1951.

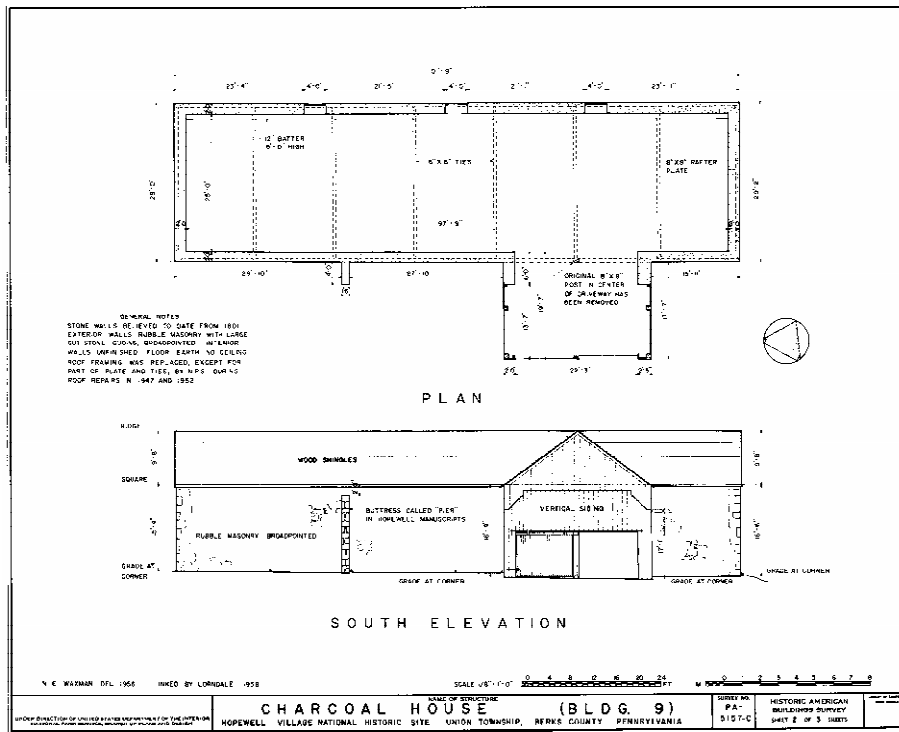
Figure 49a. Existing- conditions drawings: plan and south elevation of the charcoal house, 1956/1958.

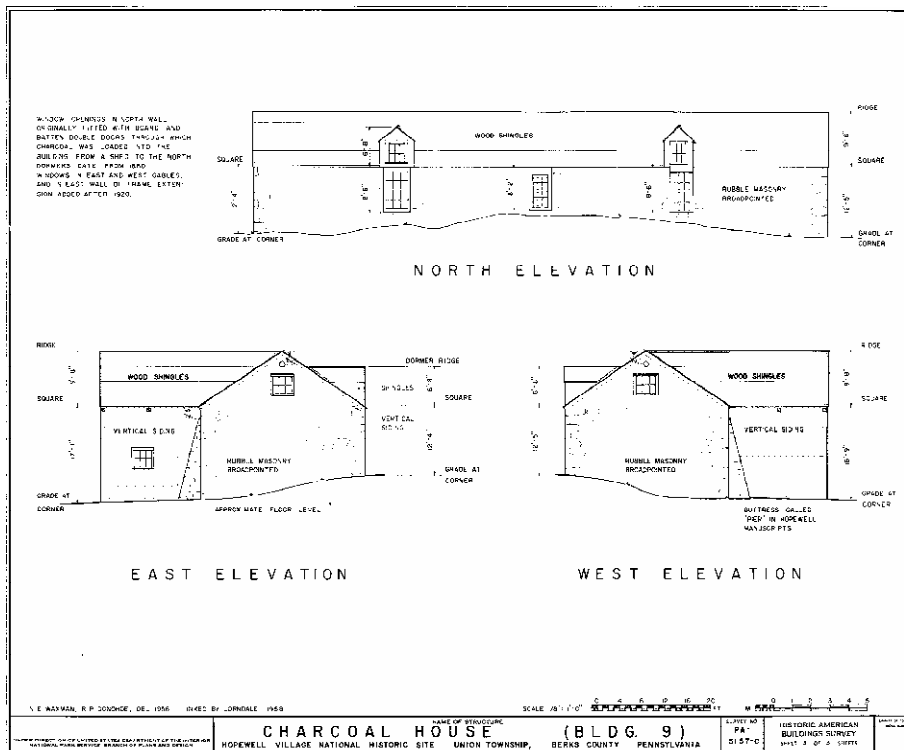
Figure 49b. Existing- conditions drawings: north, east, and west elevations of the charcoal house, 1956/1958.

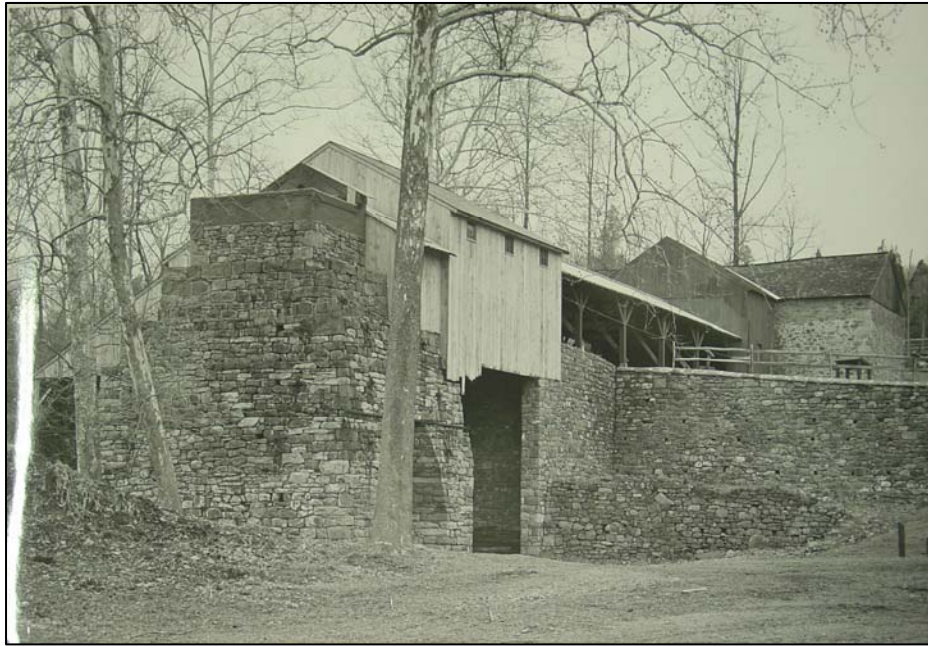
**Figure 51.** View of the Furnace Group from the southeast, showing the reconstructed bridge and wheel houses, March 4, 1958.

Brick walls were added to the upper tier of the furnace stack when the adjacent bridge house was reconstructed circa 1957- 58. Although no written description of this work was found, it is clearly shown in the photographic documentation of the bridge- house project (fig. 51). The design and historical precedent for these walls, which had disappeared by the 1930s, were based on early photographs of the furnace dated 1887 through circa 1920 (figs. 17- 21). The brick walls both heightened the furnace stack and provided a protective firewall on the north side adjacent to the wooden Bridge House.

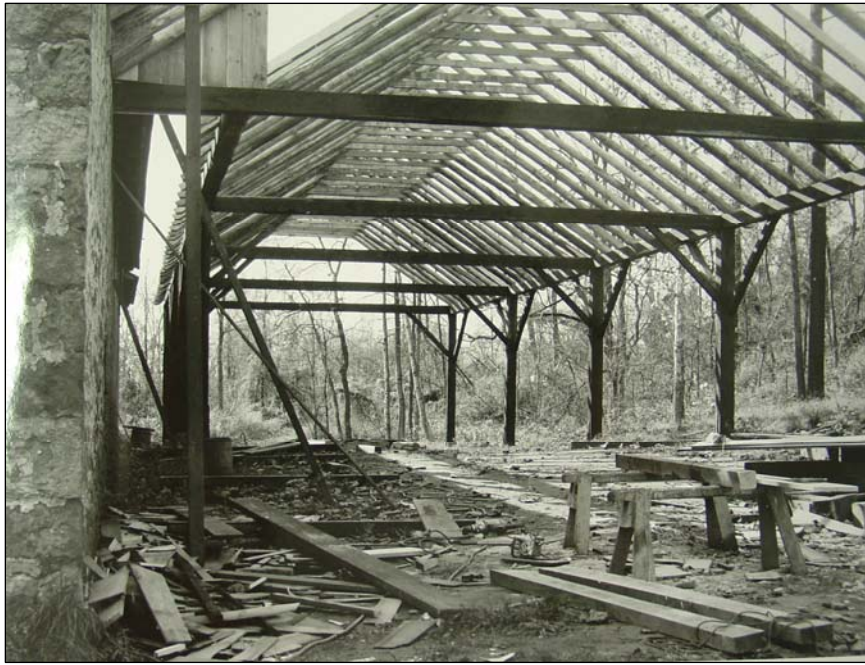
**Figure 52.**  
Reconstruction of  
the cooling shed,  
October 29, 1958.

The labor of reconstructing the open cooling shed was provided by the carpentry crew of Charles S. Painter. Work started May 23, 1958, and was completed the week of November 14, 1958. Surviving stone foundation walls and piers identified by archeology were incorporated in the reconstruction. The low wall at the northeast corner of the shed was heightened by park mason Russell Bowen. Several remaining sandstone, obelisk- shaped piers were reused, and duplicate stones were provided where they were found to be missing. Holes drilled in the stones anchored iron pins driven into the bottoms of the wooden posts. Restoration of the floor was achieved by removing an accumulation of later fill to reveal a heavy layer of charcoal. Since no detailed information or physical evidence of the shed’s framing remained – other than the stone piers that suggested a five- bay frame – typical construction methods of the period were used in the reconstruction. Wood was obtained from local sources, including white oak for most framing members, poplar for the pole rafters, and red oak for secondary members. The framing was first sawn, then hand- planed, and finally assembled with mortise- and- tenon joints. Hand- split shingles were chosen to replicate the “primitive industrial character” of the shed and attached to oak lath. The first eastern bay of the shed’s roof was joined to the plate of the charcoal house, as described in Hopewell records for 1880. The valley between the roofs was sheathed with copper flashing sloped to drain in an easterly direction. The gable ends of the roof were enclosed with vertical boards, each end embellished with a decorative cutout similar to the charcoal house – a star motif in the east gable and a diamond in the west. The exterior gables only were painted with iron- oxide paint. The remainder of the shed was treated with a 5% solution of pentachlorophenol, with an additional protective coating of creosote applied to the posts resting on stone piers.

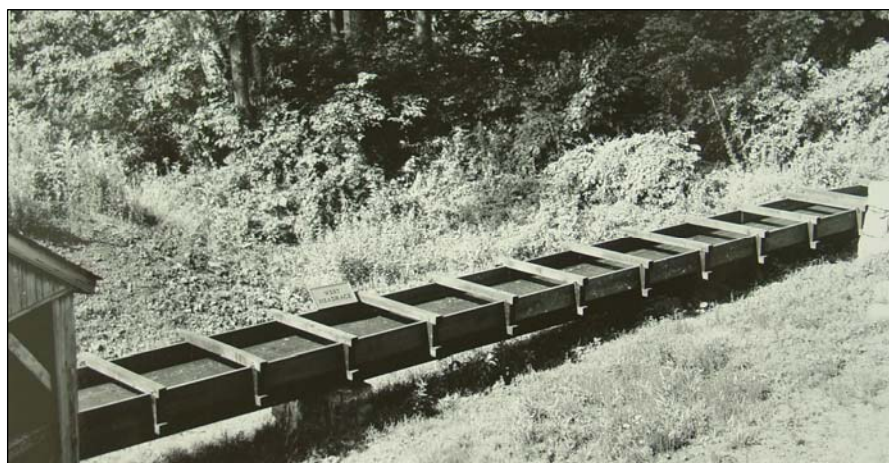
**Figure 56.**  
Reconstructed flume  
of the west head  
race, July 1964.

The work of reconstructing the flume was documented in a completion report by Superintendent Benjamin Zerbey dated October 1964, and 13 photographs in the archives of Hopewell Furnace NHS (e.g., fig. 56).<sup>126</sup> It was carried out by a day- labor crew under the direction of Charles H. Seidel, NPS Building Restoration Specialist. Work commenced on April 27, 1964, and was completed the following month on May 14. A stone retaining wall on the north side was straightened to enable widening of the flume to its historic dimensions of four feet wide by one foot high.<sup>127</sup> Six previously restored stonework piers were again used as supports for the flume's trough with no major modifications. The bottom and sides of the wooden trough were built of longleaf yellow pine, which were fabricated at the local mill with tongue- and- groove detailing. Oak was used for the 8- by 8- inch supporting timbers and the 4- by 4- inch yokes, with mortise- and- tenon connections. Brush and spray applications of creosote provided a protective coating to the wood.

A more authentic reconstruction of the west head- race flume was carried out in 1964 to replace the rotted and inappropriately sized trough constructed by the NPS in 1951- 52. The work was preceded by three historic structure reports prepared in 1961 and 1963 by Superintendent Joseph Prentice, Historian Earl Heydinger, and Architect Norman Souder.<sup>125</sup>

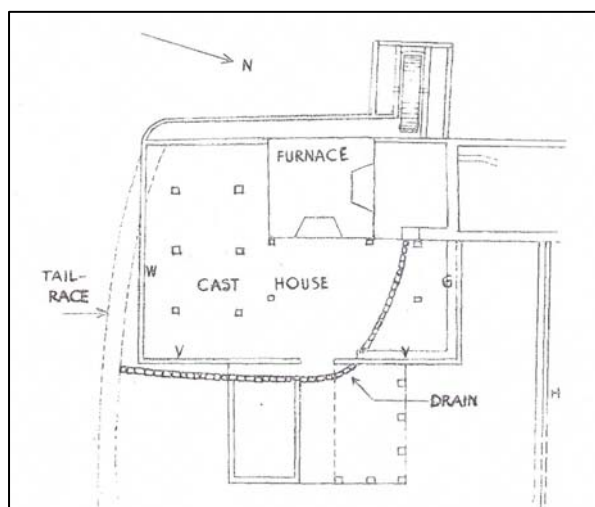
Figure 57. Plan of Hopewell Furnace, showing the 1962- 63 archeological findings of the cast house and east shed after the 1816 enlargement, including stone walls and a stone drain.

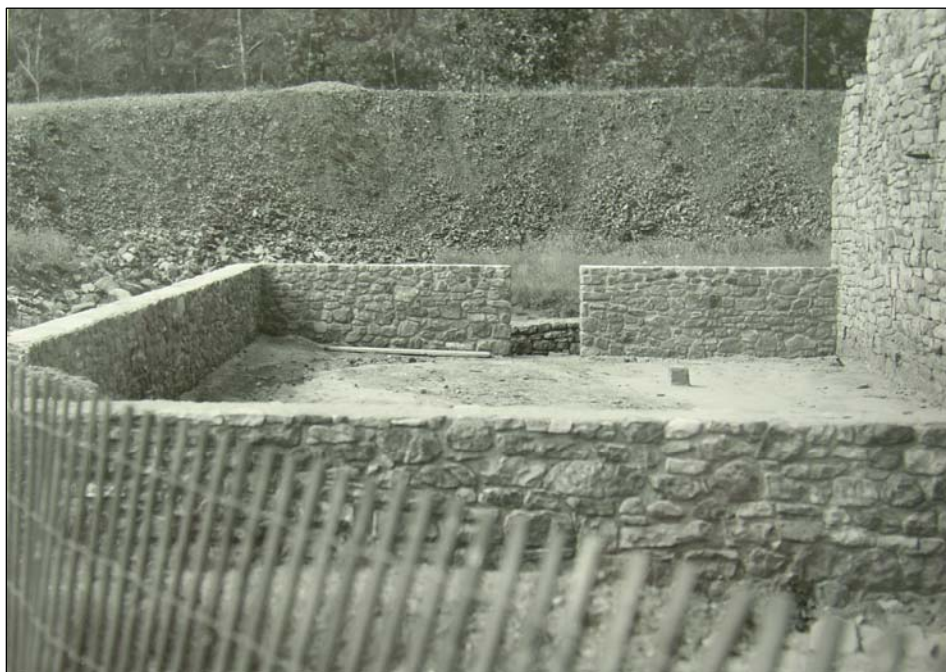
**Figure 58.** Rebuilt stone foundation walls of the cast house, south of the furnace, October 1962.

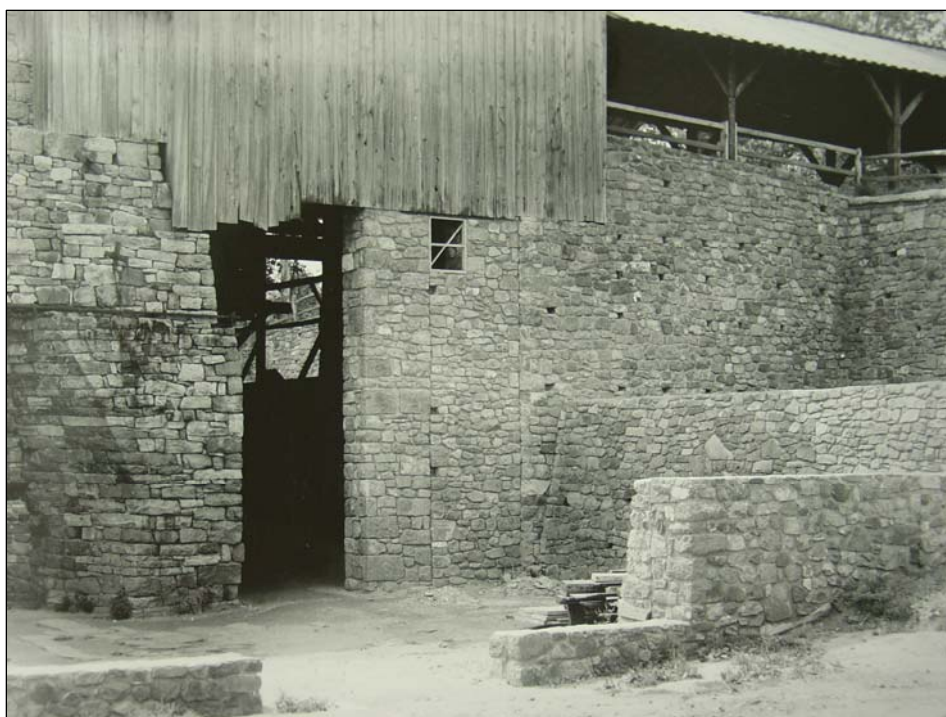
**Figure 59.** Partially rebuilt west wall of the cast house, north of the furnace, September 1963. The new wall is left of window below the bridge house.

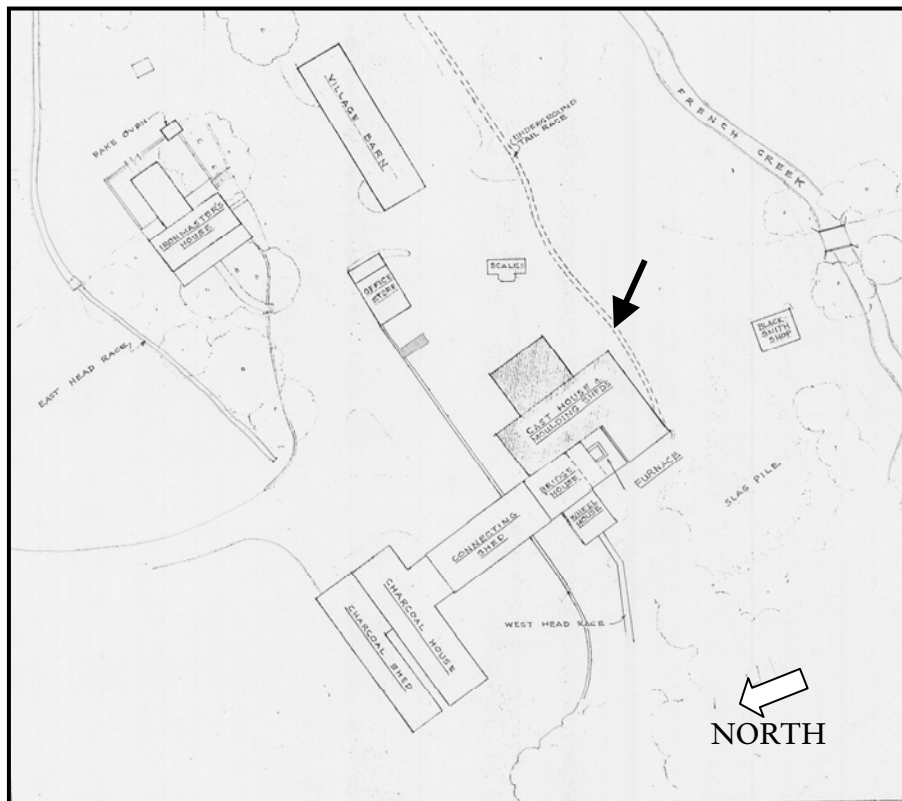
**Figure 60.** Plan showing the proposed reconstruction of the cast house and east shed, April 1964.
