# **THE FURNACE GROUP**

## **HISTORIC STRUCTURE REPORT**

**Hopewell Furnace National Historic Site  
Elverson, Pennsylvania**

**Historic Architecture Program, Northeast Region  
National Park Service  
Lowell, Massachusetts**

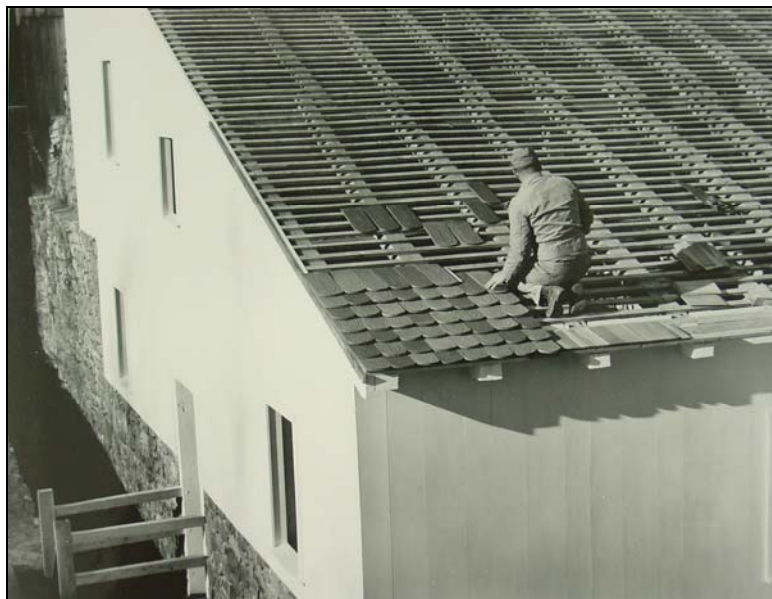
**Figure 62.** Installing tile shingles on the south slope of the cast house roof, November 17, 1964.

The use of red- clay tiles on the roofs of the cast house and east shed was based on the archeological evidence. Hand- made tiles were manufactured under contract by the Ludowici- Celadon Company of New York, to replicate an original intact tile unearthed at the site by Archeologist Leland Abel. This tile measured 15 inches long by 5 ½ to 6 inches wide by approximately five- eighths of an inch thick, and had a slightly rounded lower edge and hand- scored detailing on the upper surface. The tiles were installed on 1- by 3- inch oak lath spaced on 6- inch centers attached to the pole rafters (fig. 62). A clay lug on the back of each tile was laid on the upper edge of the roofing lath. This lug, and the weight of successive courses, held the tiles in place; no other attachments were used. The joints of the tiles were vertically aligned, rather than staggered, based on research of local practices. Vertical joints between the tiles were made watertight by the installation of wooden strips beneath the tiles, based on a similar treatment observed on a building at the ca.- 1740s High (Knittle) Farm opposite the Metropolitan Edison Generating plant. At Hopewell, the strips were said to have been fashioned from surplus shingles that were cut and planed to measure 1 ½ inches wide by about an eighth of an inch thick.<sup>134</sup> Where the roof abutted vertical surfaces, copper flashing was used.

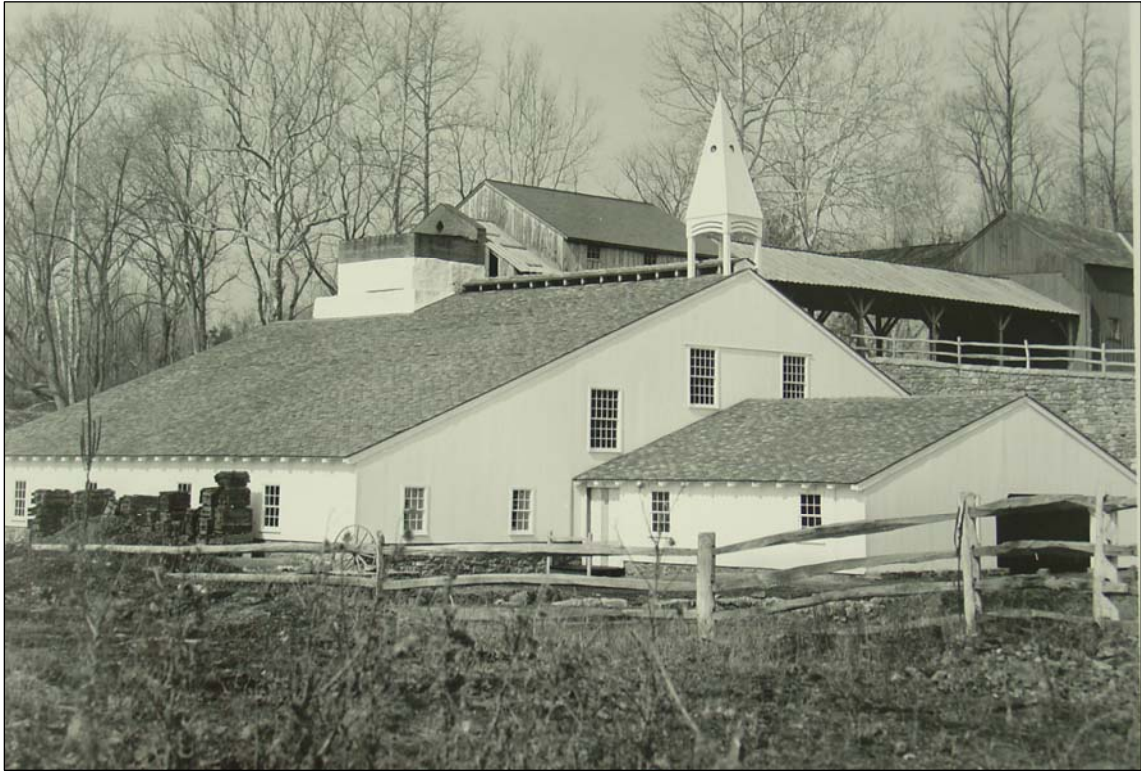
**Figure 63.** The completed cast house and east shed, March 29, 1965.

The exterior and selected interior portions of the cast house and east shed were painted white (fig. 63). Whitewash was applied to the exterior and interior stone walls of the cast house, and to the interior south face of the stone furnace stack. Due to the difficulty of maintaining whitewash on new wood, a simulated whitewash was used on the wooden portions of the building. This consisted of a primer coat of white oil- based primer, followed by a second coat of white oil paint with an additive of fine sand. The simulated whitewash was applied to the exterior wooden portions of the building, and the interior wall sheathing, sills, and plates of the cast house and north side of the east shed.

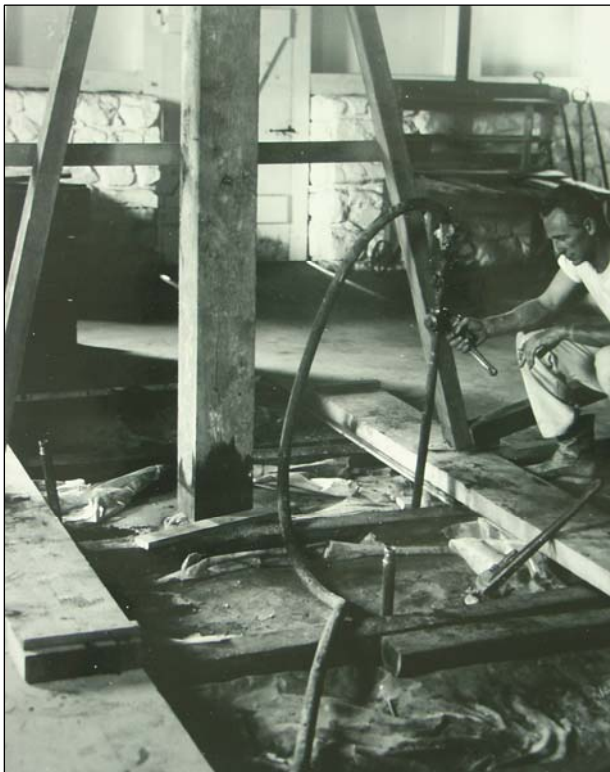
**Figure 64.** Contractor pumping grout into the ground beneath three posts of the cast house, September 1965.

A sag was detected in the roof of the cast house shortly after its reconstruction in March 1965. Investigation found that the stone- pier foundations of three interior posts in the south side of the building had settled from 2 to 2 ½ inches due to water infiltration from the tail race. This caused the braces and other structural members to pull apart, resulting in settlement of the heavy tile roof and deflection of the belfry. A company (Intrusion Prepakt) was contracted to pressure- grout the area in the vicinity of the three posts. Photographs indicate this work was carried out in September 1965 (fig. 64). A completion report prepared the following year described the process as follows:

Sixty cubic foot of grout was forced through 21 pipes which had been driven approximately 4' in the ground, under 125 lbs. pressure psi, and then into the soil. Basic ingredients of the material called “neat mix” are applied by formula in the following mixture – 94 lbs. of cement, 5 lbs of Chemix, and 30 gallons of water. “Chemix” is an admixture which controls consistency, penetration, pumping pressures, bleeding, stiffening rate, and setting time. One of its main ingredients is Calcium Chloride.<sup>135</sup>

The treatment was declared successful, although was obviously detrimental to surviving archeological resources.

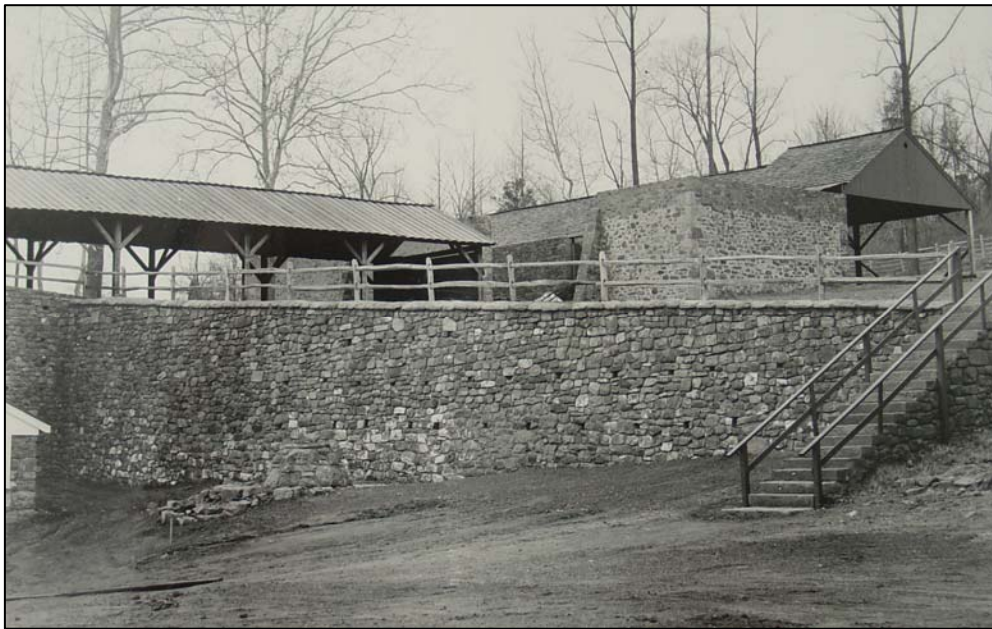
**Figure 65.** South and east elevations of the charcoal house following demolition of the roof and south extension, June 1965.

The restoration of the charcoal house attempted to return the building to its pre- 1880 appearance. This involved removing most wooden components, including the south extension, window sashes and frames in the north elevation, and the entire roof structure. The stone walls were then repaired, the south doorway reconfigured and fitted with new doors, wooden shutters installed in the former window openings, and the roof rebuilt with no dormers and no windows in the gables.

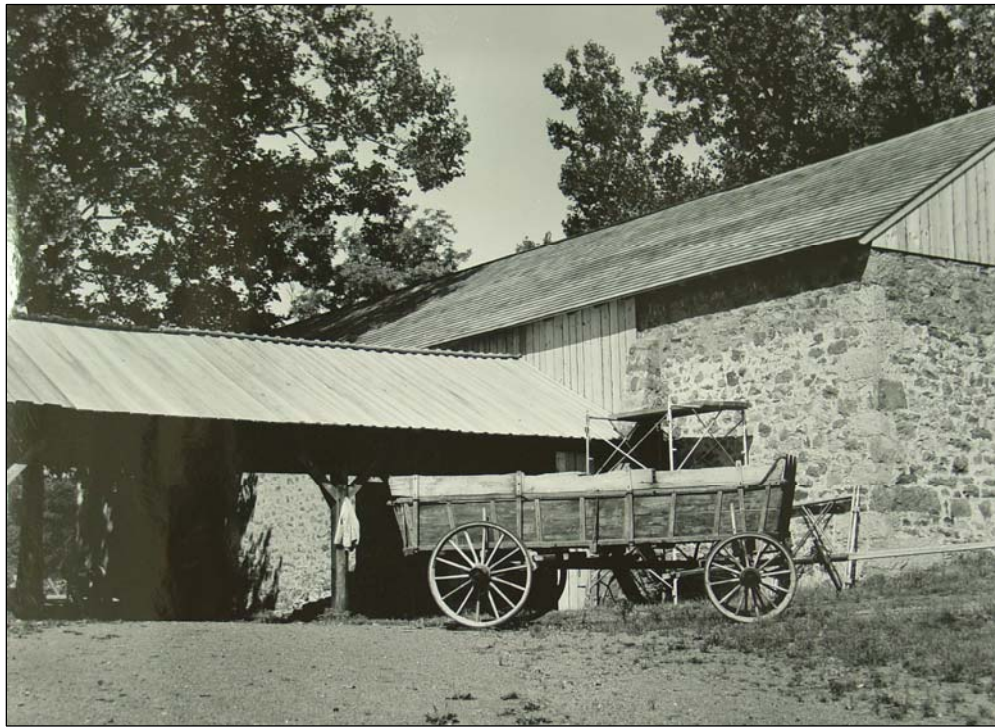
**Figure 66.** South and east elevations of the partially completed charcoal house, July 1965.

The south extension of the charcoal house that had been constructed in 1880 was removed in 1965. The connecting shed of the bridge house was then lengthened one bay to fill the void (fig. 66). This work replicated the existing materials of the connecting shed, which had been previously reconstructed by the NPS in 1957- 58.

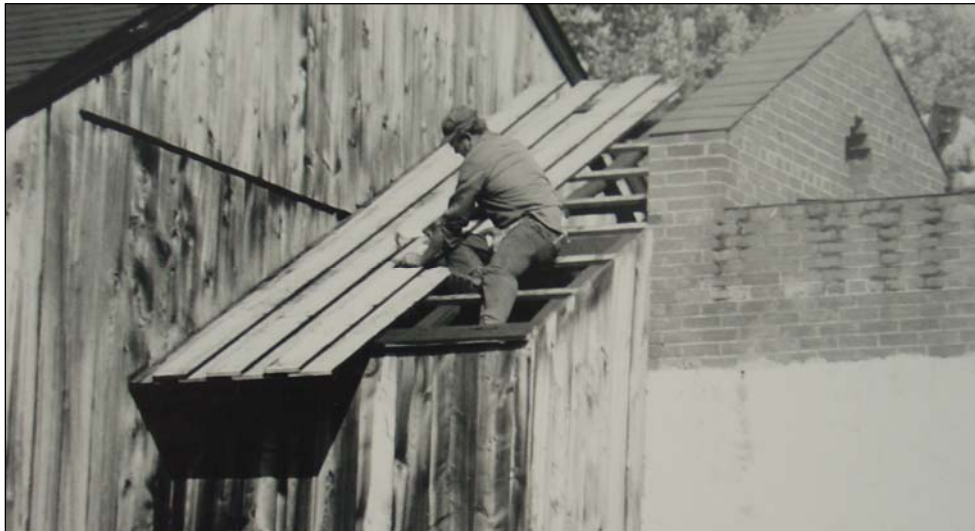
Figure 69. Reroofing the tunnel- head vestibule of the bridge house, November 1971.

The tunnel- head vestibule of the bridge house adjacent to the furnace was reroofed with new wooden planks in 1971. The only known documentation for this work is a set of photographs in the archives of Hopewell Furnace NHS (fig. 69).<sup>139</sup>

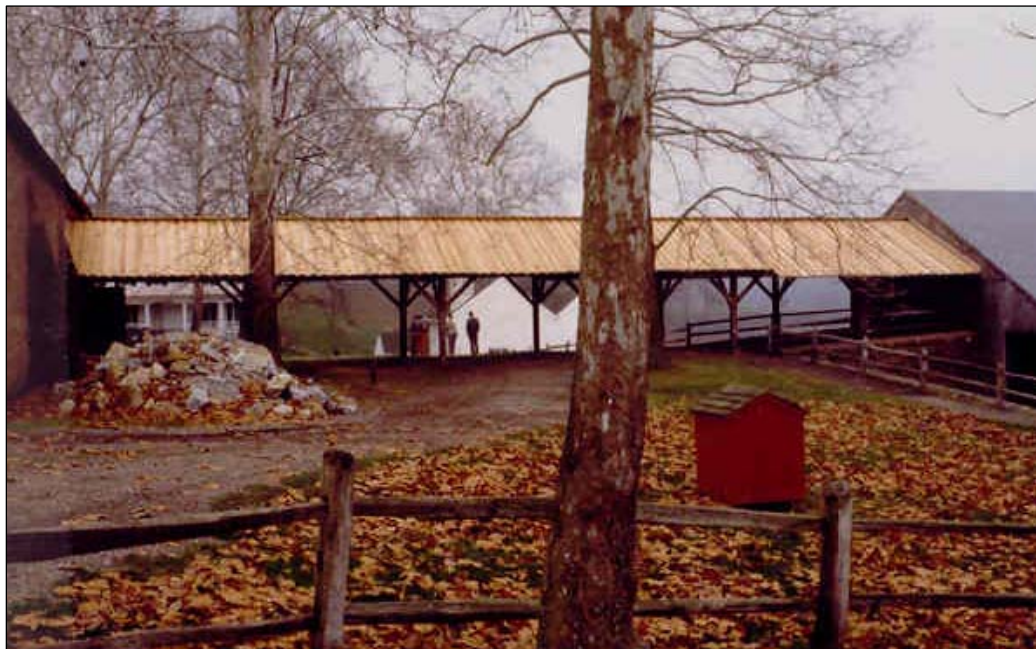
Figure 70. New roof on the connecting shed, Nov. 11, 1977.

A new roof was installed on the connecting shed roof in 1977 under contract CX4000- 6- 0025, “Roof Repairs, Connecting Shed.” Contract files indicate that white pine lumber was used. The contractor was the Roberts Construction Company of Frederick, MD.<sup>140</sup> Photographs of the completed project were taken November 11, 1977 (e.g., fig. 70).

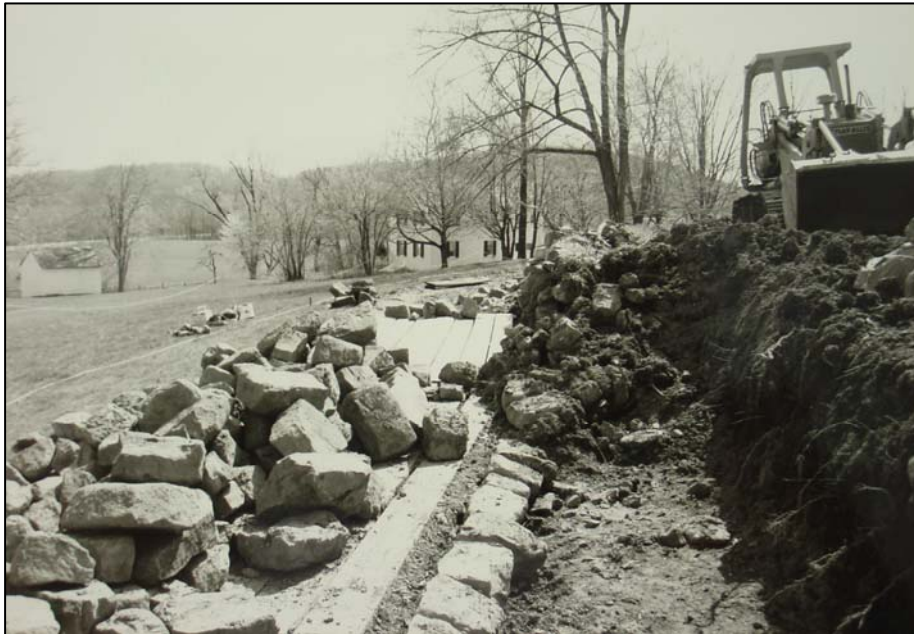
**Figure 72.** Wall restoration at the east head race, on the west side of Route 345, spring 1984.

## East Head Race Wall Restored, 1984

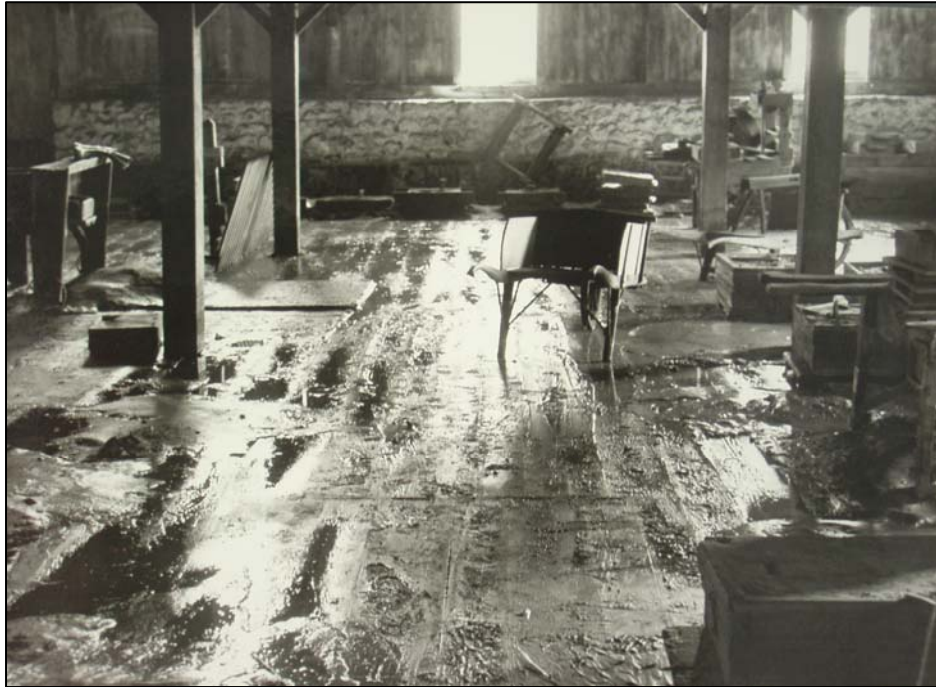
Figure 73. Post- hurricane damage in the cast house, 1987.

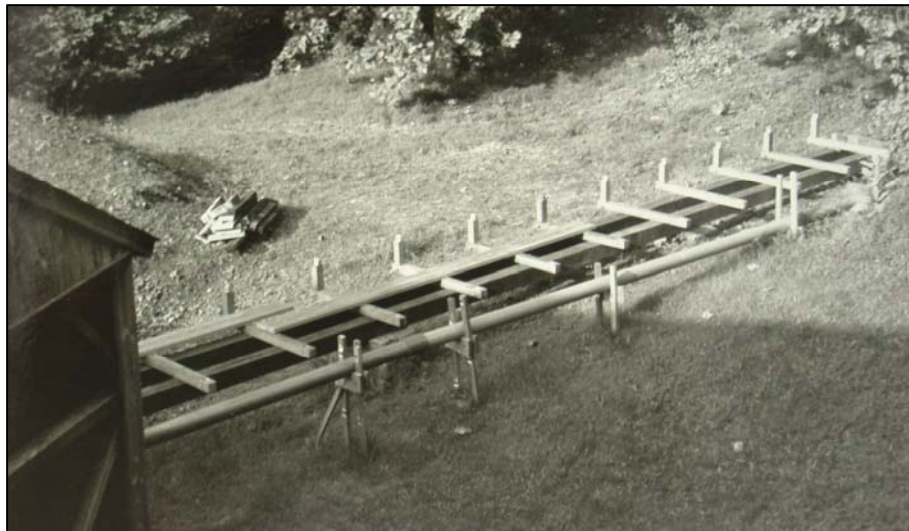
**Figure 75.**  
Reconstructing  
the flume of the  
west head race,  
August 1989.

A third reconstruction of the west-head-race flume was undertaken by NPS in the summer of 1989, replacing the wooden structure of 1964. The work is documented by nine photographs in the archives of Hopewell Furnace NHS (fig. 75).<sup>158</sup>

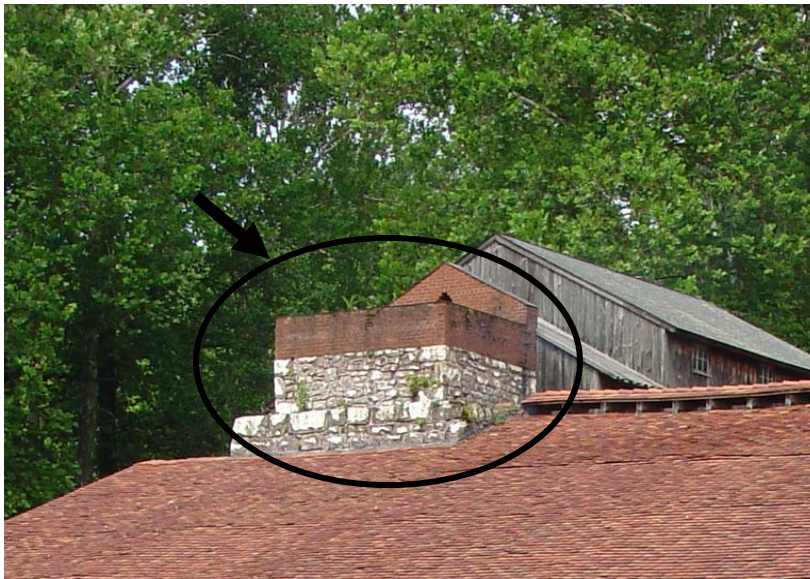
**Figure 78.** South and east exterior elevations of the upper furnace stack, July 2006.

The exterior of the furnace is constructed of rough-dressed fieldstones that rise in steps to a height of approximately 38 feet, from a base measuring 28 feet wide on the north side by 27 feet wide on the east side. The stone walls at the base were estimated in 1939 to measure about 10 or 12 feet thick, indented on the east side by a cast arch and on the north side by a tuyere arch with tunnel head above (figs. 79, 81, and 91).<sup>2</sup> Of these thick walls, only the outer layer of stones and iron lintels remain unchanged, the interior having been completely rebuilt by the CCC with reinforced concrete and cement mortar during the years 1936 to 1941. The brickwork walls of the upper furnace stack (fig. 78) and the tunnel head were rebuilt at the same time as the bridge house, in 1957-58. Repointing of the furnace was undertaken in 1988.<sup>3</sup>

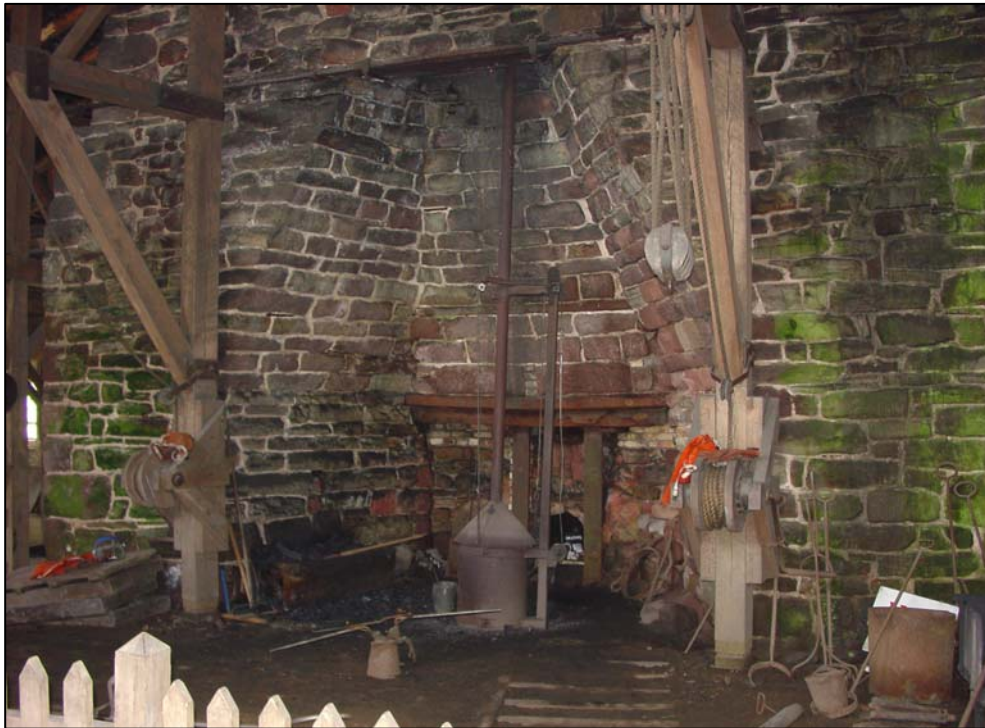
**Figure 79.** Cast arch on the east side of the furnace, July 2006.

A large recessed arch on the east side of the furnace is the “cast arch,” through which smelted iron was drawn (fig. 79). Molten iron collected in the crucible at the bottom of the bosch. The cast arch is supported and framed by iron lintels and jambs, which were preserved during the 1936- 41 stabilization and presumably predate 1883. A stone with the carved date “1771” is located at the lower left side of the cast arch opening (fig. 80). The lower portion of the furnace stack, including the cast arch, was historically protected within a structure during its many years of operation, but was exposed to the weather following the collapse of the cast house in the 1890s. It remained that way until reconstruction of the existing cast house in 1964- 65.

A modern crucible for heating aluminum currently sits in front of the cast arch and is vented through the bosch of the furnace stack (fig. 79). The molten aluminum is used by NPS interpreters and volunteers to demonstrate flask casting. During periods when no casting demonstrations are being given, the small furnace is moved to storage. Two wooden cranes flanking the cast arch were installed by the NPS sometime after 1978.

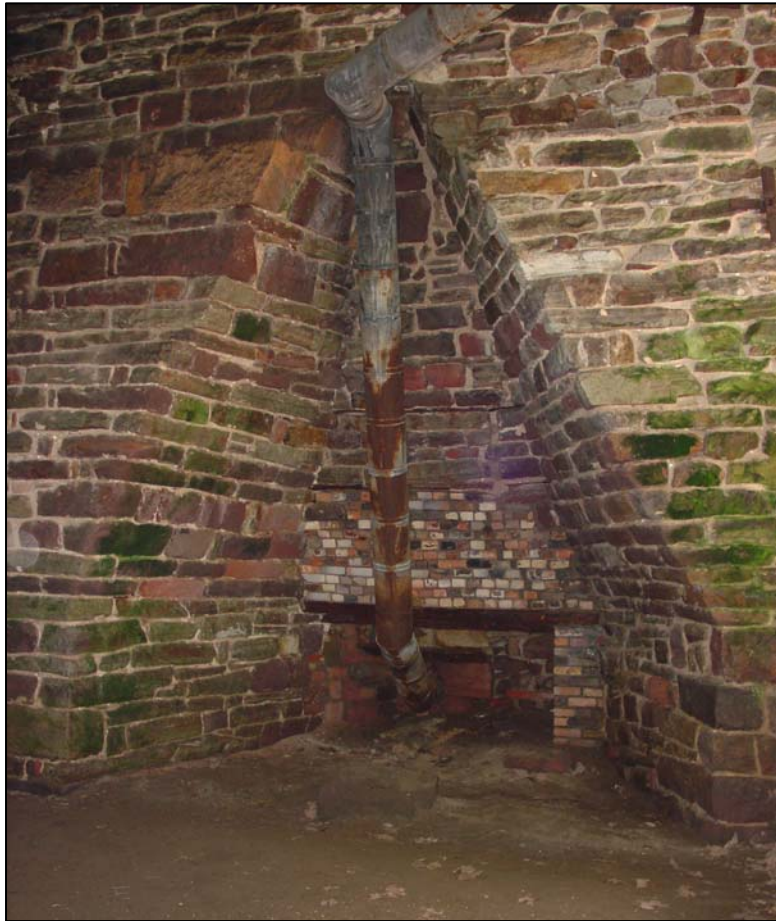
**Figure 81.** Tuyere arch on the north side of the furnace, July 2006.

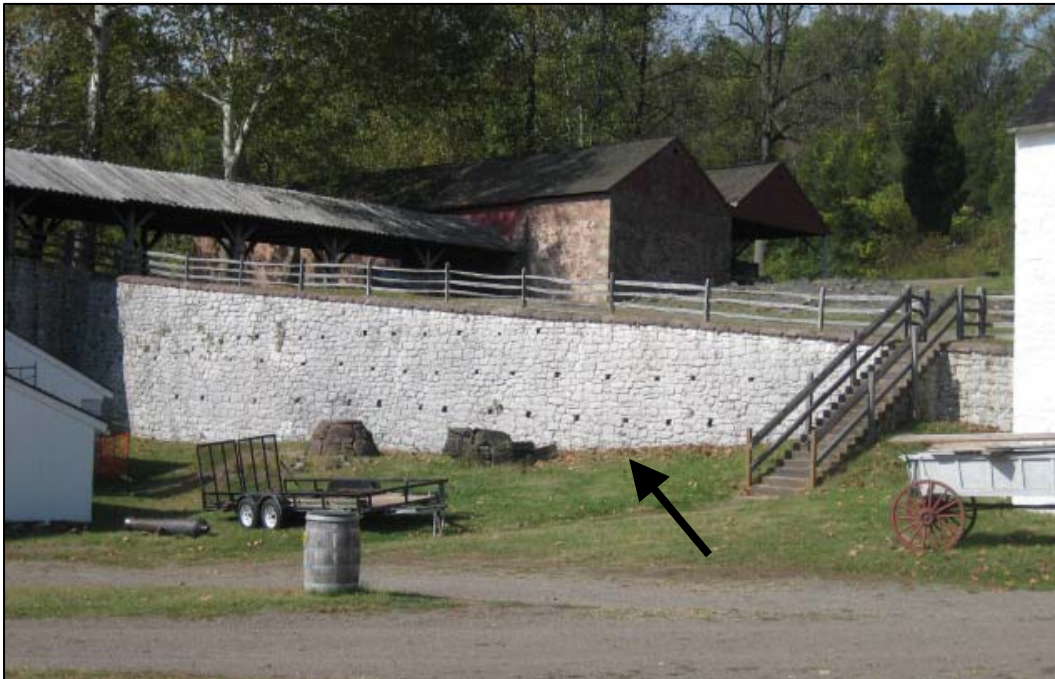
**Figure 83.** The furnace bank and retaining wall (at arrow), east of the furnace, October 2007.

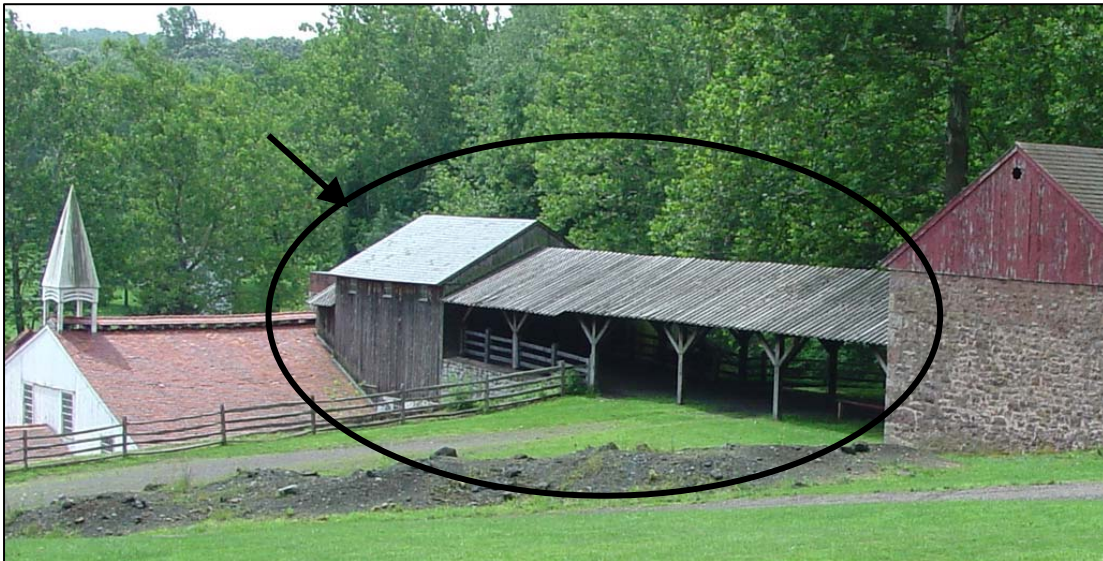
**Figure 85.** General view showing the east elevation of the bridge house and connecting shed, July 2006.

The connecting shed provided a covered passageway for the carting of charcoal from the charcoal house on the north side to the enclosed bridge house on the south side (figs. 85- 86). It is a reconstruction built by the NPS in 1957- 58 to reflect the appearance of the building circa 1879. The connecting shed is six bays long, with the bays defined by 10 timber posts and beams (five on each side) supporting a gable roof.<sup>14</sup> The northern four bays are located on the furnace bank, and the southern two bays on an extension of the furnace bank created by tall stone retaining walls that were reconstructed in 1956. The northernmost bay, adjacent to the charcoal house, was added in 1965, increasing the total length of the connecting shed to 45 feet. The flooring is compacted charcoal dust, gravel, and slag covering a subfloor of earth at the furnace bank, and a modern concrete slab supported by steel I- beams at the south extension (figs. 89- 90 and 93). The floor of the south extension slopes gently upwards to the south to meet the elevated floor of the enclosed bridge house. The connecting shed has no walls, the gable roof providing the only protection from the elements. Design of the roof with board- and- batten roofing was based on the historic photographs of 1887 and 1896 (figs. 17 and 18), while the framing of pole rafters and roof lath was most likely conjectural (figs. 89- 90).<sup>15</sup> The board- and- batten roofing was replaced in 1977 and again in 1999. Hemlock was specified for the roof in 1957, white pine for the roof replacement in 1977, and southern yellow pine that was pressure-treated for the most recent roof in 1999. The existing roof boards consist of uniform 2 x 10 stock, whereas the historic photographs of 1887 and 1896 show what appear to be thinner boards of random widths.

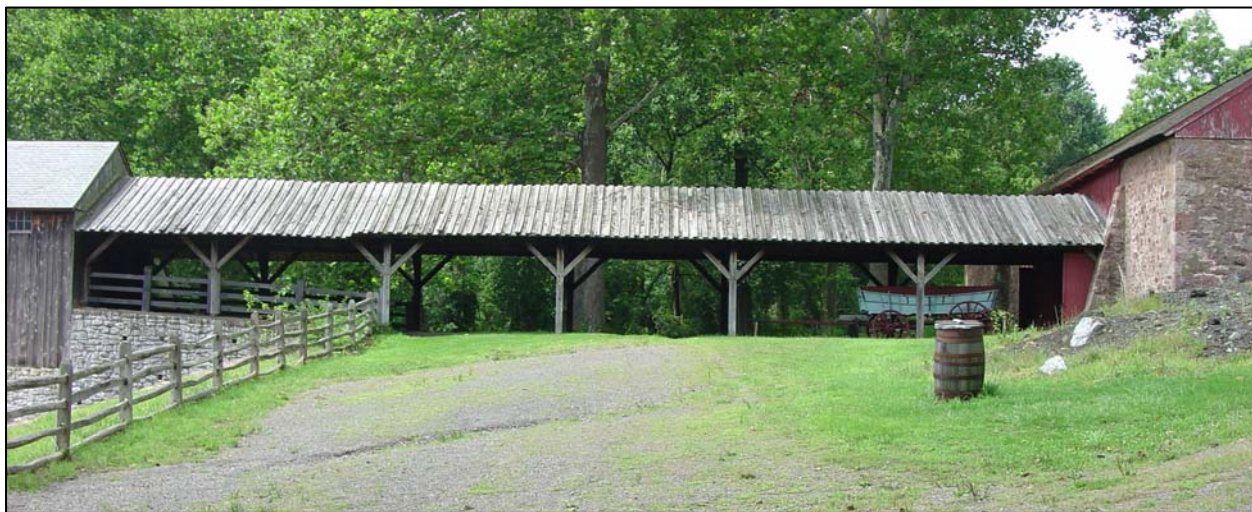
**Figure 86.** East elevation of the connecting shed, July 2006.

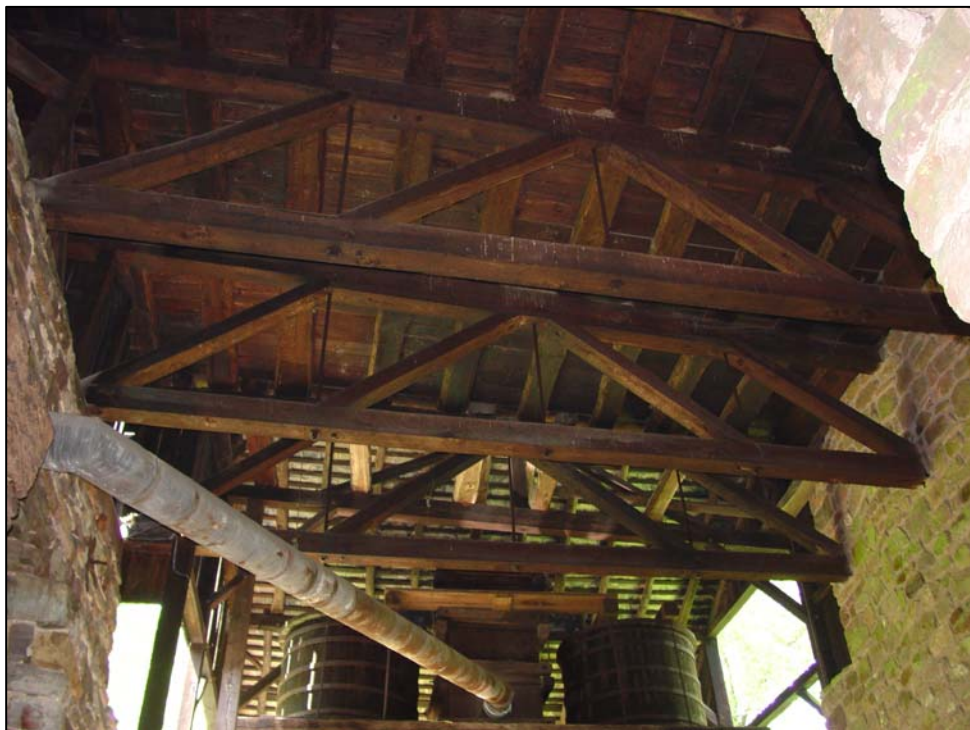
**Figure 92.** View of floor framing of the enclosed bridge house and tunnel-head vestibule, looking west, July 2006.

The enclosed bridge house is where charge was temporarily stored and weighed before loading into the furnace. It is located between the connecting shed to the north and the tunnel- head vestibule to the south, and measures 28 feet long. The existing structure is a reconstruction built by the NPS in 1957- 58 to reflect the appearance of the building circa 1879. The design was based primarily on the historic photographs of 1887, 1896, circa 1910, and 1920 (figs. 17- 21). It is a simple, gable- roofed structure supported by four floor trusses anchored on the south side by the furnace, and by a stone wall reconstructed in 1956 on the north side<sup>16</sup> (figs. 92 and 94).

A small covered space fills the gap between the enclosed bridge house and the tunnel head, or opening, into which charge was loaded into the furnace. This space, designated the “tunnel- head vestibule” by this report, is supported by the same wooden- truss system as the enclosed bridge house (fig. 92). The design of the 1957- 58 reconstruction was based primarily on the previously mentioned historic photographs. The wood floorboards of the vestibule are continuous with those of the north adjacent bridge house. The vestibule abuts and shares the north wall of the bridge house; the east and west exterior walls are sheathed with the same vertical wide- pine boards. The south wall is masonry, the lower portion made up of the stonework of the furnace and the upper portion the brickwork of the protective firewall<sup>18</sup> (fig. 78). A wide doorway in the north wall connects with the enclosed bridge house, and an arched opening in the south masonry wall opens to the tunnel head where charge was loaded through a hole in the floor. The gable roof of the vestibule sits lower than the roof of the adjacent bridge house, and is covered with the same board- and- batten roofing as the connecting shed. Like the enclosed bridge house, the vestibule has no painted finishes.

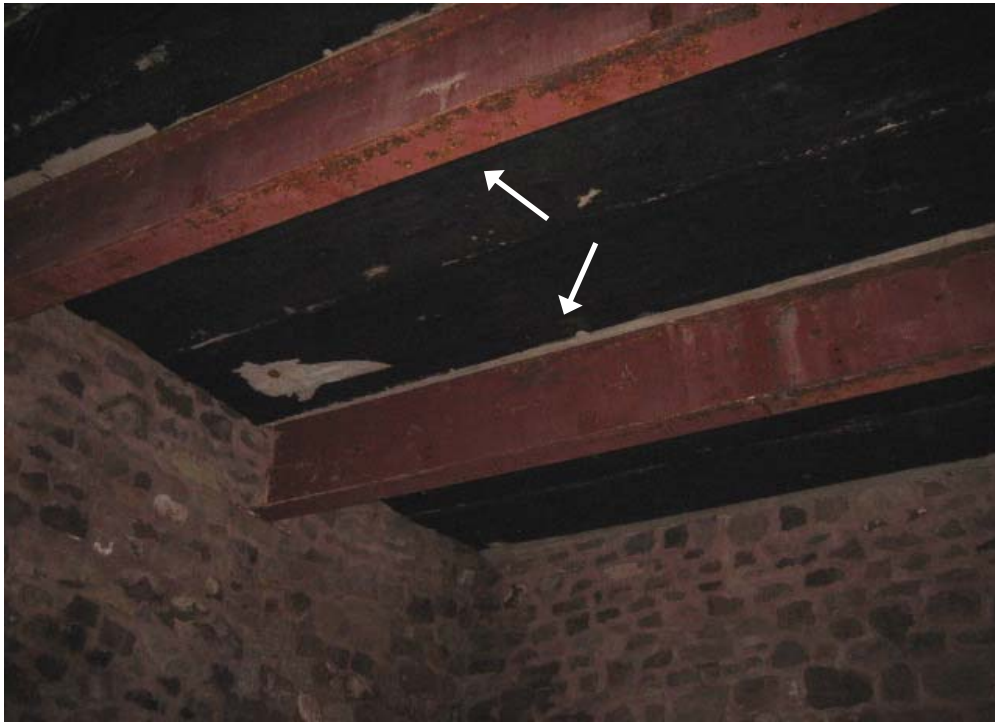
**Figure 93.** Steel I- beams (at arrows) supporting the modern concrete floor slab at the south end of the connecting shed, September 2007.

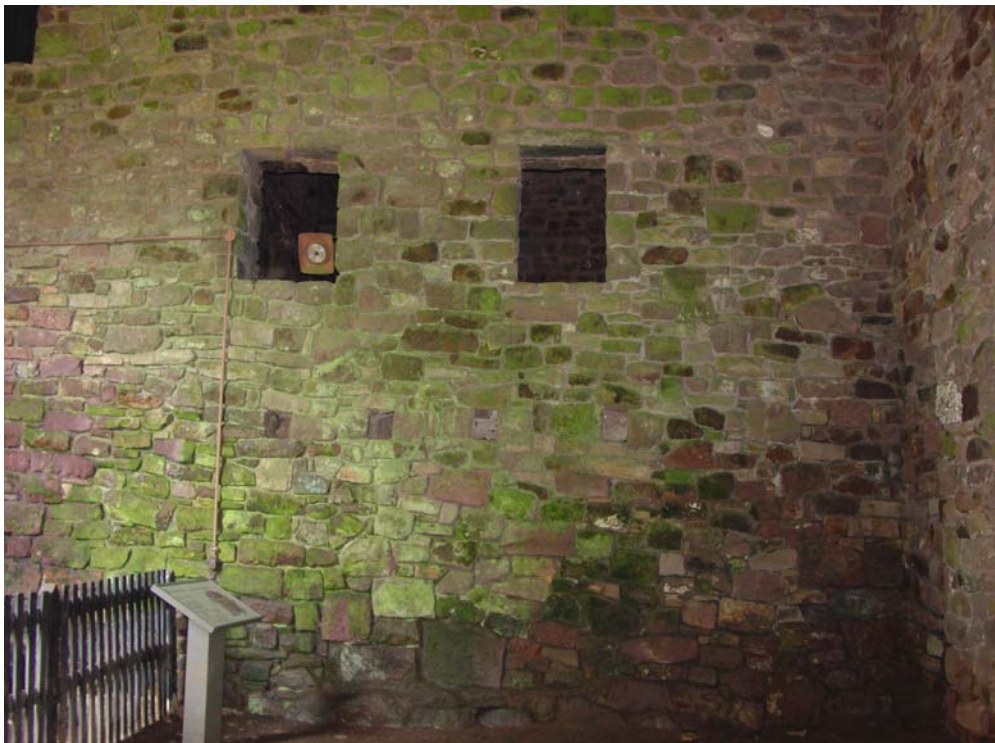
**Figure 94.** Reconstructed north wall ("Wall A") supporting the north end of the enclosed bridge house, July 2006.

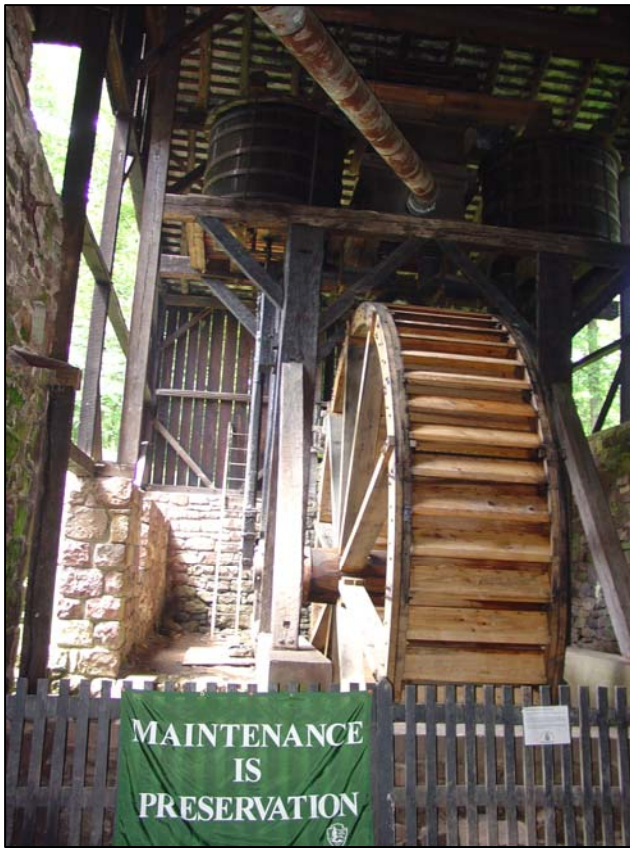
**Figure 103a.** Interior view of the wheel house, looking west and showing the water wheel and blast machinery, July 2006.

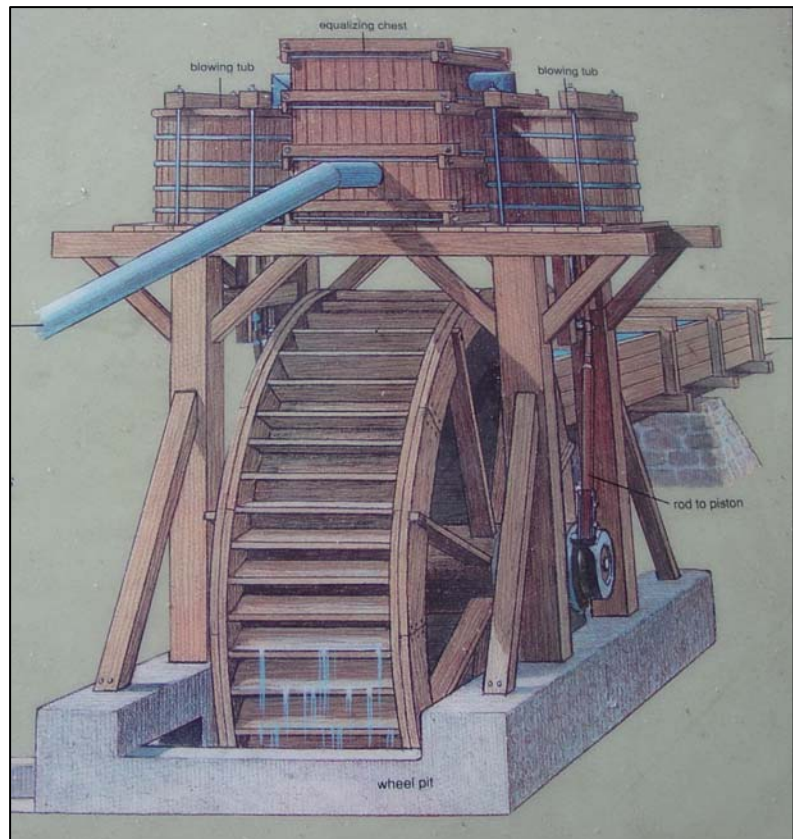
**Figure 103b.** Schematic view of the water wheel and blast machinery.

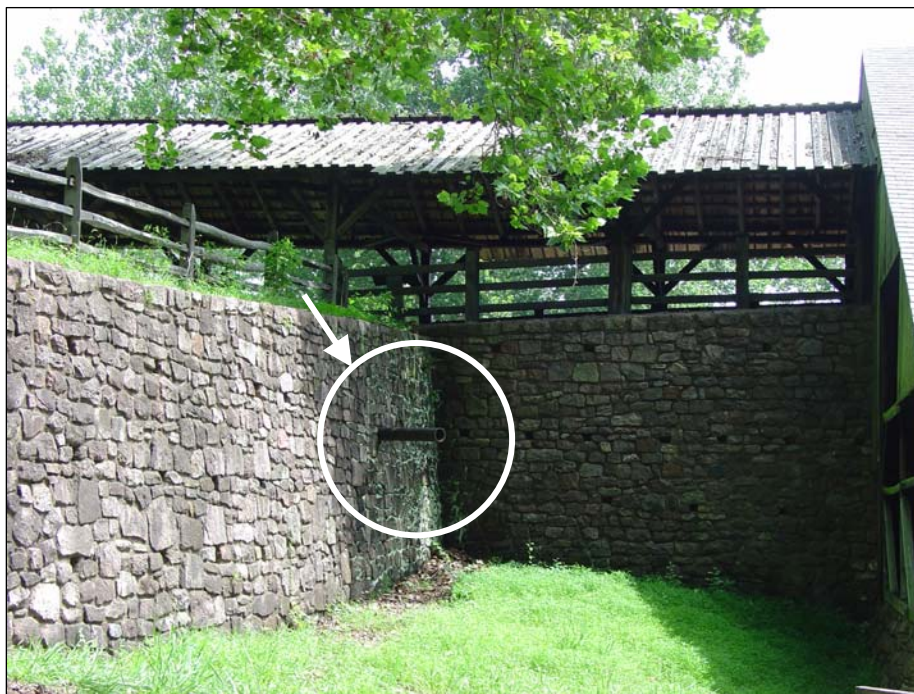
**Figure 105.** Truncated pipe (at arrow) that conveyed water from the east head race to a wooden flume (now missing) north of the water wheel, July 2006.

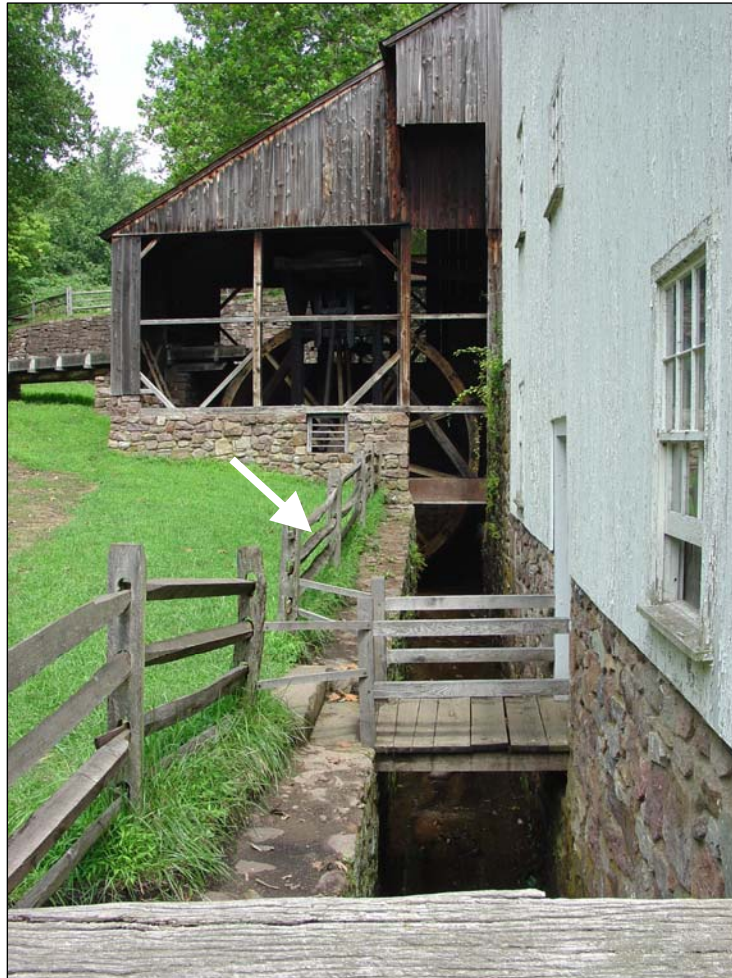
**Figure 109.** Open portion of the tail race (at arrow), on the west side of the cast house, July 2006.

No physical or documentary evidence remained for a doorway in the west wall south of the furnace (figs. 109 and 118). No historic photographs of this elevation are known, and the stone wall had disappeared to ground level by 1962. A doorway was nevertheless installed here in 1964- 65, based on evidence that used molding sand had been discarded along the exterior south wall of the cast house. The doorway was thought to provide convenient access to both the south wall and the slag pile to the west. The board- and- batten door is also conjectural.

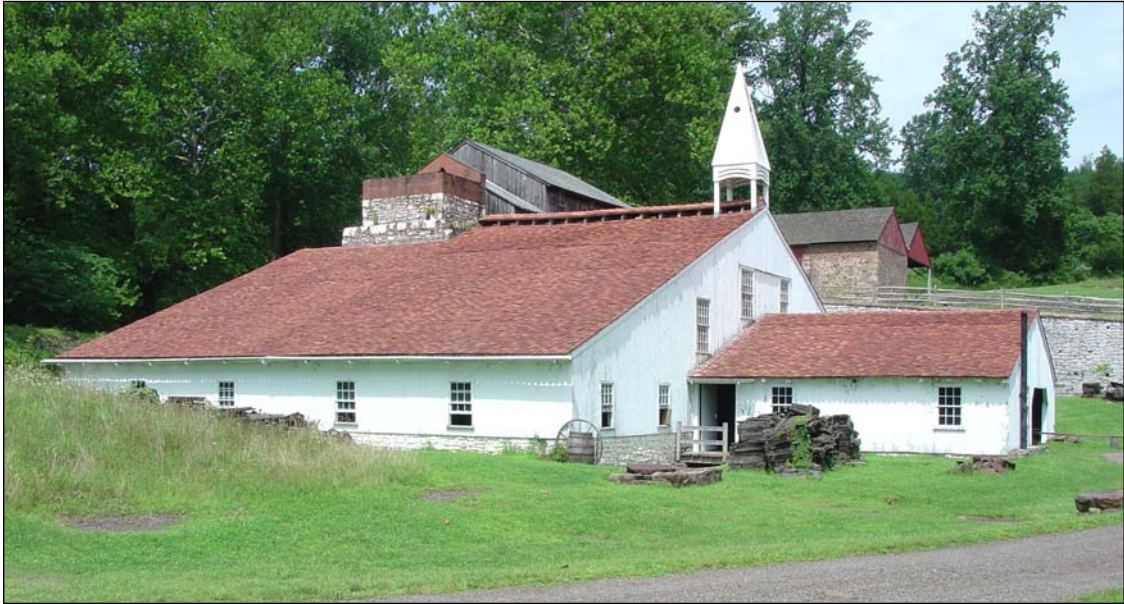
Figure 112. South and east elevations of the cast house and east shed, July 2006.

A smaller exterior doorway is located in the south wall of the east shed (fig. 112). This doorway is placed at the west end of the wall, close to the cast house; it accesses the enclosed room on the south side of the shed. No documentary or physical evidence exists for this doorway. Both the opening and its board- and- batten door are therefore conjectural. Placement of the doorway over the drainage ditch also necessitated the building of a conjectural wooden deck.

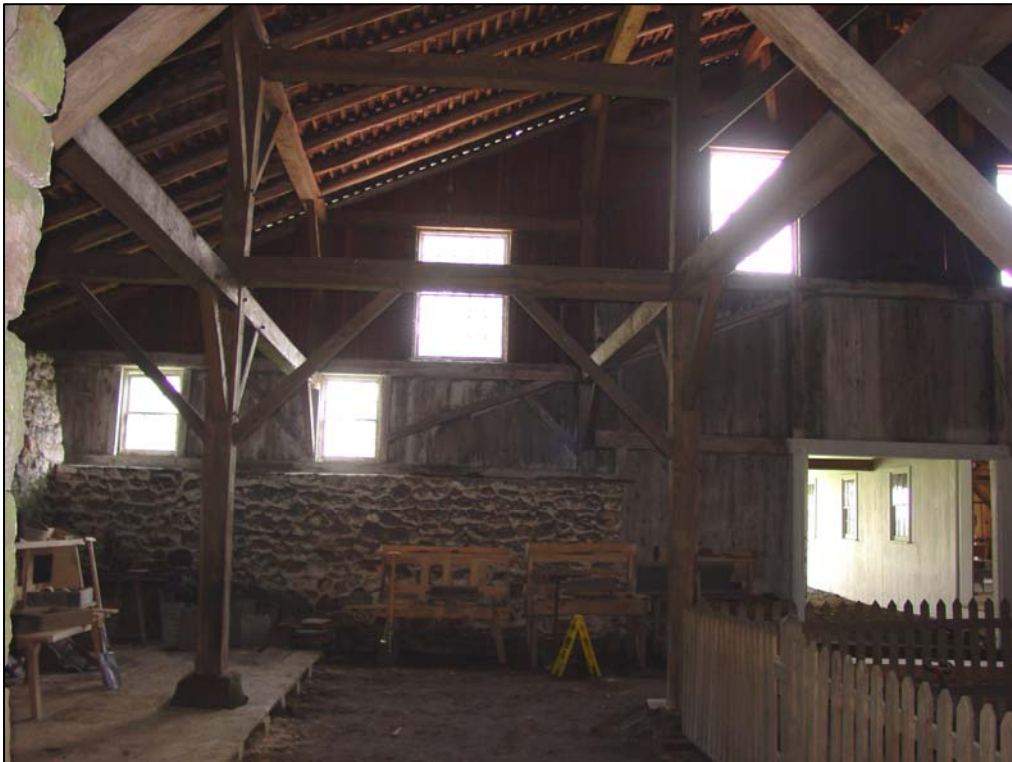
Figure 114. Interior north side of the cast house, view looking east, July 2006.

Stone walls of various heights are visible above grade in the cast house (figs. 114- 118). The south portion of the building, also called the south molding shed, has low stone walls measuring approximately 4 feet 6 inches high. The north portion of the building, also called the north molding shed, has floor- to- ceiling stone walls on the north and west sides, and a shorter (6-foot, 6- inch) wall on the east side. The walls are rubble masonry made of medium- sized unshaped or roughly shaped blocks of brown and purple sandstone. Of these walls, only the tall north wall (approximately 11 feet high) and its northeast corner remained standing in 1962. These were in poor structural condition, however, and so were completely rebuilt from the base up in 1962- 63.<sup>46</sup> Reconstruction of the adjacent west wall, which also serves as the base of the bridge house, occurred in 1963. Portions of the south and southeast walls were rebuilt in 1958, their original height estimated by the amount of fallen stones at the base of the walls. Reconstruction of the walls was completed in 1962- 63 in preparation for building of the wood-framed superstructure of the cast house. The existing cement mortar in most of the walls presumably dates to 1962- 63 (see “Mortar,” below).

The wide interior doorway connecting the cast house with the east shed (fig. 114) is documented by the 1887 photograph and the archeological finding of no foundation wall in this location. The opening measured 9.6 feet wide, according to Archeologist Leland Abel. A pair of board- and- batten doors is conjectural.

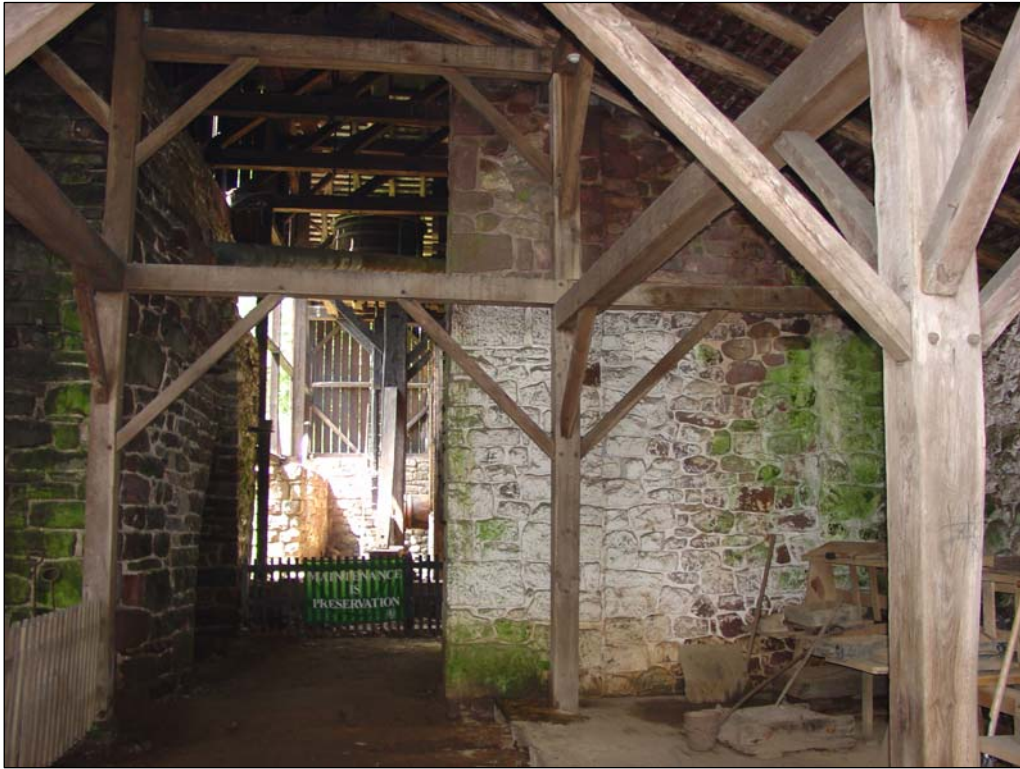
Figure 116. Interior north side of the cast house, view looking west, July 2006.

Although not technically a doorway, a wide opening in the west stone wall north of the furnace enables access to the tuyere arch and the water wheel (fig. 116). This configuration was based on historic photographs taken circa 1910 and 1920 (figs. 19 and 20), prior to the wall's deterioration and removal. The wall was reconstructed in two phases, in 1957- 58 and 1962- 63, leaving the previously described opening.

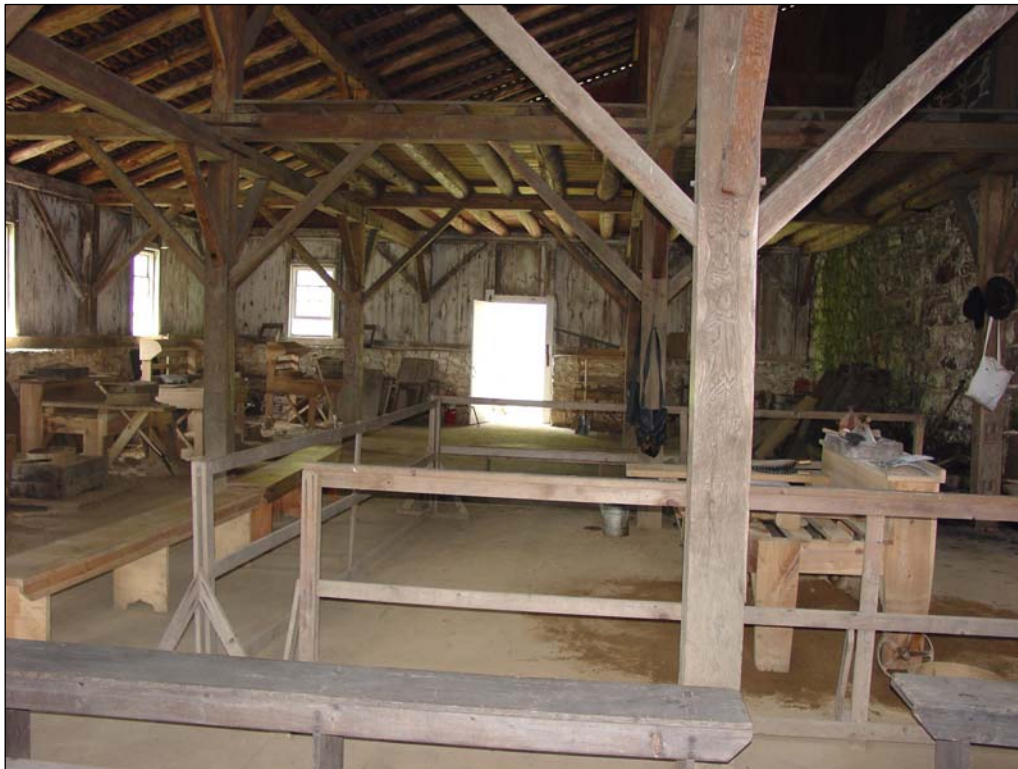
Figure 118. Interior south side of the cast house, view looking west, July 2006.
