# **THE FURNACE GROUP**

## **HISTORIC STRUCTURE REPORT**

**Hopewell Furnace National Historic Site  
Elverson, Pennsylvania**

**Historic Architecture Program, Northeast Region  
National Park Service  
Lowell, Massachusetts**

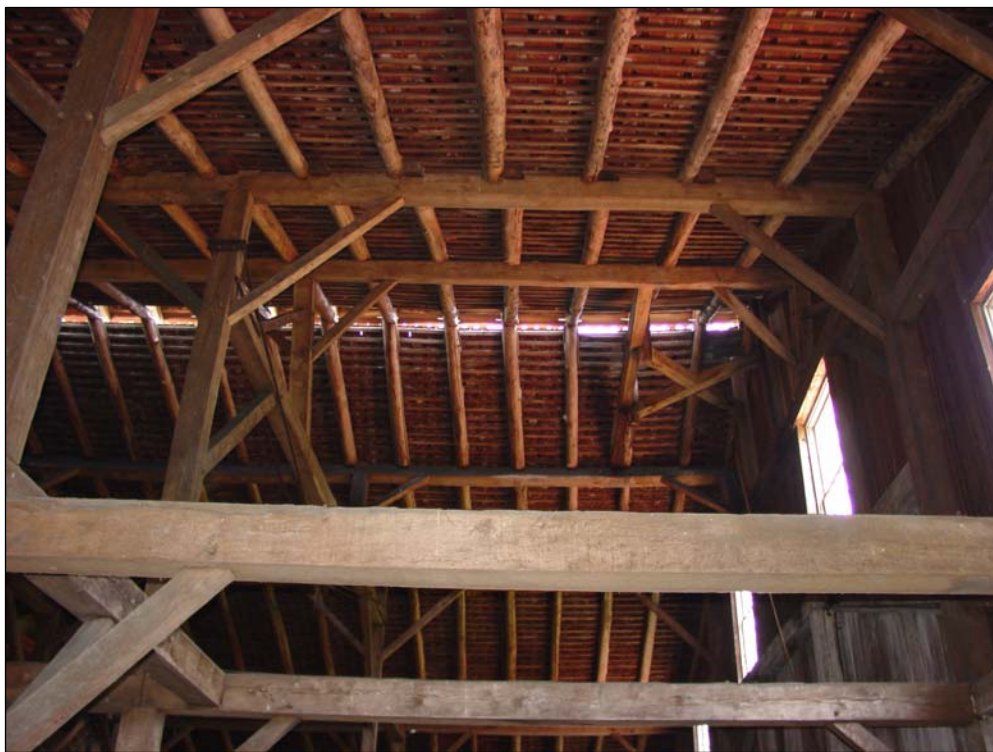
Figure 119. Detail of interior roof framing of the cast house at main ridge, July 2006.
