#### Camp Abbot

Public Meeting 4 April 2005 Agenda

# Military Munitions Response Program Site Inspections

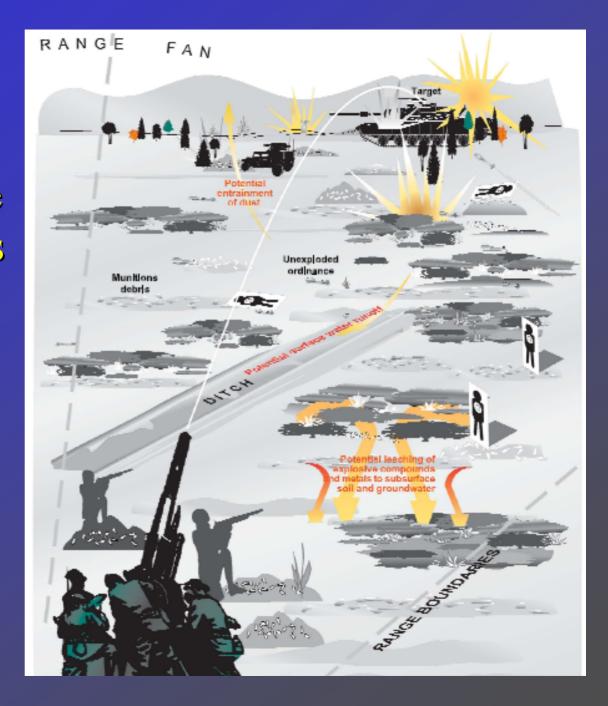
# Conceptual Site Model- Explosive Munitions Ranges

- Explosive projectiles and propellant
- Metals

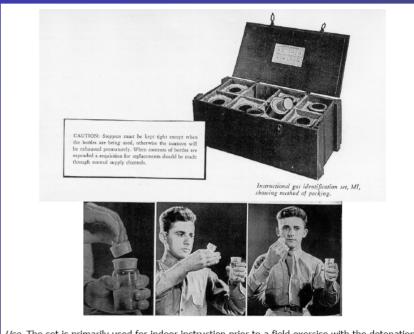
- Specialist training
  - 34 hours
  - 30 officers & noncoms
- Repair of gas masks
- Protective measures
- Offensive use
- First aid measures
- Knowledge and identity of gasses
- Sniff sets 4 oz bottles,
   charcoal w/ gas or bit of
   solid

Use. The set is primarily used for indoor instruction prior to a field exercise with the detonation gas identification set.
