## IN-MINE EVALUATION OF SMART MINE FIRE SENSOR

R. A. Franks, NIOSH, Pittsburgh, PA

An evaluation of a nuisance-emissions-discriminating smart mine fire sensor system was made in an operating coal mine. These field evaluations were conducted to determine the sensor system's ability to discern nuisance emissions, such as diesel exhaust, emissions from flame cutting and welding operations or hydrogen gas from a charging station, from real fires and to compare the number of falsely reported fire alarms generated between the sensor system and a standard carbon monoxide (CO) monitor. The sensor system's ability to operate successfully in the working environment of an operating coal mine was also evaluated. The smart mine fire sensor system consisted of four sensors whose data outputs were fused with the use of a neural-network-type computer program. Long-term trials were conducted in a haulage way, a belt entry, and a track entry. The system functioned successfully in the belt entry, in accordance with its developmental goals, where the sensor system even discriminated events not anticipated during development. It was not totally effective in the haulage way and track entry, though, d

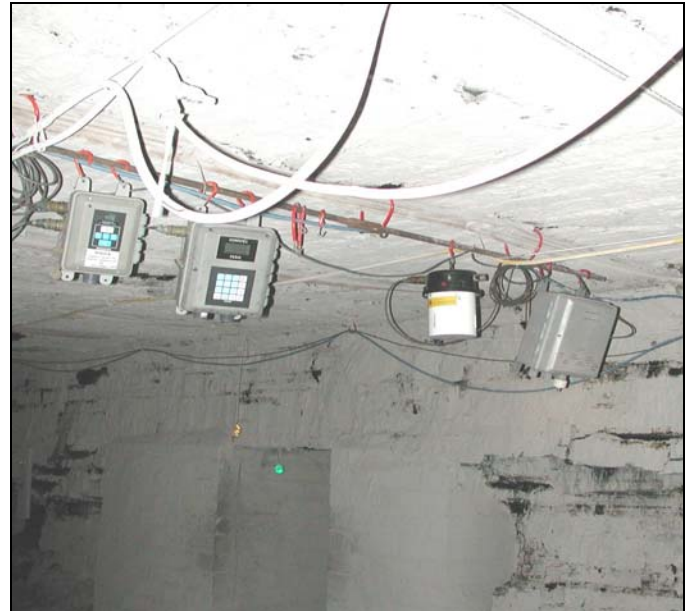
Figure 1 shows the MOS sensor unit (the unit on the right end) and the CO sensor unit (the unit on the left end) installation in the haulage way during the evaluation. The MOS sensor unit contains the

two MOS sensors. Also shown in the figure are a Conspec Diesel Discriminator<sup>6</sup> (left center unit) and a Becon Smoke Detector<sup>7</sup> (right center unit) used on the NIOSH mine monitoring system but not part of the Smart Sensor set. The Beam smoke sensor transmitter unit is not shown, but is located on the rib near the MOS sensor unit. The Beam receiver is located on the opposite rib 30 feet down the haulage way from the transmitter unit. Signal transmission and power lines were connected between the sensors and a Conspec Senturion 500<sup>8</sup> mine monitoring system at a surface station via a Conspec mine trunk cable. Linear airflow in the haulage way was usually about 350 feet per minute. There were significant temperature variations in the haulage way, ranging from 20 to 85 °F, due to the proximity of the sensors' location to the intake air shaft. The evaluation of the system in the haulage way lasted for fourteen months.

**Figure 1.** The smart mine fire sensors in the main haulage way, from left to right: Conspec CO Monitor, Conspec Diesel Discriminator, Becon Smoke Detector, and NIOSH MOS unit.

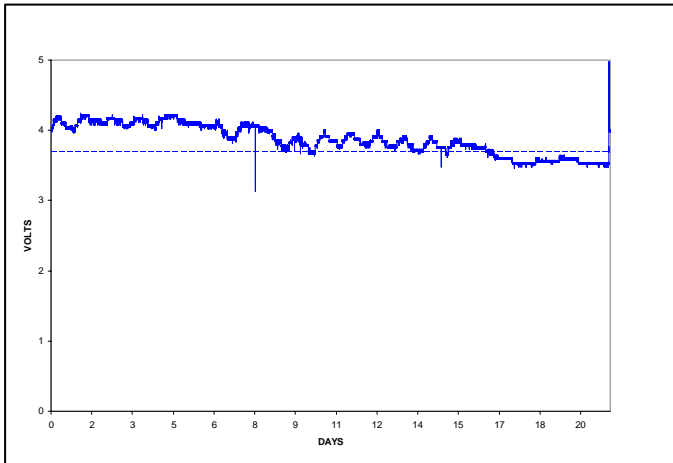
The Smart Fire Sensor System experienced significant drift problems with the Beam Smoke Sensor unit when the system was installed into the main haulage way at Cumberland mine. The drift was attributed to a combination of three or four persistent problems; loosening of screws in the Beam unit's interface assembly due to constant vibration from equipment moving in the haulage way, misalignment of the Beam transmitter unit due to the deterioration of the rib to which it was mounted, periodic build-up of dust on the lens assembly from the high air-flow and temperature fluctuations in the haulage way. No one specific cause was determined to be the reason for the drift. An example of the drift over a 20 day period is shown in figure 2.

Figure 2. Beam sensor response in the main haulage way.

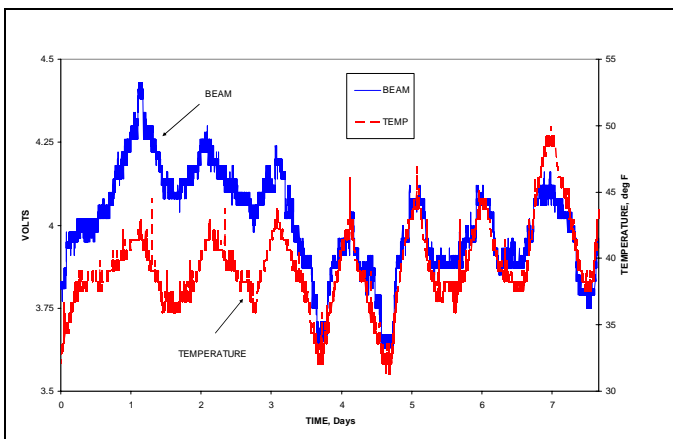
Diurnal temperature effects on the Beam and MOS2105 sensors were observed in the haulage way. This temperature change was due to the proximity of the haulage way sensor station to the intake air. An example of the close correlation of the periodic fluctuations in signal level of the Beam sensor with a similar change in ambient air temperature in the haulage way is shown in figure 3 for a seven-day period. The maximum value occurred about 6:00 PM and the minimum value about 7:00 AM on a recurring daily basis. These times corresponded to maximum and minimum outside air temperatures.

Figure 3. Beam and Temperature responses.

In an attempt to correct this temperature response problem, foam insulation was placed around the open perimeter of the Beam housing to isolate the electronics from the mine air and prevent convective cooling. However, this did not eliminate the problem. The MOS2105 sensor also showed a voltage drop due to severe winter temperatures,

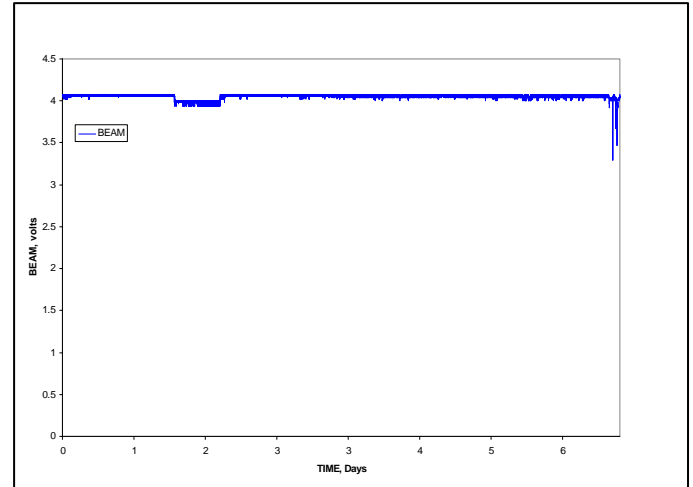
An evaluation of the Beam sensor's output temperature dependence under more stable temperature conditions in the Emerald Mine charger entry is shown in figure 4. The sensors were located in a split from the mine's electric-vehicle charger entry. In this evaluation, the temperature was not recorded by the mine monitoring system as it was at Cumberland Mine. Also, at the sensors' location in the split the air velocity had a relatively low value of about 40 fpm.

Figure 4. Beam response in Emerald Mine.

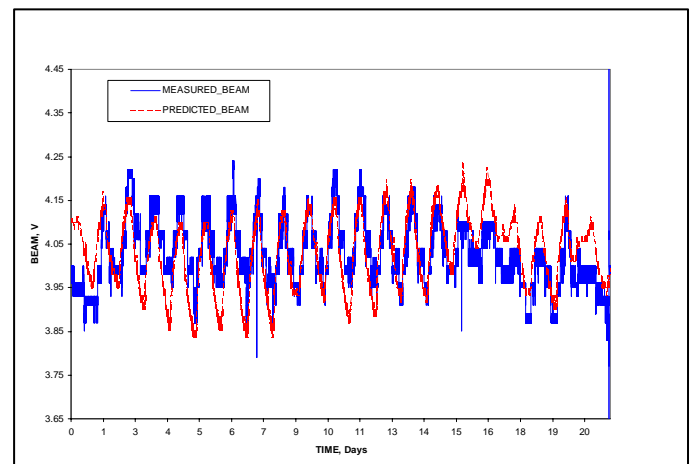
where T is the measured temperature in °F, and PREDICTED\_BEAM is the predicted Beam signal in volts. The correlation coefficient is 0.62, which defines a moderate correlation. Figure 5 indicates that the period of the measured Beam oscillations is well represented by the PREDICTED\_BEAM value, but the amplitudes are less well represented.

Figure 5. Measured and predicted Beam signals, based on ambient temperature.

An attempt was made to determine the exact dependence of the Beam's output upon ambient temperature by an evaluation of the correlation between the two parameters for a stable haulage way data set. For a 20 day period, the dependence of the measured Beam output signal upon temperature resulted in a fit of the Beam signal to a power of the air temperature measurement.

$$\text{PREDICTED\_BEAM} = T^{-0.329} \quad (1)$$

It should be noted that this correlation applies to this particular set of data, and for which there was no long term downward drift in the

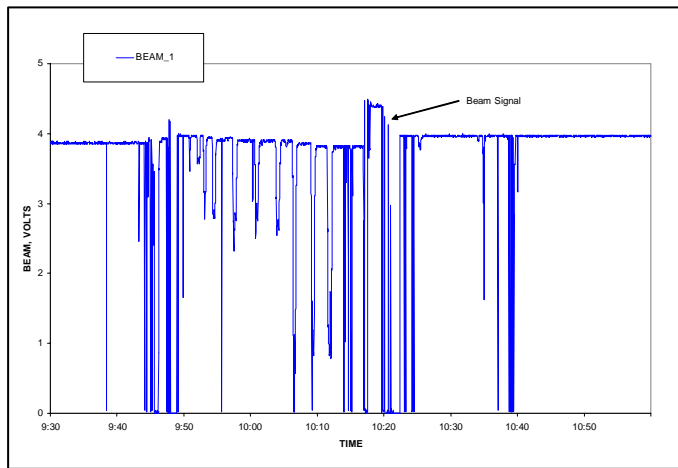
Since the Beam smoke detector is an optical smoke sensor, the Beam had a persistent problem with dust accumulation on its lens surfaces and the unit was indiscriminant in its response to the various types of particulate matter that were dispersed into its optical path. The effect of rock dust on the Beam sensor had been investigated in the SRCM. In the SRCM rock dust was hand-dispersed at entry mid-height upwind from the Beam sensor unit. The Beam sensor responses in the SRCM evaluations are shown in figure 6. The airflow was maintained at 250 fpm during these evaluations.

Figure 6. The Beam affected by Rock Dust in the SRCM.

It can be seen in figure 6 that the Beam recovered to its pre-rock dusting value after the last intense injection of rock dust into the air stream. Two differences were possible from the perspective of rock-dust deposition between the SRCM and the in-mine evaluations. One possible difference was the rate of deposition of rock dust on the Beam lens cover. In the case of the in-mine evaluation, the deposition rate would be gradual. A gradual deposition rate might not be detectable by the logic inherent to the Beam sensor. Another possibility could be the presence of diesel combustion byproducts which could accumulate as a film on the Beam's plastic surface to which the dust could adhere. During the evaluation, it was also observed that rock dust periodically accumulated on the Beam lenses. The Beam lenses were cleaned and the unit reset to restore the Beam to its normal value of 4 volts.

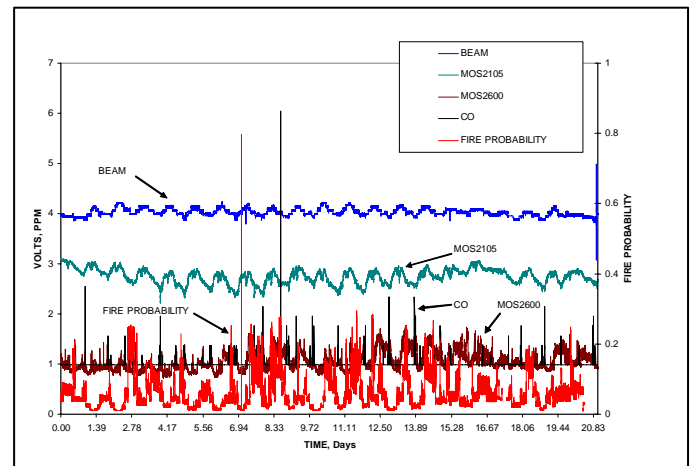
In an attempt to address the downward drift of the Beam's output signal in the environment of the main haulage way, the screw connections at the terminal strips in the Beam's interface box were tightened, and the unit was returned to service. The results of the evaluation for a 20 day period showing the stability of the Beam output signal are depicted in figure 7. This would indicate vibrations induced in the Beam's interface box was a significant factor in the long-term evaluation of the smart fire sensor in the haulage way.

Figure 7. Sensor responses and predicted fire probability in the haulage way.

It should be noted that figure 7 shows an isolated fire probability of 0.8 that occurred on day 6. However, during that time only a small decrease in the Beam output voltage occurred, so the NN does not indicate an alarm event.

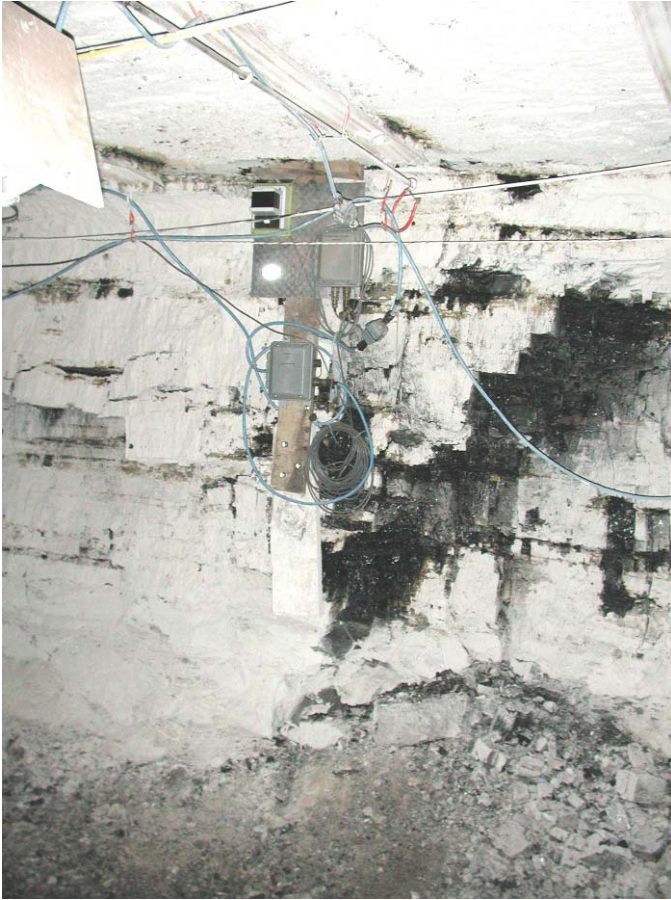
Spalling of the haulage way rib to which the Beam's transmitter unit was attached also caused alignment problems with the Beam detector. Figure 8 shows the Beam transmitter unit mounted on the rib in the haulage way. In a simple lab experiment, with the Beam set up along an approximate 6 foot path, the unit showed a significant voltage loss in the receiver output with slight lateral movement of one corner of the receiver's mounting-plate in a direction perpendicular to the optical path. Although the same displacement on the 30 foot path-length in the mine would require five times the movement, the results indicated that a continual slow movement of the rib mounting caused by the working rib would produce a continual voltage drop in the Beam. The Beam transmitter mounting supports on the main haulage way rib eventually collapsed at some point in time after the Beam unit had been removed from the haulage way.

**Figure 8.** The Beam transmitter mounted on the rib in the haulage way.

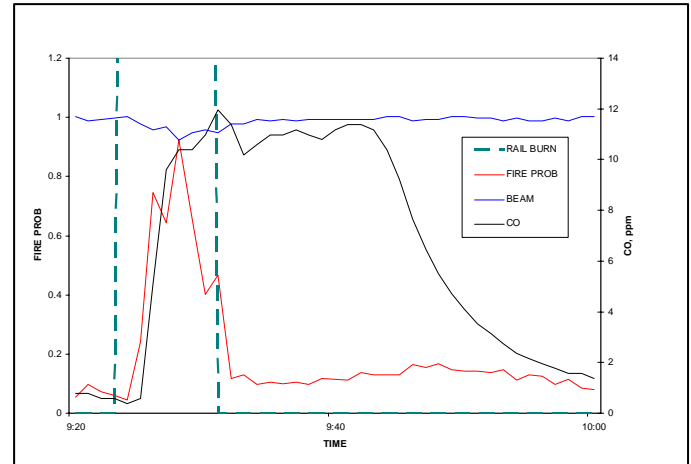
For validation purposes, the new modifications of the NN program were applied to the data from the in-mine rail cutting operation depicted in a photograph of the flame cutting experiment (figure 10). The sensor measurements are shown in figure 9. No HH alarms resulted. Figure 9 shows that there were CO values greater than the 10-ppm alarm level. Although the fire probability exceeded 0.9 during the burn, the normalized Beam values were greater than 0.8. As noted earlier, the criterion for an HH alarm required both the fire probability to exceed 0.9 and the normalized Beam values to be less than 0.8. This

**Figure 9.** CO and Beam responses, and predicted fire probability.

demonstrated the nuisance discrimination capability of the smart sensor system.

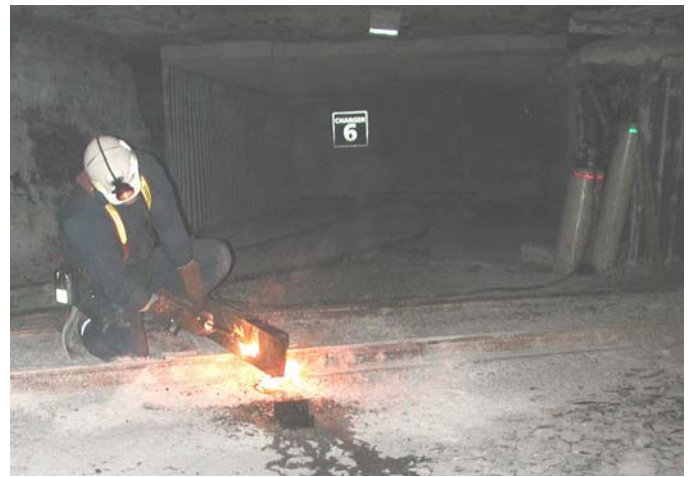
**Figure 10.** Flame cutting of a piece of rail.

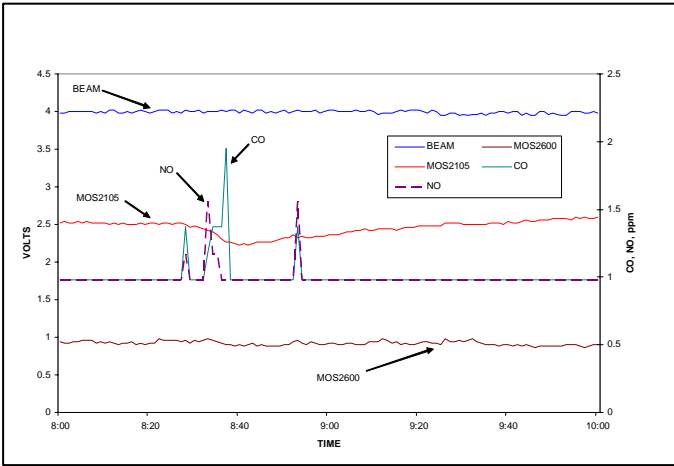
Figure 11 shows the identification of a typical nuisance emission in the haulage way during the evaluation that shows the MOS2105 sensor responded simultaneously with the NO and CO sensors. The responses by the CO and NO sensors were less than 2 ppm.

However, the absence of the Beam sensor's response is indicative of an absence of optical obscuration. The predicted fire probability from the NN algorithm was less than 0.11. Although the emission source was not known, it most likely was a diesel engine which produced insignificant smoke obscuration compared to a fire.

Figure 11. Sensor responses in the haulage way at Cumberland.

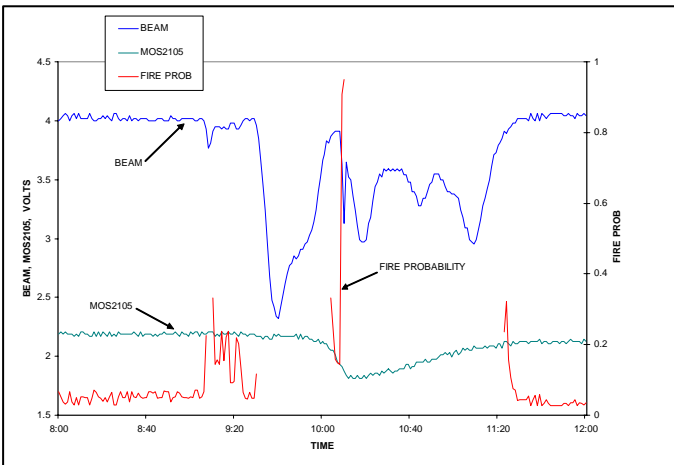
Another example is shown in figure 12. In this case, given the response of the MOS2105 to NO, and a small response of the NO chemical cell sensor to this event, the speculation was that a diesel-powered scoop operation was in progress in the belt entry to remove coal spillage upwind from the sensors which resulted in dust-laden air flow. The broken probability curve in figure 12 is a consequence of the Beam sensor response being more than ten standard deviations below its mean value and the MOS2105 sensor response increase being less than ten standard deviations above its mean value. In this case there is a source other than smoke, such as optical path blockage by equipment or dust, which induces the Beam sensor response. When this occurs, the fire probability is not calculated and no alarm is given.

Figure 12. Sensor responses and predicted fire probability in belt entry.

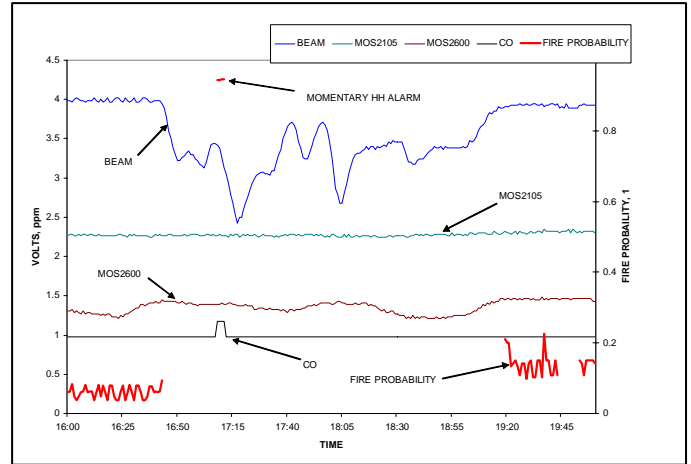
Another event of the type depicted in figure 12 occurred in the belt entry later in the evaluation. Figure 13 shows the sensors' outputs. This resulted in one HH alarm. It should be noted that breaks in the red Fire Probability curve in figure 13 indicates that the fire probability was indeterminate at that point in time as it was just prior to and just after the momentary HH alarm. Figure 13 also shows a small increase in the CO at the time of the HH alarm.

Figure 13. Sensor responses and fire probability in the belt entry.

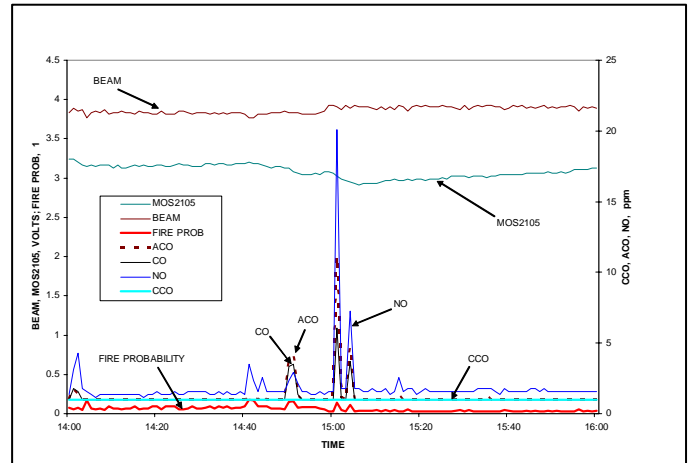
Figure 14. Sensor responses and predicted fire probability.

The Smart Sensor's discriminating capability was compared to that of a diesel discriminating monitor currently in use in mines during the evaluation in the track entry, shown in figure 14. During this event, the CO response from the CO-NO sensor (ACO) was 11 ppm for the measured CO concentration. The NO sensor response was 20 ppm. In this figure, ACO refers to the actual CO response of the CO-NO sensor. CCO refers to the corrected CO response read by the CO-NO sensor based upon the CO and NO historical record. The CO-NO sensor identified this event as a non-alarm with a base line CCO value equal to 0.98 ppm. The fire probability identified with the NN evaluation from the smart fire sensors was 0.14, and the diesel emissions probability identified with the NN evaluation was 0.24. This demonstrates a consistency of the smart fire sensor system with the diesel discriminator unit's evaluation.
