Technology News

No. 488

Migration of Blasting Fumes Into a Western Pennsylvania Home

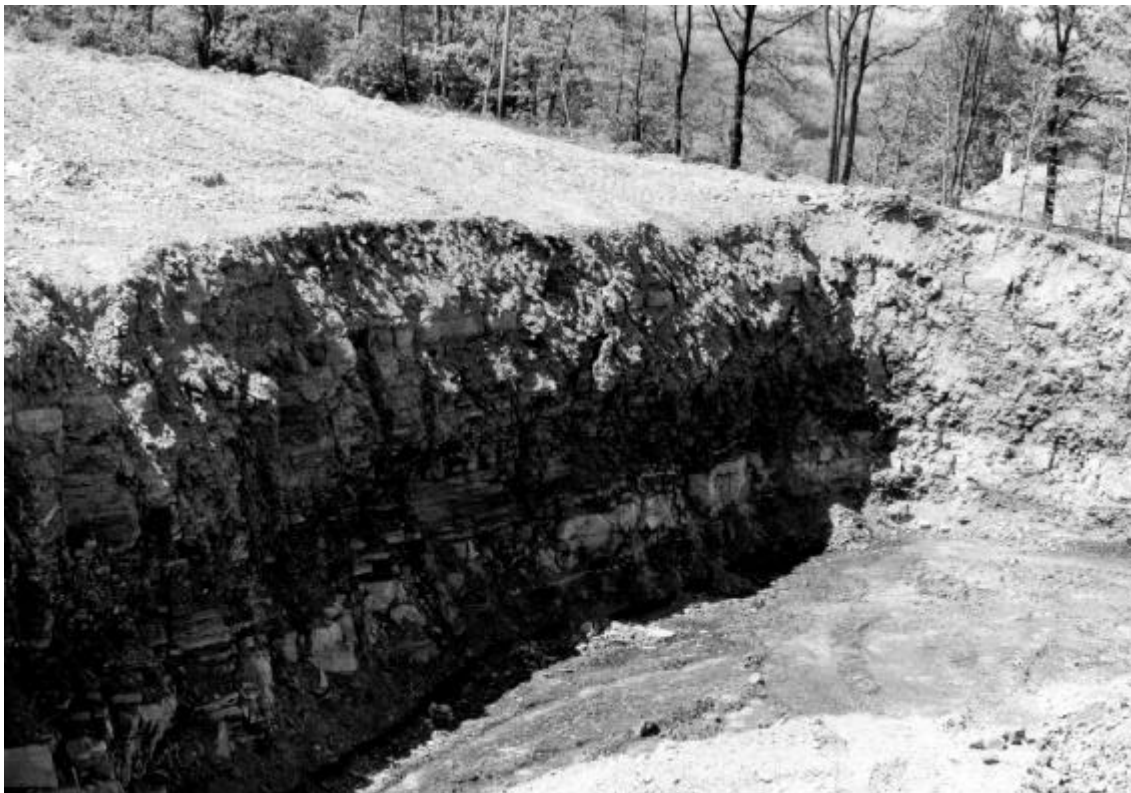
Figure 1 shows the coal strip mine believed to have generated the CO. The initial suspect for the source of the CO was the furnace in the house. Only later did it become apparent that blasting at the nearby strip mine might be the culprit. A State investigation concluded that CO had migrated approximately 500 ft from the blast, through the ground, and into the home.

Figure 1.—Blasting in this coal strip mine generated CO that is believed to have poisoned nearby residents.

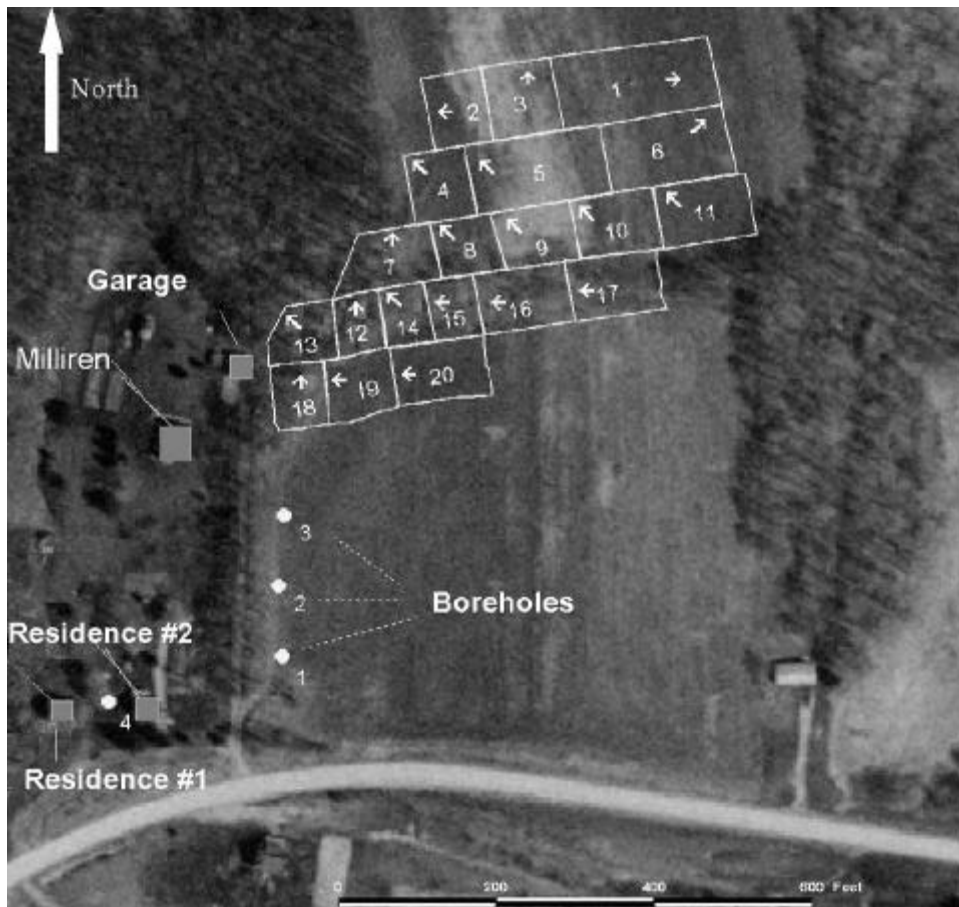
Figure 2 shows the locations and order of blasts at the mine. Initially, the mine did not plan to blast. Overburden generally consisted of weathered shale that could be dug without blasting. However, the mine decided to blast when hard sandstone that could not be dug out was encountered within 3 ft of the coal top. The blasting was intended to break up the sandstone. Blasting was done using bulk ammonium nitrate-fuel oil (ANFO) in 6.25-in holes 25-30 ft deep on a 16-ft by 16-ft pattern, with charge weights ranging from 17 to 170 lb. The closest blast to the home was 430 ft on April 17, 2000. The distance from the home to the blast area on the day when CO was first reported (March 31, 2000) was 500 ft.

Twenty blasts

were detonated at the mine between March 7, 2000, and April 20, 2000. The blaster was careful to prevent flyrock since another home was only 150 ft away and a garage was 50 ft away. The quantity of explosive used in the blasts was sufficient to break the sandstone, but was less than would normally be used to blast overburden. The holes were typically one-third explosive and two-thirds stemming, with powder factors averaging 0.43 lb/yd³. Additionally, the muck was not immediately excavated after each blast. The heavy confinement on the explosive acted to prevent the typical release of blasting fumes into the atmosphere.

Figure 2.—Map showing blasting at the strip mine and the location of nearby residents. The house labeled "Residence #1" is where the family suffered CO poisoning.

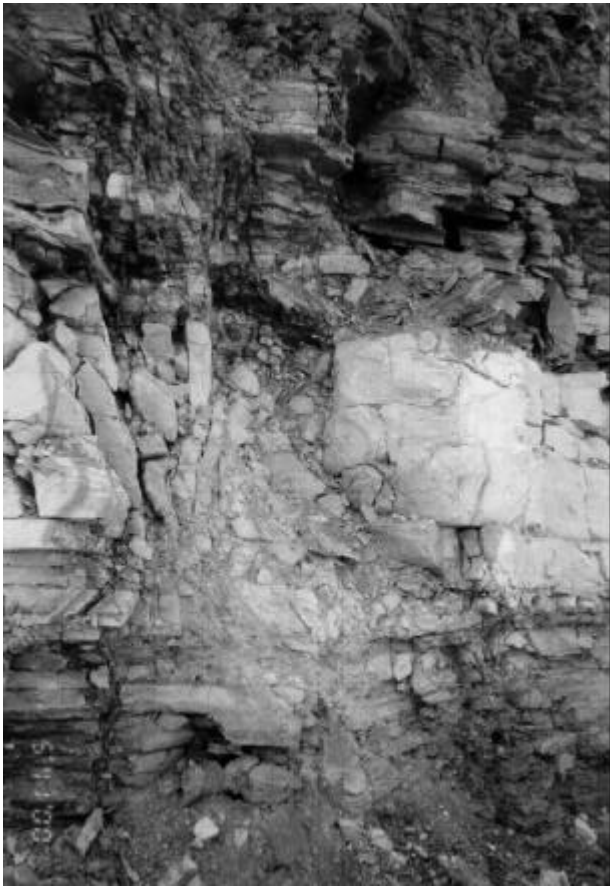
Figure 4.— A hillseam is a zone of fractures that cuts the sandstone.

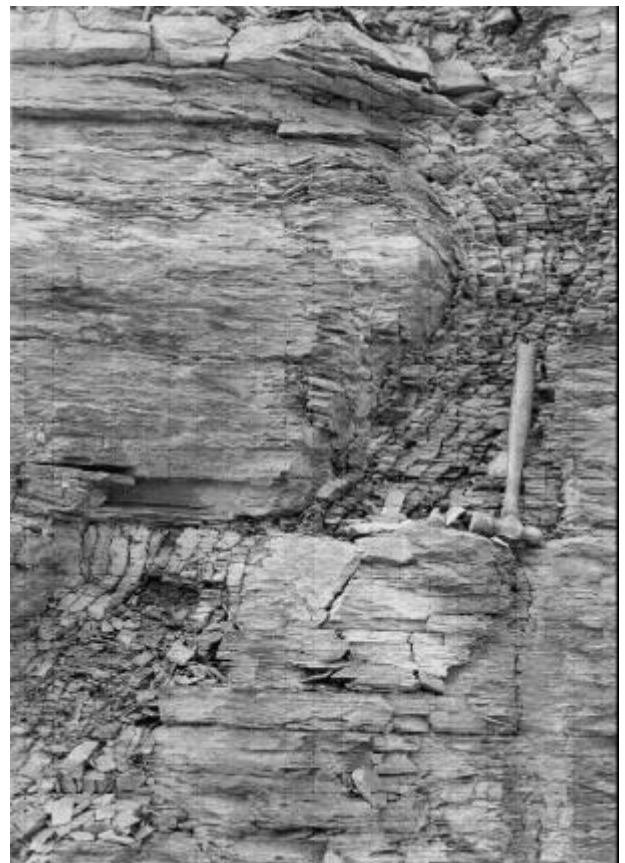
Figure 5.— This photo from another site shows a hillseam discontinuity.
