Determining the Root Causes of Flame Cutting and Welding Fires in Underground U.S. Coal Mines

Pittsburgh Research Laboratory

National Institute for Occupational Safety and Health

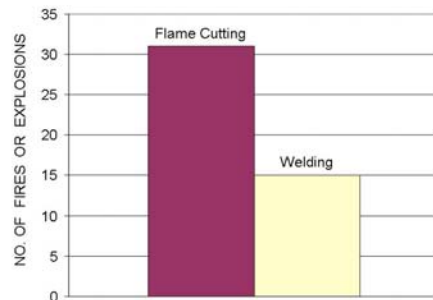
MSHA investigation reports from 1995 – 2005 were examined in order to determine the root causes of fires and explosions caused by flame cutting and welding operations in underground U.S. coal mines during this time period. From the MSHA 7000-50 reports, thirty-one fires or explosions were the result from flame cutting and fifteen fires were the result from welding (Figure 1).

FIGURE 1. NUMBER OF FIRES OR EXPLOSIONS DUE TO FLAME CUTTING AND WELDING, 1995-2005

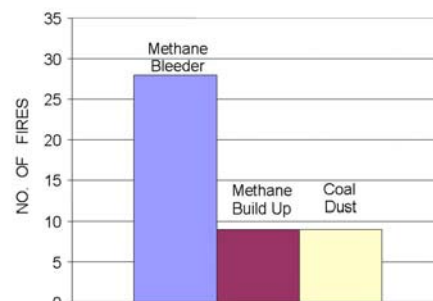
From the MSHA accident reports, the three causes of these fires or explosions, shown in Figure 2, were:

- 1) Hot slag or sparks ignited methane bleeders on the roof, ribs or floor (28 fires or explosions).
- 2) Hot slag or sparks ignited a methane build up (for example, in an air shaft or under a longwall pan) (9 fires or explosions).
- 3) Hot slag or sparks ignited coal dust on the floor of the mine (9 fires or explosions).

FIGURE 2. NUMBER OF FLAME CUTTING AND WELDING FIRES OR EXPLOSIONS WERE RECORDED AS ACCIDENTS, 1995-2005

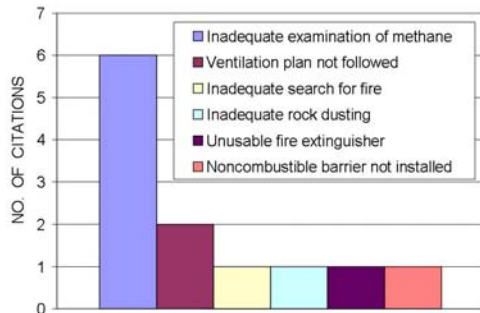
According to MSHA, 12 citations were issued for violations of safety standards that contributed to these accidents. These enforcement actions were issued under six different subparts of 30 CFR Part 75-Mandatory Safety Standards-Underground Coal Mines and 30 CFR Part 77-Mandatory Safety Standards, Surface Coal Mines and Surface Work Areas of Underground Coal Mines. Figure 3 shows the failures that contributed to these accidents, including:

- 1) Six citations for inadequate examination of methane.
- 2) Two citations for ventilation plan not followed.
- 3) One citation for inadequate search for fire.
- 4) One citation for inadequate rock dusting.
- 5) One citation for unusable fire extinguisher.
- 6) One citation for noncombustible barrier not installed.

FIGURE 3. NUMBER OF CITATIONS FOR FLAME CUTTING AND WELDING ACCIDENTS, 1995-2005

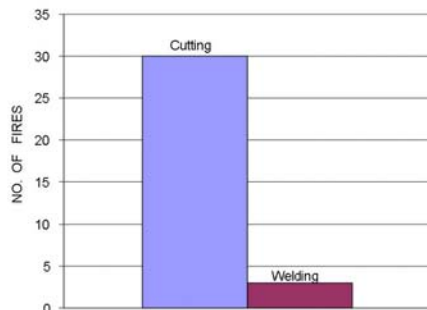
Another problem with flame cutting and welding operations is personal injuries. The mining industry accident, injuries, employment, and production data base was examined from 1995-2005 to identify the number of personal injuries from flame cutting or welding activities [MSHA 2006]. From this data there were a total of thirty-three nonfatal injuries caused by flame cutting or welding (Figure 4).

FIGURE 4. NUMBER OF FLAME CUTTING AND WELDING FIRES THAT CAUSES NONFATAL PERSONAL INJURIES, 1995-2005

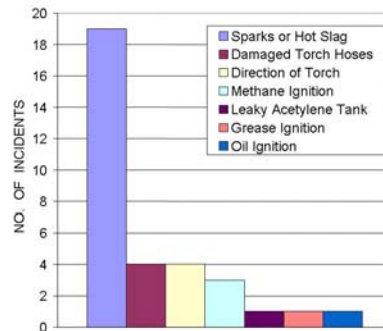
The numbers and causes of these injuries, shown in Figure 5 were:

- 1) 19 injuries resulted from sparks or hot slag.
 - Eleven of these injuries occurred when the mine worker was cutting in a position where hot sparks were able to fall into the worker's ear. For example, one of the mine workers was lying on their side next to a continuous miner, one under a cable tray, one was under a roller bearing on a conveyor system, and another was under a continuous miner cutting head cutting off bit lugs when hot sparks entered the mine worker's ear.

FIGURE 5. NUMBER OF FLAME CUTTING AND WELDING INCIDENTS THAT CAUSED PERSONNEL INJURIES, 1995-2005

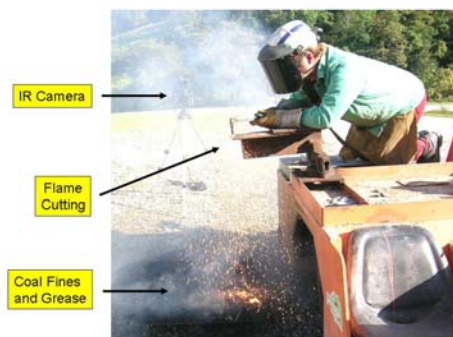
Several flame cutting experiments were performed by an experienced miner at NIOSH's Lake Lynn Laboratory to observe the effects of hot steel particles on coal fines and grease. Coal fines and grease were placed on a steel sheet (1/8 in. x 2 ft. x 2 ft.) and the miner performed a flame cutting operation directly above (Figure 7).

FIGURE 7. MINE WORKER PERFORMING FLAME CUTTING OPERATION

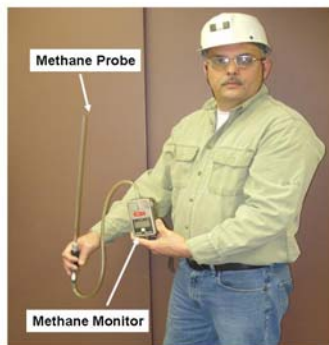
- 1) Methane checks are not being made close enough to surfaces where ignitable concentrations of methane may exist. Tests should be conducted in and around the immediate area where flame cutting and welding is conducted and where hot slag and sparks might fly. If necessary, a pump type methane monitor and probe should be used (Figure 10).

FIGURE 10. PUMP-TYPE METHANE MONITOR AND METHANE PROBE
