REMOTELY INSTALLED MINE SEALS FOR MINE FIRE CONTROL

Michael A. Trevits NIOSH, Pittsburgh, PA

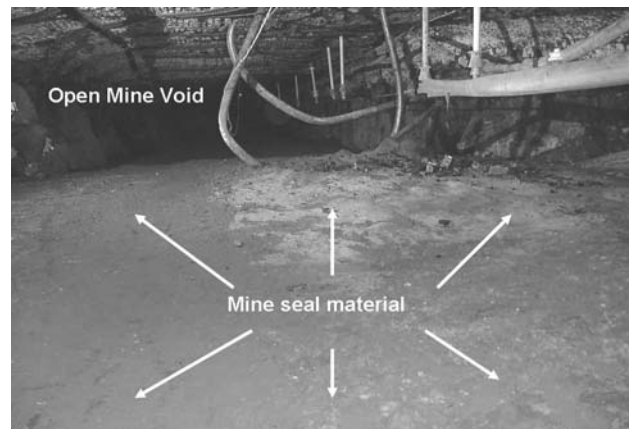
Figure 1. Remotely installed mine seal that did not close the mine void (Urosek, 2005).

Underground observations of remotely installed mine seals suggest that currently available commercial technology often does not achieve the goal of fully closing the mine opening (figure 1). If the mine seals do not mostly close the opening, then oxygen inflow cannot be controlled which can lead to growth of the mine fire. The seals that mostly close the mine opening however may be used to restrict and control the amount of air and inert gas that passes in or out of a fire area.

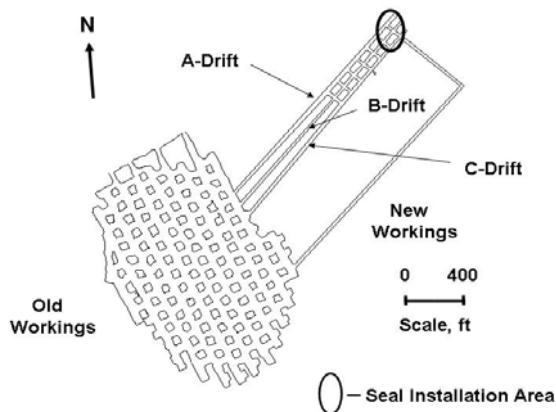
Figure 2. Layout map of the Lake Lynn Laboratory Experimental Mine.

The second phase of the work involved the remote construction of mine seals. The research was conducted at the NIOSH Lake Lynn Experimental Mine (LLEM) located approximately 60 miles southeast of Pittsburgh, Pennsylvania. The LLEM is a world-class, highly sophisticated underground facility where large-scale explosion trials and mine fire research is conducted (NIOSH, 1999) (figure 2). As a part of a prior research study, a 6-in diameter cased borehole was drilled and completed in the first cross-cut between the B and C Drifts of LLEM. It was determined that this mine area and the accompanying borehole was suitable for the seal construction work (figure 3). The thickness of the overburden in the area of the borehole is 197 ft. The cross-cut in the mine measured 19 ft wide, 40 ft long and 7 ft high, with a mine floor slope gradient of 1.13 percent. A second borehole, located about 30 ft away, was available for viewing the mine seal installation using a downhole video camera.

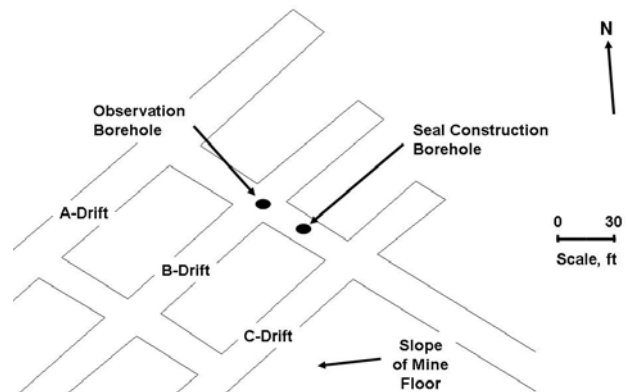
Figure 3. Underground layout of the seal construction site.

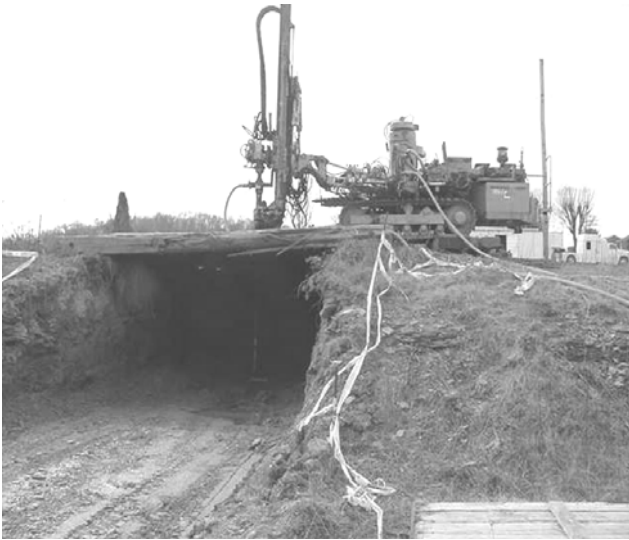
Figure 4. View of the model mine.

A model mine opening was constructed at Howard's facility for testing and direct observation of the performance of the downhole and surface equipment. The model mine opening consisted of a small excavation in a hillside. The roof of the model mine was made using crane mats so a drill rig could be located over the mine void to hold the pipe for the downhole equipment (figure 4). Two series of tests were performed at the model mine along with an initial test at the LLEM before the final seal material delivery technology and seal grout mixture was developed. Changes were made to the cement content, admixtures and additive ratios to improve stickiness, time-of-set and application uniformity. Laboratory work was also conducted to improve the grout blends by modifying admixtures and additive ratios. After each test, modifications were made to the materials and equipment.

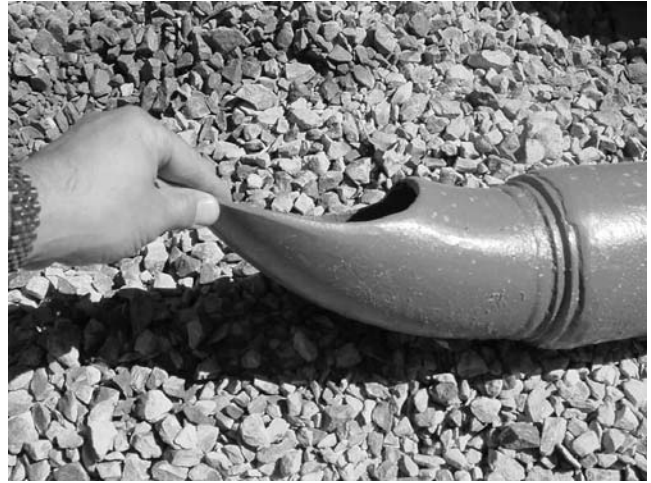
Figure 5. Elbow for bulk fill placement.

The final technique developed included a specialized directional elbow for directional placement of bulk fill material (figure 5) and a proprietary spray nozzle for material to address the remaining open areas in the mine void (figure 6). The spray nozzle required the use of two strings of pipe (one inside of the other) to convey two streams of material to the nozzle. The spray nozzle permitted the blending of the two-part grout accelerator mix with sufficient air velocity to transport the grout to the mine roof-and-rib areas. The bulk grout was pumped to the borehole using a positive displacement pump and compressed air. The sprayed grout was moved to the borehole using a conventional grout pump and compressed air. A detailed report on the development of this technology is presented by Gray et al (2004).

bulk fill, it was also decided to fit the end of the casing string of pipe with an elbow (refer to the section on Seal Material Placement Technology above) to provide a means of directionally controlling the placement of grout material (refer to figure 5). It was also thought that this elbow configuration could facilitate roof-rib closure with the bulk fill material.

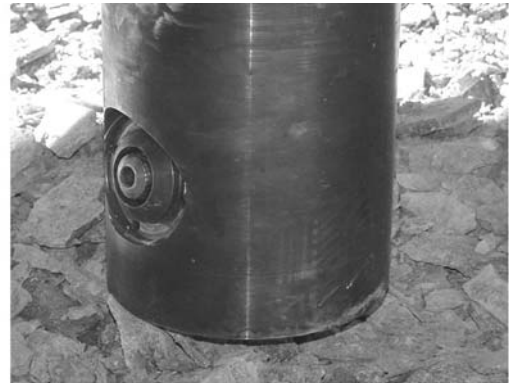
Figure 6. Spray nozzle.

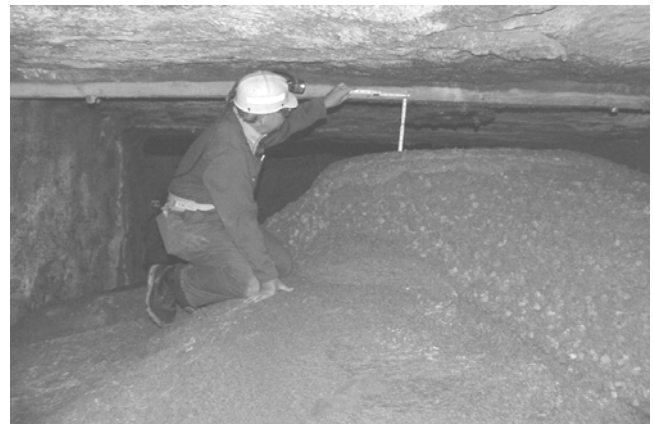
Figure 7. Underground view of bulk fill material for seal No. 1.

Placement of the bulk fill for seal No. 1 was initiated using a mixture composed of 2A crushed limestone aggregate, fly ash and cement. This mixture was pumped into the mine opening using a string of casing. Bulk fill was pumped over different time intervals with a pause between intervals to allow the in-place grout to stiffen and begin to set. This process was used to control the extent of lateral material flow out of the cross-cut areas. The pumping time and the pause intervals were determined by visual observation via a downhole video camera. The installation of this seal was not designed to be a "blind" operation so in-mine to surface communication was also facilitated through the use of a mine pager phone system. Pumping was terminated after approximately 112 yd³ of material had been placed into the cross-cut (figure 7). Underground examination revealed that the mine opening had not been completely sealed (open spaces were observed at the mine roof-and-rib areas) and some of the bulk fill material had flowed into the adjacent mine areas.

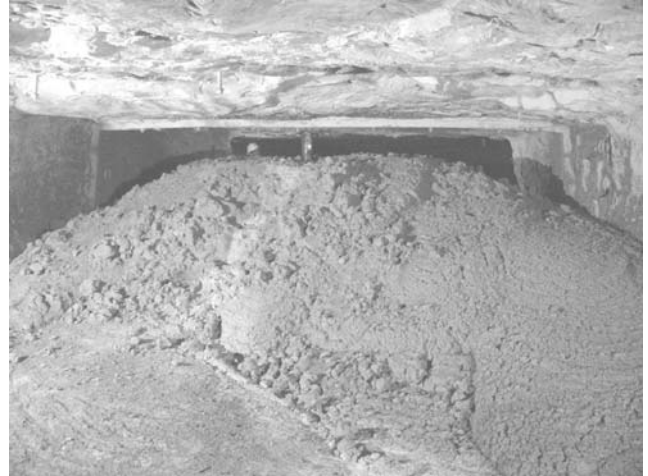
Figure 8. View of bulk fill placement for seal No. 2.

Pumping of the first part of seal No. 2 (bulk material) began using a sand, fly ash and cement mixture. This material was pumped into the mine opening using the directional elbow. The bulk material was pumped in a series of lifts to fill most of the mine opening. Pumping was terminated after approximately 55 yd³ of material had been placed into the cross-cut. It should be noted that that communication with underground personnel was allowed to orient the directional elbow and complete the construction of the first part of the seal. Underground examination revealed that seal material was placed to within 1.5 ft of the mine roof below the borehole and within 2.5 to 3 ft of the mine roof near the rib areas (figure 8).

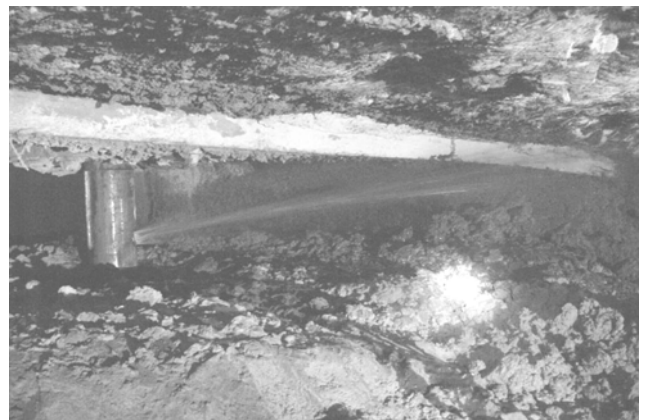
Figure 9. Underground view of spray nozzle during seal No. 2 construction.

It was decided to remove 6 in of material at the top of the seal to allow sufficient room to test the capability of the spray nozzle. For this part of the seal installation, the raw material was brought to the site using “Redi-Mix” trucks. This equipment worked well with the small volume batch plant used for this work. After conducting a 10 yd³ surface test of the seal mixture (fly ash, cement and accelerators), a dual string of drill pipe and casing affixed with the spray nozzle was then placed into the borehole in preparation for the second part of the seal construction. Once the nozzle penetrated the mine opening, seal material was sprayed in a back-and-forth motion along the mine rib areas to fill in the gaps. Interaction between observers underground and engineers on the surface ensured that the nozzle was aimed in the proper direction. Good mine roof-and-rib contact was made with the sprayed material. The problematic corner areas at the mine roof-rib intersection were filled before the grout began to build up and migrate towards the spray nozzle (figure 9).

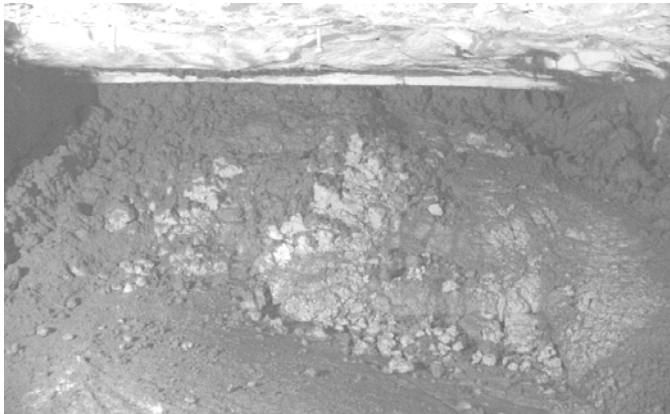
Figure 10. Underground view of mine seal No. 2 from the B-Drift.

Filling of the remaining area near the borehole was accomplished by lowering the spray nozzle into the wet material and then rotating the operating spray nozzle through a 360 degree arc. Eventually, the material built-up around the nozzle and closed the mine opening (figure 10). In all, a total of 22.5 yd³ of sprayed material was used to close the mine opening. An underground examination showed that the mine seal material (both bulk and sprayed material) was sprayed about 12 ft from the borehole towards the B-Drift and only about 9 ft from the borehole towards the C-Drift (this reduced distance was due to the slope of the mine floor). The final shape of the seal approximated a truncated pyramid whose base measured 19 ft wide (the width of the cross cut) by 21 ft deep and whose top measured 19 ft wide (the width of the cross cut) by 3 to 5 ft deep. Later, mine seal No. 2 was removed.

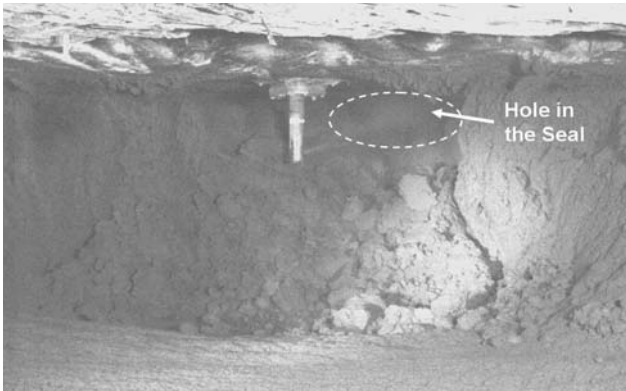
Figure 11. Underground view of mine seal No. 3 from the B-Drift.

An underground examination of the seal void showed that the mine void appeared closed on one side of the borehole along the cross-cut, but a significant hole remained on the other side of the borehole (figure 11). The Howard/GAI team later concluded that the full capability of the spray nozzle had yet to be tested. Therefore, it was thought that another attempt should be made to build a seal (called seal No. 3-A) using the spray nozzle in the down slope area of the cross-cut towards the B-Drift and that viewing of the progress of construction might be easier because this operation would take place about 20 ft closer to the observation borehole. Some of the material from Seal No. 3 was removed from the area of the borehole and along the ribs to allow the spray nozzle unobstructed movement and to permit seal material to be sprayed the maximum distance from the borehole.

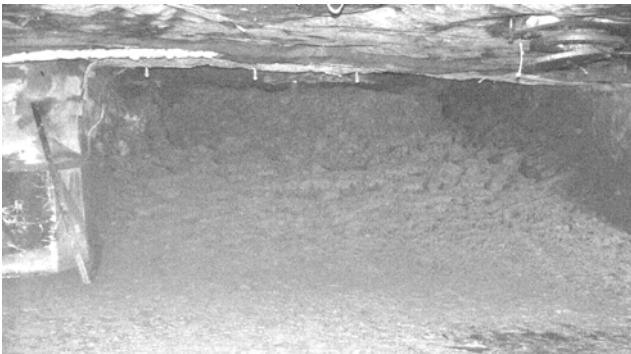
Figure 12. Underground view of mine seal No. 3-A from the B-Drift.

The material mix was altered somewhat from that used for seal No. 3 as the water component was again slightly reduced. This change would increase the stiffness of the material to minimize material flow away from the borehole on the down slope side of the cross-cut. The construction of seal No. 3-A began by rotating the spray nozzle back and forth through a 70 to 80 degree arc. The spray material was thrown a maximum distance from 20 to 22 ft from the borehole although most of the material seemed to be fall along an arc from 8 to 10 ft from the borehole. Pumping continued until about 37 yd³ had been placed in the mine void when it was determined from the video camera image that the material had been placed to within a few inches of the mine roof (figure 12). The resulting mine seal was a large bowl-shaped structure extending about 8 to 10 ft from the borehole. The addition of accelerator (Part B) to the spray was then stopped and grout was permitted to flow from the spray nozzle to help infill any remaining voids in the mass of the seal. Pumping was terminated after about 3 yd³ of this material had been pumped and a total of 40 yd³ was pumped to construct this seal.

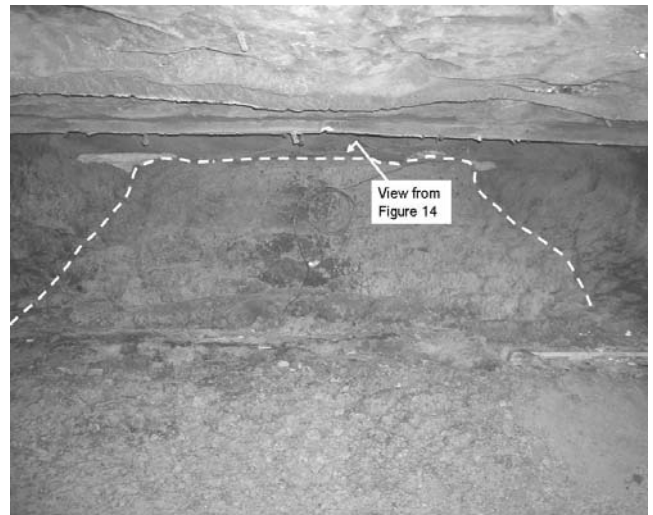
Figure 13. Underground view of mine seal No. 3-A from the B-Drift (note dotted line shows outline of the seal).

Unfortunately the observations made using the video camera did not agree with the actual conditions in the mine void. The mine roof near the area of the borehole had been broken upward on the B-Drift side and this irregularity was obscured by the general slope of the mine roof towards the video camera location. Although the video images showed the front top (from the B-Drift side) of the seal to be at or near the mine roof, in fact, the seal was nearly 18 inches from the mine roof along an arc about 8 to 10 ft from the borehole (figure 13). However, upon closer inspection inside the bowl-shaped structure, it was observed that seal material was placed to within 4 to 6 ft, radially, from the borehole and was at the mine roof level completely across the mine opening (figure 14).

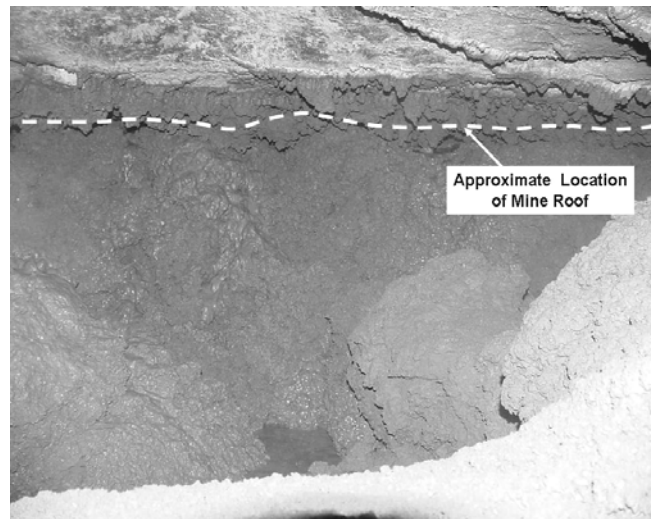
Figure 14. View of mine seal material inside of the bowl-shaped structure of Mine seal No. 3-A (close to injection borehole).

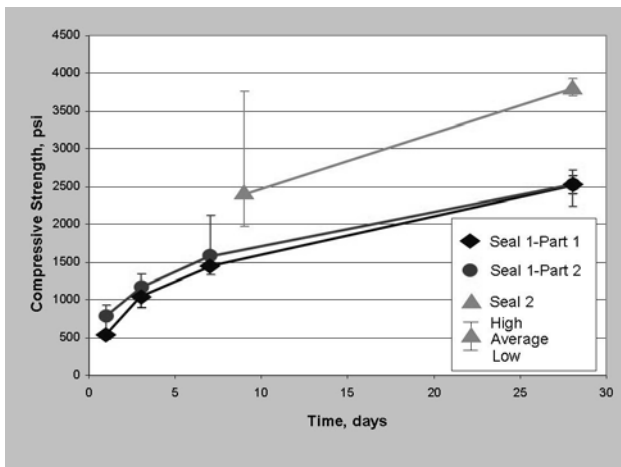
Figure 15. Results of unconfined uniaxial compression tests on bulk seal material samples.

Unconfined uniaxial compressive strength tests were conducted on 3-in diameter cylinder samples that were collected during seal construction. Samples were collected underground as the material was being placed in the mine void. The results of the tests are shown in figures 15 and 16. The marked difference between the uniaxial compressive strength of the bulk material used for seal No. 1 as compared to seal No. 2 is most likely the sand component used in seal No. 2. With respect to the sprayed material, the uniaxial compressive strength of the bulk fill material is substantially higher than that of the sprayed fill material. The reason for the lower uniaxial compressive strength of the sprayed material is that the sprayed material does not contain sand or aggregate and most likely had air bubbles trapped in the mixture from the mine seal material placement process.

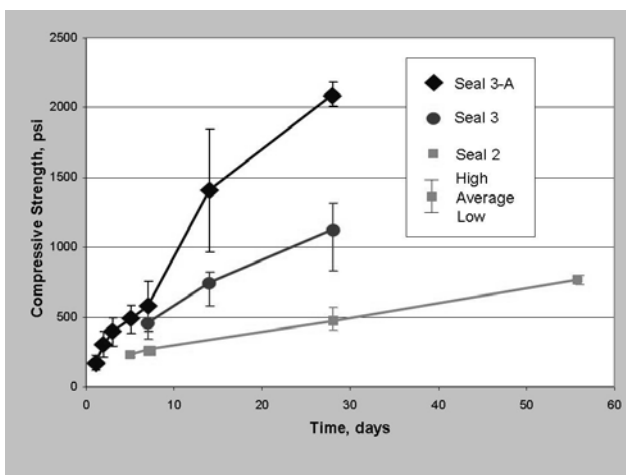
Figure 16. Results of unconfined uniaxial compression tests on spray seal material samples.

Unconfined compressive tests were conducted after 1, 2, 3, 5, 7, 14 and 28 days on samples collected from the sprayed material used to construct seal No. 3-A. The results of these tests showed that the material achieves significant strength quickly and given sufficient seal thickness could, in all likelihood, withstand the force of a mine explosion shortly after installation. Also, note that in figure 16, that there is an overall increase in compressive strength from one seal to another. This is a result of alteration of the grout mix components as discussed earlier.
