2. DESIGN AND CONSTRUCTION OF THE PCCV MODEL

2.1 Design

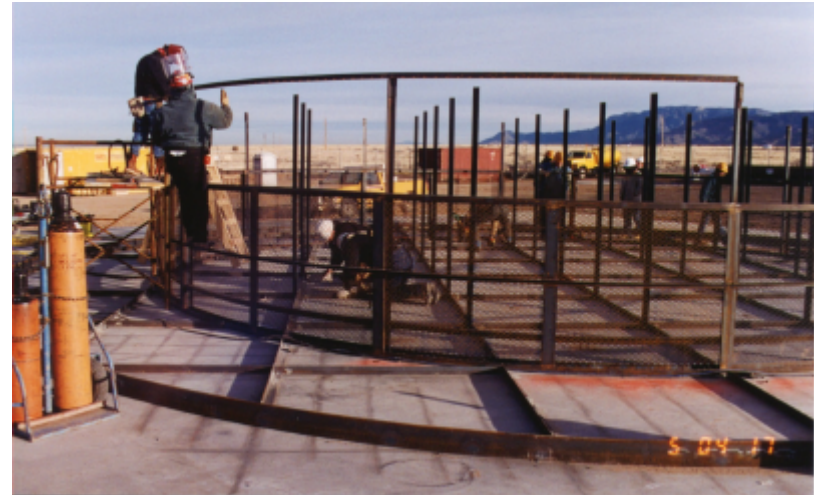
Figure 2.13 Basemat Rebar Support Frame

After the mudmat concrete had cured, a steel frame to support the basemat rebar was erected (Figure 2.13) and the rebar for the first basemat lift (F1) was erected (Figure 2.14). After verifying the position of the rebar (Figure 2.15), the formwork was set (Figure 2.16) and the F1 concrete placed (Figure 2.17). While F1 concrete was placed directly on the mudmat, there was no positive connection between the two.

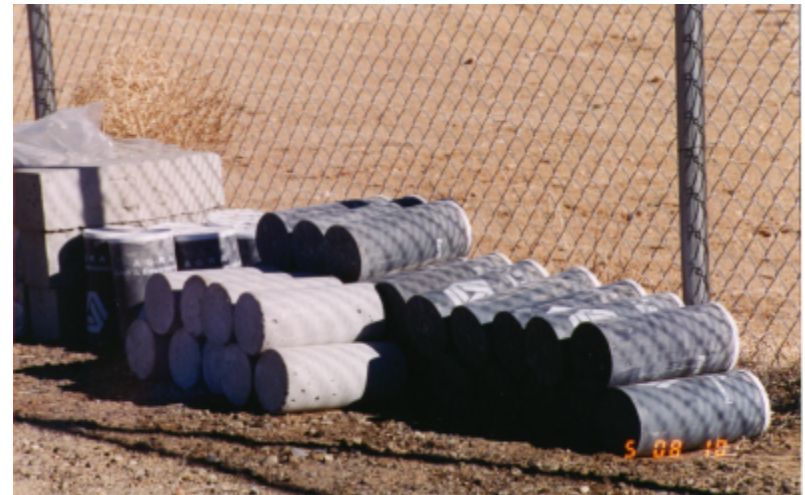
Figure 2.19 Concrete Test Cylinders and Beams

were cast (Figure 2.19) for testing at seven, 28, and 91 days and at the time of tensioning and pressure testing. Both standard-cure, SC, (two to four days in a water bath, then stored in a humidity controlled chamber until testing), and field-cured (FC) specimens (two to seven days in a water bath, then stored on-site until testing) were produced and tested.

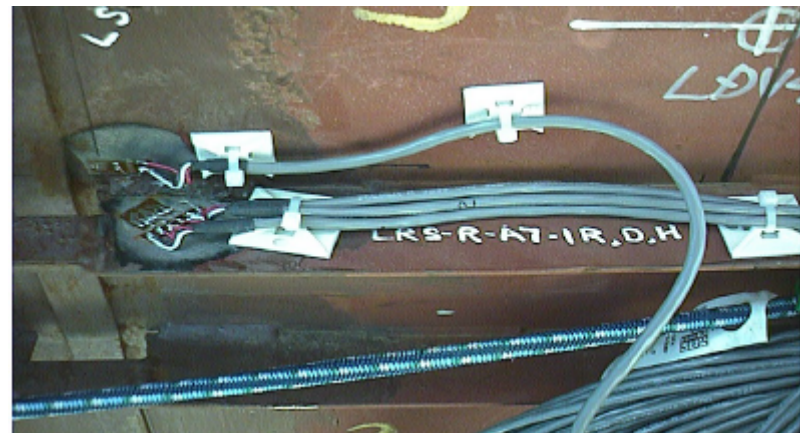
Figure 2.39 Close-Up of Liner Strain Gages near Weld

strain gages near the liner weld seams were installed. Figures 2.38 and 2.39 show typical strain gage installations near weld seams.

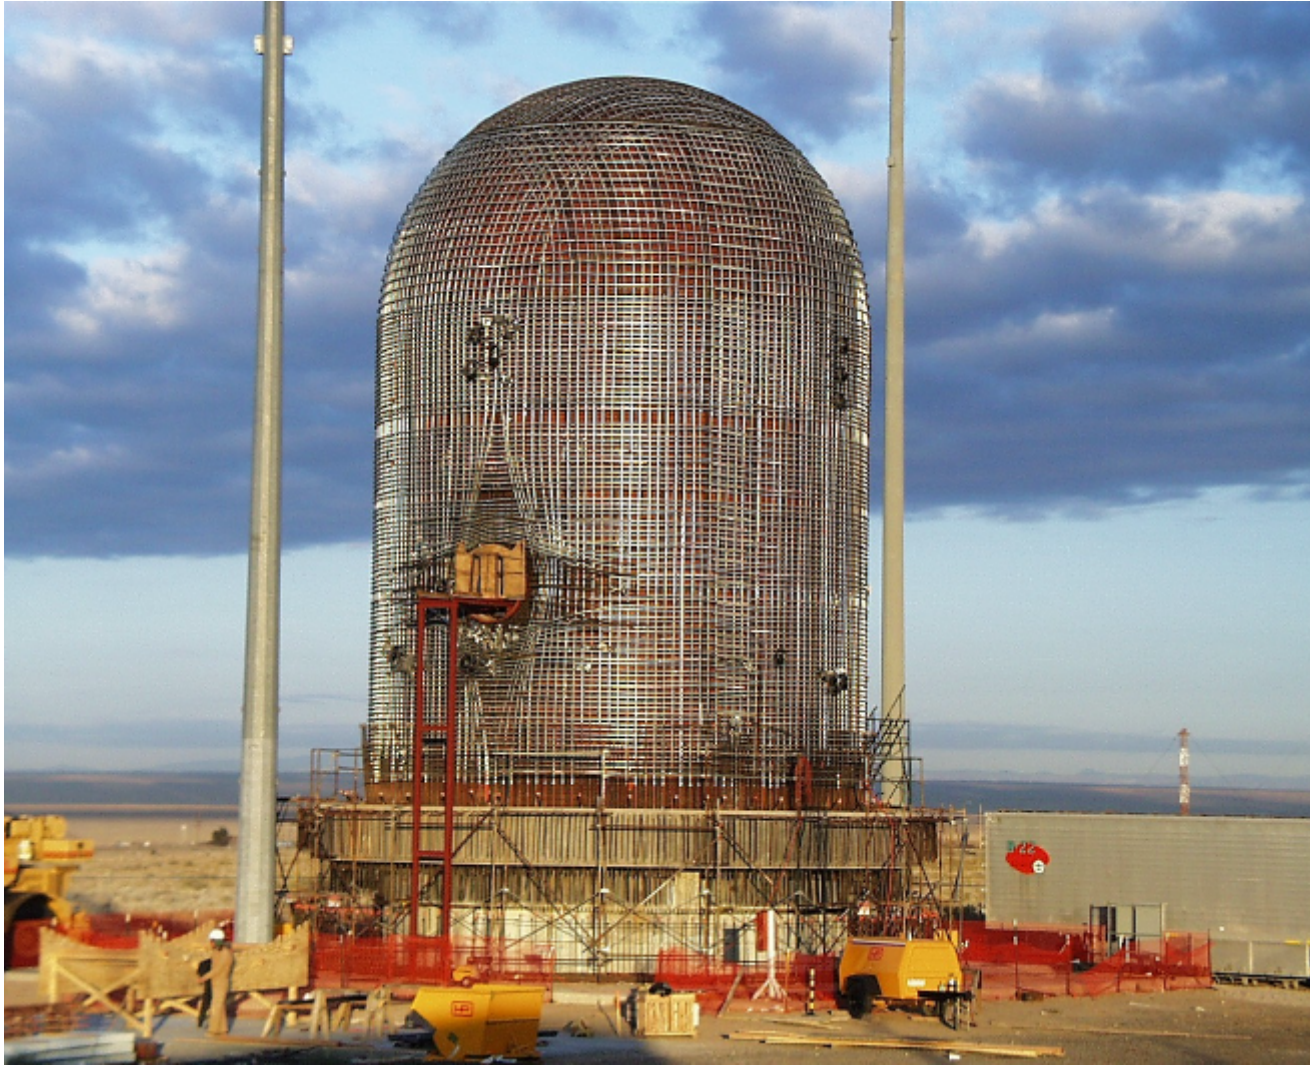
Figure 2.44 PCCV Model Tendon Sheaths

Model prestressing began on March 10, 2000. The arrangement of the model tendons is shown in Appendix A. The nomenclature for identifying individual tendons consisted of an alpha designator ‘H’ for hoop tendons and ‘V’ for vertical tendons, followed by a numerical designator (1 through 98 for the hoop tendons and 1 through 90 for the vertical tendons). The hoop tendons were numbered consecutively from 1, the lowest tendon in the cylinder wall, to 98, at the midpoint of the dome. Even-numbered hoop tendons (H2, H4, H6, ..., H98) were anchored at the 90 degree buttress and odd-numbered hoop tendons (H1, H3, ..., H97) were anchored at the 270 degree buttress. Vertical tendons were numbered consecutively from V1 at 45 degrees, clockwise to V90 at 223 degrees. The vertical tendons were arranged in two orthogonal groups, with V1 through V45 spanning the dome in a plane (nearly) parallel to the 90 to 270 degree axis and V46 through V90 in an orthogonal plane approximately 0 to 180 degrees. This arrangement is illustrated more clearly in the design drawings and shown in Figure 2.44.

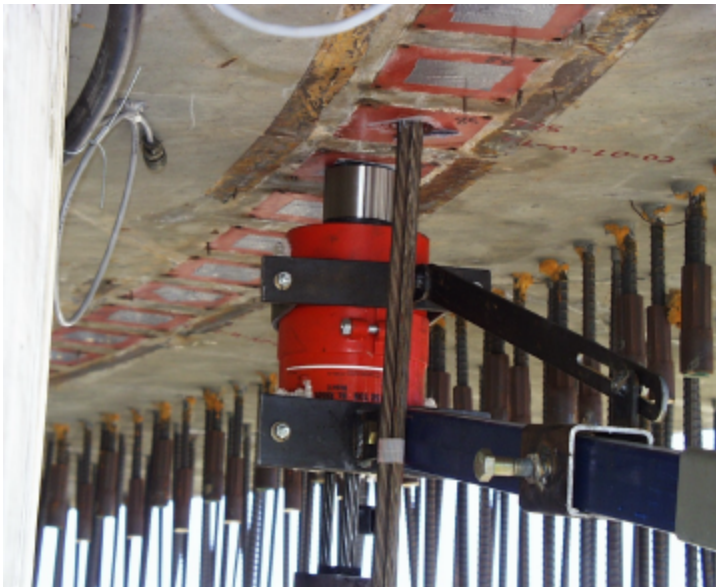
Figure 2.58 Tensioning Hardware Assembly and Load Cell

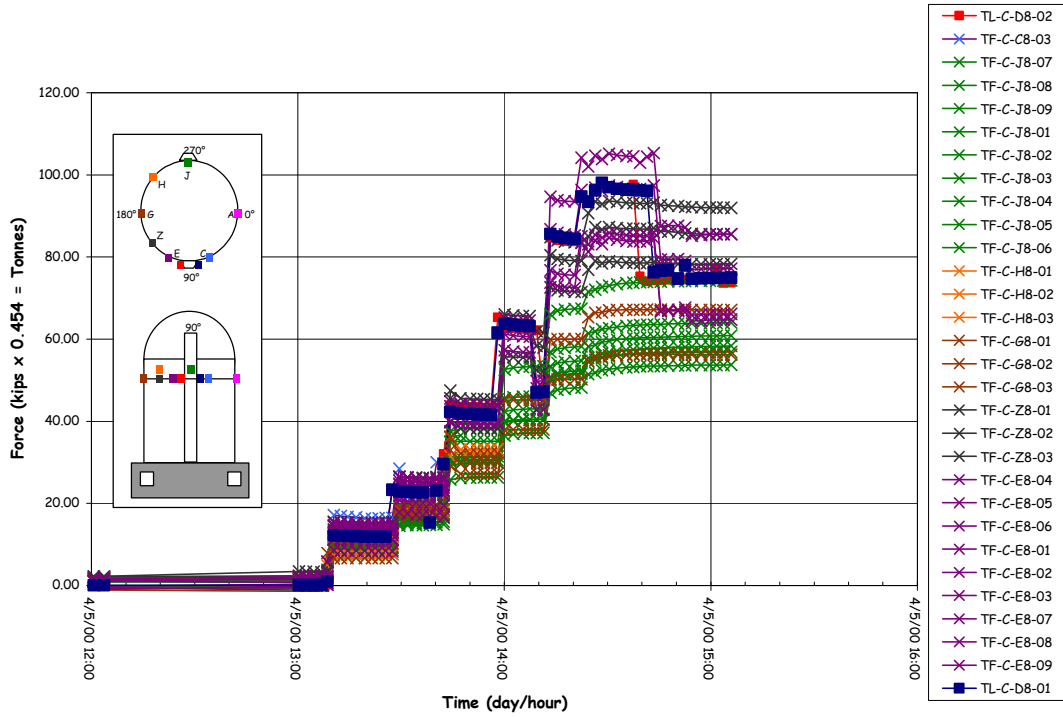
Figure 2.61 Tendon H53 Tensioning Force Time History

The instrumented tendons, those with load cells only and those with strain gages, were closely monitored during tensioning but the load cell data was not reported to the tensioning contractor, VStructural, LLC., during prestressing. The tensioning procedure was modified for the eight instrumented tendons with strain gages. Since the lead wires for these gages would be damaged if the tendon was pulled in one direction first and then the other, causing the gages and the lead wires to travel back and forth in the sheath, these tendon were tensioned simultaneously at both the A and B ends. The tensioning forces were applied in small load increments and the tendon gages were monitored continuously during tensioning. The responses of the instrumented tendons are shown as force time histories in Figures 2.59 through 2.66.

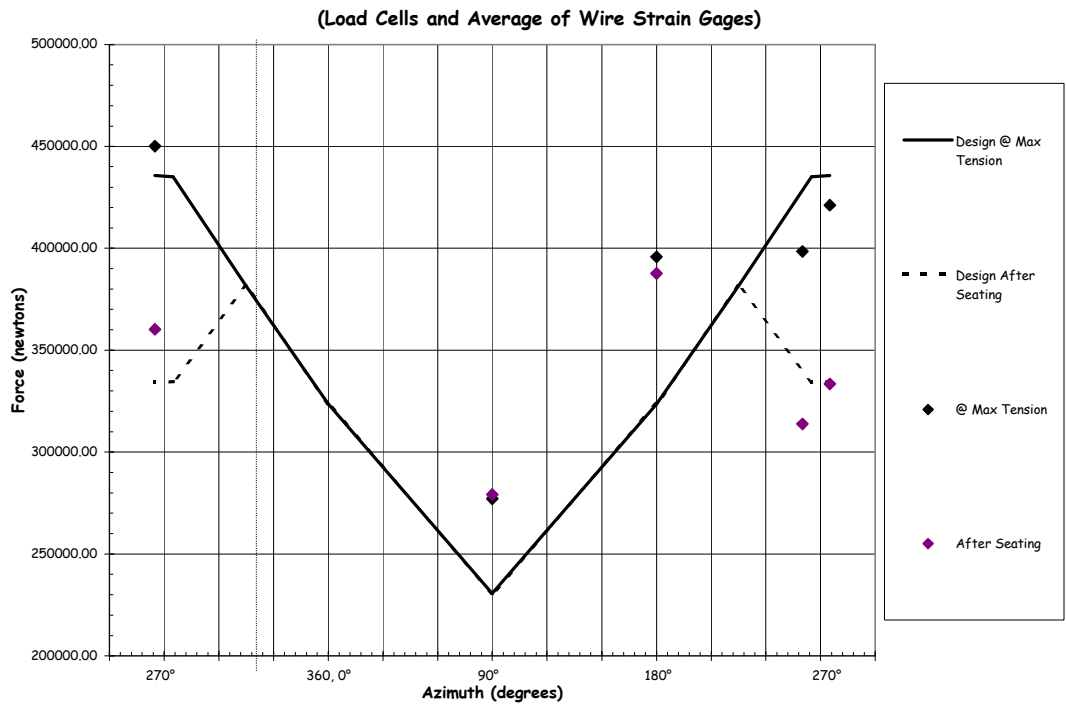
Figure 2.67 H11 Tendon Force Distribution, Elev. 1854

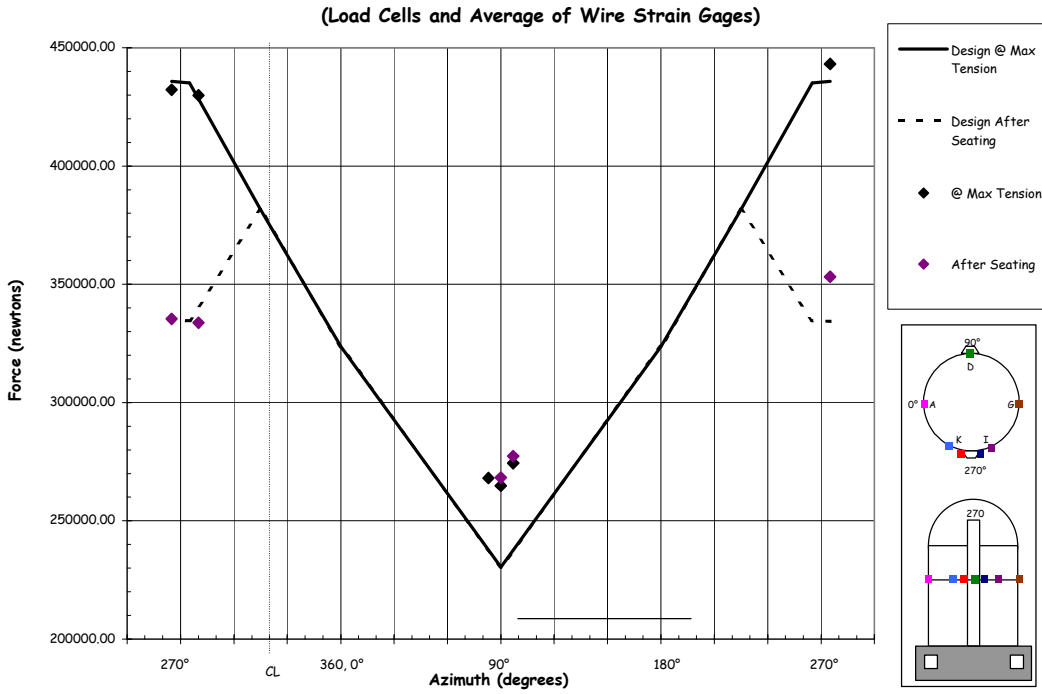
Figure 2.69 H53 Tendon Force Distribution, Elev. 6579

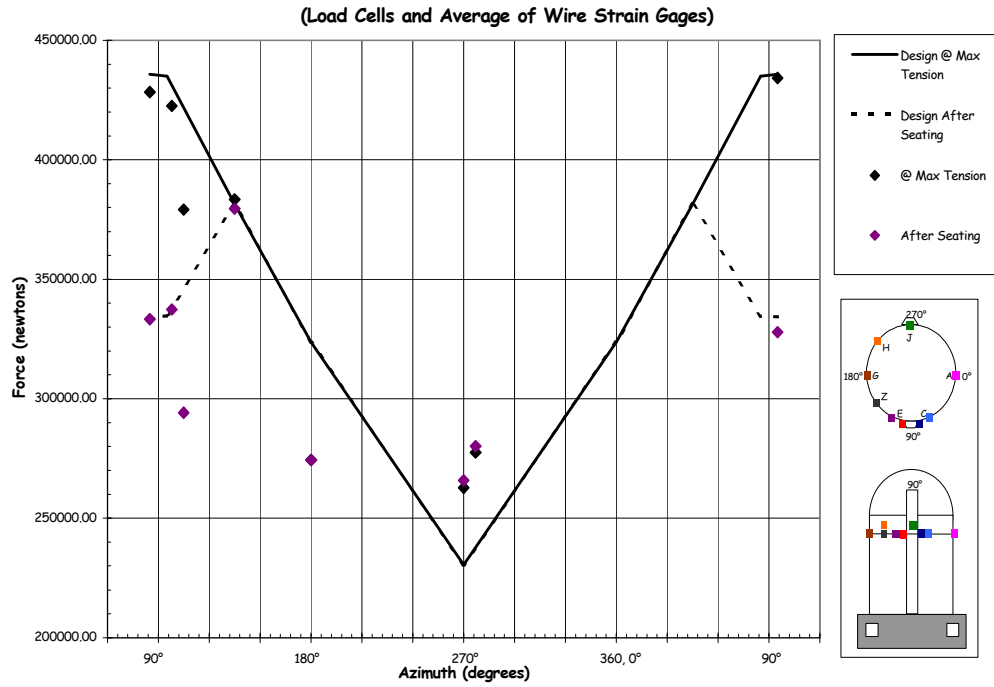
Figure 2.71 H68 Tendon Force Distribution, Elev. 8280
