9.1 INTRODUCTION

9.2 WHAT IS MEANT BY THE TERM “NONSTRUCTURAL”

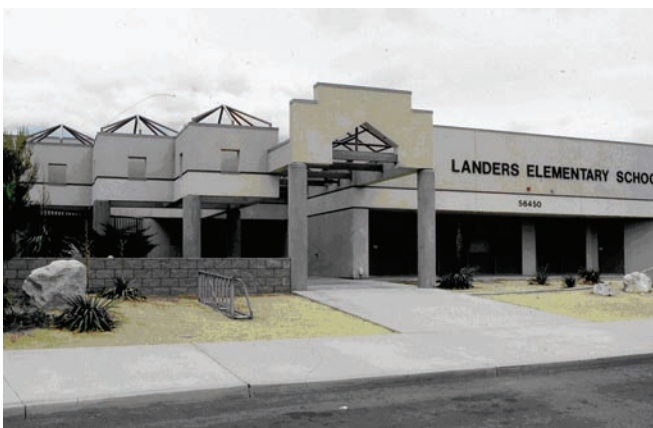
Landers Elementary School was constructed and occupied just prior to the magnitude 7.3 Landers earthquake in 1992. The building was situated just 0.4 mile from approximately 10 feet of horizontal offset along the fault trace and experienced severe shaking. Nonstructural damage was minor and included cracked stucco and dislodged suspended ceiling

Figure 9-1: Successful integration of structural and nonstructural design. Landers Elementary School, designed by Ruhnau-McGavin-Ruhnau Associates, 1990.

The lack of attention to nonstructural systems and their increasing complexity have resulted in the majority of dollar losses to buildings in recent earthquakes. These losses are the result both of the direct cost of damage repair and of functional disruption while repairs are undertaken. Today, good seismic design requires that both structural and nonstructural design be considered together from the outset of the design process. Figures 9-1 and 9-2 illustrate such a design.

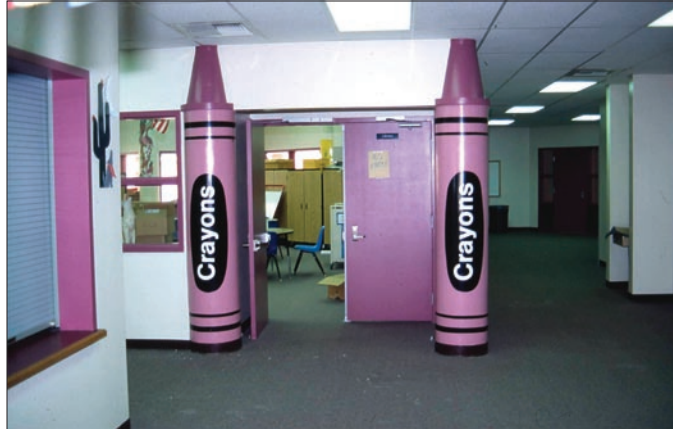
Figure 9-2: Limited nonstructural damage at Landers Elementary.

tiles in the multipurpose room. In the magnitude 6.5 Big Bear earthquake, which occurred three hours after the Landers event, at the school a water line broke and a hot water heater restraining strap failed due to the incorrect use of lag bolts (too short and not anchored into the studs). The hot water heater remained upright and functional.

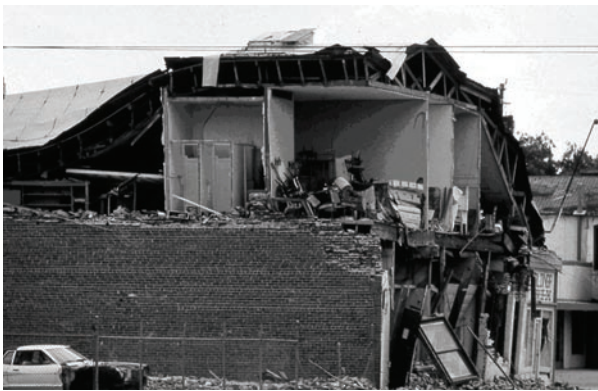
Figure 9-4: Nonstructural partition walls prevented the total collapse of this unreinforced masonry structure in the 1983 Coalinga earthquake.

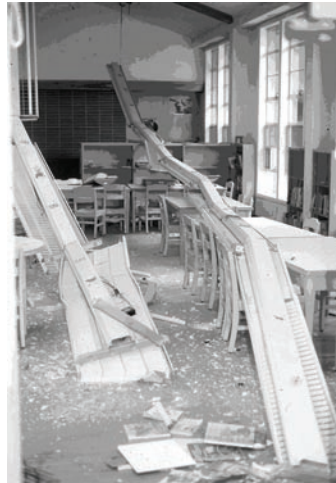
Figure 9-5: Falling objects can be a direct threat to life, as can be envisioned in this example, had children been sitting in the seats in this elementary school library in Coalinga in 1983.

There are a number of objects that can directly cause either death or injury if they are not properly designed for restraint (Figures 9-5 and 9-6). These injuries are generally due to falling hazards, such as large sections of plaster ceilings, HVAC registers, lights, filing cabinets, etc. There are also indirect threats to life and injury due to nonstructural failures. These might include the inability of occupants to safely exit a building due to damaged materials strewn across the stairs in exit stairwells (Figure 9-6).

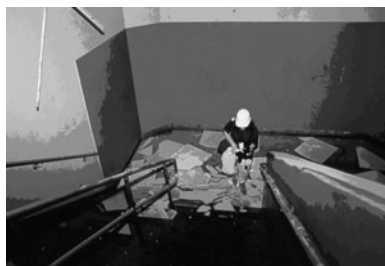
Figure 9-6: Difficulty in exiting due to debris strewn across exit stairs can be an indirect threat to life, as can be seen in this photo following the Loma Prieta earthquake in 1989.

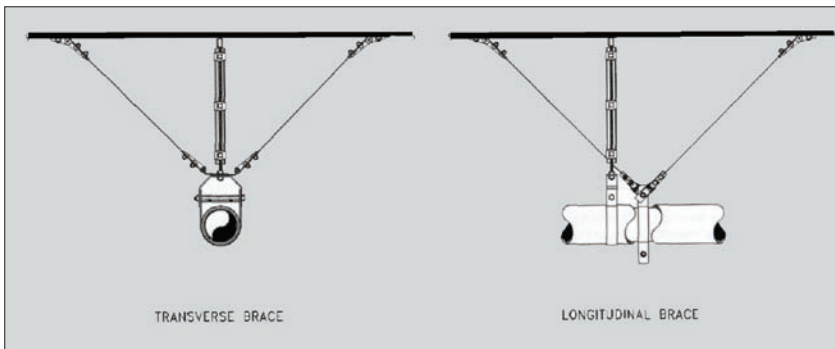
Figure 9-17:
Typical bracing for piping
(Mason Industries Inc).

Figure 9-17 shows typical bracing for large diameter piping. The seismic code specifies the types and diameter of piping, and length and type of hanger, that require seismic bracing.
