DOT/FAA/AR-01/39

In-Pavement Light Emitting Diode (LED) Light Strip Evaluation

August 2001

Interim Report

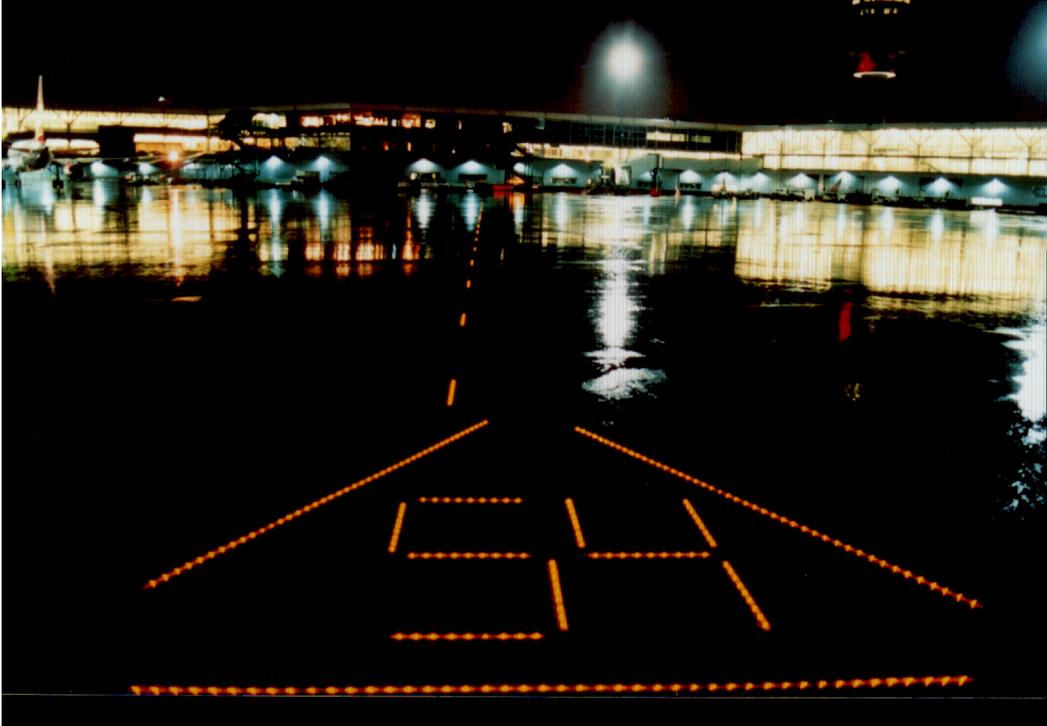
FIGURE 1. VANCOUVER, BRITISH COLUMBIA AIRPORT
DEMONSTRATION INSTALLATION

In addition, a somewhat more complex configuration in the form of a numbered gate indicator with centerline track was installed for demonstration on the Vancouver, British Columbia (BC) Airport apron. A photograph taken under standing water conditions is shown in figure 1.

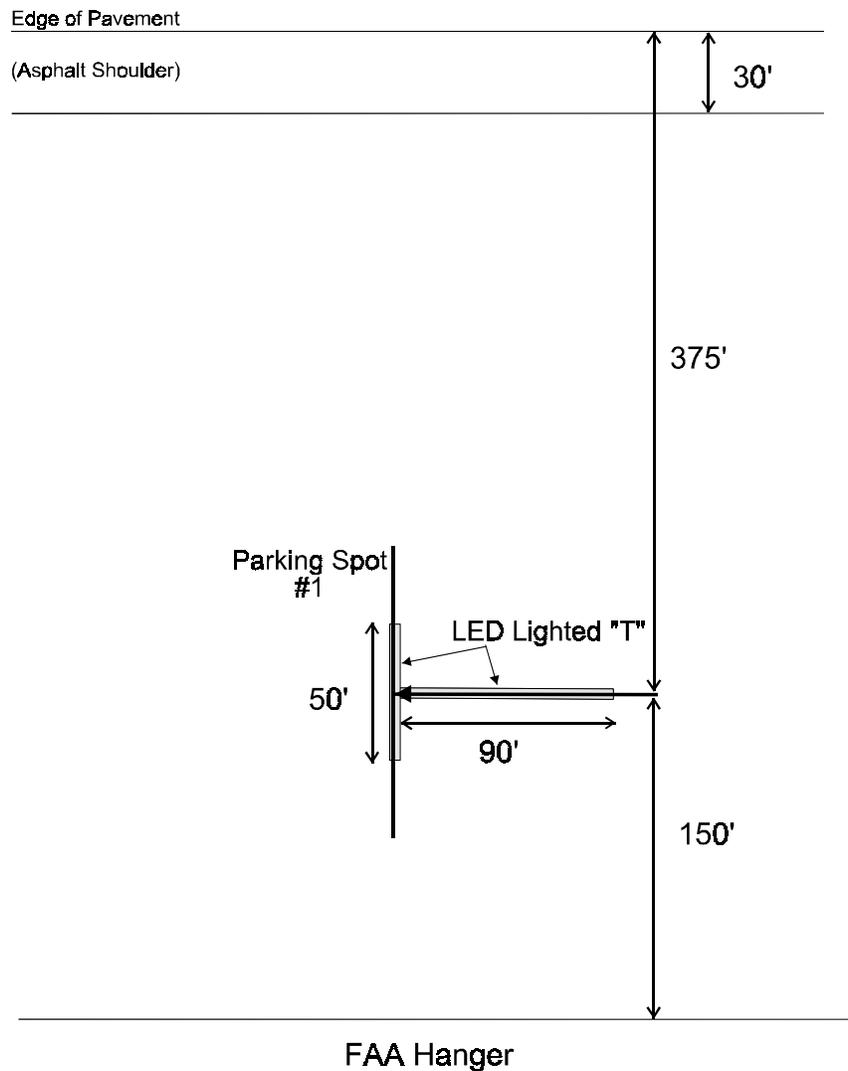
FIGURE 2. PARKING LOCATION INDICATOR LAYOUT

The test LED-strip configuration installed was in the form of a parking location “T” figure, purposely collocated with an existing painted marking of the same pattern (figure 2). It was comprised of five 3-m (10-foot) sections, or strips, forming the crossbar of the T and an additional nine sections forming the “tail” of the T. Each LED is rated at 1800 mcd at 70 mA, which equals 0.84 watts. The LEDs in the evaluation configuration were powered at 40 mA,

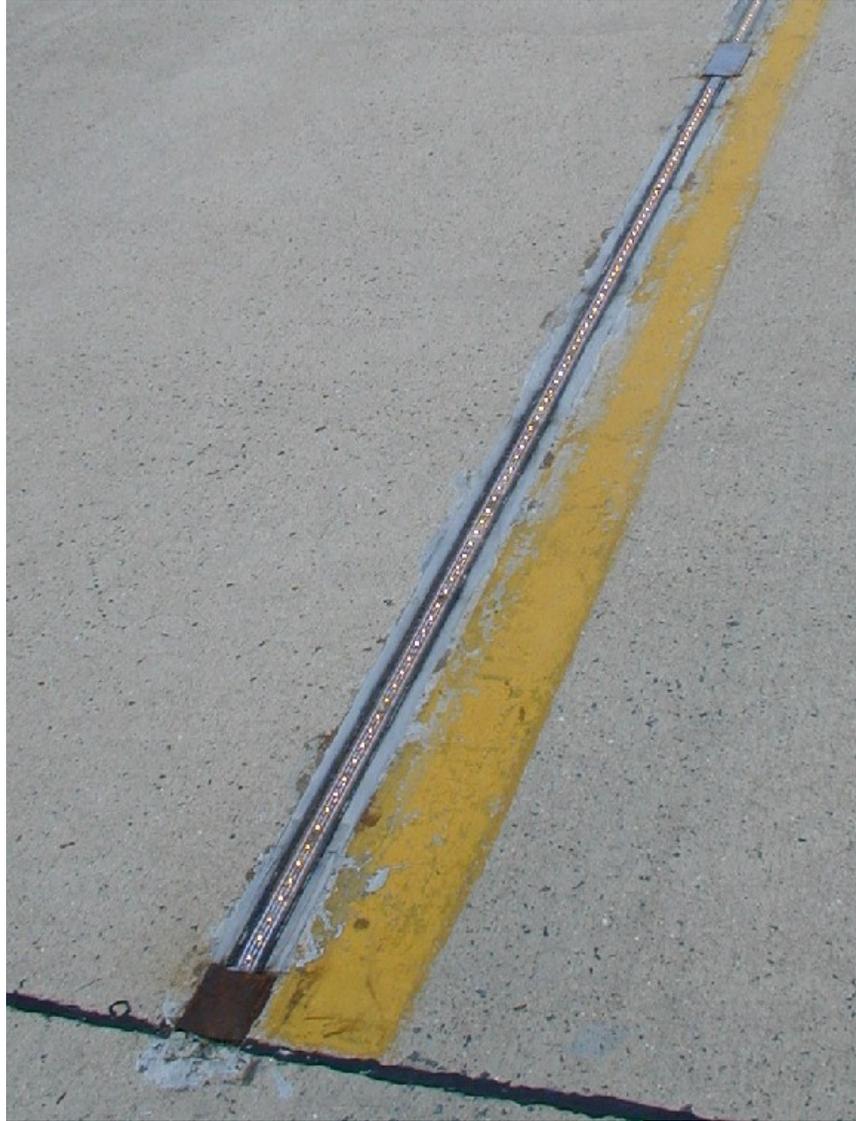
FIGURE 3. LED-STRIP SECTION PHOTOGRAPH

which produces 900 mcd and 0.48 watts. Each individual LED section contained 96 encapsulated LED devices (lights) in groups of four with 32-mm (1.25-inch) spacing between each LED (figure 3). All strips were installed in a saw-cut trench and temporarily supported during pouring of the surrounding sealant so that the top surface of each strip was approximately 2.5 mm (1/10 inch) below the surrounding concrete. Three 120Vac/12Vdc constant voltage power supplies were connected to the individual LED strips at both ends within the two five-strip and one four-strip grouping. Connections were made at both ends of all strips to provide redundancy in the event of an end connector failure.

The end connectors, provided by the manufacturer and preinstalled at the factory, used spring-loaded contacts butted against the metallic ribbon conductor encapsulated with the LED lamps. This provided only minimum contact area between the feeder wires and the ribbon conductor and was a continuing problem until it was replaced with a more positive connector retrofit.

Some difficulty was experienced with maintaining a constant level with the surrounding pavement within each strip due to what seemed to be excessive flexibility of the “U” channel provided to support the encapsulated LED lights. Even using closely spaced mounting templates, per the manufacturer’s instructions, it was necessary to add 1/2” by 1/2” angles underneath the channel for rigidity during installation in the saw-cut trench.

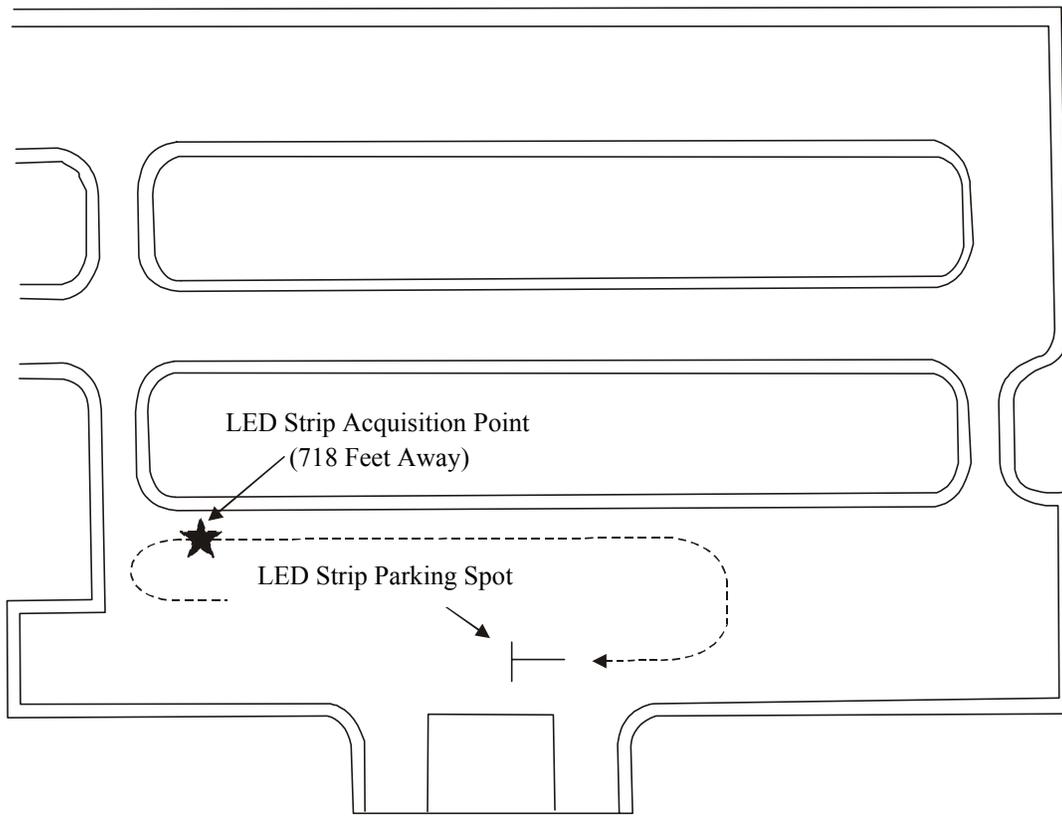
FIGURE 6. TAXI ROUTE AND DISPLAY LOCATIONS

A summary of questionnaire responses is provided in figure 5. A diagram of the taxi routes followed during the evaluation session (figure 6) also depicts the relative location of the LED-strip installation.

With regard to the first question, concerning acquisition distance, subject comments indicated that they were able to acquire and identify the LED lights from the far corner of the ramp, a point better than 700 feet away as shown in figure 6. The star on the ramp depicts the point at which virtually all of the subjects verbally announced acquisition.

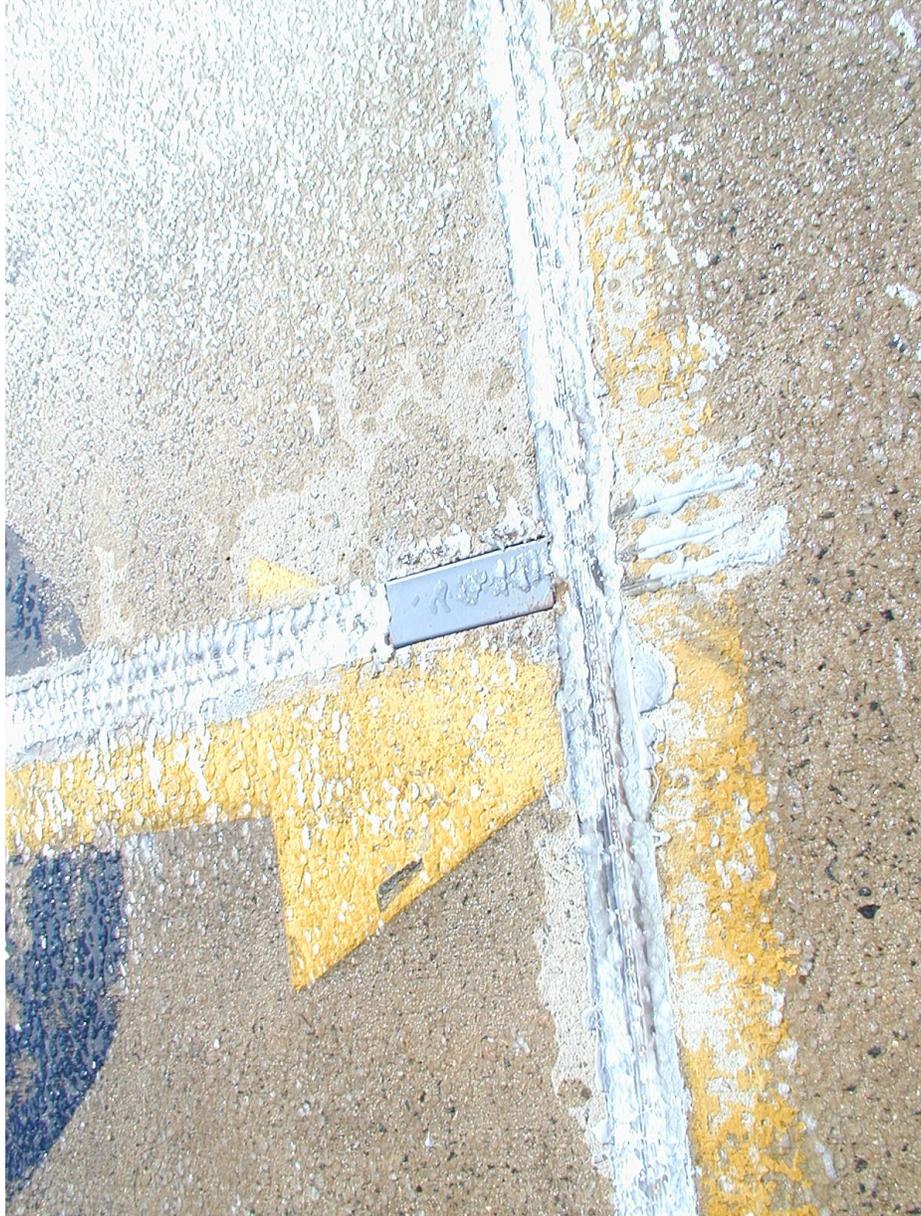
FIGURE 7. POSTSNOW APPEARANCE

During the evaluation period, the LED strips were covered by approximately 1 1/2” to 2” of snow. It was verified that the strips were illuminated but were not visible under the snow. LED lights do not generate any appreciable heat so there will be virtually no chance that they will experience any self-cleaning or melting of the snow/ice covering. Snowplowing should not be a problem, since the LED strips are installed approximately 1/16” to 1/8” below the surrounding surface, but this will also result in a covering being left after plowing. Figure 7 shows a portion of the illuminated parking location display after a period of light snow.

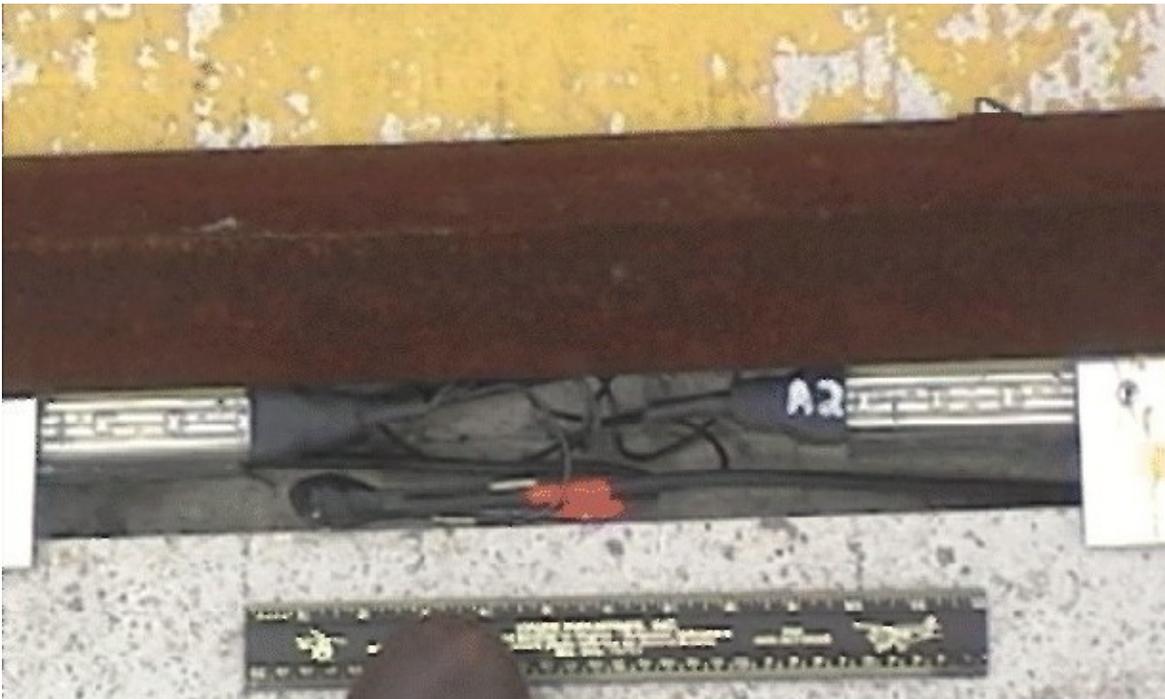
FIGURE 8. CONNECTION SPACE BETWEEN LED SECTIONS

During a period of approximately 6 months, the LED-strip parking position indicator was operated intermittently whenever visiting aircraft arrived. Almost all malfunctions or failures occurred because of the connector design mentioned earlier in this report. A gap between LED sections, of about 10 inches in length, was necessary to provide room for the connectors and for the connections with the feeder cables running beneath the LED strips (see figure 8). This void was filled with a solidified foam and protected with a U-shaped steel cover to protect the wiring and reduce water contamination. Unfortunately, the tops of the original sealed connectors protruded above the surface level of the LED strips. Under pressure from aircraft and vehicles passing over the covers, the connectors soon were bent downward, causing frequent separation of the spring-loaded butt connection. In some cases, a vehicle passing over a cover would cause a section to go out, while another vehicle subsequently passing over would cause the strip to be re-energized. The fact that each section was fed from both ends, also caused disconnections to go unnoticed until both connectors had failed.

After repeated failures, the original connectors were removed and replaced with screws inserted directly into the ends of the strips and contacting the ribbon conductor along the thread length. The feeder cables were then attached to the screws with ring connectors. This alternate connection method served well until such time as the screws rusted, breaking the contact once more.
