Evaluation of Runway Guard Light Configurations at North Las Vegas Airport

January 2007

DOT/FAA/AR-TN06/19

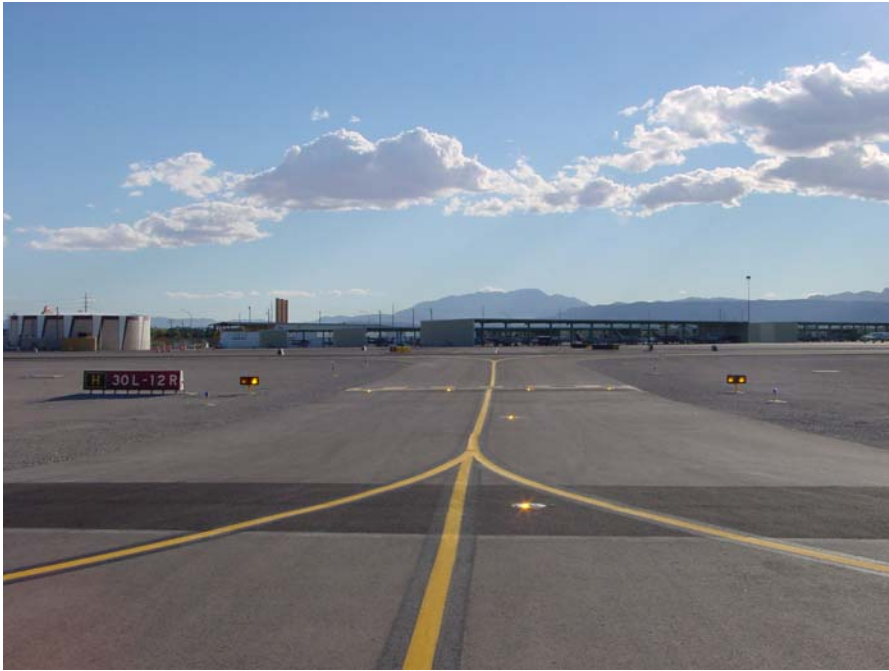
Figure A-1. Delta 1—Runway 12R-30L and Taxiway H (Northeast side)

- Delta 1—Basic Configuration with L-804 elevated RGL, L-852G in-pavement RGL, and L-852G Alert Zone Lighting (T-configuration)—Runway 12R-30L and Taxiway H (NE side) (figure A-1).
- Delta 2—Basic Configuration with L-804 elevated RGL and L-852G in-pavement RGL—Runway 12R-30L and Taxiway C (NE side) (figure A-2).
- Delta 3—Basic Configuration with L-804 elevated RGL—Runway 12L-30R and Taxiway H (SW side) (figure A-3).

This data acquisition location was the first of three approaches (identified as Delta 1, 2, and 3) to either of two runways (12R-30L and 12L-30R) from parallel taxiway D. The Delta 1 observation and data collection path was in a northerly direction along taxiway D to obtain acquisition distances for the configuration identifying the holding position at the intersection of taxiway H and runway 30L-12R (see figure 2 for illustration). The configuration at this location was comprised of standard painted runway holding position markings with associated L-858R mandatory instruction signs (white runway designation on a red background), L-804 elevated RGL, L-852G in-pavement RGLs, and L-852G alert zone lights (T-configuration).

The approach to this holding position, as well as those for the other two Delta locations, required making observations along a path primarily at right angles to the signs, lights, and markings; therefore, one would expect greater difficulty in acquiring and identifying the configuration components. This is evident when considering the relatively short distances at which the signs could be read, a result of the acute viewing angles at which observations were begun. Obviously, the signs would have been much more effective if viewed head-on initially, as is borne out at other locations (Hotel 1, Alpha 1, etc.). The elevated lights, on the other hand, provided approximately double the acquisition range during three of the four daylight and night conditions. The elevated lights were less effective during full daylight, when the yellow light could not compete with the bright Nevada sunlight. The in-pavement lights, in the T-configuration, were of only reduced effectiveness due to the physical cutoff of the lenses recessed within the fixture combined with the acute viewing angles along the approach path. The relatively narrow beam of the in-pavement lights normally restrict their utility to situations wherein they are viewed principally from angles well within the main beam.

It should be noted that during the dusk period, a pilot approaching the Delta 1 hold position faces directly into the setting sun once turning onto taxiway H. In this situation, the lighting array was more effective than the sign in identifying the critical location, and certainly more effective than the glare-masked markings.

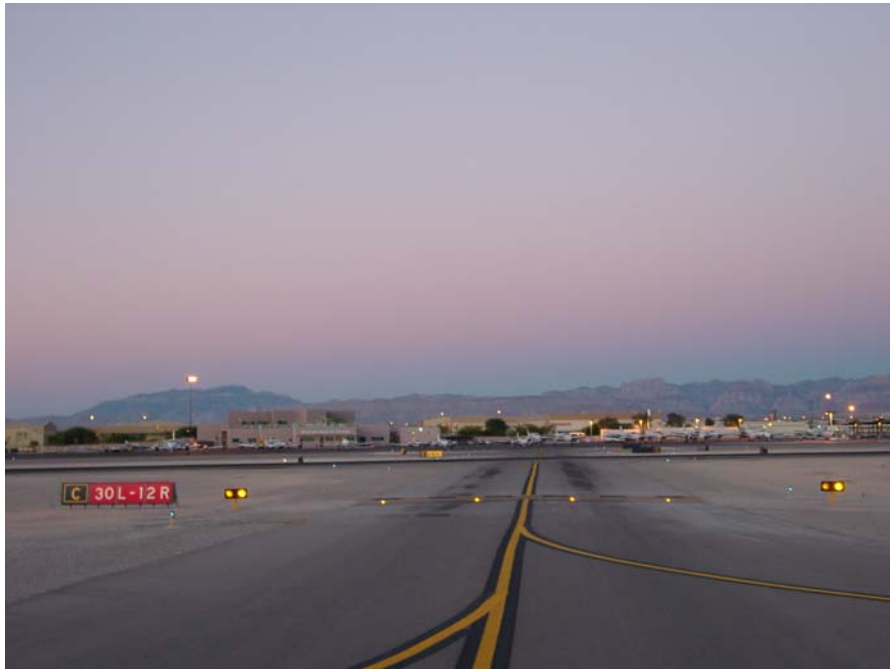
Figure A-2. Delta 2—Runway 12R-30L and Taxiway C (Northeast side)

This data acquisition location was the second approach to either of two runways (12R-30L and 12L-30R) from parallel taxiway D. The Delta 2 observation and data collection path was again in a northerly direction along taxiway D to obtain acquisition distances for the configuration identifying the holding position at the intersection of taxiway C and runway 30L-12R (see figure 2 for illustration).

The configuration at this location was comprised of standard painted runway holding position markings with associated L-858R mandatory instruction signs (white runway designation on a red background), L-804 elevated RGLs, and L-852G in-pavement RGLs.

The Delta 2 location is similar in some ways to the Delta 1 location, in that the observation path is at a slightly greater than 90° angle to the hold position. As a result, comments pertaining to sign and elevated light effectiveness for the Delta 1 location apply here also, i.e., that the elevated lights proved better acquisition distances in all but the full daylight condition. In-pavement light effectiveness is marginally increased over the Delta 1 location due to the fact that taxiway C intersects taxiway D at a somewhat greater than a 90° angle, thus making the physical cutoff less critical. Marking effectiveness is reduced, to some extent, by the fact that the taxiway hold position elevation, relative to the elevation of taxiway D, is considerably higher at Delta 2 than at Delta 1.

Here again, a pilot approaching the Delta 2 hold position faces directly into the setting sun once turning onto taxiway C. As before, the lighting array was more effective than the sign in identifying the critical location, and certainly more effective than the glare-masked markings.

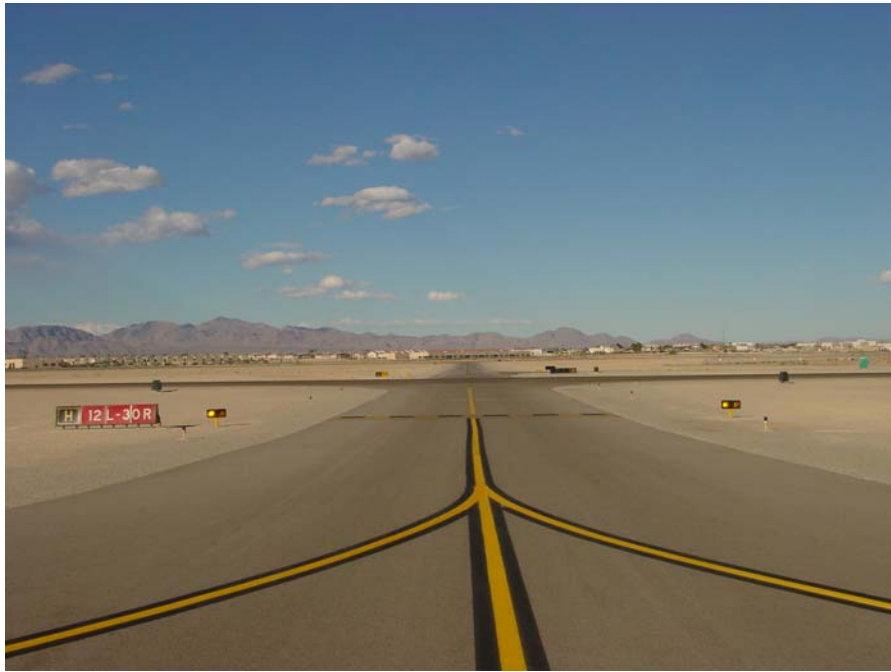
Figure A-3. Delta 3—Runway 12L-30R and Taxiway H (Southwest side)

This data acquisition location was the third approach to either of two runways (12R-30L and 12L-30R) from parallel taxiway D. The Delta 3 observation and data collection path was in a southerly direction along taxiway D to obtain acquisition distances for the configuration identifying the holding position at the intersection of taxiway H and runway 12L-30R (see figure 2 for illustration). The approach to this holding position involved making observations along a

The configuration at this location was comprised of standard painted runway holding position markings with associated L-858R mandatory instruction signs (white runway designation on a red background) and L-804 elevated RGLs.

The Delta 3 location is the last of the three Delta sites and is, once again, approached from a most acute angle along taxiway D. As expected, the lights (in this case, only elevated fixtures) are notably more effective than either the sign or markings, except during full daylight. A rather unique affect was observed during afternoon periods when the sun was in its western quadrant, shining directly on the yellow filters of the elevated lights. In this situation, both lights of the elevated RGL appeared to be illuminated, and no wig-wag effect was discernable.

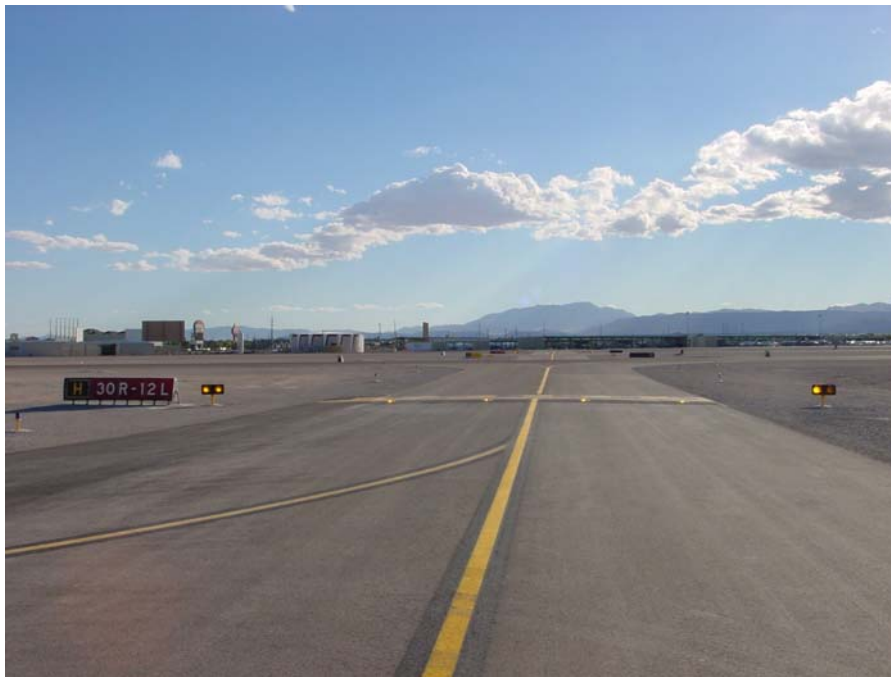
Figure A-4. Hotel 1—Runway 12L-30R and Taxiway H (Northeast side)

- Hotel 1—Basic Configuration with L-804 elevated RGL and L-852G in-pavement RGL—Runway 12L-30R and Taxiway H (NE side) (figure A-4).
- Alpha 1—Basic Configuration with L-804 elevated RGL—Runway 12L-30R and Taxiway A (E side) (figure A-5).
- Alpha 2—Basic Configuration with L-804 elevated RGL—Runway 7-25 and Taxiway F (S side) (figure A-6).
- Alpha 3—Basic Configuration with L-804 elevated RGL—Runway 12R-30L and Taxiway A (W side) (figure A-7).
- Alpha 4—Basic Configuration with L-804 elevated RGL—Runway 12L-30R and Taxiway A (W side) (figure A-8).

At this location, the approach path taken by the subject began at the intersection of taxiways A and H and proceeded directly toward the Hotel 1 hold position at the intersection with runway 30R-12L. In each instance, and under all daylight and night conditions, the subjects were able to acquire and identify the elevated lights from the turnaround point (maximum range) at taxiways A and H intersection. The in-pavement lights were also acquired at the maximum range, except during the dusk period when the setting sun was directly facing the viewer. The sign was also visible at the maximum range, but could not be read (a requirement) before reaching the somewhat closer distance shown in table 4. The markings were, as with the previous sites, effective only at close range during the day or when illuminated by the vehicle headlights after dark.

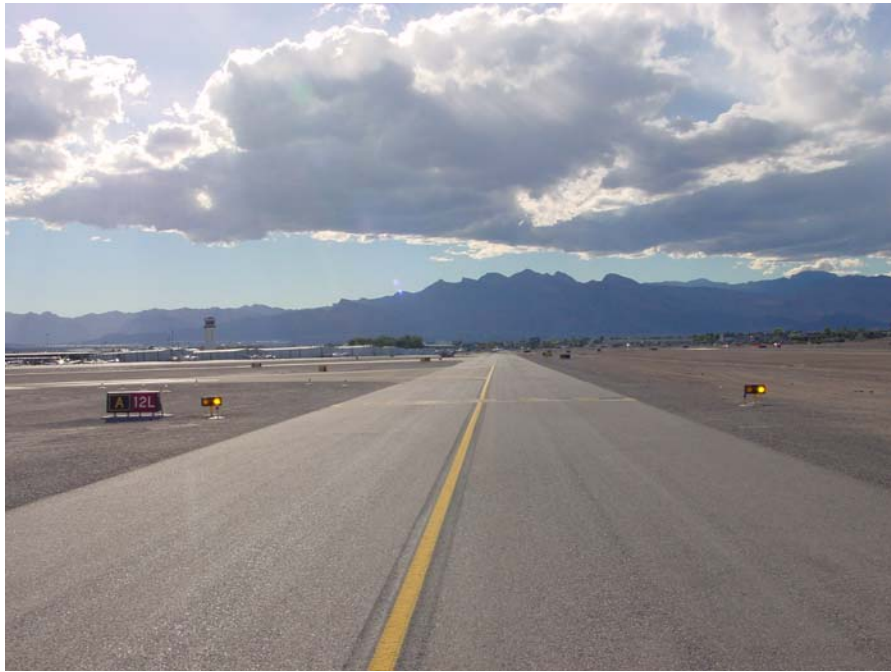
Figure A-5. Alpha 1—Runway 12L-30R and Taxiway A (East side)

Subject pilots also noted here that two sets of elevated RGLs were visible at the same time (locations Alpha 1 and at the hold position on taxiway A and runway 12R) looking in the northwest direction. Again, the subject expressed no concern about this.

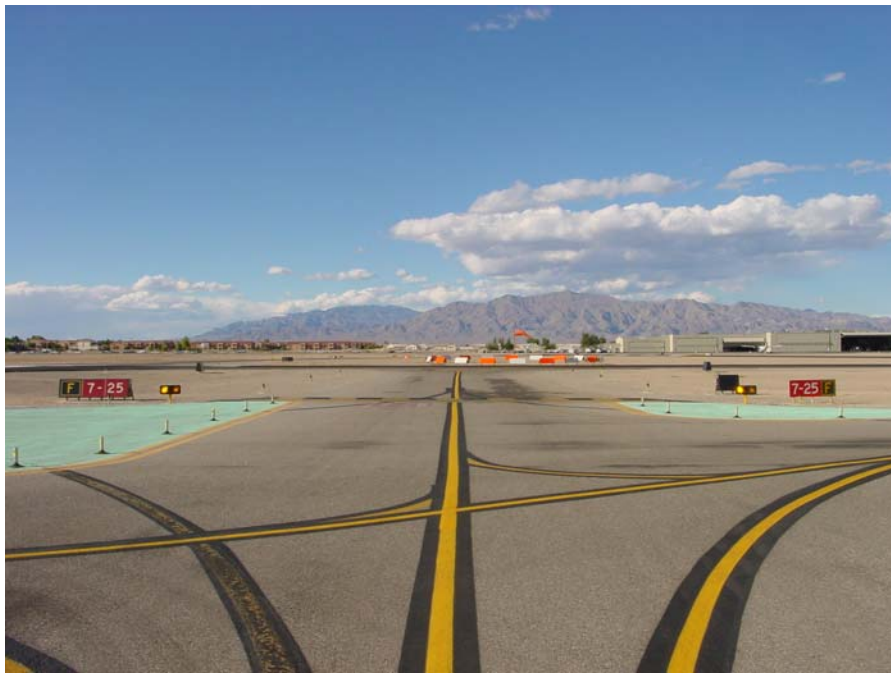
Figure A-6. Alpha 2—Runway 7-25 and Taxiway F (Southwest side)

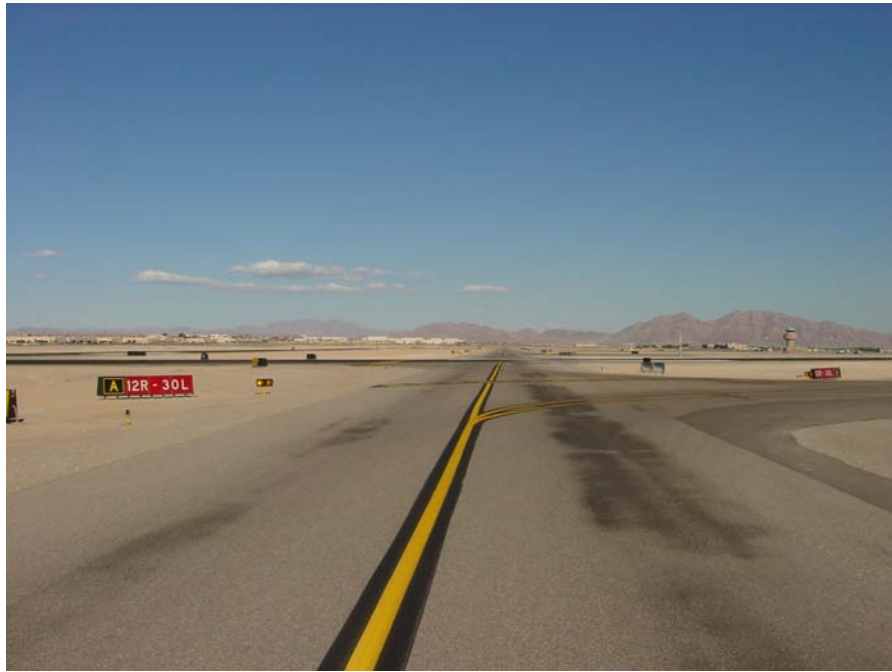
Figure A-7. Alpha 3—Runway 12R-30L and Taxiway A (West side)

The distance at which the approach to the Alpha 3 was initiated was, of necessity, quite short (580 feet). As a result, both the signs and the elevated lights were noted and identified by virtually all subjects immediately upon starting the approach. The painted markings were acquired only as the vehicle approached close and, during nighttime conditions, illuminated the paint with headlights.

It was noted that the L-858B sign on the left of the taxiway was blocked by another taxiway information sign positioned approximately 25 feet prior to the hold line. Pilots noted that the sign was blocked, but still were able to recognize the sign’s message.

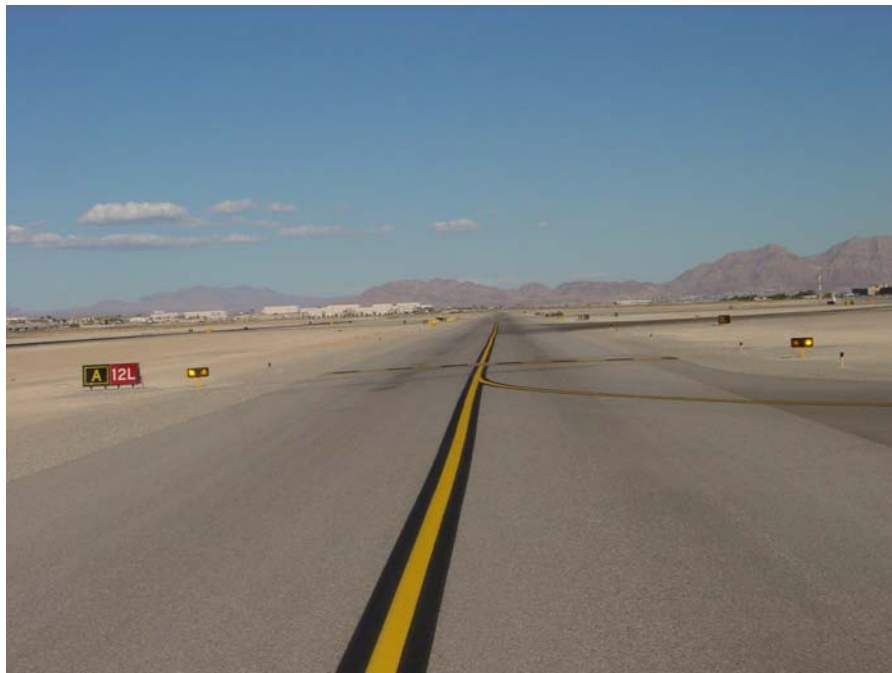
Figure A-8. Alpha 4—Runway 12L-30R and Taxiway A (West side)

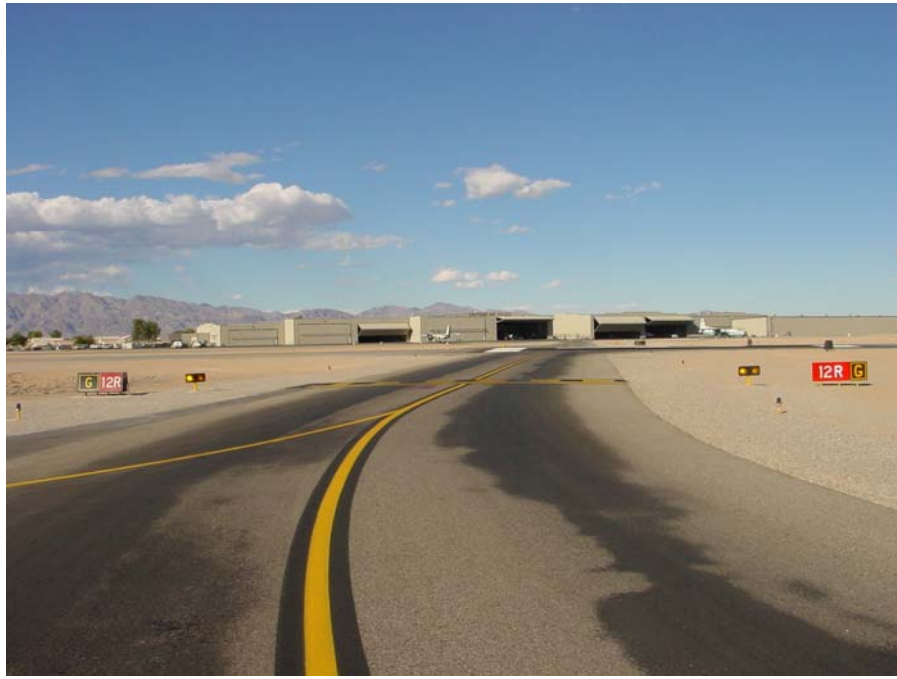
Figure A-9. Golf 1—Threshold of Runway 12R and Taxiway G (Southwest side)

Taxiway G is a relatively short dog-leg to the right before terminating at the entrance to runway 12R. Virtually all subjects were able to acquire and identify both the signs and elevated lights from the approach starting point at the hold position south of runway 7-25. The painted markings were especially deficient in providing warning at this location since they were coated with aircraft exhaust and oil contamination and could only be identified, close in, by their appearance at the outermost edges of the taxiway.
