The Technology Used to Investigate Some Mine Fire and Explosion Accidents

Harry C. Verakis, CFEL, CMSP

Mine Safety and Health Administration, Technical Support Directorate, USA

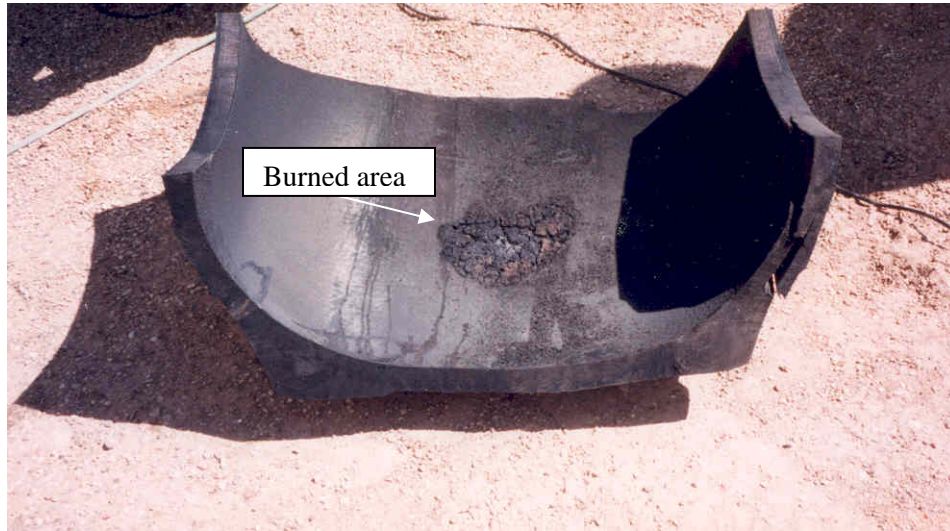
Figure 1 – Burned Area of a Mine Vehicle Tire that Exploded

A tire explosion occurred during an operation to repair the brakes on a bottom dump trailer⁸. A contract employee assigned to repair the brakes on the trailer was unable to remove the tire/rim assembly by mechanical means. He then used an oxygen/acetylene torch to apply heat to the rim of the tire. After about 45 minutes to an hour, the tire exploded and fatally injured the contract employee. The tire was examined to pinpoint the cause of the explosion. A section that showed apparent heat damage was cut out of the tire (see Figure 1) and the rubber liner from that section was tested in the laboratory by using a differential scanning calorimeter (DSC). The DSC test produced thermograms showing the exothermic behavior of the undamaged liner and a portion of the liner that had apparent heat damage. The analysis of the DSC data determined that the liner exhibiting heat damage was exposed to a temperature exceeding 425°C (797°F). The laboratory analysis showed that the tire material decomposed and produced hot embers and a combustible gas mixture within the tire. The heated tire material provided an ignition source for the combustible gases which subsequently ignited, causing the tire to explode. It was calculated that the tire explosion created a maximum pressure of about 22.4 bars (325 pounds per square inch).

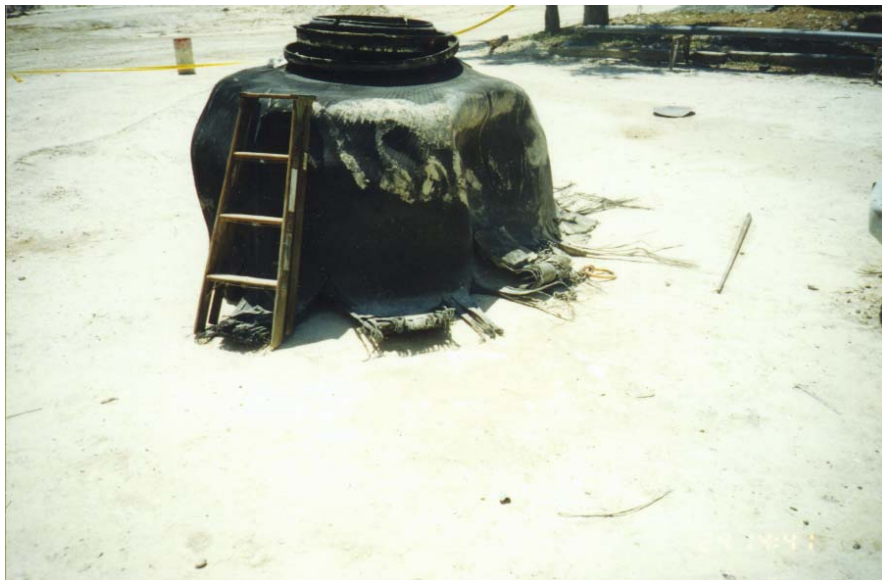
Figure 2 – View of an Exploded Mine Vehicle Tire

Another tire explosion occurred at a surface mine crushed limestone operation⁹. An employee used a torch to cut the drum off of a tire assembly. While prying the cut drum with a pry bar, the tire exploded fatally injuring the employee and injuring two other employees. As shown in

Figure 2, the explosion turned the tire completely inside out and sent pieces of the sidewall in all directions. Laboratory analysis was performed on the tire material and an actual torch cutting test was performed on the tire rim to simulate the torch cutting as used prior to the explosion of the tire. The torch transferred sufficient heat to ignite material within the tire, generating combustible vapors and increased internal pressure. The smoldering material inside the tire served as the ignition source that ignited the combustible vapors within the tire causing it to explode.

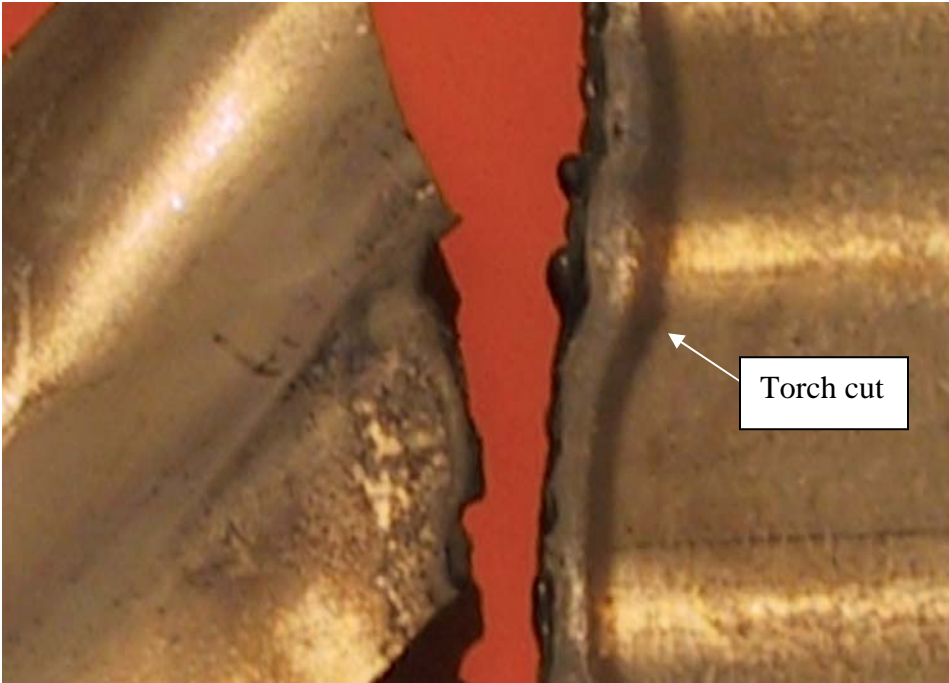
Figure 3 – Galvanized Steel Sheet Covering a Man Door Opening in a Coal Mine Shaft

An independent contractor was developing a vertical shaft to a coal mine when an explosion occurred near the bottom of the shaft¹⁰. Three miners were fatally injured and three other miners were injured. Prior to the explosion, the miners were working on an elevated work deck, attempting to remove corrugated, galvanized steel sheeting. The sheeting blocked access to the unventilated water ring being constructed. The shaft was about 289 meters (950 feet) deep and within 9 meters (30 feet) of intersecting the coal seam. The miners partially opened the steel sheeting with an axe and then a hand-held methane detector was placed into the opening to test for methane. After reading 0.2 percent methane on the detector, a miner used an oxygen-acetylene torch to cut the steel sheeting. An explosion occurred when an explosive methane-air mixture contained inside the water ring was ignited by the torch cutting process. Numerous items were taken as evidence from the site. One piece of evidence in particular was the corrugated, galvanized steel sheeting. The sheeting was examined in the laboratory using a stereo microscope and showed evidence of cutting as indicated in Figure 3. A reference sample of corrugated, galvanized steel sheeting was cut with an oxygen-acetylene torch of the type used by the fatally injured miner. The reference sample was used for comparison with the galvanized, corrugated steel sheet recovered from the accident. As part of the investigation, the microscopic examination of the steel sheeting from the accident and comparison with the reference sample provided evidence that the steel sheeting blocking access to the water ring was apparently cut with an oxygen-acetylene torch.

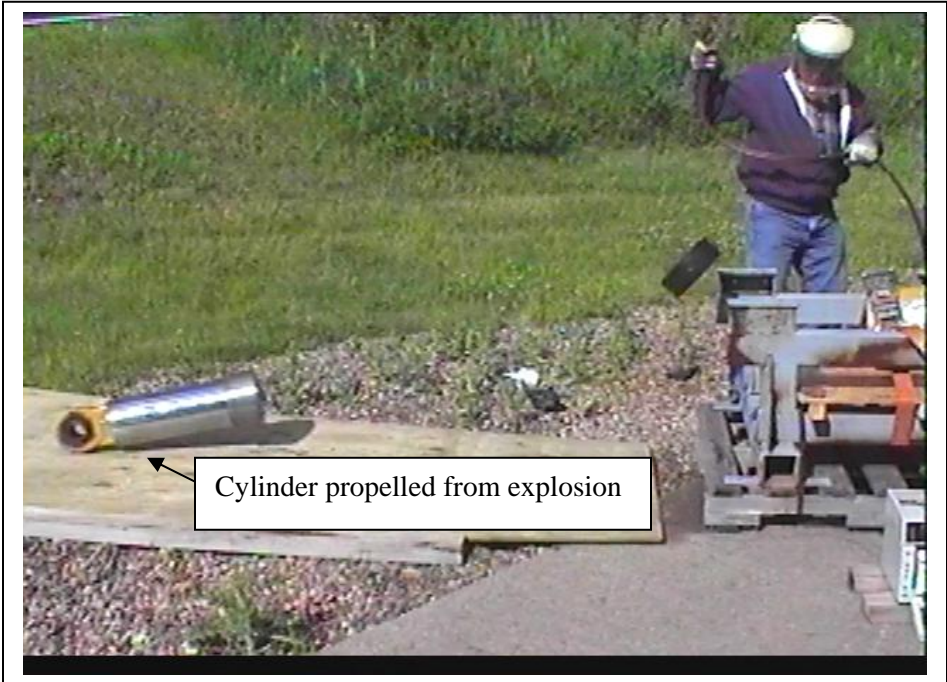
Figure 4 – Empirical Test Illustrating an Explosion in an Equipment Cylinder

An explosion of a suspension cylinder on a haulage truck occurred at a surface gypsum mine¹¹. The explosion propelled the 0.6 meter (25 inch) long, 0.2 meter (7 inch) diameter cylinder rod, striking and fatally injuring a miner. The miner had broken off a nitrogen charging valve on the cylinder. A penetrating lubricant was sprayed into the cylinder to loosen the remaining threads of the broken valve. The lubricant failed to loosen the remaining threaded piece. Heat from an oxygen-acetylene torch was then used in an attempt to loosen the remaining threaded piece. The heat from the torch ignited the combustible vapors of the penetrating lubricant in the cylinder, causing an explosion which propelled the cylinder rod that struck the miner. The cylinder assembly was taken from the accident as evidence. A laboratory experiment was set up with the cylinder assembly. The penetrating lubricant that was used in the accident was sprayed into the nitrogen charging valve port. Subsequently, the flame from an oxygen-acetylene torch was directed onto the nitrogen charging valve port. An explosion occurred, forcefully propelling the cylinder rod as shown in Figure 4. The laboratory experiment provided conclusive evidence of the cause of the explosion in the suspension cylinder. The laboratory experiment subsequently served as a training and educational tool for accident prevention.

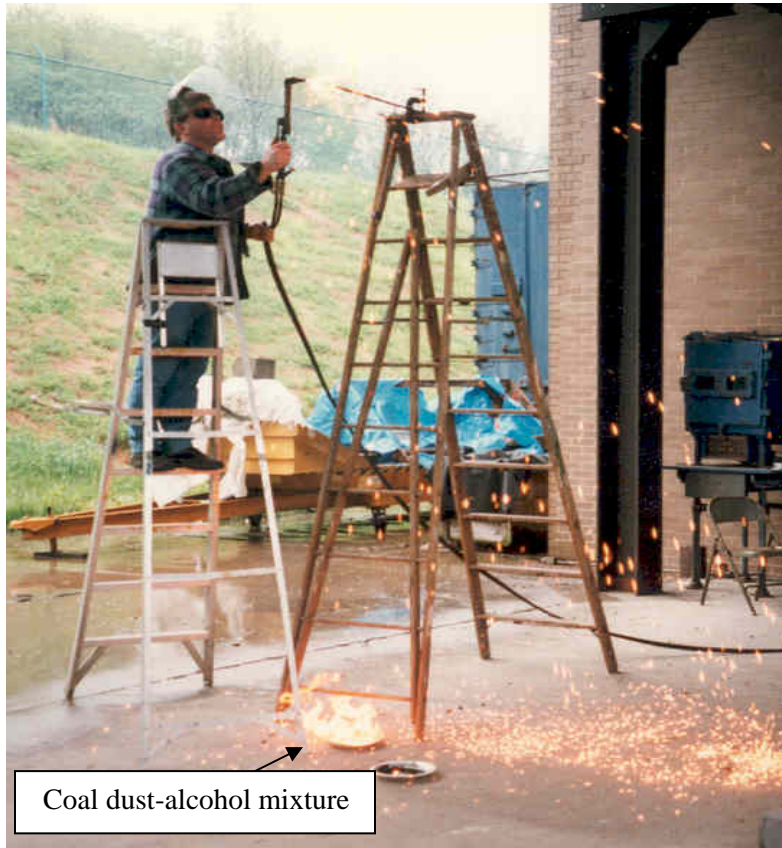
Figure 5 – Experiment Showing Sparks from Cutting Torch Igniting Coal-alcohol Mixture

torch to cut a bolt off of a floatation cell that was located on the second floor of the plant. The fire was caused by molten metal and/or sparks igniting a mixture of coal dust and alcohol which had accumulated on the top of and around two clay settling tanks located on the first floor and off to the side of the torch cutting operation. Alcohol had been spilled during a filling operation about a week prior to the fire. The fire consumed a 1400-gallon tank of alcohol that was located near the clay settling tanks. The fire also consumed most of the two 1000-gallon clay settling tanks. These tanks, located on the lower floor, were within the travel distance of sparks generated from the cutting operation. Initially, it was presumed that spilled alcohol was ignited by sparks from the cutting operation. However, a mixture of coal dust and alcohol was shown to ignite more readily in experimental tests. The tests were set up to simulate the cutting of a metal rod with the generation of sparks which landed on containers holding a thin layer of alcohol and a thin layer of coal dust-alcohol mixture. The experimental tests served as the basis for determining the cause of the fire. Figure 5 illustrates the test showing the ignition of the coal dust-alcohol mixture.

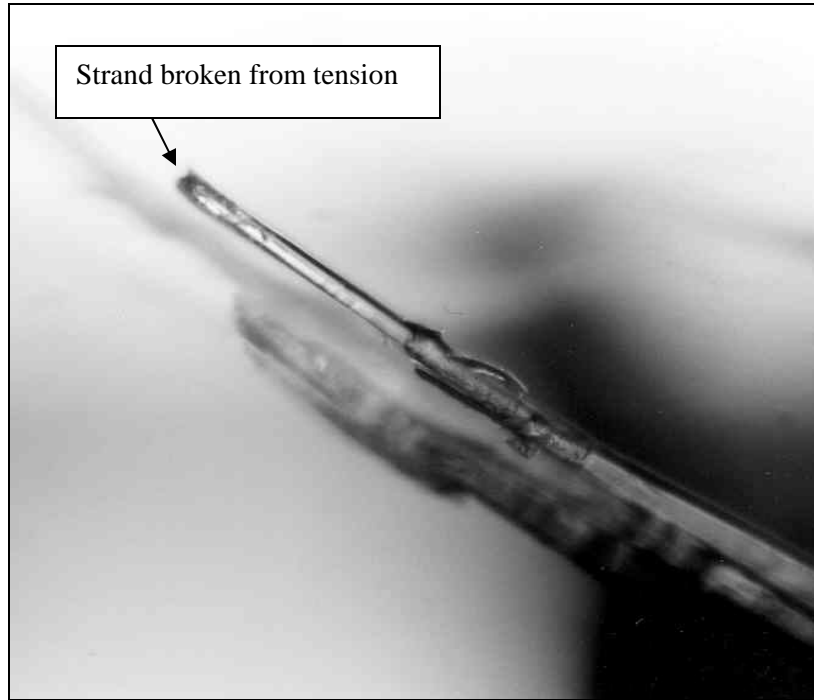
Figure 6 – Microscopic Examination of Strand of Ply Material from Conveyor Belt

A fire involving a conveyor belt occurred in an underground salt mine¹³. Fortunately, there were no injuries from the fire. The fire occurred as a result of a misaligned conveyor belt rubbing against a steel beam of the conveyor structure. The misaligned conveyor belt caused a jam at the take-up pulley. The fire burned approximately 30.5 meters (100 feet) of conveyor belt, but the fire also spread to a transfer conveyor belt. Eight-five meters (280 feet) of the transfer conveyor belt was consumed by the fire. As part of MSHA's investigation, an examination was made of a segment of the misaligned belt recovered from the fire to determine if the belt was under load and tore apart. By visual examination, the tears in the partially burned edge of the segment indicated the belt was under load and burning occurred near the center and the belt tore apart from the center toward the edges. This explanation was confirmed by microscopic examination of a section of the segment; unburned strands of the ply material broken from tension were observed as indicated in Figure 6.
