## Insulation of Cable Reel and Spooling Devices

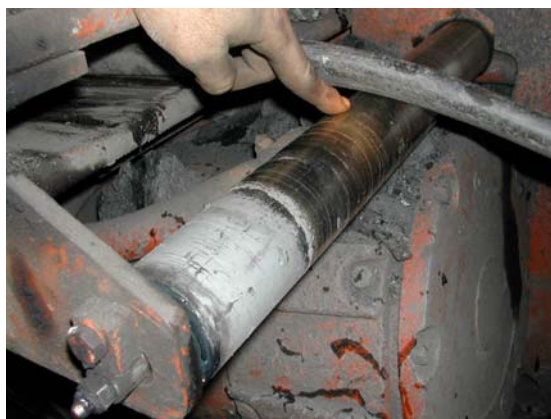
The Mine Safety and Health Administration (MSHA) has found that an exposed, accessible cable roller(s) located between the sheave wheels and the area housing the cable reel and spooling device on a shuttle car can pose a shock hazard. The potential shock hazard is created when accessible, uninsulated and ungrounded metal roller(s) comes in contact with an exposed trailing cable. Rollers are typically located between the sheave wheel carrier and the cable reel housing/spooling device assembly as shown in the picture below.

The purpose of this roller is to prevent the trailing cable from coming into contact with the machine frame or other machine components. The roller is electrically isolated by the bearing assemblies from the grounded machine frame. Most rollers are not made from or covered with a flame-resistant insulating material. If an exposed conductor, in a damaged section of an energized cable, comes into contact with this roller, the roller will become energized. Since the roller is readily accessible and shuttle car operators routinely clean the area around the roller, if the roller becomes energized, miners could become exposed to a shock hazard. Not all shuttle cars are designed or installed with this type of metal roller.

MSHA has revised its' policy on cable reels to require insulation on certain trailing cable components. This change in the Program Policy Manual Volume II, Section 18.45 as explained in MSHA Program Policy Letter P07-V-04 can be viewed at <http://www.msha.gov/regs/complian/ppls/2007/PPL07-V-4.asp>.

Contact the OEM or the rebuilder of the shuttle car to obtain a trailing cable roller that is made of or covered by a MSHA accepted material. OEMs of shuttle cars and coal transports have been notified of MSHA's policy relating to the insulation of cable reels and spooling devices.
