Tongass National  
Forest

September 2004

# COBBLE

## Landscape Assessment

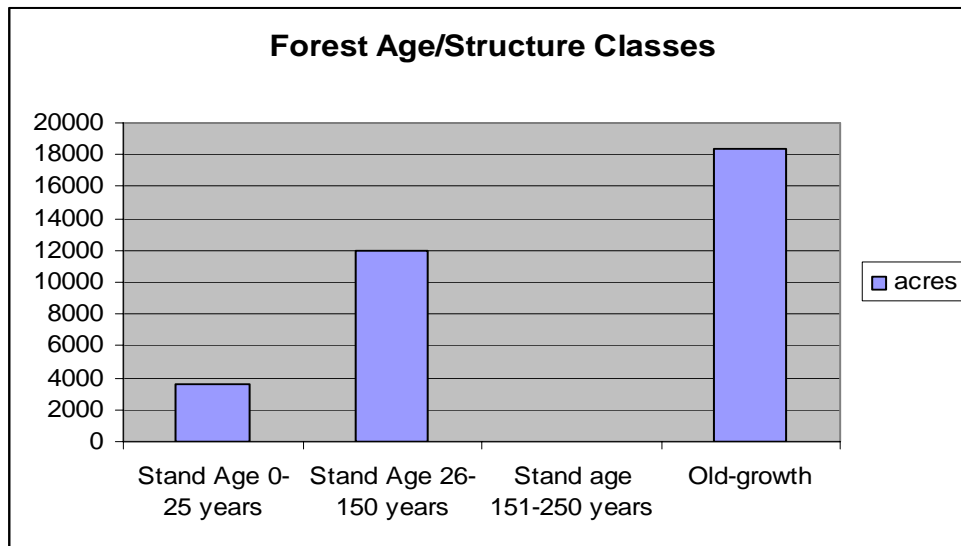
**Figure 2-3. Forest age structure/classes in the Cobble area**

The current forest age class distribution in the project area is represented in Figure 2-3. Stand ages were broken out to represent the three stages of stand development after harvest and include unharvested forest (old-growth). Currently, 3,573 acres of 0-25 year old second-growth; 11,992 acres of 26-150 year old second-growth; and 18,325 acres of old-growth are found in the area. These figures include private land. No known 151-250 year old second-growth is found in the area.

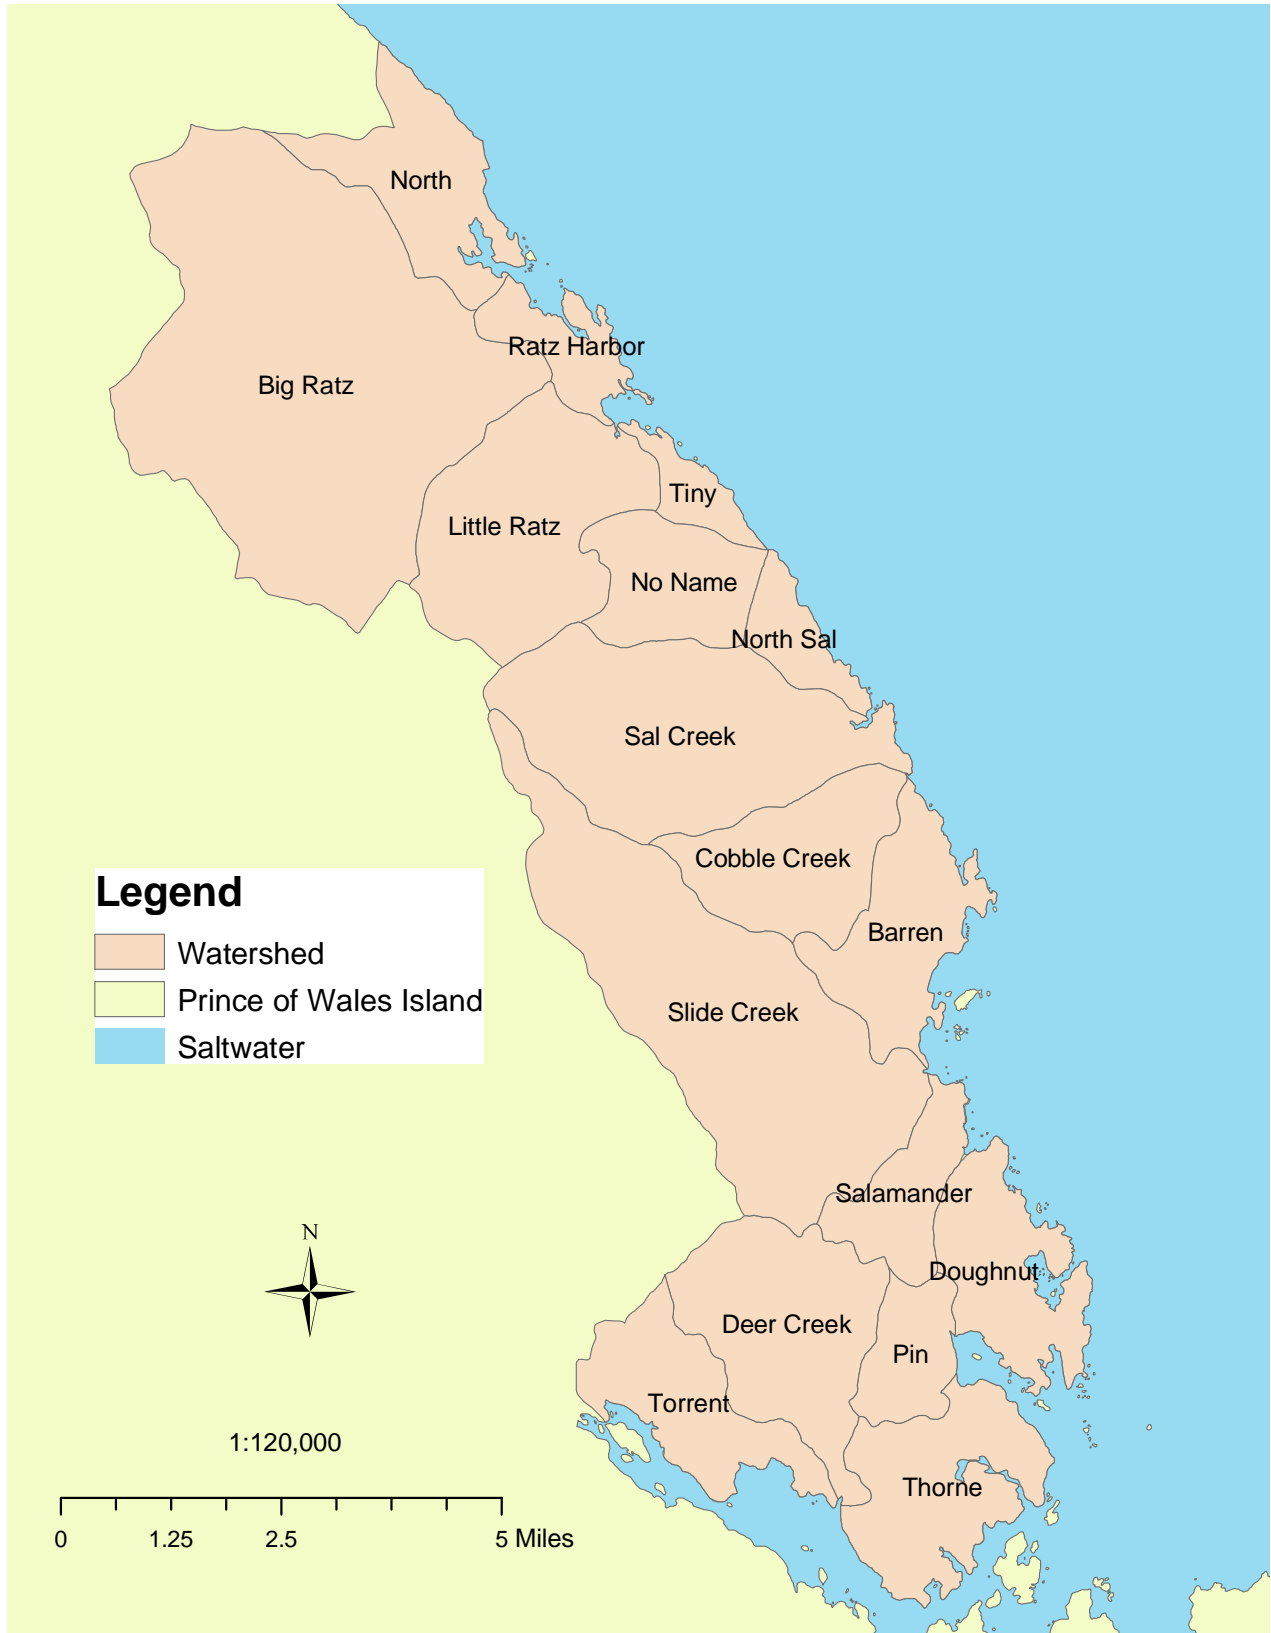
Figure 4-1. Map of watersheds in the Cobble area

Among watersheds, Big Ratz, Slide, and Sal have the most stream miles with 57.6, 37.3, and 35.4, respectively. Tiny, Pin, and No Name have the highest stream densities with 5.3, 5.4, and 5.9 (Table 4-2). This suggests that Slide, Sal, Big Ratz, and No Name have more highly developed drainage networks, making them a higher risk for sediment transport into their individual main channels.
