# ***Russian River Landscape Assessment***

***Prepared by the  
U.S. Department of Agriculture  
Chugach National Forest  
Seward Ranger District***

August 2004

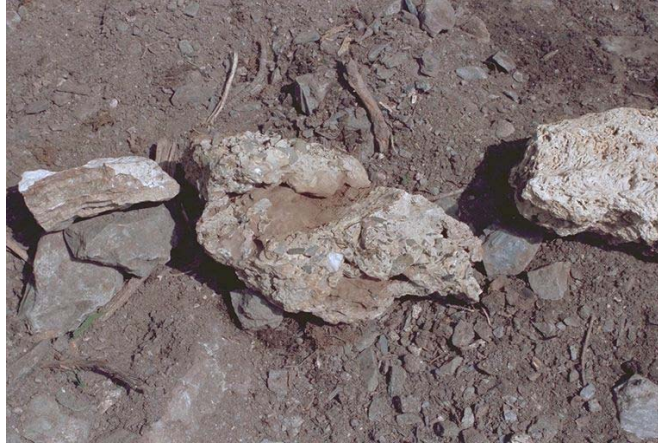
**Figure 4.2: Travertine boulders on the RS&S #2 mining claim**

The third and fourth travertine deposits mentioned above are currently of unknown extent, but appear similar in character to the other two travertine deposits. No travertine outcrop has been identified on either of these; only scattered travertine boulders/cobbles/pebbles (Figure 4.2).

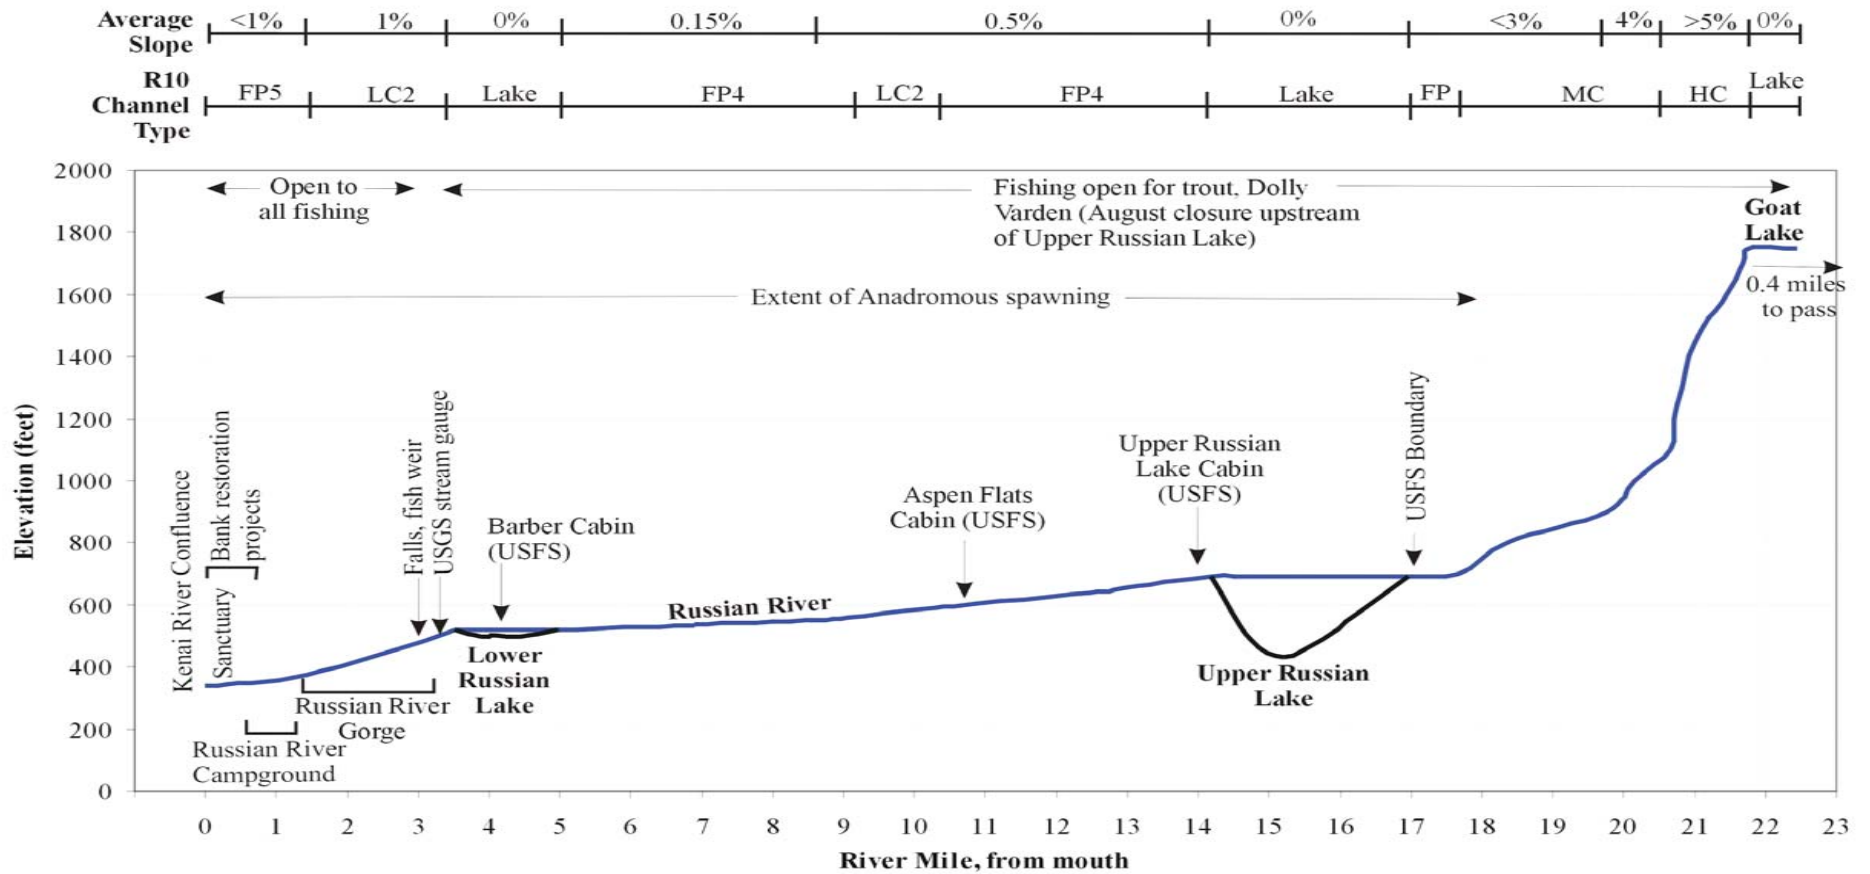
**Longitudinal Profile of the Russian River**

Vertical exaggeration 200X

**Figure 4.7: Generalized longitudinal profile of the Russian River, by river mile.**

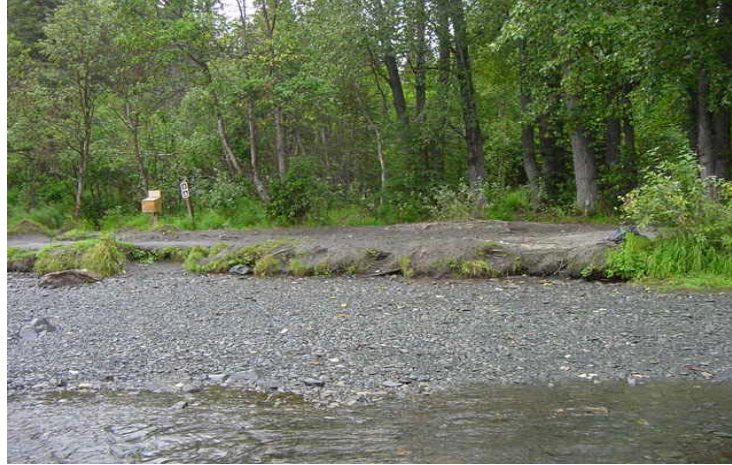
**Figure 4.8: Trampled, compacted, and eroding streambank near the mouth of the Russian River (photo by Dean Davidson, Chugach National Forest).**

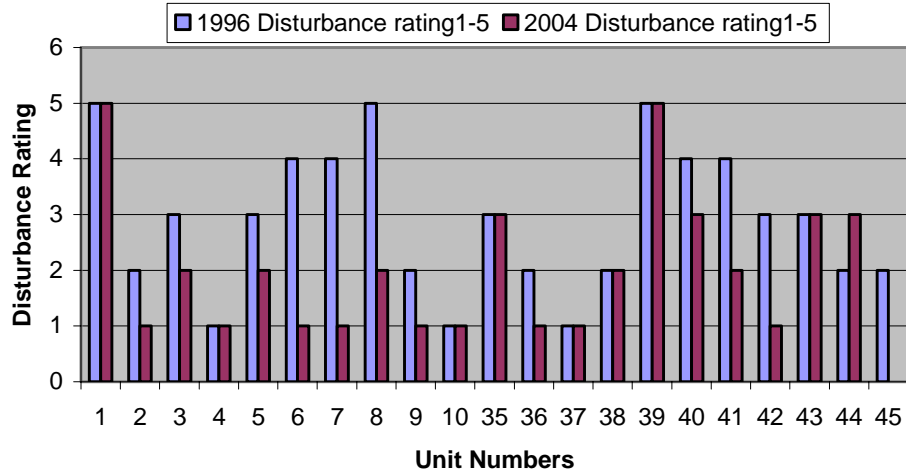
Figure 4.14: Bank Disturbance Rating 1996 & 2004 for units in Segment 1 (Confluence to Grayling).

Monitoring efforts on the Russian River have been ongoing since 1996 with fifty-one permanent plots being laid out along the banks for vegetation surveys as well as bank condition surveys. These plots are re-monitored every 3 to 4 years. Data from 2004 was compared with the data from 1996 and it shows for Segment 1 (Grayling downstream to the Confluence) that 11 units are showing improvements, 8 units have had no change and only 2 units show more disturbance. The disturbance rating is a number system from 1 to 5, with 1 being relatively undisturbed (0-5%), 2 being light disturbance (6-25%), 3 being moderate disturbance (26-50%), 4 being moderate to heavy disturbance (51-75%), and 5 being heavy disturbance (76-100%). Figures 4.13, 4.14, and 4.15 show the differences from 1996 to 2004 in disturbance along the river. We have also seen an improvement in the amount of overhanging vegetation along the riverbank, which supplies insects to the river.

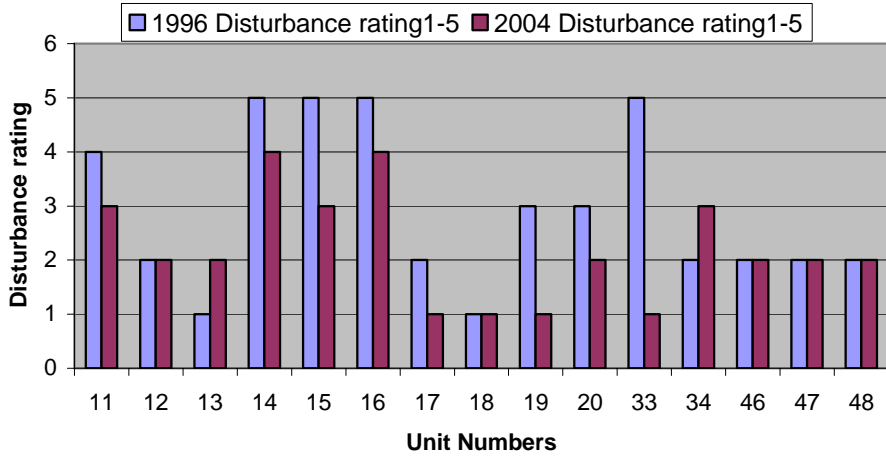
Figure 4.15: Bank Disturbance Rating 1996 & 2004 for units in Segment 2 (Grayling to Pink Salmon).
