**Eyak – Heney Landscape Assessment
Cordova Ranger District
Chugach National Forest**

09/30/2002

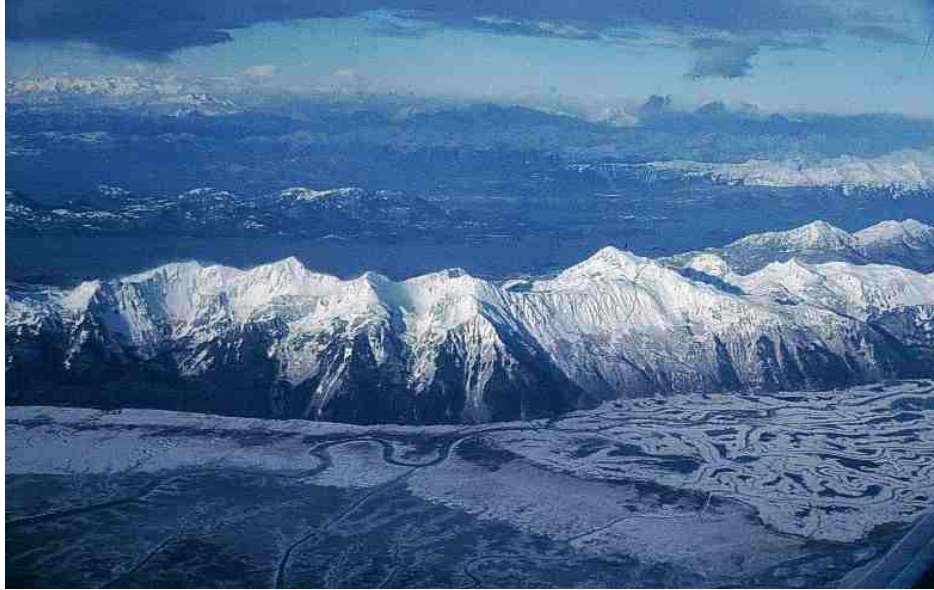
Figure 2.2: View of Heney Range, looking northwest.

Eyak River meanders at the base of the Heney Range in the Scott River outwash plain.

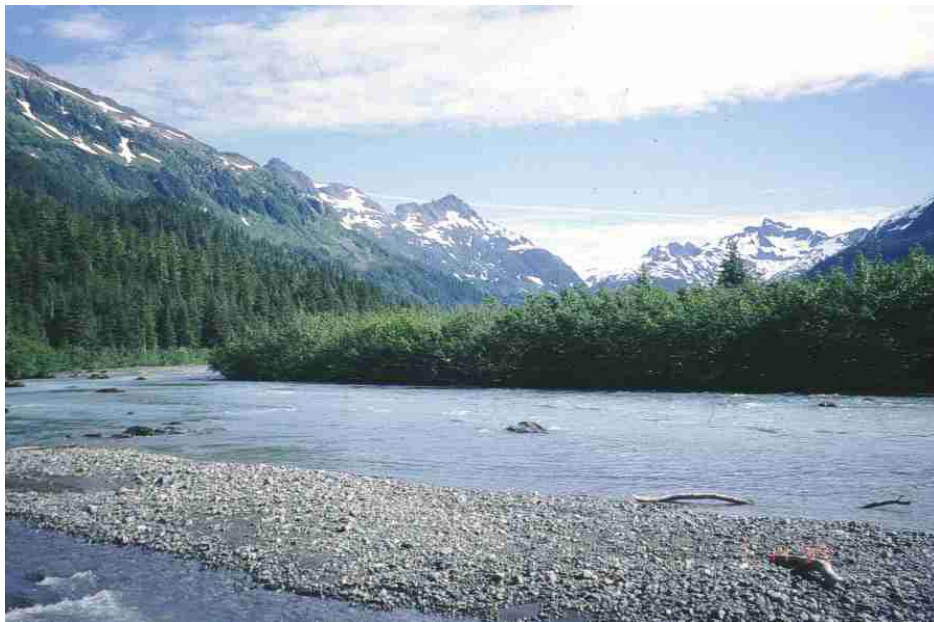
Figure 2.8: Power Creek Valley, upstream of the canyon, looking upstream.

1951) (figure 2.8). In the lower portion of this valley, Power Creek is braided and meandering with gradients from 0.5 to 1.5% (Whitewater Engineering Corporation, 1996b).

The headwaters of Power Creek, as well as its tributaries originating on the steep valley walls, are generally classified as high gradient incised glacial torrent channels (HC9). Power Creek valley is predominantly classified as a large braided glacial outwash channel (GO3). The Power Creek canyon also represents the high gradient contained process group (HC9). The Power Creek delta is classified as a large braided glacial outwash channel (GO3) (USDA Forest Service, 1998).

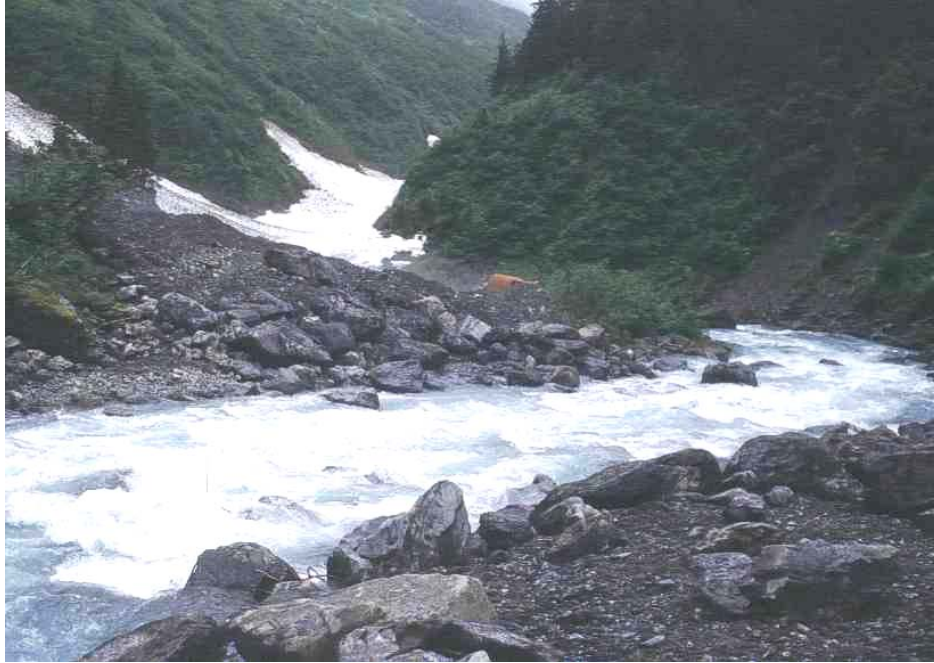
Figure 2.9: Power Creek Canyon downstream of dam site, looking downstream.

Two miles upstream of Eyak Lake, Power Creek enters a steep-walled 200 to 450-foot deep canyon in which lies the 52-foot Ohman Falls (Miller, 1951; Whitewater Engineering Corporation, 1996c). In this gorge, the stream drops 175 feet in a horizontal distance of 500 feet, with channel substrates ranging from large boulders to small gravels (figure 2.9). Downstream of the falls, gradients decrease from 15% to 0.4%, and the channel substrate sizes decrease from large boulders to small and medium gravel (Whitewater Engineering Corporation, 1996a).

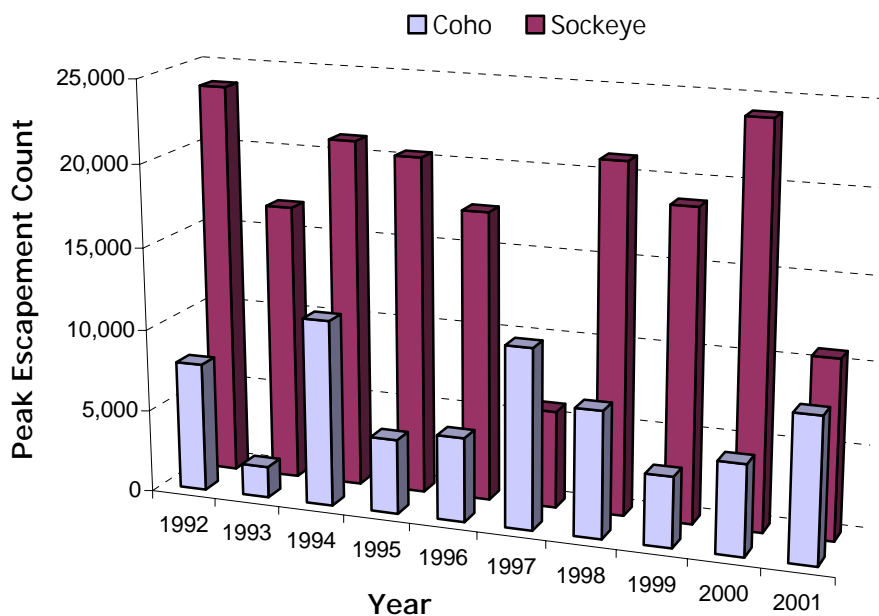
Figure 2.11: Peak aerial escapement counts for sockeye and coho salmon in the Power Creek-Eyak Lake drainage from 1992 to 2001.

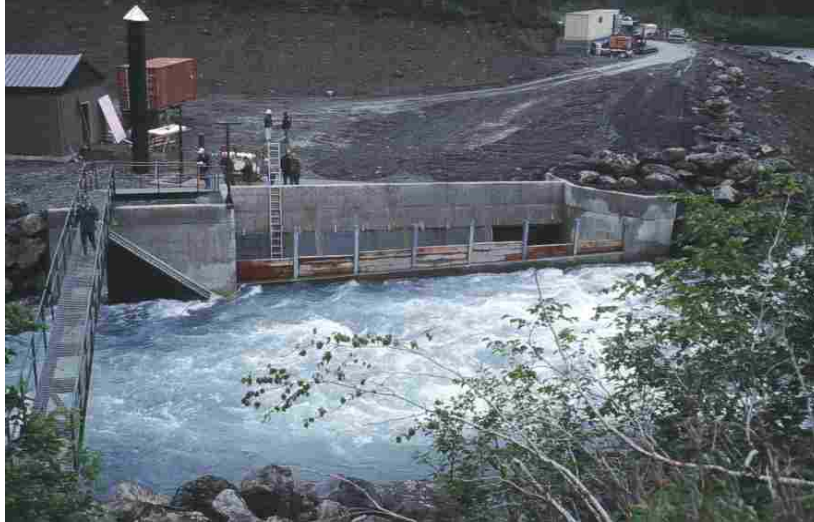
Figure 2.18: Power Creek diversion dam and intake.

The impoundment created by the Power Creek diversion dam has a surface area of 1 acre and a gross storage of 5 acre-feet. The dam was constructed on alluvial and landslide deposits consisting of boulders and cobbles with a sand and silt matrix. Grouting and a clay blanket were used to minimize seepage through this material (Whitewater Engineering Corporation, 1996b). Because of the high sediment load in Power Creek, the weir is operated in a manner to provide for unimpeded sediment transport. The forebay water level is adjusted in response to flows. The overflow section will handle the 100-year flood event (Covel, personal communication). Because there is little ponding upstream of the dam, the Power Creek hydroelectric project has little impact on water quality. Water temperature and streamflow should be the same above and below the project (Whitewater Engineering Corporation, 1996b).

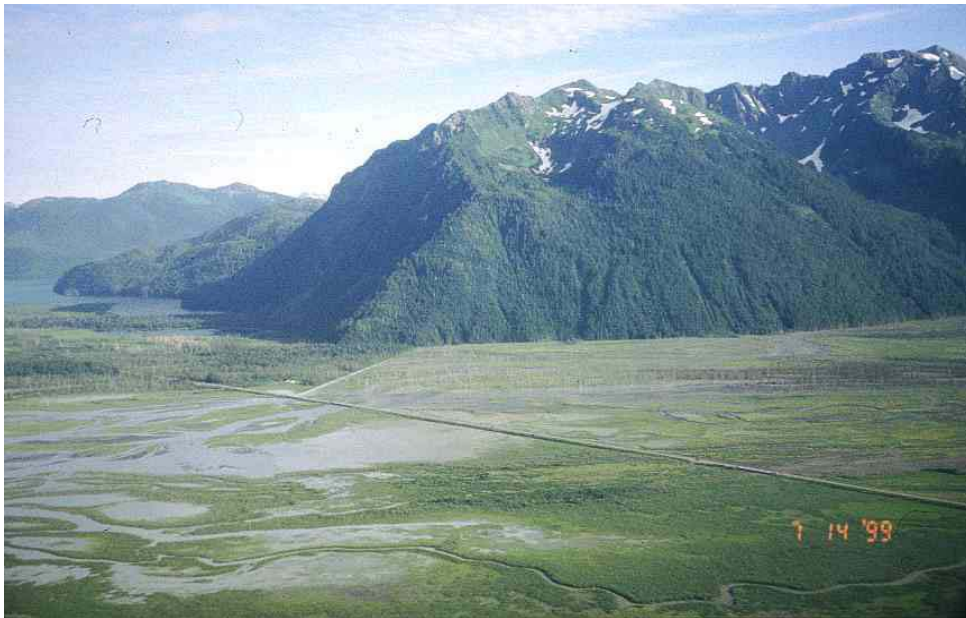
A small percentage of the melt water from the Scott Glacier flows down the western side of the outwash fan through Lydick Slough and into the Eyak River, which enters the western Copper River Delta downstream of Eyak Lake (Boothroyd, 1972) (figure 4.2). The Scott River is a dynamic system; as a result, the Scott Glacier outlet and the Scott River channel experience frequent changes. Aggradation of sediment in the Scott Glacier outwash fan creates a natural dam for Eyak Lake. Subsequently, peak flows on the Scott River pose a flood danger to Eyak Lake and houses along Eyak River, commonly called “6-mile subdivision”. A dike was built north of the Copper River highway in the 1960’s to prevent this flooding. The presence of this dike and the fixed location of the Scott River at the highway bridge prevent channel migration and cause continued aggradation of the outwash plain in the current location of the Scott River, exacerbating the flooding risk. Downstream of the highway, the Scott Glacier outwash fan extends to the tidal flats. Numerous small sloughs with natural levees traverse this area, and numerous brackish to fresh ponds lie between the sloughs (Boothroyd, 1972).

Figure 4.2: Scott River outwash plain, looking northwest toward Eyak Lake on the left side of the photograph. The Copper River Highway and the flood control dike are visible in the center of the photograph.

The area was uplifted about 6 – 8 feet during the 1964 earthquake. Generally the Copper River Delta is subsiding and is uplifted every 400 years or so.

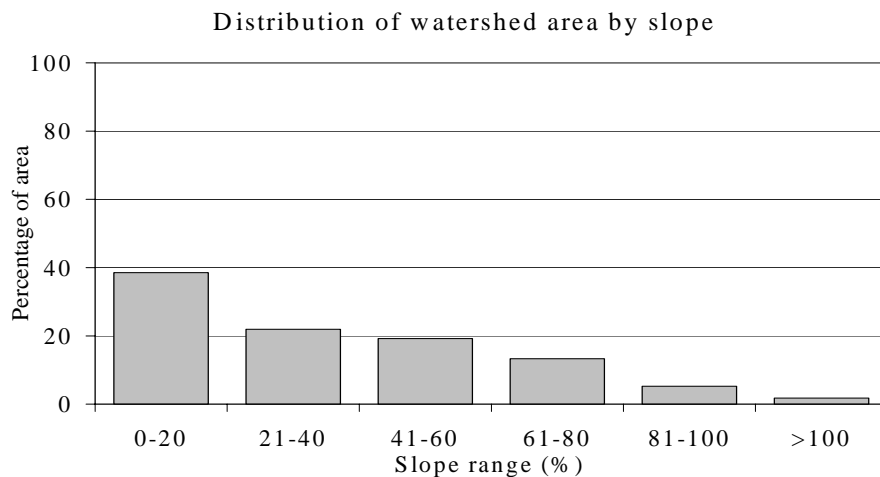
Figure A-2: Distribution of analysis area by slope. Data from USDA USFS (1997).

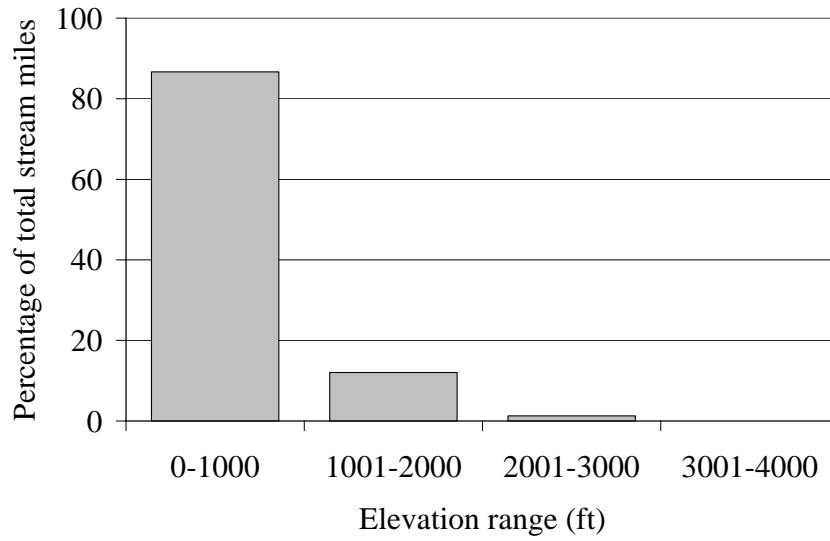
Figure A-4: Distribution of stream miles by elevation. Data from USDA USFS (1996).
