# SINTEF REPORT

# MECHANICAL OIL RECOVERY IN ICE-INFESTED WATERS (MORICE)

PHASE 4

Hans V. Jensen, Laurie Solsberg

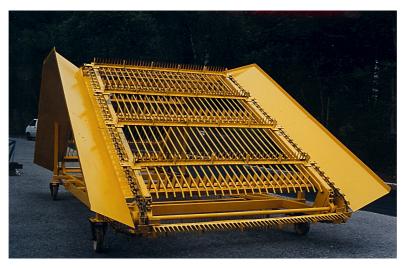
The main design changes of the LGB were associated with widening the unit. During the Phase 3 tests, ice pieces conveyed by the belt with a centre of gravity outside the belt would fall off. It was decided that there should be some means to prevent the loss of this ice. At the same time, oil should be flushed off these ice pieces, like all ice processed. Next, the flushed-off oil should be guided to the recovery area inside the belt for pickup. Designing a combined flushing tray and ice support on either side of the LGB solved these two problems. The tray covering the whole length of the belt was fabricated from steel plates welded together and to the frame of the belt, see Figure 2.1.

Figure 2.1 Lifting Grated Belt

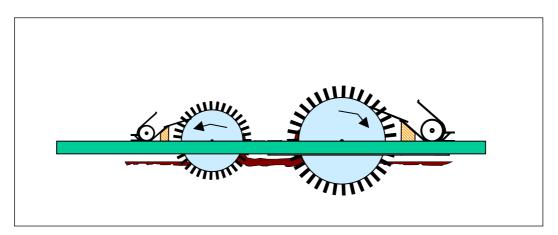
During previous work in the program Brush/Drums were used in various configurations and of different size. For Phase 4, a small Brush/Drum recovery unit comprising two small drums was designed, based entirely on the recommendations arising from Phase 3. These included:

- Use two contra-rotating Brush/Drums
- Install troughs with screw augers to convey recovered and scraped off product to the outlet at the middle of the trough
- Install walls to prevent oil from escaping to the sides
- Design a floating unit that will relate to the water surface instead of the LGB. This was to assure that the fairly small tolerances for the draft of the drums would not be exceeded as the draft of the LGB changes with different loads on the work platform (ice load, weight of recovered product stored on deck).

Figure 2.2 Brush/Drum concept used in Phase 4.

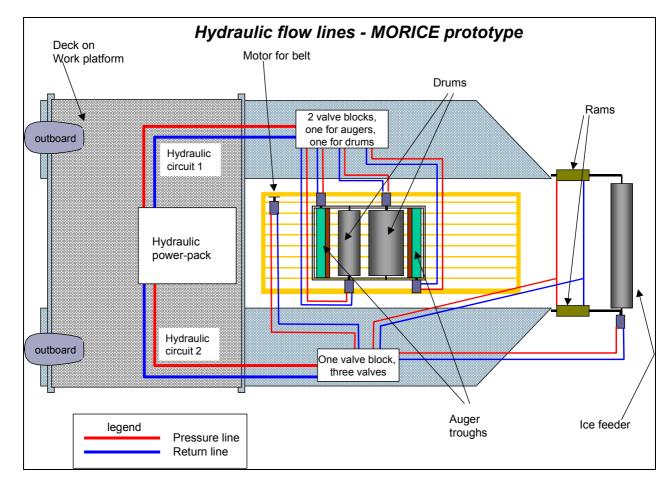
- motor to power the ice feeder, and rams for its vertical control
- motor for driving the LGB
- motors for two recovery drums
- motors for two augers in the collection troughs of the drums

Figure 2.3 Schematics of the hydraulic flowlines.

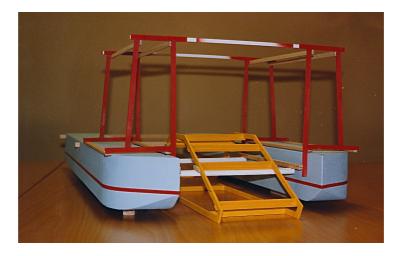
To compensate for the lack of a 3-dimensional design tool, a model of the platform in scale 1:10 was made prior to starting its construction, see Figure 3.1. The two pontoons fit side by side into a standard 40 foot (12 m) container. The length of the vessel is approximately 9 m (30 feet), and the total width between the pontoons is a maximum of 3 m (10 feet). The cross section of each pontoon is rectangular, 110 cm (43 in.) wide and 95 cm (37 in.) deep.

Figure 3.1 Scale model of the work platform and LGB.

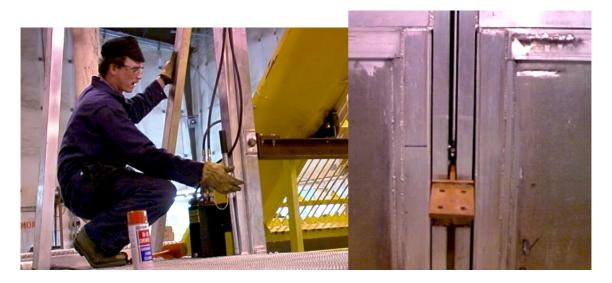
system. These hydraulic cylinders have to be strong enough to support the weight of the whole LGB with recovery unit and ice, in any position from the lowermost operating position to the uppermost transport position by just closing the hydraulic circuit. A stroke length of 1000 mm (3 feet) was chosen for the rams.

Figure 3.2 Lifting system, handpump (left), ram protected inside post (right).

Two manually operated pumps were chosen for the rams, and to save weight and costs as well as excessive pumping, very slim rams were chosen. The posts that would support the rams were to be made out of aluminum channels, and the rams could be positioned inside the posts for protection. At the same time, a frame holding the posts in place could be used to form the skeleton of a superstructure on the platform, see Figure 3.3. This frame would be covered by a tarp to make a nearly closed-in area over the LGB and the recovery unit to protect these vital components from exposure to cold wind. An air heater would ensure that the temperature inside the tarp could be kept at above-freezing temperatures.

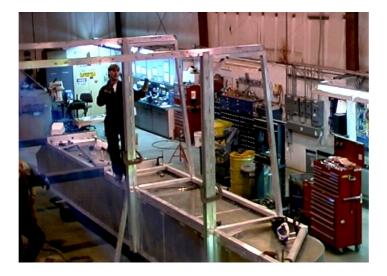
Figure 3.3 Platform Superstructure under construction.

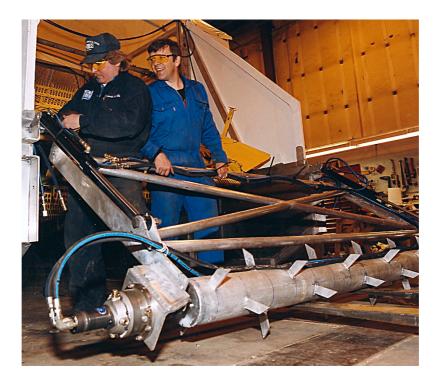
Earlier in the program, different ways of feeding the ice towards and/or through a recovery unit had been discussed. Now it was time to try to apply this concept by making an ice feeder that would push the ice in between the pontoons. The ice feeder is shown in Figure 3.4 below.

Figure 3.4 Ice feeder.

The ice feeder is mounted on a frame with its rotational axis approximately 1 m in front of the bow. A hydraulic motor powers it, and the vertical position is adjusted with two rams, one on each side. Including the tines, the diameter of the ice feeder is approximately 14 in. (35 cm). When rotating, the tines act as claws working from above the ice. Depending on the vertical position of the feeder, the ice could either be pushed gently by the feeder, or be submerged. The rotational speed of the feeder decides the rate at which the ice is processed, and it could be reversed if too much ice enters the LGB.

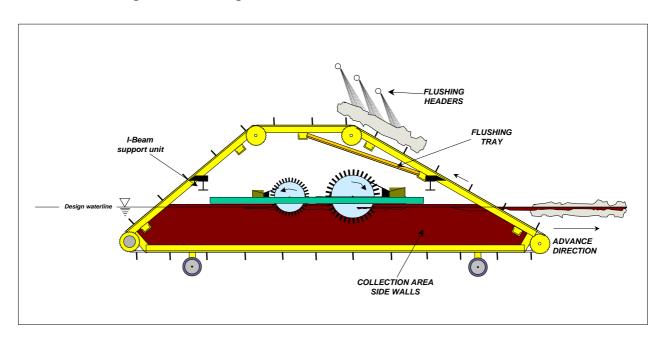
Figure 3.5 Lifting Grated Belt with flushing system and recovery unit.

Figure 3.5 shows the Lifting Grated Belt unit with the flushing booms above the front inclined plane and the oil recovery unit within the frame. The unit advances to the right as ice pieces are lifted and deflected over the grated inclined plane by means of the moving rakes. Oil at the water surface is intended to pass through the grating and into the collection area. Some oil that adheres to the large ice pieces may be removed by the flushing operation on the ascending side of the belt when the ice is lifted out of the water. A flushing tray just below the front section of the moving belt prevents the flushing water from interfering with the oil recovery operation below. A trough at the end of this tray was available to guide the flushing product to the front of the recovery area.

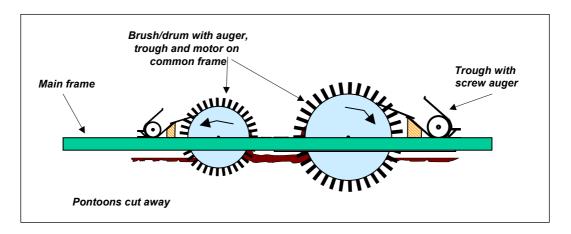
Figure 3.6 The Brush/Drums with one large and one small drum.

A conceptual sketch of the recovery unit prepared for Phase 4 is seen in Figure 3.6. It has a larger drum in the front with a smaller drum placed just behind it. The diameters of the two drums were approximately 45 cm (18 inches), and 32 cm (13 inches), respectively. Hydraulic motors individually powered the drums. Each of the drums has its own scraper and trough to collect recovered product. A screw auger in the trough, powered with a hydraulic motor, conveys the product towards the middle of the trough where a hose for the transfer pump is connected.

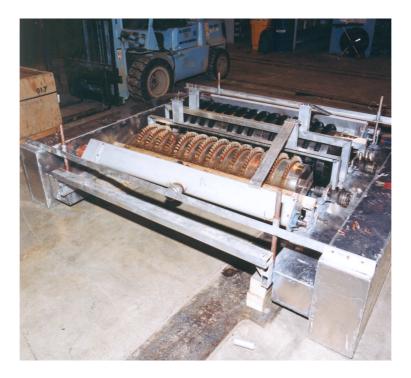
Figure 3.7 Photo of the recovery unit for Phase 4.

With hydraulic operation of the drums, the reversing action of the smaller drum referred to above calls for very good control of the motors. For proper operation, a control system for both manual and automatic operation of the drums was developed.

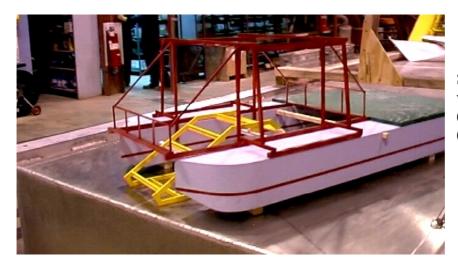
Scale model of work platform with Lifting Grated Belt (yellow), support structure (red) and work deck(green).

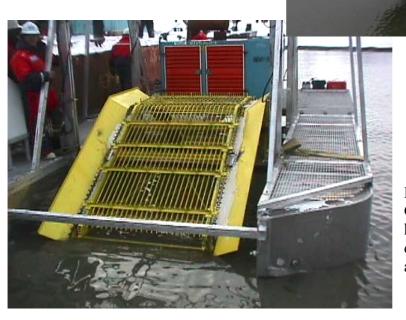
Platform with Lifting Grated belt and a 2 ton hydraulic power pack on deck. The next pictures are with this load.

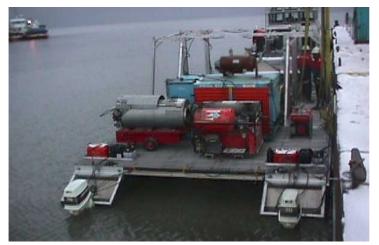
Work platform with all auxiliary equipment on deck.

Same as above, seen from the side. Some of the load on the deck has to be reduced, or moved forward. Reserve buoyancy is not a problem.

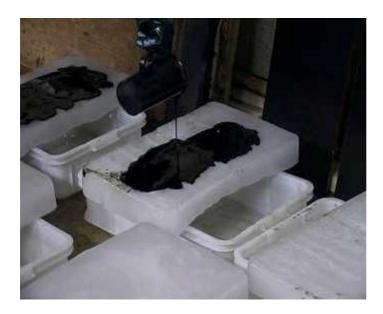
Preparing oil on ice for testing flushing water nozzles.

Various nozzles were tried, and different water temperatures and pressure.

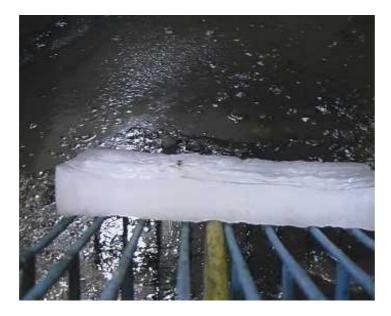
Hot water spray melted a lot of ice before cleaning it.

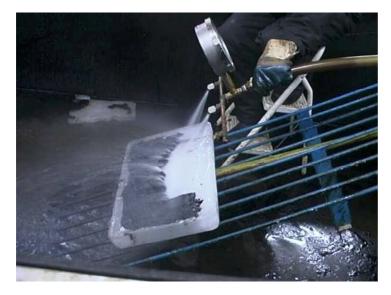
Nozzles with high flowrate, low pressure and low temperature.

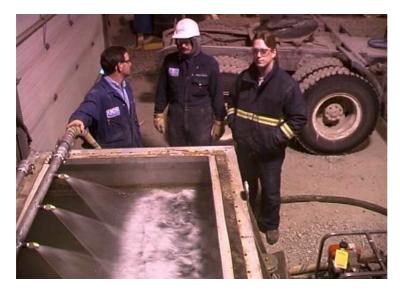
Chosen nozzles installed on spraybar.

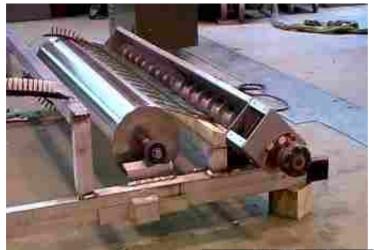
Drum and trough with screw auger under construction.

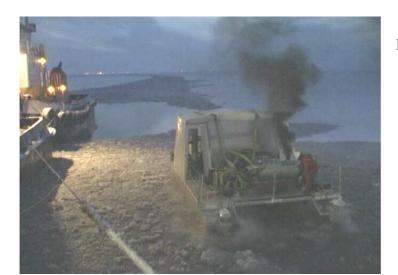
First time in the ice field.

Ice feeder at the bow.

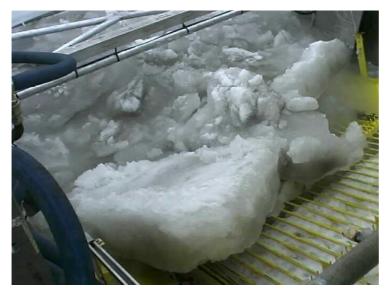
Mowing ice up the Lifting Grated Belt.

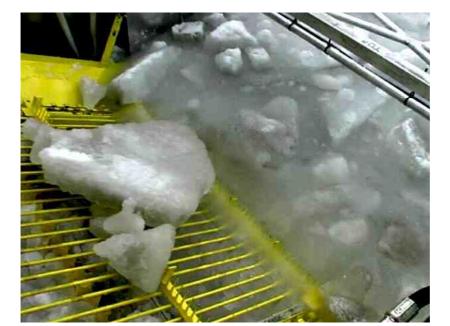
Various sizes of ice in front of belt.

Small ice under grating, resting on flushing tray.

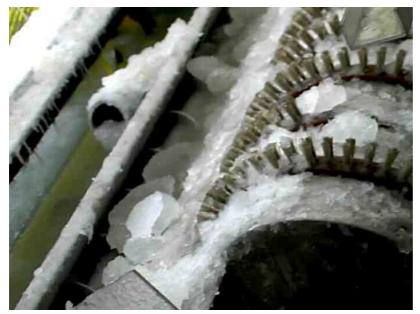
Small ice on Brush/Drum and in through.
