**Supplement to the Environmental Assessment
For
Lift 21 at Mt. Hood Meadows Ski Resort**

**Hood River Ranger District
Mt. Hood National Forest
Hood River County, Oregon**

Lift tower and terminal grading plans from Mt. Hood Meadows Ski Resort

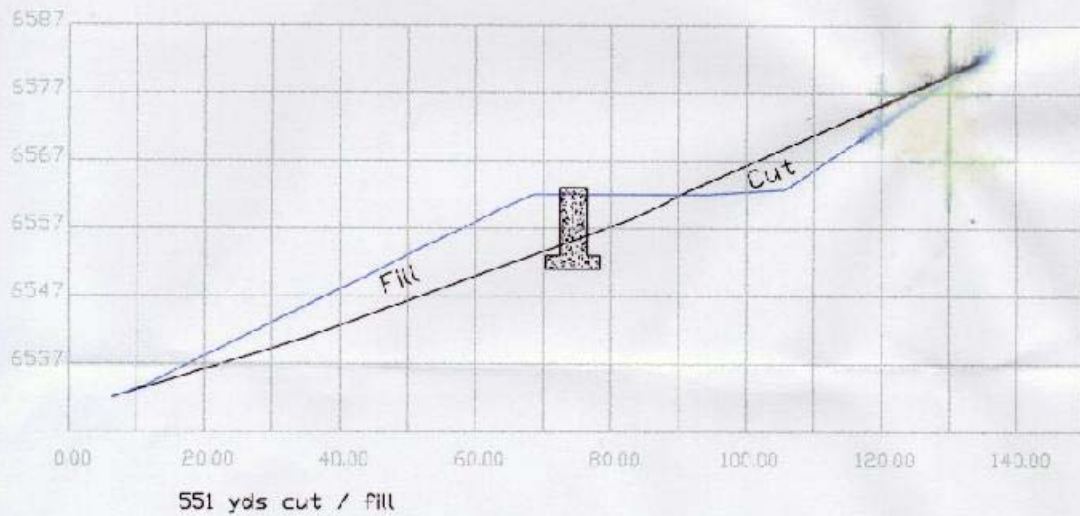
Section A-A Top terminal

Page 13. Upper terminal construction - *... approximately 551 cu yards of material...* The fill slope would be approximately 8' high.

The major earthmoving is at the terminal sites. In those locations, an engineered “cut and fill” would be utilized. This means excavated material is removed (cut) and placed (filled) in the immediate space surrounding the terminal to level the ground for skier loading and unloading areas. At the lower terminal, the fill is on the south side toward Mitchell Creek. The upper terminal fill is on the southern side for skiers to unload toward White River canyon. Diagrams of the terminal grading plans and a “typical” tower foundation are found at Appendix C attached to this supplement. Final engineered plans would have more refined details once the chairlift manufacturer designs the lift.

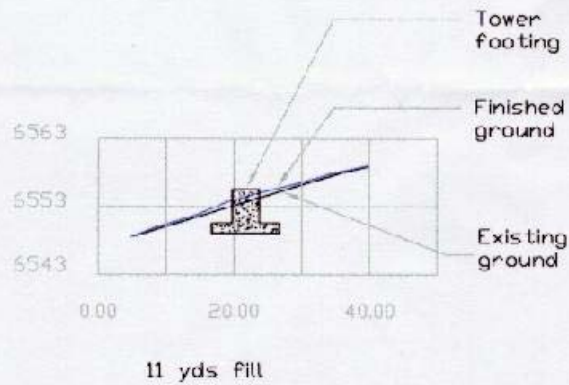
Section B-B Typical tower

At each tower foundation, soil is removed and spread on the ground immediately around the tower footing where it is stabilized and re-vegetated in the vegetation zone. The exceptions are two towers in riparian reserves. Here the soil would be moved with low ground compaction tools to the nearby temporary access road, spread on the road as restoration fill, and stabilized/seeded with the road when the project is complete. The amount of material excavated from these 2 towers would be approximately 22 cu. yds.

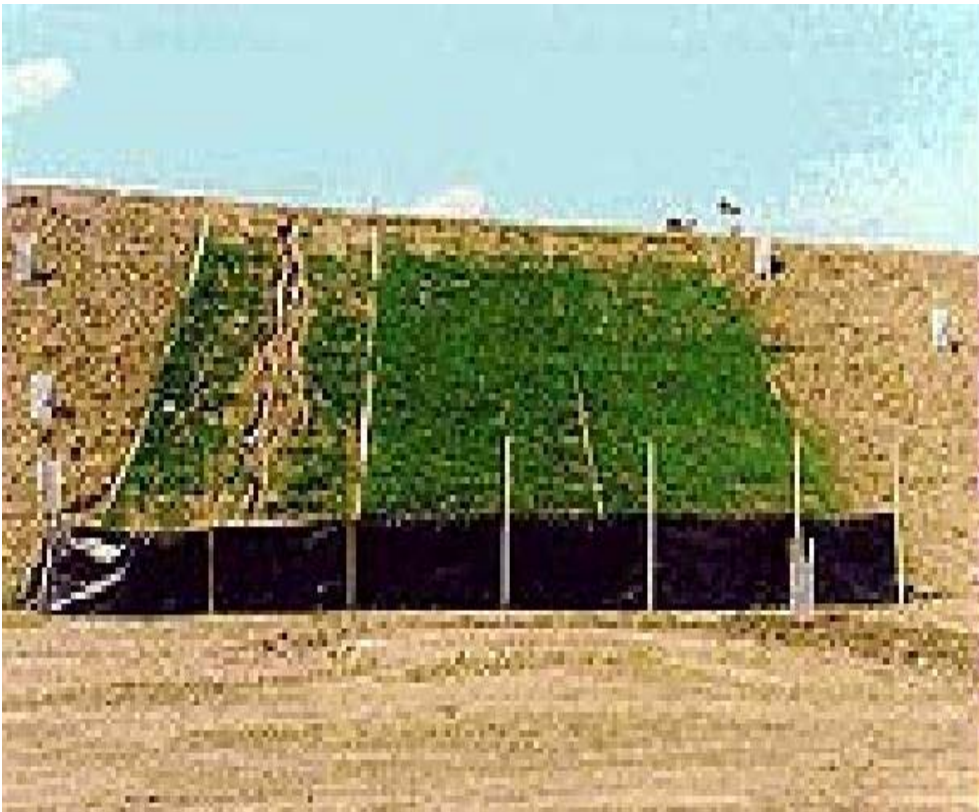
The photos below show the effectiveness of “soil lock” products similar to those that have been recently used at Mt. Hood Meadows ski area. These photos are from a test site in Australia and compare an untreated block on the left of the photo, with 2 treated blocks. Note the rilling erosion in the untreated block, as well as vegetative recovery after 5 weeks. The rill erosion can still be seen on the untreated block (far left) after vegetation recovery

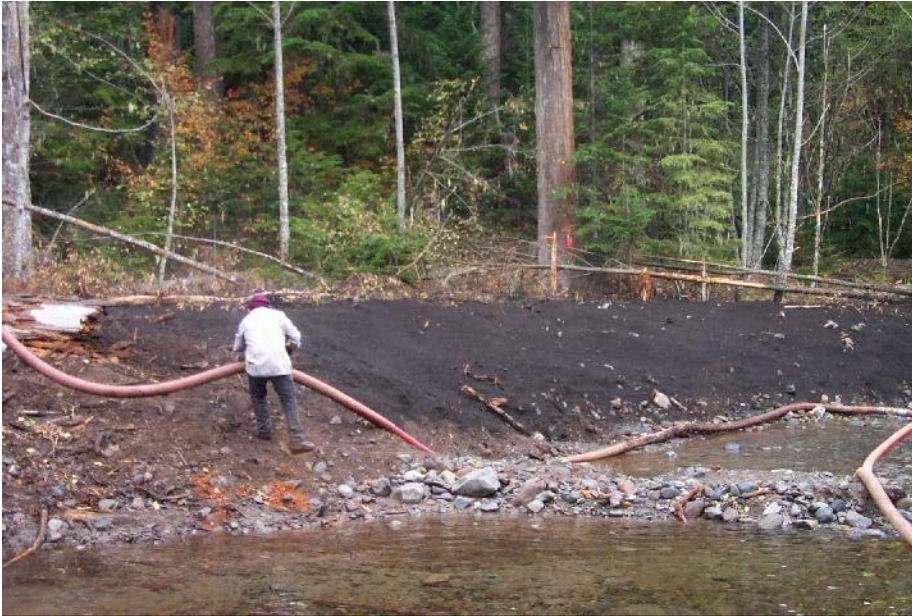
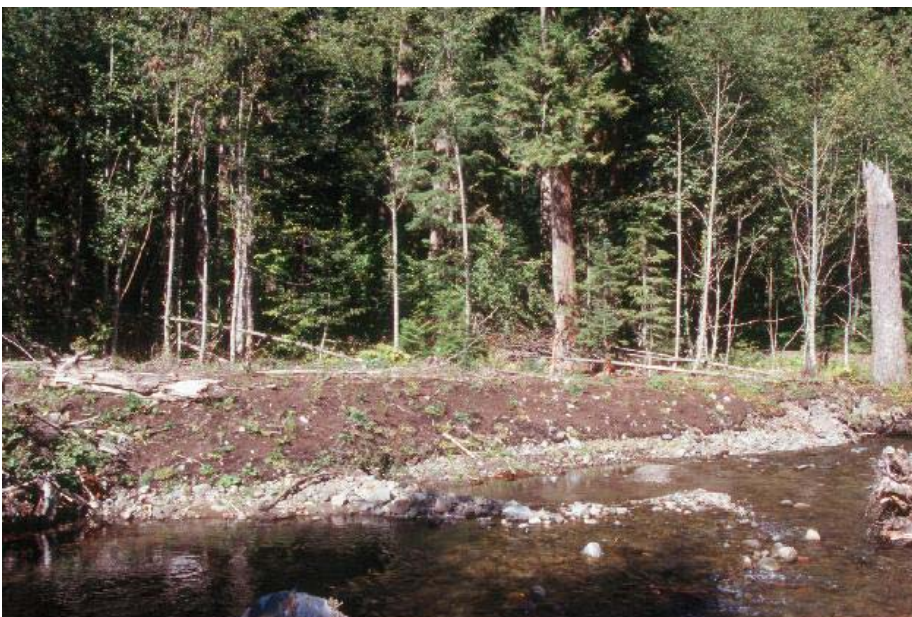
On a more local level, the photos below show an application of compost along Clear Branch Creek, a tributary to the Middle Fork of the Hood River. The goals were to reduce erosion risk while facilitating the revegetation process on the creek. The bottom photo is one year following the application. Cedar was planted on a five-foot spacing. However, numerous volunteer native plants are filling the gaps in between the planted trees. No surface erosion occurred on this site.

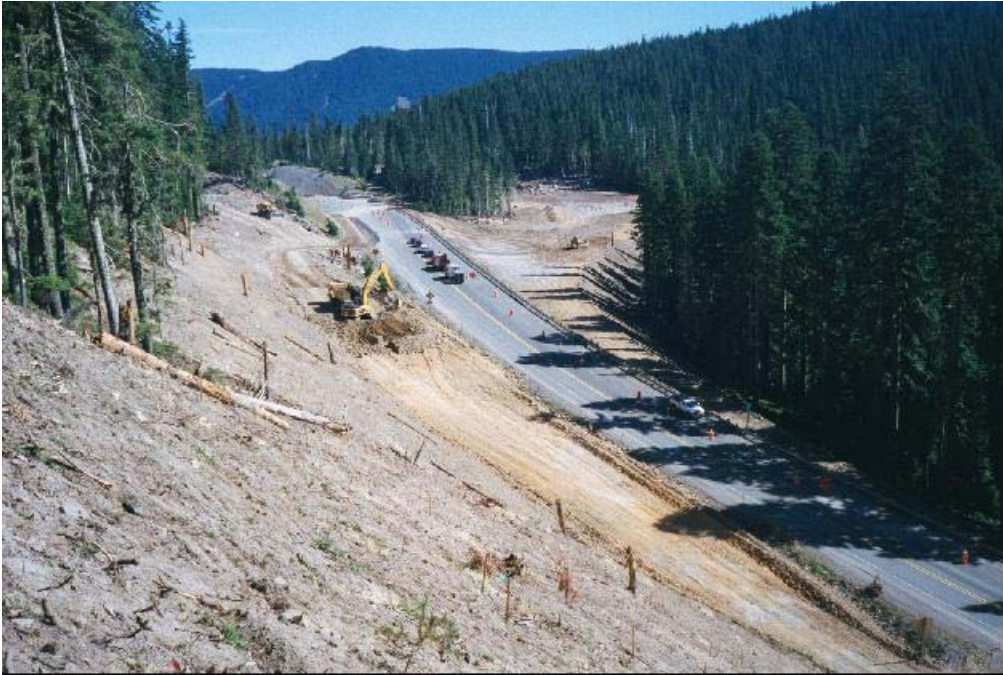
Hwy 35 slope during construction, 1999

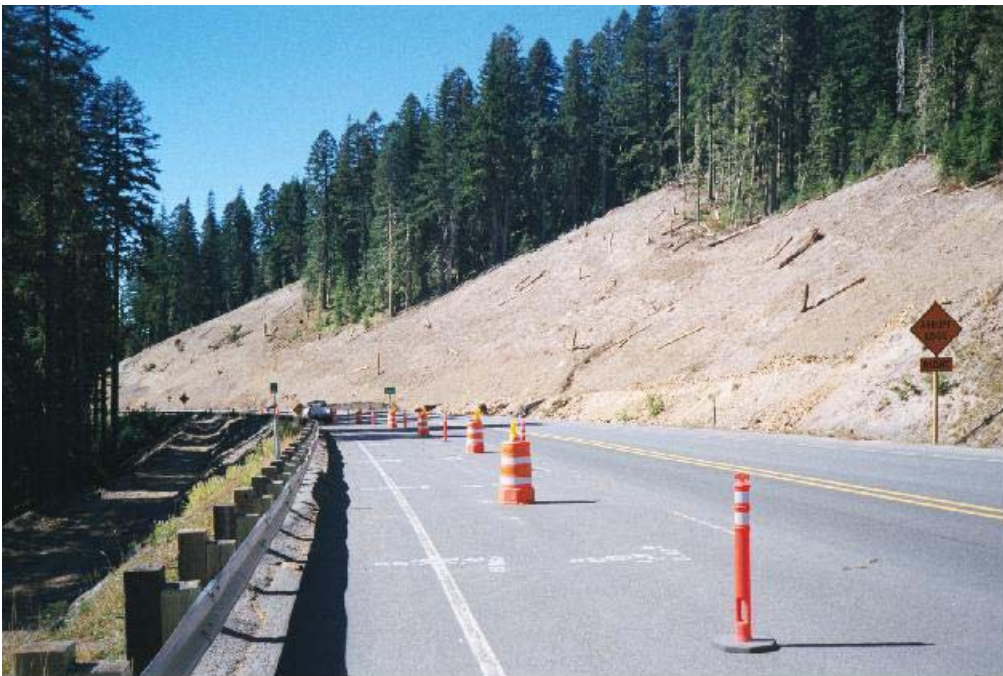
Hwy 35 Slope Before Hydroseeding, 1999
Slope Was Treated October 1999

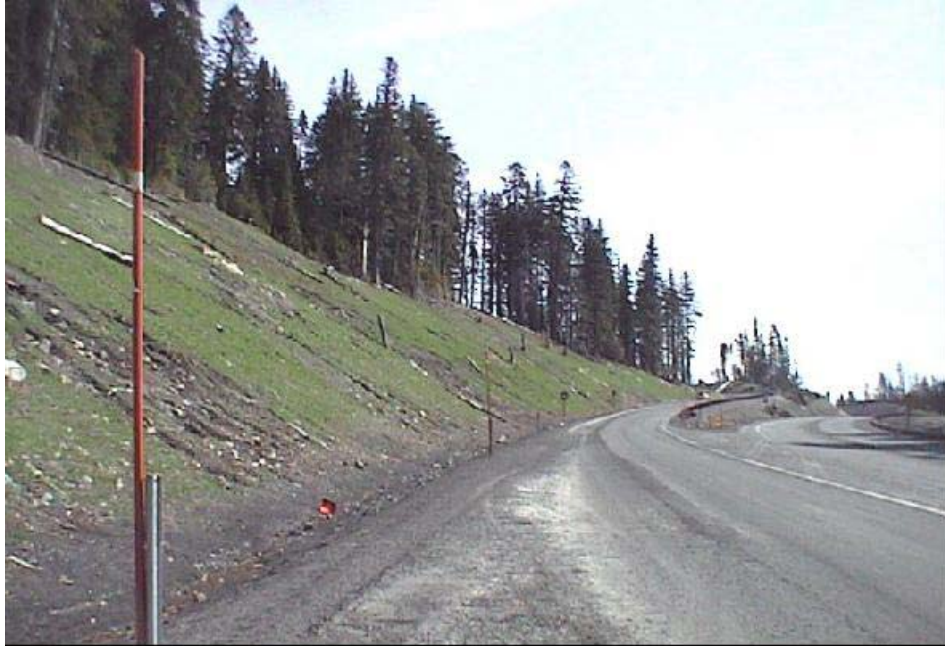
Hwy 35 Slope Second Growing Season, May 2001

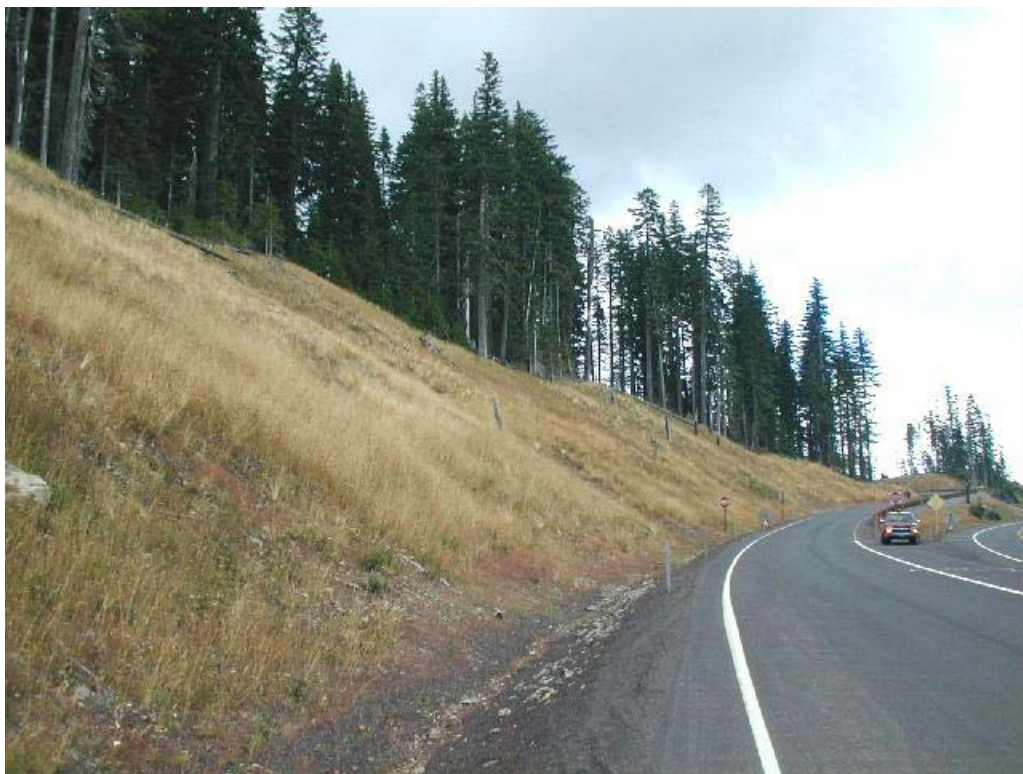
Hwy 35 Slope, August 2001
Very Good Native Plant Establishment
