Mica Shipwreck Project

Deepwater Archaeological Investigation of a 19th Century Shipwreck in the Gulf of Mexico

Prepared under MMS Cooperative Agreement
1435-01-01-CA-31178
by
Texas A&M University
Department of Oceanography
College Station, Texas 77843

U.S. Department of the Interior
Minerals Management Service
Gulf of Mexico OCS Region

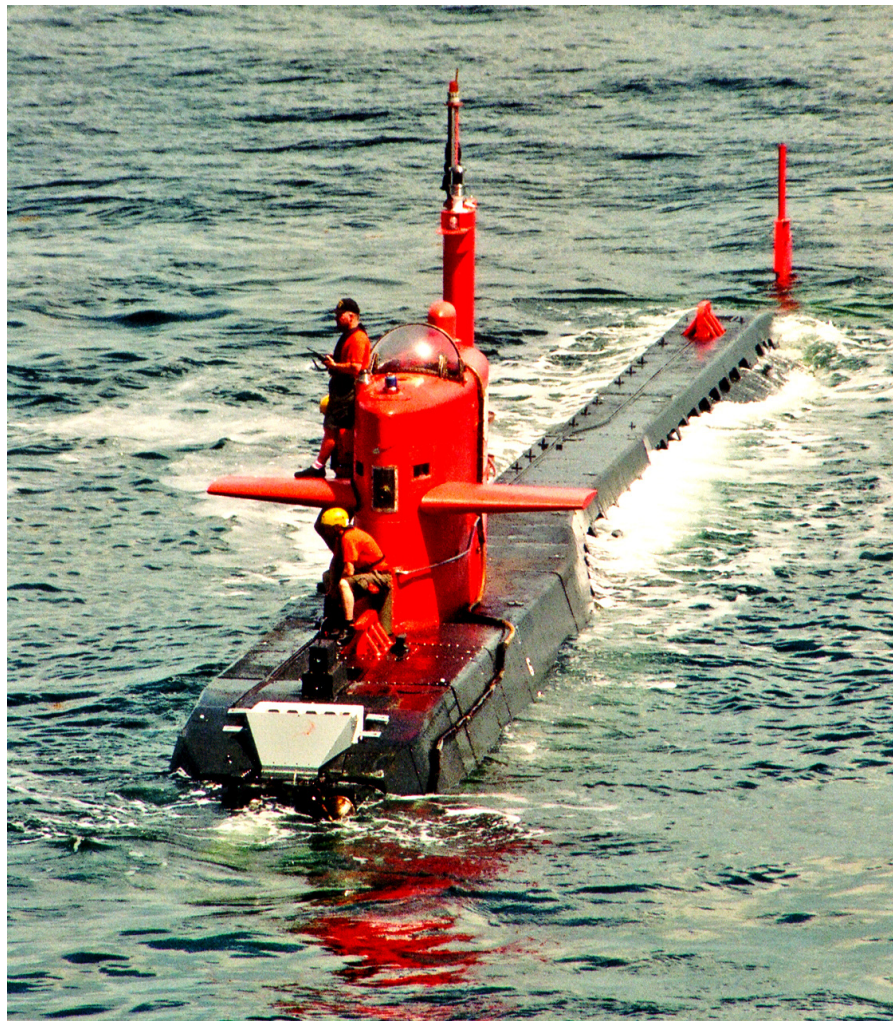
Figure 5. The United States Navy Submarine *NR-1* surfaces during the investigation (Photograph by Toby Jones).

The main tool used for the study of the Mica Shipwreck site was the nuclear powered submarine NR-1 (Figure 5). The submarine was designed, built, and operated by the United States Navy. The 45.72 meter (150 foot) submarine was launched in 1969 and is capable of diving to 914.4 meters (3000 feet). It has numerous unique features that make it a valuable asset to marine archaeologists. The submarine is equipped with a large manipulator arm and 14 digital video cameras that have zoom, pan and tilt features. Numerous lights are attached to the hull of the submarine, providing ample illumination in the otherwise pitch-black environment. There is a work module attached to the external hull of the submarine, located immediately in front of the manipulator arm, which contains various tools. These tools are used by the manipulator arm, and include soil coring devices as well as gripping and cutting attachments. There are three view ports on the lower bow surface of the hull, directly behind the manipulator arm. From this vantage point it is possible to observe the actions of the manipulator arm as well as directly observe the wreck site without the use of cameras.

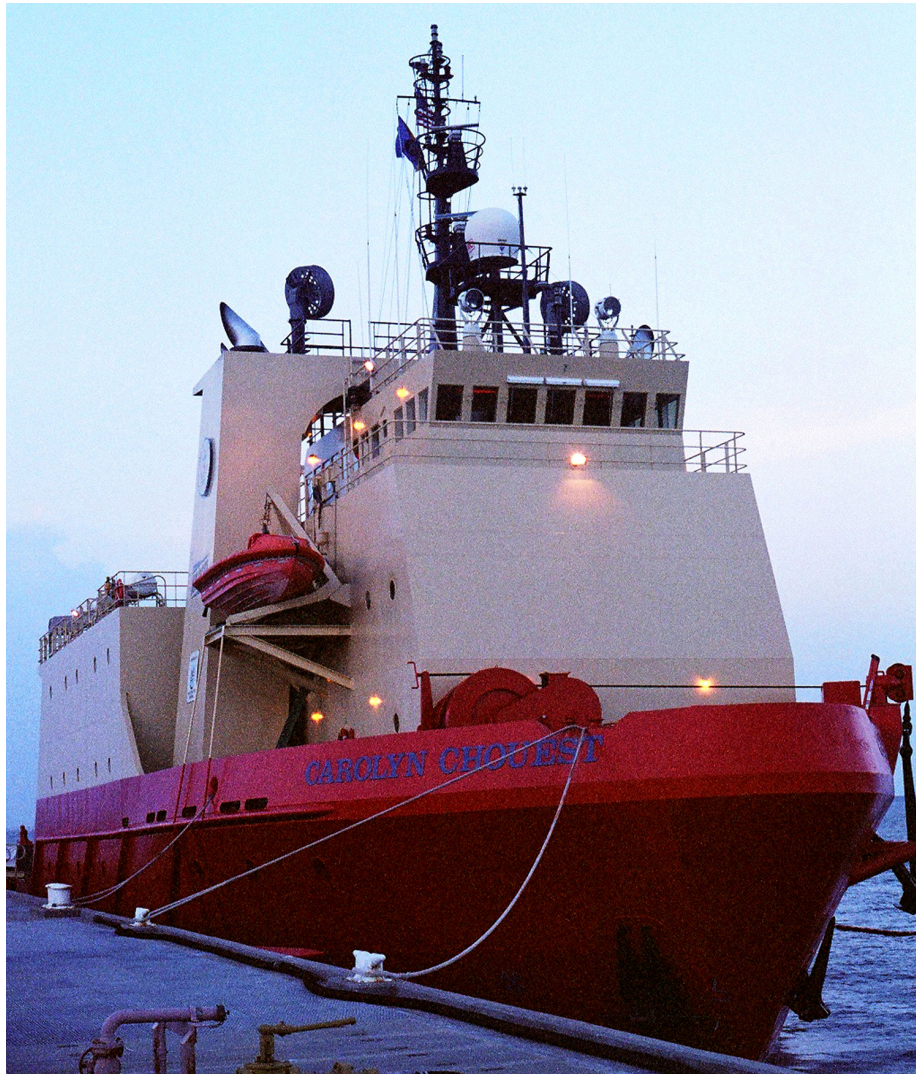
Figure 6. SSV *Carolyn Chouest*, the surface support vessel for *NR-1*. The vessel was docked at Pensacola Naval Air Station, Pensacola, Florida (Photograph by Toby Jones).

SSV *Carolyn Chouest* is the surface support vessel for NR-1 (Figure 6). The 72.5 meter (238 foot) vessel has a beam of 15.9 meters (52 feet) and a draft of 5.2 meters (17 feet). The surface vessel tows NR-1 between work areas, as well as serving as a floating supply warehouse and quarters for the extra crewmembers. During the Mica shipwreck investigation, the scientists were housed in staterooms on the SSV *Carolyn Chouest*, and used this vessel as the main work platform.

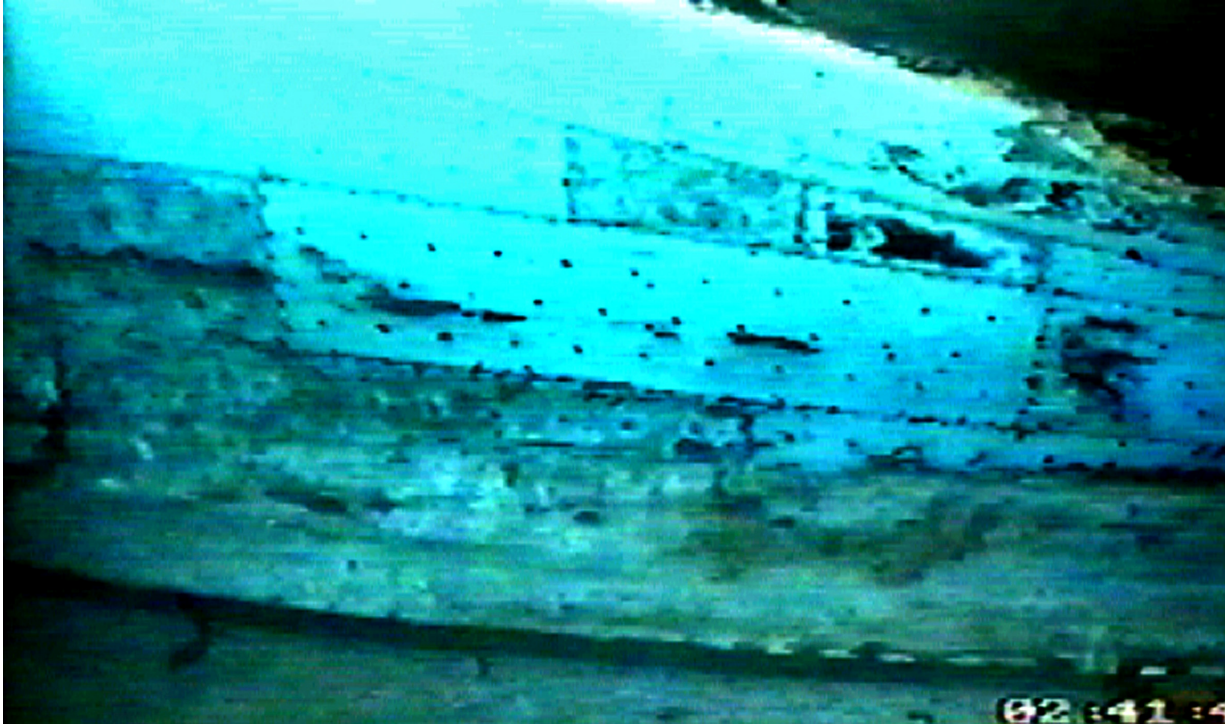
Figure 8. Detail of the starboard stern quarter of the Mica shipwreck. Note the dense nailing around the edges and the quincunx pattern in the middle of each sheet. No scale. (Photograph courtesy of the United States Minerals Management Service and ExxonMobil Corporation).

The outside part of the stem of the ship is copper sheathed, easily identified by virtue of the green patina it developed over time. Each sheet of metal overlapped and was fastened to the hull with copper nails or tacks that also had a dull green patina. There were nails fastened in evenly spaced diagonal rows across the face of each piece of sheathing (Figure 8).

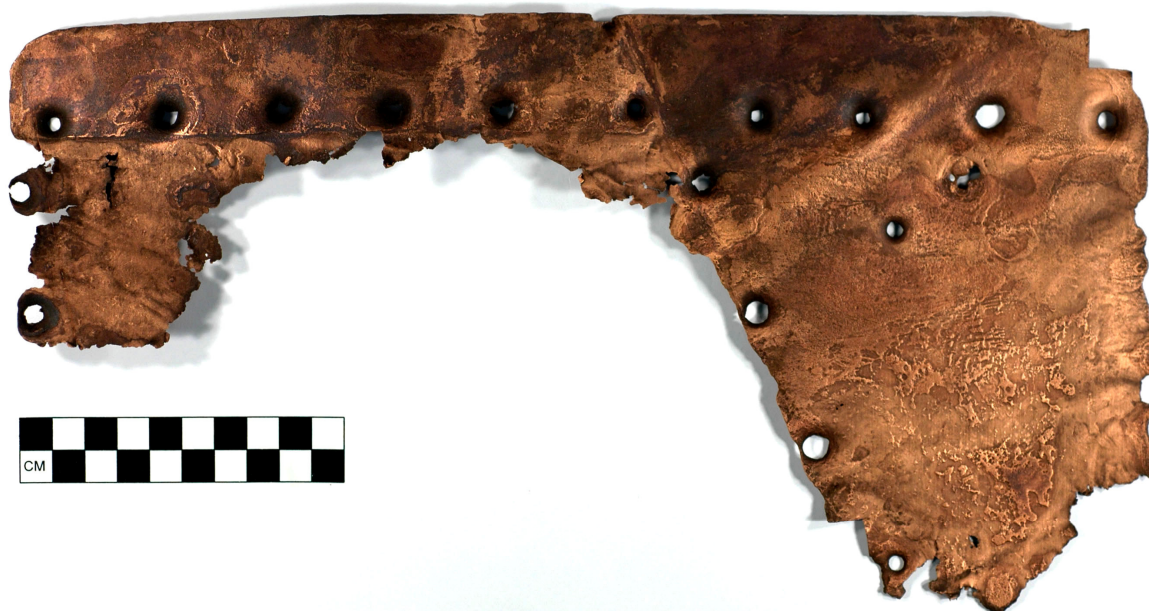
Figure 13. Largest fragment of metallic sheathing recovered from the Mica shipwreck (Photograph by Toby Jones).

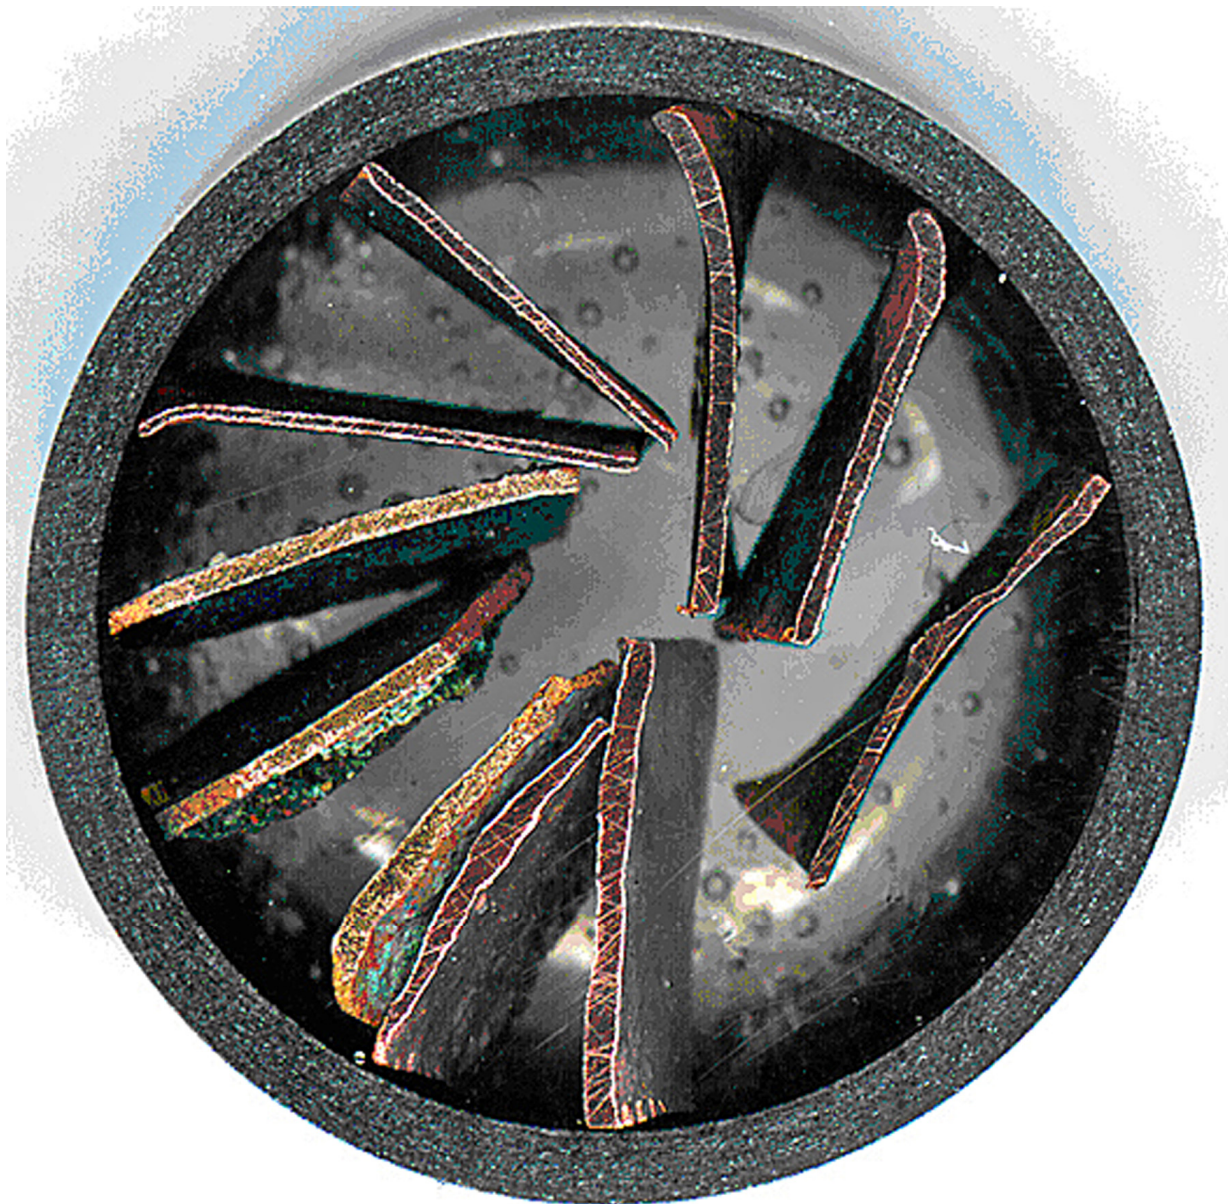
Figure 14. The refracting electron microprobe sample carrier. It contains pieces of metallic sheathing awaiting analysis (Photograph courtesy of Dr. Renald Guillemette).

In order to analyze samples on the refracting electron microprobe, small pieces of sheathing were bedded on edge in epoxy (Figure 14). The face of the block was polished to expose a fresh surface of metal, and coated with a fine layer of pure, powdered carbon. By focusing the x-rays on a freshly cut edge, the probe could avoid areas where superficial corrosion had altered the structure and composition of the metal. While the sheathing fragments were not

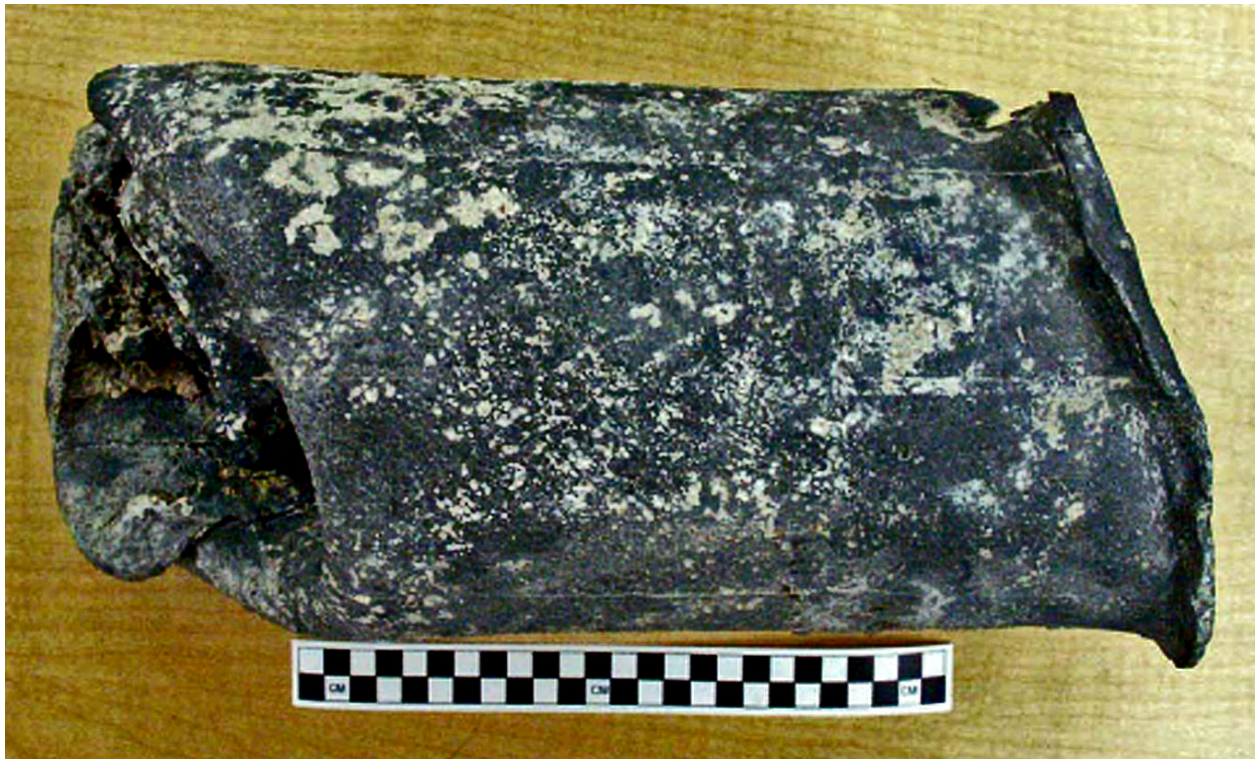
Figure 15. Forward face of lead hawse pipe from the Mica shipwreck. Casting seams are evident on the both the external (right) and internal (left) openings (Photograph by Dave Ball).

The lead hawse pipe recovered from the site measures 17 centimeters (6.8 inches) in diameter and 41 centimeters (16.2 inches) long (Figures 7 and 15). The thickness of the hawse pipe wall is about 2 centimeters (0.5 inches). An examination of the pipe shows that it was built by joining eight long pieces of lead to form a cylindrical shape. The seams can be observed on both the internal and external surfaces. The average width between the seams is 7 centimeters (2.5 inches). Based on the wear patterns, it is possible to ascertain that the hawse pipe belongs to the starboard side of the ship. The lower outboard lip was substantially worn, probably from the rubbing of an anchor cable or chain while the vessel was riding at anchor (Jones 2004: 69) (Figure 16).

According to metallurgical analysis, the hawse pipe was composed of lead with traces of copper and bismuth (for analysis results see Appendix 3). The almost pure composition of the hawse pipe was an expected result due to the metallurgical characteristics of lead that makes it an easy metal to smelt, and to be free of impurities. Comparisons of the Mica hawse pipe with those of other shipwrecks as well as modern lead show that the purity and grain structure of this archaeological sample is almost identical with others. The other hawse pipes of the Mica shipwreck were not found and may be buried in the sediment inside the hull. Other small fragments of lead might have belonged to the ship's pump(s) (Jones 2004: 69).

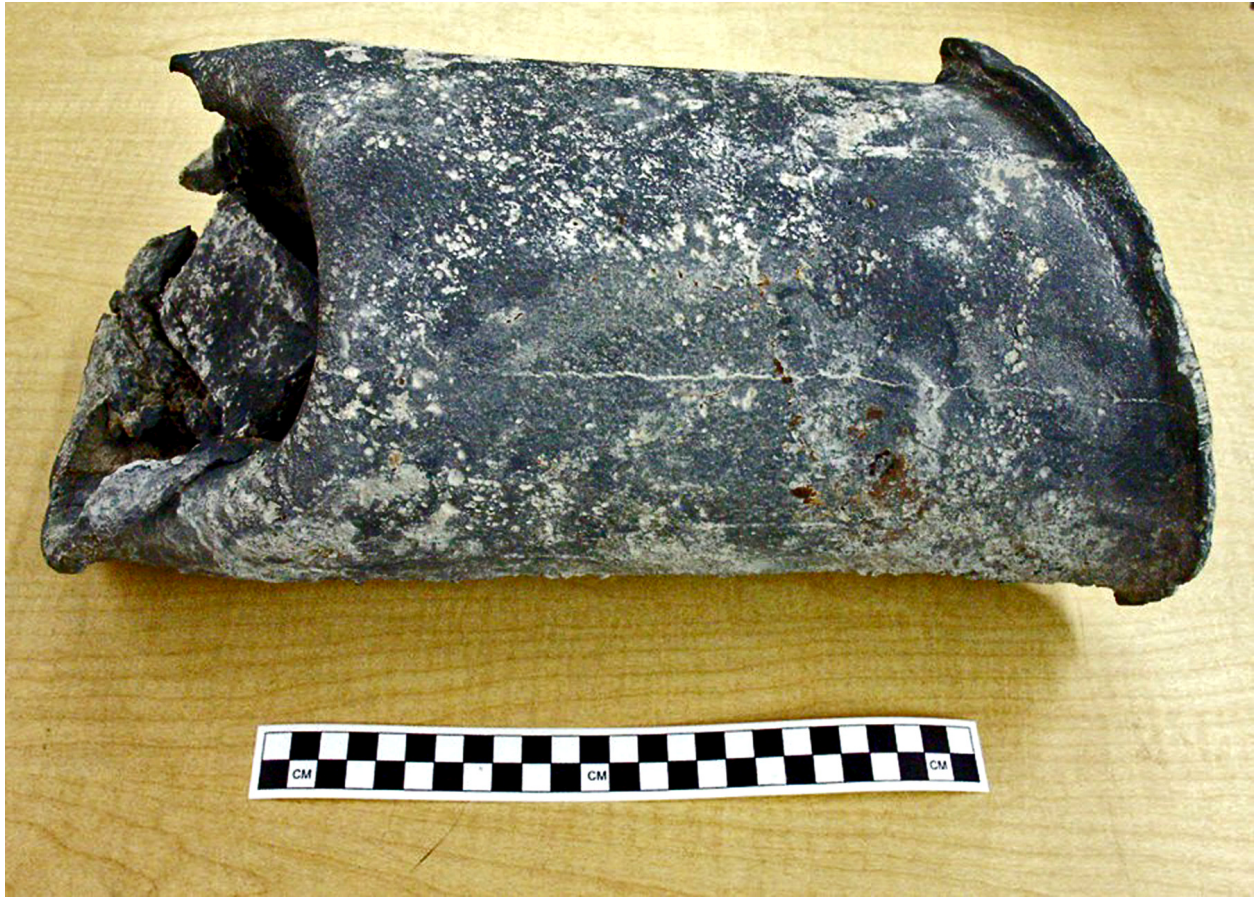
Figure 16. Interior opening of conserved lead hawse pipe from the Mica shipwreck. Note the possible cut marks on the curled-in exterior surface, visible in the lower left (Photograph by Dave Ball).

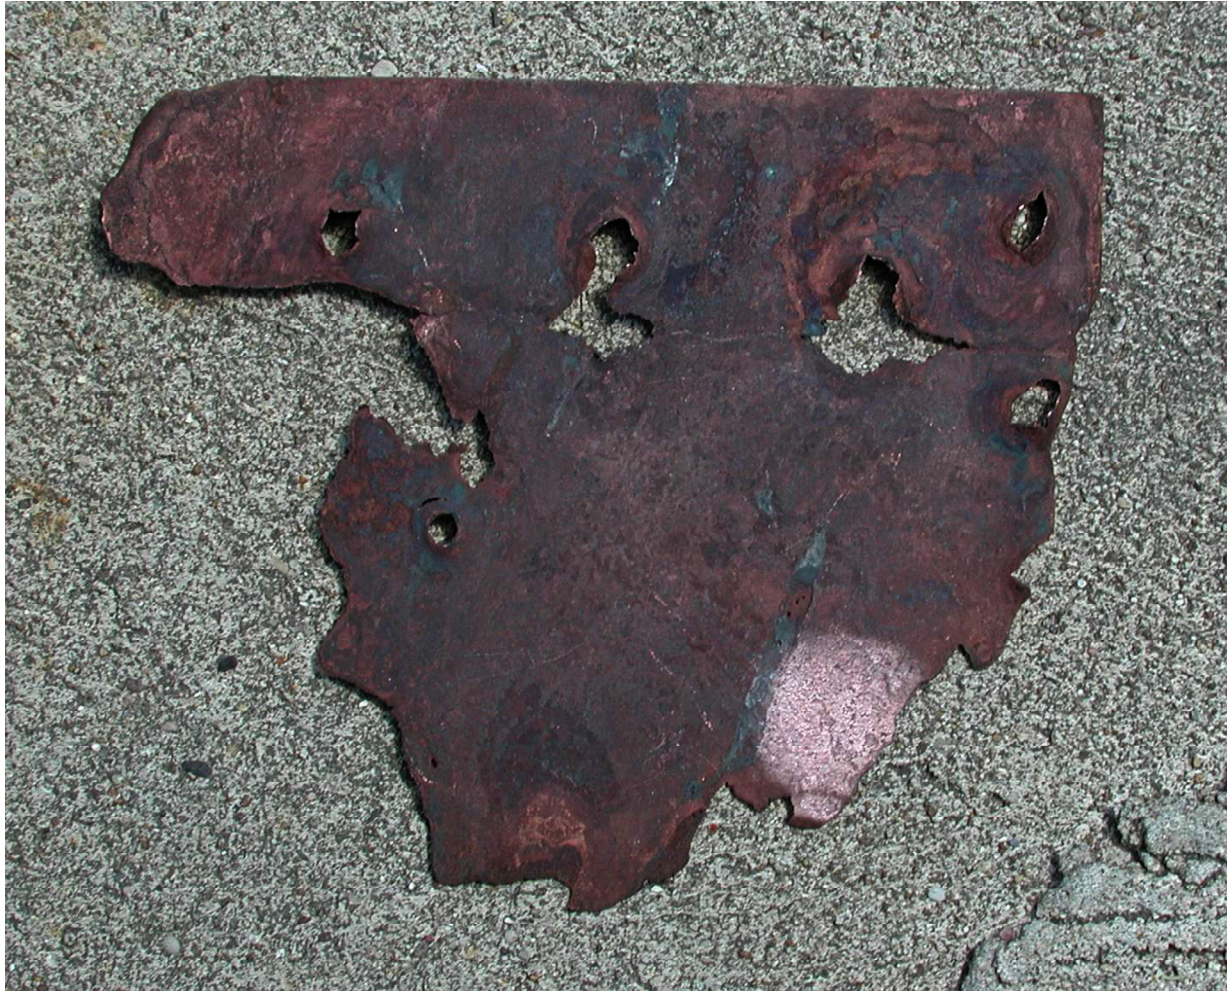
Figure 17. A fragment of the copper sheathing retrieved from the Mica shipwreck. The bright spot in the lower right corner has been mechanically cleaned with a glass bristle brush (Photograph by Toby Jones).

Metallic sheathing fragments were treated using desalination and electrolytic reduction. None of the sheathing fragments appeared to have been sealed, and were experiencing extensive tarnishing. These fragments were mechanically cleaned with glass bristle brushes and then immersed in benzotriazole and finally coated with Krylon 1301 clear matte acrylic spray by Toby Jones at the Conservation Research Lab at Texas A&M University (Figure 17).

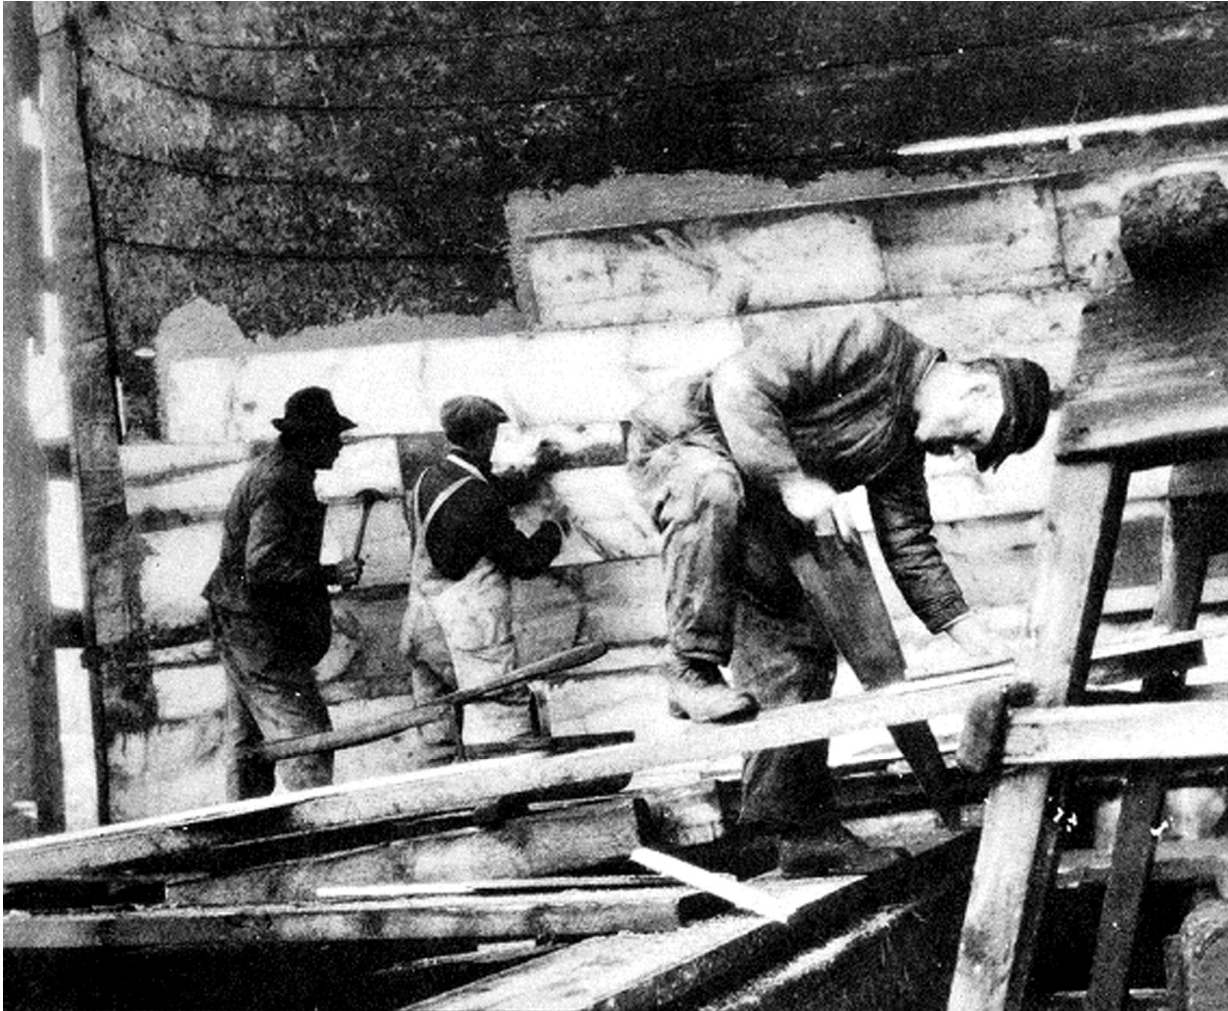
Figure A2. Carpenters applying pine sheathing before the application of metallic sheathing (From Church 1938, Figure 17).

Sacrificial planking could be used in lieu of thick paper to provide a barrier between the dissimilar fasteners. The thin wood planking, like that found on the Mica wreck, could also serve another purpose, namely as a spacer. By nailing the hull planks to the frames, then nailing the sacrificial planking to the hull planks, and finally nailing the sheathing to the sacrificial planking, there would be no nail holes that penetrated completely through all three layers. This arrangement would prevent leaks if the outer fasteners fell out, while preventing interior fasteners from working loose. The sacrificial planking may also have been placed on the vessel while it was being re-sheathed. In order to avoid driving sheathing nails through preexisting holes, the ship owner may have had sacrificial planking placed on the hull to give the nails a better hold. An example of sacrificial planking being applied can be seen in a contemporary photograph of a whaling ship being sheathed (Figure A2).

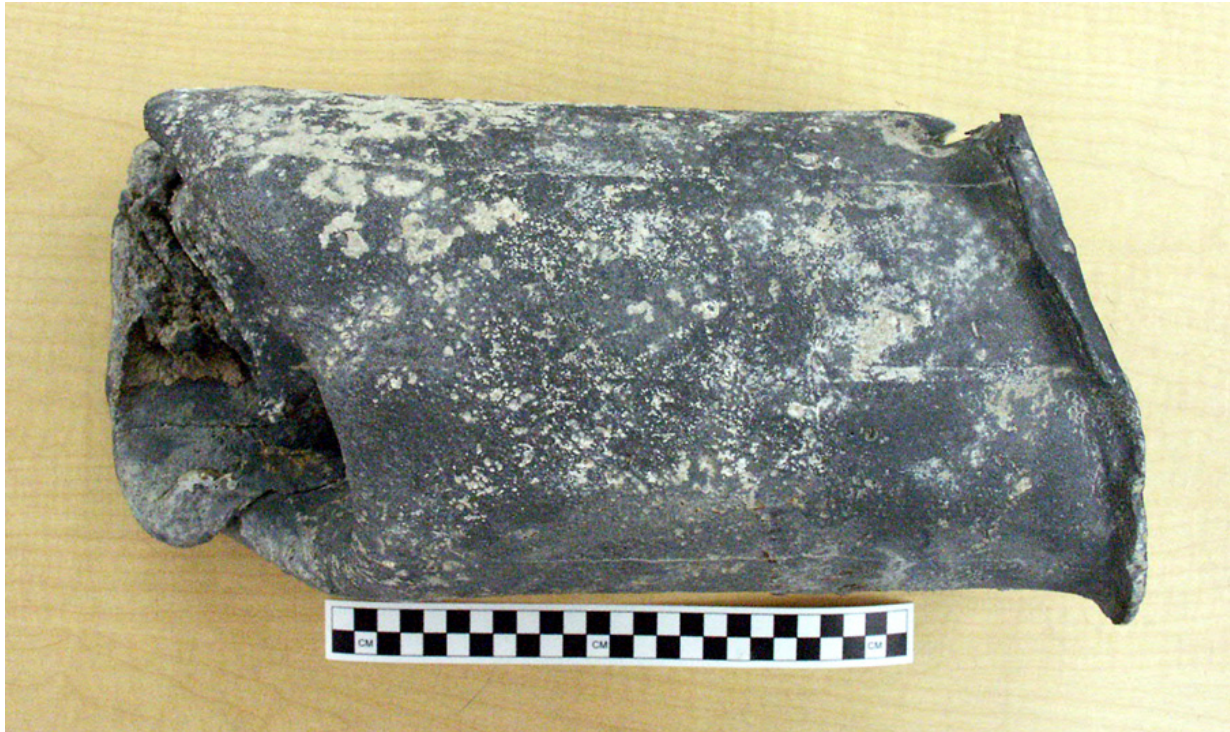
ARTIFACT 7

Notes: Casting seams, cut marks and internal wear are evident.
