***ABBREVIATED PRELIMINARY ASSESMENT***

***RUTH #1 MINE***

Willamette National Forest  
Marion County, OR

Revised  
October 2004

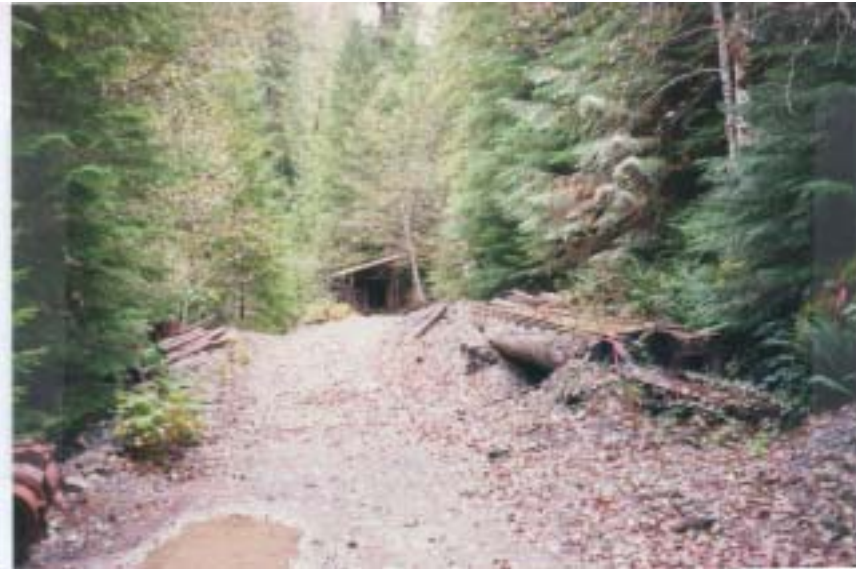
Photo 1. Access to Level 5 of Ruth Mine (photo by R. Seeger).

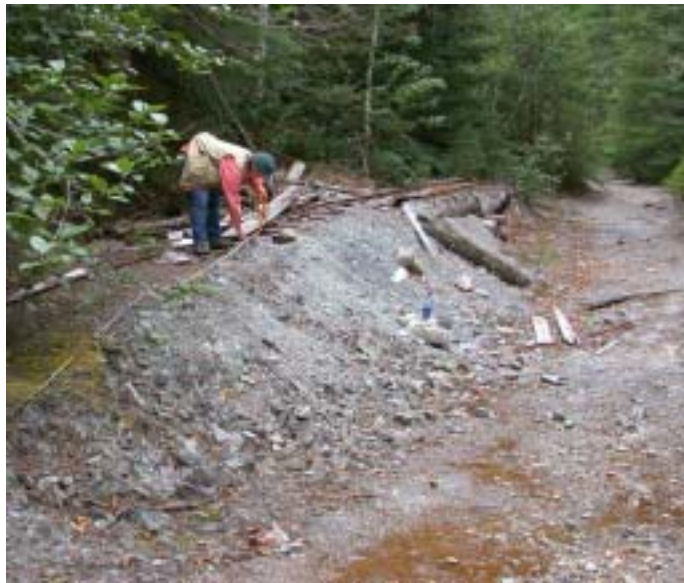
Photo 2. Level 5: Ore Car Track and Possible Loading Site. Niton Sample ID 28. Lead 4810 mg/kg. (photo by D. Boles)

Car Tracks, Level 5.	Lead	4810	Birds	16.0	Industrial	750
Niton Sample ID 28.	Manganese	28,288	Invertebrates	100.0	Industrial	19,000
<b>08/30/04</b>	Nickel	26,394	Plants	30.0	Industrial	20,000
	Zinc	38,886	Plants	50.0	Industrial	100,000
Waste Material used for	Iron	175,923	Plants	10.0	Industrial	100,000
road construction by pipes,	Lead	2939	Birds	16.0	Industrial	750
Level 5. Niton Sample ID	Manganese	26,099	Invertebrates	100.0	Industrial	19,000

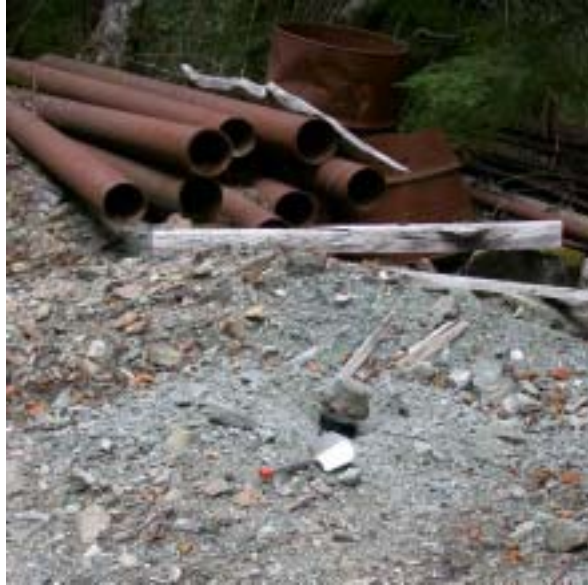
Photo 3. Level 5: Side of Access Road. Niton sample ID 29  
Lead – 2939 mg/kg. (photo by D. Boles)

The waste rock pile for Level 5 was used to construct the haul roads. Approximate depth of this material is 3 feet and approximately 16 feet wide. It is unclear as to the exact length of road that was built from waste rock material. However, based on visual observations of the area, an approximate volume of material in the roadway, ore car rails, and miscellaneous piles is 945cy. Battle Axe Creek is approximately 30 to 40 feet below the road and the adit drainage discharges into the river. There are signs of material leaving the site and migrating down to the river.

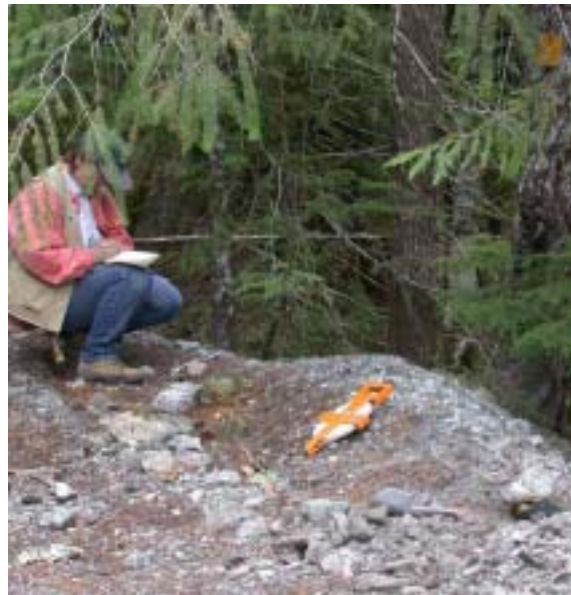
Photo 4. Level 5: Lower Road Segment by Washed out Bridge.  
Niton Sample ID 33. Lead 4568 mg/kg. Material Approximately 3' Deep.  
(photo by D. Boles)

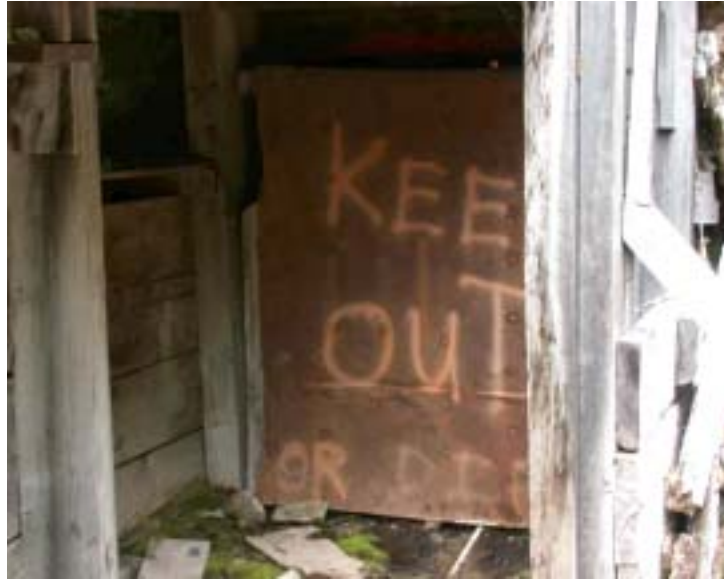
The Site consists of three adits and several small waste-rock dumps. The 4<sup>th</sup> Level consists of one adit with a steel door on the portal and a second adit with a partially collapsed portal (see photos 5 and 7, respectively in Appendix C). The second adit connects to the main adit 20 feet inside the side drift. The 5<sup>th</sup> Level adit has a wooden door on the portal.

Photo 5. Level 4: Main Adit (photo by D. Boles)

The Site poses a physical hazard to the general public recreating at the Site in that the wooden door on the portal at the 5<sup>th</sup> Level is not secured with a lock and one of the portals on the 4<sup>th</sup> Level is unsecured.

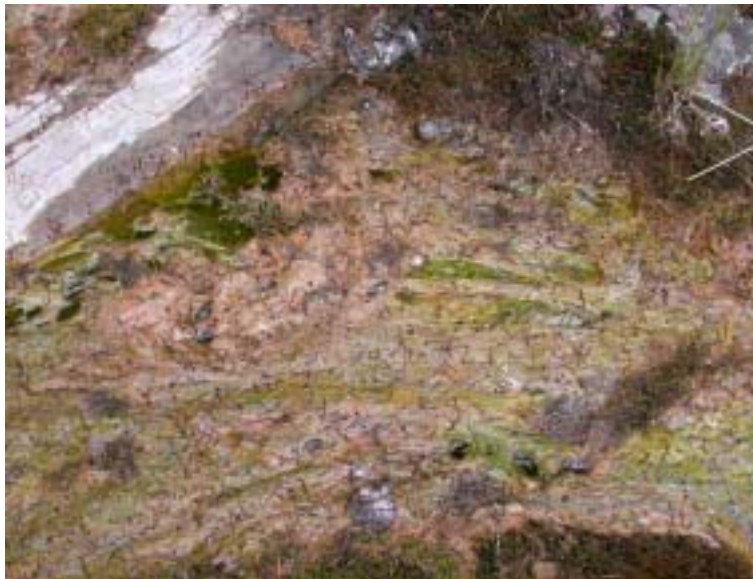
Photo 6. Level 4: Adit Discharge (photo by D. Boles)

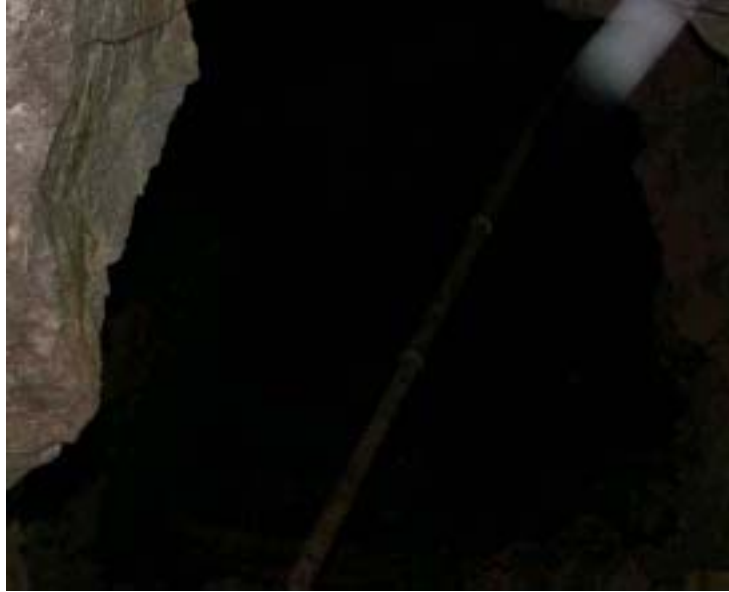
Photo 7. Level 4: Taken Inside of Second Open Portal  
(photo by D. Boles)

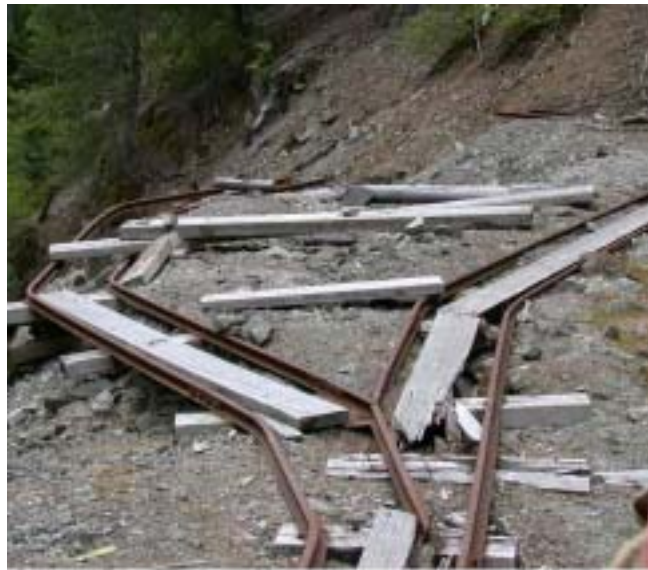
The waste material for Level 4 is directly in the drainage of a small tributary. Water was seen disappearing in the rubble and then reappearing further down gradient. A culvert, approximately 36 inches in diameter, has been washed out, indicating this tributary does carry some good flows during spring runoff. The waste rock material in this area is hard to quantify because of it being scattered down gradient. An estimate would be 4500cy.

Photo 8. Level 4: Waste Rock and Ore Car Rails  
(photo by D. Boles)
