Summary Report on Building Performance

Hurricane Katrina 2005

FEMA 548 / April 2006

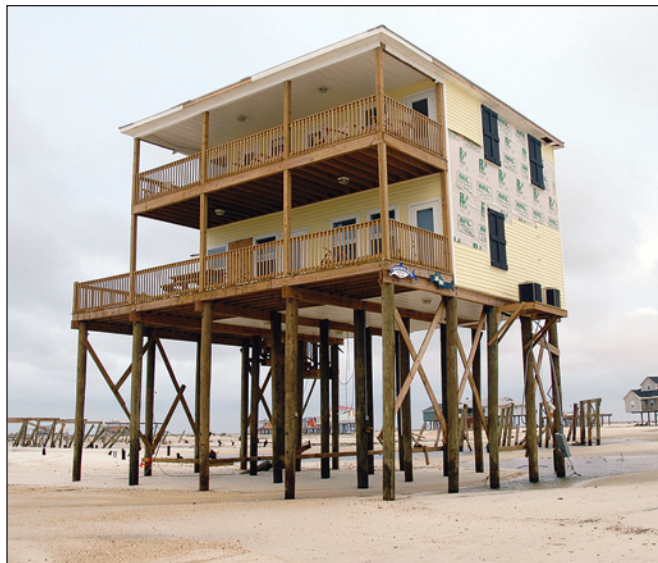
Figure 2-1. Successful example of well-elevated and embedded pile foundation following Katrina. Note adjacent building failures where foundations were not high enough or where pile embedment was insufficient (Dauphin Island, Alabama).

To perform successfully, piles must be adequately embedded. Where piles were not adequately embedded, pile foundation failure occurred and resulted in destroyed or missing houses or racked piles and leaning buildings (see Figures 2-1 and 2-2).

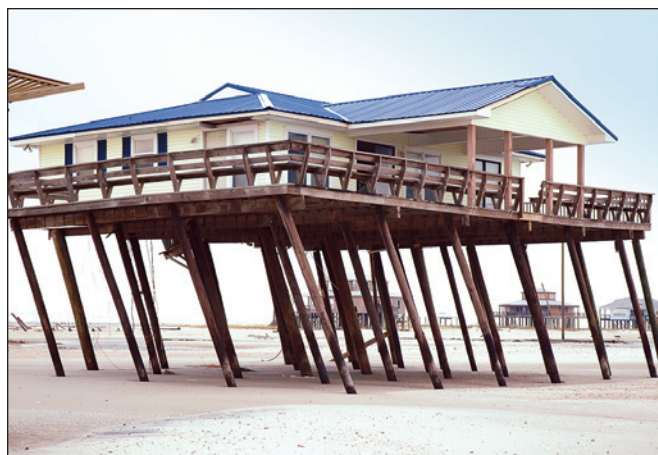
Figure 2-2. House that nearly failed due to insufficient pile embedment (Dauphin Island, Alabama)

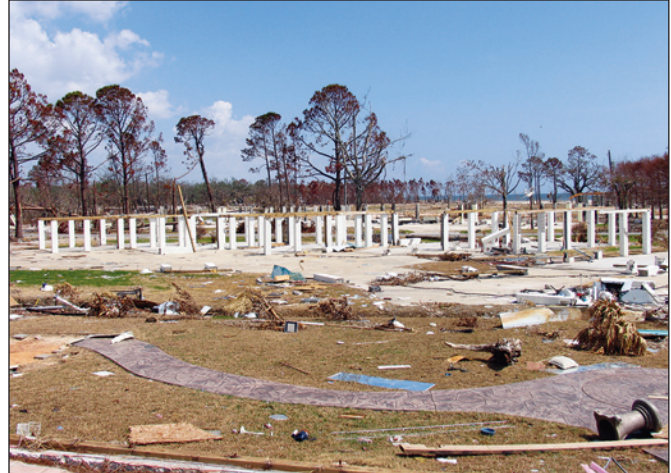
Figure 2-3.
Typical building failures when surge and waves exceeded pier foundation height (Long Beach, Mississippi)

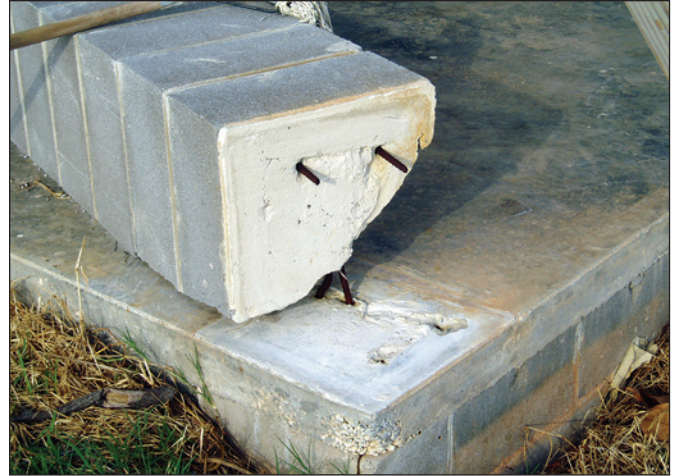
Figure 2-4.
Pier connection failure (Belle Fontaine Point, Jackson County, Mississippi)

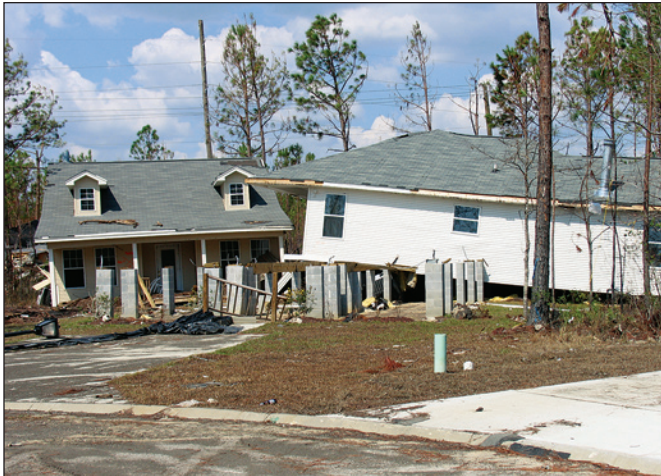
Figure 2-5. Buildings floated off of pier foundations (Pass Christian, Mississippi)

For example, 19 of 32 new houses in a Pass Christian subdivision (approximately 1 mile from the Gulf shoreline) floated off of their pier foundations due to flood heights of approximately 8 feet above the BFE and poor connections between the building and the floor beams or the floor beams and the piers (see Figure 2-5). Buildings that remained attached were flooded to approximately 8 feet above the floor elevations, but received minimal structural damage and appeared repairable.

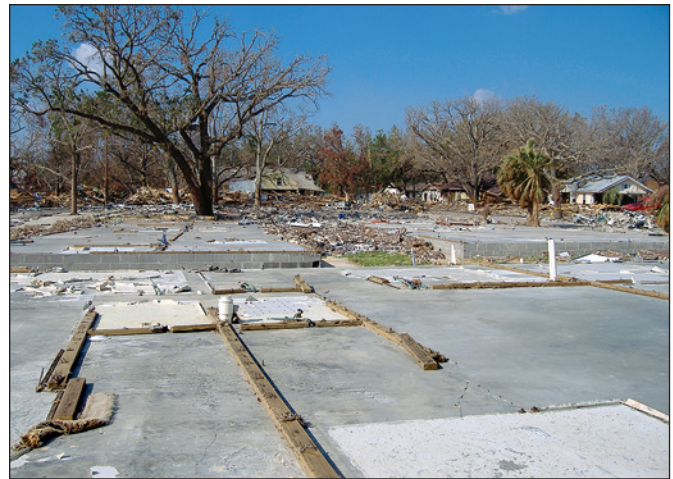
Figure 2-6. Waves, surge, and floating debris destroyed many single-family homes on slab foundations. Note the debris from houses that washed landward into other buildings (Biloxi, Mississippi).

storm surge exceeded the slab elevation by more than about 3 feet and where breaking wave heights are believed to have exceeded 1.5 feet, wave damage to load-bearing walls resulted in severe building damage or total loss. As an example, in Biloxi, Mississippi, high surge elevations and floodborne debris impacts caused total destruction of buildings supported on slab-on-grade foundations (see Figure 2-6).

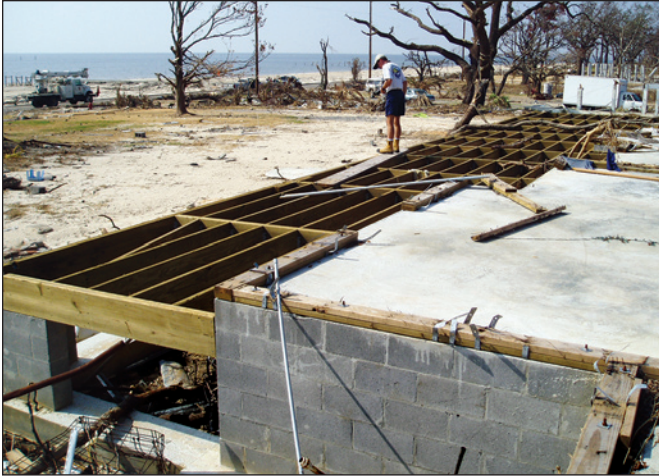
Figure 2-7. Stem wall foundation survived intact, but waves and surge above the floor destroyed the house, sweeping it off the foundation (Waveland, Mississippi).

Stem Wall Foundations: Stem walls typically use a masonry wall to contain and elevate compacted fill, which, in turn, supports a slab. The higher elevation above surrounding grade makes the foundation preferable to a slab-on-grade, and adds a safety factor against local stormwater flooding. Stem wall foundations are frequently used to meet the elevation requirements when the BFE is several feet above grade. Similar to buildings with slab-on-grade foundations, buildings with stem wall foundations experienced severe damage when flood levels and wave heights exceeded the top of the slab (see Figure 2-7). As with other shallow foundations, stem wall foundations are susceptible to undermining due to erosion or localized scour.

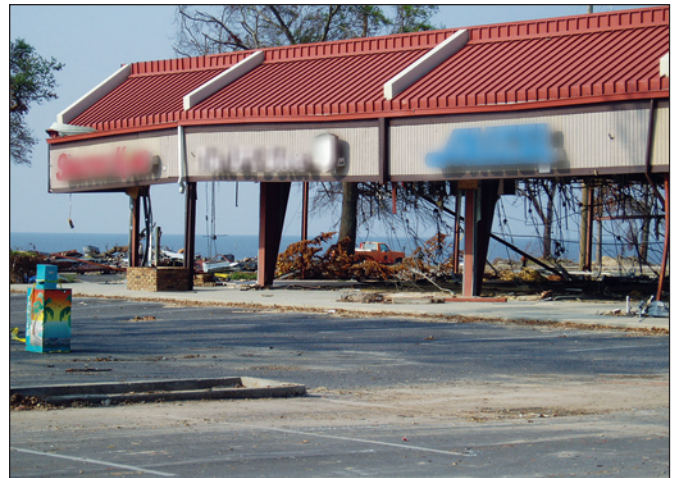
Figure 2-8. Steel frame strip mall construction with exterior wave damage (Gulfport, Mississippi)

A wide variety of commercial buildings experienced flooding and severe damage from the storm. These buildings included downtown storefronts in the older business districts, stand-alone food service/resort retail businesses, motels, churches, seafood handling/processing facilities near the harbors, strip malls, and larger retailers. No type of commercial building constructed on slab foundations near the coastline escaped damage when the storm surge or wave elevations exceeded the first floor levels (see Figure 2-8).

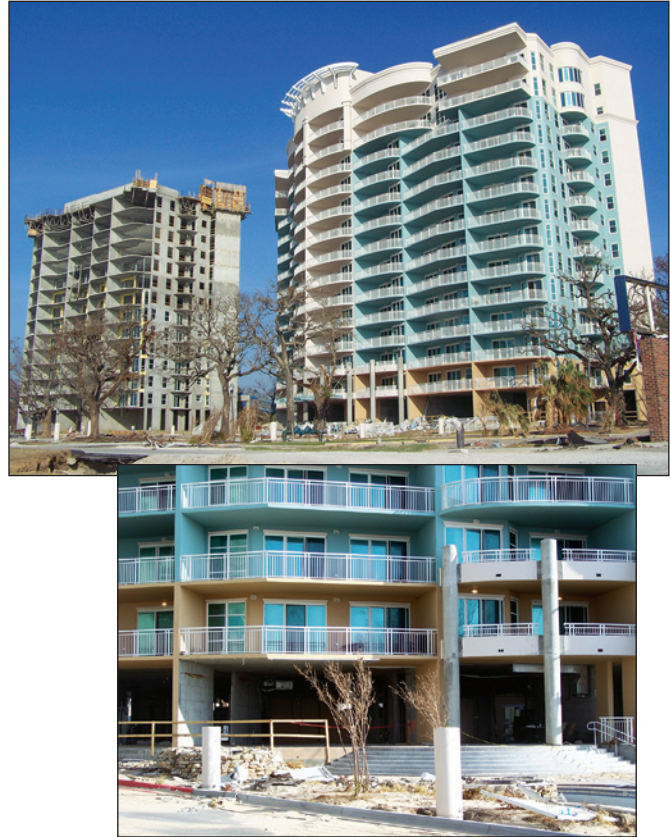
Figure 2-9. High-rise buildings along Beach Boulevard received non-structural flood damage to the lower floor, and no apparent flood or wind damage to higher residential floors (Gulfport, Mississippi)

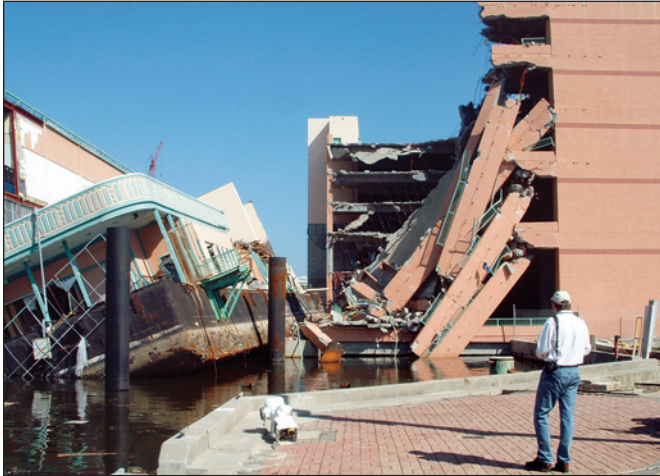
Figure 2-10.
 Parking deck collapse due to impact by casino barge, on left (Biloxi, Mississippi)

Some of the high-rise casino hotels and condominiums close to the shoreline experienced some of the worst storm surge depths and wave heights. The foundation stability of the large buildings was not affected; most were cast-in-place, reinforced concrete. Although sited near the shoreline and experiencing the worst flood conditions, the high-rises were some of the better examples of successes. However, some of the high-rise casino hotels were damaged when adjacent casino barges were pushed into them by storm surge (see Figure 2-10).

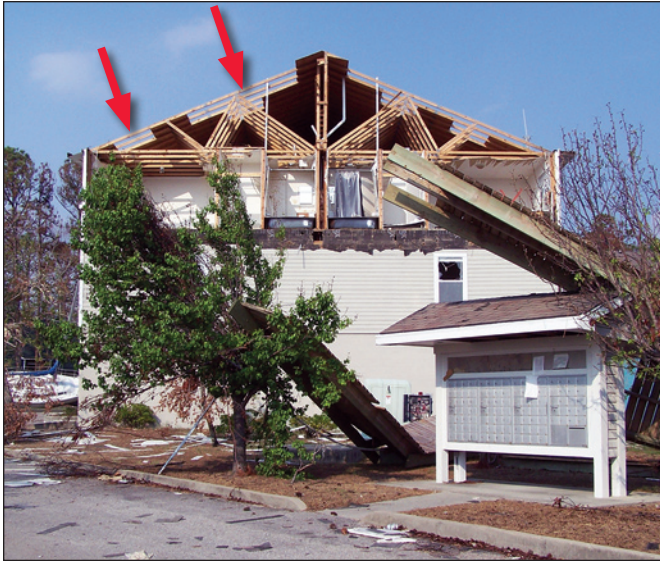
Figure 2-12. Failure of the gable end wall of this apartment building led to pressurization of the attic and the release of sheets of plywood sheathing. Note the plywood roof sheathing “unzipped” by wind pressures (arrows), (Ocean Springs, Mississippi).

series of subsequent failures. Wood frame commercial buildings failed similarly to wood frame residential buildings. Figures 2-12 and 2-13 are examples of wind-related failure in residential and commercial buildings.

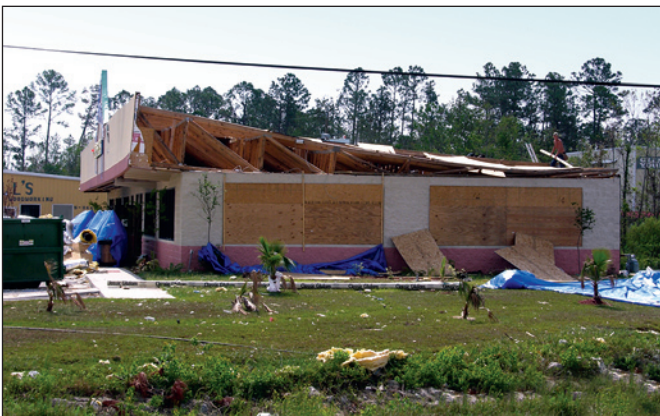
Figure 2-13. Failure in a wood frame commercial building. Trusses lost roof sheathing, allowing trusses to tip over (Ocean Springs, Mississippi).

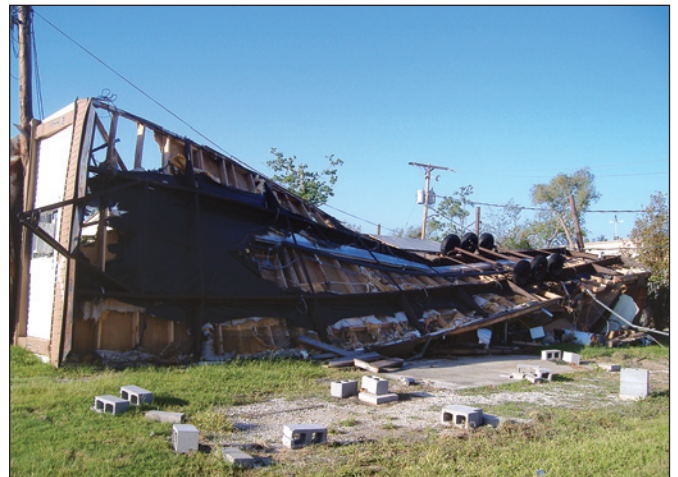
Figure 2-14. Manufactured home rolled over by Hurricane Katrina’s winds (Chalmette, Louisiana)

While most of the damage to manufactured housing was from flooding, wind damage was noted in both older and newer manufactured homes. The styles of manufactured home installations impacted performance during Hurricane Katrina. When properly anchored, manufactured home damage under wind loads was less significant. Unanchored or improperly anchored homes or homes with damaged anchors were prone to wind-related damage (see Figure 2-14).

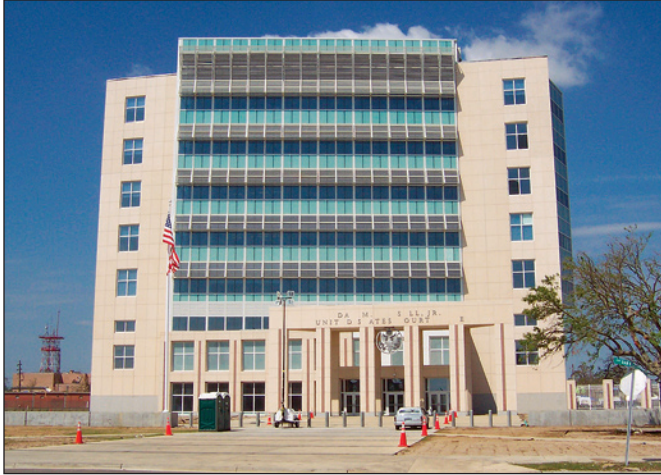
Figure 2-15.
Reinforced concrete/steel frame building that performed well structurally, but did have some building envelope damage and roof mounted HVAC equipment damage (Gulfport, Mississippi)

In general, reinforced concrete and heavy steel buildings observed by the MAT performed well structurally (see Figure 2-15). While the MAT noted little structural damage to most buildings constructed with reinforced concrete frames, extensive damage to unreinforced masonry buildings was observed.

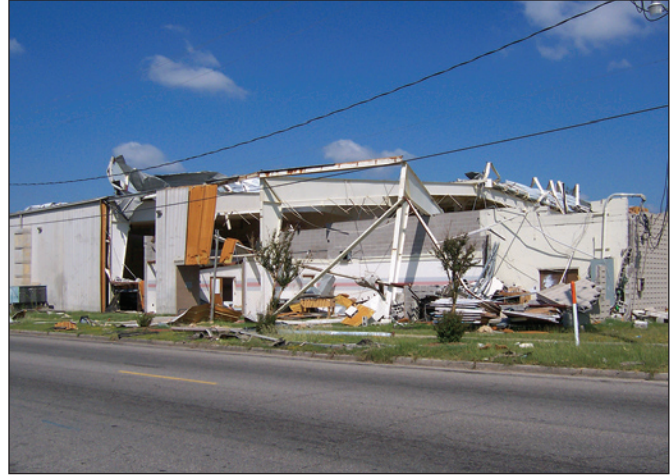
Figure 2-16.
Pre-engineered metal building failure (Gulfport, Mississippi)

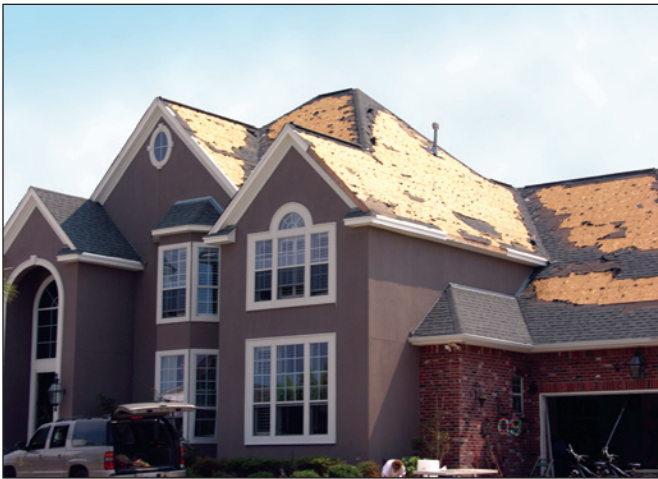
Figure 2-17.
Extensive loss of roof covering and underlayment (Slidell, Mississippi)

Damage to roof coverings can cause major building performance problems during hurricanes. Rainwater entering a building through damaged roofs causes significant damage to the building contents and interior. Throughout the areas observed by the MAT, many of the residential buildings had asphalt shingle roof coverings. The vast majority of the observed roofs experienced damage, ranging from loss of a few hip trim shingles or tabs to loss of a large number of shingles and underlayment (see Figure 2-17). Failures of hip/ridge trim shingles and failures along the eaves and rakes were common.

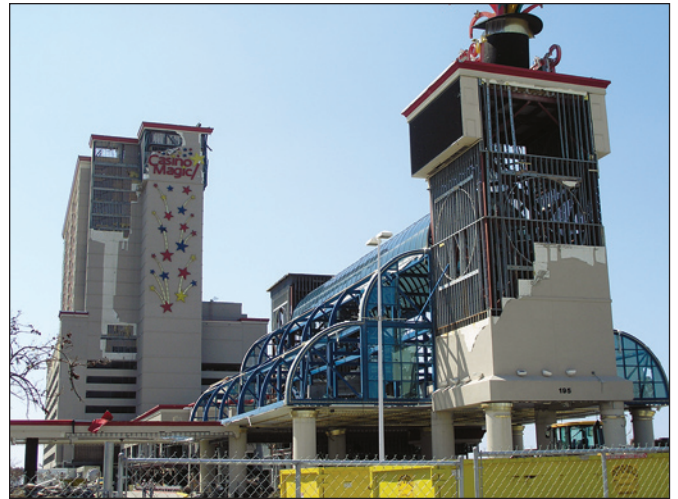
Figure 2-18.
Multi-story building showing severe EIFS damage. In some areas, the gypsum board on the interior side of the studs was also blown away (Biloxi, Mississippi).

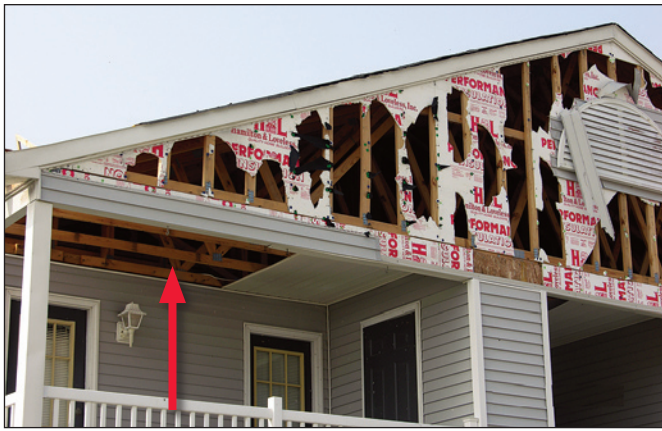
Figure 2-19. Loss of vinyl siding and foam insulation at a gable end wall. Note the missing vinyl soffit (red arrow). Not visible was the loss of roof sheathing caused by progressive failure that was initiated by soffit loss (Long Beach, Mississippi).

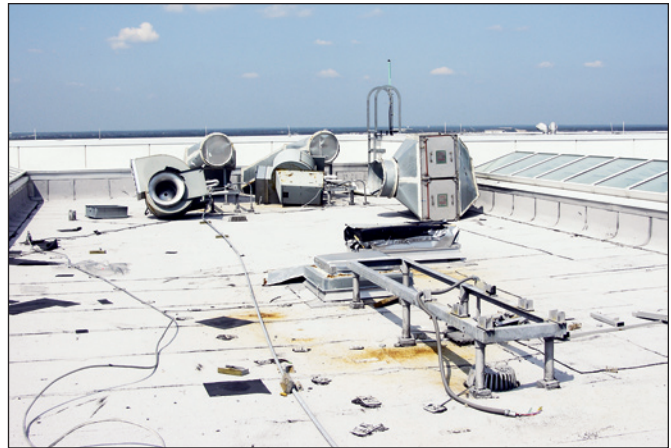
Figure 2-21. The equipment on this new Federal courthouse blew away because it was resting on vibration isolators that provided lateral resistance, but no uplift resistance. Two large openings through the roof were left after the ductwork blew away (temporary covers had been placed over the openings).

The MAT observed many damages to mechanical and electrical devices mounted on the exterior of buildings. Lost equipment included fan units and HVAC units, electrical and communications equipment, and lightning protection systems. There are several effects due to loss of this equipment. In many instances, the displaced equipment left large openings through the roof and/or punctured the roof membrane. Equipment loss often affected the operational functions of the facilities. Blown-off equipment became high-momentum windborne debris in some cases. The equipment observed on critical and essential facilities was not anchored more effectively than the equipment on common commercial buildings (see Figure 2-21).

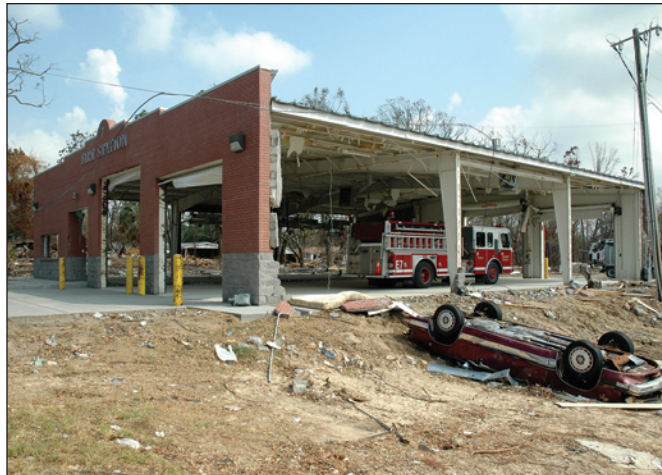
Figure 3-2.
Newly constructed Gulfport Fire Station 7 destroyed by waves and storm surge (Gulfport, Mississippi)

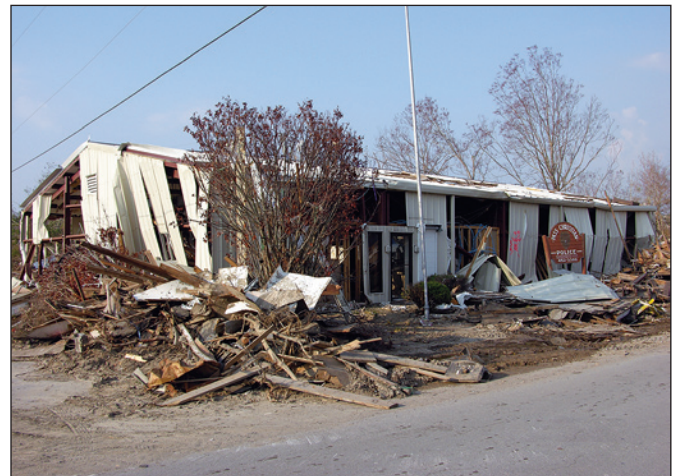
Figure 3-3.
Police department destroyed by storm surge (Pass Christian, Mississippi)

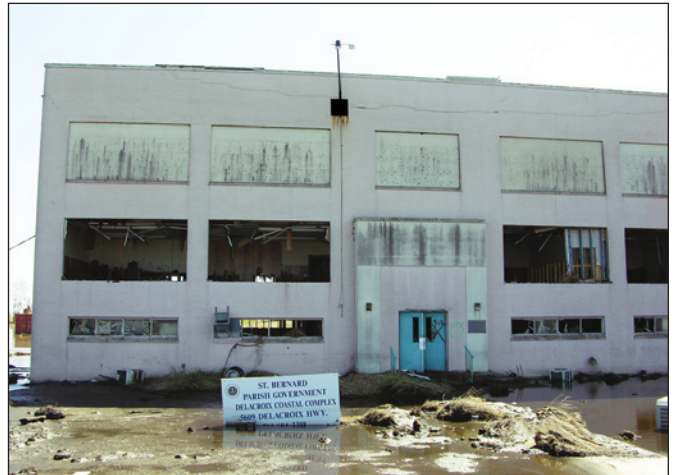
Figure 3-6.
Storm surge damage to the St. Bernard Parish Coastal
Government Complex (Delacroix, Louisiana)
