HURRICANE

*Katrina*

IN THE GULF COAST

# J. Historic Buildings Pre- and Post-Disaster Mitigation

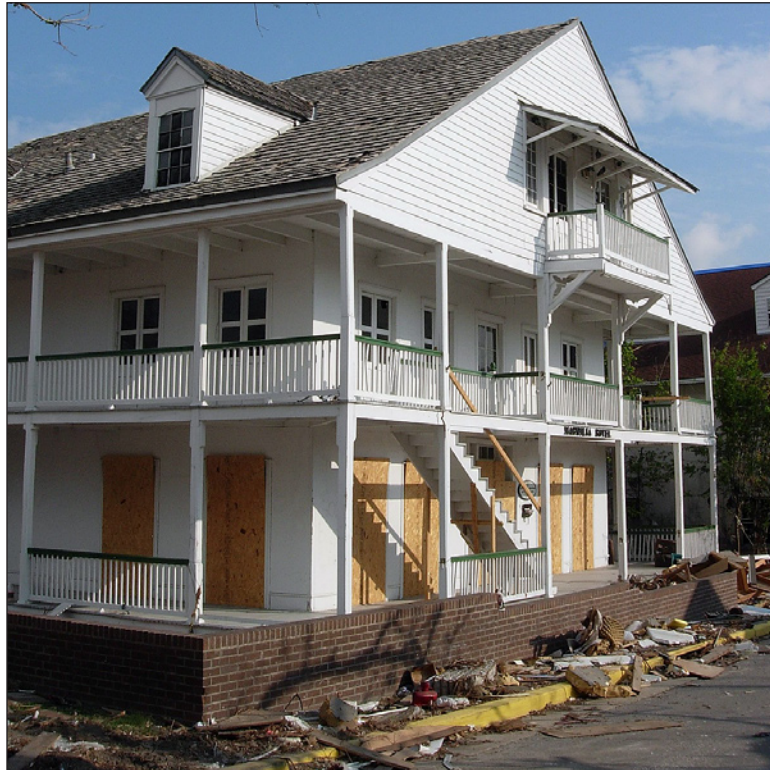
Figure J-1.  
Built by John Holm in 1847, the Magnolia Hotel, badly damaged from Hurricane Camille in 1969, was moved 100 yards north and restored by the City of Biloxi in 1972. While the main structure remains intact, the wood railing and one wood stair to the second floor porch were damaged; the other wood stair was completely destroyed (Biloxi, Mississippi).

Although consideration for relocation should be given to historical buildings that are located in an area prone to flooding from hurricanes, all properties that have sustained significant damage from a hurricane should be evaluated for possible relocation as part of the restoration process. Relocating a building to higher ground will reduce the risk of further damage from future hurricanes. Hotel Magnolia (see Figure J-1) underwent relocation after being badly damaged in 1969 from Hurricane Camille. As a result, the hotel experienced only minimal flooding.
