WATER AND SOIL

F-1 Adequacy and Cumulative Effects of Best Management Practices

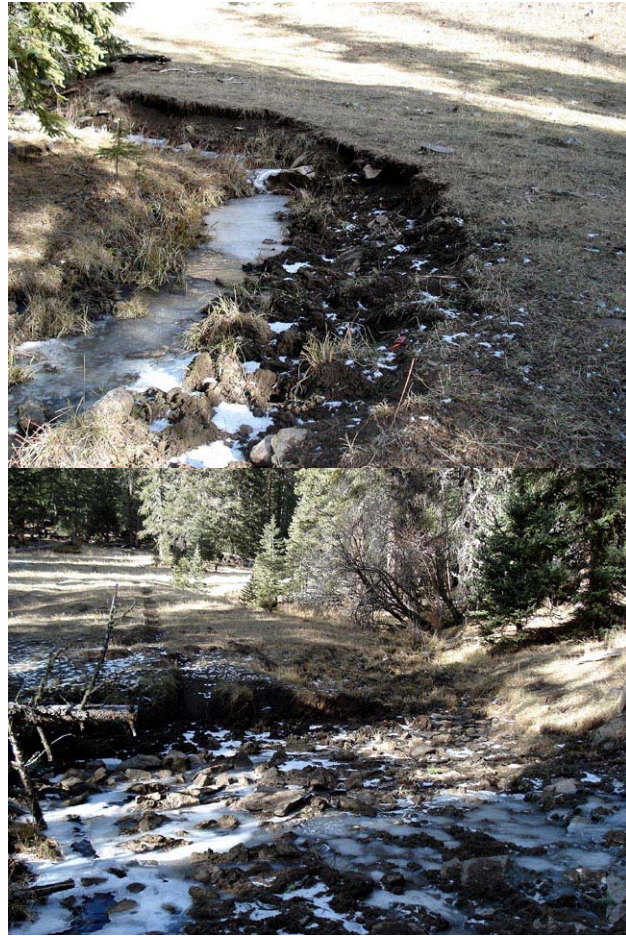
Smith Creek (S. Fk. Judith)

“Post-holing”, bank trampling, bank shearing, loss of woody shrubs, over-widened channel (BA=70%)

Smith Creek: This area was scheduled for a riparian enclosure in 2006 but it was not completed; only the fence right-of-way was cleared. Heavy bank trampling and high grazing impact on this non-functioning reach provides a sharp contrast to the enclosure downstream. The stream suffers from long term cumulative grazing impacts: over-widened channel, very little woody shrub recruitment, high eroding banks, sedimentation and reduced flows. Average bank alteration – 70%; standard – 30%.

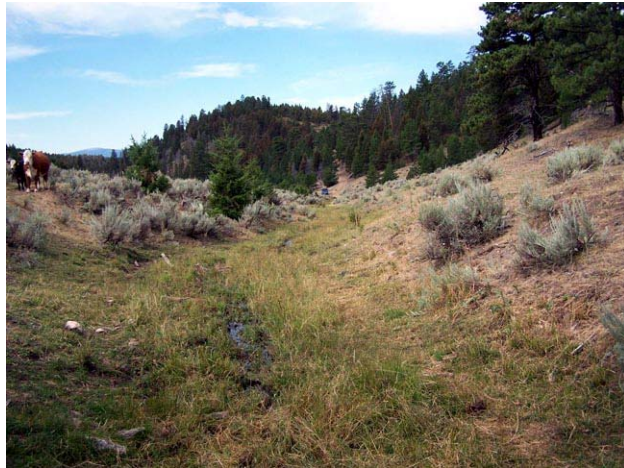
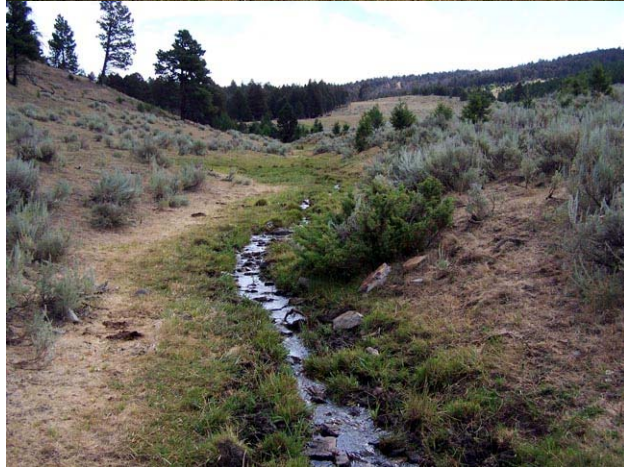
Whitetail Creek (Smith River)

Sedimentation, forage over-utilization, bank trampling, "post-holing" (BA=54%)

Whitetail Creek: Monitored Reach 164 at its start below the holding pasture in the Copper Creek Allotment. The division fence between Whitetail and Decker Pastures is just South of the creek. Cattle trail along the edge of the creek and a lot of trampling of the spring where the creek starts. The creek dries up within a mile of this transect. Average bank alteration – 54%; standard – 30%.

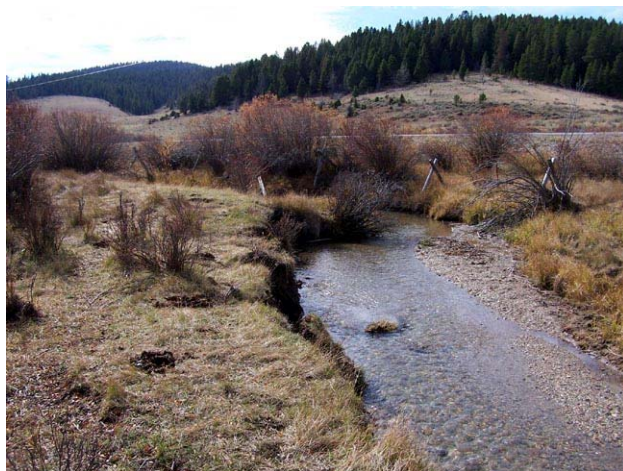
Bank collapse, loss of shrubs, and over-widened channel (BA=22%)

Newlan Creek, Lower Transects: Started on Reach 175 at the upper end where Newlan Creek enters the Sawmill Pasture. First transect was 49%. The willows got a lot denser and the second transect was 16%. Went to the lower end of the reach and ran two transects going up the creek. The first one was 29% and second was 15% with the willows getting denser further up the creek. Average bank alteration – 27%; standard – 20%.
