# Preassessment Screen Determination for the Palmerton Zinc Pile Superfund Site

Pennsylvania Department of Conservation and Natural Resources;  
Pennsylvania Department of Environmental Protection;  
Pennsylvania Fish and Boat Commission;  
Pennsylvania Game Commission;  
United States Department of Commerce and;  
United States Department of the Interior  
in their Capacity as Trustees of Natural Resources

December 2003

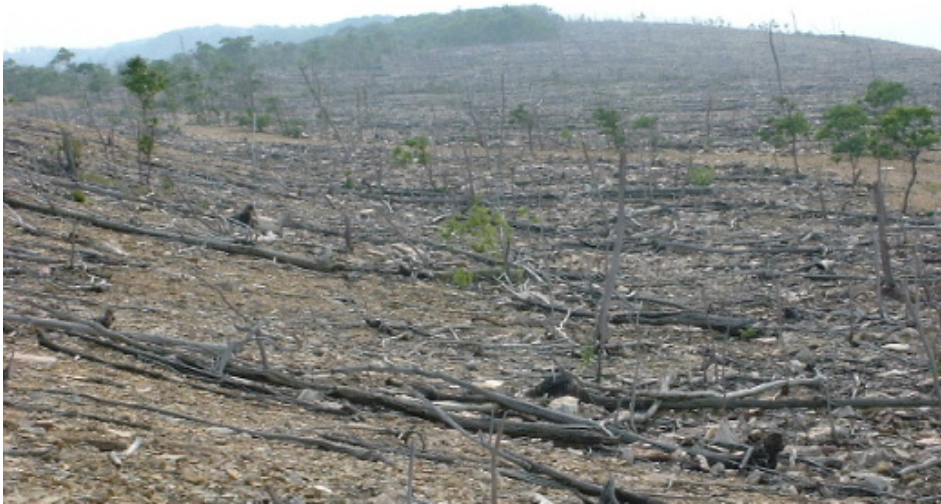
**Figure 3. Photograph showing the loss of vegetation and topsoil on Blue Mountain.**

Blue Mountain, Operable Unit 1 (OU1) - Over 2,000 acres of forest were defoliated on Blue Mountain and nearly all top-soil from this acreage eroded into Aquashicola Creek and the Lehigh River. In 1987, EPA selected an interim remedy for Blue Mountain that included spreading a sewage sludge/lime/fly ash mixture and seeding with grasses and tree seedlings on a portion of this denuded area. More than 60 miles of roads were bulldozed on the side of the mountain to facilitate the land-based remedial effort on approximately 800 acres. The interim remedial work was initiated in 1991 and completed in 1995. EPA has determined that grass coverage performance standards have been met; however, the woody stem performance standard of 435 stems per acre has not been met. Additional monitoring studies have concluded that metals remain mobile through biological uptake into plants and thus are available to higher trophic level biological receptors (Lee, 1995; USEPA 2001; USEPA 2002a).

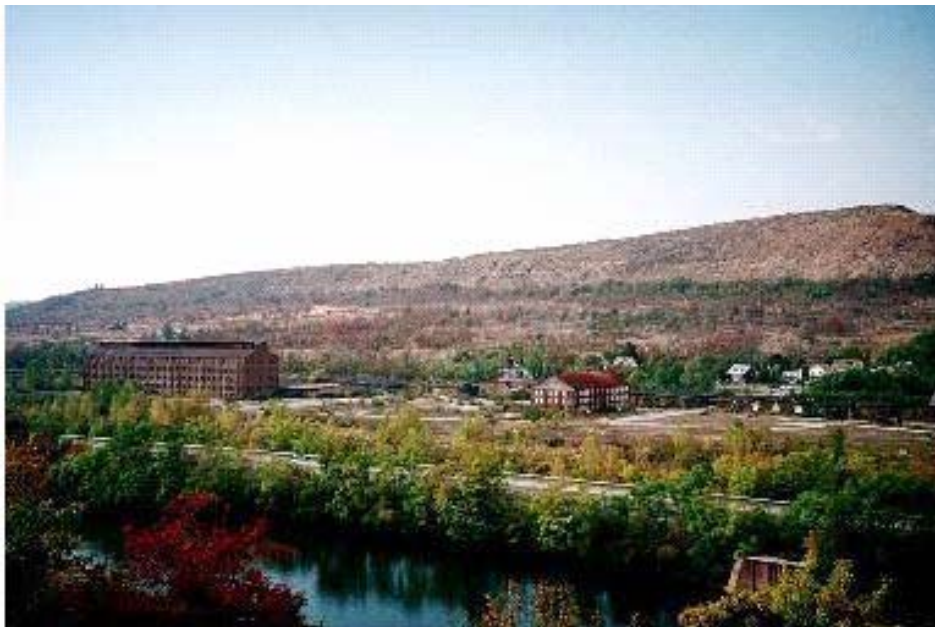
**Figure 4. Photograph of the western extension of Stony Ridge behind the west smelter.**

Although sampling of Stony Ridge was included in the ERA, Stony ridge it is not included in any of the operable units. Severe erosion of contaminated soils from Stony Ridge into residential areas caused the initiation of the Stony Ridge Emergency Response Action in 1996 intended to minimize erosion of contaminated soils. EPA's efforts to stabilize a limited area of eroding and contaminated soils on Stony Ridge are completed, although minor maintenance is conducted on a periodic basis to ensure continued stability of the contaminated hillside.
