## Scientific Evaluation of a Sediment Fill Technique for the Restoration of Motor Vessel Injuries in Seagrass Beds of the Florida Keys National Marine Sanctuary

W. Judson Kenworthy, Kamille Hammerstrom, and Mark S. Fonseca (NOAA/NOS/NCCOS Center for Coastal Fisheries and Habitat Research, Beaufort, NC)

### *Project Description*

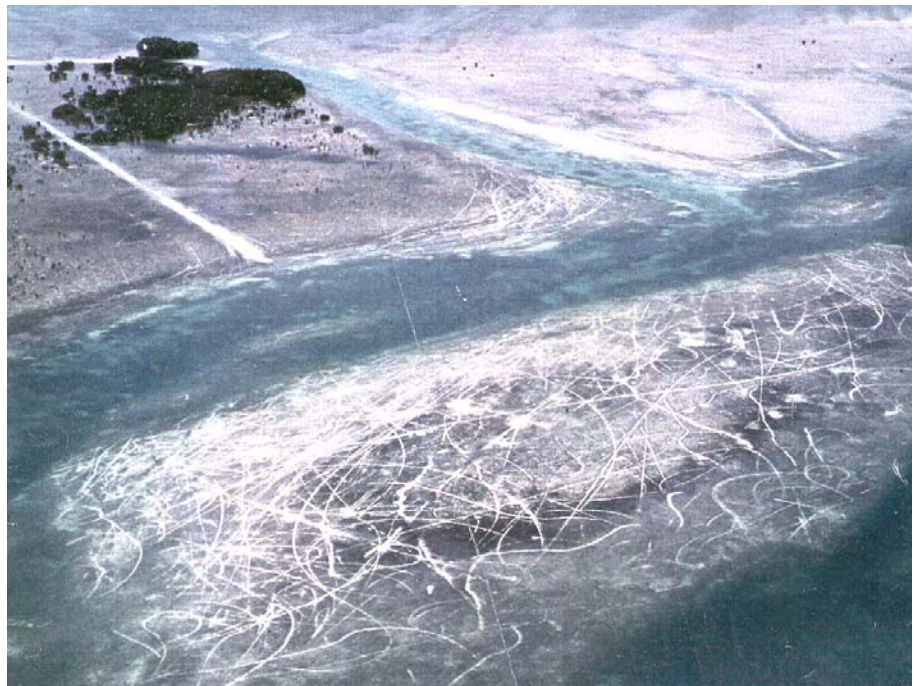
**Figure 1.** Aerial photograph of a shallow seagrass bank severely scarred by boat propellers.

Propeller scar damage disrupts the seagrass rhizome matrix and excavates sediments, leaving behind unvegetated trenches that may be up to 40 cm deep, 50 cm wide,

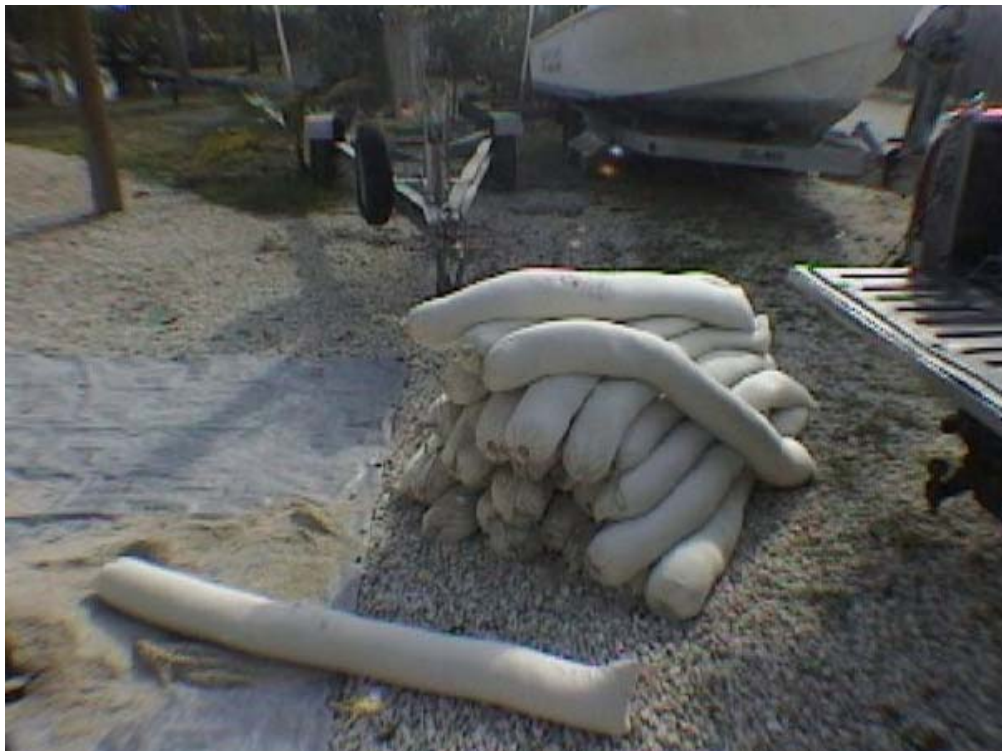
**Figure 2.** Filled sediment tubes ready to be deployed.

Seagrass Recovery, Inc., a private company based in Ruskin, FL, has created and patented the Sediment Tube<sup>®</sup>, a biodegradable cotton tube that is filled with sediment and laid directly into a propeller scar (Fig. 2). A single tube is approximately 1.5 m long, 15-20 cm in diameter, and weighs 13.6-18.2 kg when filled with crushed calcium carbonate screening sand. The sediment tubes serve three possible functions: 1) to restore propeller scars to grade; 2) to deliver a desired sediment grain size; and 3) to prevent further erosion of the scar by water flow (Fig. 3). The objective of this project was to test this method of propeller scar restoration in a variety of energy regimes and sediment types. We also combined sediment tubes with bird stakes, a proven method of enhancing growth of colonizing seagrass species (Powell et al. 1989; Powell et al. 1991; Fourqurean et al. 1995; Kenworthy et al. 2000).

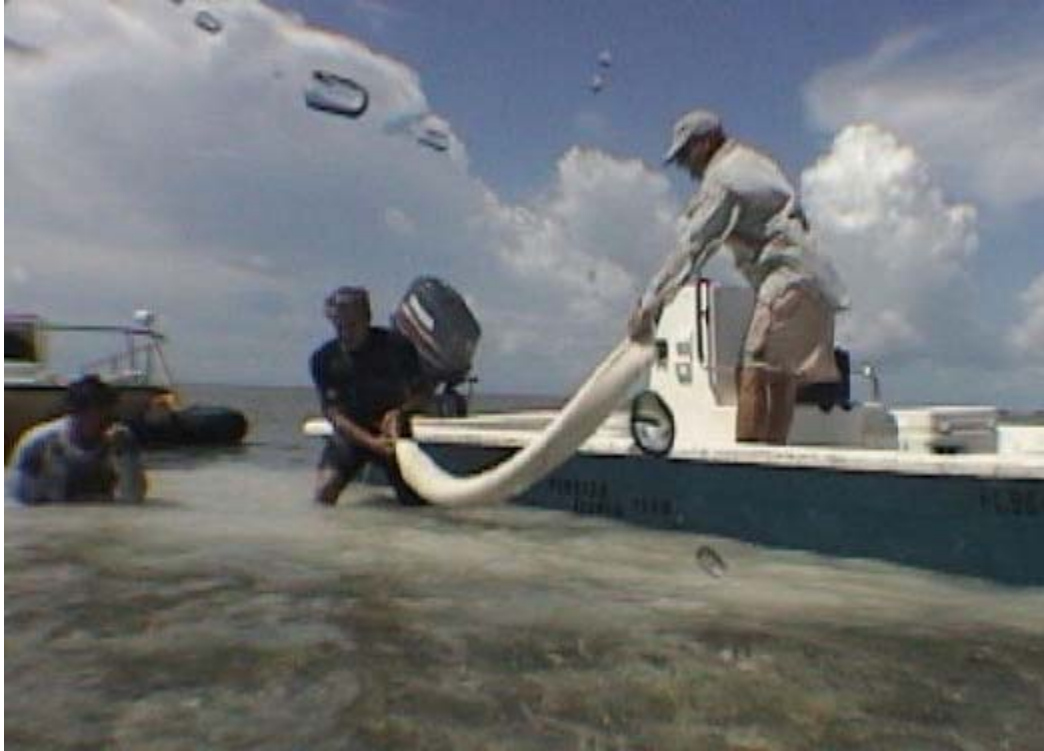
**Figure 7.** A shallow draft vessel was maneuvered close to the propeller scar and the sediment tubes were lowered into place.

Sediment tubes were filled by hand, using a funnel and a shovel. The sediment fill was composed of native crushed carbonate screening sand. Sediment grain size ranged from 0.063 to greater than 0.85 mm, with approximately 45% of the sediment particles  $\geq 0.85$  mm in diameter. Approximately 5% of the sediment was very fine silt. Filled tubes were loaded onto a shallow-draft vessel and motored out to deployment sites. At the sites, each tube was lowered into the water near a propeller scar and then maneuvered into place (Fig. 7). Each sediment tube treatment required four tubes to complete the tube treatment (see Fig. 6).

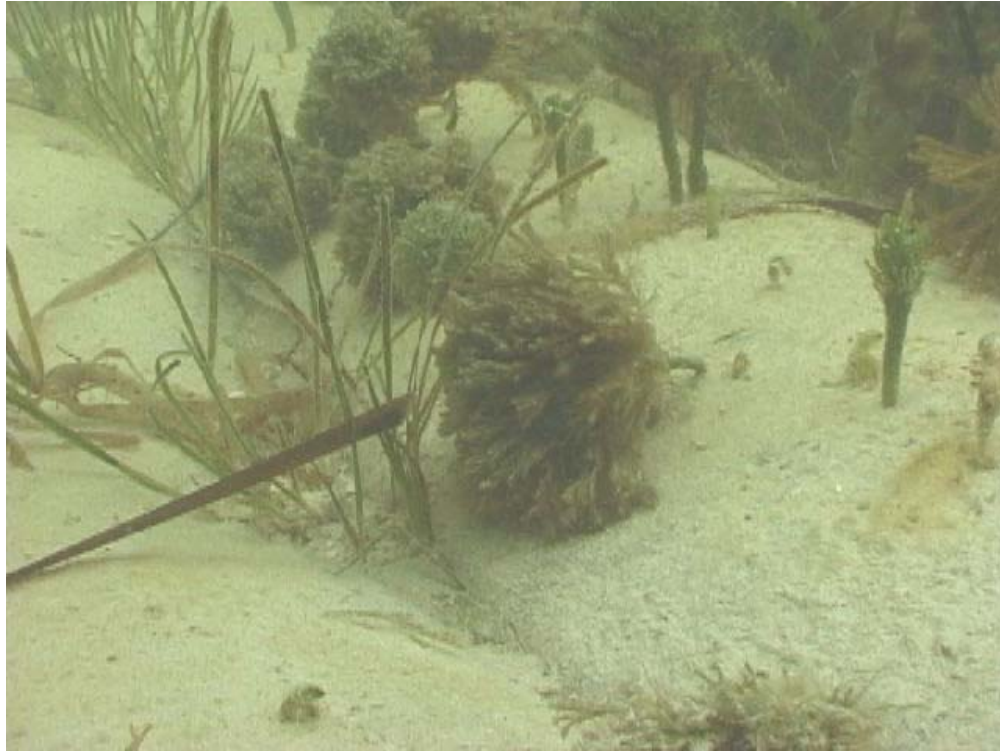
**Figure 8.** Macroalgae and *Halodule wrightii* planting units in a sediment tube treatment in September 2001, three months after deployment.

A few bird stakes had to be replaced, but no other treatments were damaged during the study. Rhizophytic macroalgae quickly recruited to the sediment tubes (Fig. 8). Sediment tube fabric had begun to break down by September 2001, three months after deployment. By August 2002, only the seam portions of the sediment tubes were apparent and we did not find any evidence of fabric during the May 2003 survey. Despite the degradation of the fabric, most of the carbonate sand remained in the scars throughout the duration of the study. Recovery within scars was variable. Some scars reached total seagrass cover equal to the surrounding, undisturbed seagrass bed after two years, while other scars fared much worse and still had low cover values two years after treatment. The wide range of recovery rates caused very high variability about the recovery trajectories.

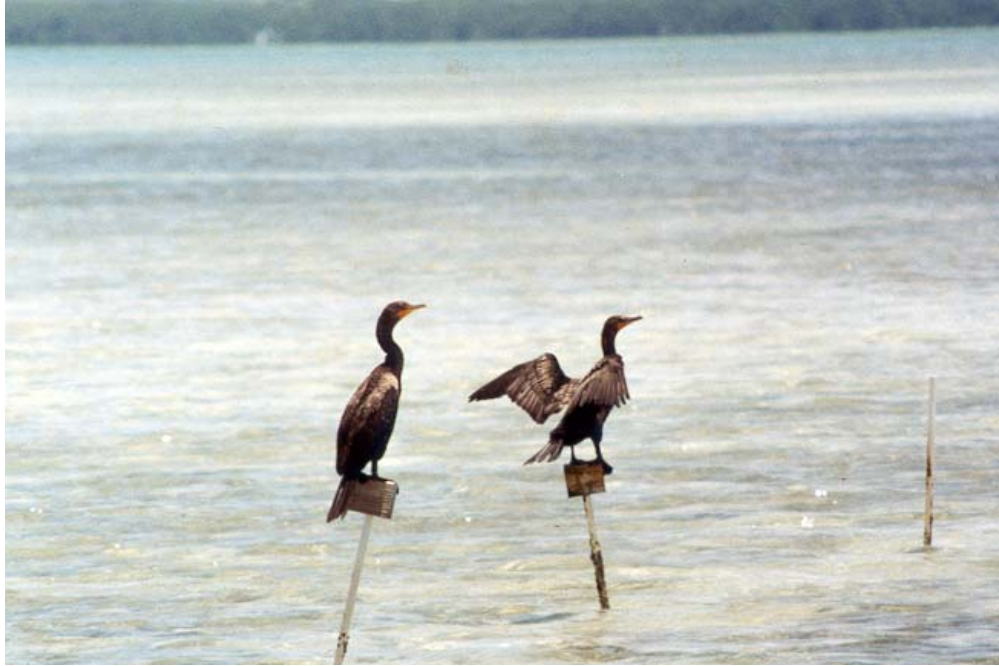
**Figure 14.** Cormorants roosting on bird stakes.

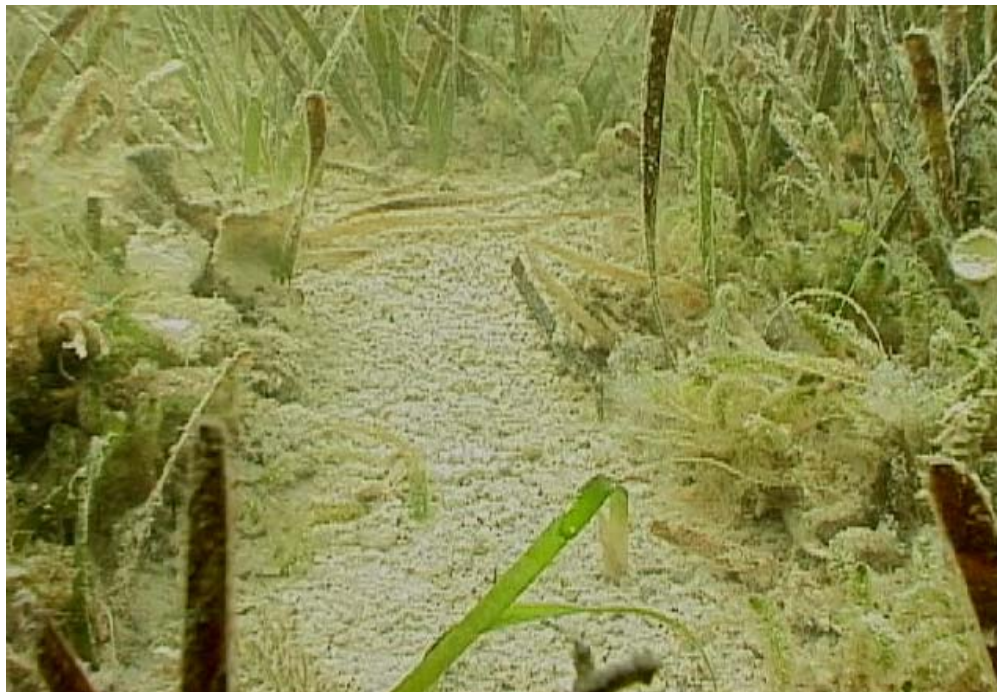
**Figure 15.** *Thalassia testudinum* short shoot (arrow) growing in a sediment tube treatment.
