# Dwight Historic District Design Guidelines

## New Haven Connecticut

Robert W. Grzywacz  
Architect

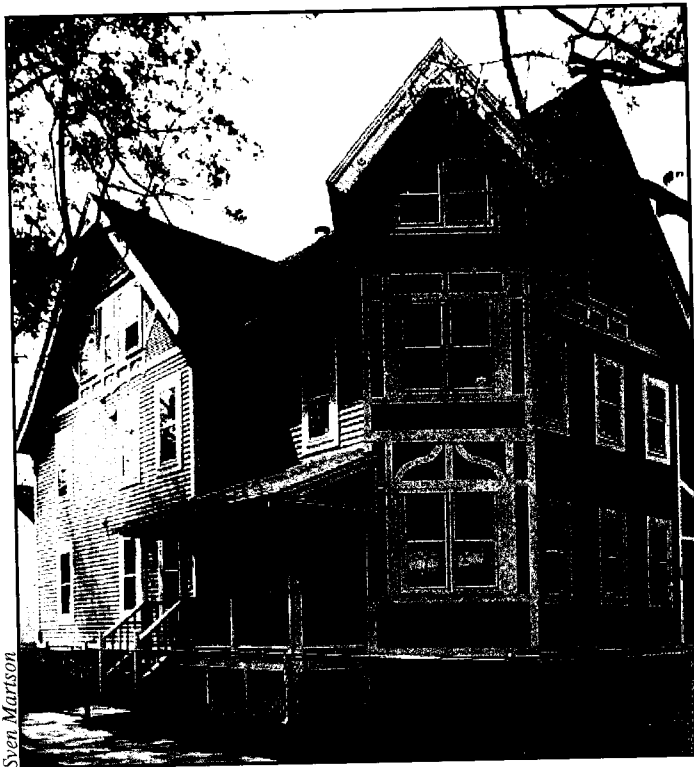
*The Minotte Estes Chatfield House of 1882 on Elm Street was recently renovated as affordable housing by a local non-profit housing provider. These Guidelines are designed to encourage similar historically sensitive rehabilitation projects.*

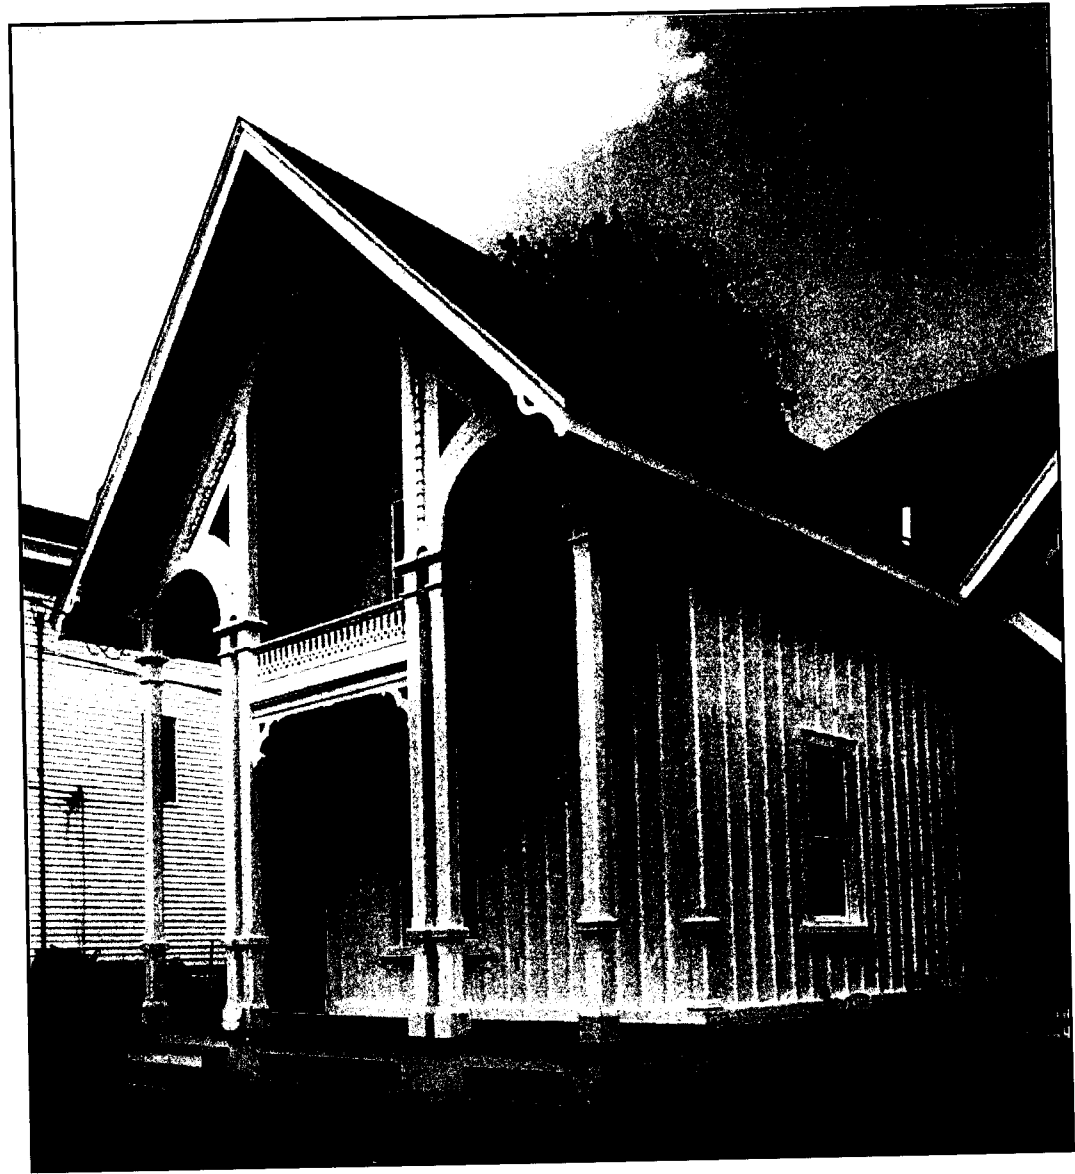
*It is hoped that these Guidelines will inspire more rehabilitation of the historic houses of Dwight like this unique Gothic Revival example, built around 1865, on Beers Street.*

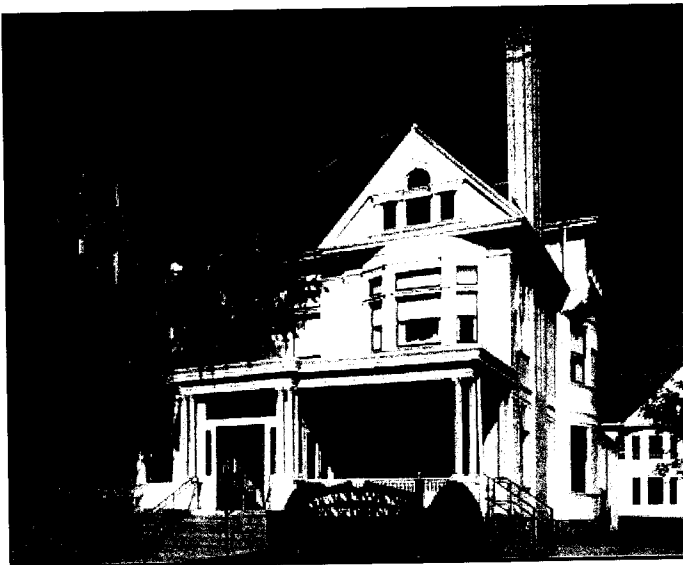
*Dwight Place was the name of the current southern block of Dwight Street. This 1890s view (above) shows the block shortly after Frederick P. Newton had this William H. Allen designed home (left) built in 1894. Stylistically the house is a combination of a Queen Anne complex massing of volumes with classical details, like the Palladian window in the gable, starting then to become popular in the Colonial Revival style. The other houses in the historic view were replaced with apartment buildings in the 1920s. This house was converted into a funeral home in 1929.*

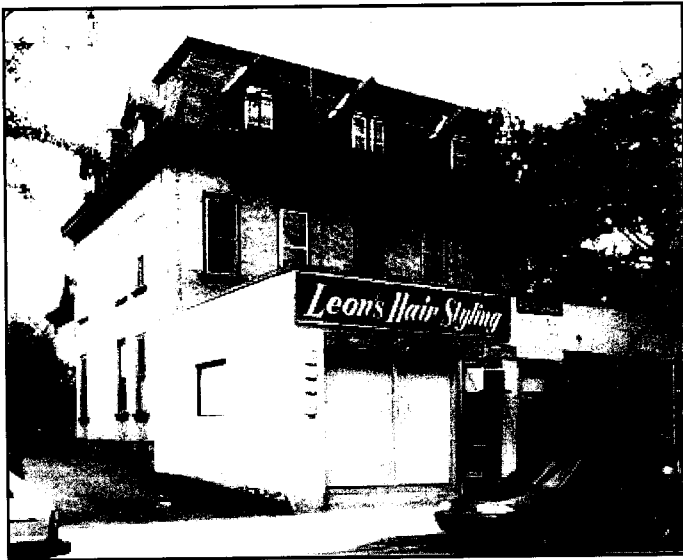
*George T. Alling built this Second Empire house around 1869. Though somewhat obscured by the 20th century retail addition along Chapel Street, the house remains largely intact. The distinctive mansard roof with ornamental dormers hints at the fact that this house, when built, was the latest in fashion. Behind the asphalt shingles undoubtedly lies the original wood siding. Beyond its history, this building is important for its corner location, anchoring crucial streetscapes at Orchard Street, the entrance to the Hospital of Saint Raphael's.*

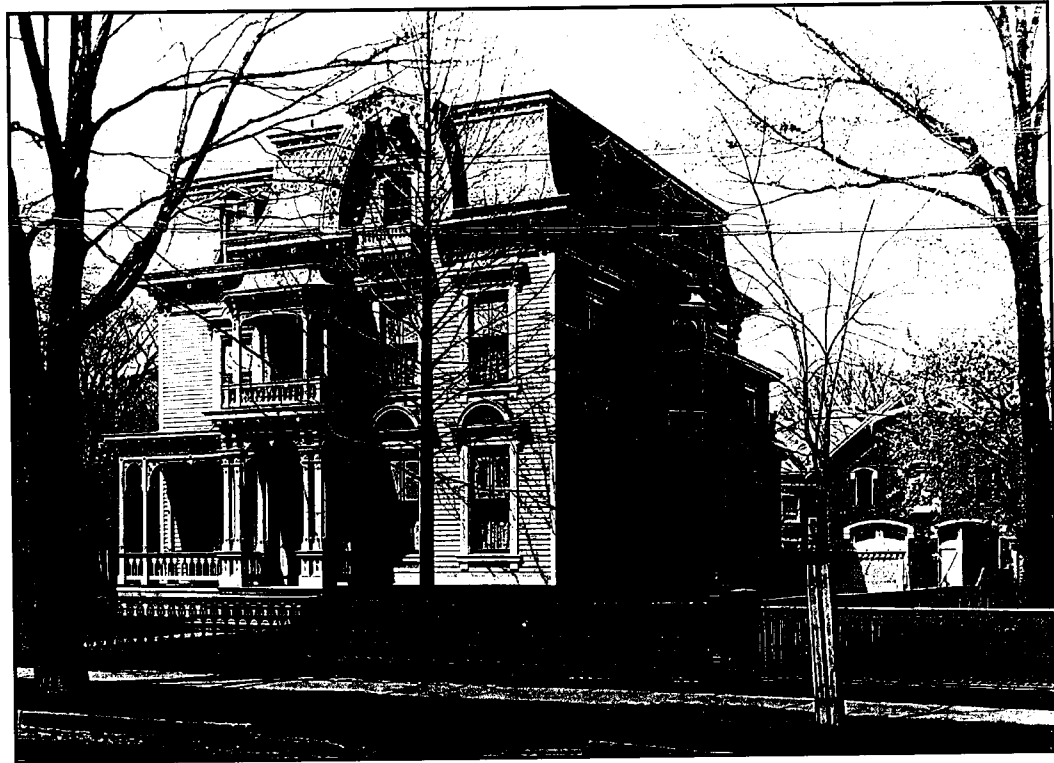
*Walter Camp, "father of the great American Game of football" grew up and lived in this Chapel Street house (right) until his death in 1925. Modern additions of a stair tower and entry porch and substitute siding have obliterated most of the great decorative flourishes this house once possessed. For a feeling of what this ca. 1865 house was like, 38 Howe Street (above) was its near twin. The arched central and pedimented side dormers remain, but all the window hoods and casings and the highly ornamental porch are lost.*

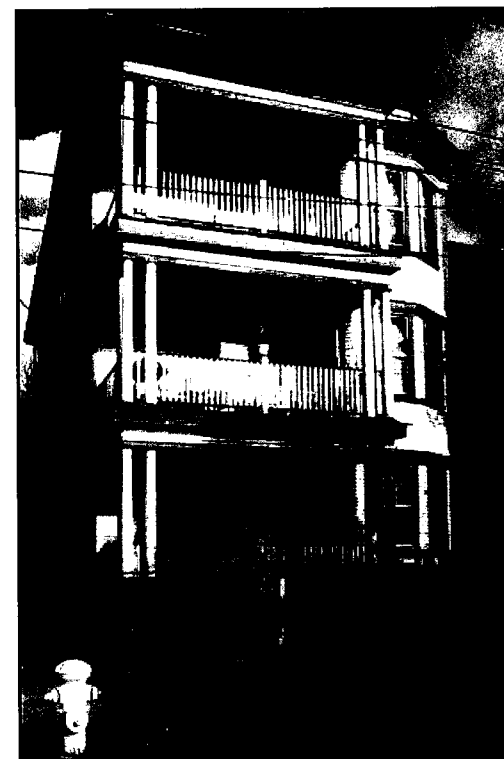
*This ca. 1885 triple decker remains in very good shape. Built in response to a great unmet demand for affordable housing for factory workers, the triple decker was very popular with immigrants having extended, multi-generational families. The three identical floor plans allowed three generations of the same family to remain close, duplicating European social arrangements.*

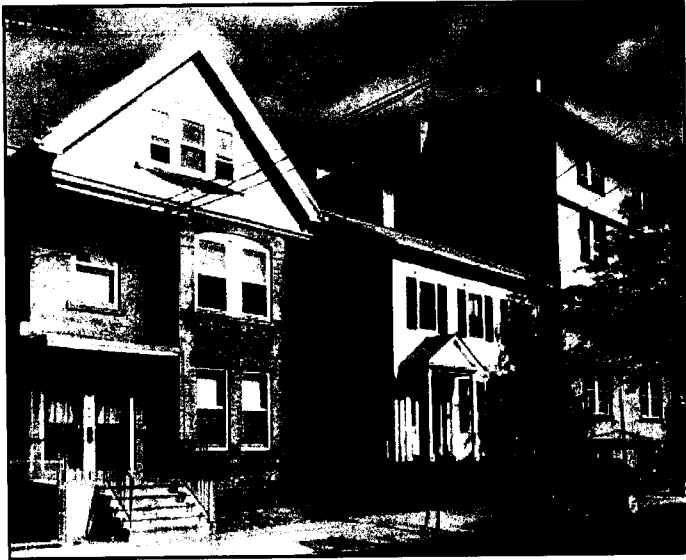
*In a short distance Park Street embodies much of the history of Dwight. The center house, built around 1840 (or possibly earlier) is from the first generation of Dwight construction. Left, is a typical Queen Anne of ca. 1890. Brick houses are more typical in Dwight than the rest of the city. Harrison Court Apartments (right), were converted from the 1867 Mathusheck Piano Manufacturing Co. factory building in 1912.*

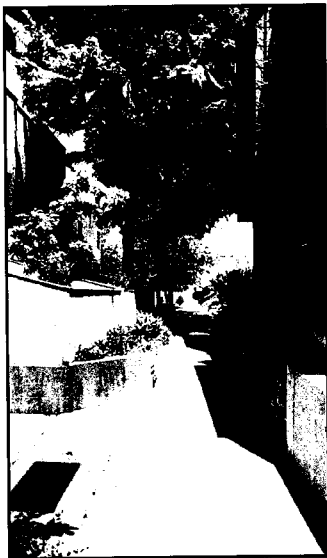
*Dwight Cooperative Townhouses, built in 1968 and designed by local architect Gilbert Switzer, is representative of the new scale of housing development created by urban renewal. While compatible in height with the neighborhood, these developments large size, comparable to a city block, and inward focus remove them from the fine grained texture of the surrounding streets. Nonetheless, some of the intentions, like creating quiet, landscaped walks such as this, were realized.*

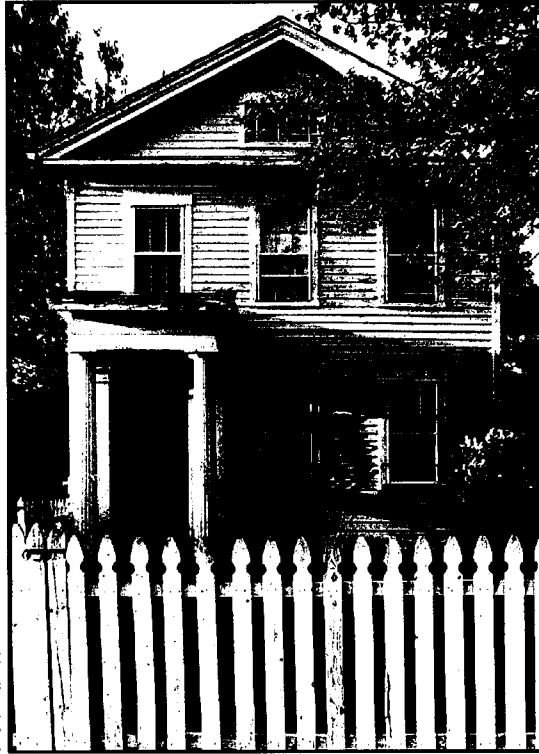
Front yards, porches, siding, trim and ornamental woodwork, windows and doors and distinctive roof lines and cornices all combine to make each historic house a contributing member of the Dwight neighborhood. The ca. 1835 Edgewood Street Greek Revival, left shares these original attributes with this ca. 1880 Greenwood Street Italianate house, right. Though each is a different style, they both share a common heritage. Historical characteristics, like these, give a unity to the diverse styles of architecture that make up Dwight.

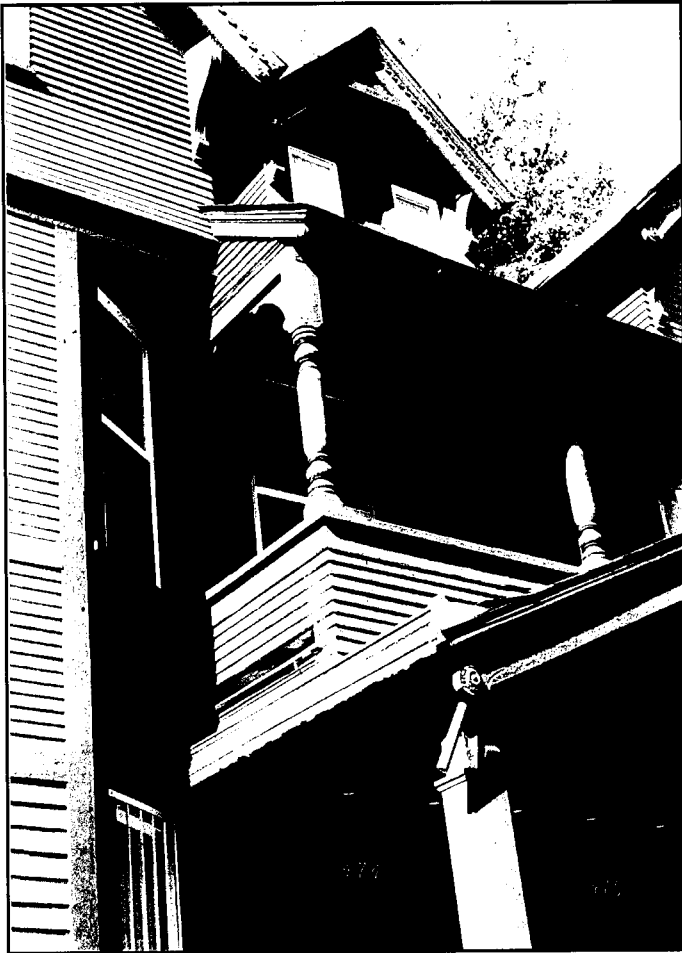
*A wood building exterior is composed of simple elements, like siding and flat trim boards, and ornate pieces like brackets, moldings, turnings, and sawn profiled boards. While each element may be simple, the overall effect is often very rich as in this carefully maintained ca. 1890 Elm Street example. Much of the effect here is due to a careful restoration where all decorative pieces were retained or replaced.*

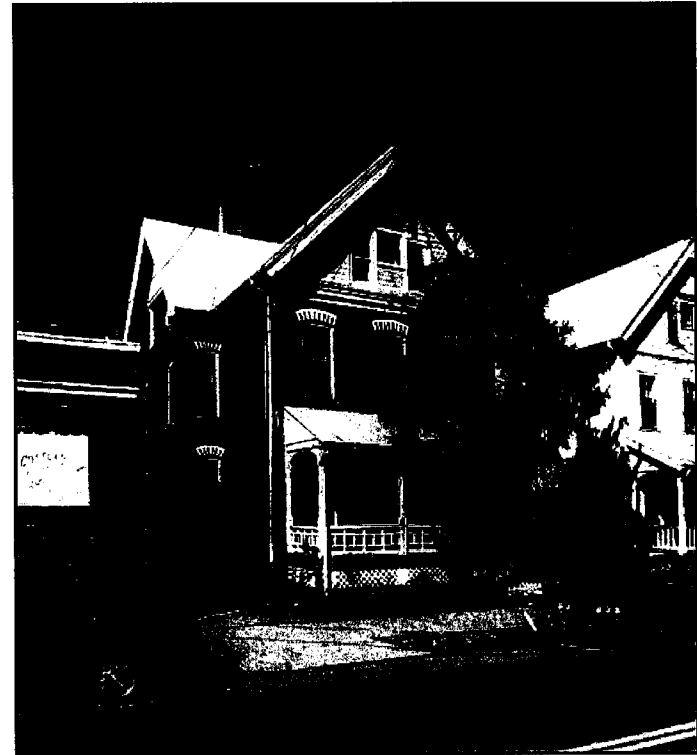
*Front yard plantings should be carefully chosen so that their mature size compliments the size of the house and front yard. Large trees, such as this, in addition to feeling visually out of proportion, can trap moisture on house elements causing wood to deteriorate.*

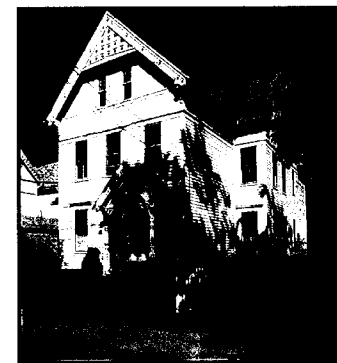
*This picture shows the importance of sensitively scaled front yard plantings. The privet hedge is in the process of being pruned. To the left, the hedge has been cut to waist height, about 30”, while to the right, it remains at around 48”. The reduced height is more in scale with the house and is much more inviting.*

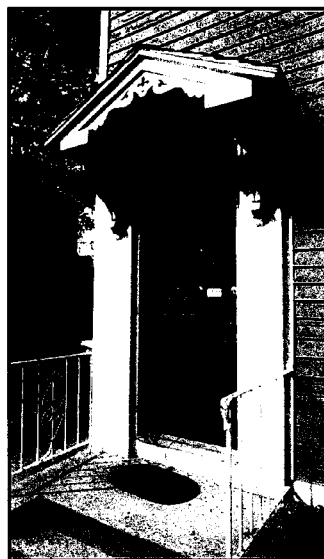
*Extensive or modest, the front porch is usually the most prominent feature of the front of a house and the most important in defining its character. This example, from a ca. 1825 Greek Revival on Edgewood Street, is about as simple as a period porch can be. Yet, without it, this house would lose much of its character and would contribute significantly less to its neighborhood. Simple pilasters combine with a small hood and brackets in the Eastlake style popular in the last quarter of the 19th century. Also note the style and rail door, divided into multiple panels and with a large single pane of glass, or light. The technology for economically making pieces of glass this size and larger came into use toward the middle of the 19th century. Knowing when changes like this took place can help to date portions of a building.*

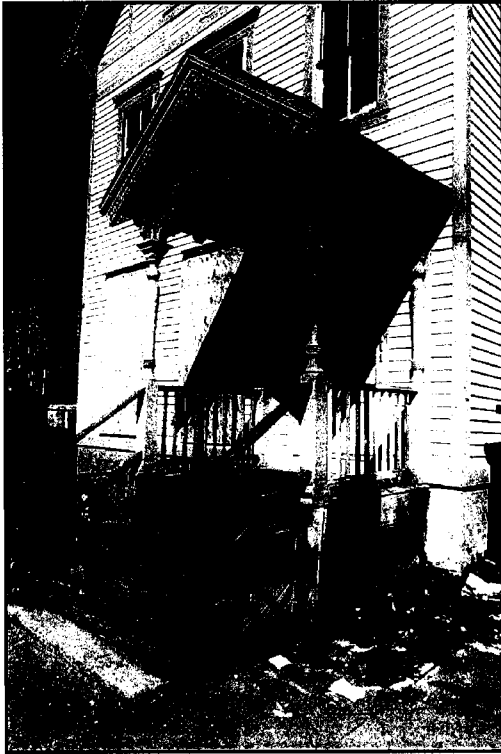
*While the posts, decorative bargeboards and beams, and roof of the porch at this ca. 1895 Edgewood Avenue house are intact, previous repairs have removed the original deck and steps and replaced them using incorrect “two by” boards meant for rough framing. This unsympathetic alteration could be corrected by rebuilding with historically appropriate and readily available materials.*

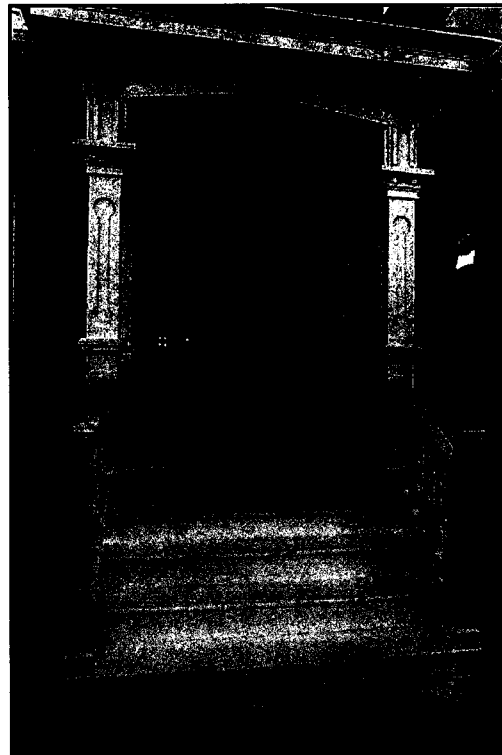
*The original porch for this ca. 1875 house on Kensington Street had been removed long ago. This porch is a complete replacement based on other houses in the neighborhood. The columns and brackets are custom millwork of historically correct sizes and ornamentation. Porch flooring and stair treads are 5/4 stock, as would occur on a historic porch. Handrails, a modern addition not typically part of a historic porch, have been designed to compliment historic elements.*

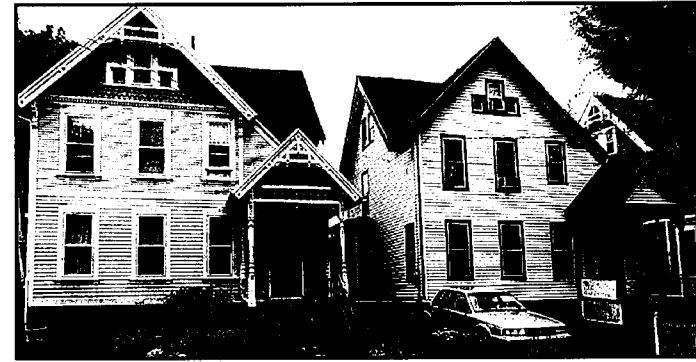
These two ca. 1890 Elm Street Queen Annes graphically demonstrate the importance of original siding and trim materials to defining the character of a house. Originally identical, the house on the right has been covered with vinyl siding; much of the historic character once present (still seen in the house on the left) has been obscured.

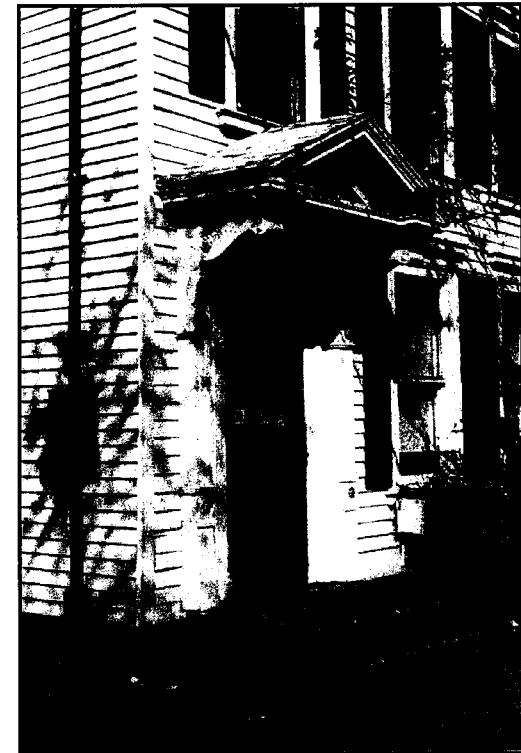
While use of substitute siding materials, like vinyl and aluminum, is discouraged by these Guidelines, a compromise solution which would be acceptable under the Guidelines would be to restore the original siding, trim and ornament on the street face of a house while putting substitute siding on the building faces not easily seen from the street. This solution is most appropriate where houses are close together and the house in question is not on a corner, in other words, where only one face of the house is readily seen, and where most of the building ornament occurs on this one face. In this ca. 1843 house on Crown Street, vinyl siding has been put on the side and rear walls while the front has been fairly faithfully restored (a notable exception being the fake shutters). Even though the side wall clapboard coursing does not align with that on the front, as the original wood undoubtedly did, the general spacing of the boards is similar, the stop channel for the vinyl is unobtrusive, and a viewer's attention is properly drawn to the front of the building.

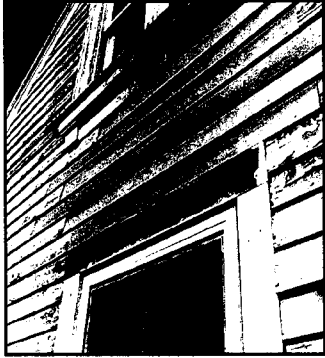
*Often original siding is in surprisingly good condition. Over a century of service is a tribute to the durability of the material. Repairs frequently consist of the replacement of a few individual clapboards (seen here as the smooth boards above the window).*

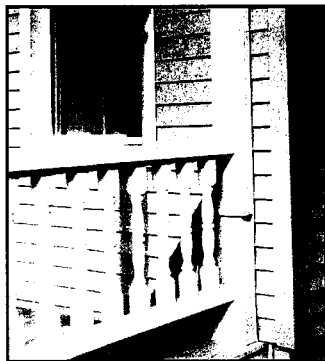
*A fairly careful use of vinyl siding is evidenced on this Beers Street house. Careful attention was paid to corner boards and window casings.*

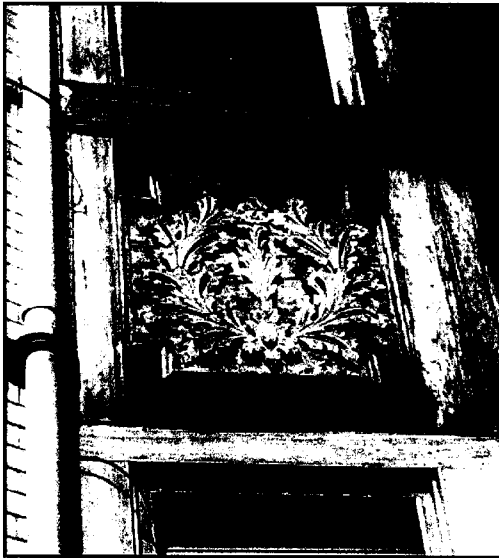
*While the front of the ca. 1890-95 Dwight Street Colonial Revival house from which this panel comes is rather austere as is appropriate for the style, the side bay features these exuberantly carved wood panels. Details like these would be extremely expensive to reproduce today. Every effort should be made to preserve similar elements that have survived on other houses.*

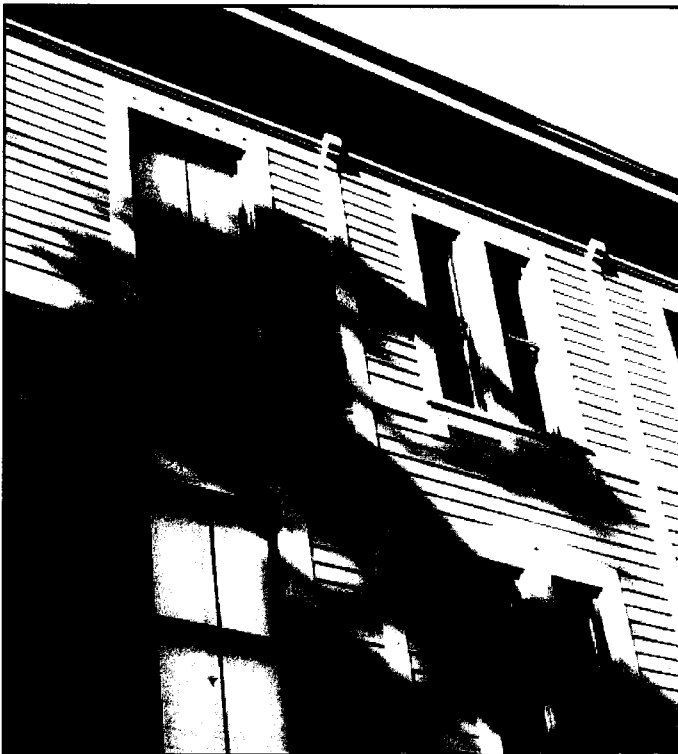
*The front of this ca. 1885 apartment building on Edgewood Avenue is in many ways typical of most Dwight buildings. Most of the character is derived from the combination of crisp clapboard siding and the intervening flat trim boards characteristic of the Stick style. The simple coved Egyptian cornice with restrained brackets caps the building, while the peaked and finely incised ornament on the window head casing shows Eastlake influences. All this occurs in a simple building which the casual observer might think was unexceptional save for its careful level of maintenance. The building was probably erected by Mark M. Selleck, a grocer, who lived at 162 Edgewood.*

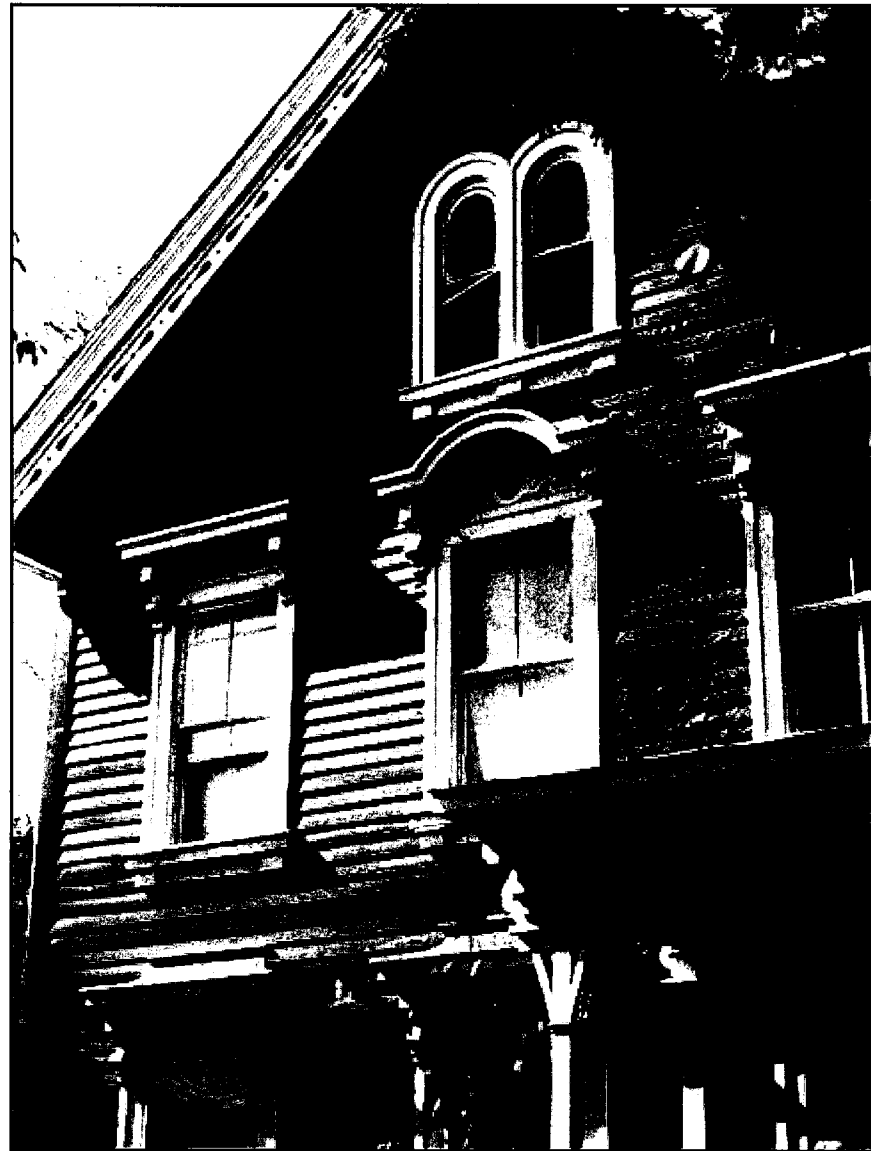
*Many features define the character given by windows including proportion, size, spacing, casing ornamentation, sash thickness, profiles, mullion size, and number of panes. In this Elm Street house, all the original details remain intact, and losing any would be unfortunate. The upper sash of the left attic window is deteriorated but likely could be repaired or a replacement could be made by a skilled millworker.*

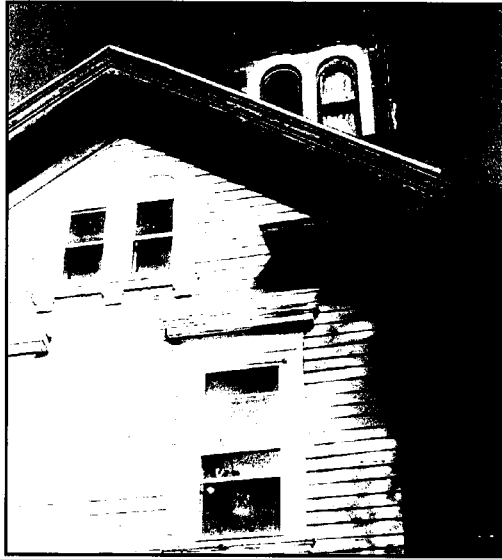
*A good contrast is shown, above, between the visual effect of original windows, seen in the arched head windows shown in the cupola, and insensitively used replacement, or in this case storm, windows as seen in the similarly arched windows of the gable. The gable windows destroy the shape, proportions, and lifting effect of the original design. In contrast, the storms applied to the second story window are fairly benign. They maintain the window size, shape and proportion, and, if done in a compatible color with the rest of the building, do not draw attention to themselves. Storm windows provide comparable energy efficiency to window replacement at less cost and are a preferable energy strategy where lead paint abatement is not an issue. Below is an example of vinyl windows selected to replicate the original window size and pane divisions.*

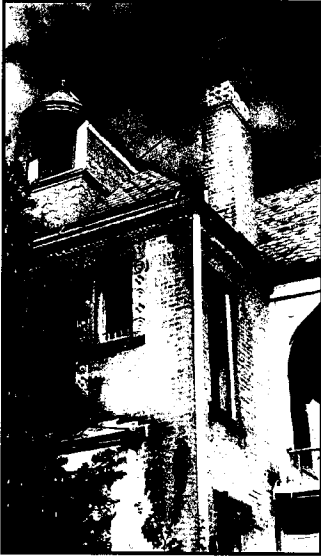
*Dormers, chimneys, gables, decorative shingles and prominent cornices all combine in later 19th and early 20 century architecture.*

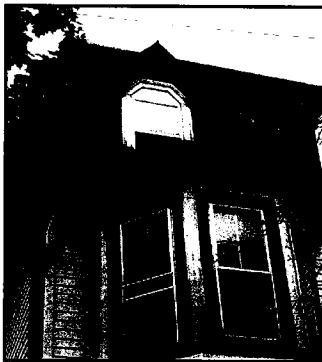
*This particularly well detailed ca. 1875 George Street mansard roof is notable for its dormers, slate shingles and upper and lower cornices.*

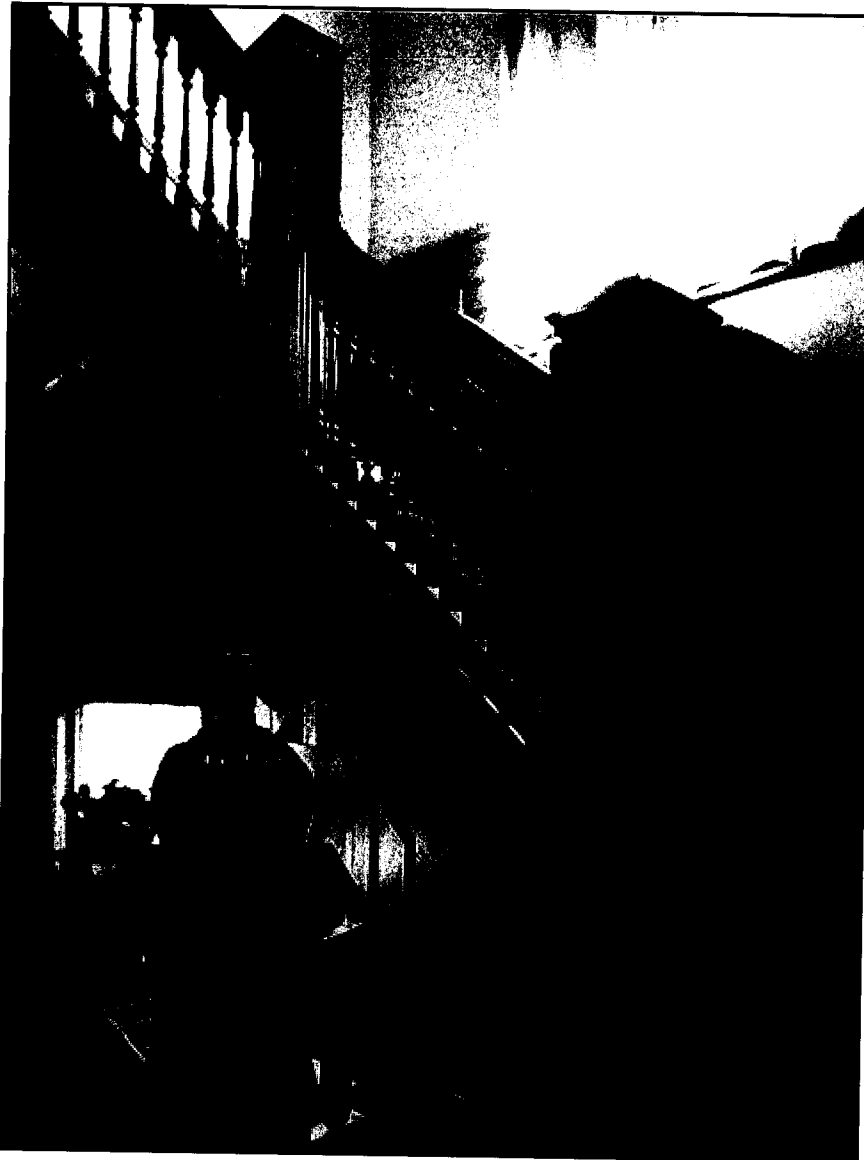
*A careful renovation plan can incorporate significant elements of an historic house interior with a plan that meets the needs of modern living. Here, a wide opening for paired pocket doors framed by a robust casing of a ca. 1870 house serves to link what will become a modern living room and dining room.*

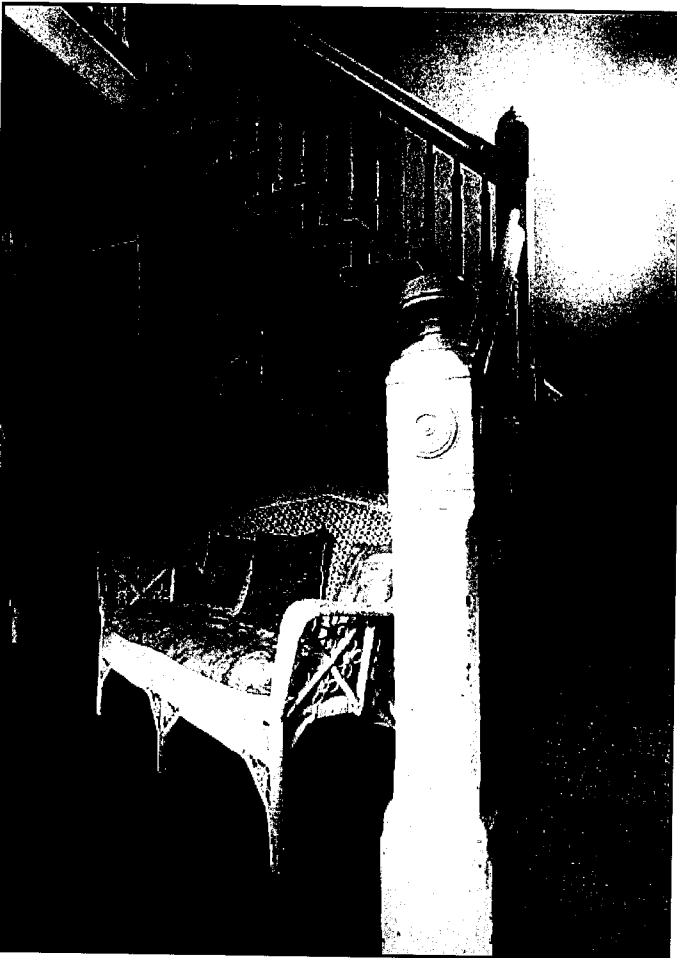
*One of the charms of an older house is the presence of distinctive features like this built-in china cabinet with a glazed door (left), equally appropriate in a dining room today as it was over 125 years ago. This Elm Street stair (below) has been carefully restored as part of a complete interior renewal.*

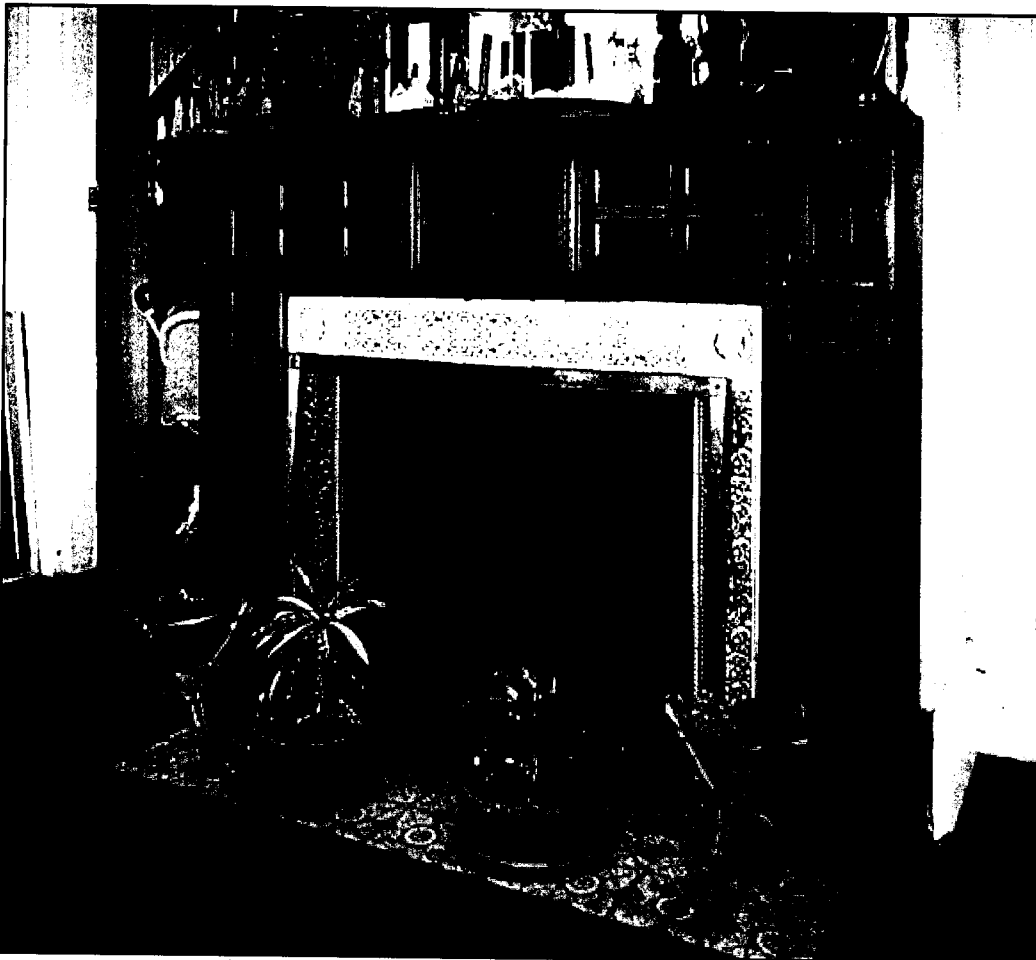
*The marble fireplace surround and mantel (right) is Italianate in style and dates from around 1875, while the ornate wood Queen Anne example (below) is from 1888.*

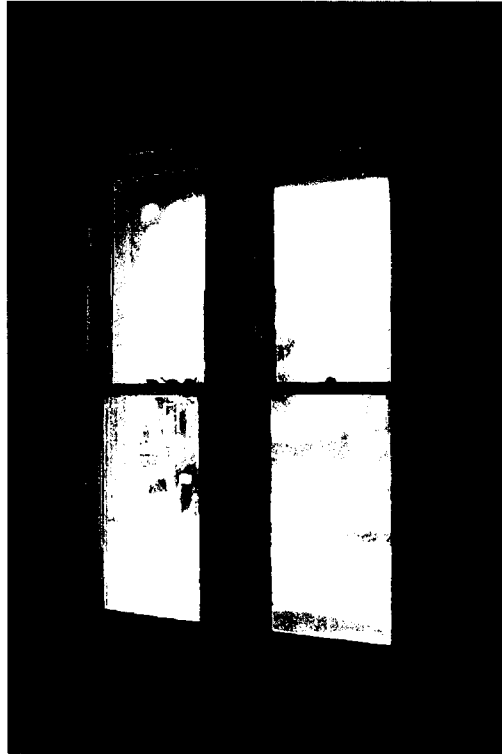
*It is quite common to find original windows and casings intact even after a century and a half of use. Cords and weights can be replaced, while weatherstripping would add to energy conservation.*

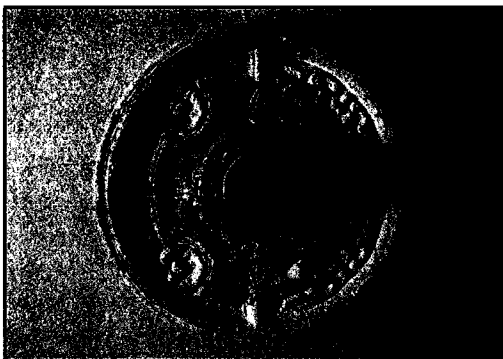
*In principal rooms, plaster ceilings frequently featured ornamental central medallions such as this. Even a partially damaged ceiling can be patched to preserve an element like this. New wiring can be fished through to avoid damage.*

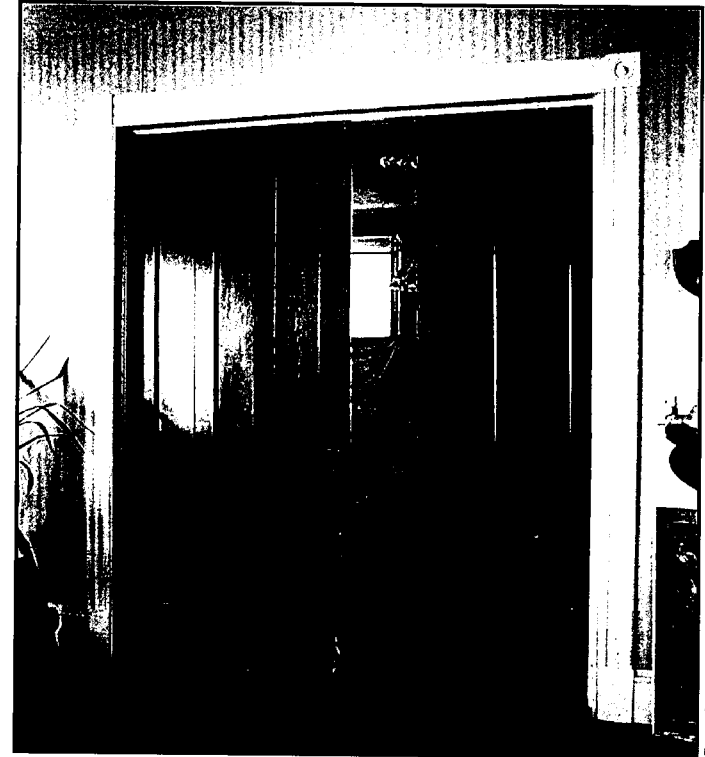
*Stile and rail doors of many different patterns and sizes are found in the homes of Dwight. This pair of very large pocket doors are part of a ca. 1888 University Place residence.*

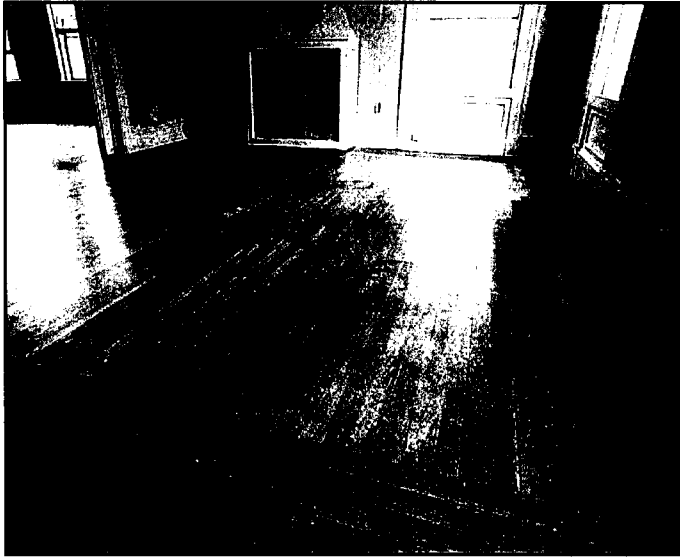
*Hardwood floors like this were particularly popular in houses built in the second half of the 19th century and the early part of the 20th century.*

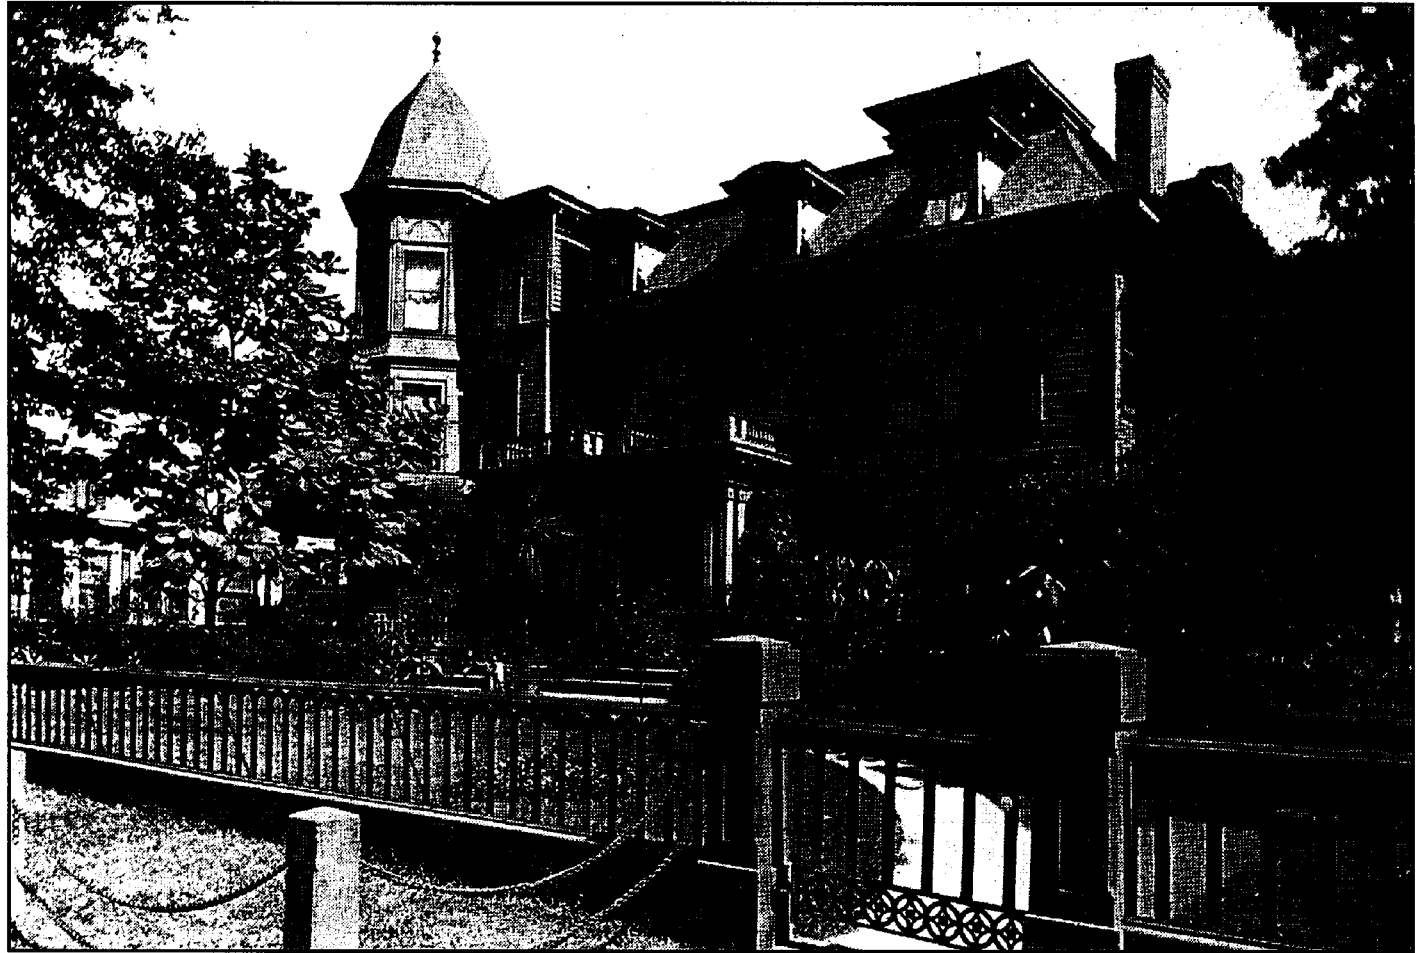
*Few pictures can show how much change has occurred in Dwight so clearly as this view of Hopkins House at 1207-9 Chapel Street from around 1910. The main block of the house includes an Italianate cupola and a Second Empire mansard roof, possibly indicating a first structure and a major remodelling. The octagonal corner tower, Queen Anne in style, might yet be another addition. All this is now gone, replaced by the ca. 1945 commercial building, right. Note the wrought iron fence mounted on a stone curb with stone gateposts. A similar fence surrounded 1198 Chapel (across the street); the stone parts remain, though the building burned in the 1980s), and was typical for this 19th century high fashion block. Hopkins House was associated with the Hopkins School.*

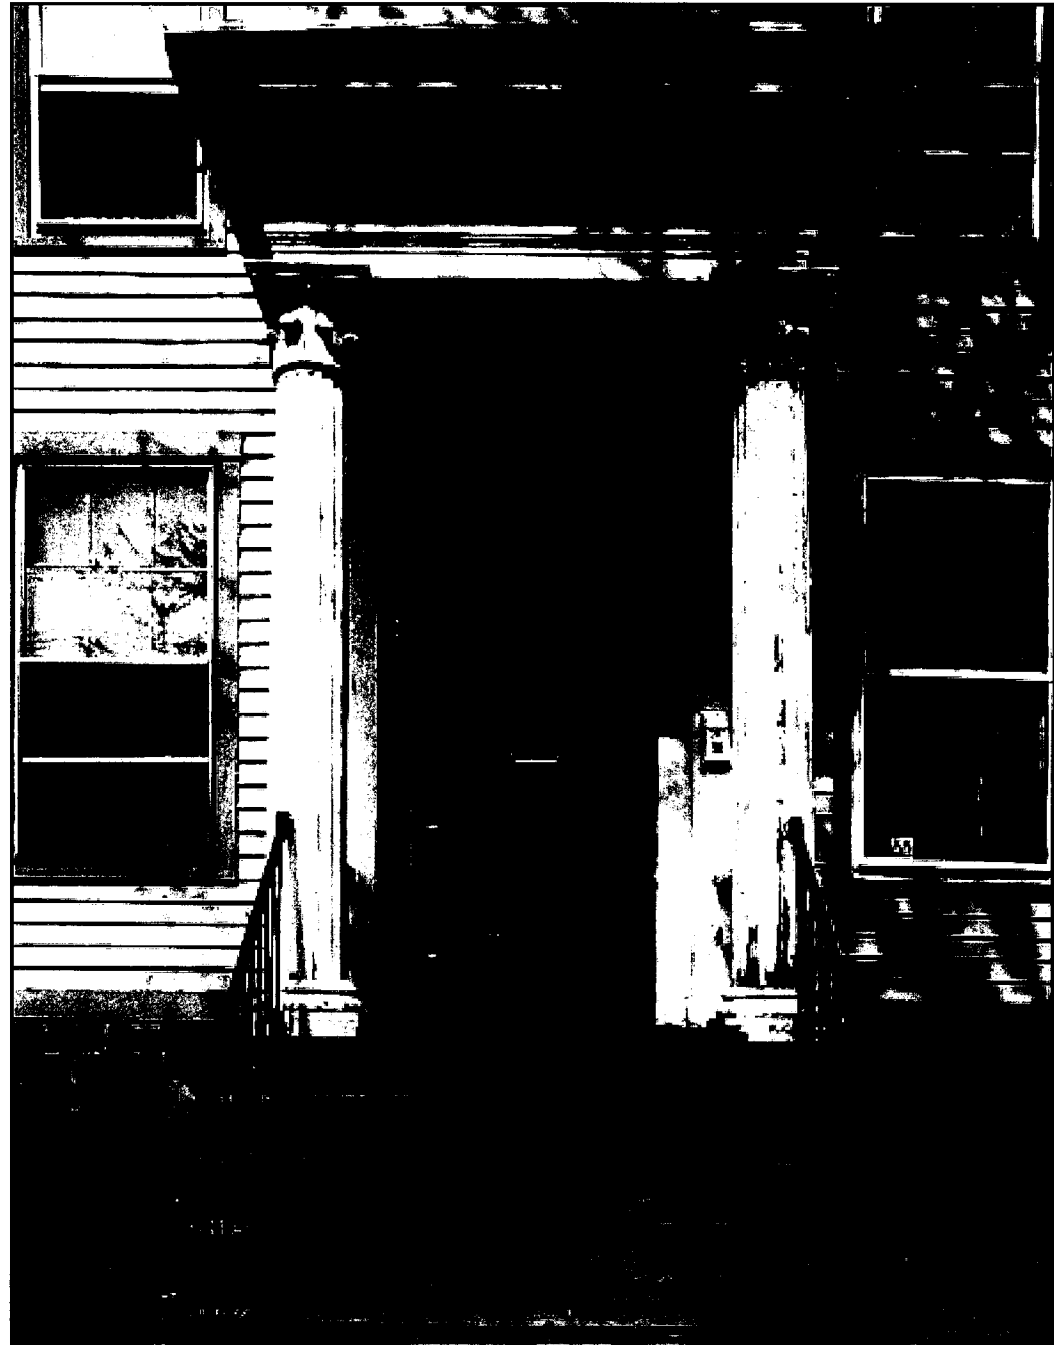
*While the porch of this ca. 1840 Dwight Street house is exceptional, note that it is also part of a house with most of its original character intact. The front door, if not original, is clearly very old. The windows are the 6-over-6 with wood sash, appropriate for the period, and complemented nicely by the narrow wood clapboard siding.*

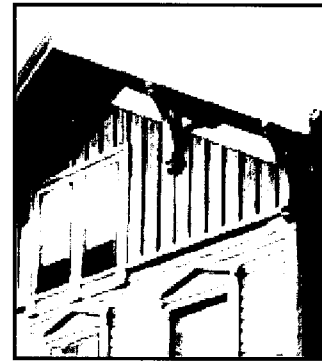
**Board-and Batten Siding** - siding consisting of long vertical boards and thin strips or battens; the battens are used to cover the gaps between the siding boards.

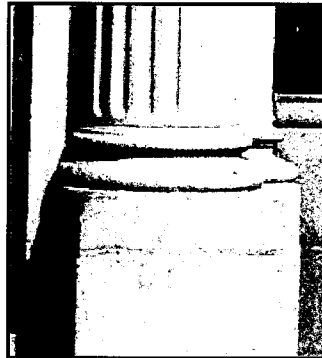
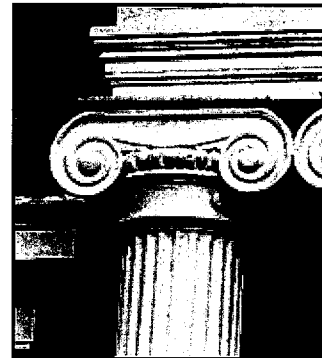
**Base** - lower, usually molded, part of a **column**, **pilaster**, or pier, wider than the shaft, and often resting on a plain faced **plinth** or pedestal. The base shown here is between the fluted column shaft and the rectangular plinth block .

**Capital** - top most member of a column. Capitals, like other classical details, have multiple styles, the most common being **Doric**, **Ionic**, and **Corinthian**. Shown is an **Ionic** capital.

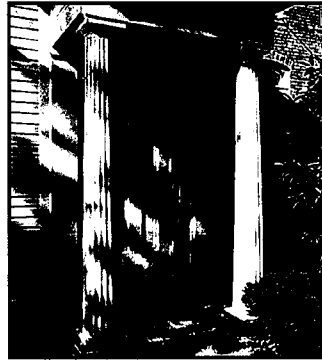
**Column** - Vertical architectural support, often highly detailed. A column always is composed of a shaft, almost always a **capital** (the top) and often a **base**. Different details distinguish styles like this **Roman Doric** example.

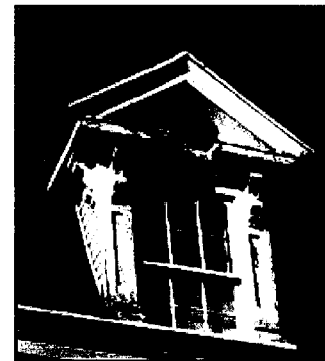
**Dormer** - A structure projecting from a sloping roof usually housing a window.

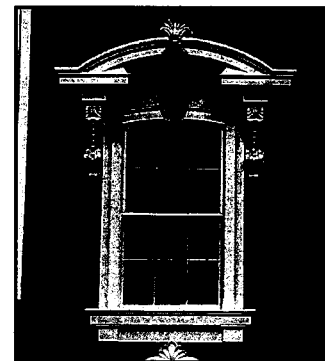
**Double Hung** - a type of window consisting of two sash (individual frames holding panes of glass) both movable and often the same size. Referred to by the number of panes in each sash, such as this "6 over 6" example.

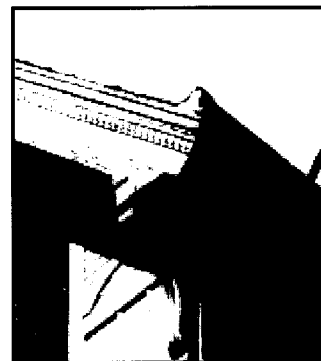
**Yankee Gutter** - a type of rain gutter built on top of or into a roof or eave. Because it is built onto or into a roof, backups, ice buildups, or leaks in Yankee Gutters can damage roofs and penetrate houses.
