South Greensboro Historic District Design Guidelines

Written and Illustrated by:
Jo Ramsay Leimenstoll, AIA

Prepared For:
City of Greensboro Department
of Housing and Community
Development and the
Community Partners Program of
the National Trust for Historic
Preservation

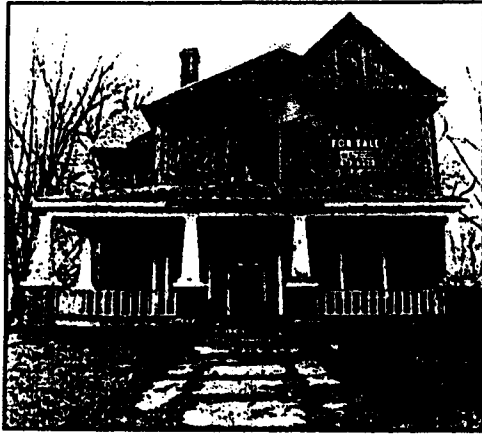
These design guidelines would apply to the rehabilitation of neighborhood houses like this one in the Historic House Marketing Program.

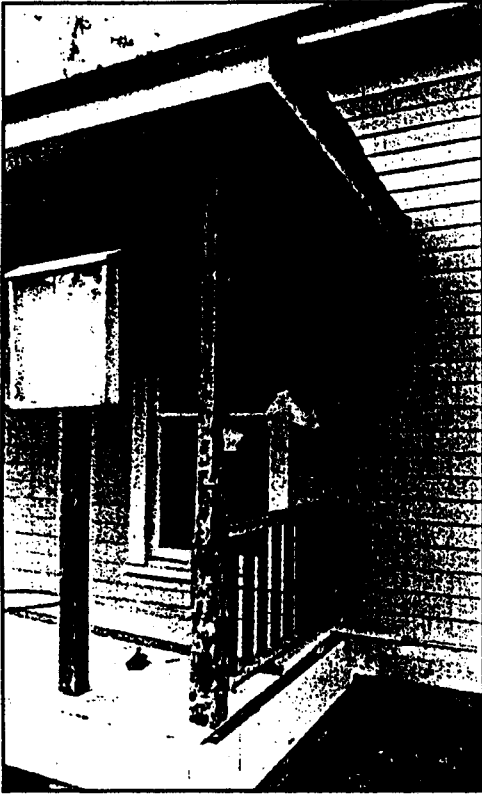
Most projects, like this one, will incorporate a combination of the three rehabilitation options. Original windows, porch columns with sawn brackets, and much exterior trimwork were retained and repaired. The front porch floor and ceiling were replaced to match, while compatible new porch railings and a substitute exterior siding were installed.

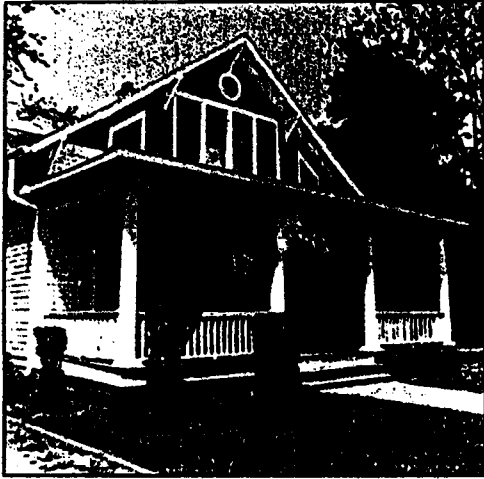
Craftsman style elements such as the exposed gable brackets and the wood shingles in the front gable embellish many of the early twentieth century bungalows, like this one, in the historic district.

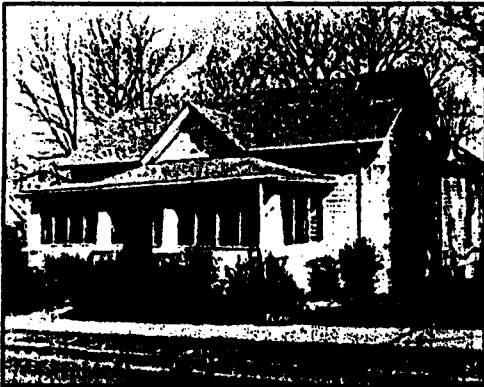
An enclosed front porch, compromises the historic character of the house and streetscape.

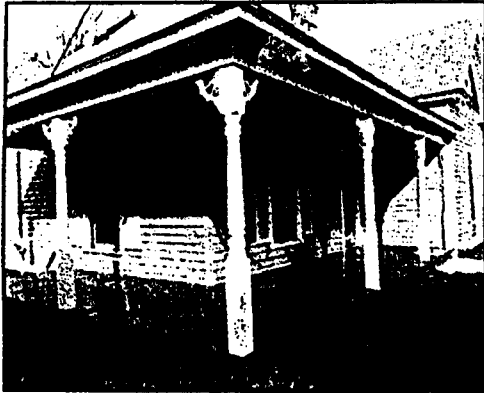
This porch rehabilitation involved various options: the turned columns, cornice, and beaded board ceiling were repaired, the floor was replaced, and only a single missing bracket was special ordered.

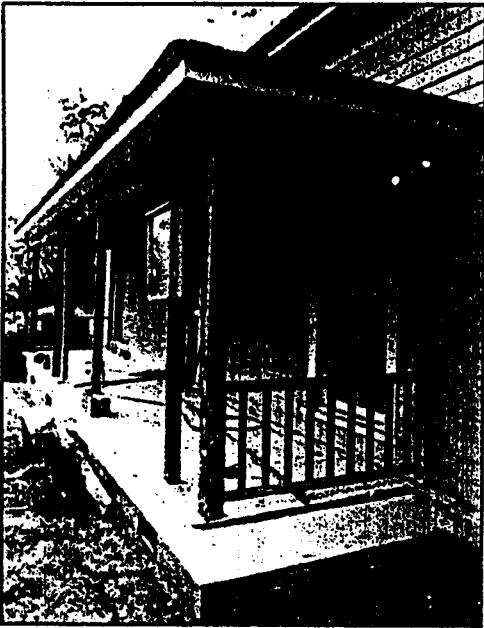
To save costs, compatible replacement railings will be used between the original porch columns which were repaired and stripped of lead paint.

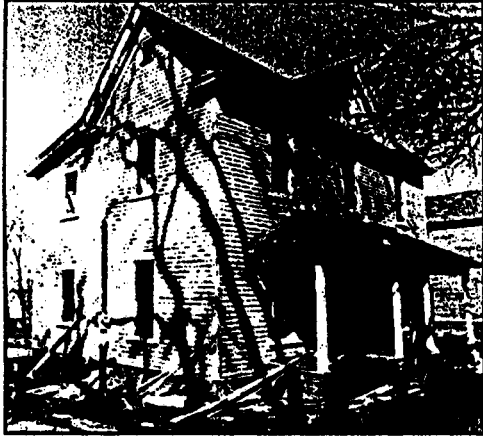
Small sections of deteriorated wood siding were replaced in kind and the original siding was stripped of lead paint before repainting this house.

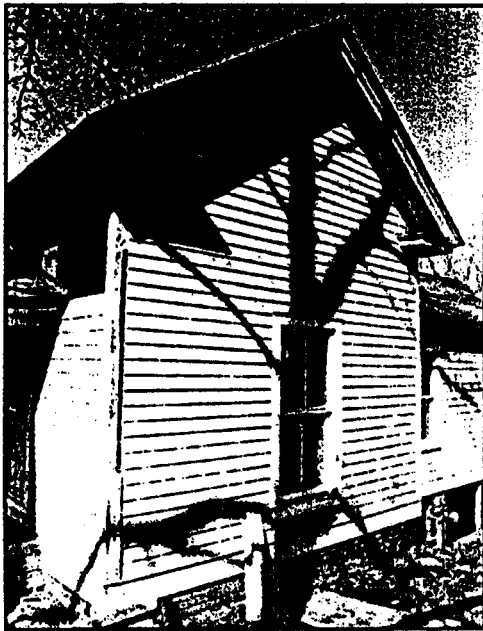
Here, deteriorated wood clapboards were replaced with fiber-reinforced cement siding to match their size and spacing. The wood trim was retained.

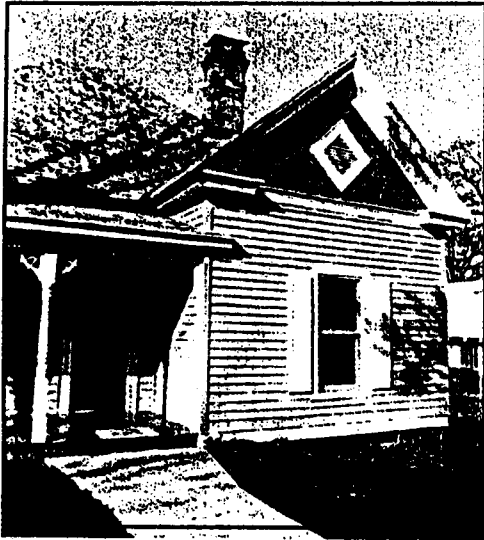
The wood clapboards on this house had been covered by asphalt shingles earlier. Vinyl siding was installed over the asphalt shingles, but the wood shingles in the front gable and the original trimwork were retained and repaired.

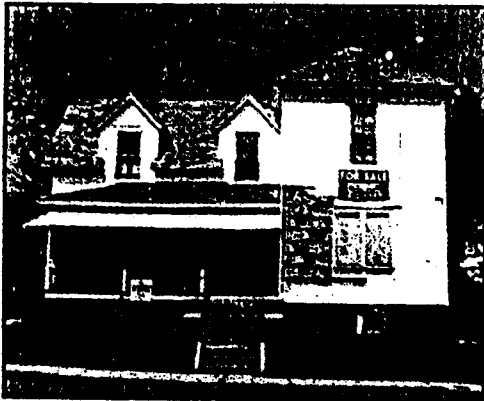
The wood clapboards on this house had been covered first in asphalt shingles and then vinyl siding. Since the vinyl siding was intact except for the small area seen on the front wall, the vinyl was repaired and retained.

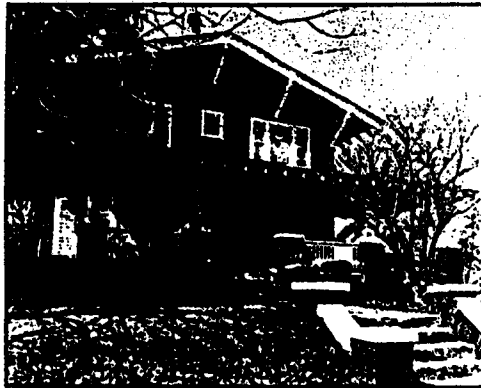
Projecting brackets and exposed rafters like those found on this bungalow are distinctive exterior trimwork features that should be retained.

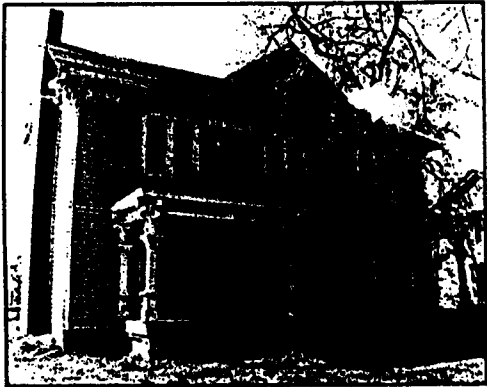
These paired arched windows are so distinctive, any replacements would have to be custom built.

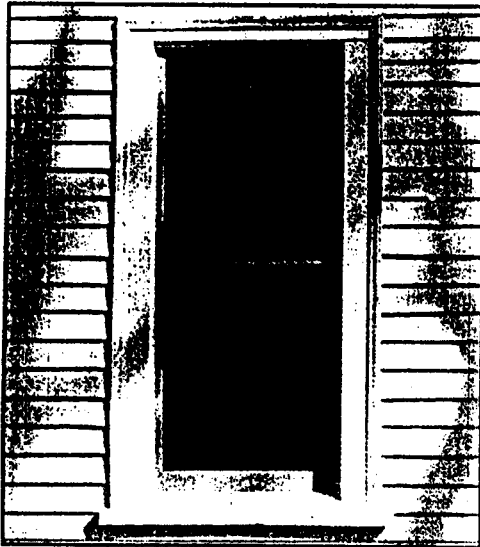
This stock double-glazed wood window replaced an original 2 over 2 sash. The casing was also replaced with a wider trim piece to accommodate the slightly narrower width of the new window.

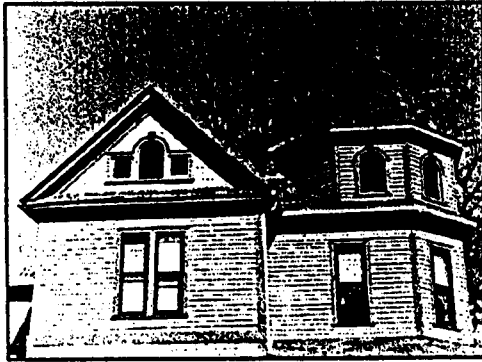
The complexity of this significant roof with its multiple gables, turret, and corbeled chimneys makes it vulnerable to leaks and water damage. Routine inspections and cyclical maintenance are important in preserving prominent roofs like this in the neighborhood.

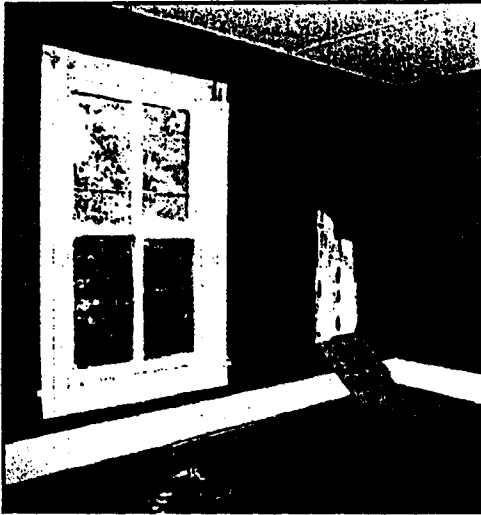
A torn sheet of plywood paneling reveals the original plaster walls. Since the plaster is quite damaged, it will be replaced with gypsum board.

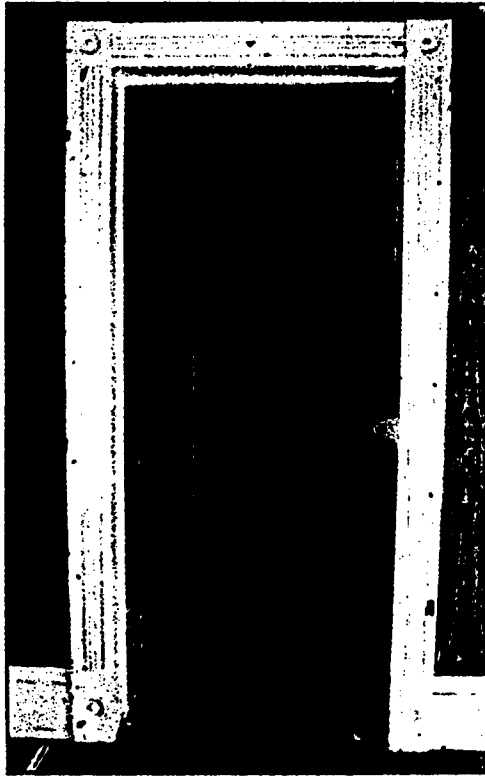
Distinctive moldings and corner blocks like these should be preserved when possible.

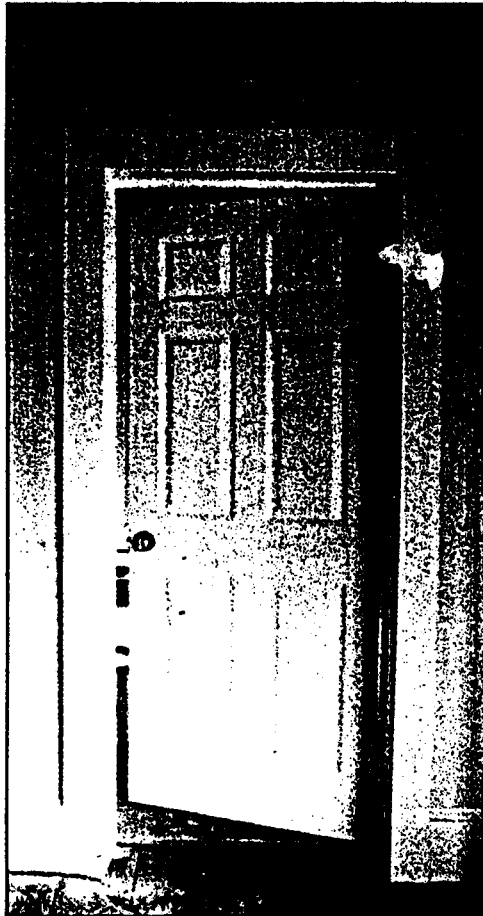
Stock six panel wood doors are a compatible interior door replacement choice for many homes in the district. Here one is used to replace a missing door from the front hall into the parlor.

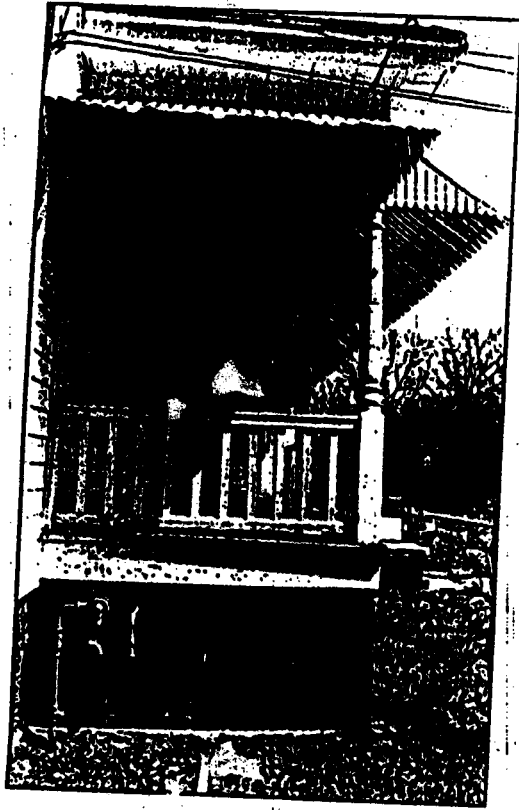
Deteriorated lead-based paint on this front porch presents a triple health hazard. Lead dust from the paint could be inhaled by someone scraping and repairing the porch surfaces, a child could ingest lead paint if chewing on the railing, and falling paint chips can contaminate the surrounding yard.

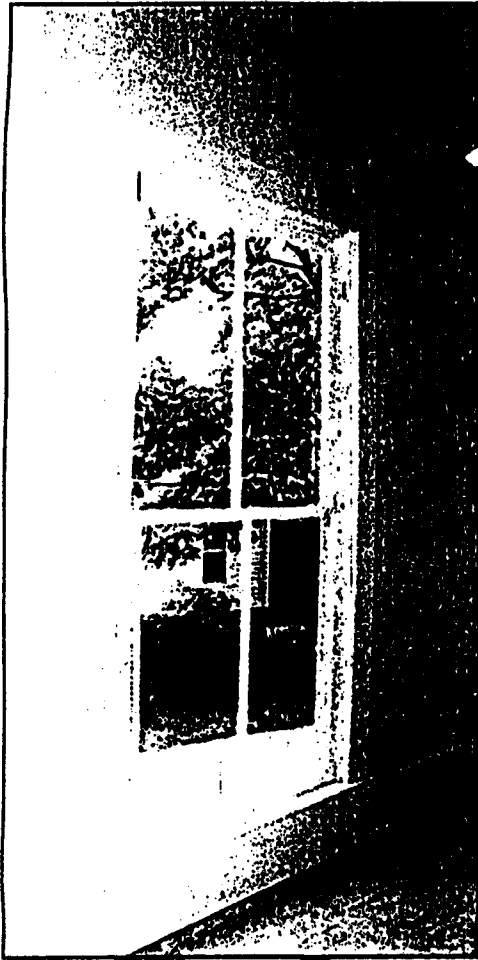
Operable windows that are coated in lead-based paint can pose an ongoing health hazard. Each time doublehung windows are opened or closed, surface friction caused by the moving sash may release lead dust into the room. This large doublehung window in a front parlor was stripped of all lead paint during rehabilitation to ensure its operation would not generate lead dust.
