**A MANUAL ON CONSERVATION
METHODOLOGY
FOR HISTORIC BUILDINGS & STRUCTURES**

Puerto Rico and the Virgin Islands

US Department of the Interior
National Park Service
National Center for
Preservation Technology and Training
Publication No. 1997-07

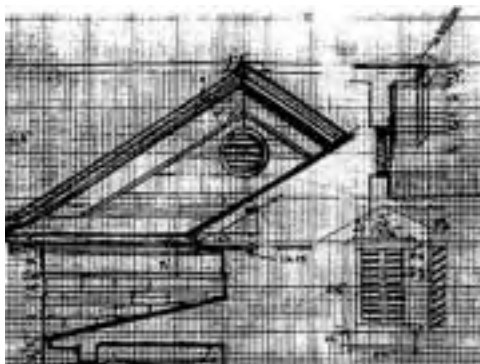
Field notes of Colegio de Arquitectos proposed headquarters in Santurce, PR. (HABS 1990)

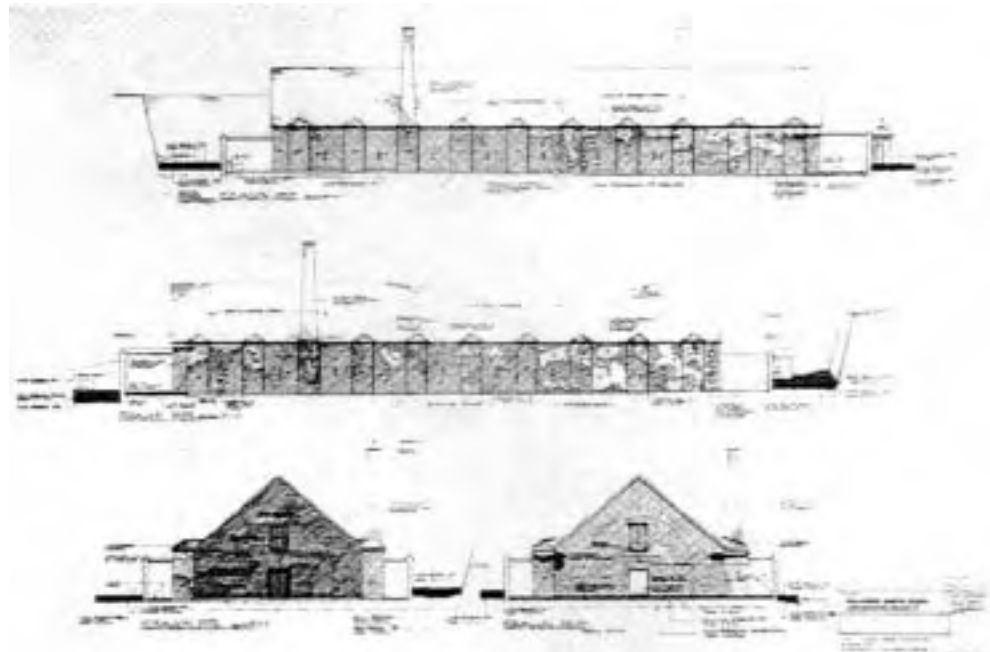
Condition survey drawings for the Polvorín de Santa Elena (1782) on El Motto grounds in Old San Juan, PR. (Otto O. Reyes Cassanova, AIA, Architects, i991)

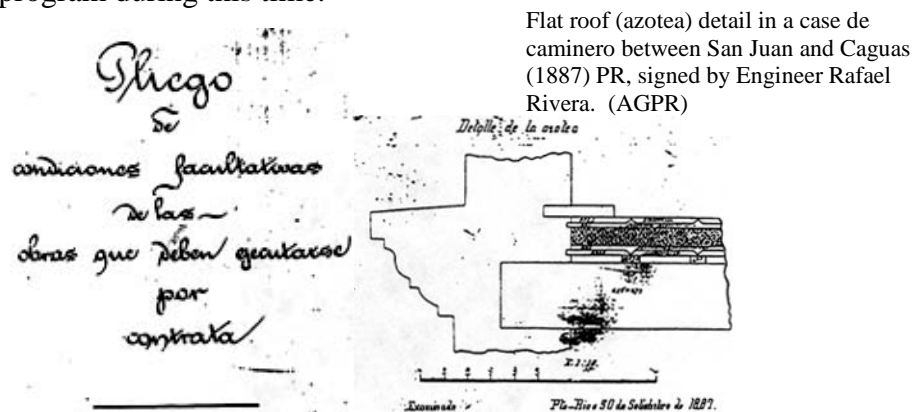
Flat roof (azotea) detail in a case de caminero between San Juan and Caguas (1887) PR, signed by Engineer Rafael Rivera. (AGPR)

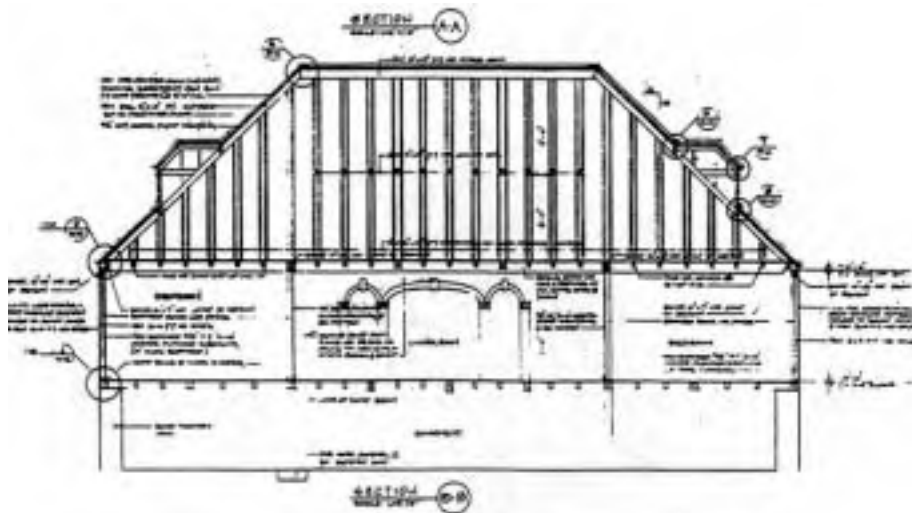
Annaly House Reconstruction Project section at Estate Annaly in St. Croix, USVI. Chaljub – Lanio Architects, Inc. (1990)

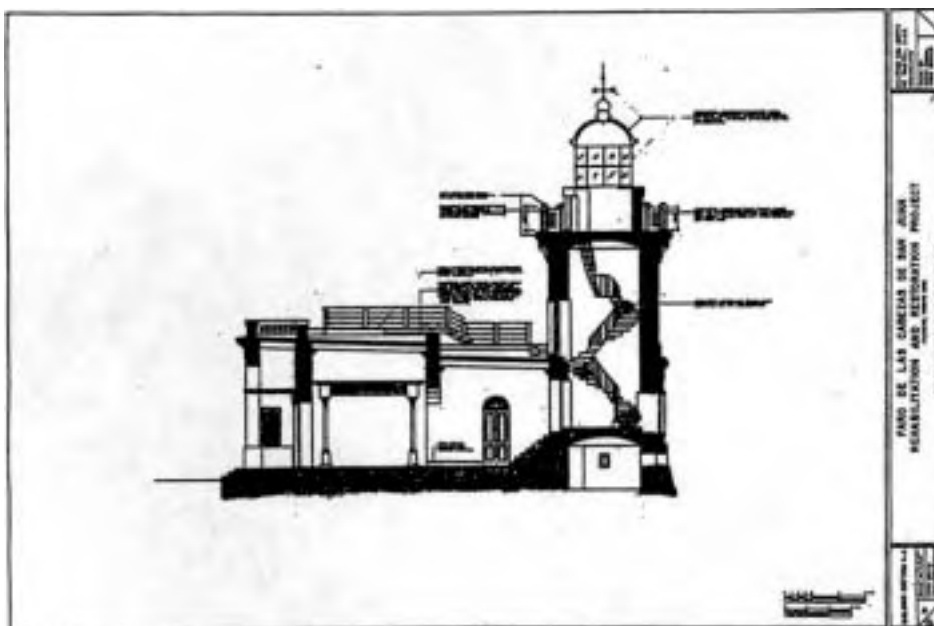
Longitudinal section through historic lighthouse at Las Cabezas de San Juan at Fajardo, PR, showing present interventions, specifically the addition of a wooden steel deck on the rooftop as an observation deck for visitors. Beatriz del Cueto de Pantel, AIA. (1990)

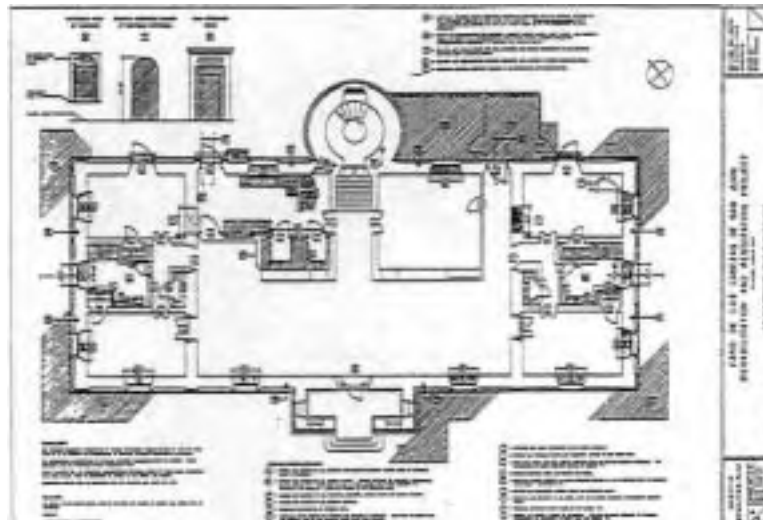
Selective demolition plan for the Faro de Las Cabezas de San Juan Rehabilitation and Restoration Project in Fajardo, PR (1989)
