# Soiling Patterns on a Tall Limestone Building: Changes over 60 Years

Soiling of limestone caused by air pollution has been studied at the Cathedral of Learning on the University of Pittsburgh campus. The Cathedral was constructed in the 1930s during a period of heavy pollution in Pittsburgh, PA. Archival photographs show that the building became soiled while it was still under construction. Reductions in air pollutant concentrations began in the late 1940s and 1950s and have continued to the present day. Concurrent with decreasing pollution, soiled areas of the stone have been slowly washed by rain, leaving a white, eroded surface. The patterns of white areas in archival photographs of the building are consistent with computer modeling of rain impingement showing greater wash off rates at higher elevations and on the corners of the building. Winds during the rainstorms are predominantly from the quadrant SW to NW at this location, and wind speeds as well as rain intensities are greater when winds are from this quadrant as compared with other quadrants; the sides of the building facing these directions are much less soiled than the opposing sides. Overall, these results suggest t

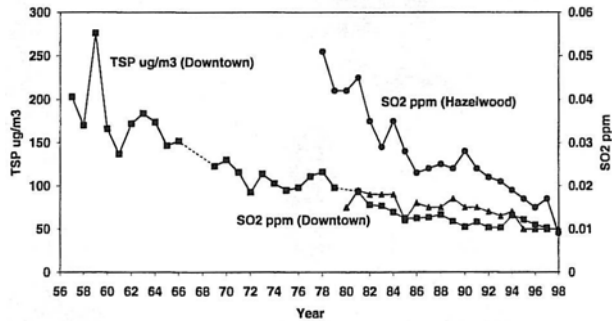
**Figure 1.** Annual arithmetic average concentrations of total suspended particles (TSP) and SO<sub>2</sub> in Pittsburgh. The TSP measurements were made with high-volume samplers at two downtown locations: the County Office Building (1957-1982) and Flag Plaza (1983-1997). The SO<sub>2</sub> measurements were made with continuous monitors at Flag Plaza downtown (1980-1998) and in the Hazelwood section of the city (1978-1998). These measurements were conducted as part of the National Air Sampling Network and the Air Quality Program of the Allegheny County Health Department. Reliable TSP data are not available for 1967, 1968, and 1980.

Figure 1 shows annual average concentrations over time for total suspended particles (TSP) and for SO<sub>2</sub> in Pittsburgh (13). The TSP data cover the years 1957-1997 and are for downtown, 3.2 km west of the Cathedral. The SO<sub>2</sub> data are for downtown (1980-1998) and for the industrial area of Hazelwood, 3.3 km south of the Cathedral (1978-1998). The data show steady decreases in concentration over time, mainly due to reductions in emissions from heavy industry and from mobile sources. Data on visibility reduction due to smoke from the early part of this century to the present suggest that average TSP levels were much greater than 200 µg/m<sup>3</sup> in the 1930s and 1940s before regular TSP monitoring began (14). This is confirmed by archived data on dustfall in downtown Pittsburgh that show values decreasing from 30 ton/km<sup>2</sup> month in 1938-39 to 14 ton/km<sup>2</sup> month in the mid-1950s (14). The dustfall values have continued to decrease and are now less than 5 ton/km<sup>2</sup> month.

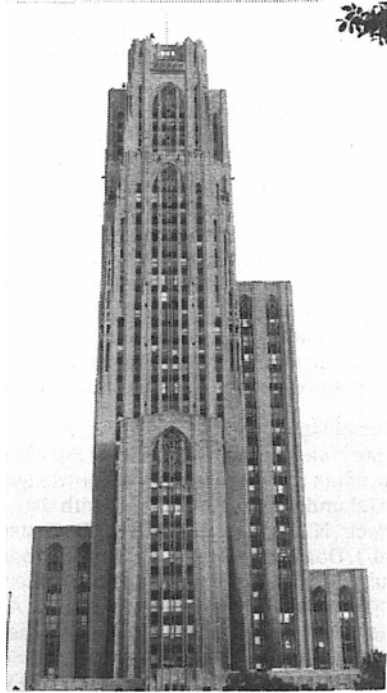
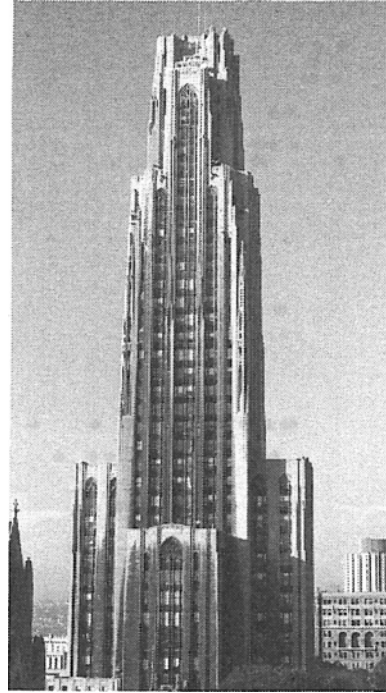
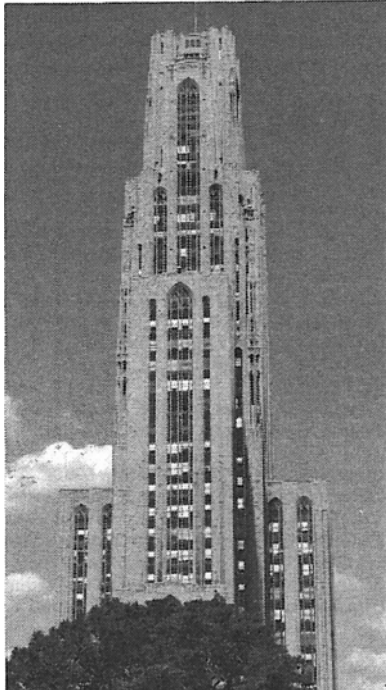
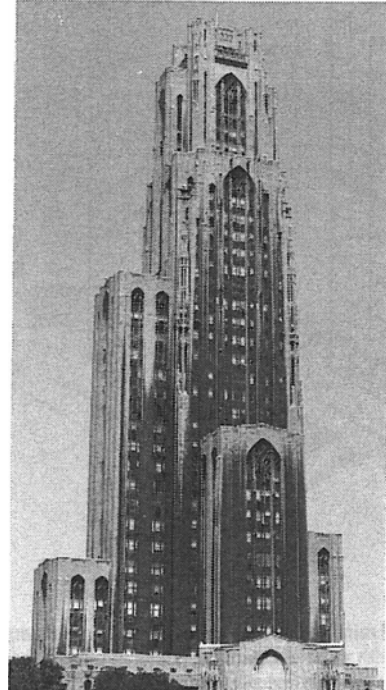
**Figure 5. The four walls of the Cathedral of Learning in 1999. The Fifth and Bigelow faces are mostly white, while the Forbes and Bellefield faces have extensive soiling. Photographs by Wei Tang**

We can gain insight into the competing processes of pollutant deposition and rain wash off by comparing soiling on different sides of the Cathedral and at different elevations. Figure 5 shows photographs of the four faces of the Cathedral as they appeared in 1999. The Fifth Avenue and Bigelow Boulevard sides show very little soiling as compared with the Forbes Avenue and Bellefield Avenue sides. The latter two building faces show less soiling near the top as compared with lower elevations, suggesting more efficient wash off at greater heights. The patterns also suggest more efficient wash off near corners on the building, with greater amounts of soiling near the center of the walls.

The figure shows that calculated rain fluxes to the Fifth Avenue and Bigelow Boulevard sides are much greater than those to the Forbes and Bellefield Avenue sides. This is consistent with the greater amounts of soiling in Figure 5 for the Forbes and Bellefield faces. On all four sides, the fluxes at the top are considerably greater than those at lower heights. Furthermore, the fluxes on the sides are greater than those in the center sections. These results are in agreement with the observations of less soiling near the top and at the corners of the building. Comparing model results with the meteorological input data shows that the greater rain fluxes on the Fifth and Bigelow sides are due in part to the large fraction of time (0.50) when the wind is from the quadrant SW through NW. Furthermore, the rain intensities are high when the wind is from the SW, W, or NW (average 4.0 mm/h) as compared with all other directions (average 2.6 mm/h), and the wind speed is greatest when the wind is from these three directions (average 2.5 vs 1.7 m/s).
