HISTORIC AMERICAN TIMBER JOINERY

A Graphic Guide

By Jack A. Sobon

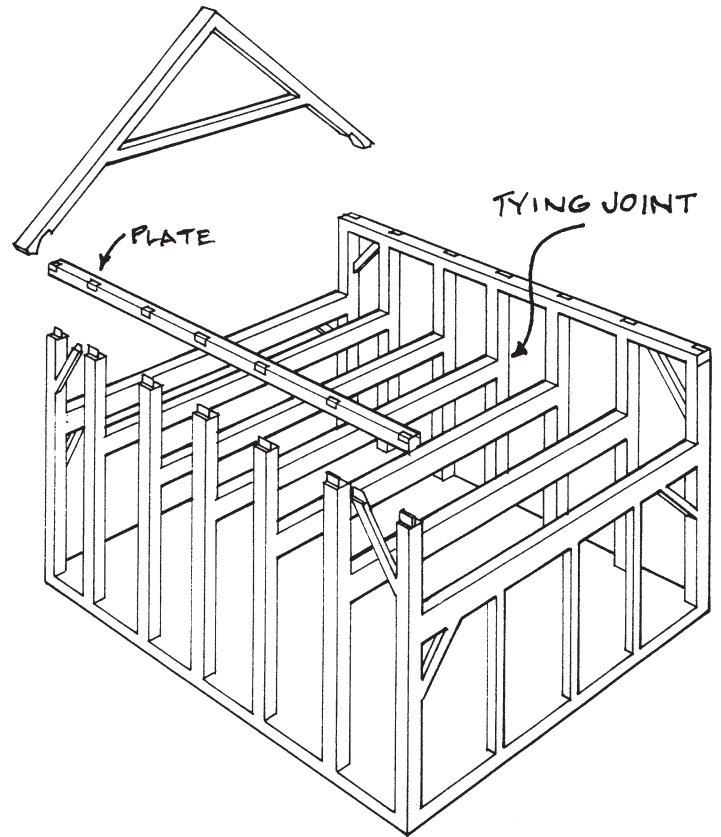
Fig. 1. In the typical New York State timber-framed Dutch house, the plate is 3 to 4 ft. above the second floor. The closely spaced H-bents, typically 3 to 5 ft. on center, illustrate the tie-below-plate condition.

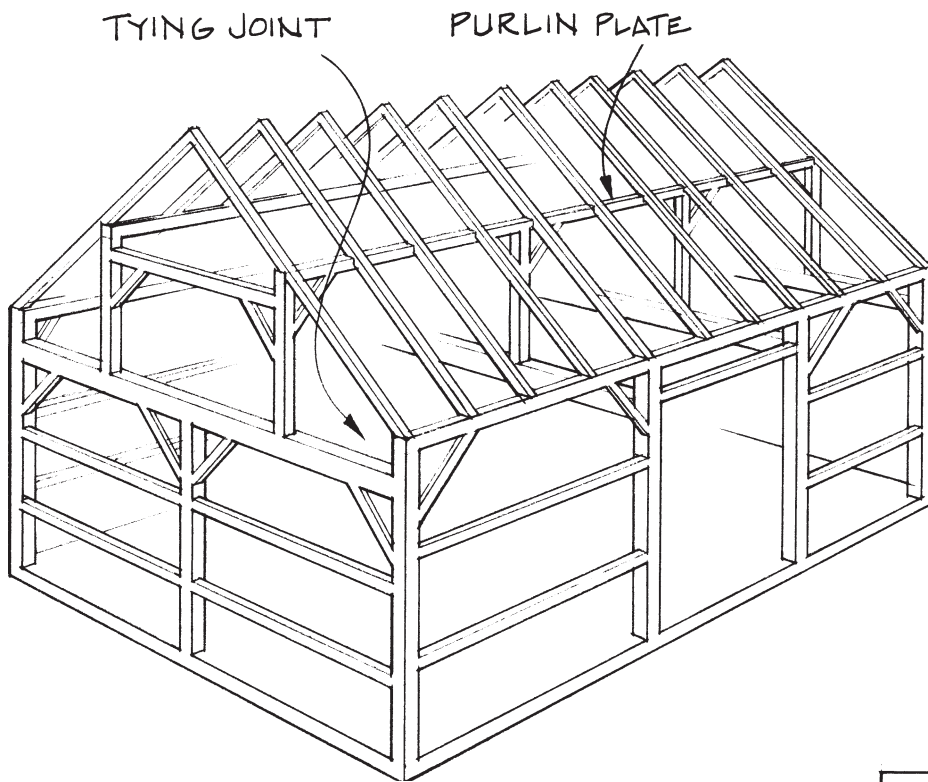
Fig. 2. The three-bay, side-entrance barn, common throughout western New England and New York after about 1800, made use of the tie-below-plate tying joint. The rafters were additionally supported by continuous purlin plates at their midspan.

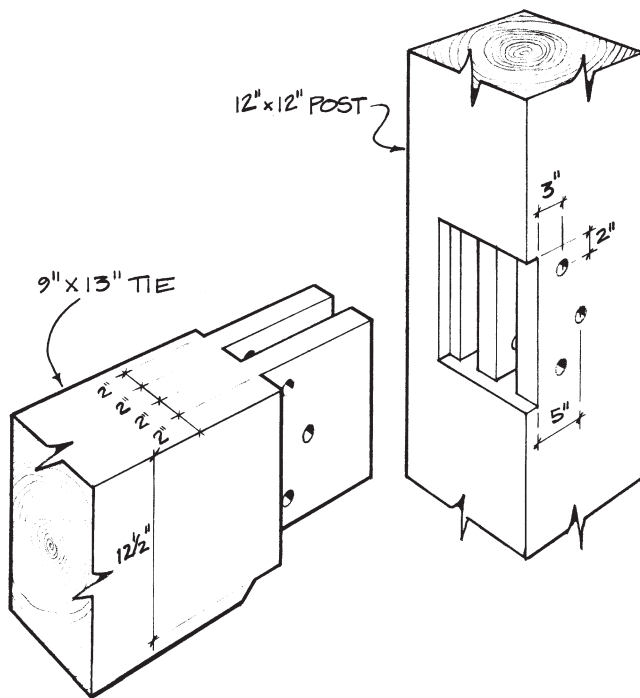
Fig. 8. Paired or twinned through mortise and tenon as found in a ca.-1840 barn in Middleburg, New York. The joint is housed flush with one side. As is typical of square rule structures, the tie beams are reduced to a consistent depth (here 12½ in.) at the joint. This rugged connection has well resisted the forces in the 50-ft.-wide barn.

Paired Through Mortise and Tenon (Fig. 8). In frames with larger members, paired or twin tenons were occasionally used. Such a configuration will likely outperform a simple mortise and tenon, with reduced tendency for pin shear and mortise face splitout. However, the advantage must be judged against the substantial additional work in the cutting of the joint. Paired tenons are sometimes found in mill structures, barns and large wooden machines like cider presses.

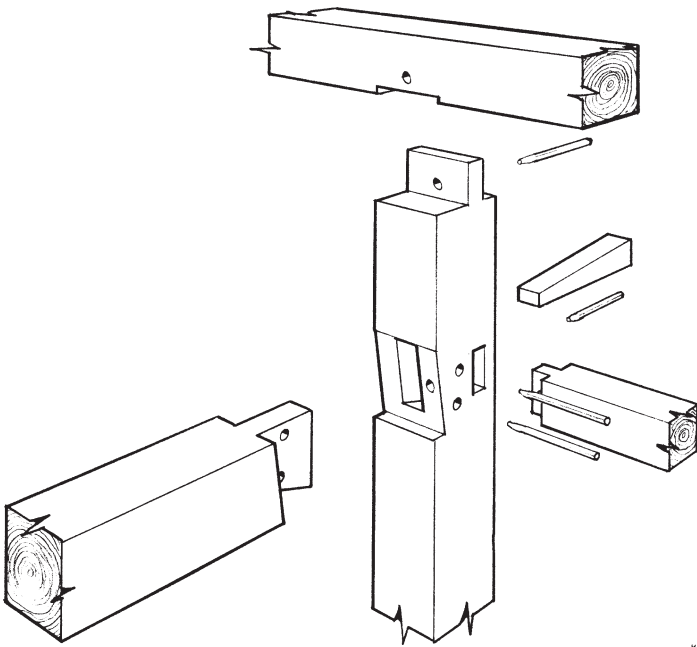
Fig. 9. Above, exploded view of wedged dovetail through mortise and tenon in a late-1700s three-bay 30x40 English-style barn in Adams, Massachusetts, framed almost entirely of beech.

The Wedged Dovetail Through Mortise and Tenon (Figs. 9 and 10).

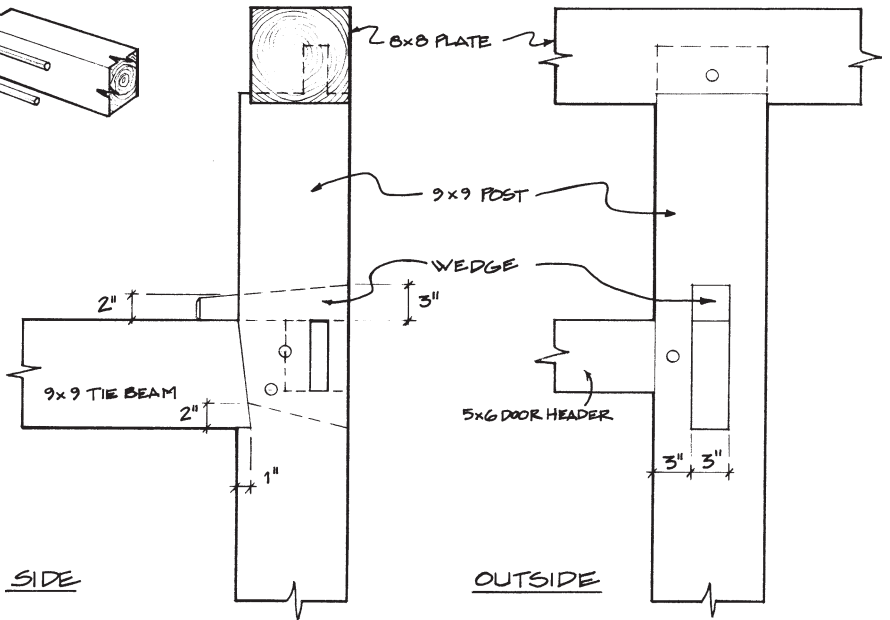
Fig. 10. At right above, side and end views of the same joint with dimensions. A door header joins the post at the same height as the tie beam.

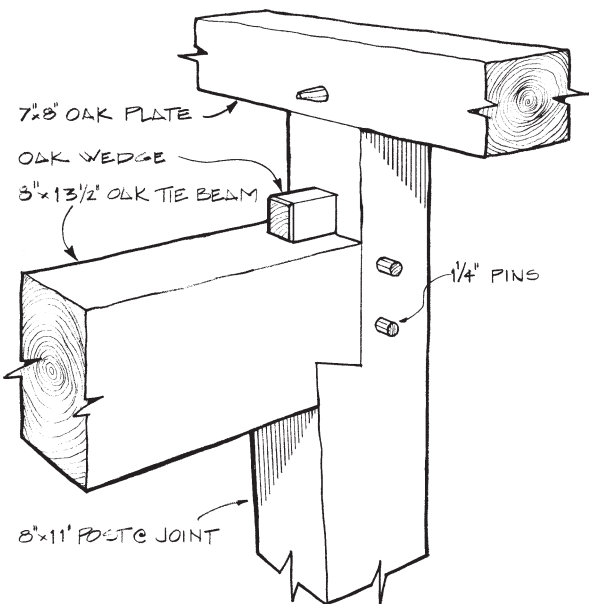
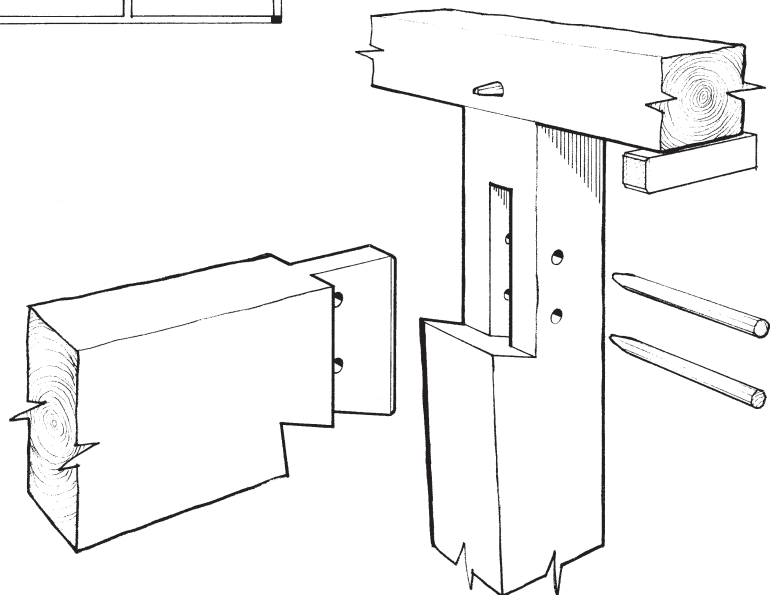
Figs. 11 and 12. Below and below right, assembled and exploded views of a wedged dovetail through mortise and tenon with dovetailed housing, as found in a 28x34 three-bay side-entrance barn in East Chatham, New York, probably dating from the second half of the 18th century. This unique joint has exceptional tensile strength.

The Through Mortise and Tenon with Dovetailed Shoulder (Figs. 11 and 12). A local (Columbia County, New York) variation of the wedged dovetail joint has the dovetail on the tenon continue into the housing which, because of the flare of the post, is about 3 in. deep. Only two buildings have been found with this joint. Judging by their location and similarities, they are likely the work of the same builder. The drawback to this joint would be the potential for the tie beam to fail in shear where it is notched to fit the housing. Apparently the load on the joint in this 28-ft.-wide barn is matched by the heavy oak tie beam, for nothing has failed in over 200 years.

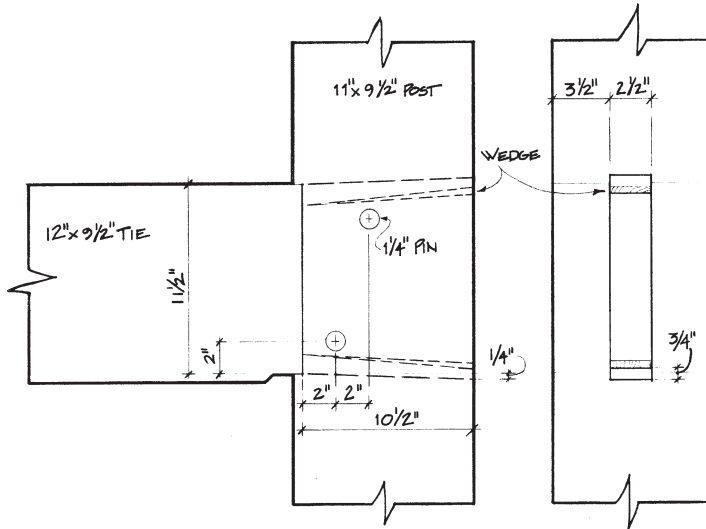
Fig. 13. Kerf-wedged dovetail through mortise and tenon joint found in the upper floors (after 1810) of the Machine Shop at Hancock Shaker Village, Hancock, Massachusetts. It was used for both the tying joints and the queenpost trusses. This joint is much more common in furniture than in framing. Because of shrinkage in the height of the tenon, the wedges are loose, indicating that the pins are carrying the load.

The Kerf-Wedged Dovetail Through Mortise and Tenon (Fig. 13). A variation allows a basic tenon to become a full dovetail. Kerfs are sawn near the edges of the tenon, and wedges are driven in to expand the tenon to fit a dovetail-shaped mortise. The kerfs are not parallel to the tenon edges, but angled away from the edge to avoid creating a splitting plane in the tie beam tenon when the edges of the tenon are bent away to follow the splay of the mortise ends. The advantage of this type over the wedged half-dovetail is that the tenon is not reduced in cross-section to create the dovetail. The disadvantage is that the angle of the dovetail must be shallow, and thus it will be affected relatively more by shrinkage of the tenon. In the illustrated example, the tenon flares only $\frac{1}{4}$ in. on the top and bottom. After seasoning and shrinking of the members, the two pins may be carrying the entire load. It would seem that seasoned timber is necessary to use with such a subtle dovetail flare. I have found only two timber examples, though the joint is common in furniture.

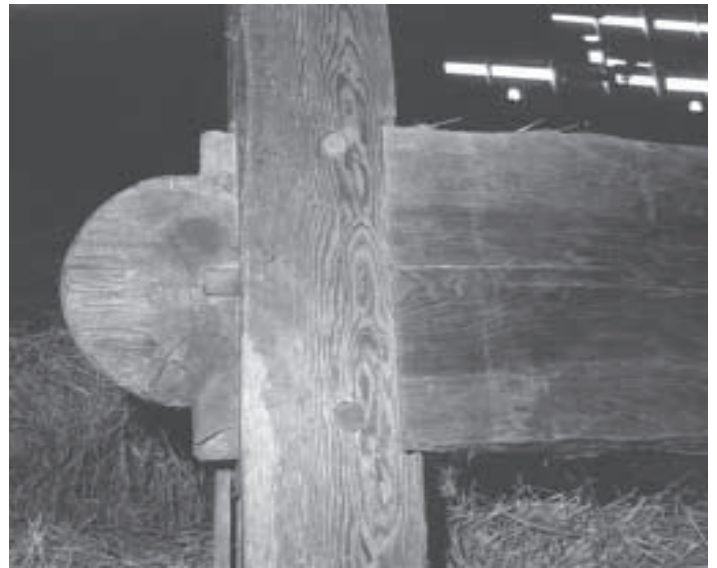
This unusual tenon profile appears on three Dutch barns in Coeymans, N.Y., likely the signature of a particular builder.

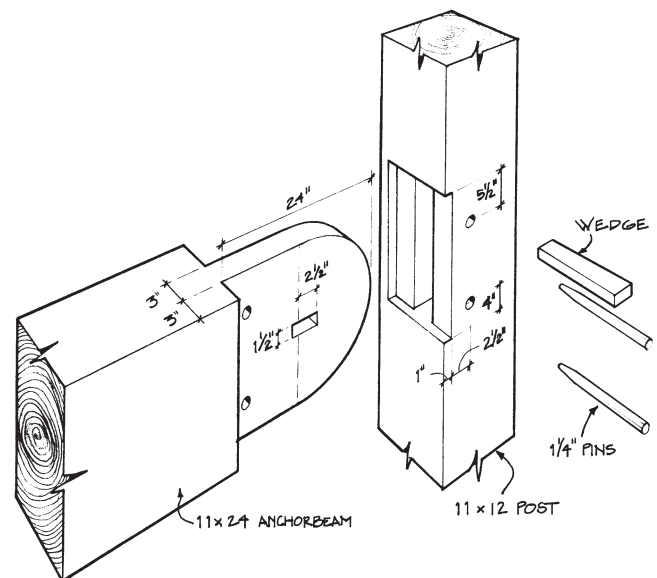
Fig. 14. Below, a through mortise and extended tenon as found in an 18th-century 47x45 Dutch barn in Root, New York. Two pins and a single wedge secure this housed version. Note that the pins are not equidistant from the top and bottom of the tenon. Perhaps this was done to reduce the tendency of the 24-in.-deep white pine anchor beam to lift off the shoulder as it shrank.

Through Mortise and Extended Tenon (Figs. 14-16). When the building is aisled as in Dutch barns, the primary tying joints typically occur at the posts that flank the central aisle. These posts are joined by an *anchorbeam*, creating an H-shaped bent. The side aisles are treated as lean-tos and gain their strength from the H-bent. Since the tying joint is now interior, the tenon can be extended for additional strength without being exposed to the weather. (In Europe, such tenons are often exposed on the exterior of buildings.) Adding a foot or so of tenon prevents relish failure. By adding wedges through this tenon, all five potential modes of failure mentioned earlier are effectively eliminated save one: where the post breaks at the tying joint. The wedges can be driven additionally after the building is finished and the wood seasoned. The only disadvantage is that an additional 2 ft. or more of length are required on the anchorbeams, typically the largest timbers in a building. (Sections 12 by 24 in. are not uncommon.) The profile of the tenon varied with the builder.

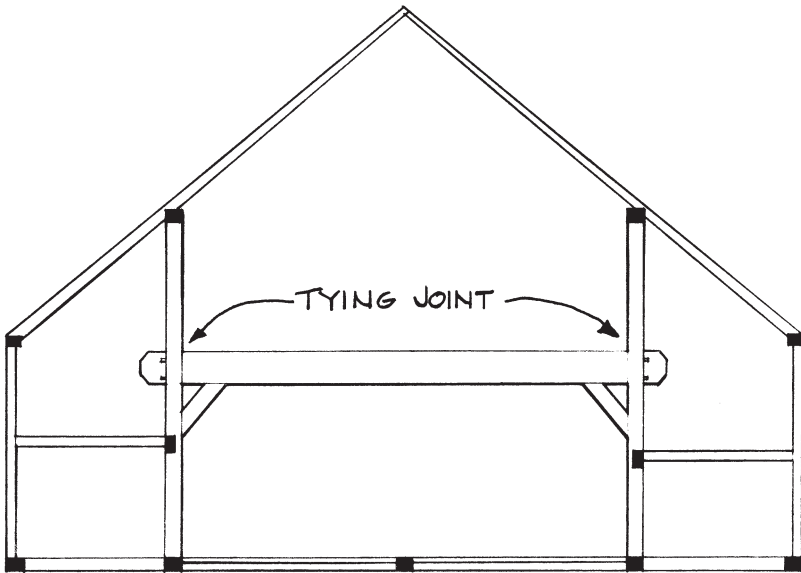
Fig. 15. The New World Dutch barn is an aisled building. The structural core is the H-shaped bent, each composed of aisle posts and an anchorbeam with heavy braces. Because the tying joint is interior, the tenon can be extended without being exposed to the weather.

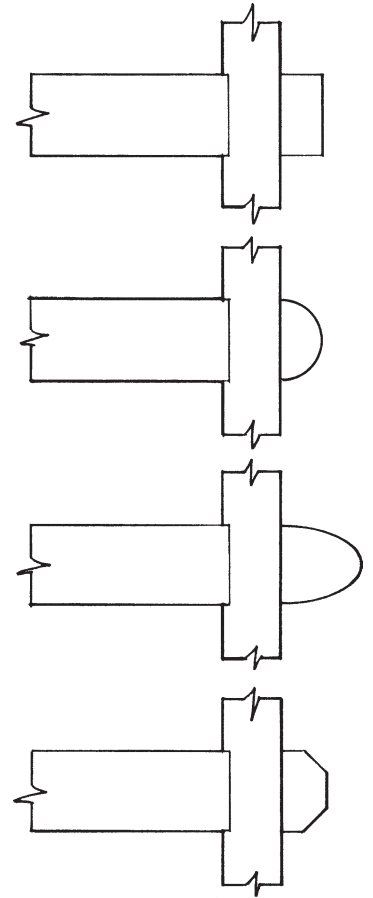
Fig. 16. Common variations on the shape of the protruding tenon. All versions have been found with two wedges, one wedge or no wedges.

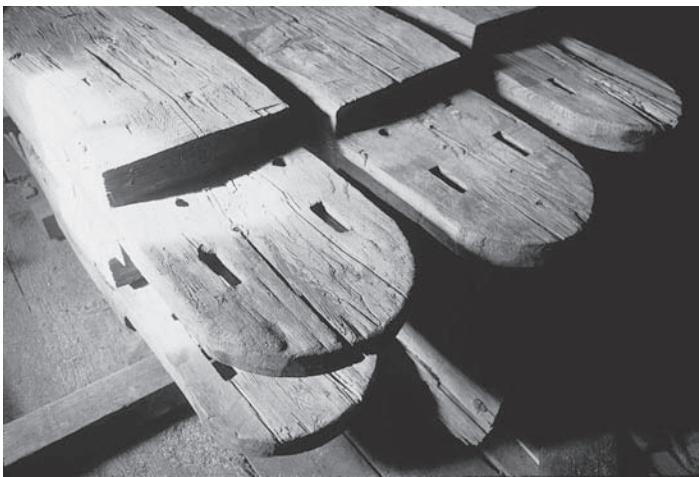
Anchorbeam tenon ends from a pre-1820 Dutch barn taken down in Altamont, New York.

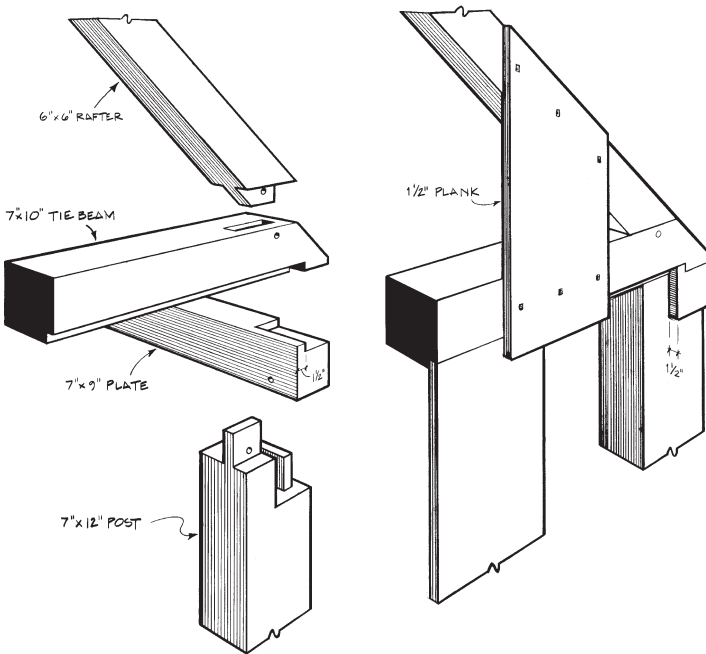
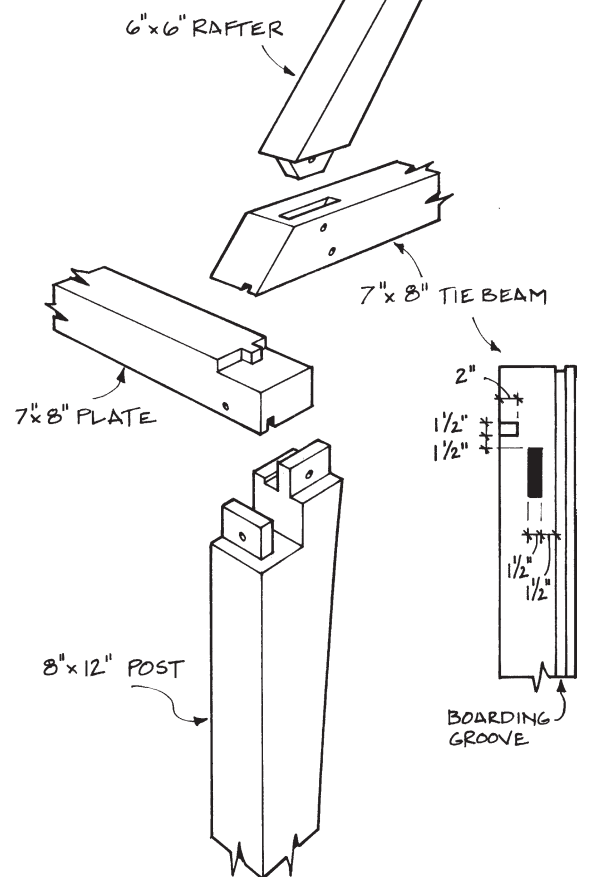
Fig. 4. Full-width cog (1/2 in. square section) found on the corner joints in a 1773 three-bay 28x36 barn in Adams, Massachusetts. This barn has dropped tie beams on interior bents. Note lapped end-boarding.

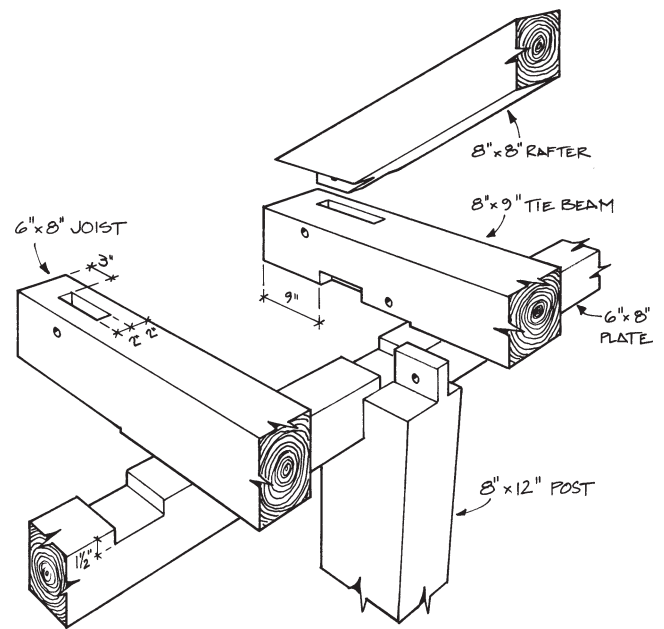
Fig. 7. In this early 19th-century 32x40 two-story house in Washington, Massachusetts, rafters tenon equally into tie beams and joists, which extend 9 in. past the plate for a boxed-in cornice. Principal tie beams sit on tapered posts and are cog-lapped over the plate. Joists do not run the full width of the house but frame into a central summer beam; they are notched through the plate without cogging. Roof purlins framed between principal rafters support the commons at midspan.

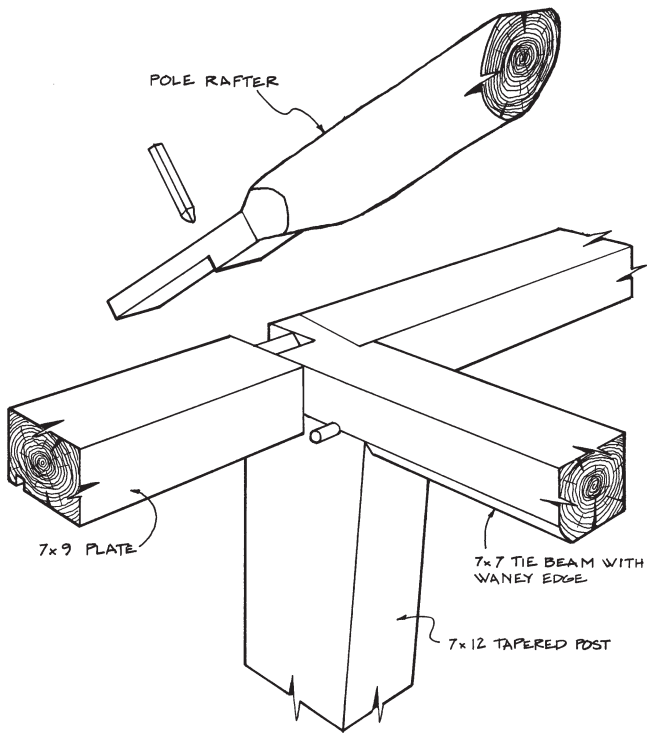
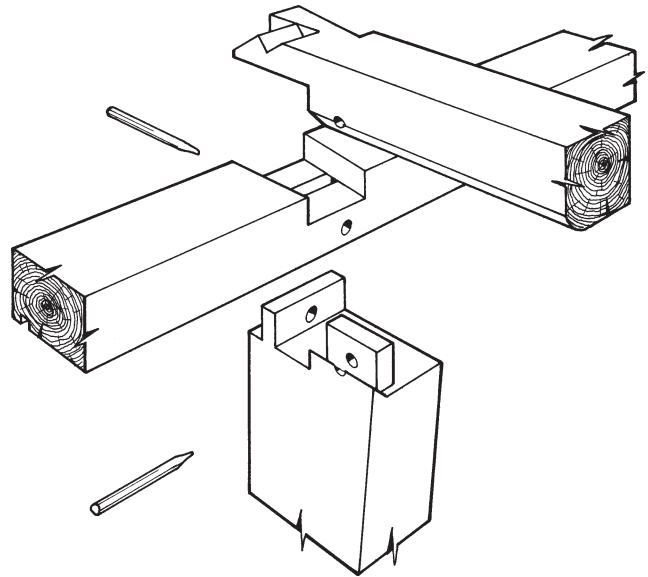
Figs. 9 and 10. This tying joint is found in a 28x38 three-bay, pre-1812 English barn in Goshen, Massachusetts. All of the tying joints are of this type. Instead of the rafter tenoning into the tie (as is more common), it is step-lapped, as are the intermediate common rafters to the plate. The post is scribed to meet the waney edge of the tie beam. (The corner joints are the same, without relish past the dovetail, but with rafter pins extending through the dovetail into the plate.)

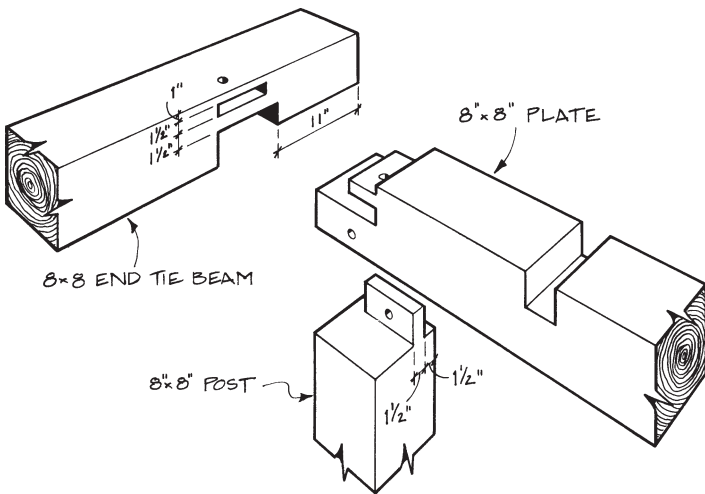
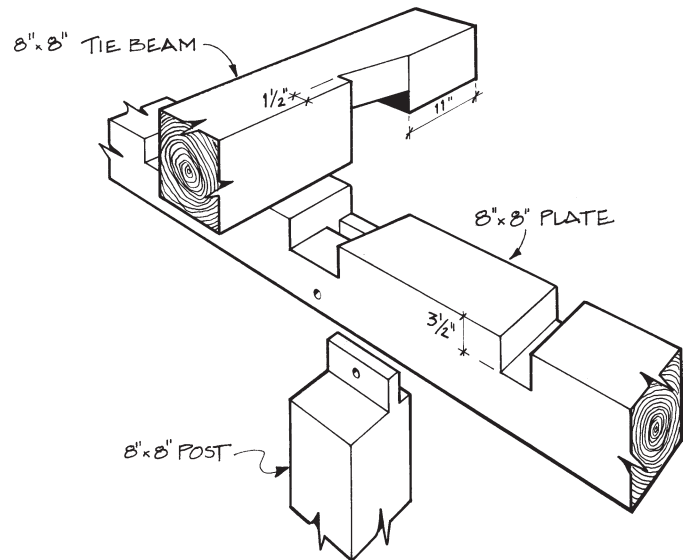
Figs. 11 and 12. In the 1791 Cheshire house (photo page 19), a 30x40 Cape, non-jowled posts terminated in a single top tenon. Tie beams and floor joists extended 11 in. at the front eave to support a boxed-in cornice. At the front corners (above left), a combination of lap, tenon and overhanging tie avoided the plate relish problem. The two intermediate tying joints on the front wall (above right) were lap dovetails. Curiously, one had the dovetail reversed: a mistake? All the floor joists notched through the plate for additional tying. At the rear wall (not shown), there was no overhang. The intermediate tie beams joined the plate with a straightforward, 4-in.-deep horizontal mortise and tenon instead of lap dovetails; at the corners the joint was the same as the front but without the 11-in. projection.

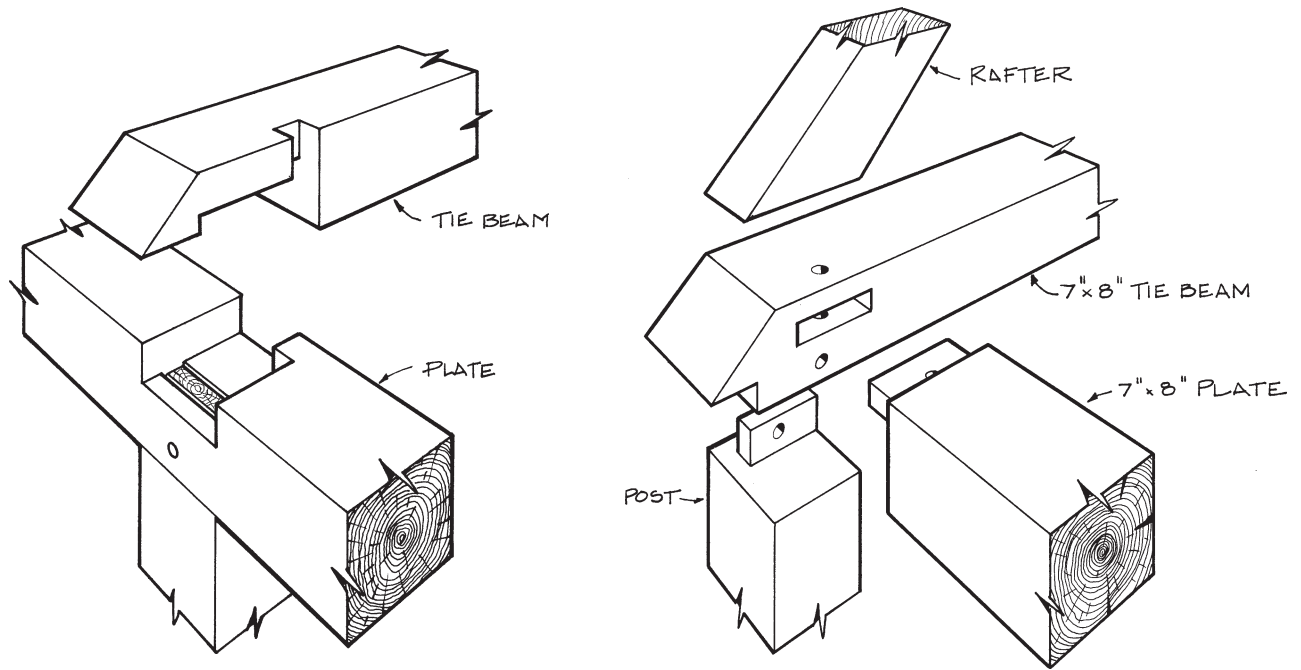
Figs. 13 and 14. Two-way cog, $2 \times 2\frac{1}{2} \times 3$, in a lap joint in a pre-1810 house, 26x27, in North Adams, Massachusetts. The tie beam end was notched on the bottom and the side to engage the plate. Joists and ties extended about 7 in. to frame a cornice. At right, the end condition. A simple mortise and tenon is substituted for the lap. Rafters were butted and nailed.

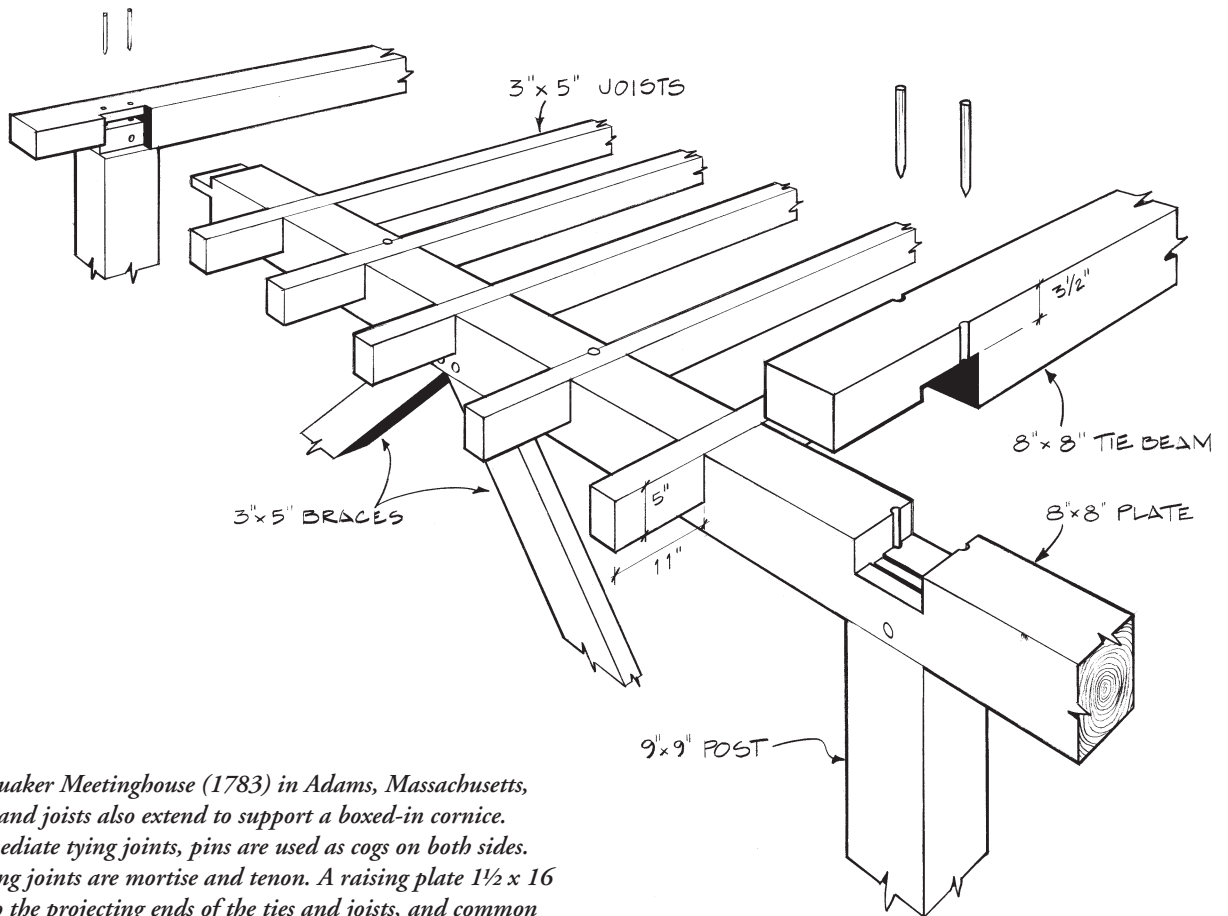
Fig. 15. Quaker Meetinghouse (1783) in Adams, Massachusetts, where ties and joists also extend to support a boxed-in cornice. On intermediate tying joints, pins are used as cogs on both sides. Corner tying joints are mortise and tenon. A raising plate $1\frac{1}{2} \times 16$ is nailed to the projecting ends of the ties and joists, and common rafters, each pair with a collar, are nailed to the plate.

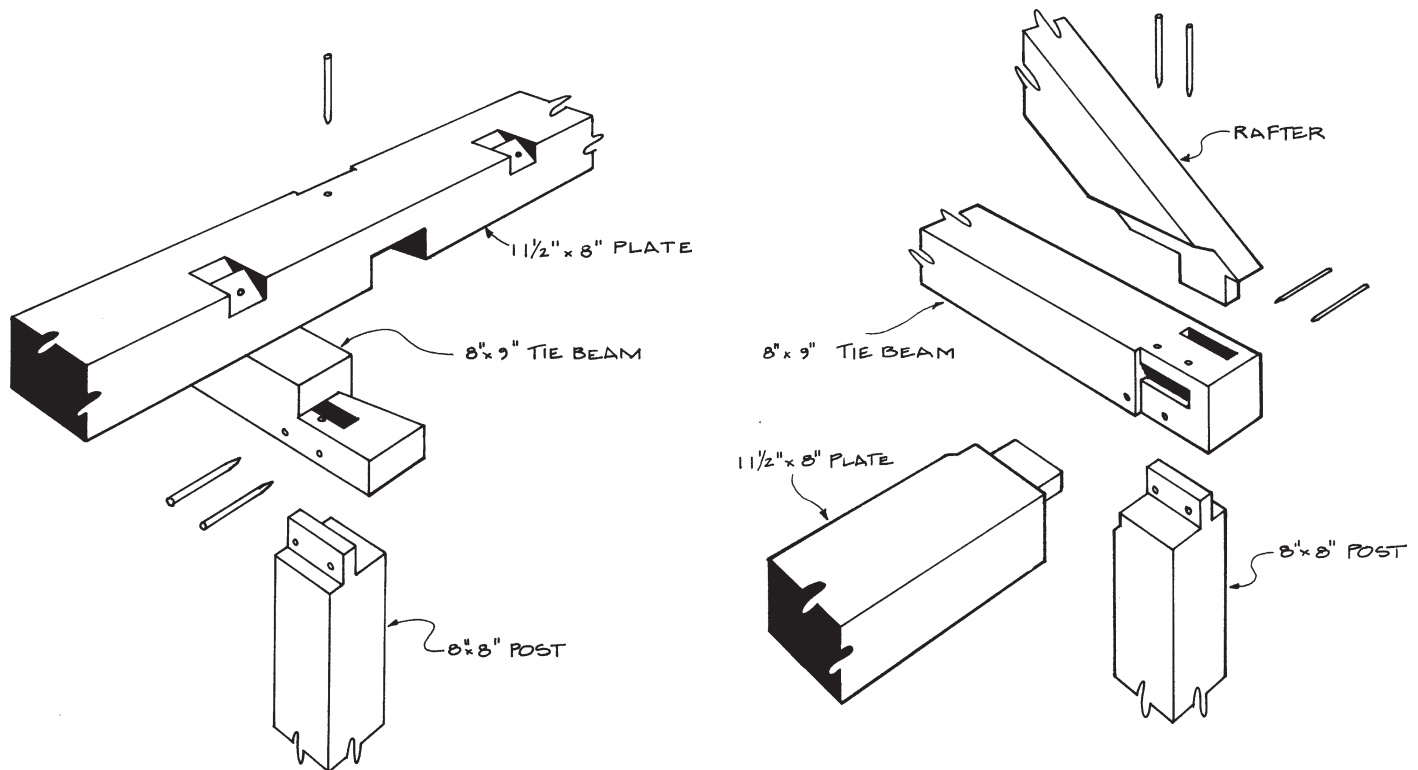
Figs. 18 and 19. The front plate lapped over the dovetailed end of the tie beam in a Charlemont, Massachusetts, house, now dismantled. A single vertical pin also resisted movement. The front plate, together with the tie beam dovetail, projected 6 in. to become a solid cornice base. Rear plate (not shown) did not overhang, and the rear tying joints on the intermediate tie beams relied on through mortises and two pins. The common rafters step-lapped into the plate, except at the front corners, as shown (note hewn rafter tenon).

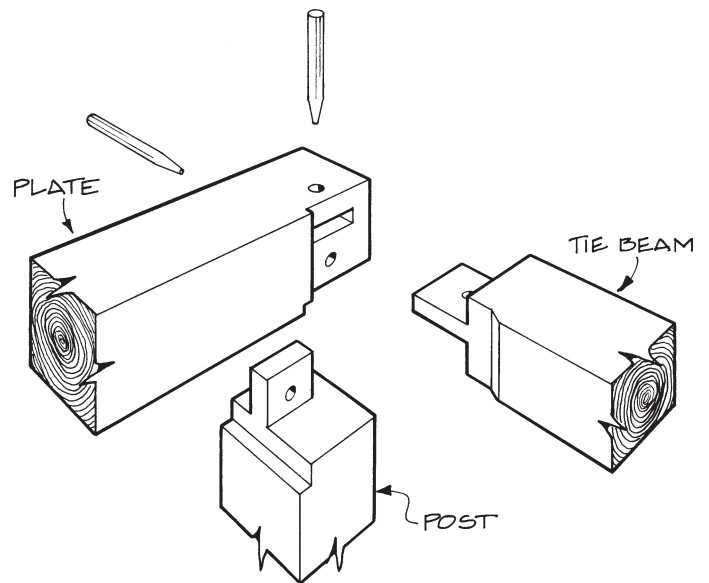
Fig. 21. Simple joint found at the corners of a square rule barn in Huntington, Massachusetts.

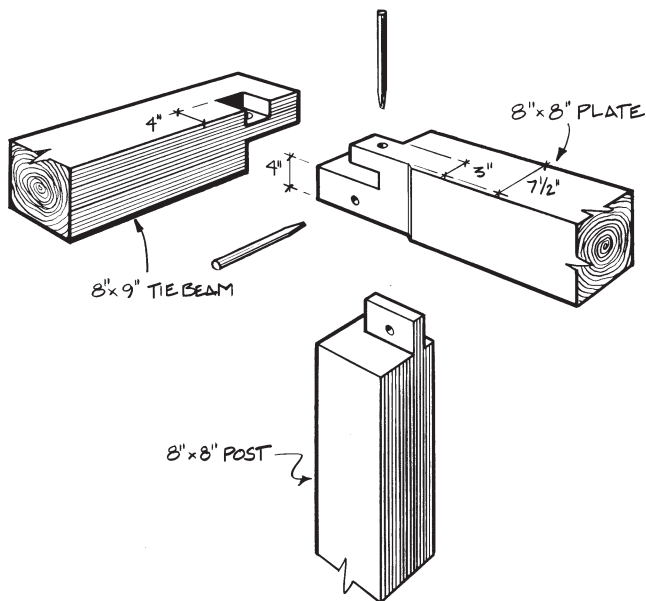
Fig. 20. A cross between a cog and a mortise and tenon, this joint occurs (as far as is known) only at the corners of a 1785 three-bay 30x40 barn in Adams, Massachusetts. Intermediate tying joints are the dropped type. Common rafters with collars are step-lapped into the plate except at the corners where they are butted and nailed.

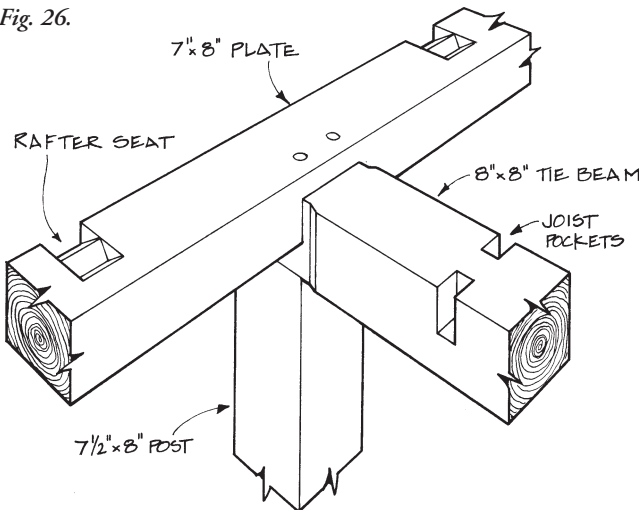
Fig. 26.

Figs. 25-27. Intermediate (Figs. 25 and 26) and end (Fig. 27) tying joints in a two-story 28x36 post-1810 square rule house in Windsor, Massachusetts. The plate is 2 in. above the tie, allowing the post to tenon into it. The braces from the post up to the plate fit elongated mortises and were apparently inserted after the plate was slid on, and the extra space in the mortise was then filled with a wedge. The end tying joint is similar but with 2 in. of plate relish and only one pin.

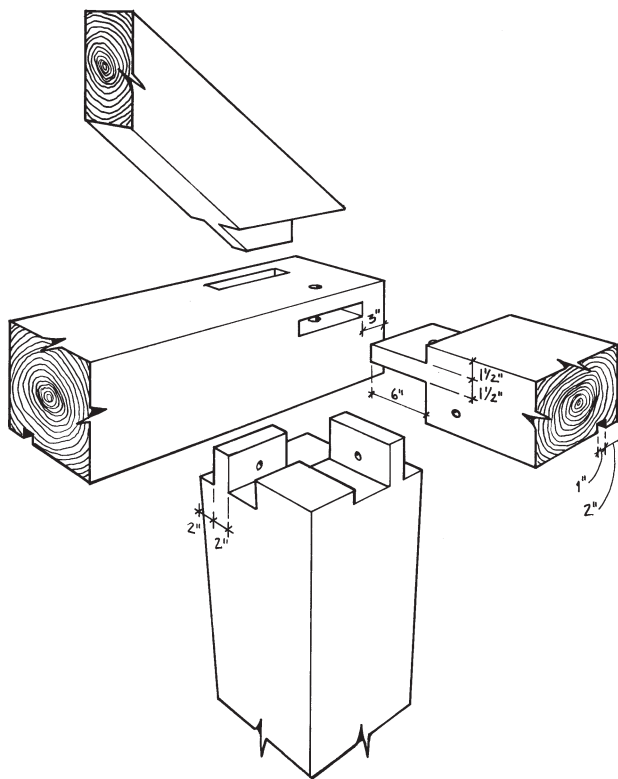
Figs. 28 and 29. This triple bypass corner tying joint was found in an early scribe rule (late 1700s) four-bay, side-entrance barn in Hoosac, New York. The 36x49 barn appeared to be Germanic in origin, with purlin plates and a ridge beam. Intermediate ties were the dropped type. Long braces extended German-fashion from the sill up to the corner posts. These undoubtedly helped stabilize the structure during the setting of the plates. Boarding grooves were worked in both plate and tie. This barn was carefully dismantled but unfortunately burned while in storage.

TRIPLE BYPASS. This connection is arguably the most perplexing of tying joints located thus far. It is found along the border of New York and New England in four states. Some refer to it as *secret* joinery because it can mystify the casual observer. Its name, coined by Don Carpentier of Eastfield Village in East Nassau (Rensselaer County), New York, is apt. The connection has three mortise and tenon joints, not counting the rafter joint (Figs. 28-30). In Buskirk, New York, a barn with all of its tying joints of this type shows evidence of having been dismantled previously. All the tie beam tenons are inserts (free tenons). Undoubtedly the dismantler was perplexed at how to take the barn apart. He cut the tenons off (a hanging offense in my book) and then spent considerable time putting tenons back on.

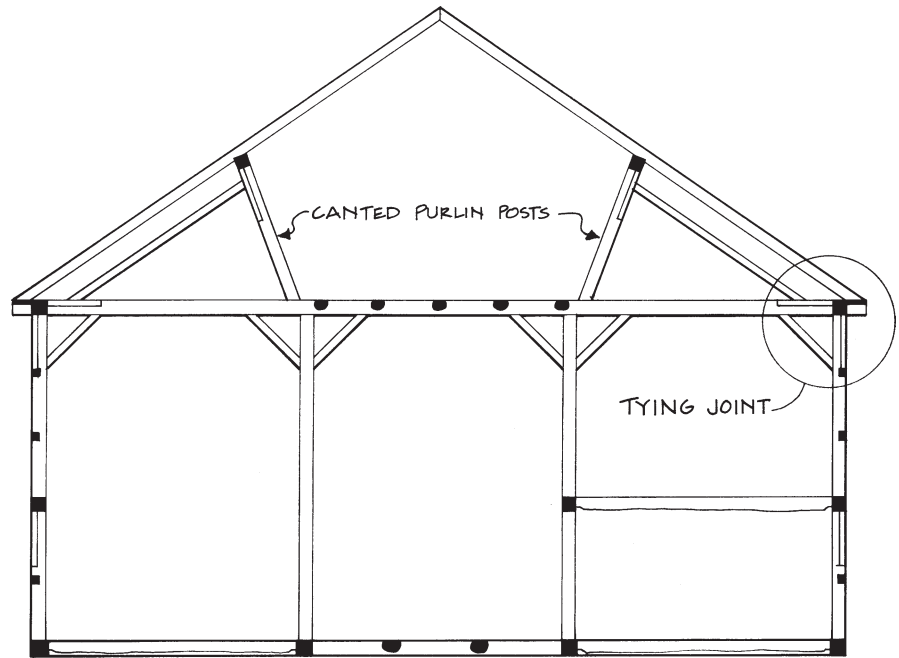
Figs. 34 and 35. Sectional drawing of a ca.-1850 barn, now rebuilt elsewhere, that once stood in Shrewsbury, Massachusetts. Measuring 37x50, it has canted purlin posts, continuous purlins and interrupted plates. All principal timbers are 7x7. To support a substantial Greek Revival cornice, the builder has inserted outriggers into the plates and secured them with nails (Fig. 35 below). A 2x11 raising plate is nailed to the outriggers, and the projecting tie beam ends stiffen the assembly and support the rafters. Braces in three planes reinforce the structure.

INTERRUPTED PLATE. In the mid-19th century, a new barn type emerged in New England, a gable-entry, aisled barn that could vary in length from two to 10 bays (or more). Bays were typically 12 ft. Such barns were often built into side hills to allow access on more than one level. Figuring prominently in their design was a frame with interrupted plates. These shorter plates, tenoned between tie beams or posts, allowed standardized joints and components. A builder could vary the size without changing the design. Bents were raised and connected by plates and braces. As soon as two bents were connected, the frame was braced and stable. There were variations in this joint depending on cornice design. Some barns had two plates. One was in the normal position to receive the tops of the wall boards. The second tenoned between the projecting tie beam ends to support the fascia and soffit.

The interrupted plate was not an improvement over the continuous plate. Wind loads cause the plate braces to exert tension on the short plate tenons, typically 3 to 4 in. long, which can handle only small tension loads. But roof boarding, flooring and cornice work often provided enough continuity to make up for what the continuous plate had provided, and some barns had continuous purlin plates with a scarf where necessary. Some houses as well were built with interrupted plates, but by this period balloon framing was becoming popular for houses, and timber framing was in decline.

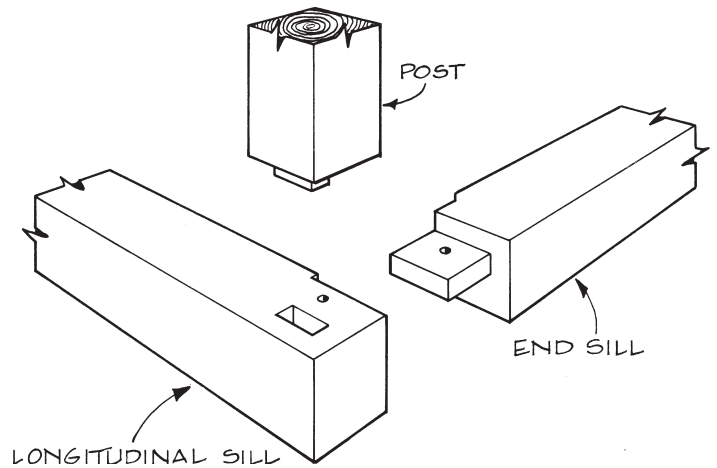
Figs. 1 and 2. Blind (above) and through (below) mortise and tenon joints, both sized according to square rule layout.

Through Mortise and Tenon. Much less common is this through mortise and tenon variety (Fig. 2). It occurs typically where sills are square in cross-section, or rectangular and set on edge, as the through joint increases tensile capacity for a narrow sill. Unfortunately, weather resistance is diminished compared with the blind joint, and the mortises are more likely to split open and the relish to fail.

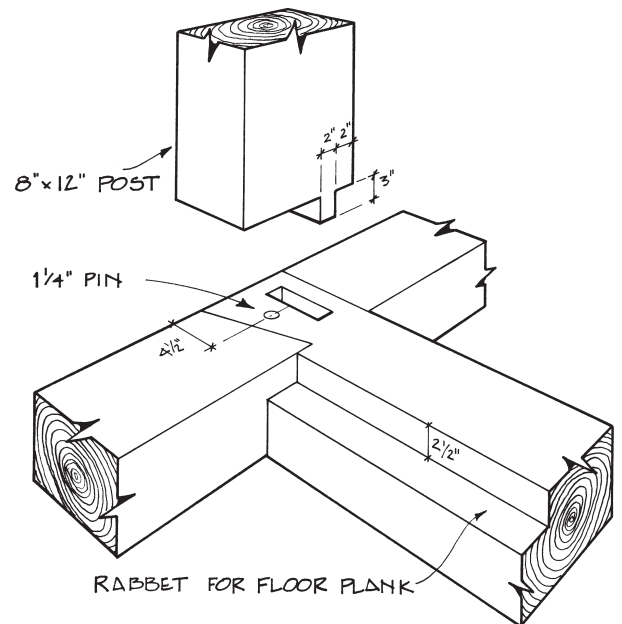
Fig. 6. Views of lapped half-dovetail girder joint in a pre-1820 scribe rule Dutch barn moved from Fort Plain, N.Y., to Altamont. The interior sill is rabbeted for the 2 1/2-in. splined plank threshing floor.

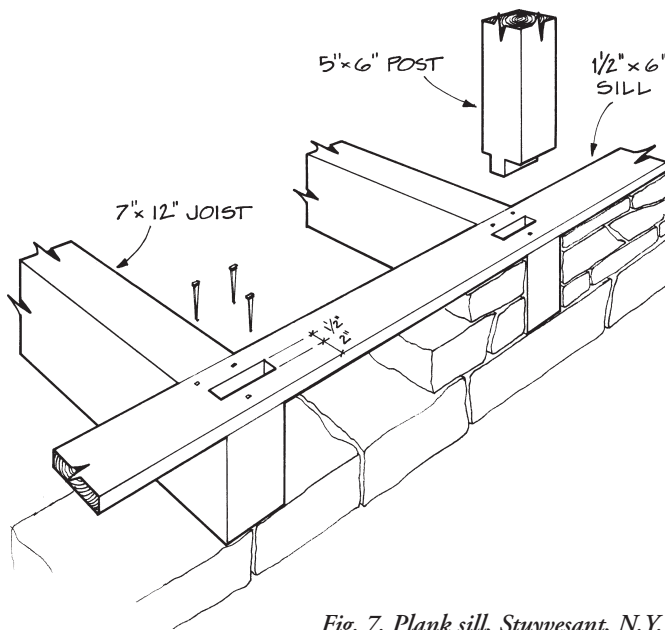
Fig. 7. Plank sill, Stuyvesant, N.Y.

Plank Sill. This unusual sill system has been seen on at least two scribe-rule-framed 18th-century New York Dutch houses, one standing in Stuyvesant (Fig. 7) and the other (now dismantled) formerly in Cohoes. Both houses, built with unfired brick infill between the posts, measure about 18 ft. wide, with full-span floor joists. Because of their long span and wide spacing (4-5 ft.), the joists are 12 in. deep. But a corresponding 12-in. sill is both impractical and unnecessary. With the plank sill system, the joists are set into the stone or brick foundation and a 1½x6 plank is notched in flush to their tops and nailed to secure them. The plank is through-mortised for the posts, and the mortise extends an inch into the joist as well. This design saved on material and joinery, and was probably also a time-saver during the scribe layout process. It has proved itself over time.

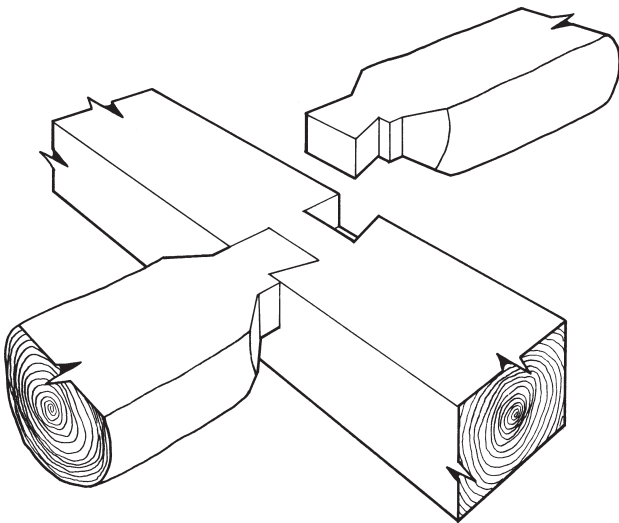
Fig. 12. Half-dovetail butt-cogged flattened log joists.

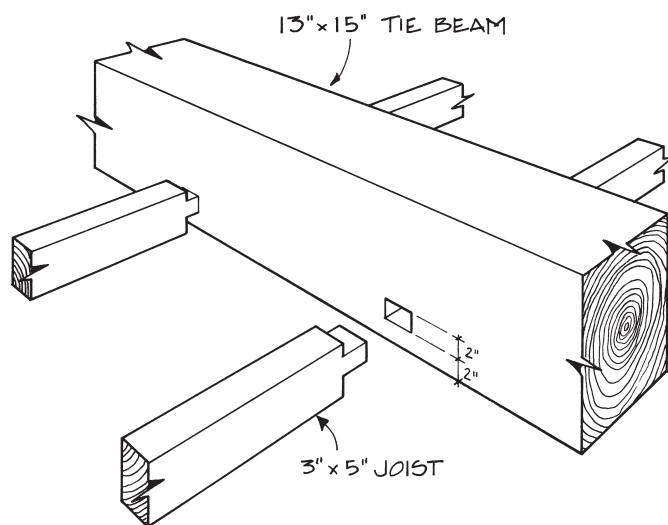
Fig. 26. Beech ceiling joists with shortened shoulders are secured from movement by a single cut nail in the Second Congregational Church, Newport, New Hampshire (1823).

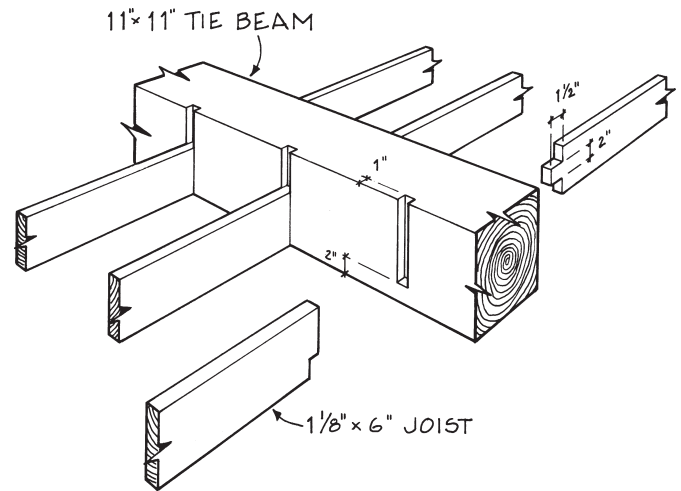
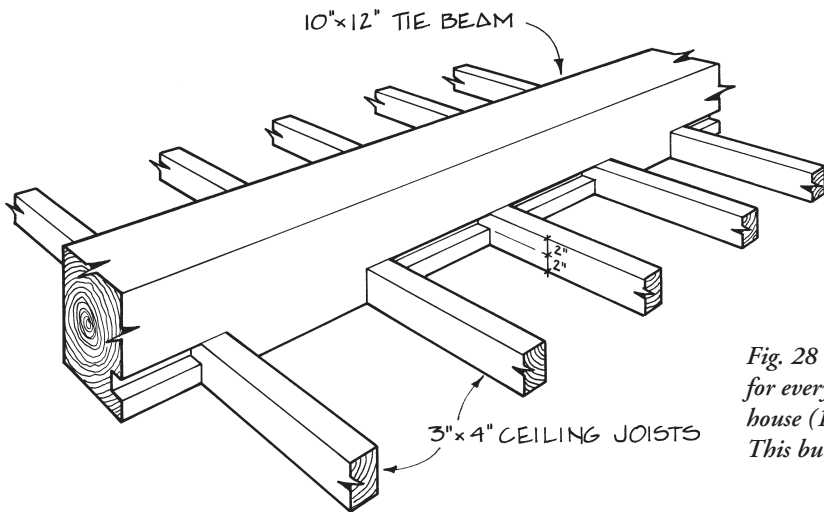
Fig. 27 (right). Board ceiling joists tenoned at one end and notched at the other drop into vertical chase mortises on the tie beams of the 1815 Methodist Church at Chenango Forks, N.Y. (now dismantled and reassembled in Burbank, Ohio). The bearing for the joist in the tie beam is only an inch deep. Close truss spacing of about 8 ft. permits the use of light boards. Similar joinery is found on an 1840 church in Brimfield, Massachusetts.

Fig. 28 (left). Long pulley (chase) mortises were cut in the tie beams for every three ceiling joists in the Hatfield (Massachusetts) Meeting-house (1750). The opposite side of the ties had simple 2x3 mortises. This building was destroyed while being rolled to a new site in 1979.

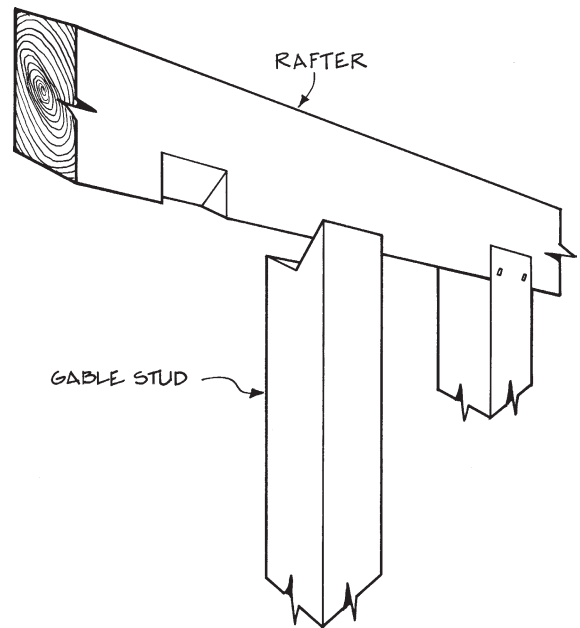
Fig. 4. A beveled lap provides a sound solution to inserting studs after erection. It is a joint easily fashioned in situ.

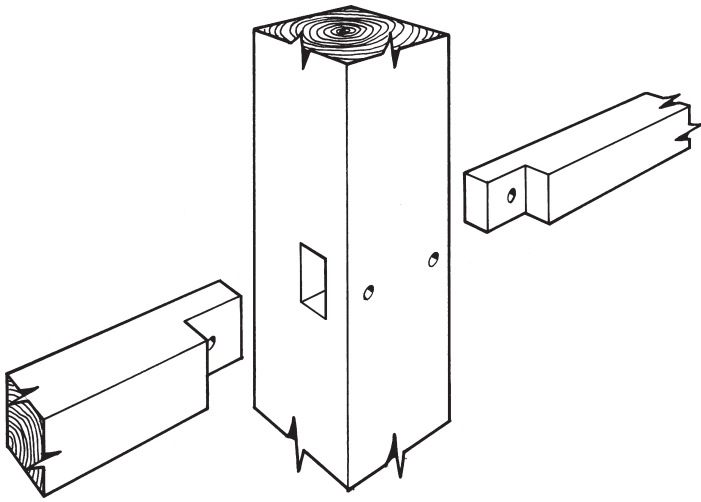
Fig. 5. Barefaced and pinned girts in a typical scribe rule building.

Girt joinery closely resembles stud joinery. The barefaced tenon is common, as are the sizes 3x4 and 4x4 (Fig. 5). Many barns built before the advent of the circular sawmill used girts hewn on only one face and squared up to a consistent size only at the joints (Fig. 6). For girts with longer spans or with floor loads to support as well, a standard mortise and tenon replaced the barefaced tenon (Fig. 7).

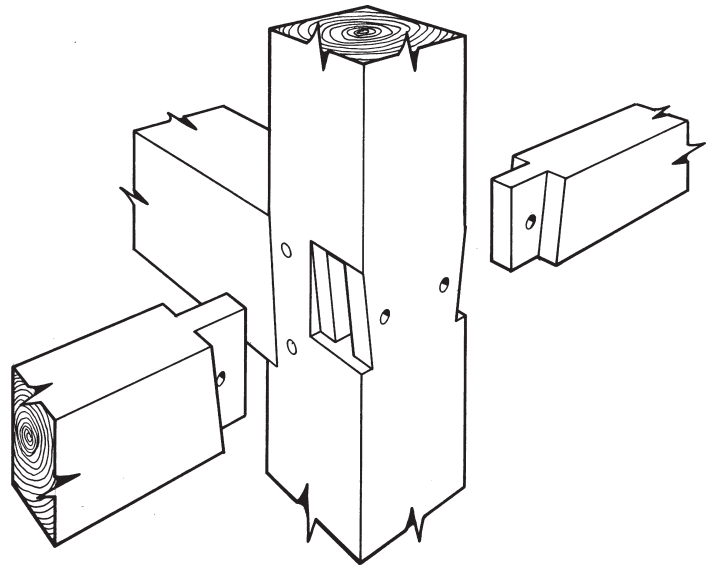
Fig. 7. Wall girts at floor level in a scribe rule building. These load-bearing girts rely on standard mortise and tenon joints with diminished bearing shoulders.
