HISTORIC AMERICAN TIMBER JOINERY

A Graphic Guide

By Jack A. Sobon

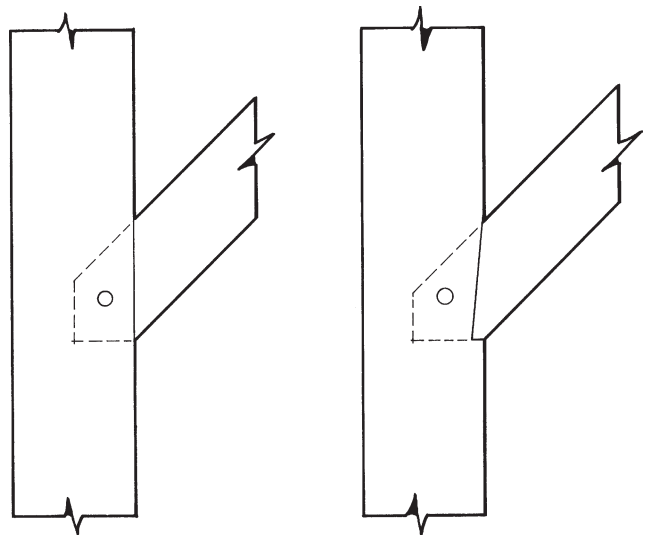
Fig. 8. Scribe rule braces: nonbearing shoulder on the left, diminished bearing shoulder on the right.

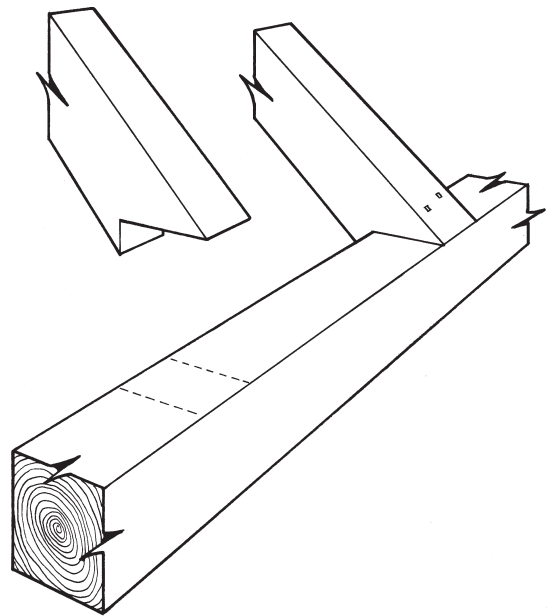
Fig. 1. With a birdsmouth cut to fit the inside of the plate, roof thrust is adequately resisted. Here the joint is secured with nails.

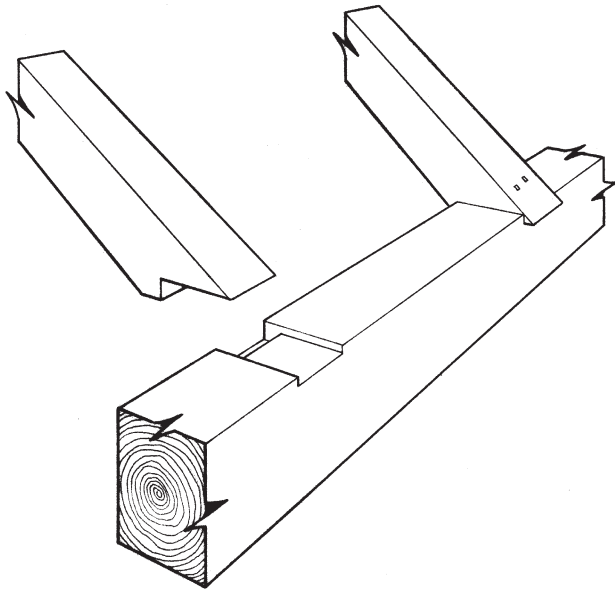
Fig. 2. The housed birdsmouth supports the lower side of the rafter and eliminates the tendency of the rafter to split up the mouth. This example is also housed into the top of the plate.

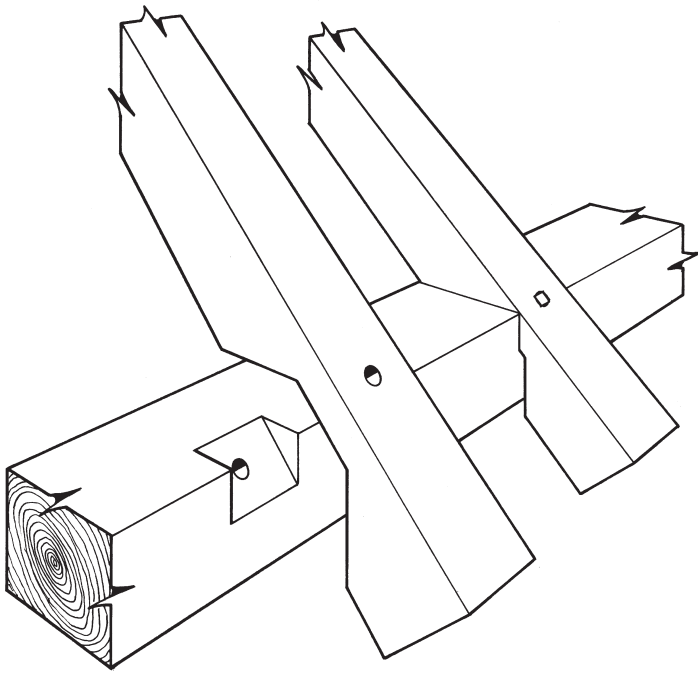
Fig. 6. In a mid-19th-century house in Shelburne, Massachusetts, the rafters have a level cut with a through tail to support a cornice.

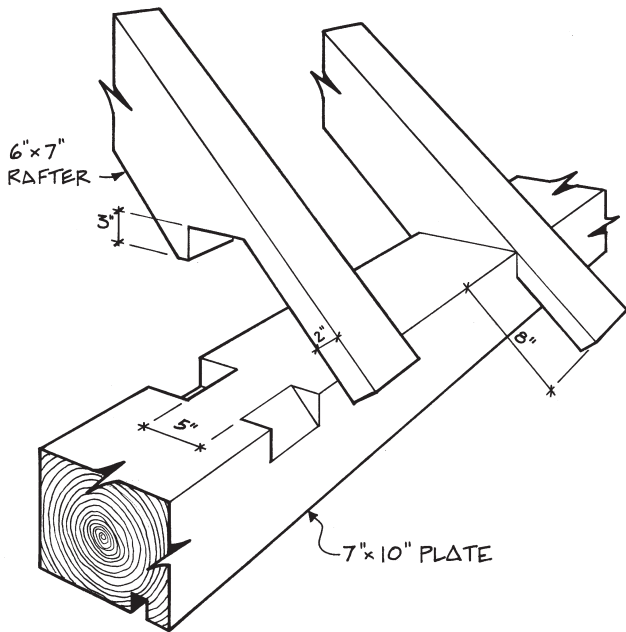
Fig. 7. Housed birdsmouth rafters with through tails found in a well-crafted 18th-century barn formerly in Hoosac, New York. Rafters were supported at midspan by a purlin plate and joined to a ridge at the peak. Groove in the underside of the plate was for vertical wall boarding.

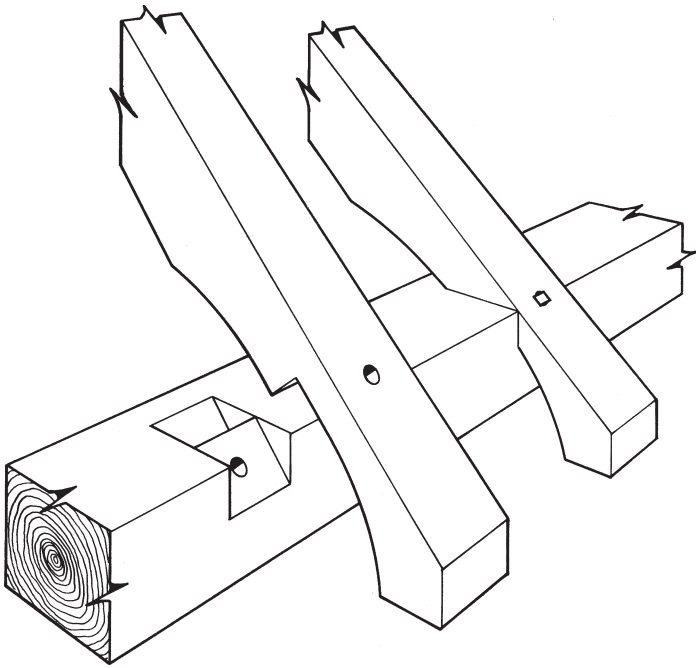
Fig. 9. The step-lap rafter can be shaped with an adze. Here the tail has a plumb and a level cut to support a cornice. A squarish pin through the tail secures it.

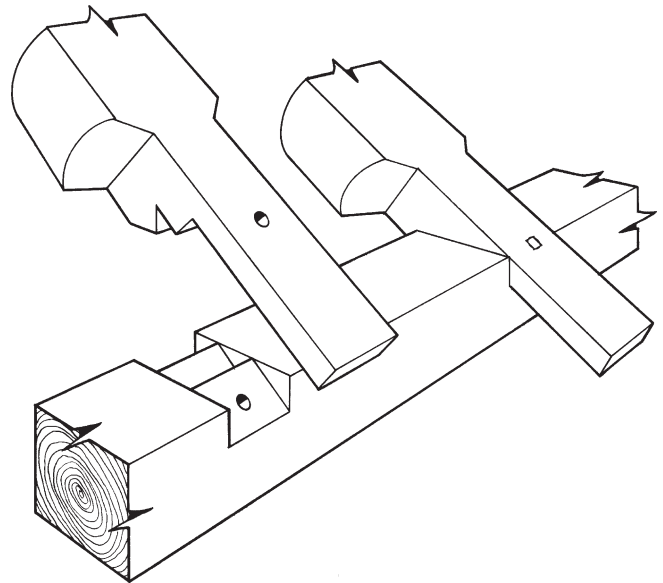
Fig. 13. The ultimate rafter-plate joint must be this example found in an 18th-century barn in Sheffield, Massachusetts. It combines the step-lap with the housed birdsmouth to create this magnificent but obviously time-consuming joint.

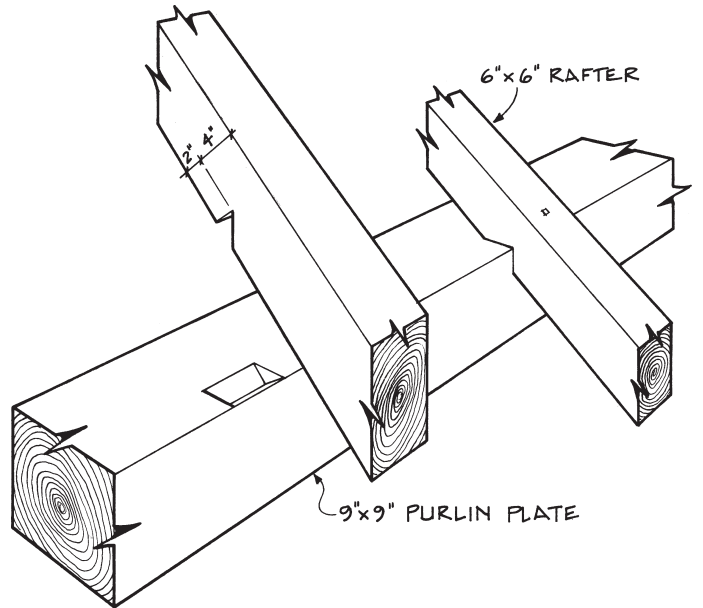
Fig. 21. This purlin plate joint was found in a 45-ft.-square barn in Middleburg, New York. It is simple and effective.

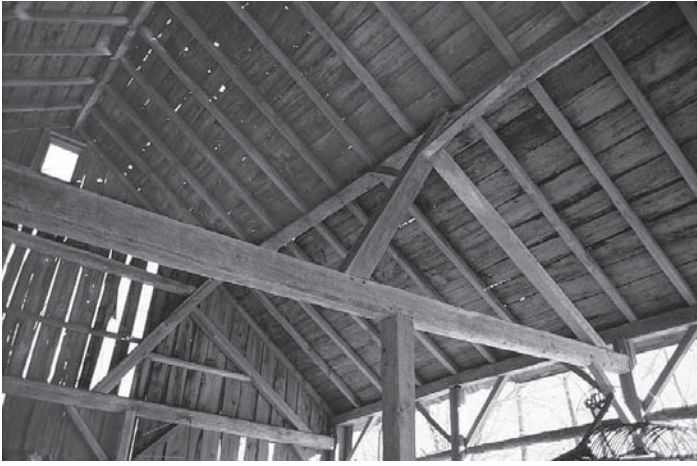
Mid-19th-century Hinsdale, Massachusetts, barn before dismantling. The continuous purlin plate assembly is canted perpendicular to the roof, and the purlin plate is flush with the roof. The rafters tenon into both upper and lower faces of the purlin plate.

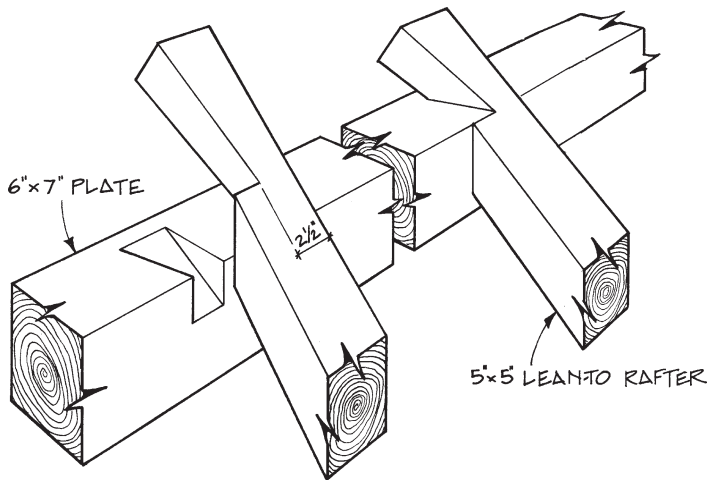
Fig. 38. In this ingenious and singular example from a barn in Seekonk, Massachusetts, the lean-to rafter is half-dovetailed in both width and thickness to lock into the main plate.

OTHER ROOF JOINERY. Lean-to additions are common on old structures, some built simultaneously with the main frame. By lessening the pitch of the lean-to roof, to produce a *broken back* roof, the rafter connections are simplified. The lean-to rafter can bear on the plate or on top of the main roof rafters (Figs. 36-38).

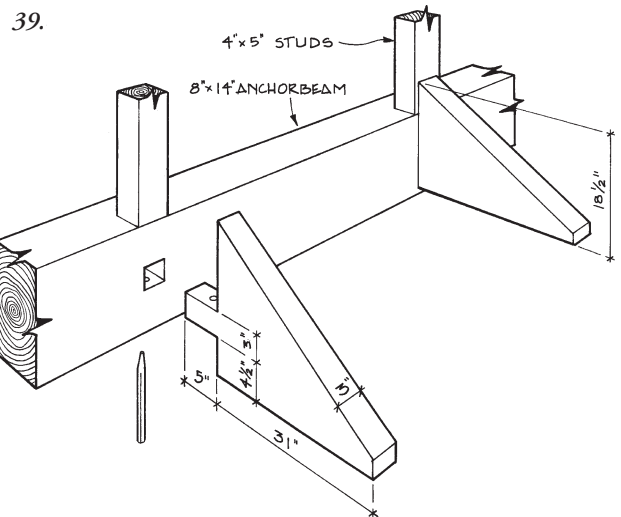
Figs. 39 and 40. Above (39), many end anchorbeams have telltale mortises, but only one example of this type has been found with all pentice parts intact, on a 44x45 barn that originally stood in Berne, N.Y. Though the 3x3 tenon 5 in. long would seem undersized, it worked for over 200 years. Below (40), many Dutch barns had cantilevered pentice arms (or outriggers) mortised full-size through the gable anchorbeam. Four or five of these supported the pentice plate and rafters.

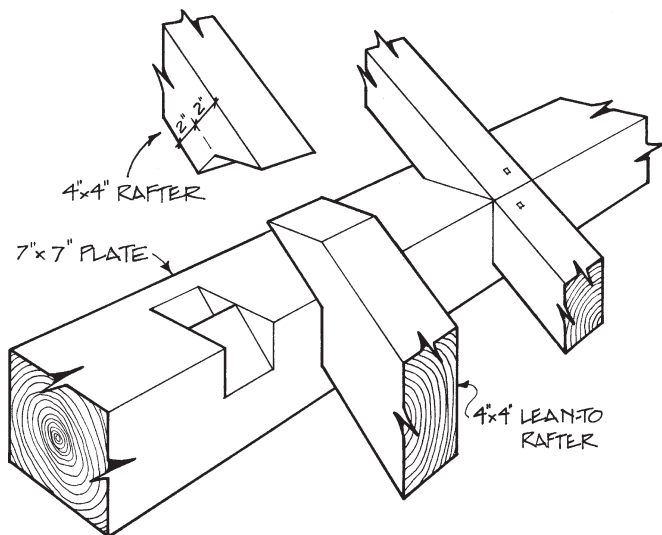
Fig. 37. In this early 19th-century Pittsfield, Massachusetts, house, the lean-to pitch matches the main roof pitch and the rafters are beveled in the step-lap seat.

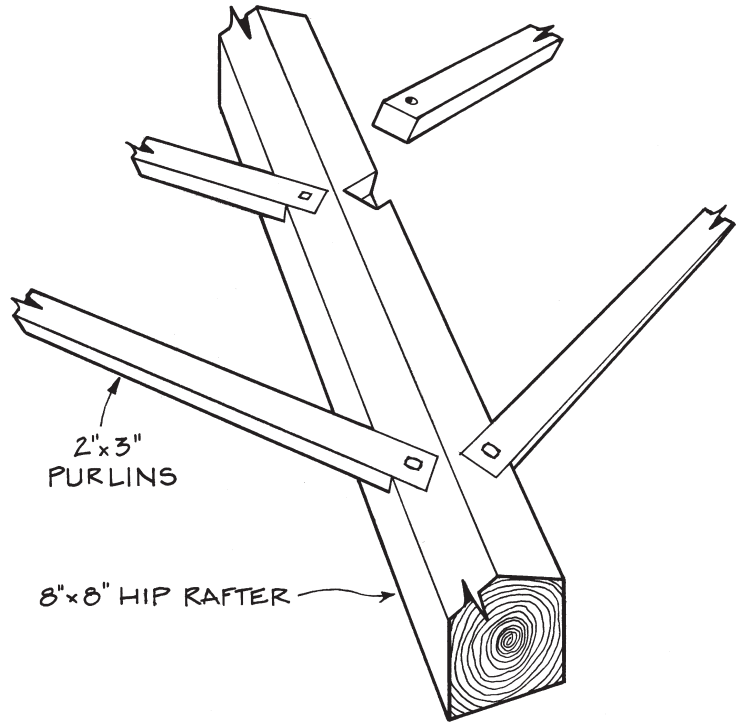
Special-case configuration of common purlins in an 18th-century hipped-roof meetinghouse, Pownal, Vermont.

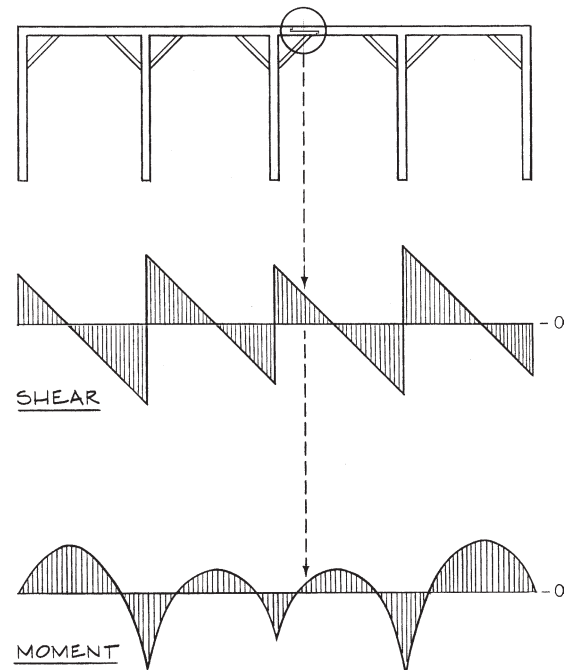
Fig. 1. Elevation of a plate continuous over five posts, showing a typical scarf location. Diagrams show resultant shear and moment values, both positive and negative, with horizontal line at zero force.

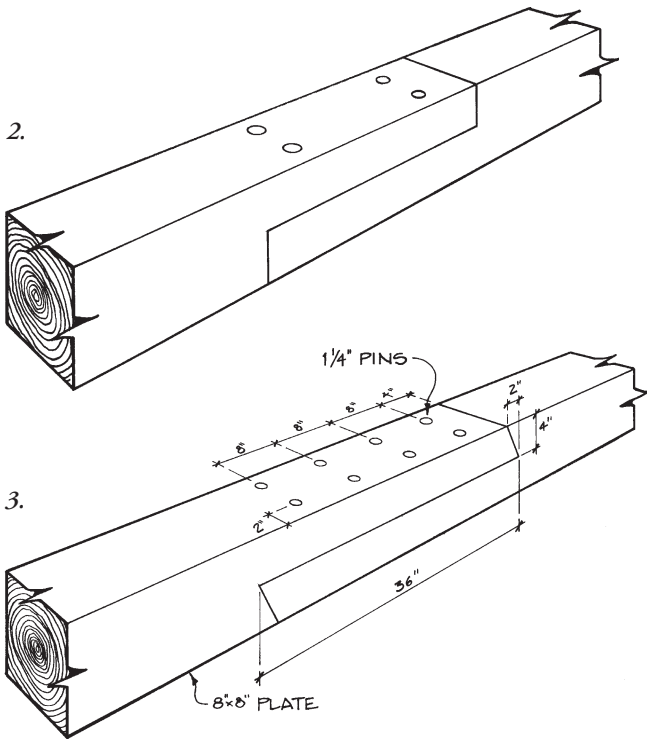
Figs. 2 and 3. At top (2), halved scarf with four pins. Above (3), halved and undersquinted scarf found in an early-19th-century barn in Monterey, Massachusetts. The barn's only scarf, perhaps necessitated by an oversight in timber procurement, it has held up well despite its center-of-span location. Note 1-in-2 angle of squint.

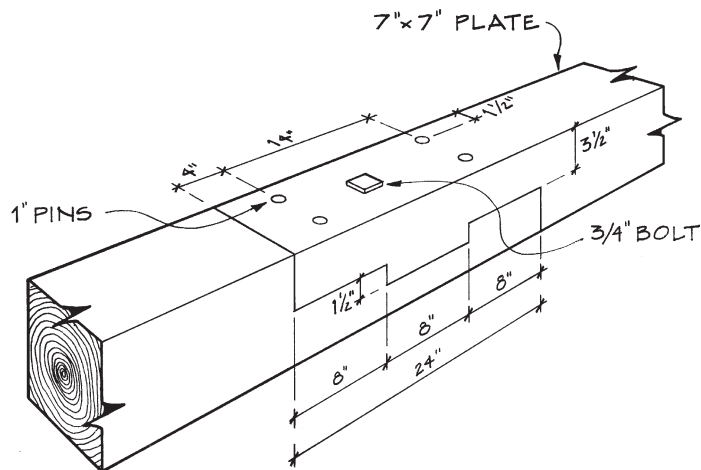
Fig. 6. Halved and tabled scarf in a 25x35 three-bay 1860s barn in Windsor, Massachusetts. This simple, effective joint relies on one bolt to keep it together.

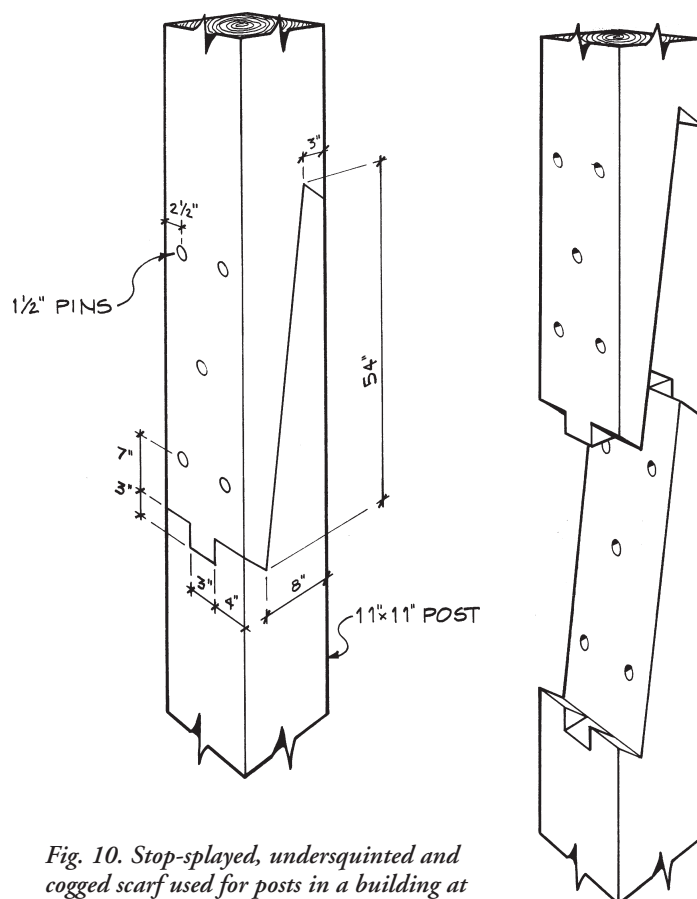
Fig. 10. Stop-splayed, undersquinted and cogged scarf used for posts in a building at Hancock (Mass.) Shaker Village, 1835. Apparently original, these joints are still tight. Note squint angle of 1 to 1.

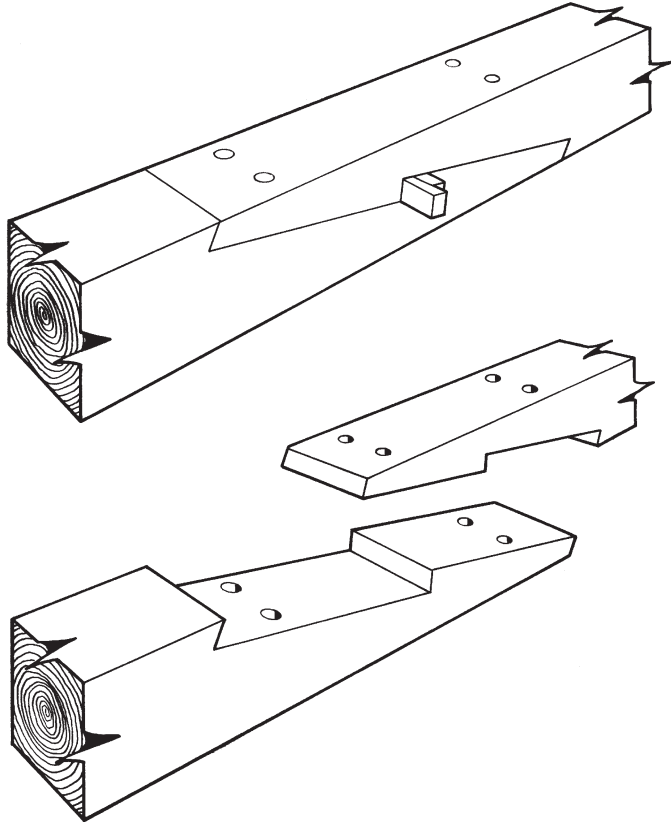
Fig. 11. Assembled and exploded views of stop-splayed, undersquinted and wedged scarf with four pins. Opposing wedges pre-stress the joint.

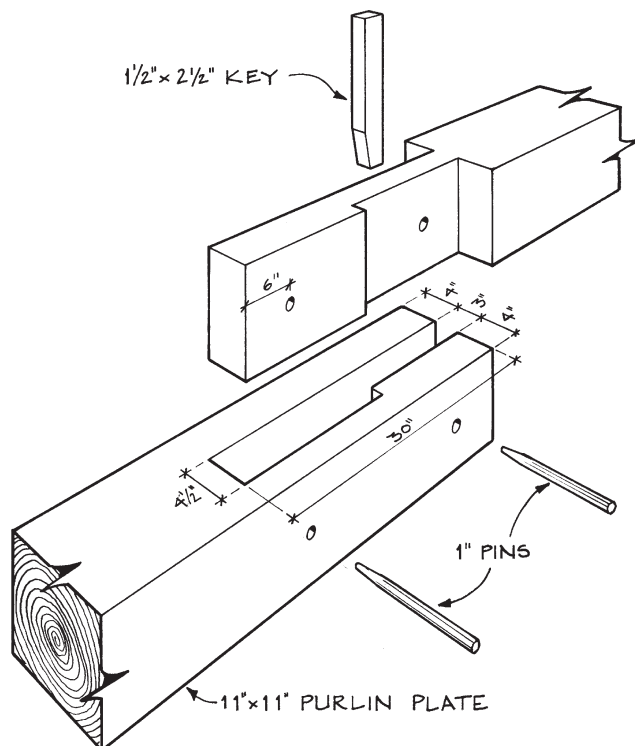
Fig. 17. Tabled and bridled scarf with key, 5-bay barn 62x81, Genoa, Nevada, ca. 1858.

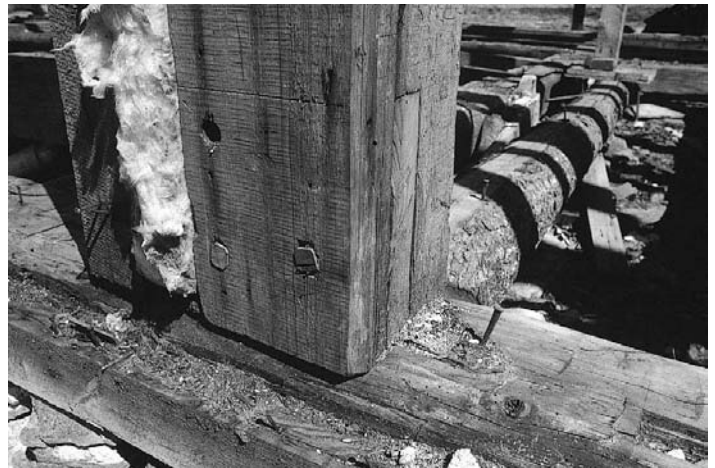
A free tenon in the bottom of a post in this house in Windsor, Mass., may be a repair or a fix for a mistake. Shadows are cast by joists above.

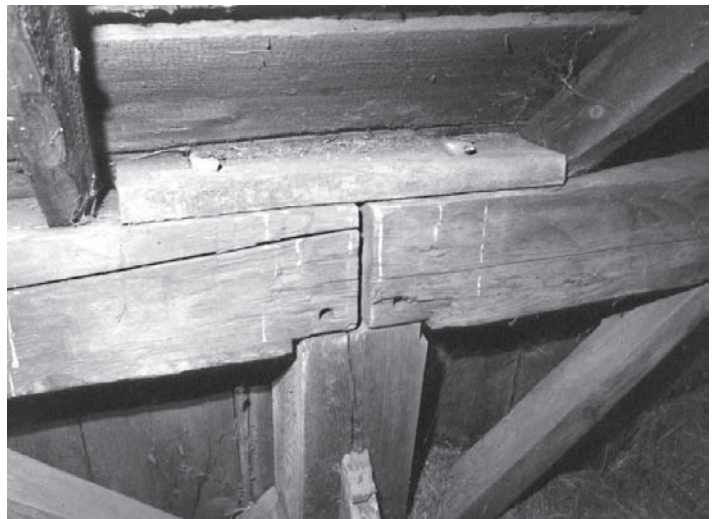
This strange arrangement in a barn in Rochester, Vermont, uses the post-top tenon as a sort of free tenon to join the plates, though pins are invisible. The builder must have realized the inherent weakness of the connection and added the fish plate on top, secured with two pins.

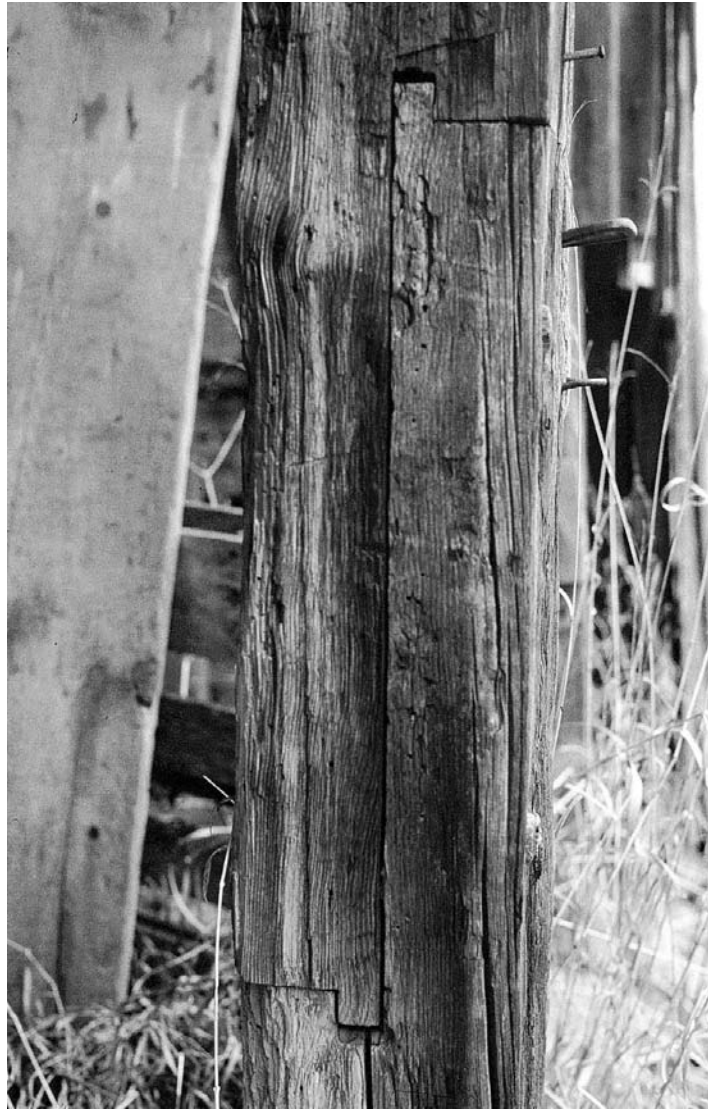
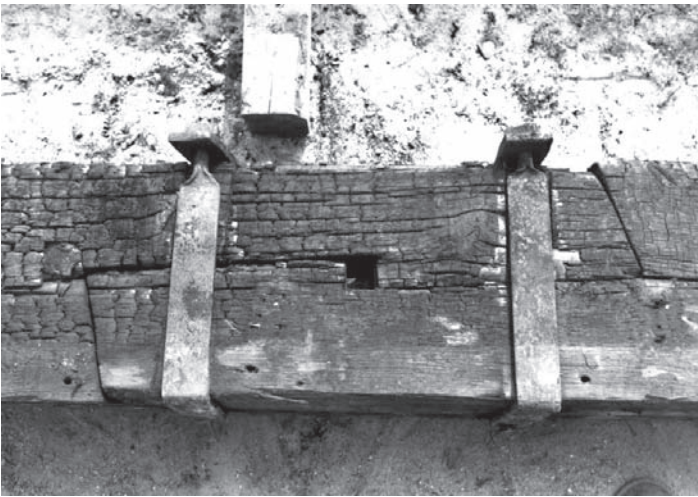
At top, bladed scarf with key, barn sill in Woodford, Calif. The sill is 8x8 Ponderosa pine, the scarf only 16 in. long. Top right, a bladed scarf used to repair a 7½ x 9½ post in a barn in Buskirk, N.Y. The tenons are 1 in. thick and 1 in. long, the scarf 23 in. long, with four pins. Above, a stop-splayed, undersquinted and tabled scarf with key used in a 6½ x 13 truss chord in the 1796 Cabildo in New Orleans (roof burned 1988, reconstructed 1992). There is barely a splay, and two forged iron straps still hold the joint together. At right, this unusual stop-splayed, undersquinted and tabled scarf in Pine Plains, New York, did not employ a key: the halves had to be slid together sideways.
