TIMBER FRAMING

JOURNAL OF THE TIMBER FRAMERS GUILD

Number 74, December 2004

TOPICS Rick Collins	2
HISTORIC AMERICAN ROOF TRUSSES IV. COMPOSITE AND RAISED BOTTOM CHORD TRUSSES Jan Lewandoski	4
COMPOSITE AND RAISED BOTTOM CHORD TRUSS ENGINEERING Ed Levin	20
D-I-Y DOWN UNDER II Rob Hadden	22

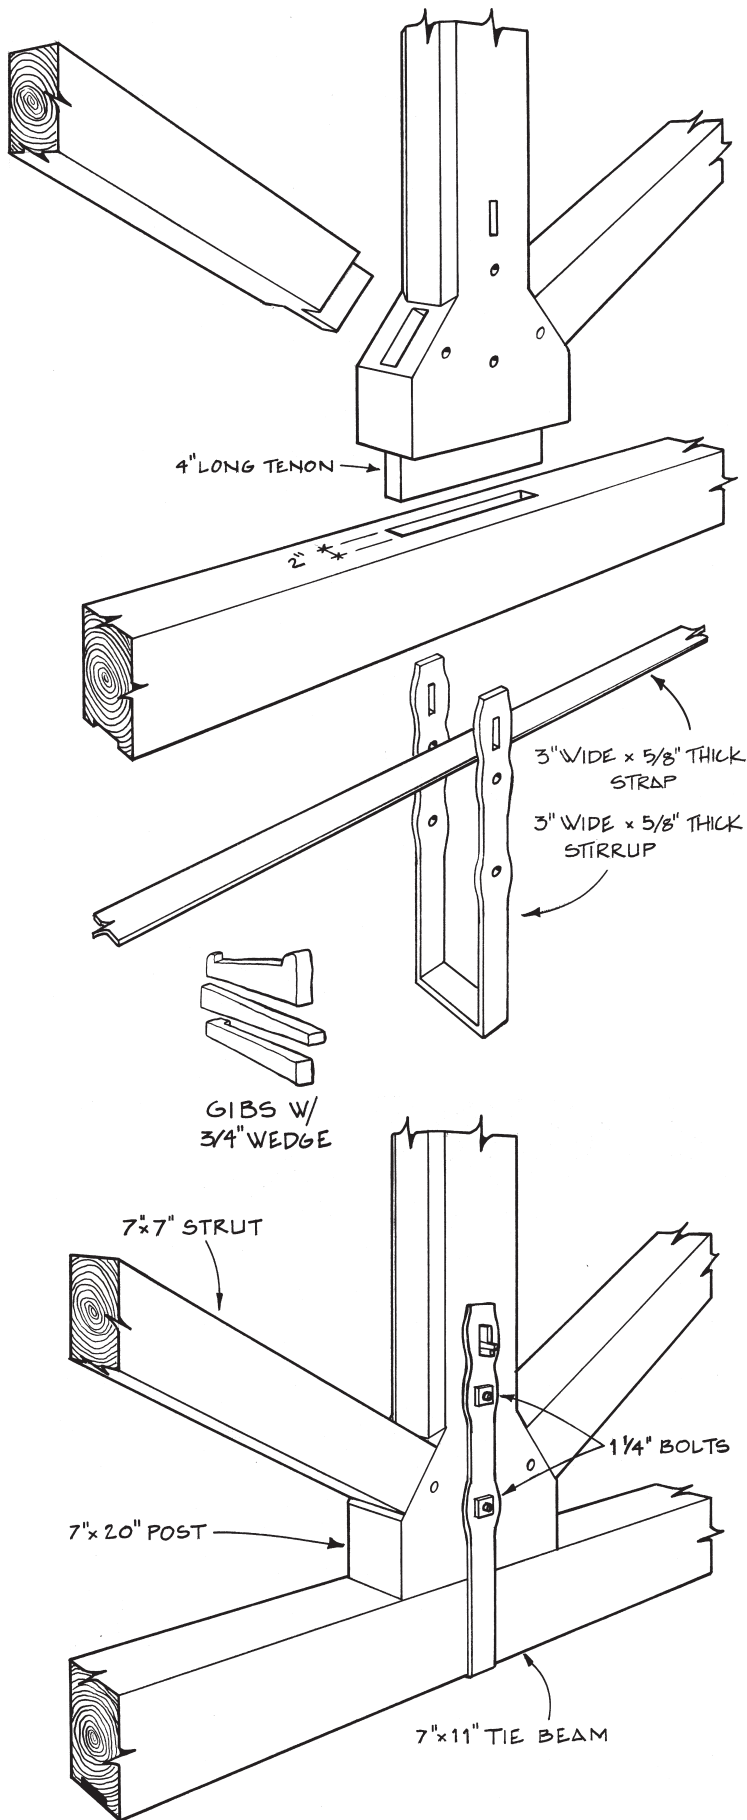
Fig. 6. Exploded and assembled views of Central Moravian post foot. Wedged and bolted straps reinforce critical joint and entire lower chord.

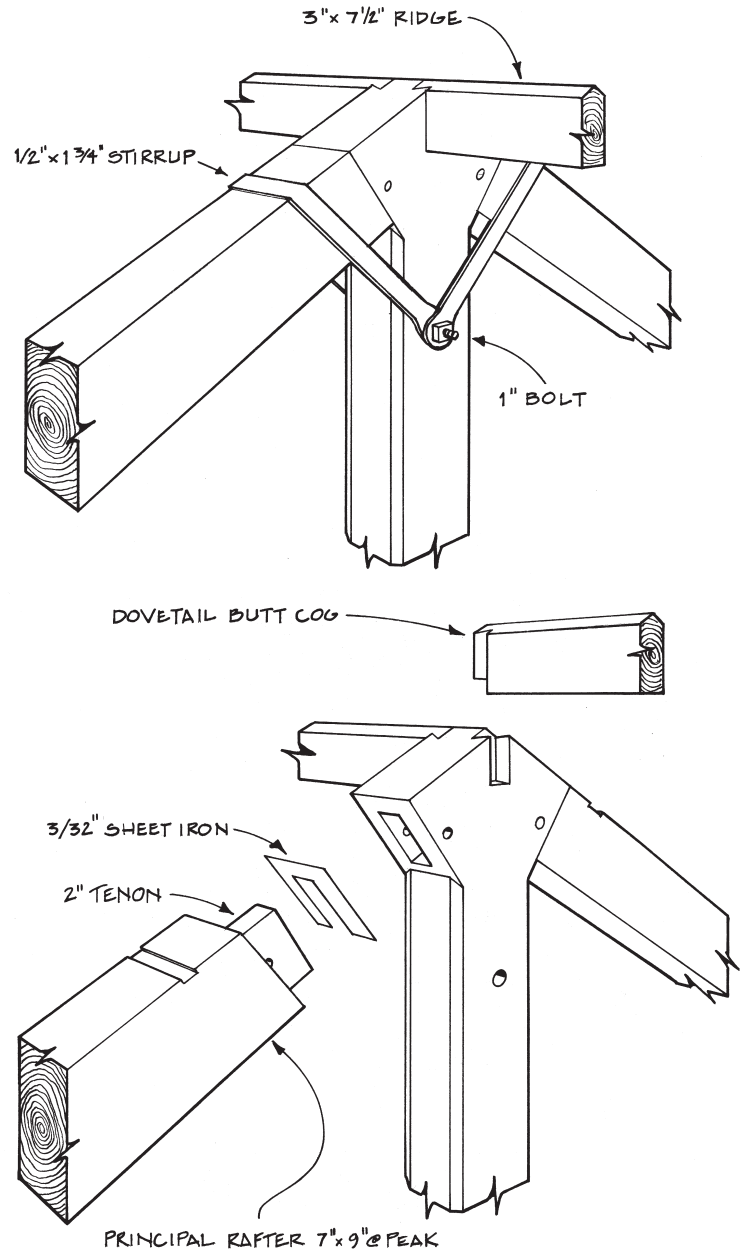
Fig. 10. Kingpost head, exploded and assembled views, at Central Moravian Church. Sheet iron may be meant to protect joint from deforming. Post is oak; principal rafter is pine. Iron strap at top represents more belt-and-suspenders engineering.

While the wooden truss forms were handled in a somewhat unusual and perhaps archaic way, the builders were not shy about incorporating metal. In addition to the bolting we have noted, the king- and queenposts, merely stub-tenoned where they enter the bottom chord, rely on carefully fastened U-straps that join the members to carry the major share of joint tension (Fig. 6 previous page). At the other end of the kingpost, a forked iron yoke helps restrain the principal rafters to the kingpost head, a measure hardly necessary considering the extra-normal bearing (Fig. 10).

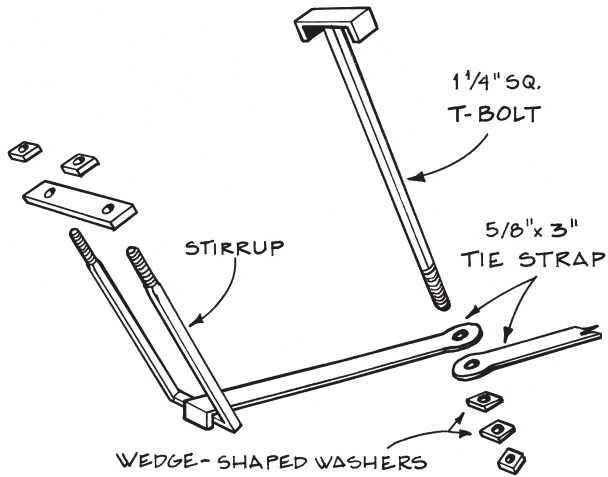
Fig. 12. Exploded view of Central Moravian hardware fastening principal rafter (or upper chord of kingpost system) to lower chord, meanwhile restraining upper chord of queenpost system and attaching to 5/8-in. x 3-in. iron tie strap running under entire lower chord. The strap is segmented and periodically bolted to the lower chord through eyes at the segment ends, with wedge-shaped washers provided to obtain perfect bearing for the nut on the angled surface.

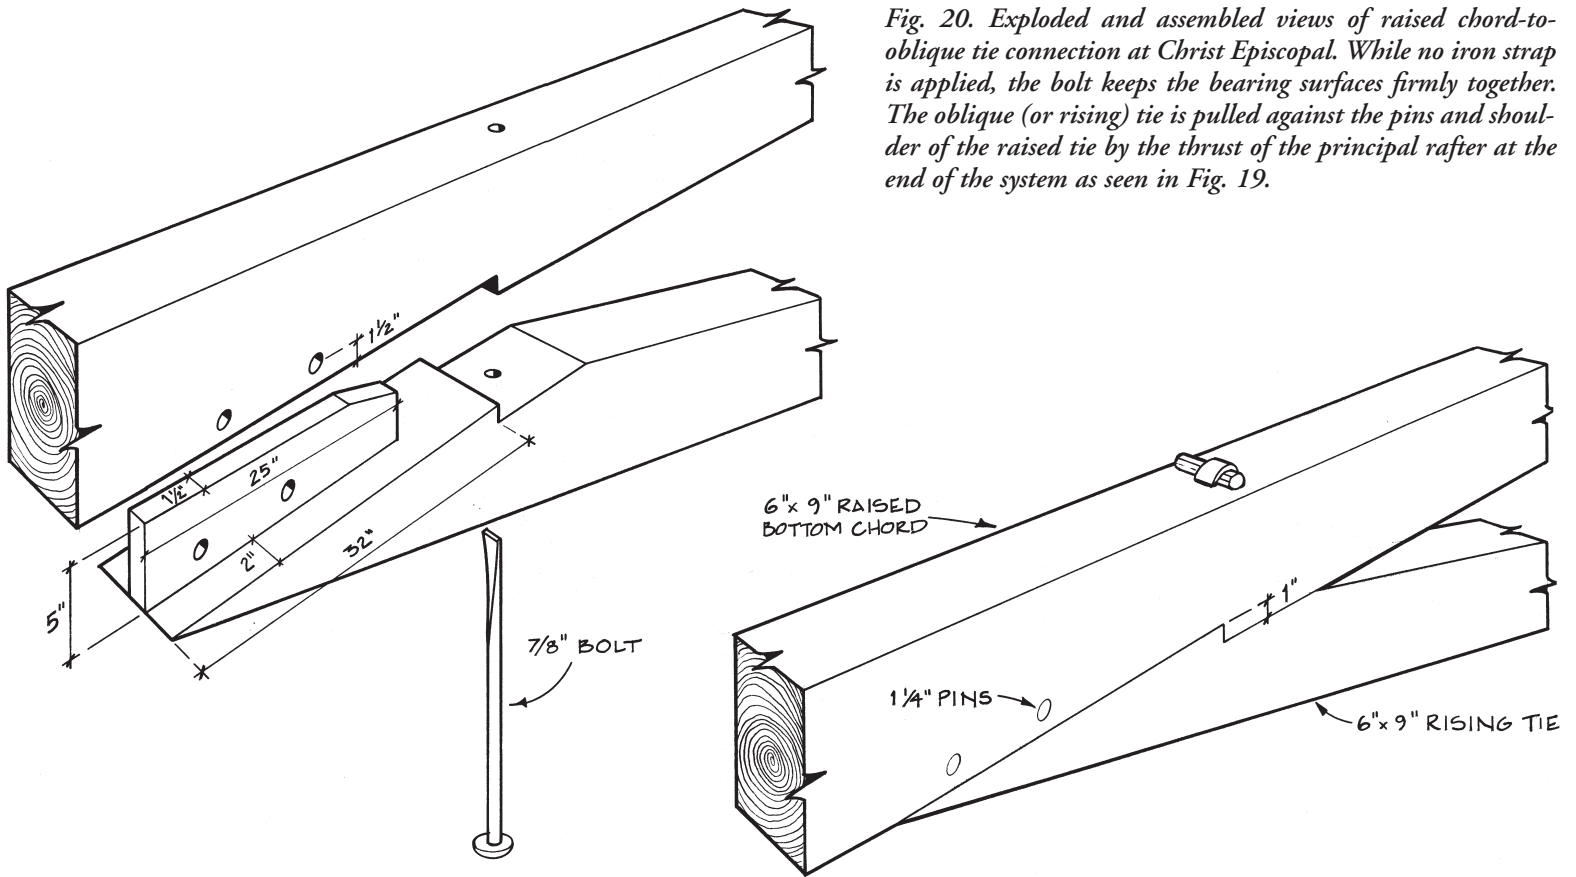
Fig. 20. Exploded and assembled views of raised chord-to-oblique tie connection at Christ Episcopal. While no iron strap is applied, the bolt keeps the bearing surfaces firmly together. The oblique (or rising) tie is pulled against the pins and shoulder of the raised tie by the thrust of the principal rafter at the end of the system as seen in Fig. 19.

A notable but unexpected point of failure in the Shrewsbury trusses occurred where a short vertical strut joins the bottom of a raised chord, quite near its rafter junction, to the top of the oblique tie near its midspan, within 1 ft. of the bearing of the large double-pinned brace rising from the wall post to the bottom of the oblique tie. At first glance this strut would appear to provide an improved load path from rafter and collar to a point lower on the wall post (Fig. 22). But an oblique tie broke at exactly this point on the west side of one of the trusses. It appears that the truss can fail at this

point if the bearing wall at its opposite end drops because of sill or foundation problems. Should that happen, the short strut could force itself into the oblique tie and the force then go through the oblique tie and into the diagonal brace (bending the wall post), or it could deflect and break the oblique tie, already weakened by its two closely spaced mortises for brace and strut.

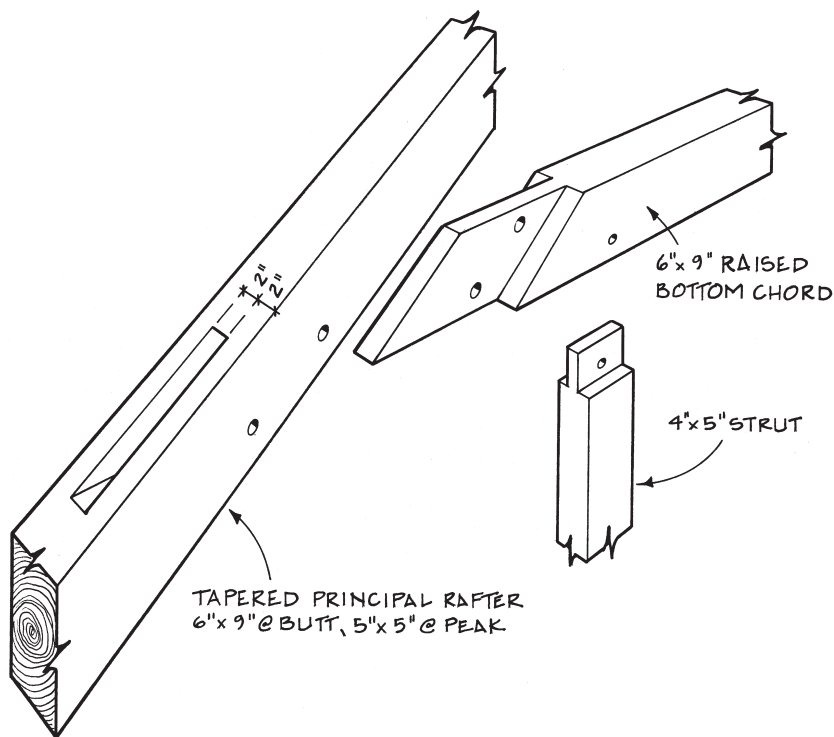
Fig. 21. Principal rafter-to-raised bottom chord joint at Christ Episcopal. Through mortise is especially laborious to cut and implies an assumption of considerable tension in the connection. Tenon relish behind pins is extended greatly, allowing pins to be set well away from interface of joint for maximum mortise strength in withdrawal.

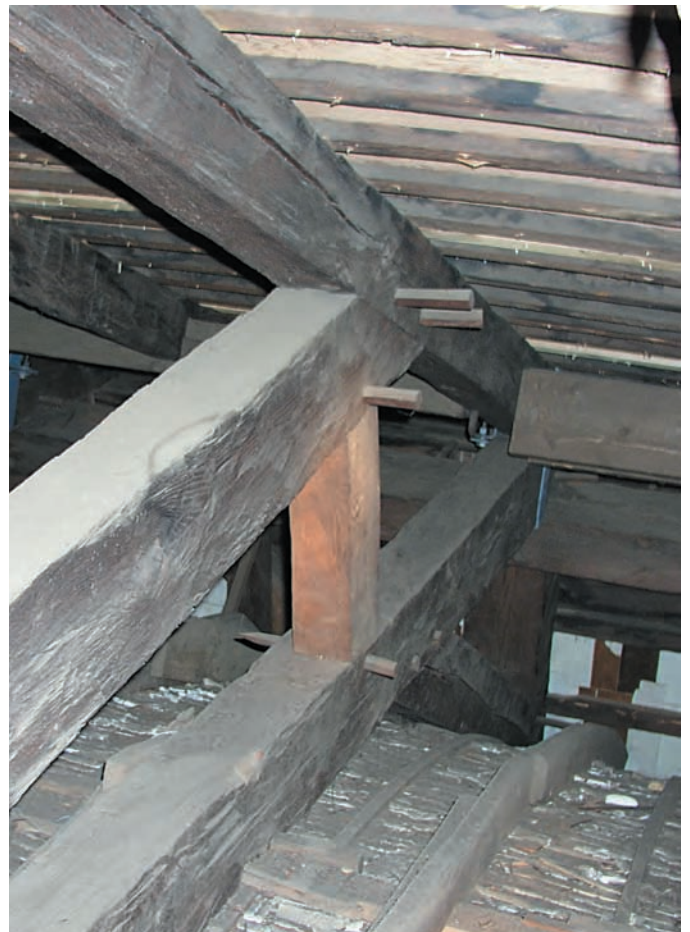
Fig. 22. Principal rafter at Shrewsbury descending past connection with raised chord to meet oblique tie over plate. Brace rises from post to oblique tie, and vertical strut connects latter and raised chord. Some back-primed shingles visible at wall.

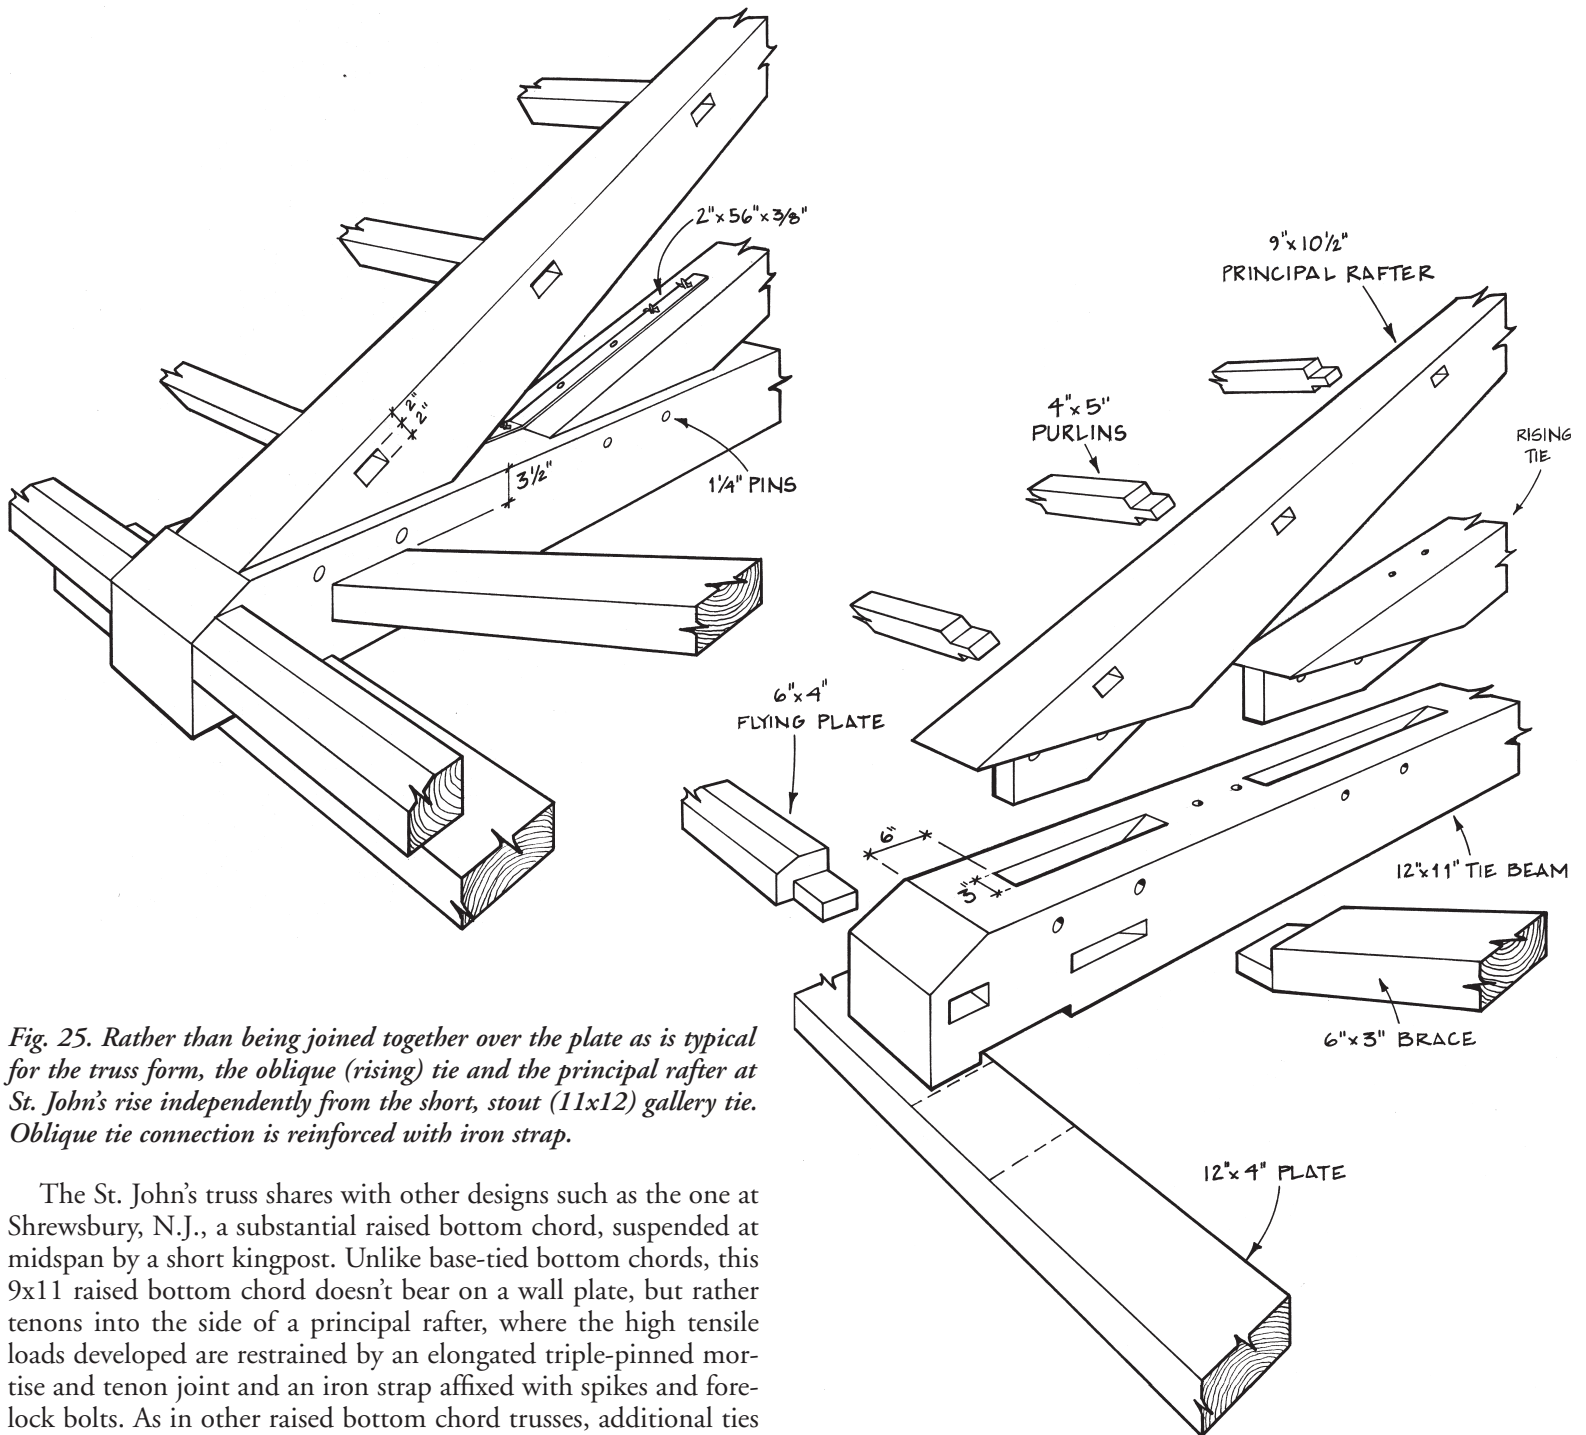
Fig. 25. Rather than being joined together over the plate as is typical for the truss form, the oblique (rising) tie and the principal rafter at St. John's rise independently from the short, stout (11x12) gallery tie. Oblique tie connection is reinforced with iron strap.

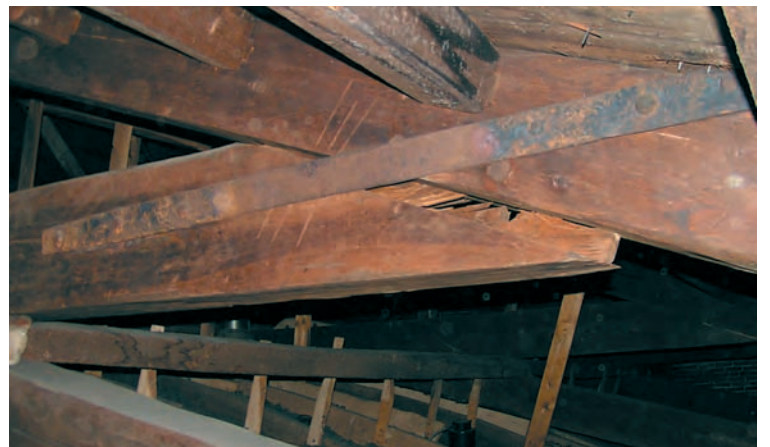
Fig. 29. Tenon destruction in raised chord withdrawn from principal rafter in St. John's truss. Strap may conceal shear failure in chord.

The problem at St. John's is that the gallery post extensions prop the principal rafters near midspan but do not directly or even closely support the raised bottom chord and its joints with the principal rafter. Perhaps consequent from this anomaly are the only failures we observed at St. John's: two separated junctions between raised bottom chords and principal rafters, one noteworthy and one resulting in complete destruction of the chord tenon at this pinned and strapped joint (Fig. 29 overleaf).

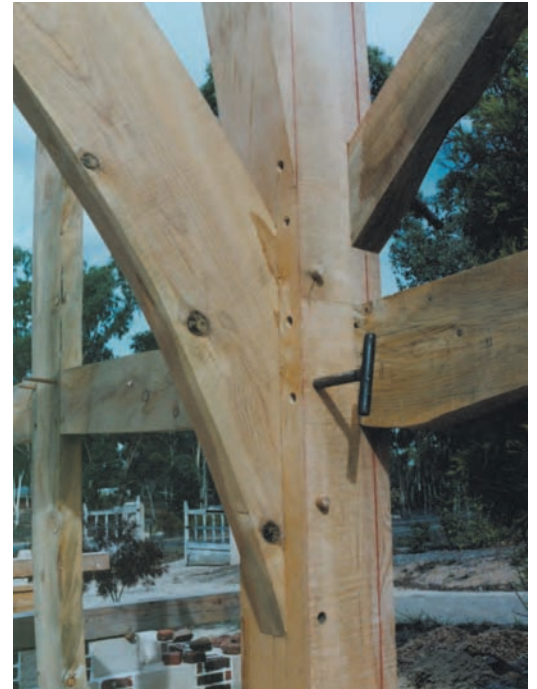
Inch-and-a-half reference line plainly visible on side of post aligns mortises for rail and brace, plus tenons for plate above and sill below.

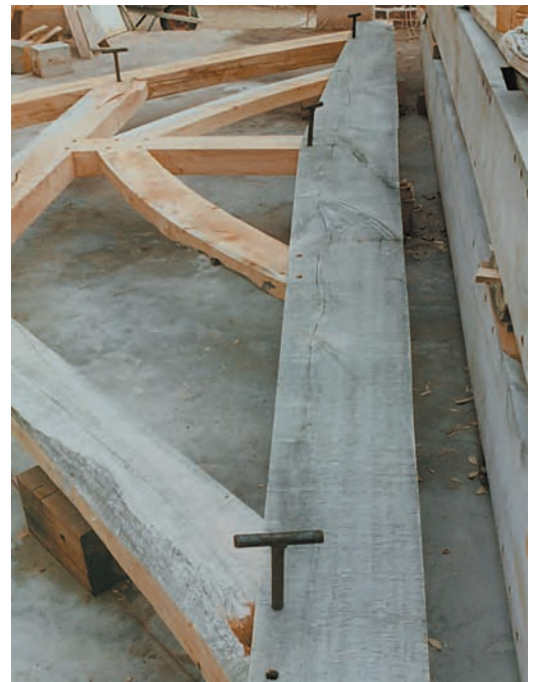
Completed layout assembly of Kentish-style truss. Note struck chalk line on layout floor. Iron drift pins are indispensable in scribe rule layout.

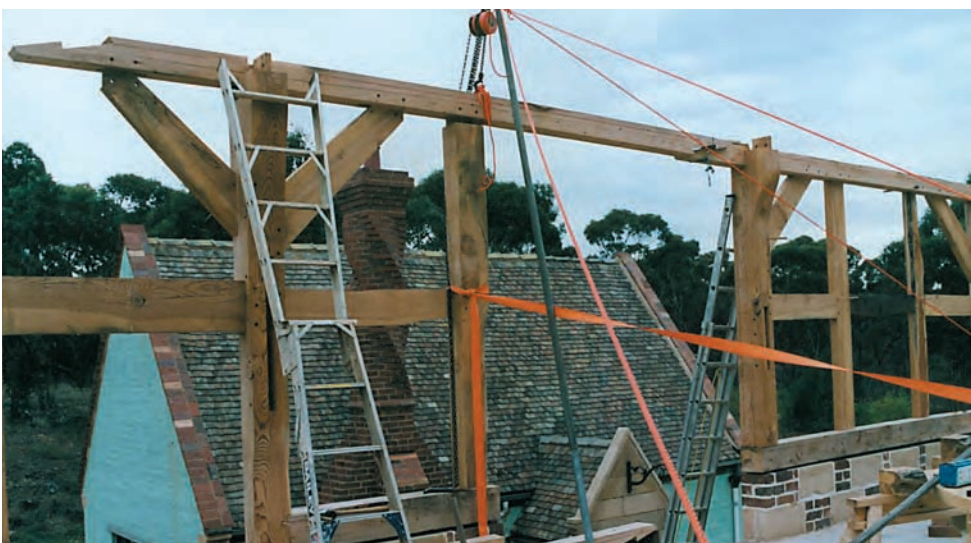
Setting the 5-piece scarfed 75-ft. plates. Post jowls are uniquely shaped. In the background, the author's first effort (1994-2000), a masonry building with timber-framed roof.

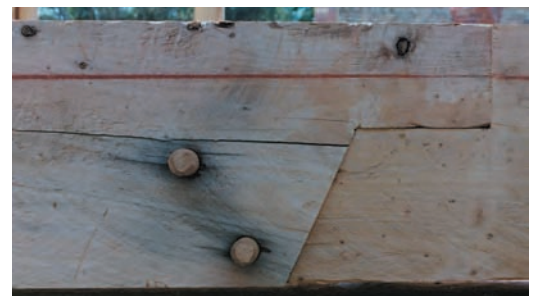
Bridled scarfs join sills or plates where continuously supported. Elsewhere scarfs are stop-splayed.
