Stone Wall Repair Workshop: Ellsworth Rock Gardens Voyageurs National Park 2007

National Center for Preservation Training and Technology
Grant #2210-MT-07-NC-08

September 4, 2007

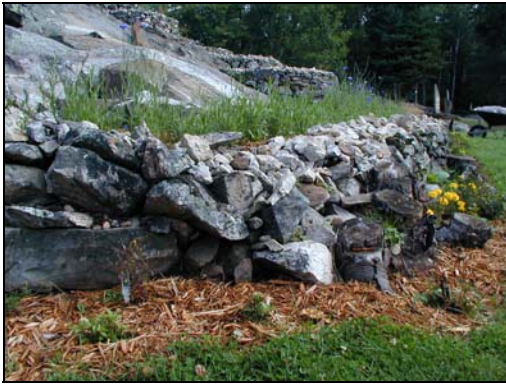
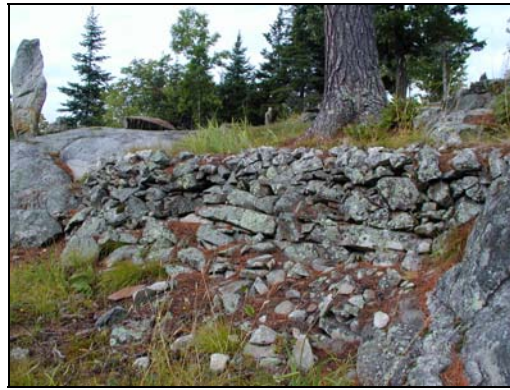
- Intrusive vegetation (especially grass, vines, and shrubs)
- Large amounts of accumulated organic material
- People, animals and tree roots dislodging rocks
- Compaction from foot traffic
- Vandalism
- Uninformed repairs
- Displaced “frosting” from wall tops

Examples of damaged stone walls

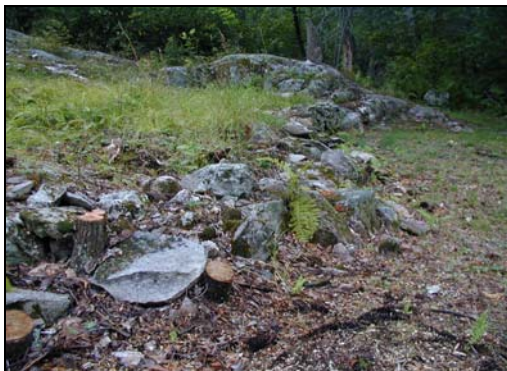
Stone wall before repairs

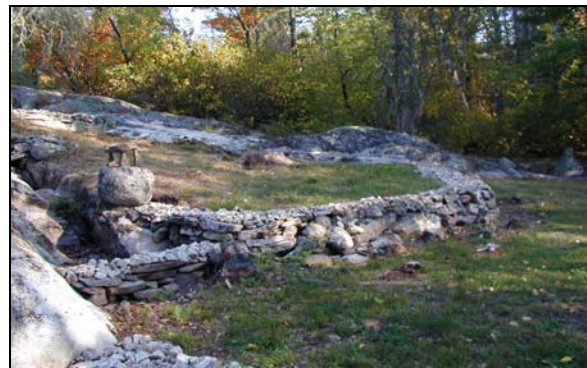
Same wall after repairs in 2006

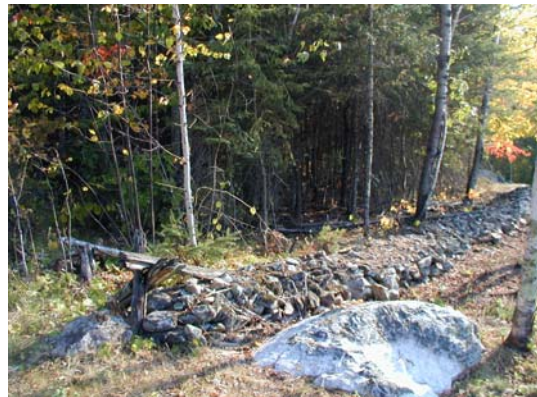
This is one of six sections of free-standing stone wall that divide the summit of the garden from what appear to be Mr. Ellsworth's working parts of the garden, containing compost containment areas and piles of rock. Although there are sculptures beyond this wall, it seems that they were meant to be viewed from a distance or represent areas of the garden that were works in progress. This wall is different in that instead of frosting, it was topped with a rail fence. A 40' section of this stone wall was repaired by removing rocks to base, cleaning out organic debris, and restacking the wall. The wood fence will be reconstructed in the future based on historic photos and fence remnants that can still be found on site.

Before repairs—note remnant of fence

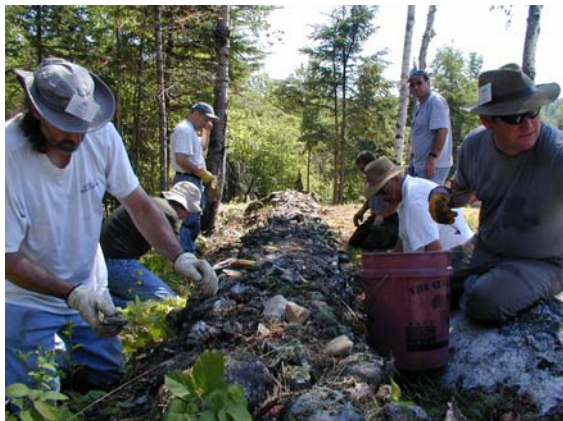
Repairs in progress

1. Perimeter wall behind serpent sculpture (#57)
40' (L) x 12" (H) x 28" (D)
Removed rock to base, cleaned out organic debris, restacked
Large amount of excess rock at downhill end that looks like sculpture pieces but no mortar found. Left this rock in a pile near wall.
Photos 2a-2h

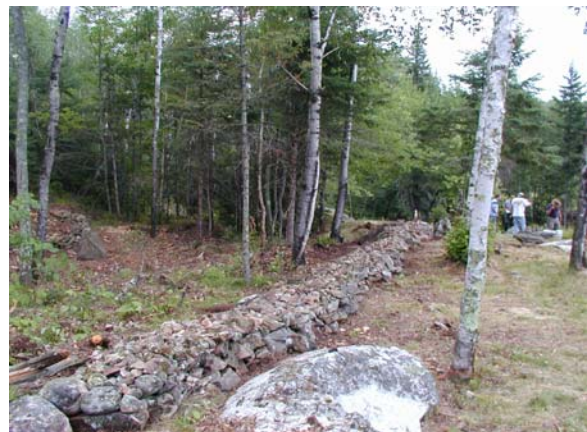
Repairs completed

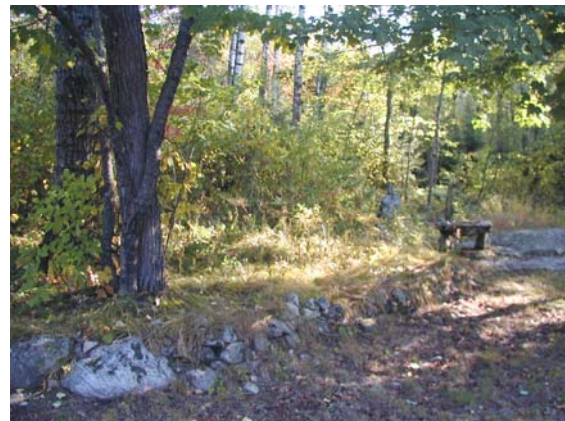
This bed is located at the base of the garden near the site of the Ellsworth's summer home. The front of the bed is more formal with frosting covering the wall, while the wall on the backside is constructed of cobbles.

Before repairs

3. Bee balm flower bed behind picnic shelter
29' (L) x 12" (H) x 16" (D) of stacked wall with frosting at the front of bed
20' (L) x 12" (H) x 16" (D) of cobble wall at back of bed
Front of bed generally located between sculptures 176 & 100
Back of bed constructed of cobbles, not well defined & appears to incorporate a path leading back in the woods (to gateway found in 2006?)
End of bed near sculpture 176 impacted by 3 large trees
Large amount of grass and organic debris removed between rocks; redefined edges of bed to the extent possible
Photos 1a-1d

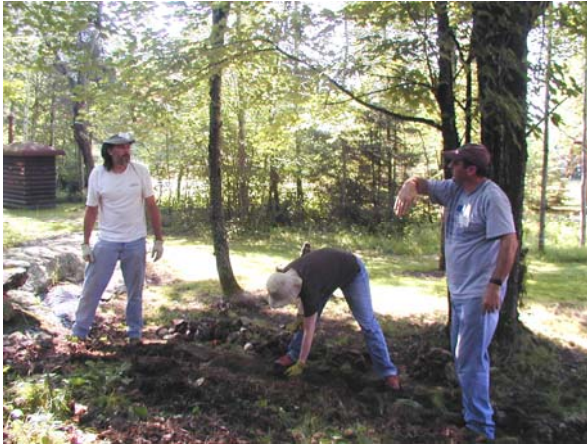
Repairs in progress

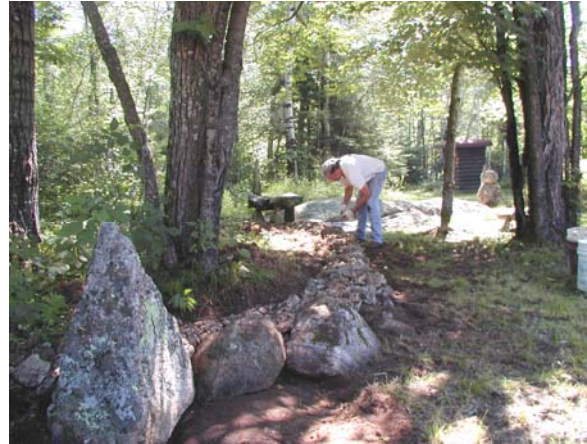
Final repairs

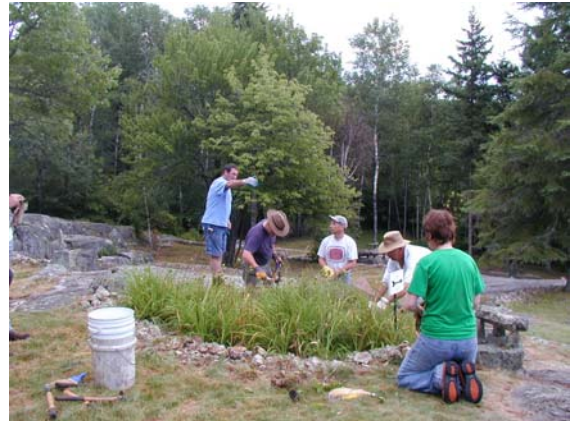
A small but prominent flower bed mid-way down the granite slope, this flower bed required repairs to a section of wall that was slumping on the downhill side.

Before repairs

4. Flower bed located between sculptures 43 & 44 and near arrow sculpture (#45) on the granite outcrop descent path
Wall is level with ground on uphill side and 3' tall at the tallest point on the downhill side
33' (L) x 3' (at tallest point) x 16" (D)
Removed frosting, dug out thick sod & other organic material, replaced frosting, repaired section on downhill side that had slumped
Photos 7a-7d

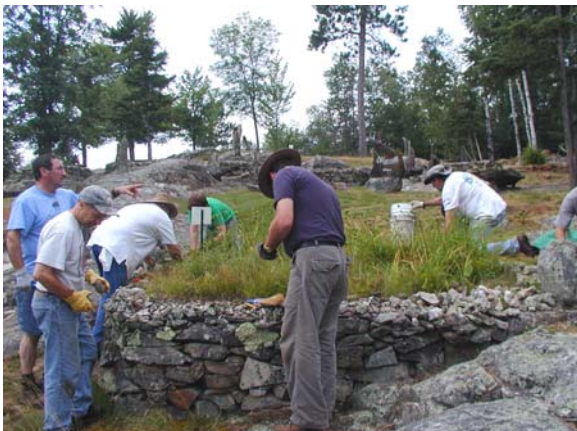
Repairs in progress

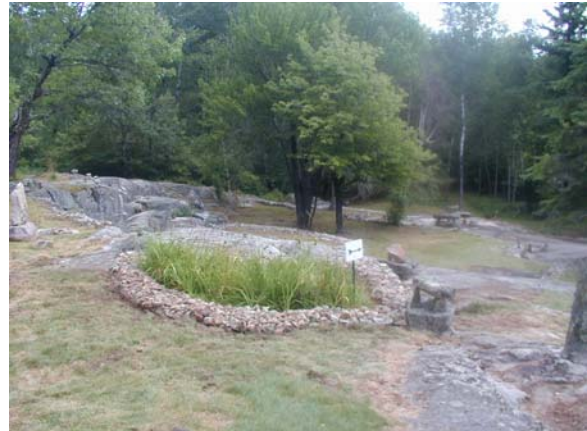
Completed repairs

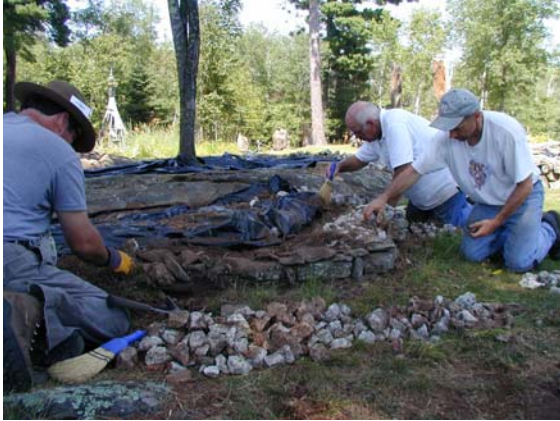
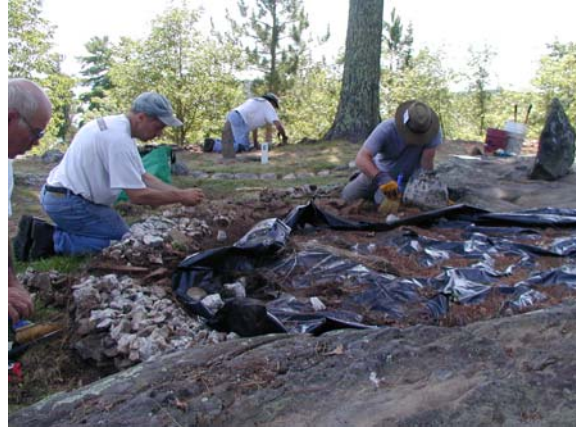
The crew removed the frosting layer, cleaned out the pine needles and other organic debris and replaced the frosting on this small flower bed located on the summit.

Repairs in progress

5. Small flower bed on upper terrace near leaf sculpture (#108). A round boulder with missing top (sculpture #104) is located at one end of stone wall. Other end of wall butts up against a bedrock outcrop.
19' (L) x 10" (H) x 12" (D)
Removed frosted, cleaned out organic material, and replaced frosting.
Photos 4a-4d

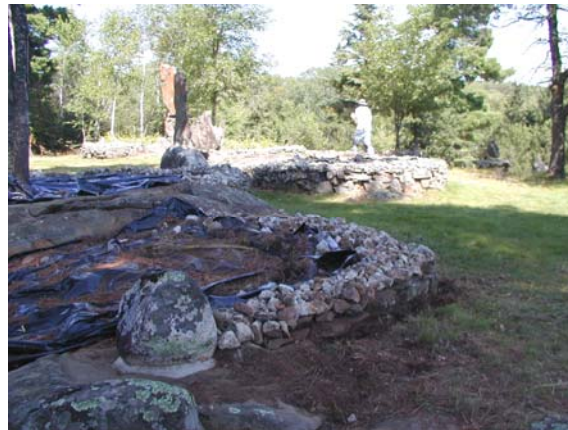
Repairs completed

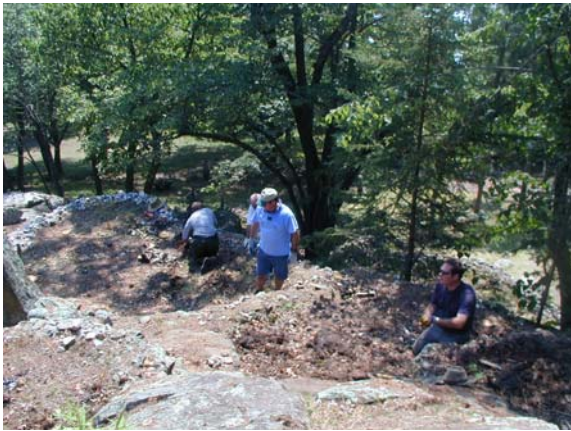
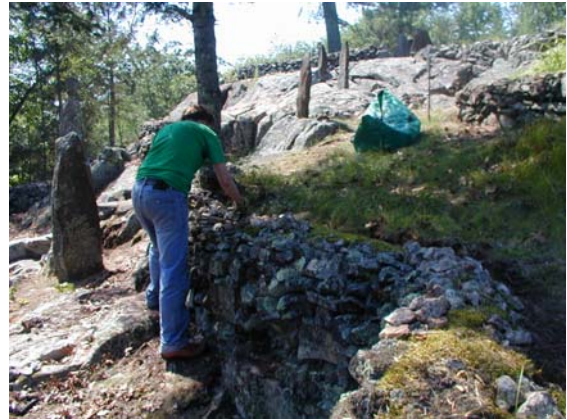
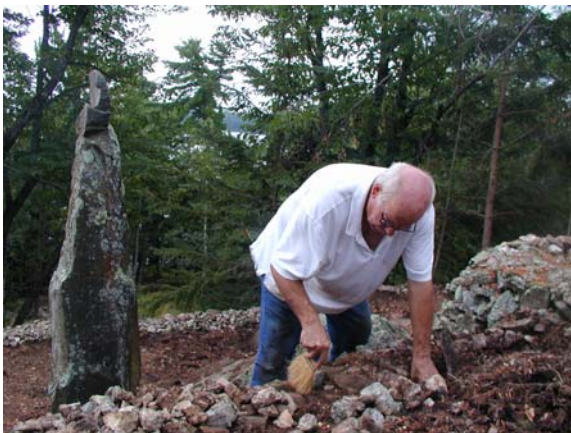
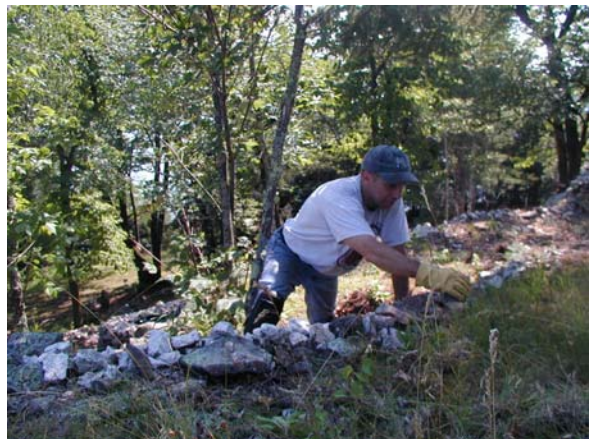
This is a series of terraced flower beds flanking a stairway that is part of the primary entrance path into the gardens from the base of the hill. This side of the slope is quite steep so the downhill sides of the flower beds typically measure three to four feet in height. A thick layer of organic debris had accumulated in these beds from many years of being overgrown with balsam trees. A large amount of frosting, wall rocks, and an occasional sculpture piece were found in these beds from flower beds located above. The work was primarily limited to removal of the frosting layer, cleaning out organic material and replacing the frosting. A drainage feature was uncovered in one of the terraced walls toward the base of the garden.

Repairs in progress

10. Series of terraced flower beds on east side of primary entrance path
 - a. 16' (L); 36" average height on downhill side; 14" (D); cleaned frosting layer

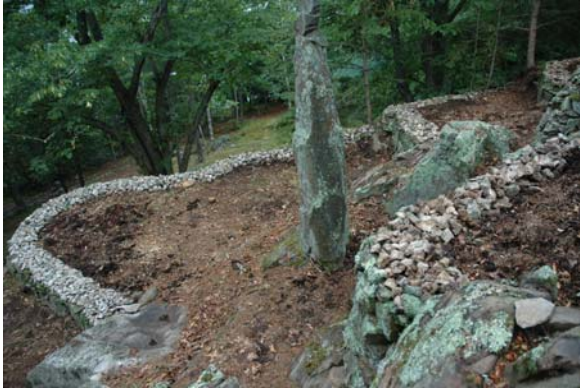
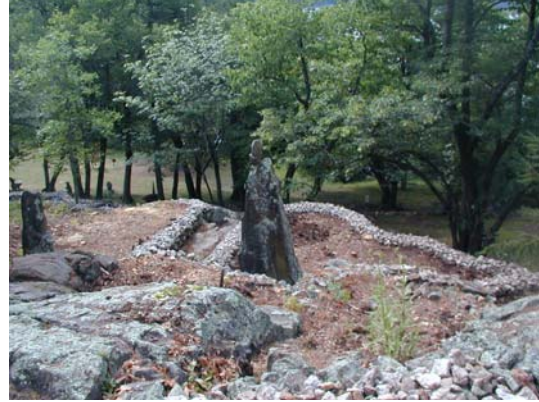
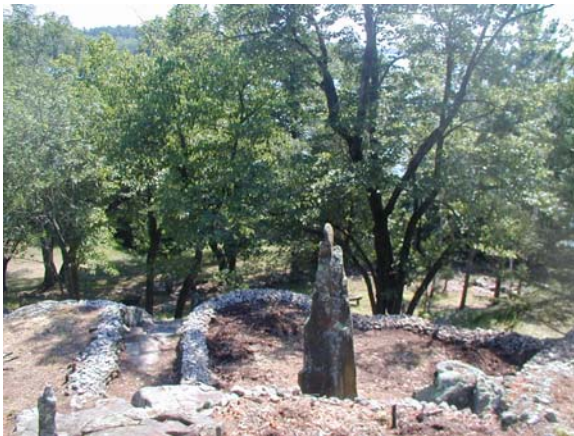
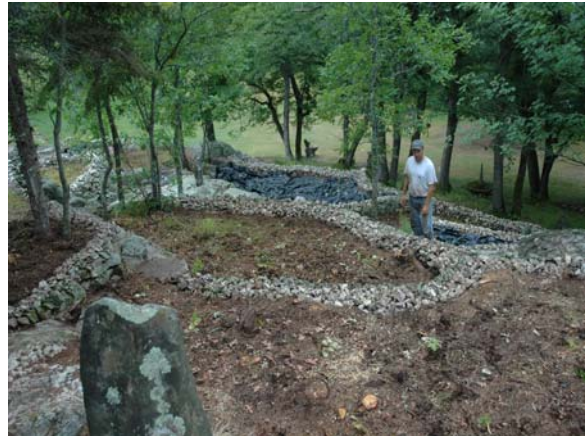
Completed repairs

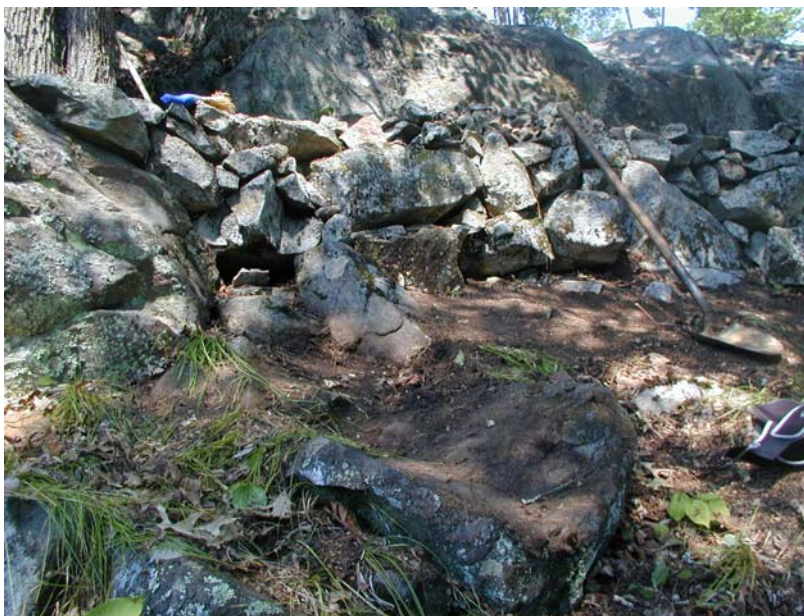
Drainage feature in stone wall

15. 16' long section of wall between pagoda sculpture (#83) and base of garden at primary entrance
Average height 32" on downhill side; 21" (D)
Cleaned debris and accumulated organic material from top layer of rocks. This wall does not have frosting.
Drainage feature uncovered at west end of wall.
Photos 11a & 11b

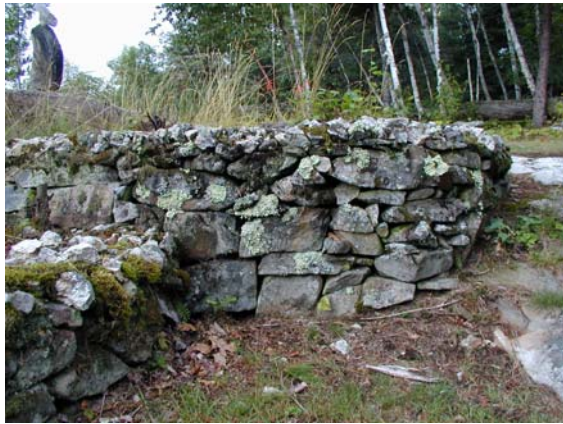
Two flower beds adjoin on the path going down the granite slope. The stone walls of both of these beds had become entrenched in thick sod and moss. The crew removed the frosting layer, dug out the sod and moss and replaced the frosting. In addition, the instructor repaired a corner of one bed which had been damaged.

Before repairs

2. 2 connecting flower beds below raven sculpture (#67)
18' (L) x 19" (H) x 16" (D)
30' (L) x 28" (H at corner) x 16" (D)
Removed frosting, dug out grass & organic debris, replaced frosting
Neil repaired corner that was damaged during blitz
Photos 15a-15d

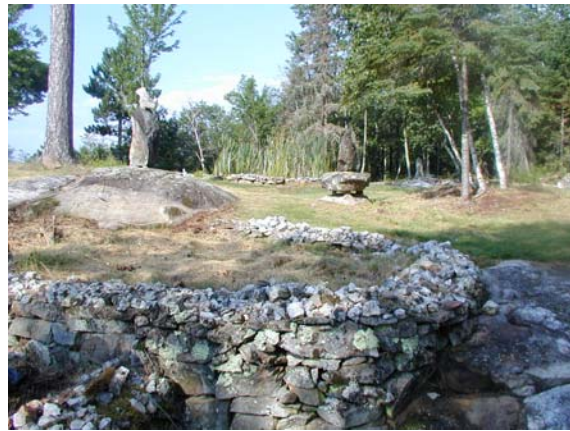
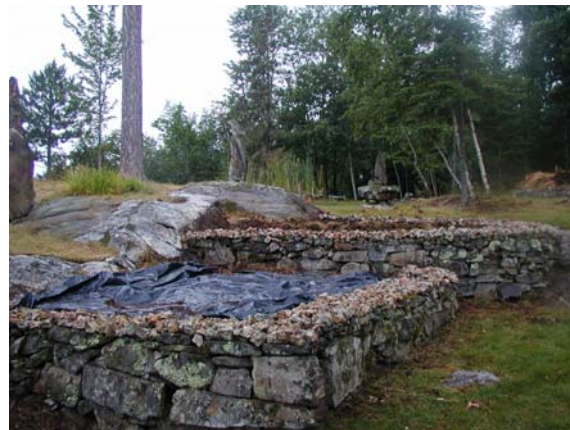
After repairs

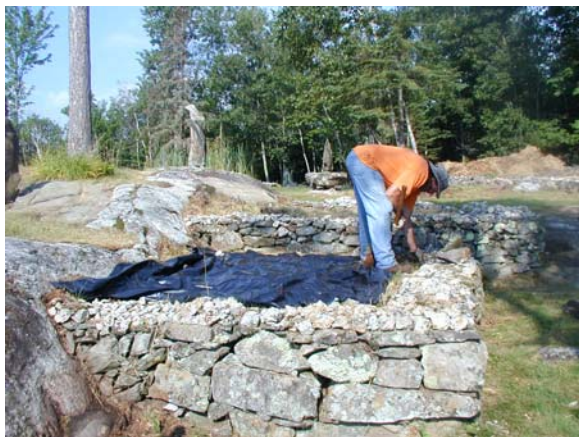
During repairs

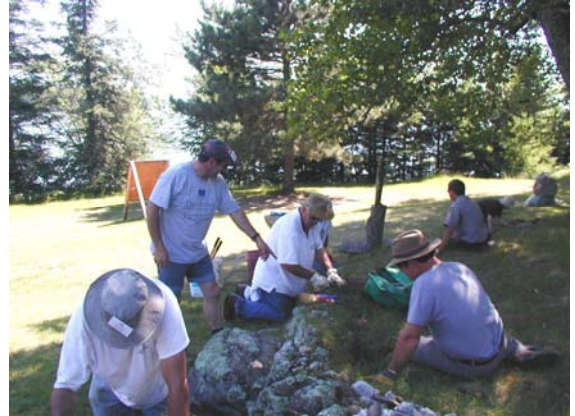
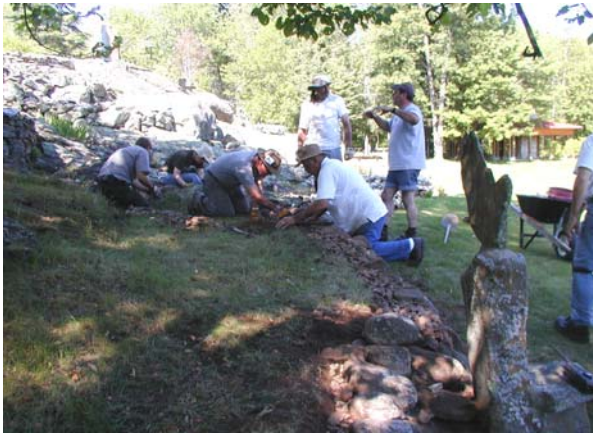
Located at the base of the hill and behind the much-photographed table and chair sculpture, this flower bed had become thickly embedded with grass. The crew removed the frosting layer and embedded grass and restacked the frosting.

Repairs in progress

14. Flower bed wall at base of garden starting from table & chair and east to bedrock
20' (L) x 12" (H) x 14" (D)
Removed sod and accumulated soil from frosting layer.
Photos 20a-20g

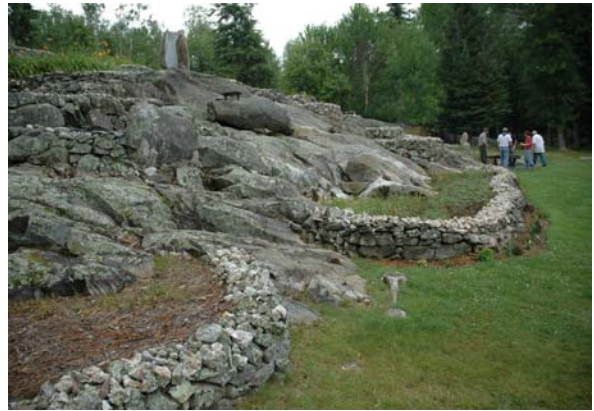
Completed repairs (bed on left)

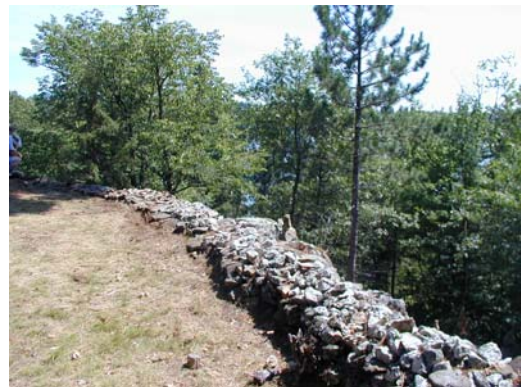
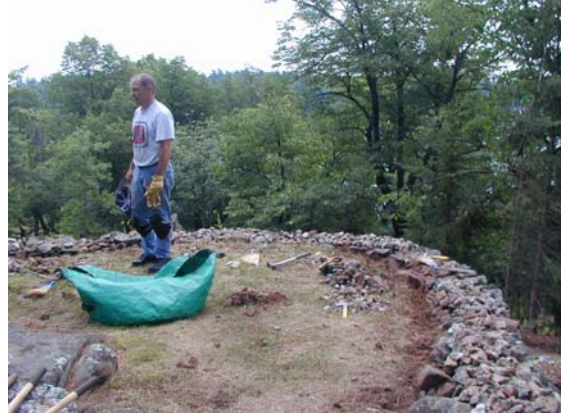
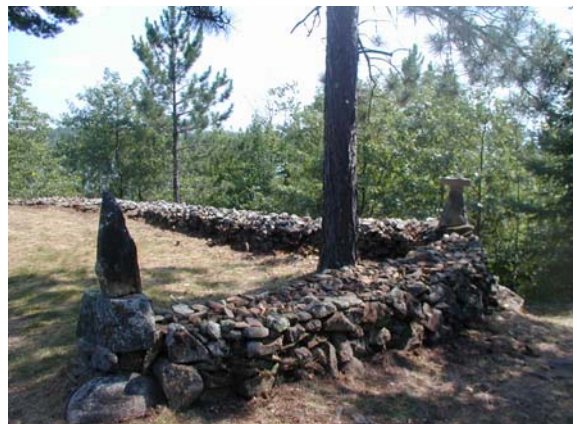
A series of stone walls overlook Kabetogama Lake and separate the summit from the terraced gardens below. Breaks in the wall provide access to areas below via stone steps or following natural contours in the granite outcrop. Much of the missing frosting that covered this wall was recovered from the terraces below.

Repaired section of same wall

6. 36' long section of Kabetogama Lake overlook wall from staircase at teepee ring west to corner
3" (H) on summit side; average of 16" (H) on hillside; 18" (D)
Retrieved a lot of rock fallen down hill; this wall is still missing a lot of frosting
Photos 3a-3b

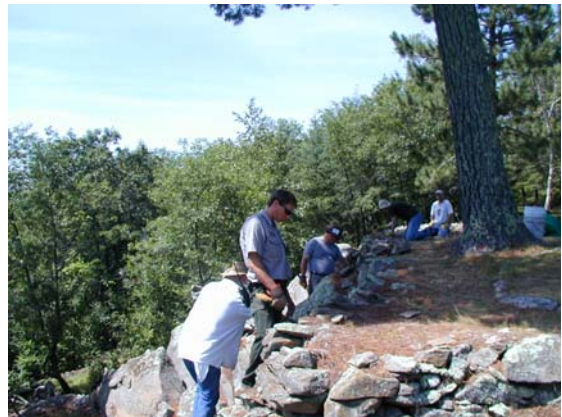
Repairs in progress on same wall

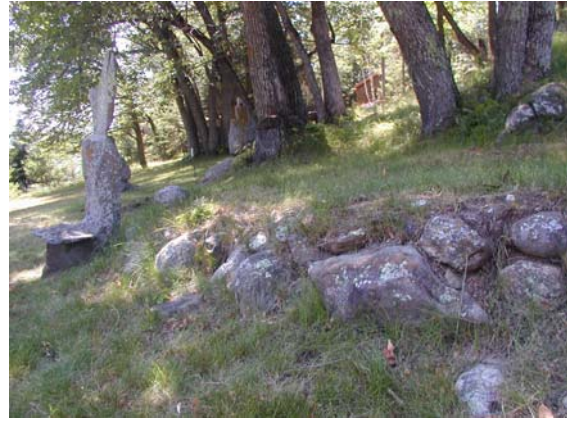
Double boulder wall before repairs

- d. two 8' connecting sections above knight; 20" average height on downhill side; 12" deep; cleaned frosting layers
 Photos 9a-9j
12. Single boulder wall (continuing repairs from 2006) and double-boulder wall at base of garden east of primary entrance path from below sculpture #8 east to sculpture #2
30' (L) x 12" (H) x 12" (D)
Rolled boulders out one at a time, removed grass and accumulated soil from between rocks and rolled back in place
Photos 5a and 5e

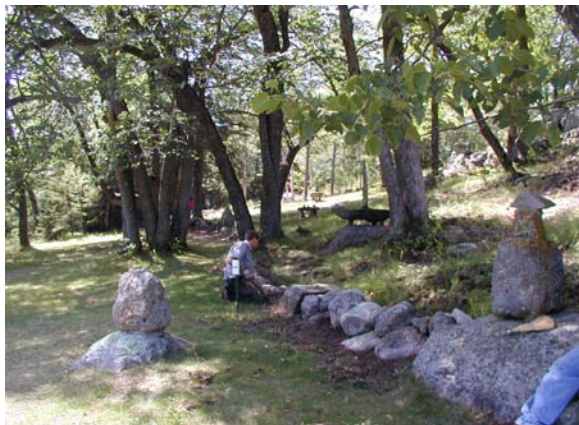
Repairing double boulder wall

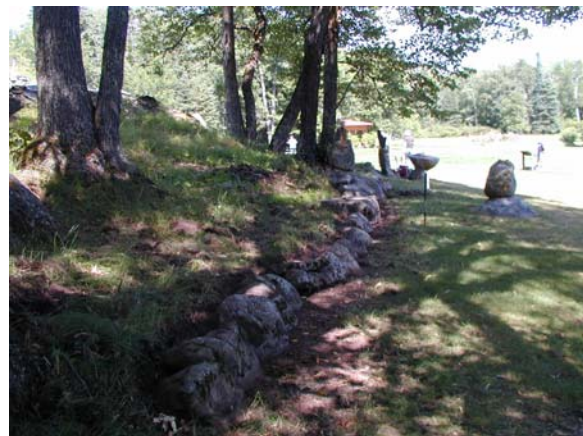
Completed repairs

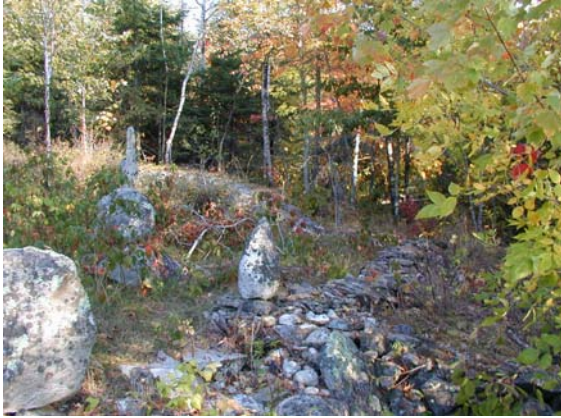
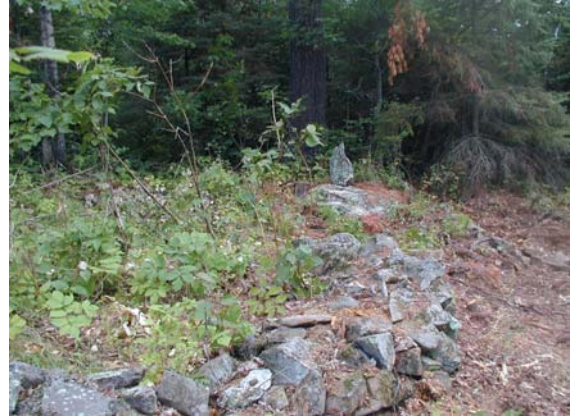
Located in an area of the gardens that was recently covered in dense vegetation, these walls are more crudely constructed than most others built by Mr. Ellsworth. It may represent an area of the gardens that has not been finished or it could reflect earlier construction. The function of these walls is also not clear and it will take additional research of this area of the gardens for the walls to make sense. Work was limited to cleaning out organic debris from between the rocks and repairing one section that had fallen over.

Before repairs

17. Walls in newly exposed area north of perimeter wall and east (below) teepee zone. One 34' long section of wall extends between sculpture #164 and sculpture #165 and the other section extends from sculpture #164 approximately 35' to the north. These are crude rubble walls approximately 24" H and 16" D. There is no frosting on these walls. Neil reset fallen boulders between sculpture #163 & #164 flanking a possible staircase.
Photos 14a-14i

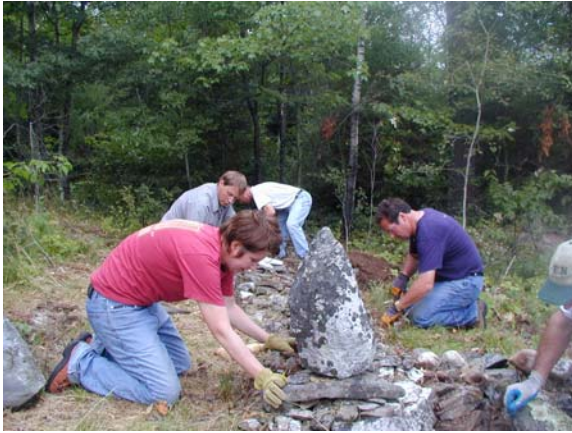
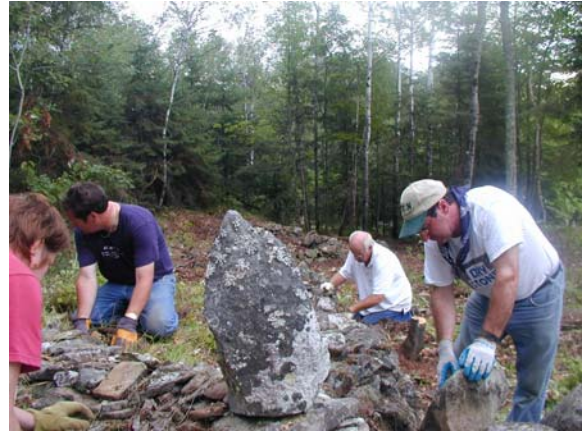
Repairs in progress

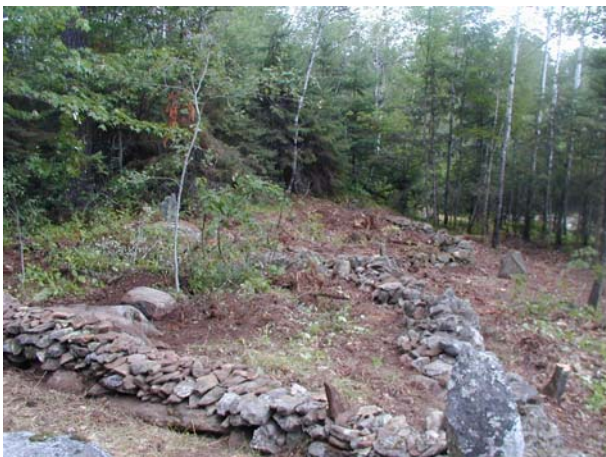
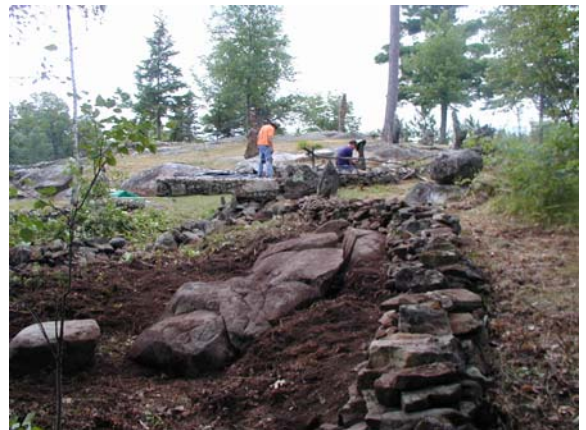
Completed Repairs
