# Sitka Sound Landscape Assessment

**U.S. Department of Agriculture  
Forest Service  
Tongass National Forest  
Sitka Ranger District  
Sitka, Alaska  
September 2004**

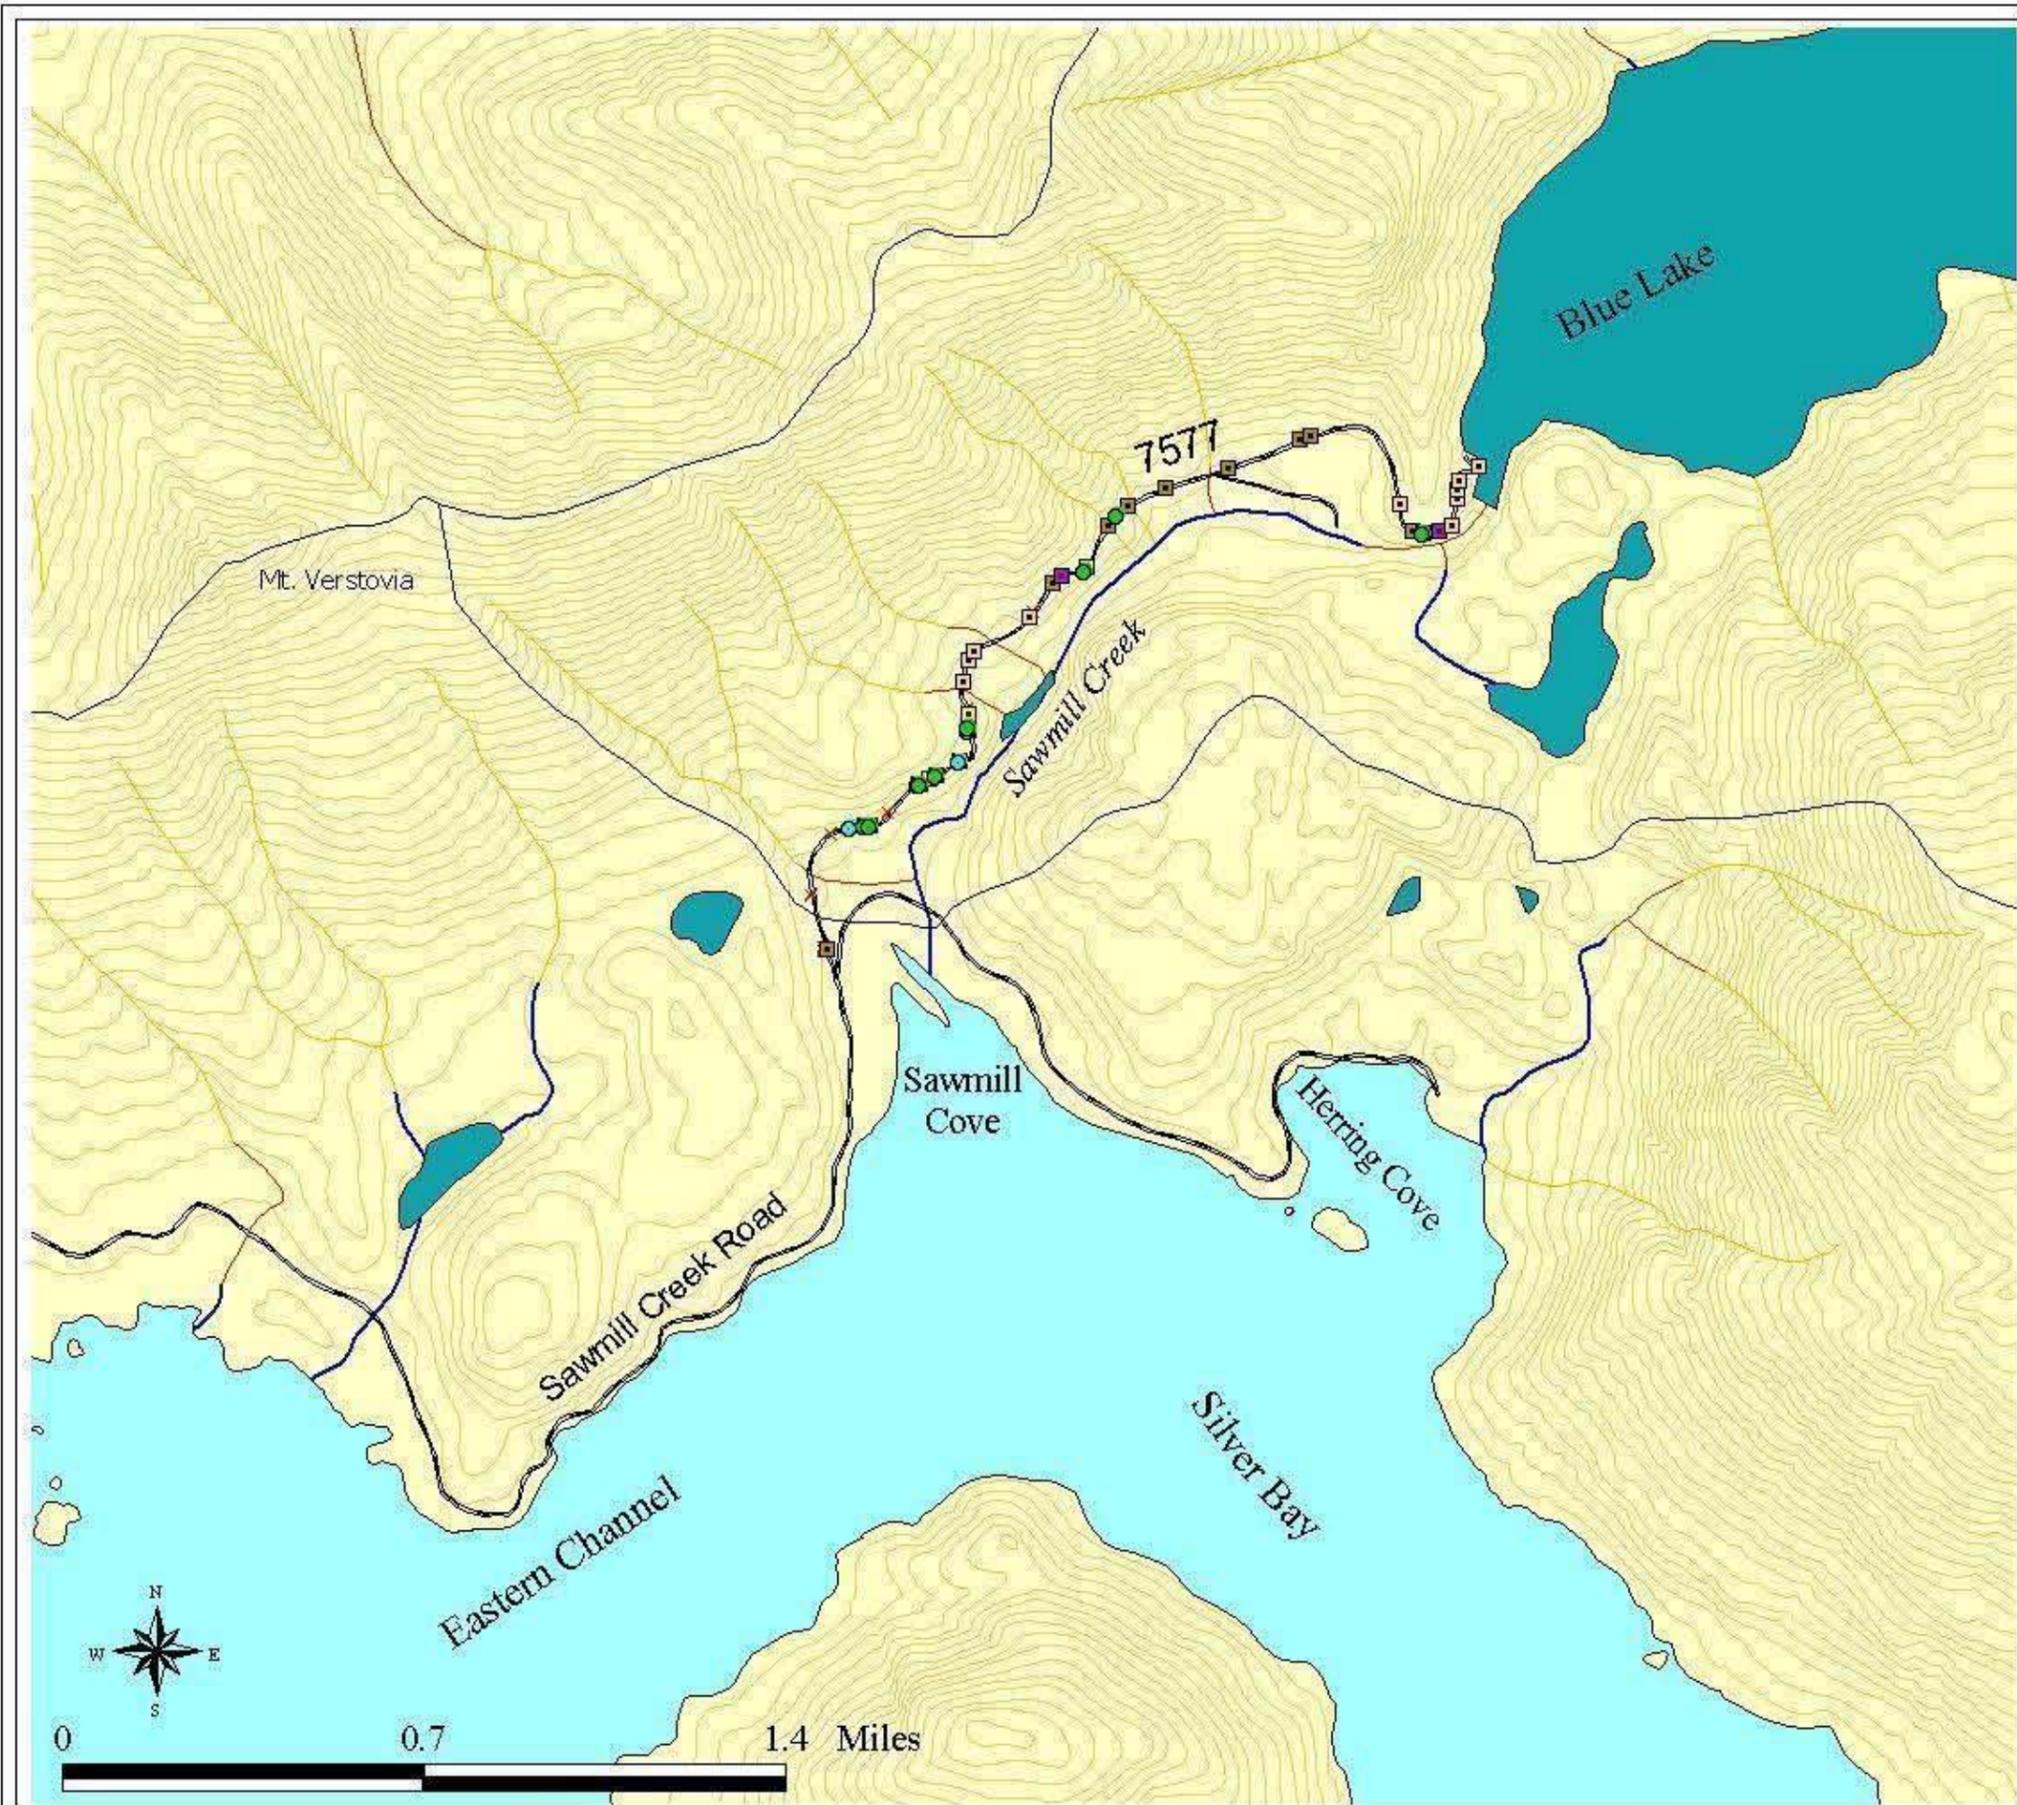
Figure 3-13. RCS Data for Blue Lake Road  
Sitka Sound Landscape Assessment

- Parameter**
- Cutslope Erosion
  - Ditch Erosion
  - Stream Encroachment
  - Fillslope Erosion
  - Surface Erosion
  - Slide
  - Water on Road
- Outlet Erosion**
- Bank Protection Needed
  - Fillslope Protection Needed
  - Other
- Inlet Erosion**
- Bank Protection Needed
  - Fillslope Protection Needed
  - Inlet Improvement Needed
- Failure or Problem Mechanism**
- Cutslope slump into Culvert
  - Debris Flow
  - Hydraulic Capacity Exceeded
  - Fill Slump or Slide
  - Road Crown Needs Grading
  - Sediment Accumulation in Culvert
  - Sediment Accumulation in Ditch
  - × Culvert Blockage
- Access & Travel Management**
- Slide Blocking Traffic
  - Washout Blocking Traffic
- Streams**
- ~ Class I
  - ~ Class II
  - ~ Class III
  - Roads

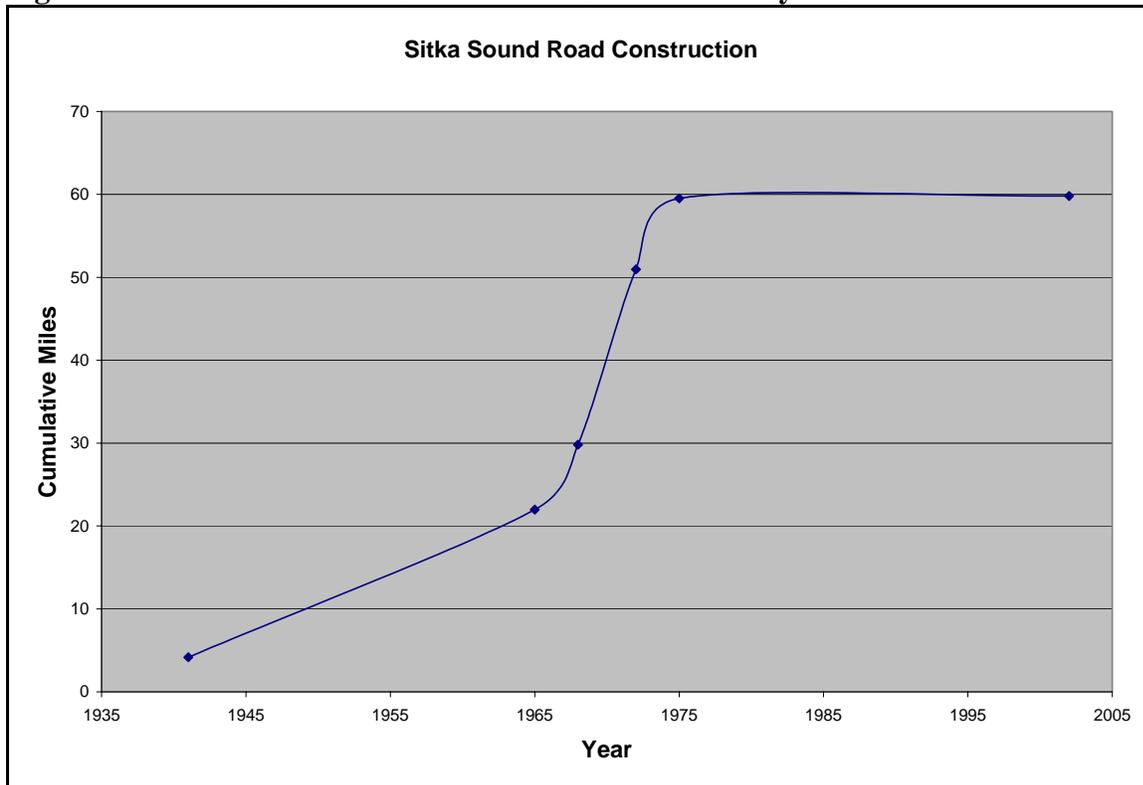
**Figure 4-1. Road Construction in the Assessment Area by Year**

With the exceptions of Harbor Mountain Road and access roads to administrative sites, all of the National Forest System Roads were constructed in support of timber sales and were intended for log transport. The Construction of System roads in the Assessment Area was complete by 1980 and the last 20 years have seen no system road construction on National Forest lands except for an extension to Road 7513 (Starrigavan Campground).
