Health Consultation

CHROMASCO MINING AND SMELTING CORPORATION

MEMPHIS, SHELBY COUNTY, TENNESSEE

JUNE 2004

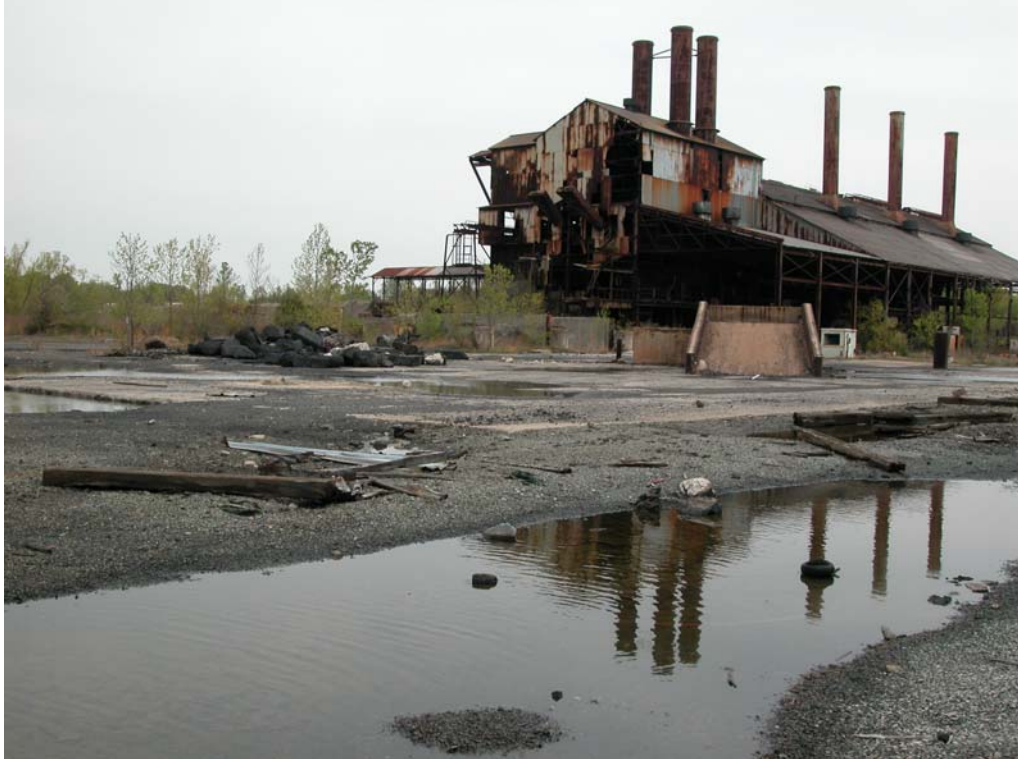
On April 16, 2004, EEP staff members, David Borowski and Bonnie Bashor, performed a site visit at Chromasco. Jerrell Moore of DSF and a Chromasco site manager provided access and assistance. The Chromasco site perimeter was well maintained. All fences and gates appeared sturdy. No signs of trespassing, such as litter or tire tracks, were observed. Several old buildings are in various stages of disrepair (Figure 2). Although little vegetation is present at the site, the surface appeared intact. Much of ground surface around the buildings is entirely concrete or asphalt. Several 2–3 foot wide streams and wet weather conveyances appeared to contain surface water.

Figure 2. Photo of abandoned building and nearby paved areas.
Chromasco, Memphis, Shelby County, TN

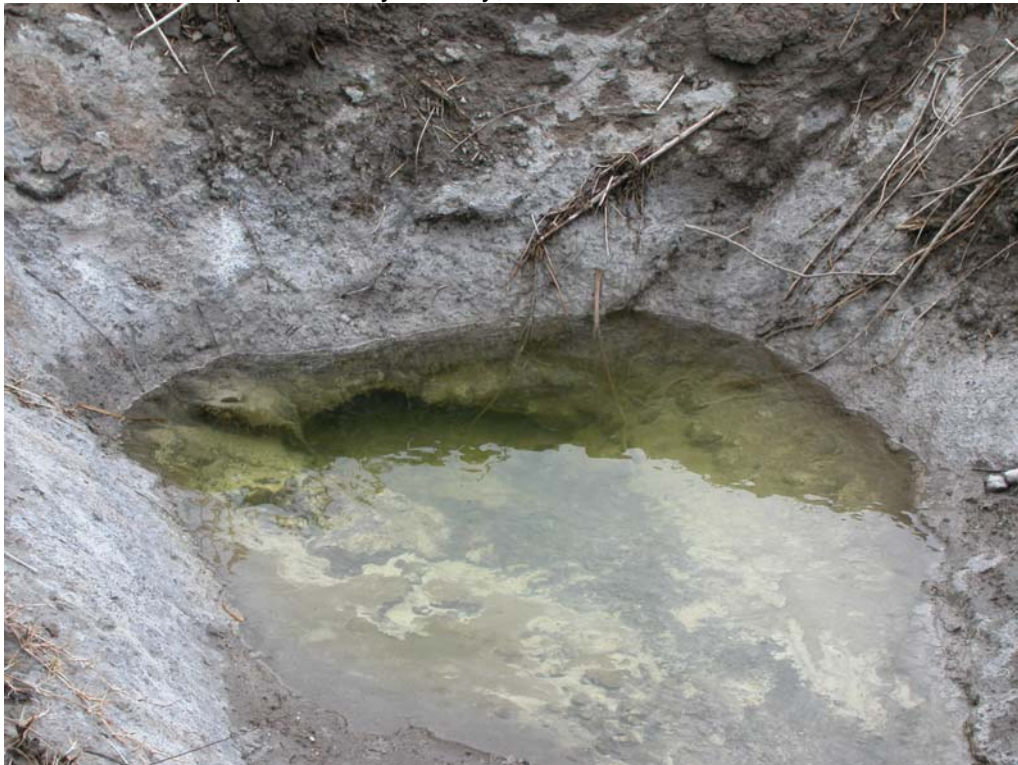
Indicators of metals pollution were obvious. On the ground, pieces of raw materials and lumps of slag were present. An on-site stream, running in a channel about 2 feet below ground level, contained flowing water that was green in color (Figure 3) – a common characteristic of chromium in water. During the site visit, the wind was blowing strongly; however, no fugitive dust was observed on that cold wet day.

Figure 3. Photo of stream water with a green tint.
Chromasco, Memphis, Shelby County, TN
