Dredging, Beach Nourishment and Bird Conservation Workshop Atlantic Coast Region

Beach Nourishment and Bird Habitat Restoration in Southern New Jersey

Philadelphia District Shore Protection and Ecosystem Restoration Projects

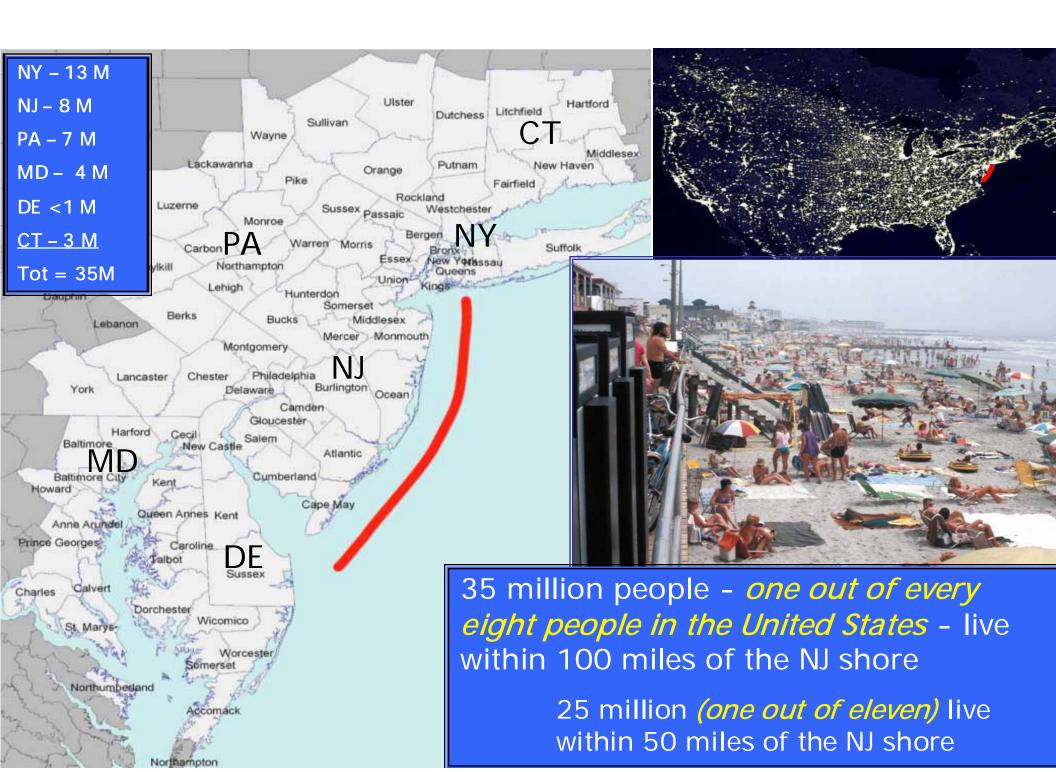
Constructed Project (Date Initiated)

Authorized, Not Constructed

Not Yet Authorized

Manasquan Inlet to Barnegat Inlet

Barnegat Inlet to Little Egg Inlet (LBI)

Great Egg Harbor Inlet to Townsends Inlet Brigantine Inlet to Gt. Egg Inlet – Brigantine Is. (2005)

Brigantine Inlet to Great Egg Inlet – Absecon Is. (2003)

Great Egg Harbor Inlet – Peck Beach (Ocean City - 1992)

Townsends Inlet to Cape May Inlet (2002)

Hereford Inlet to Cape May Inlet

Cape May Inlet to Lower Twp. (Cape May City - 1990)

Lower Cape May Meadows-Cape May Point (2004)

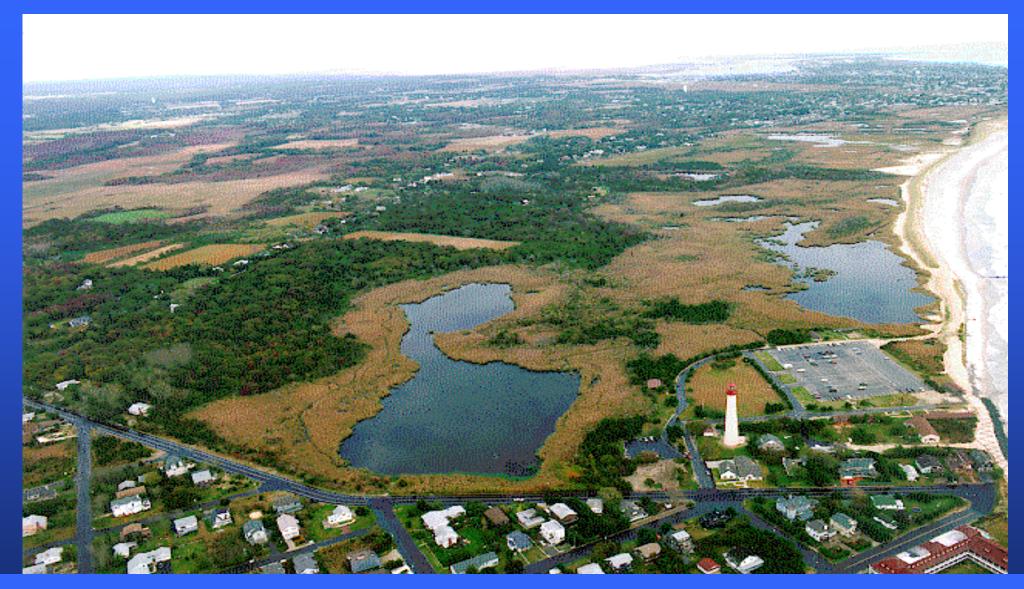
Lower Cape May Meadows, looking toward Cape May City, October 1996.

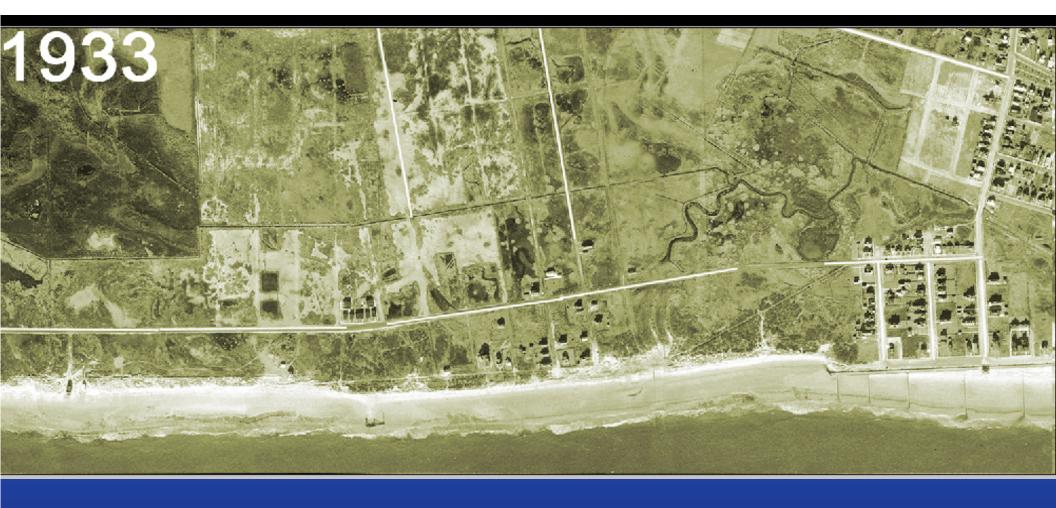
Cape May Meadows Shoreline Change 1933 - 1995

- Ecosystem Degradation at Meadows
 - 1,110 feet of shoreline eroded since 1936
 - 124 acres lost since 1955
 - 138 additional acres lost by year 2050 if no action
 - degradation of remaining habitat through saltwater intrusion
- Storm Damage Vulnerability to Cape May Point and West Cape May

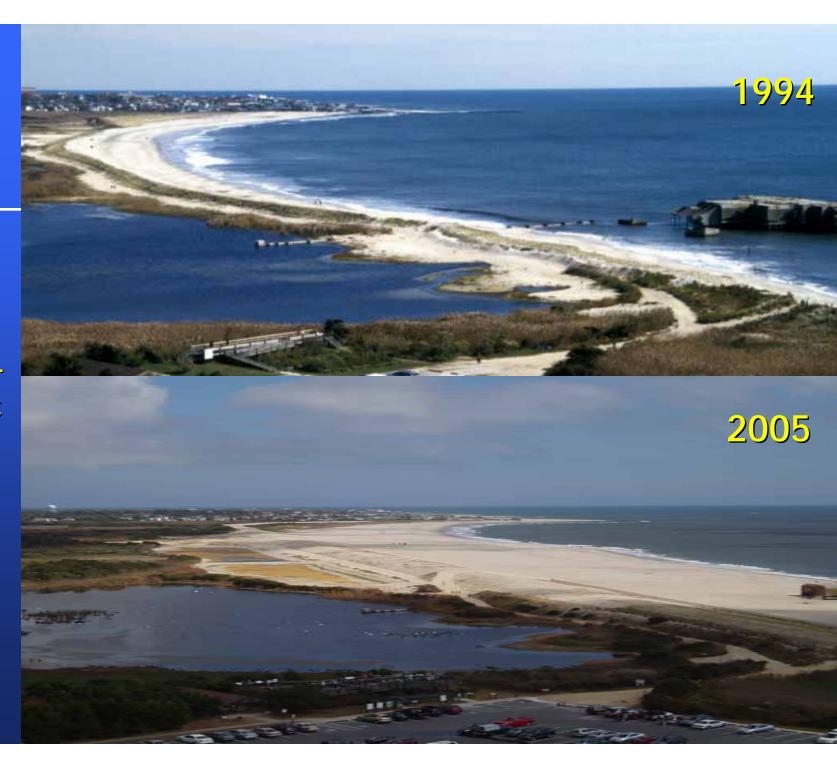
Lower Cape May Meadows – Cape May Point

Piping Plover Design Features

- Plover crossovers
- Lower berm elevation
- Plover ponds
- Modification of dune fencing/planting

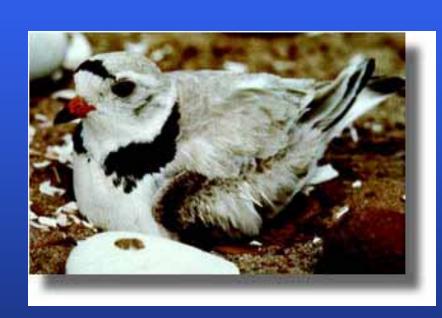
Ployer Crossovers

- 3 crossovers
- 100 feet wide
- -1 on 10 side slope

- ALL broods used new plover ponds for feeding (some exclusively)
- Plover crossovers and unvegetated dunes used by adults and chicks
- Some nesting took place on new unvegetated dune
 - 8 chicks fledged from 5 pairs

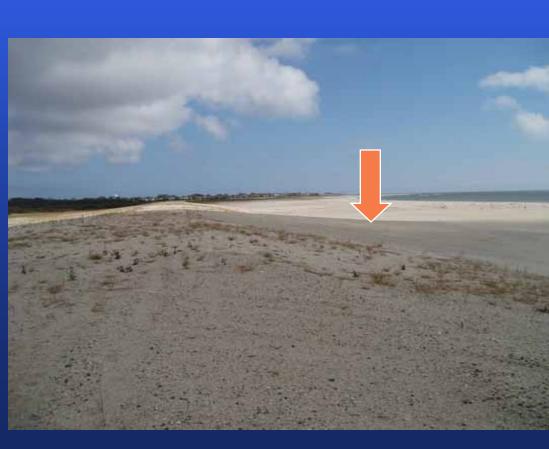
Pond/Wetland Restoration 3/7/05

- Old dune relocated seaward
- Ponds excavated
- Minimal vegetation planted around 1 pond

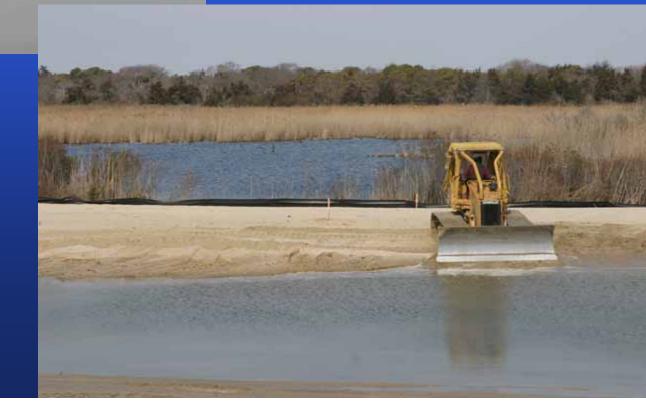
Ployer Ponds

Pond 1 - 1.4 acres

Pond 2 - 2.5 acres
