# The Assateague Island Beach Restoration Project

# NPS and COE partner on restoration plan

**Appendix D  
Restoration of Assateague Island**

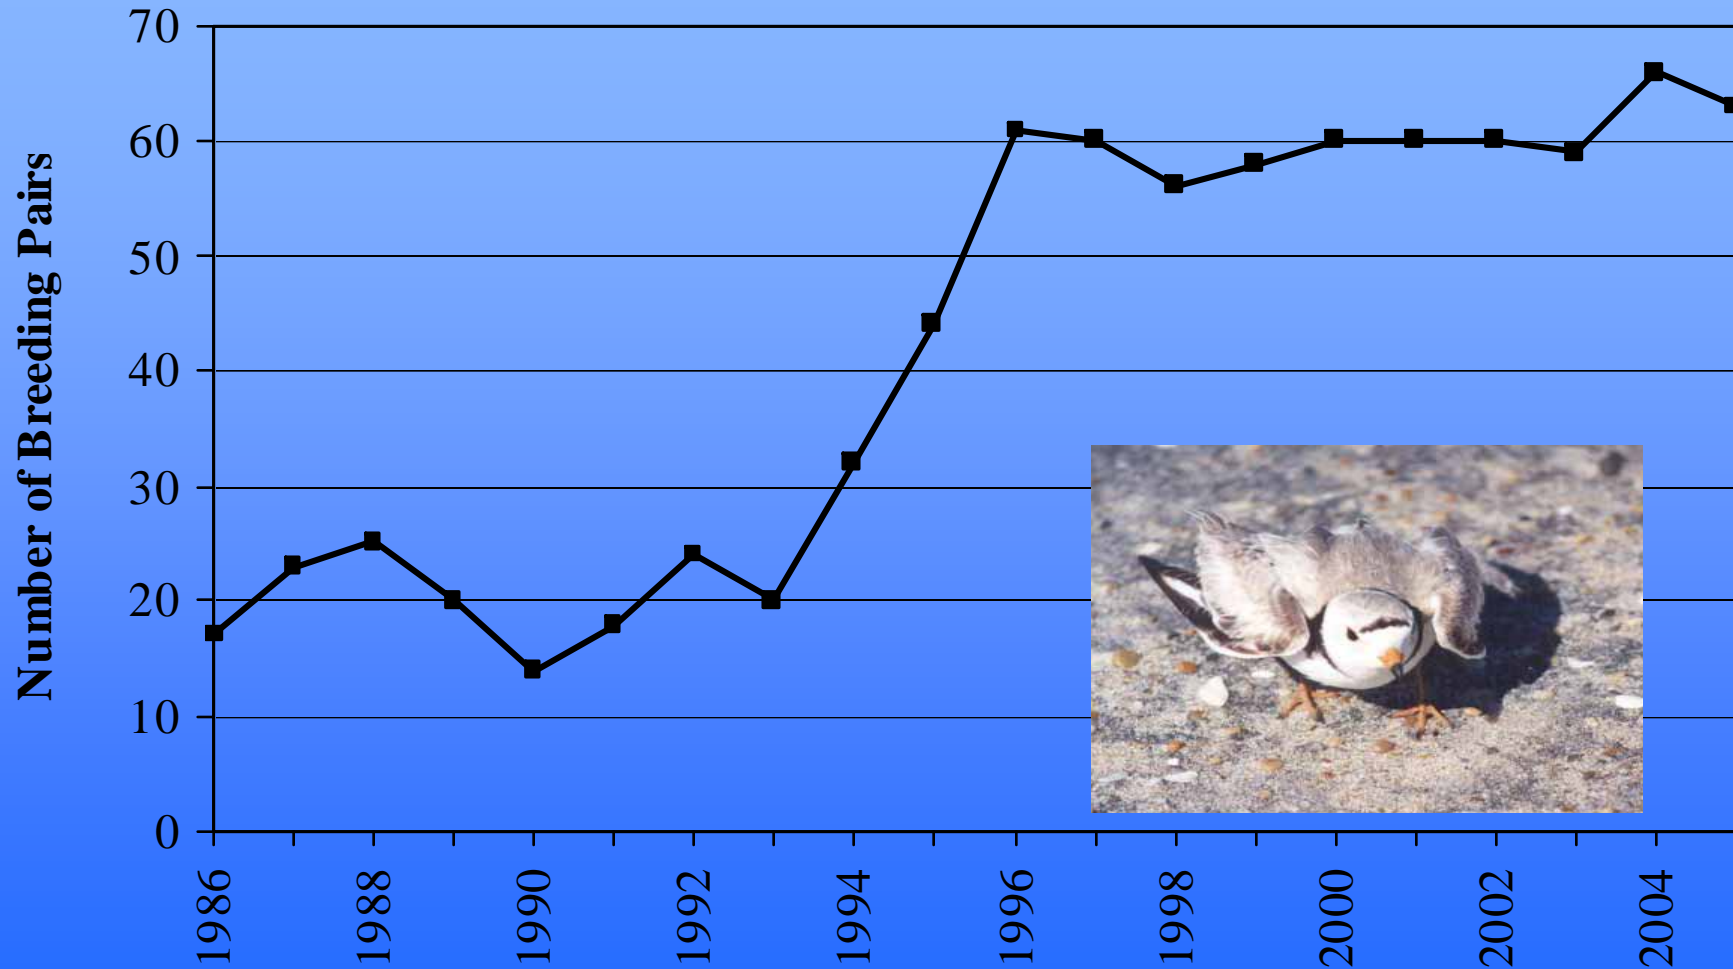
Number of breeding pairs of piping plovers at ASIS each year, 1986-2005.

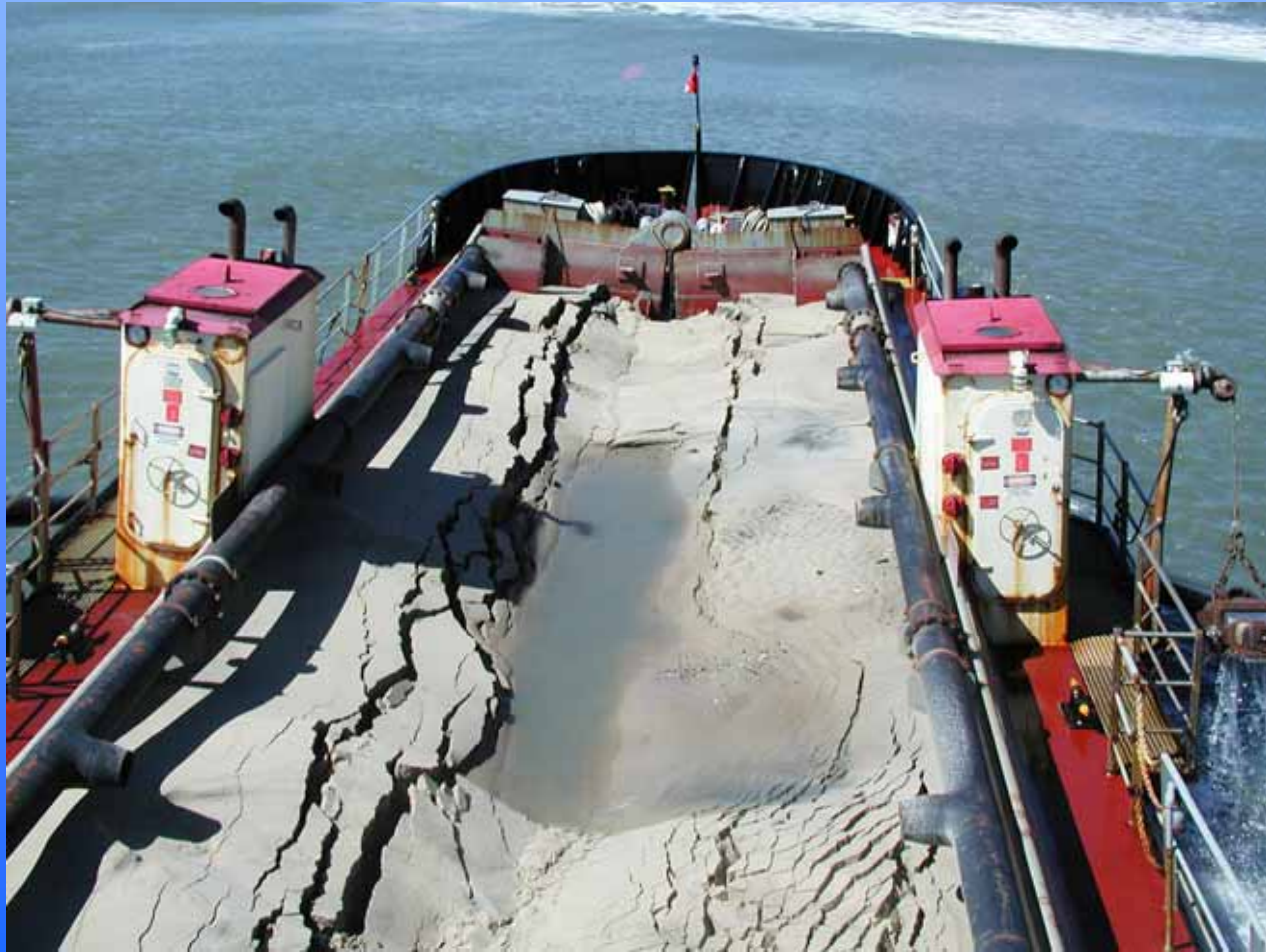
# Long-term restores along-shore sediment flow

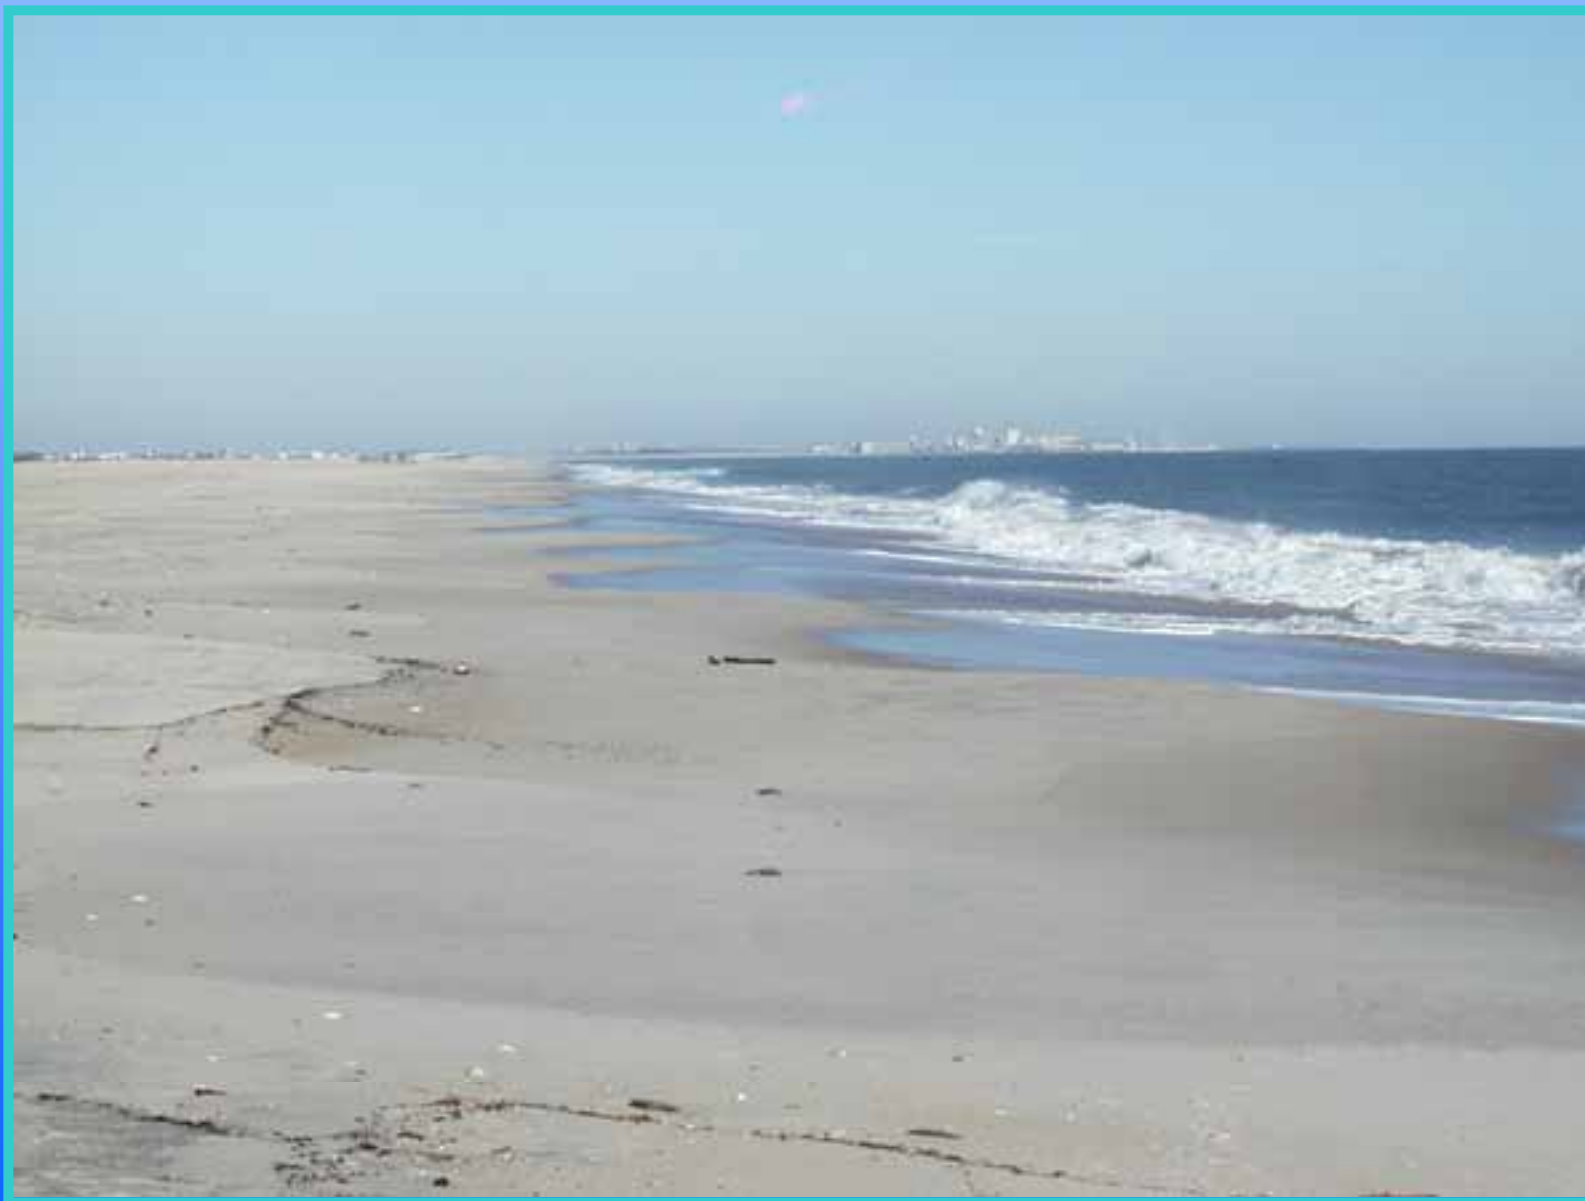
## 5-year storm period used to model berm height

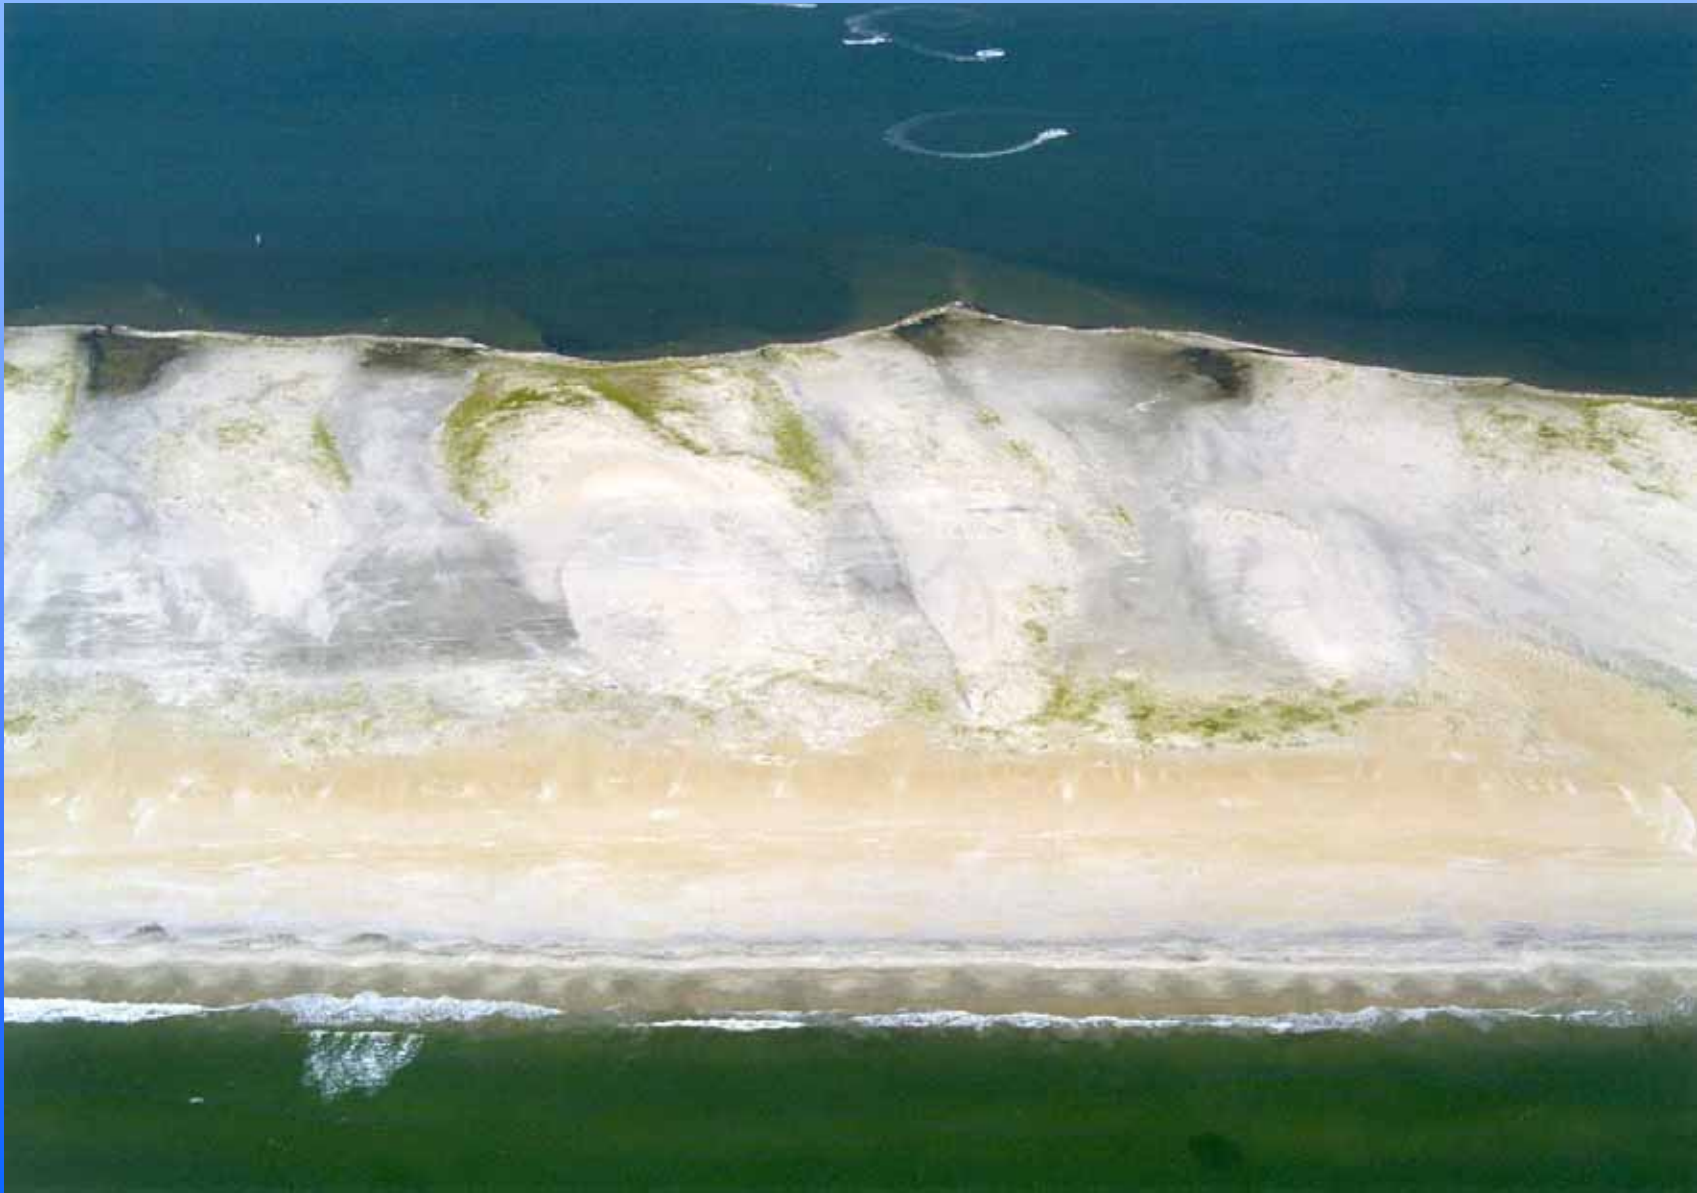
**Berm is constructed in area of overwash**

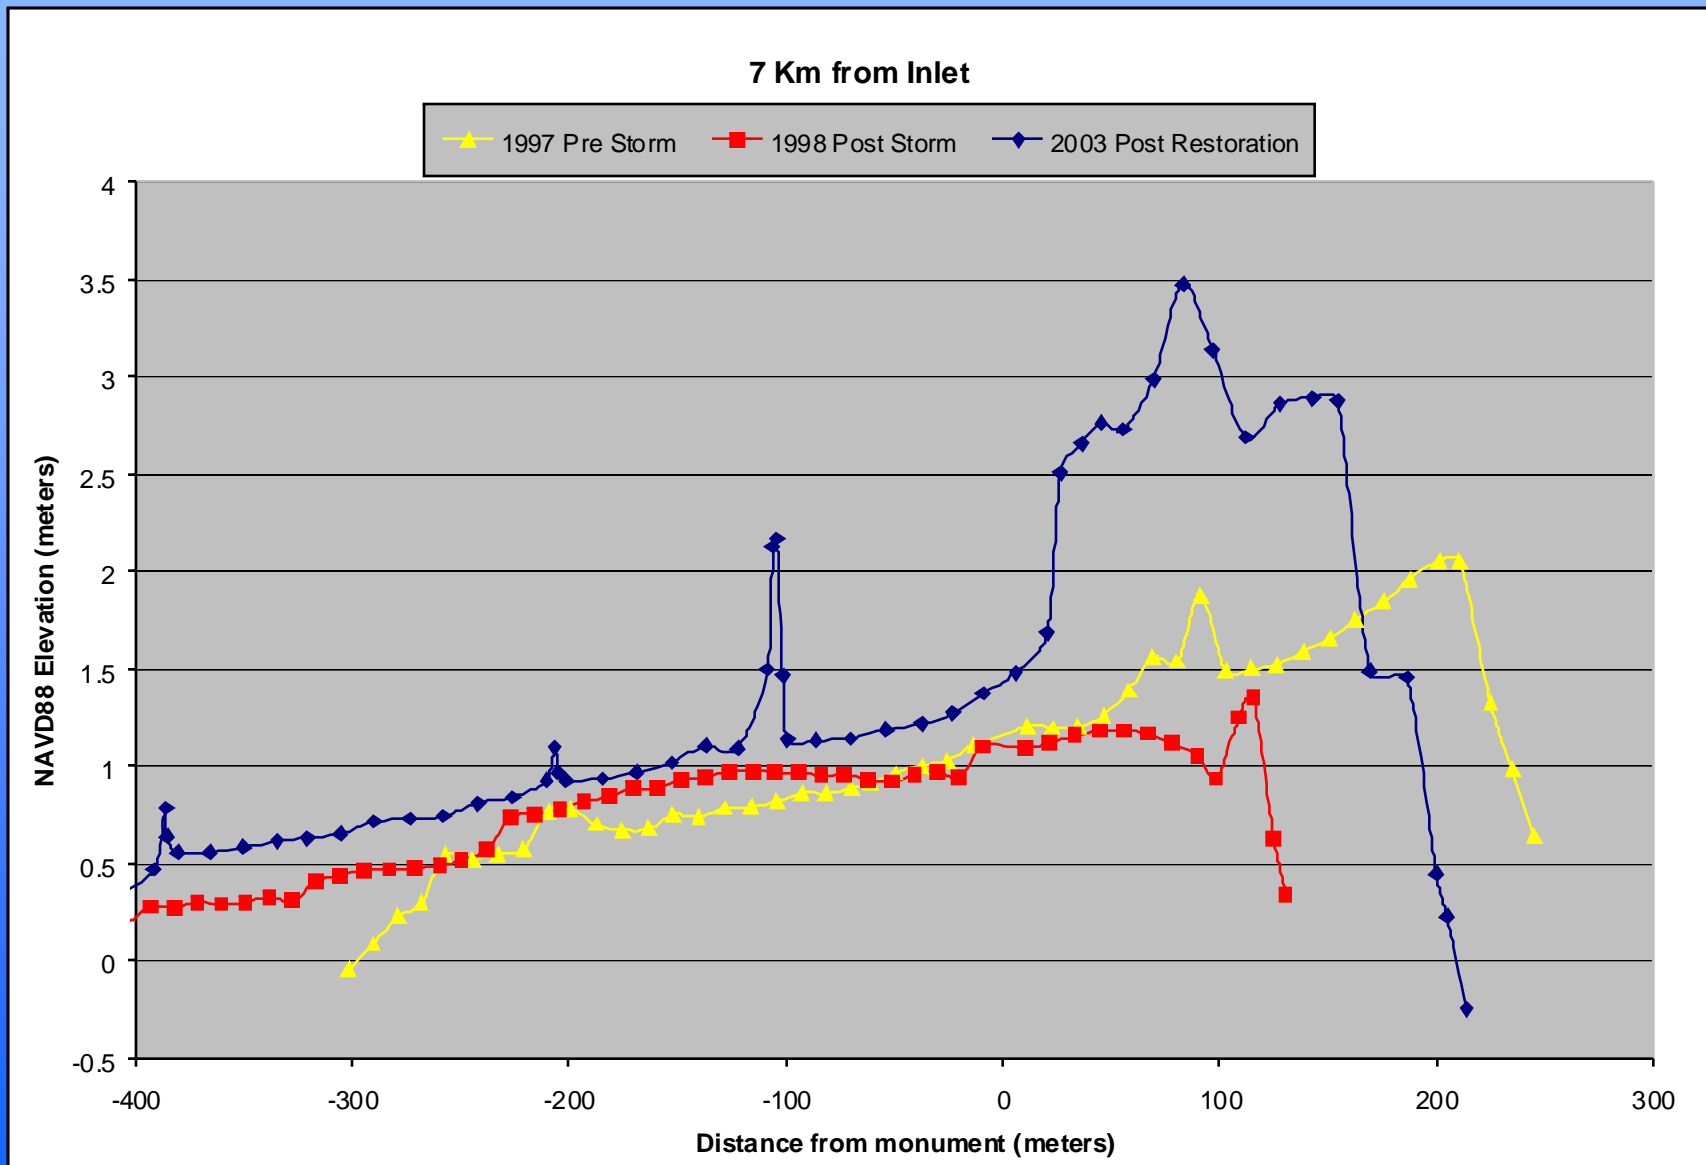
# Berm is constructed in area of overwash

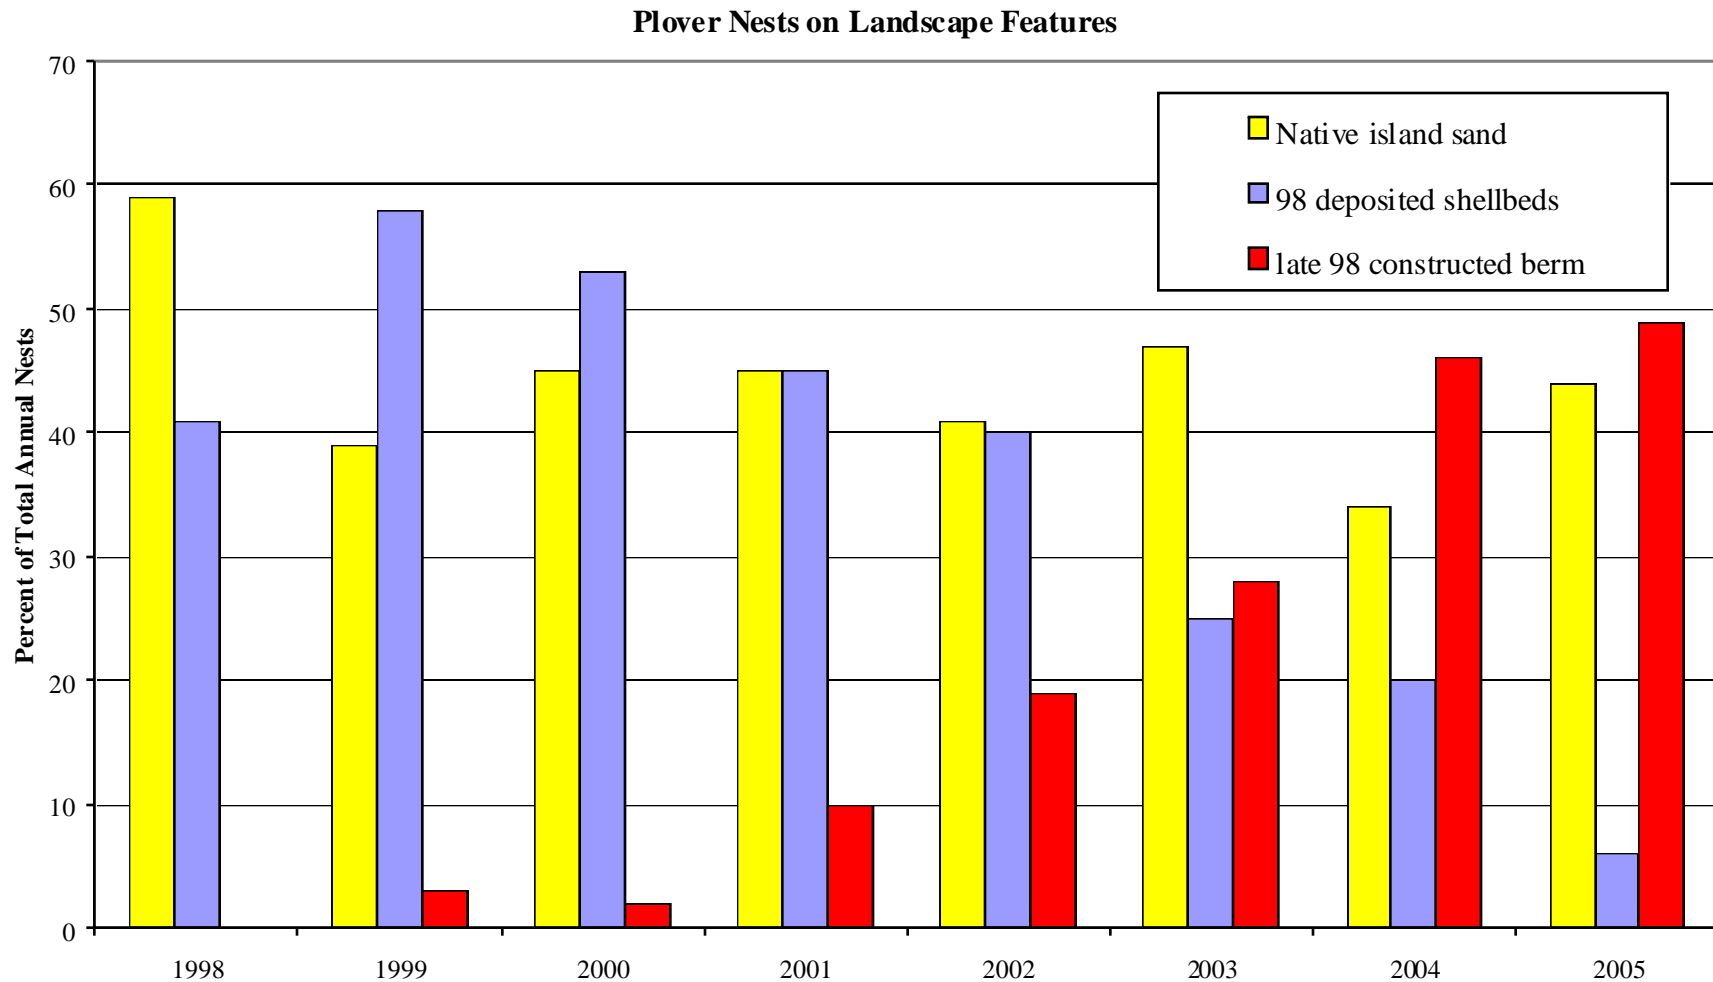
# Berm sucks up plover nests. Good or bad?

**North End is 424 hectares. Storm Berm footprint is 19 ha (5%).  
The 1998-deposited shellbeds have been effectively buried or vegetated.**

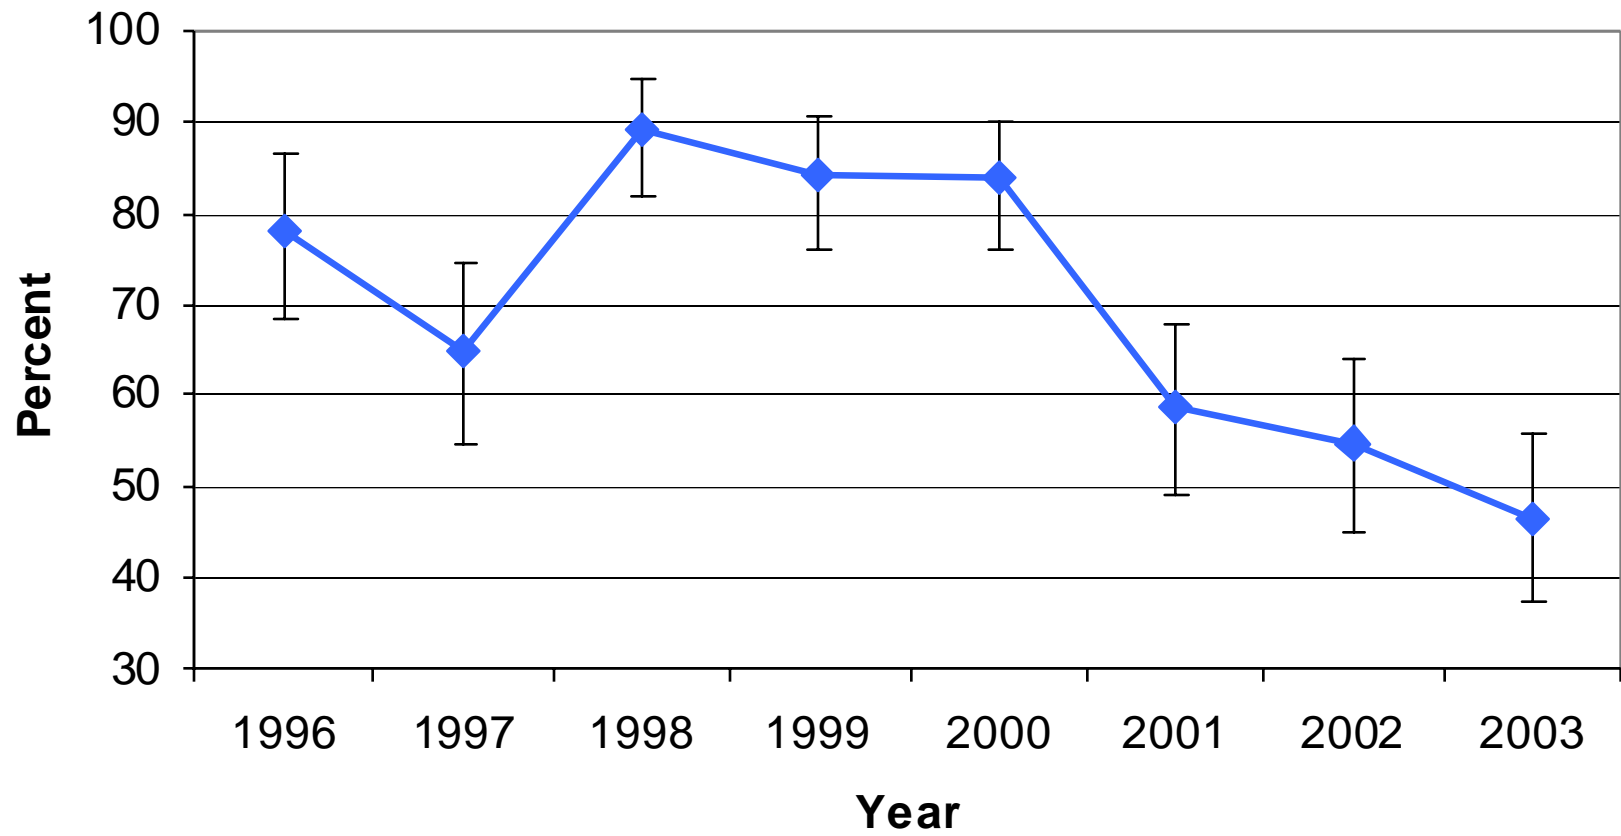
# Berm has promoted vegetation growth

**Average Percent Sparse Vegetation From KM 5 to KM 7.5 on Assateague Island's North End**
