Response of Roseate Terns to a Shoreline Protection Project at Falkner Island, Connecticut

Project Background
of the
Shoreline Revetment Project
with
Catherine Rogers

Response of Roseate Terns to the Rock Revetment with Jeff Spendelow

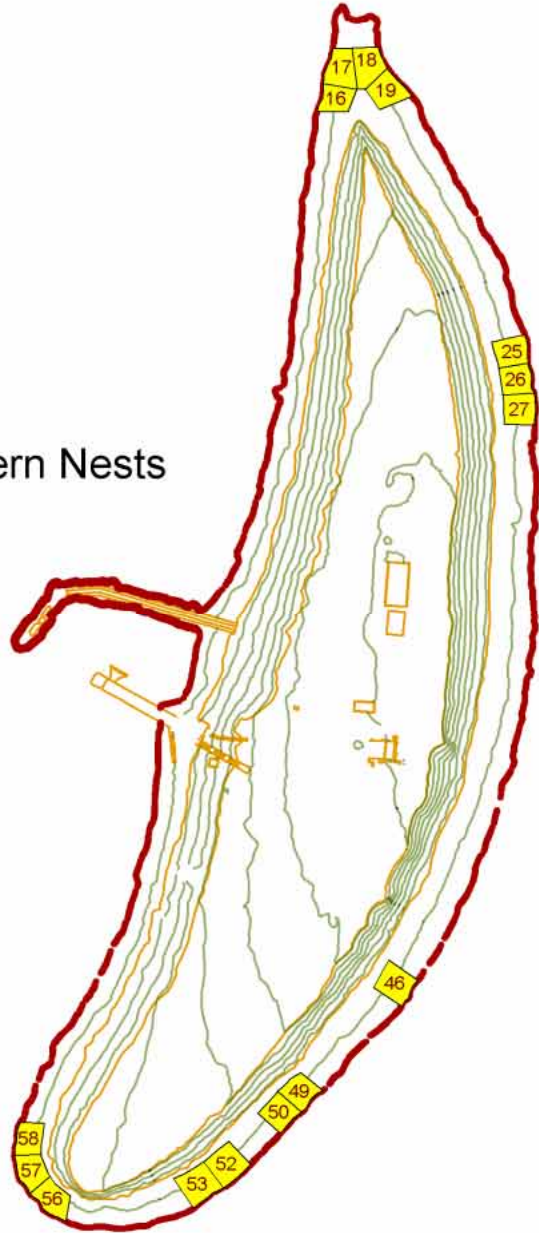
Roseate Tern Nests

Falkner Island, CT

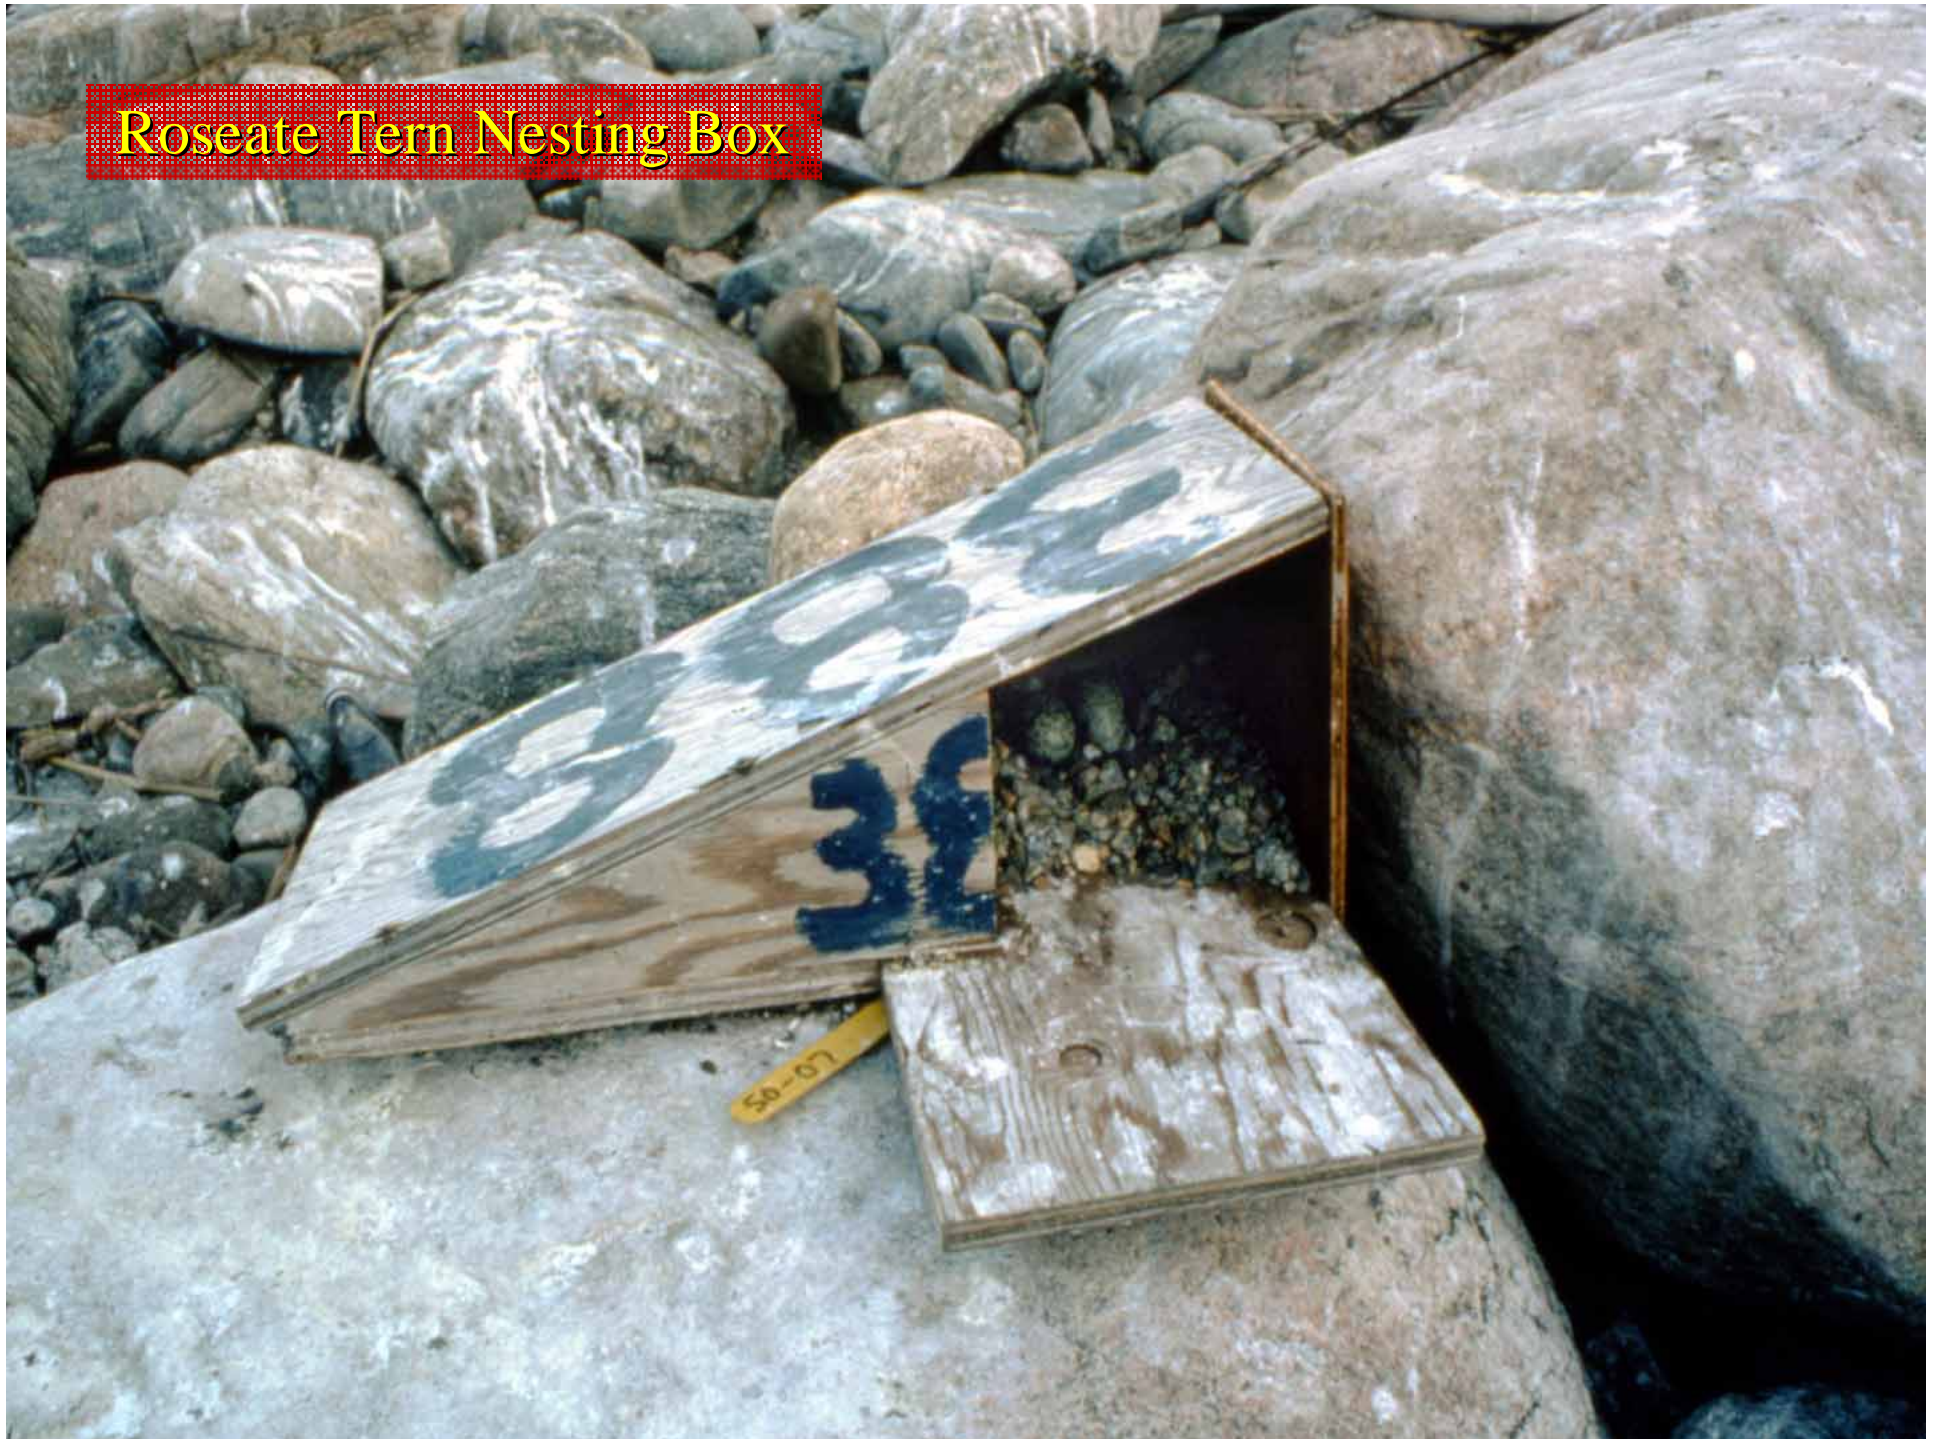
Roseate Tern Nesting Box

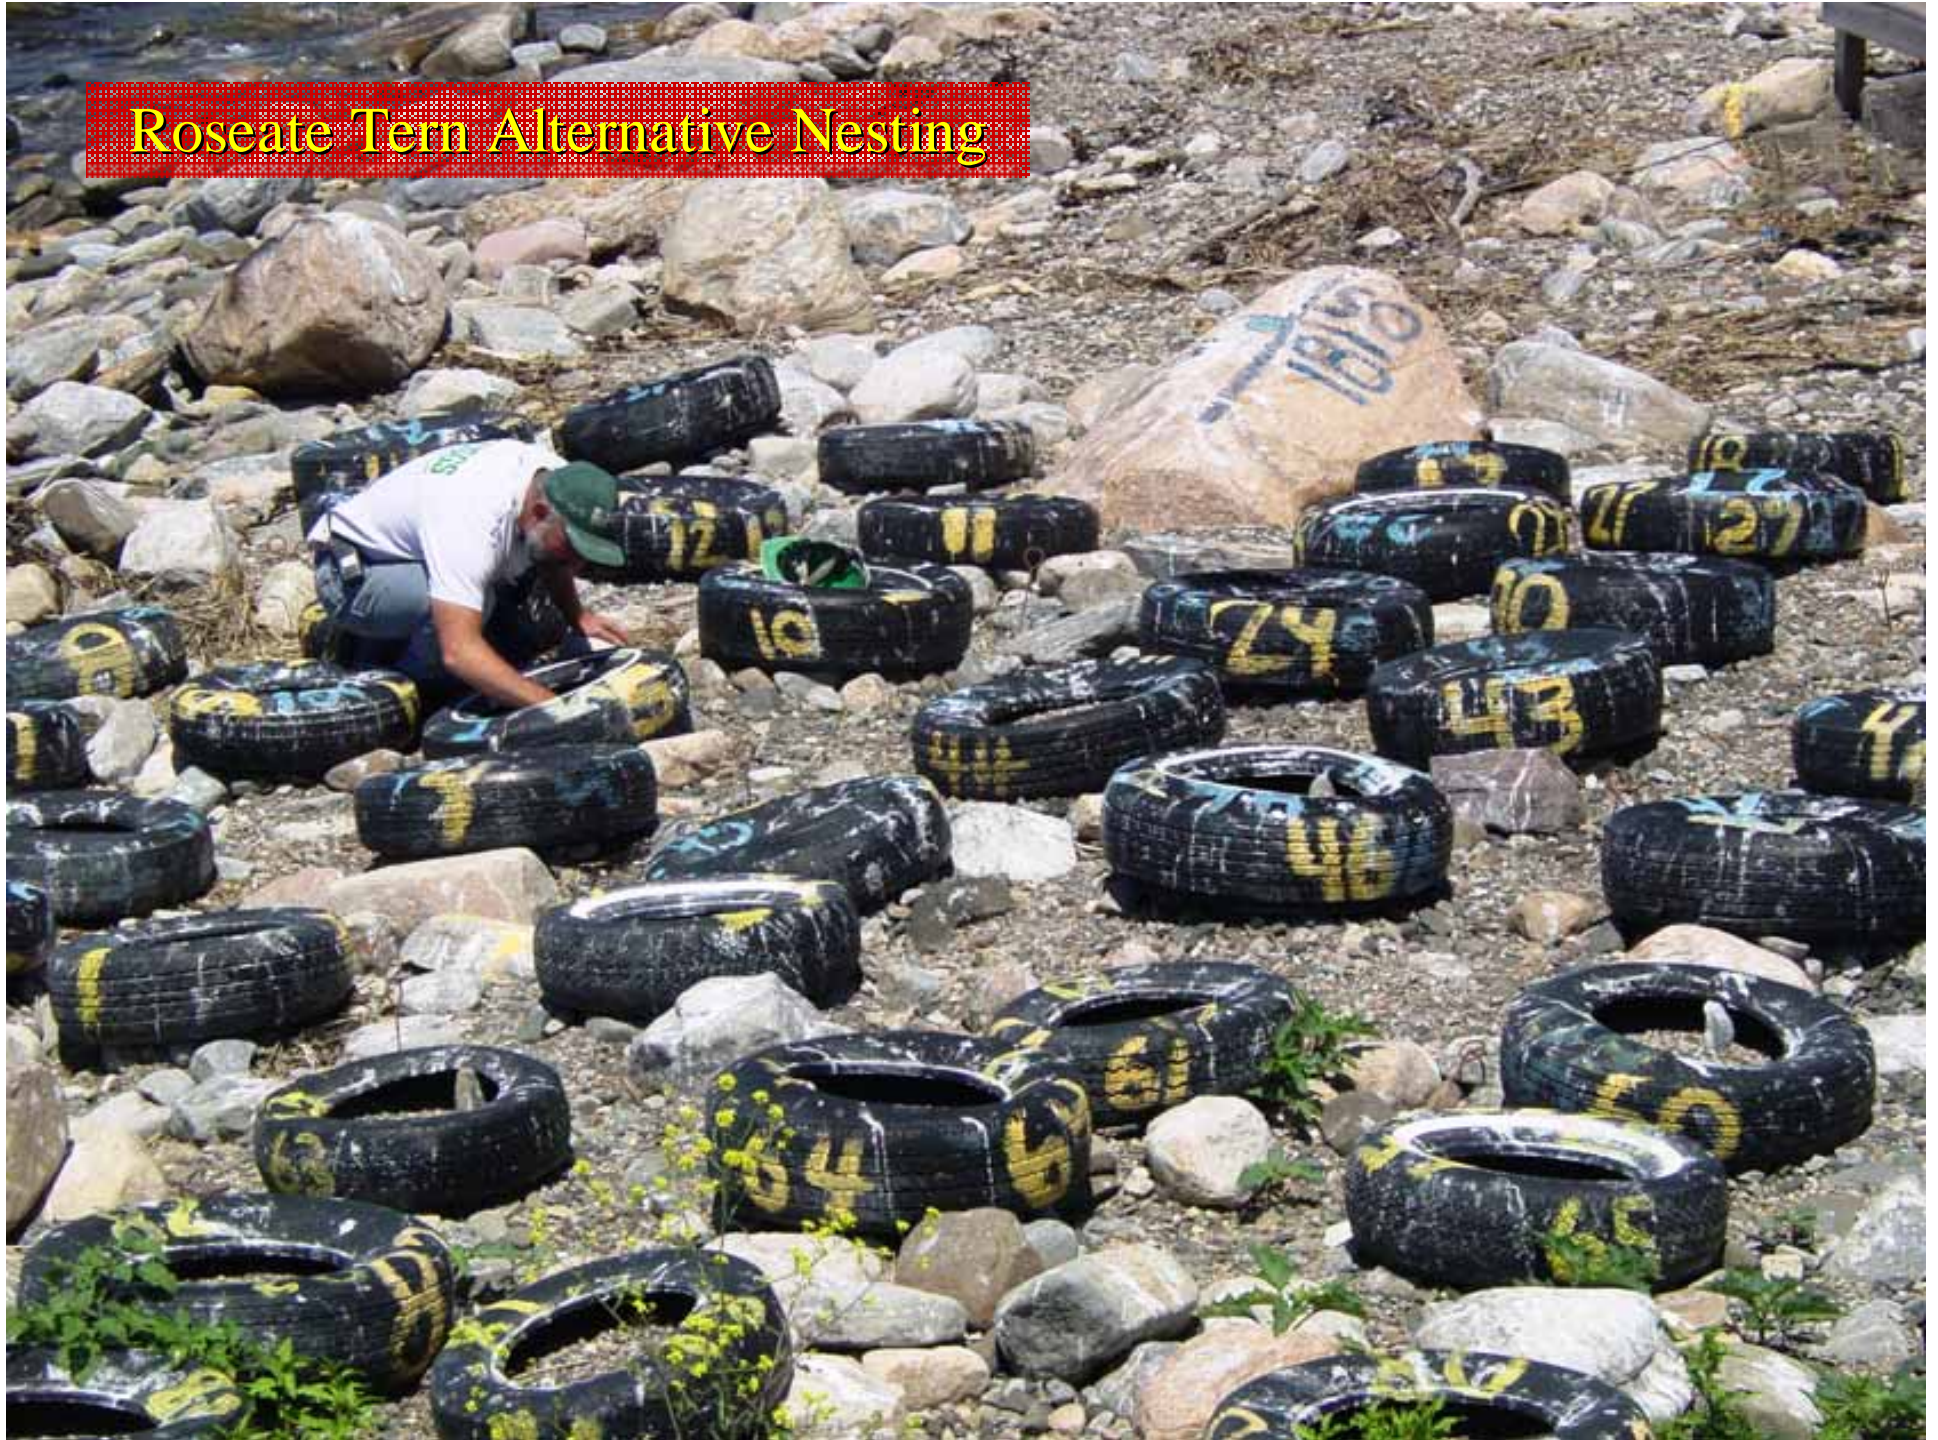
Roseate Tern Alternative Nesting

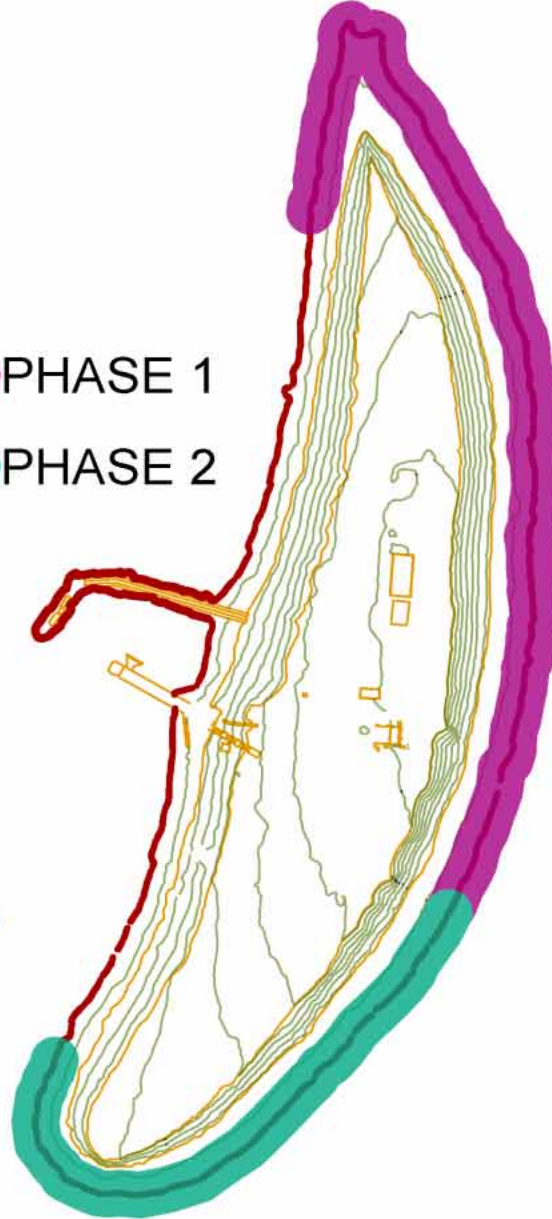
Access

Falkner Island, CT

- PHASE 1
- PHASE 2

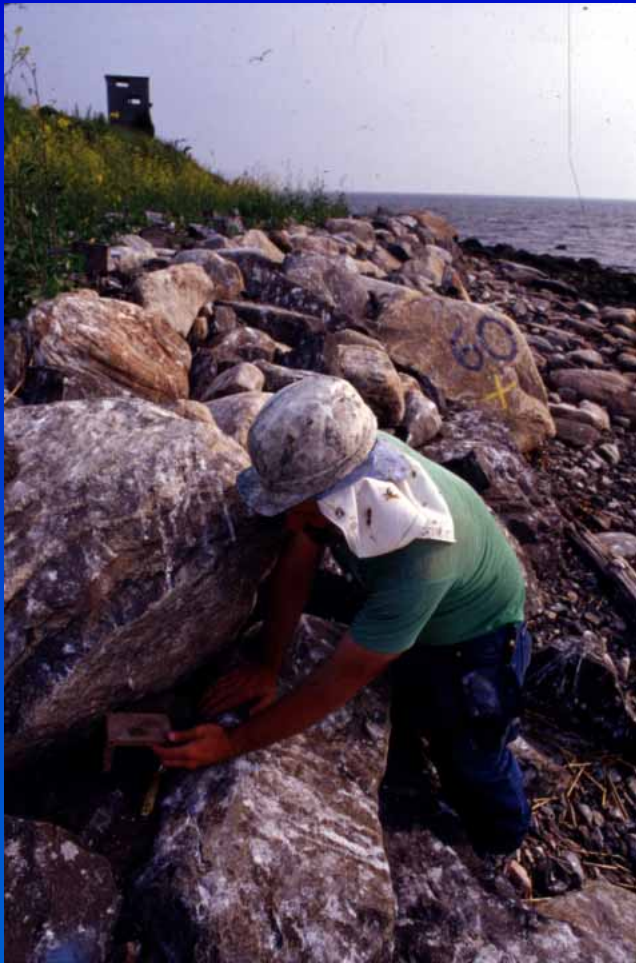
Adding chick shelter to
secondary revetment
on SW Shelf

- Nesting habitats for 3 of 6 subcolony areas modified extensively
- Northern tip (plots 17-18) nesting area modified slightly, but nearby “chick-hiding habitat” (plots 16 & 19) modified extensively
- Creation of “secondary revetment” (SW Shelf) not in original plans, and constructed differently than main revetment
- Extension of SW Shelf into ROST subcolony area due to communication error

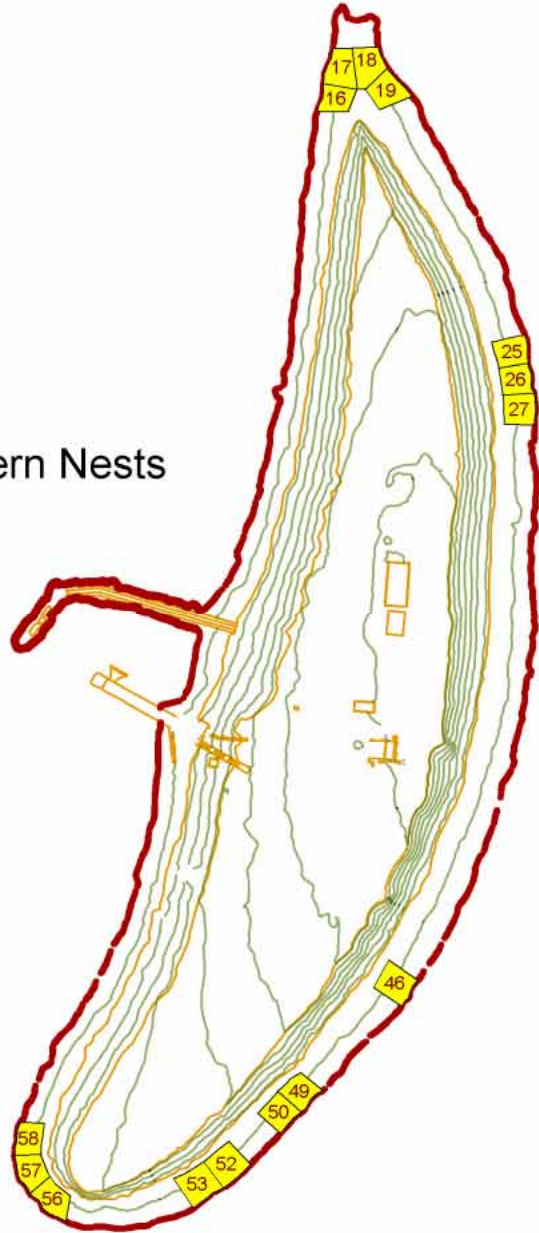
Roseate Tern Nests

Falkner Island, CT

0 50 100 200 Feet
