Volunteer Lieutenant Dies Following Structure Collapse at Residential House Fire - Pennsylvania

Fatality Assessment and Control Evaluation Investigative Report #F2002-49

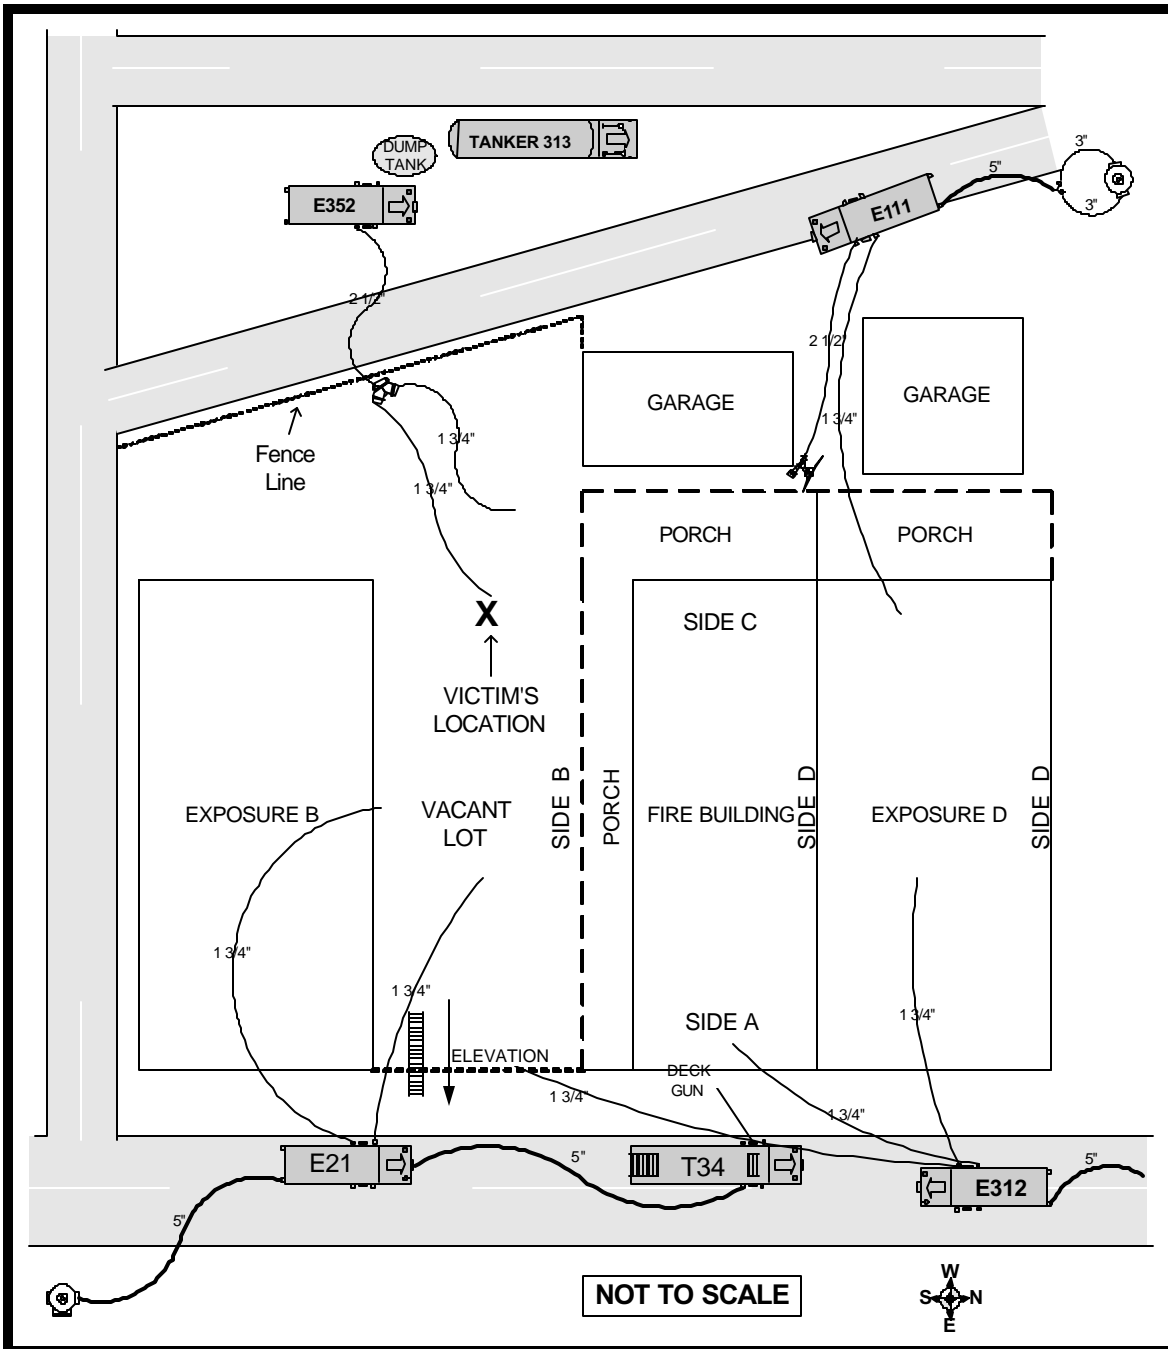
this block were originally built as row houses and at one time there was a dwelling that connected the fire building and Exposure B (Diagram 1). The fire building, Exposure B and Exposure D were very similar in construction. At the time the fire occurred, Exposure D was being used as a storage area for vending equipment and other miscellaneous items.

Diagram 1. Incident scene aerial view

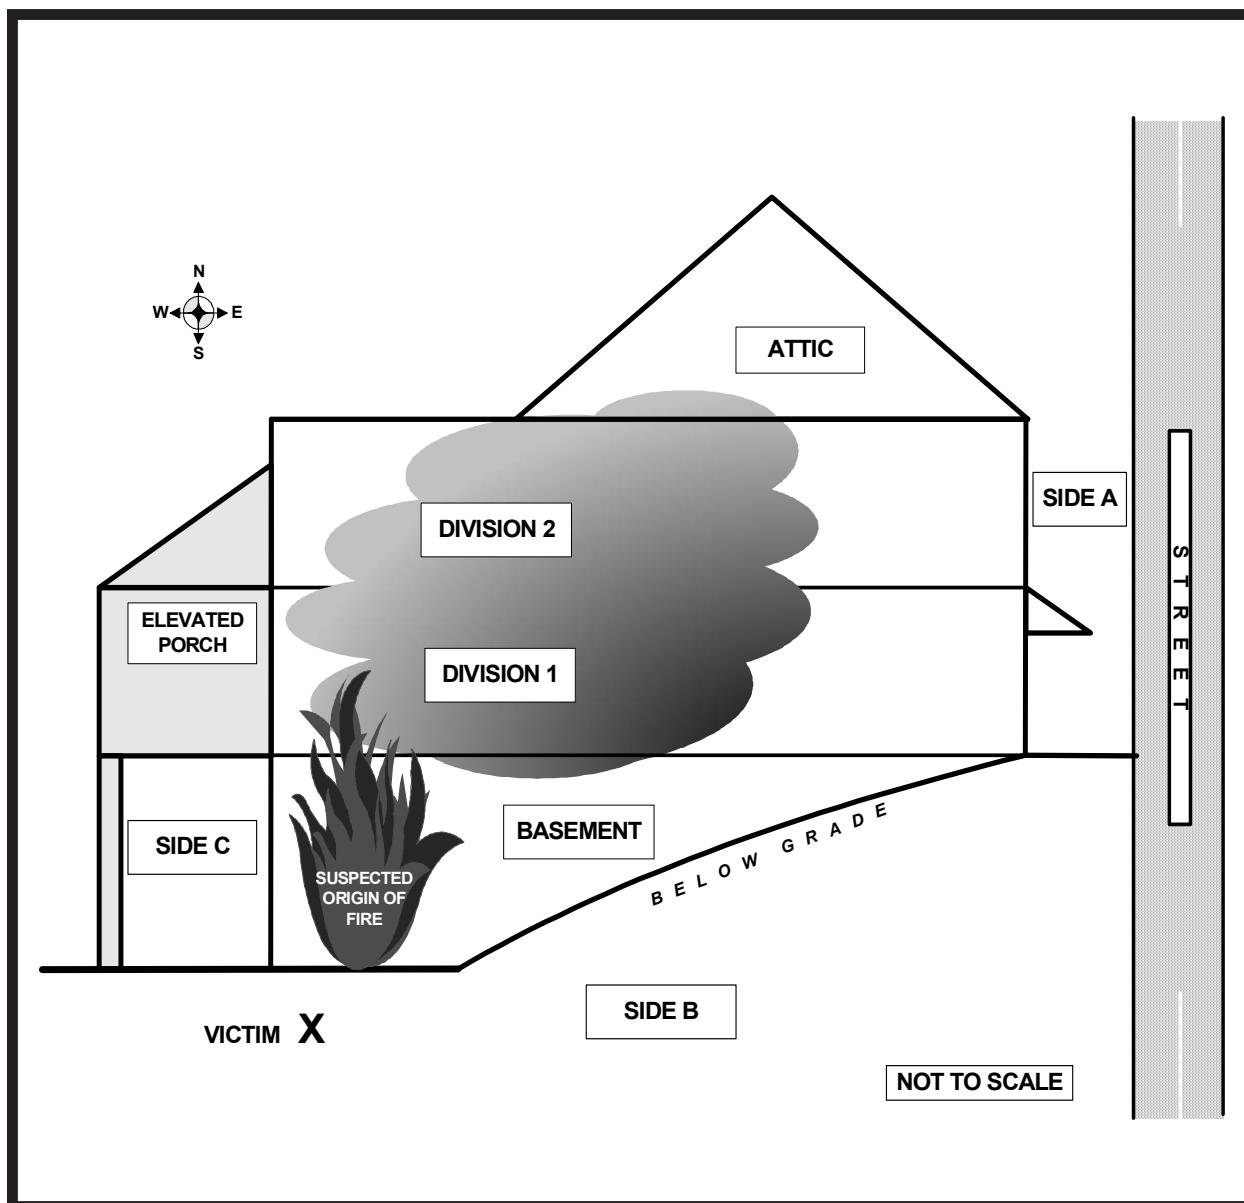
The structure was built into a sloping hillside and had three habitable levels topped by an attic storage area (Diagram 2). Total combined living space measured approximately 4,680 square feet. The first floor (Division 1) had living areas, a kitchen, bathroom, office, laundry, and indoor access to an elevated porch from Side C. Entry to the first floor was made from street level at the front of the house. The second floor (Division 2) had four bedrooms, one bathroom, and was accessible from the first floor by an internal staircase that was located at the front of the house. There was also an exterior stairway attached to the north-facing outer wall of Exposure D that led from street level up to Division 2. The basement was being used as separate living quarters and had a living room, bathroom, bedroom, kitchen, and furnace room. Both the fire building and Exposure D had an overhanging porch from the 2nd level attached on Side C (Photo 1). The porch wrapped around B/C corner and extended the entire length of side B of the fire building. Witnesses reported that at the time of the fire, the porch was being used to store many miscellaneous items including a clothes washer and dryer. From the area under the porch there was direct access to a garage that sat behind the dwelling.

Diagram 2. Side view of fire building showing elevation

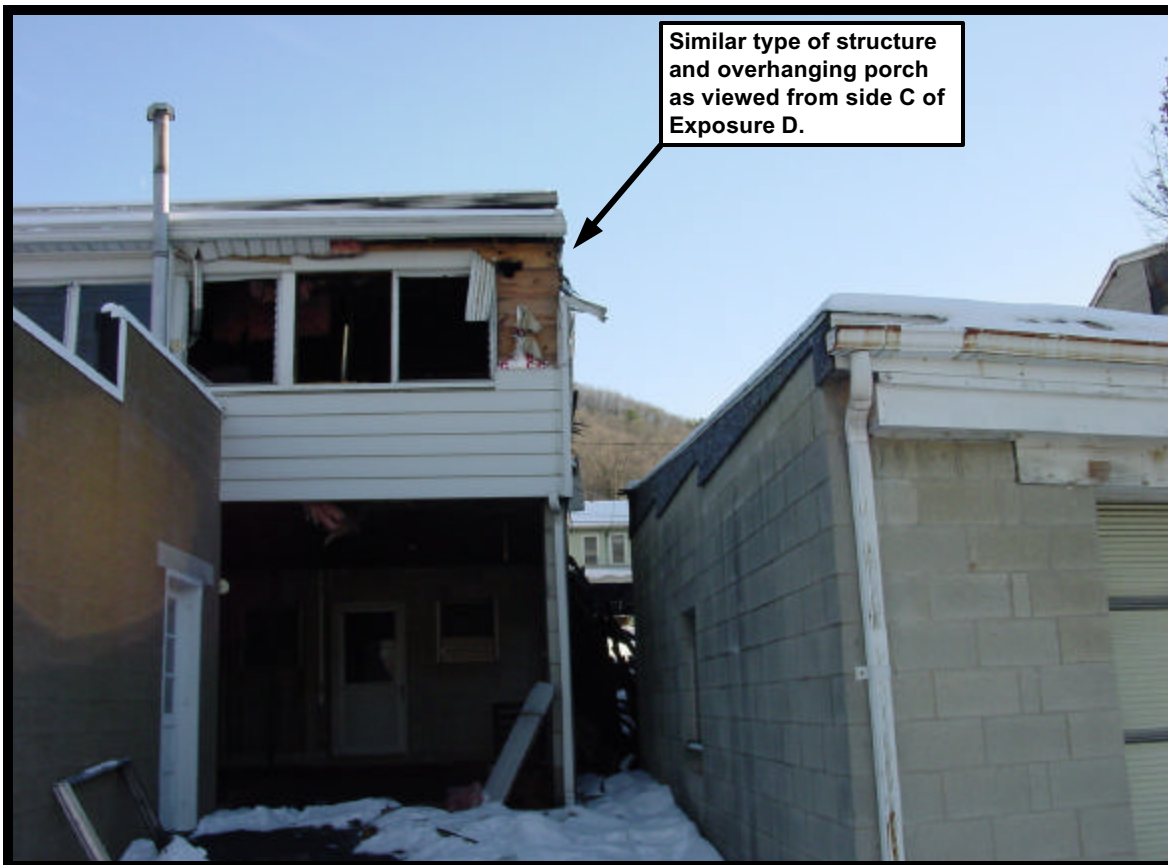
Photo 1. Rear Porch, Exposure D
