Riparian Forest Restoration in San Juan Pueblo and Española

**Ohkay Owingeh (San Juan Pueblo)
CFRP Project 03-DG-11031000-008**

**PROJECT
CLOSEOUT
REPORT**

Riparian Forest Restoration in San Juan Pueblo and Española CFRP Project 03-DG-11031000-008 - Ohkay Owingeh (San Juan Pueblo) Project Closeout Report

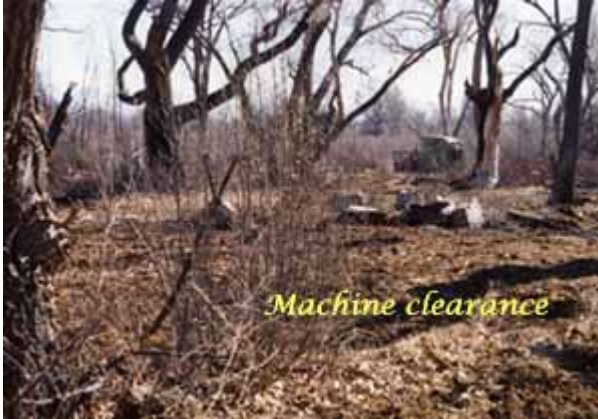
Mechanical cutter-mulcher machines removed invasive trees - mostly Russian olive and Siberian elm - where they were dominant or co-dominant species and where ground disturbance by tractors would be minimal and native trees easily avoided. Where machine access was impractical (where the ground was too soft or uneven, for instance) or where native vegetation to be preserved was too thick for machines to avoid it properly, clearance was done by hand with chain saws. Piles of slash from

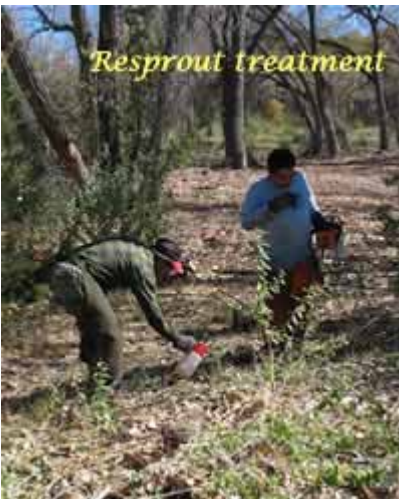
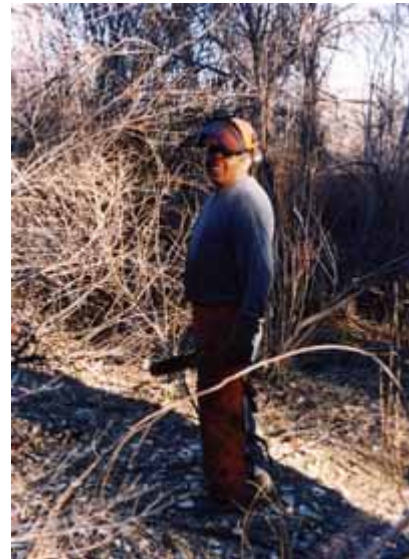
Following manual removal of invasive trees by hand crews, cut stumps were treated with Garlon® 4 herbicide. In places where invasives were re-moved mechanically, resprouts were treated with Garlon

during the 2004, 2005, and 2006 growing seasons. Herbicide was not allowed to come in contact with any open water so as to prevent any chance of affecting newly-planted wetland plants or other non-target plants or animals. Prior surveys had confirmed that no willow flycatcher habitat existed within the project area, but areas of dense vegetation bordering the Rio Grande were left intact just in case, and all mechanical tree removal was carried out during the winter when disturbance to any migratory birds would be minimal.

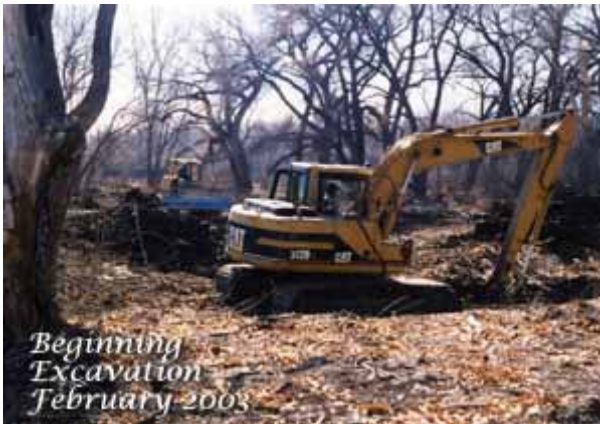
The basic excavation strategy was to enhance remnants of former river channels and other relict topography still present from before channelization: to deepen, expand, and connect low places to create as much new wetland as possible. Deepened channels allow plant roots better access to ground water throughout the year, and in many places they create seasonal open water where none was present before. Irrigation of nearby fields, along with somewhat higher river levels,

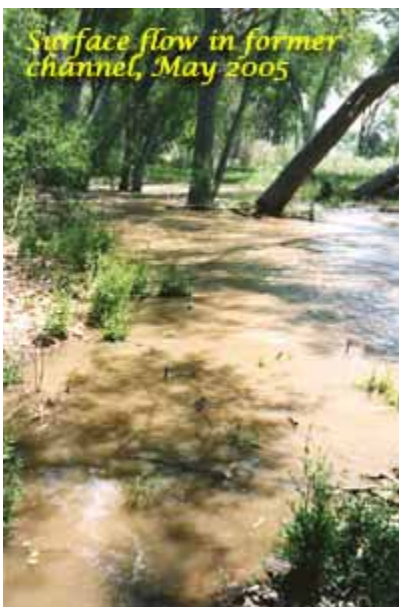
Excavation was intended to permit surface water from the Rio Grande to flow through the site during spring runoff and other high-flow events. A connection was made to the Rio Grande to allow this, and the success of this approach was confirmed in the runoff during the spring of 2005, when flow levels in the Rio Grande above the Chama confluence reached 6,570 cubic feet per second (cfs) and flows of 200 or 300 cfs or more ran through old river channels parallel

to the current Rio Grande channel for a mile and a half or more. This river level falls between the calculated 5-year return period flow of 5,720 cfs and the 10-year flow level of 7,770 cfs, and is in fact

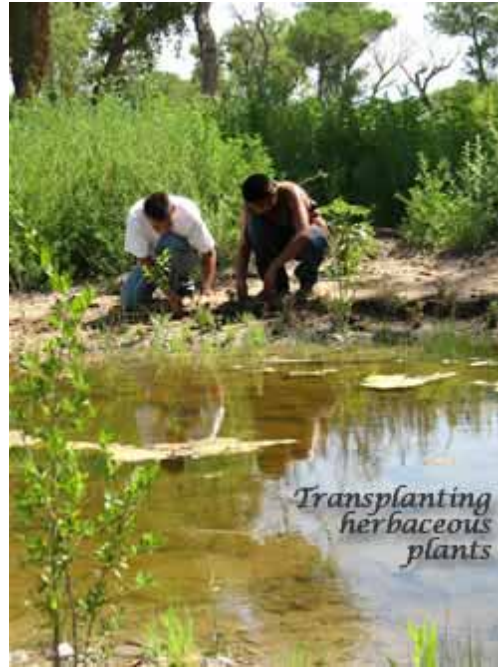
Coyote willow root crowns were excavated from nearby fields with a backhoe, pruned severely, and then transplanted into moist soil in the project area. Our experience has been that this technique permits

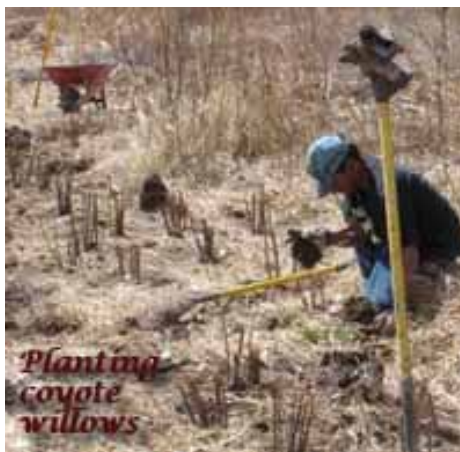
transplanting willows more or less any time of year (instead of only in the winter for pole plantings that need to develop roots before springtime). In addition, transplanted willows sprout more vigorously and produce more stems than pole-planted coyote willows or purchased seedlings.

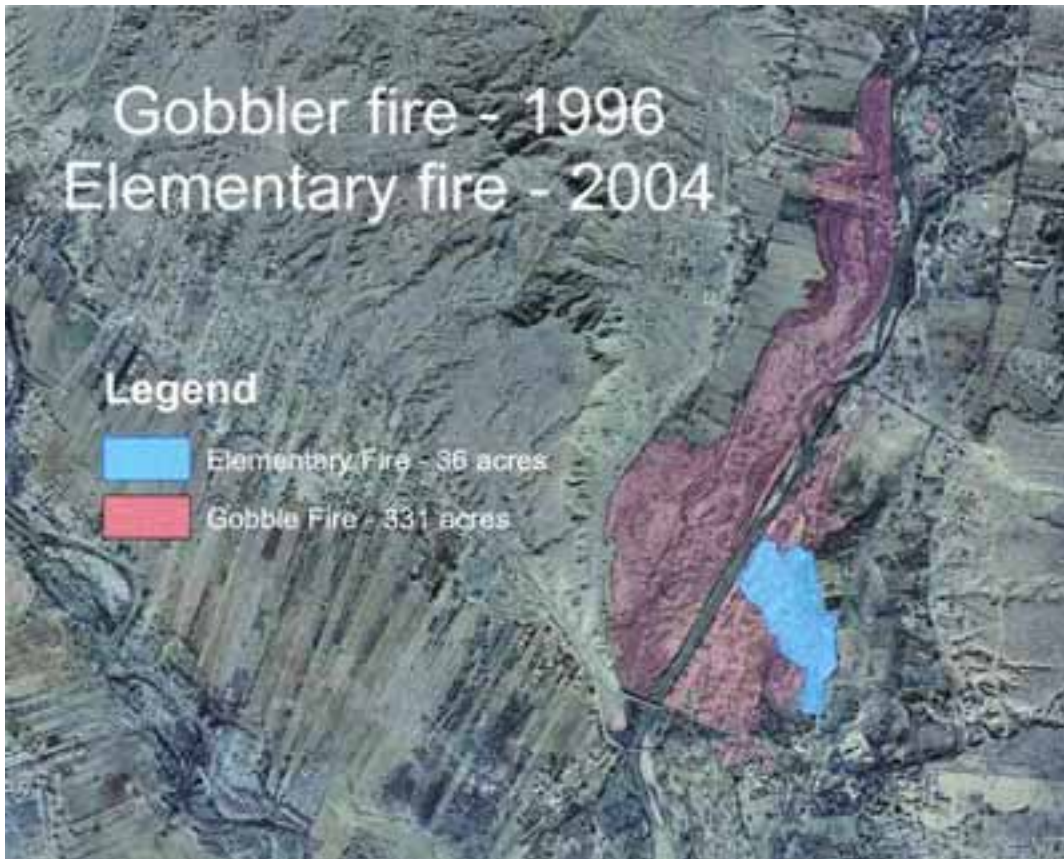
It is interesting to compare this fire with the 1996 “Gobbler” fire that started very nearby at almost exactly the same time of year and under almost identical weather conditions: a windy spring day in a dry year. The Gobbler fire, however, spread through a bosque dominated by dense Russian olive, and eventually consumed 331 acres on both sides of the Rio Grande. The areas affected by the two fires are compared in the map below.

These two fires come about as close to a replicated experiment as is possible with wildfires, and certainly seem to provide a strong indication that bosque restoration substantially diminishes the risk and severity of wildfires in southwestern riparian areas.

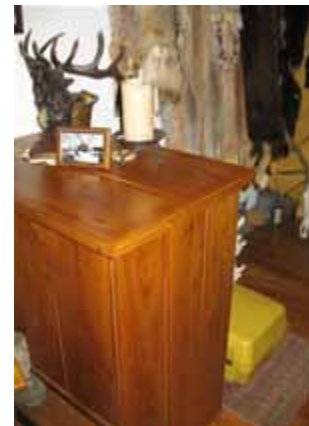
As it turns out, they can be – and, after sawing and air-drying, some of the resulting boards were milled into 1x random width and length lumber, and into flooring. A small cabinet was made out of the boards (as shown in the photograph on the right), and the flooring was installed in a home in Hernandez, New Mexico.
