**National Transportation Safety Board**

# Clarendon, Texas

May 28, 2002

Collision of Two Burlington Northern  
Santa Fe Freight Trains

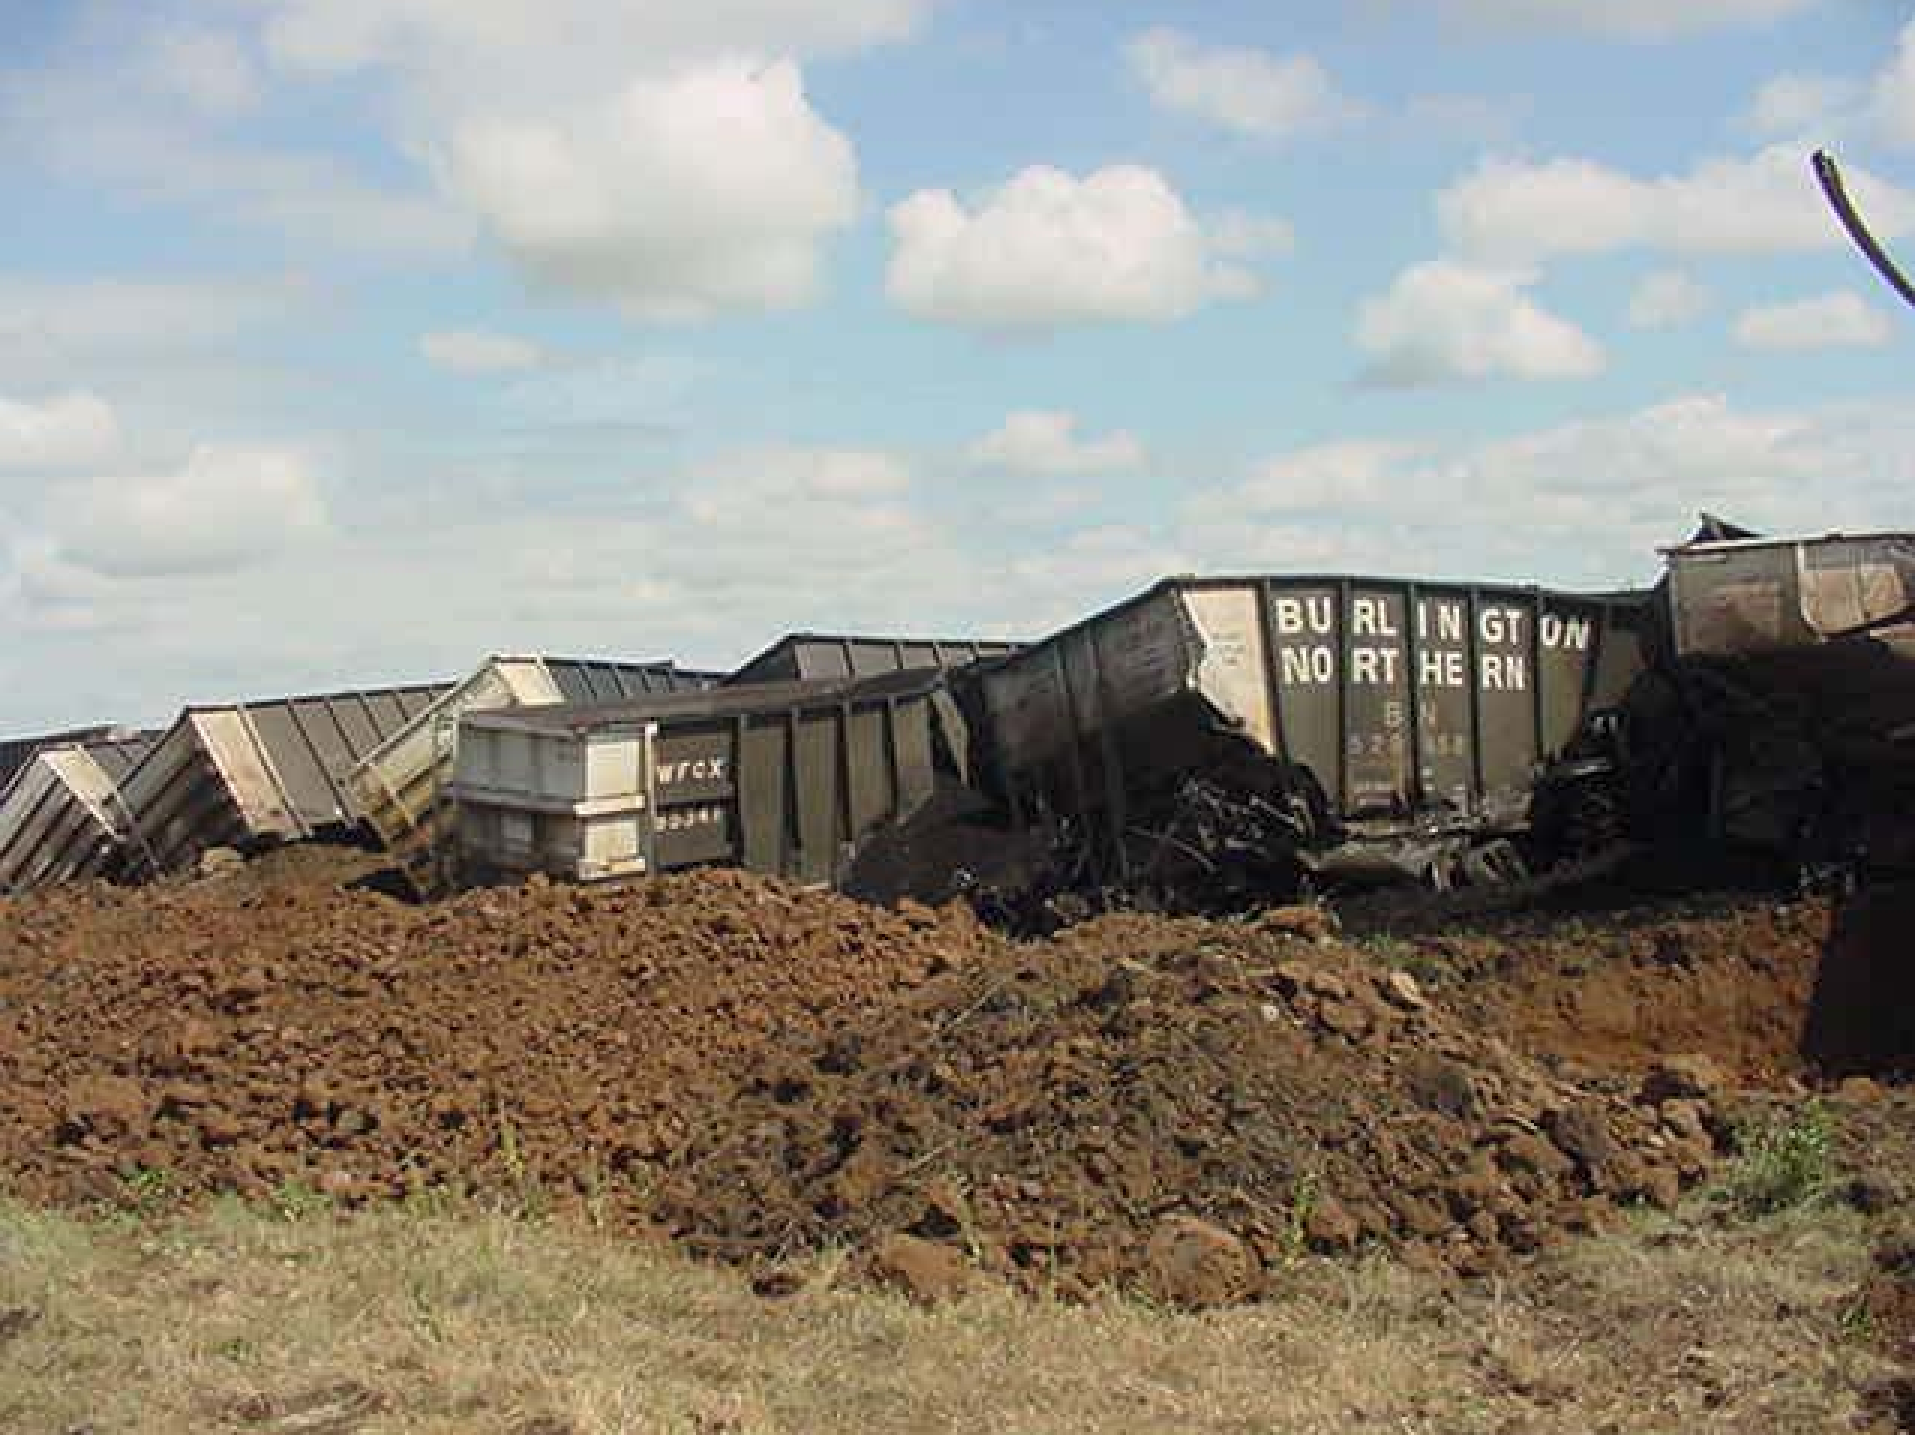
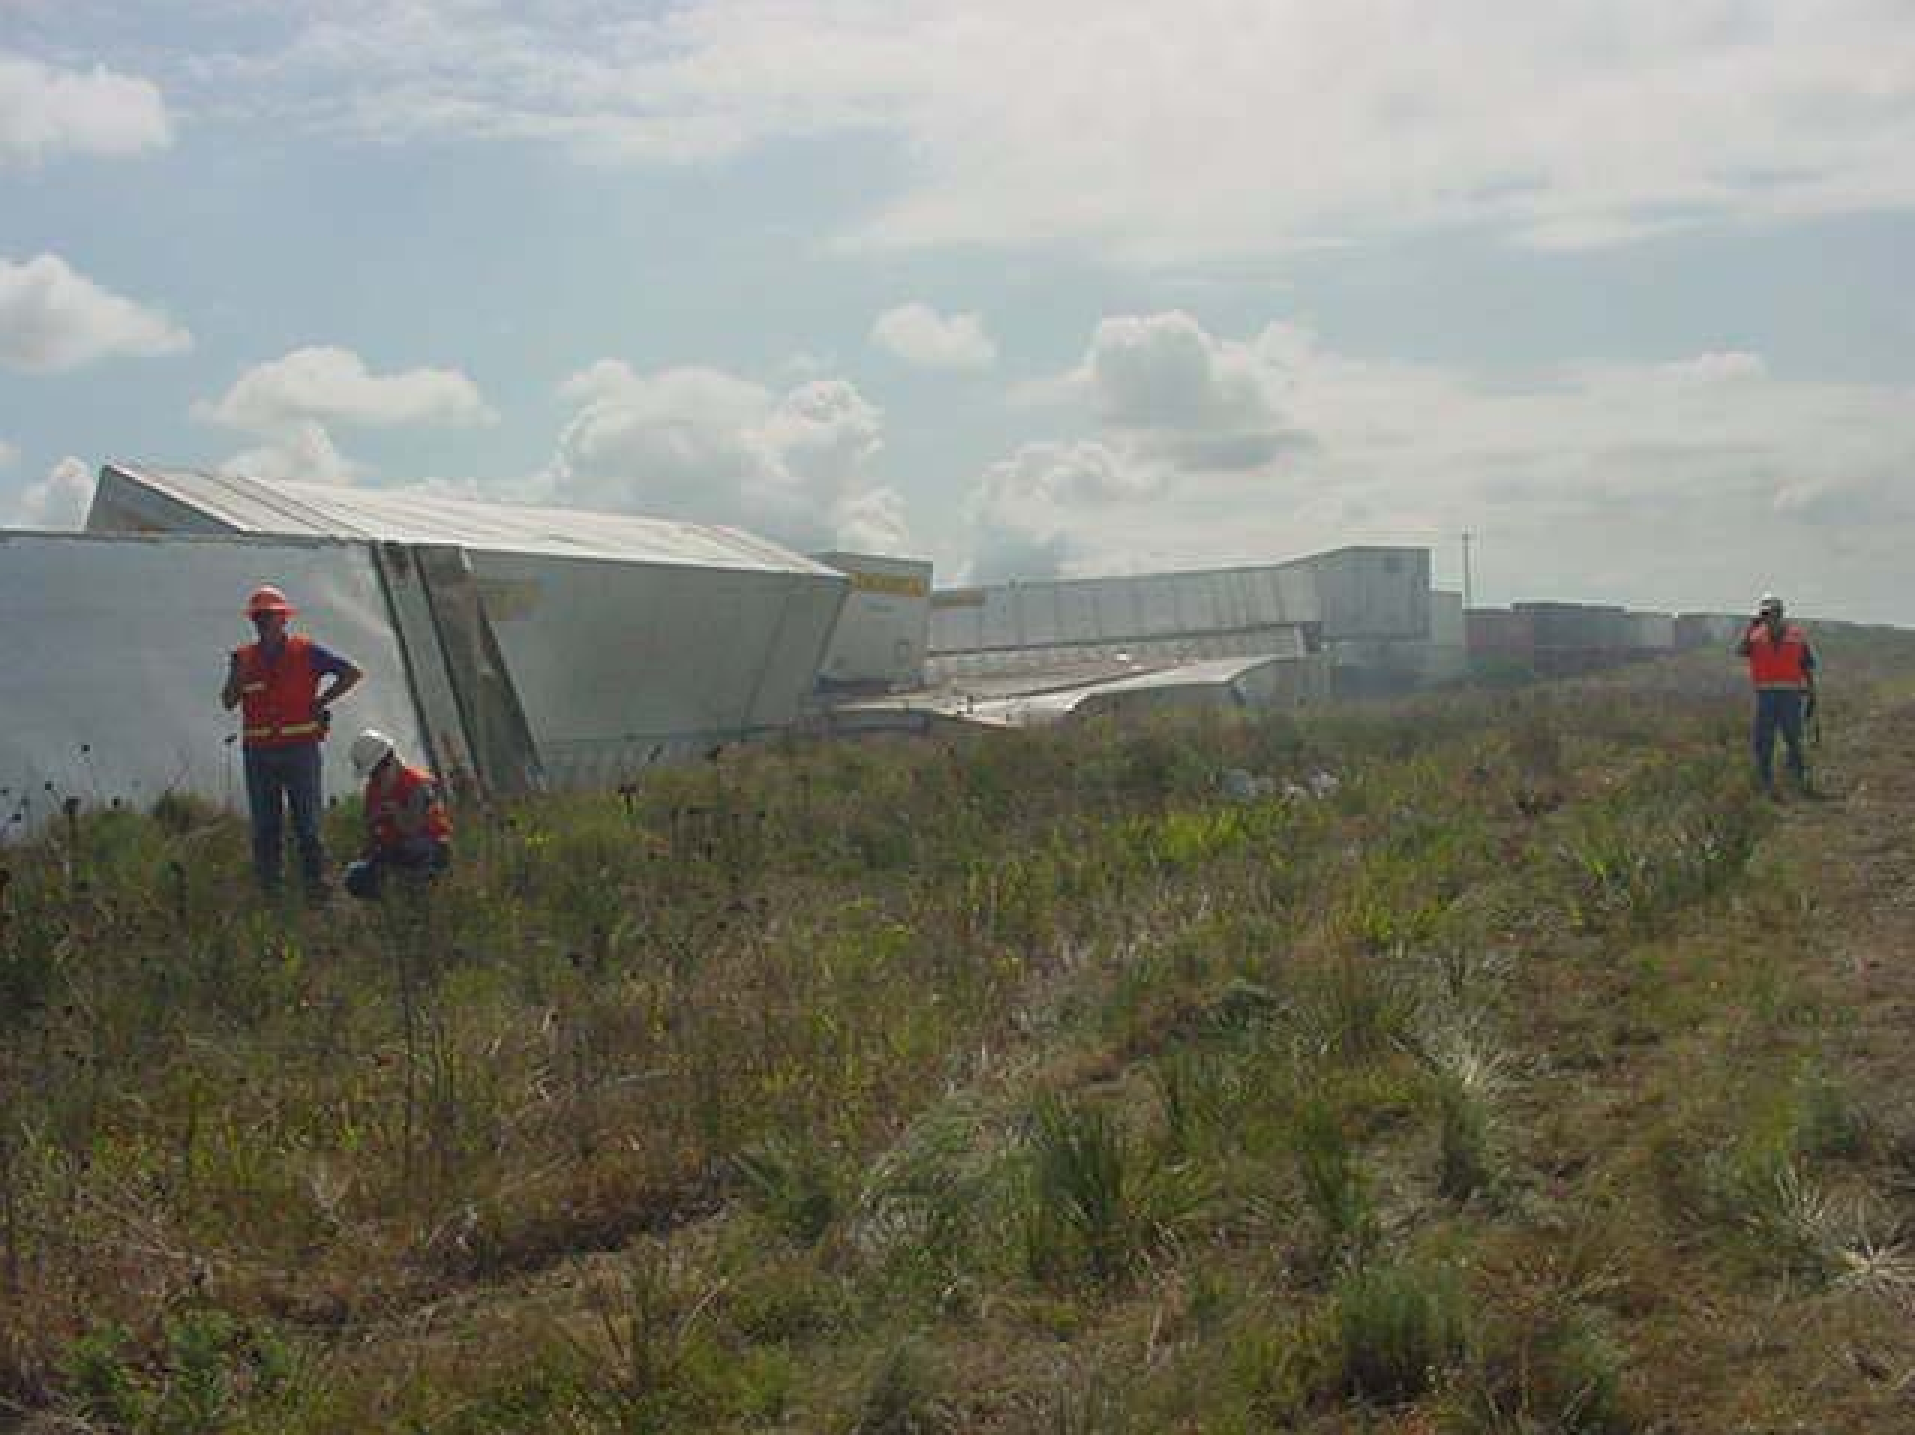
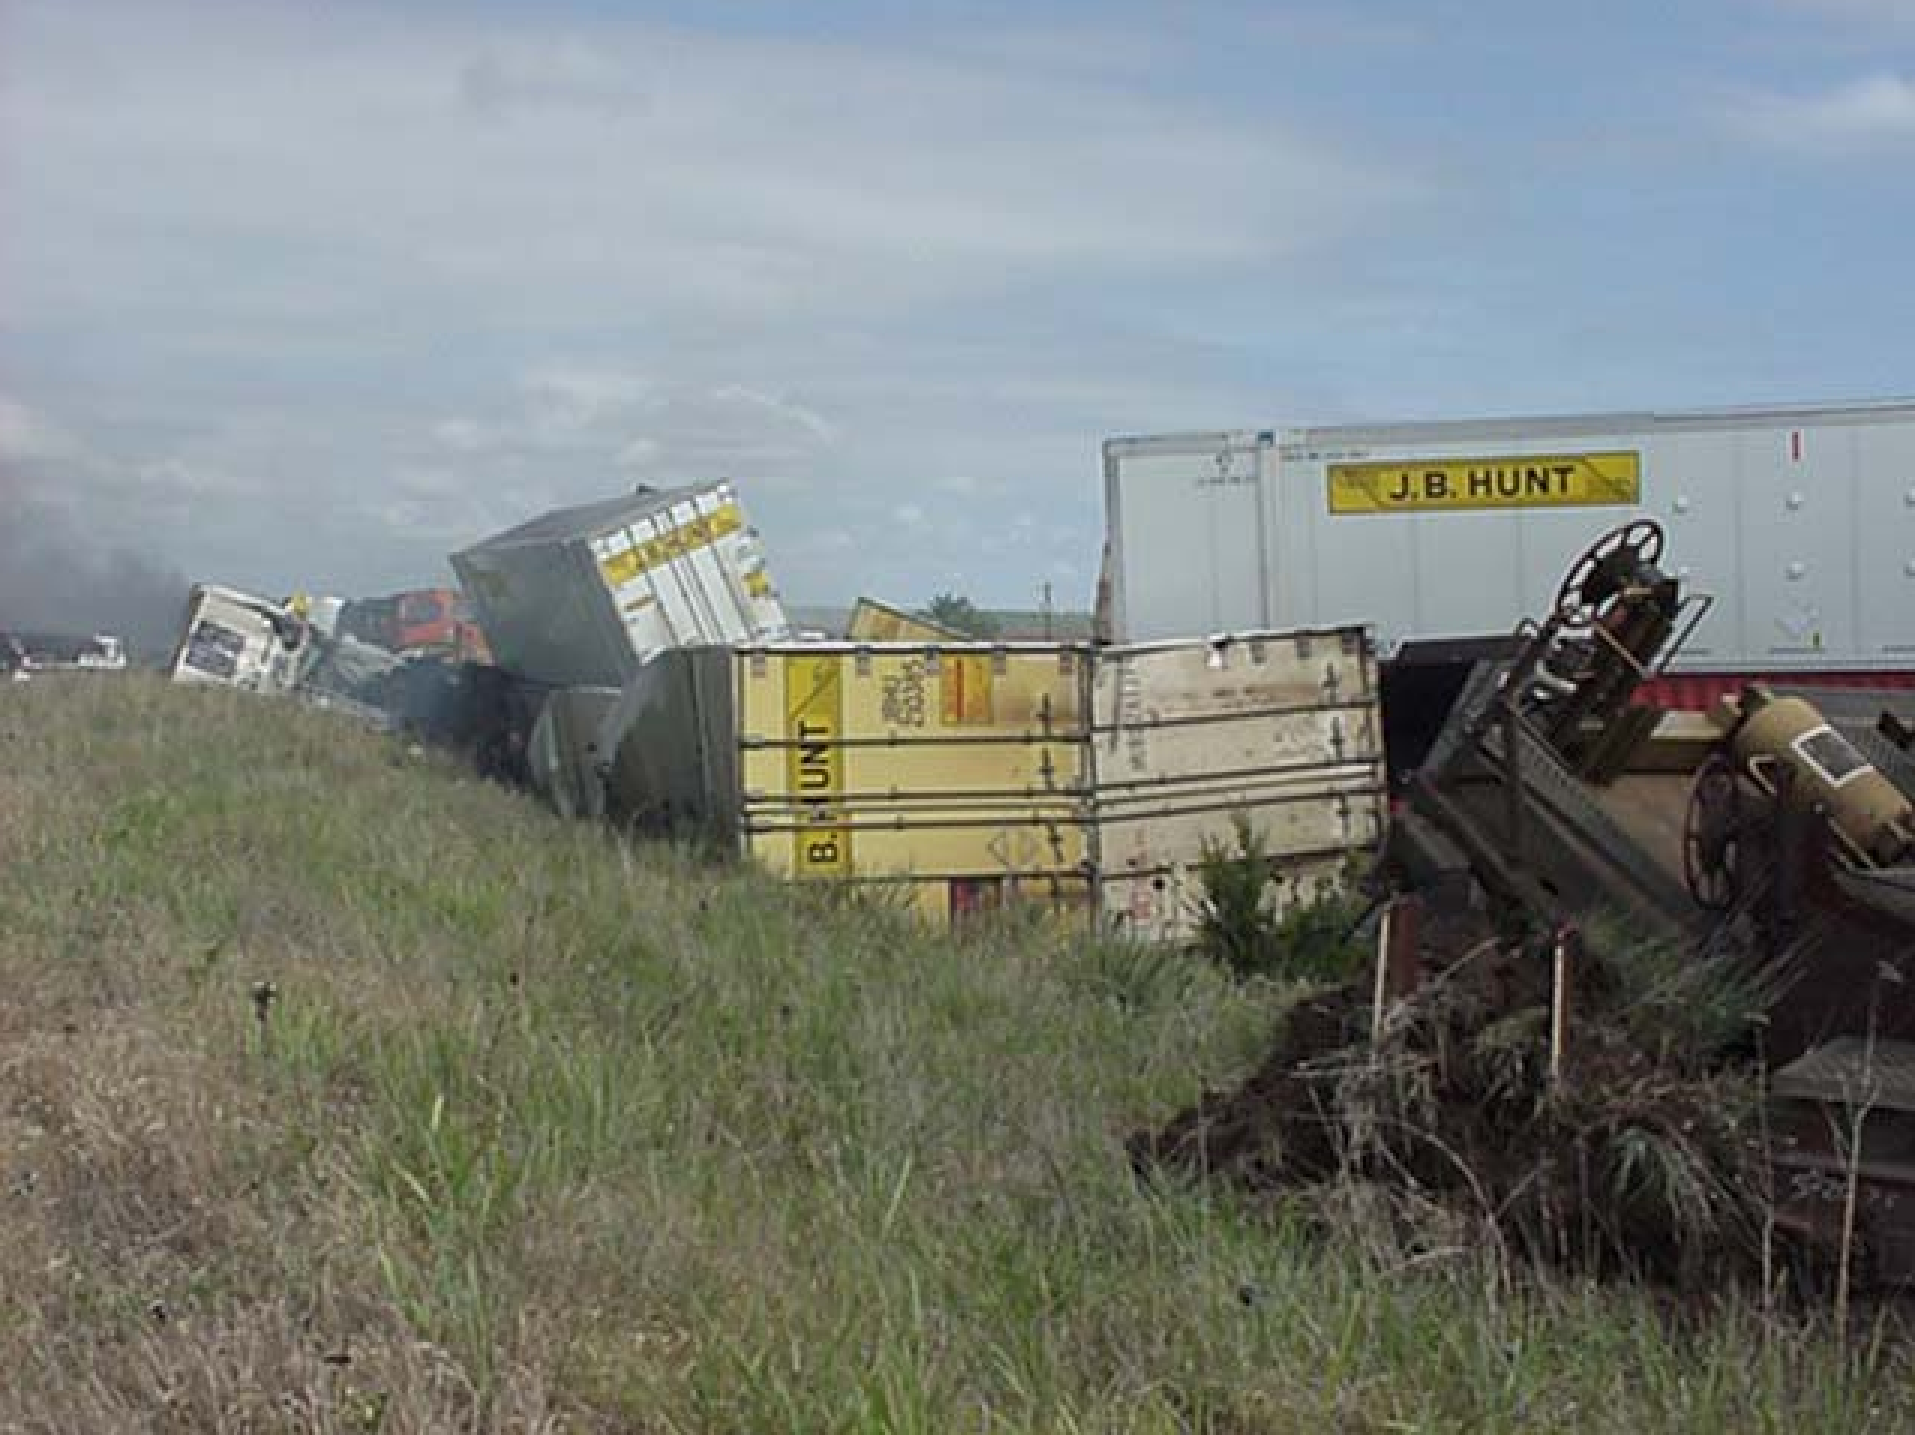
# As a Result of the Collision:

- 2 locomotives and 23 cars of the coal train derailed.
- 2 locomotives and the first 12 platforms of the intermodal train derailed.
- 18 loaded containers were destroyed.
- \$8 million in damages.

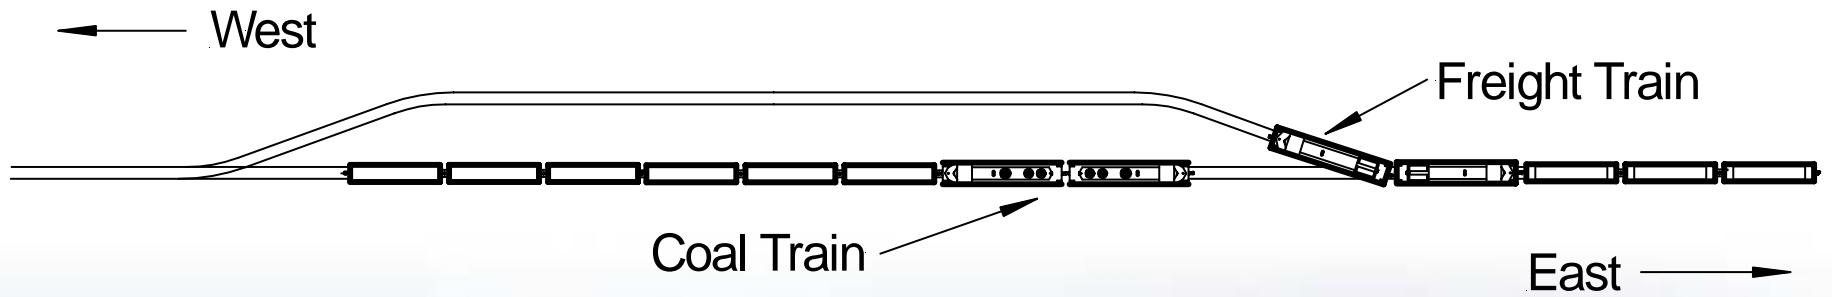
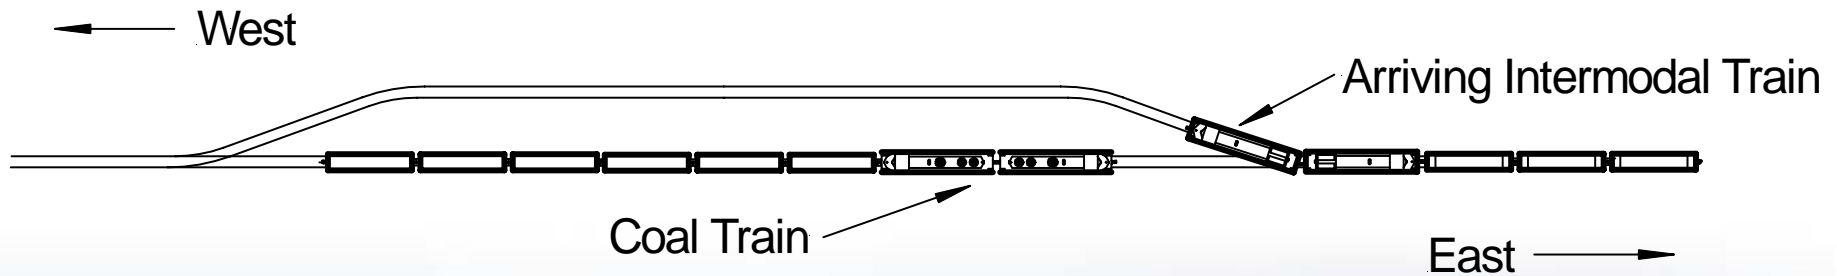
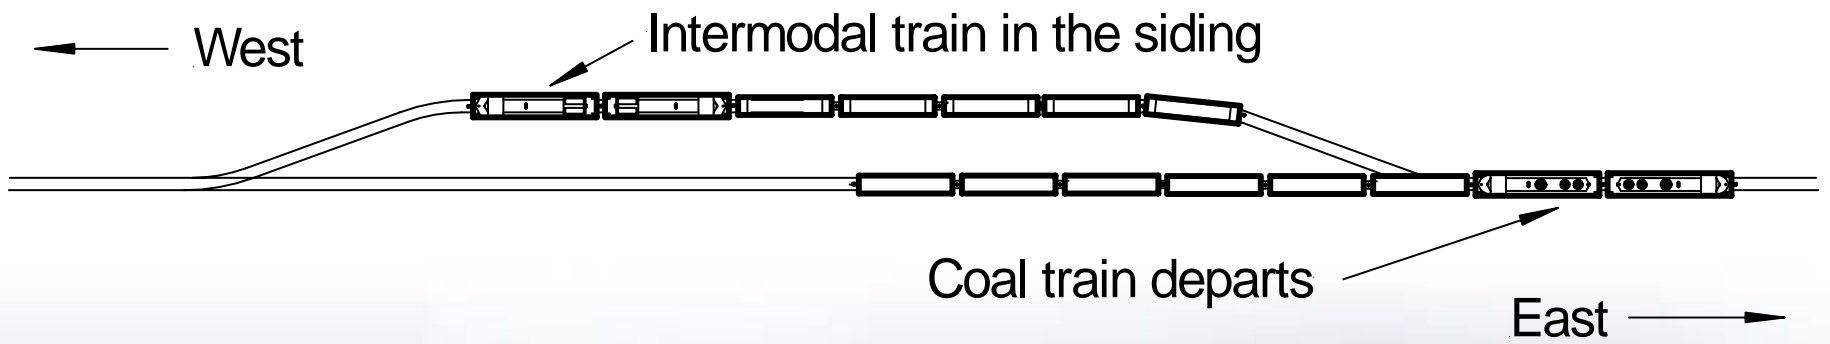
# What Should Have Happened

# “After-Arrival” Authority

- “After-arrival” track warrant allows a train to proceed from one location to another.
- Not in effect until after the arrival of a specified train.
