## **4.1 PREDICTING DAMAGE LEVELS**

## **4.2 DAMAGE MECHANISMS**

### 4.3 CORRELATION BETWEEN DAMAGE AND INJURIES

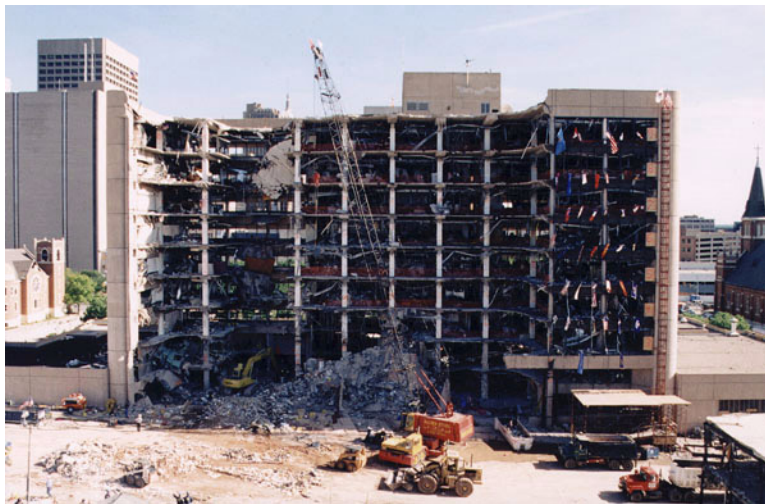
Figure 4-3 Exterior view of Alfred P. Murrah Federal Building collapse

Three types of building damage can lead to injuries and possible fatalities. The most severe building response is collapse. In past incidents, collapse has caused the most extensive fatalities. For the Oklahoma City bombing in 1995 (see Figure 4-3), nearly 90 percent of the building occupants who lost their lives were in the collapsed portion of the Alfred P. Murrah Federal Office Building. Many of the survivors in the collapsed region were on the lower floors and had been trapped in void spaces under concrete slabs.

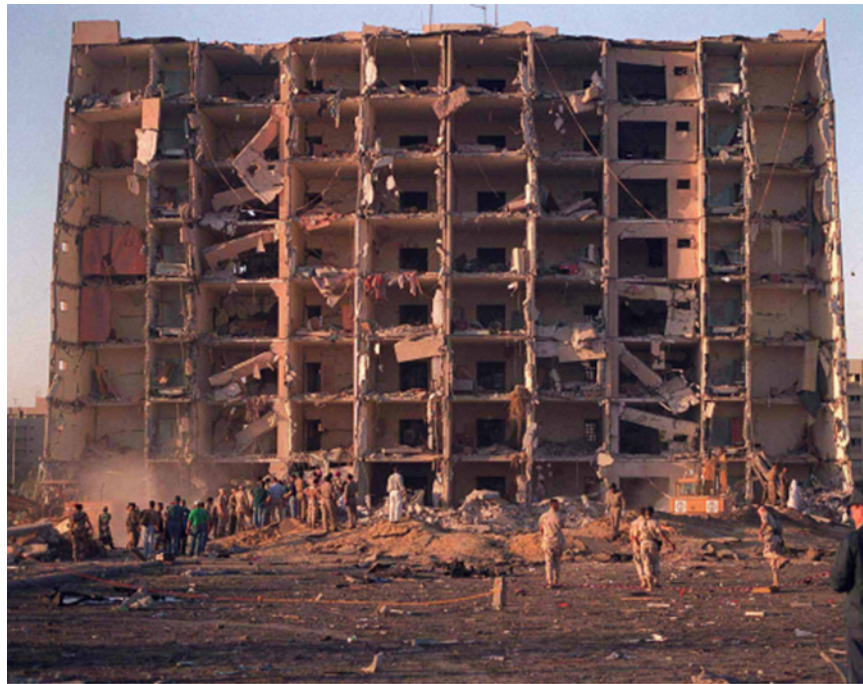
Figure 4-4 Exterior view of Khobar Towers exterior wall failure

- In the Oklahoma City bombing, several persons lost their lives after being struck by structural debris generated by infill walls of a concrete frame building in the Water Resources building across the street from the Murrah building.
- In the Khobar Towers bombing in 1996 (see Figure 4-4), most of the 19 U.S. servicemen who loss their lives were impacted by high-velocity projectiles created by the failed exterior cladding on the wall that faced the weapon. The building was an all-precast, reinforced concrete structure with robust connections between the slabs and walls. The numerous lines of vertical support along with the ample lateral stability provided by the “egg crate” configuration of the structural system prevented collapse.

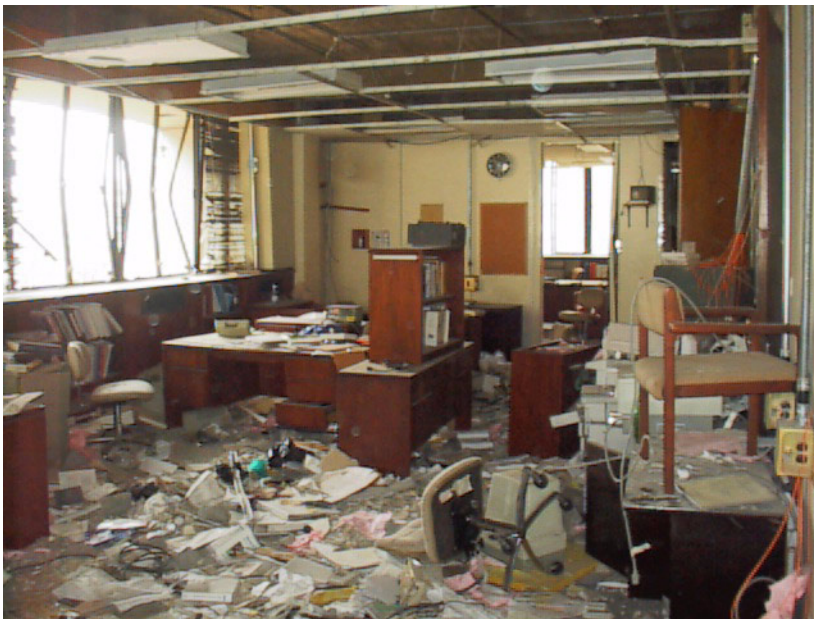
Figure 4-5 Photograph showing non-structural damage in building impacted by blast

Even if the building remains standing and no structural damage occurs, extensive injuries can occur due to nonstructural damage (see

Figure 4-5). Typically, for large-scale incidents, these types of injuries occur to persons who are in buildings that are within several blocks of the incident. Although these injuries are often not life-threatening, many people can be affected, which has an impact on the ability of local medical resources to adequately respond. An example of nonstructural damage causing injuries is the extensive glass lacerations that occurred in the Oklahoma City Bombing within the Regency Towers apartment building, which was approximately 500 feet from the Murrah Building. In this incident, glass laceration injuries extended as far as 10 blocks from the bombing. Another example is the bombing of the U.S. embassy in Nairobi, Kenya. The explosion occurred near one of the major intersections of the city, which was heavily populated at the time of the bombing, causing extensive glass lacerations to passersby. The ambassador, who was attending a meeting at an office building across from the embassy, sustained an eye injury as a result of extensive window failure in the building.
