3.1 GENERAL DESIGN CONSIDERATIONS

3.1.1 NATURE OF HIGH WINDS

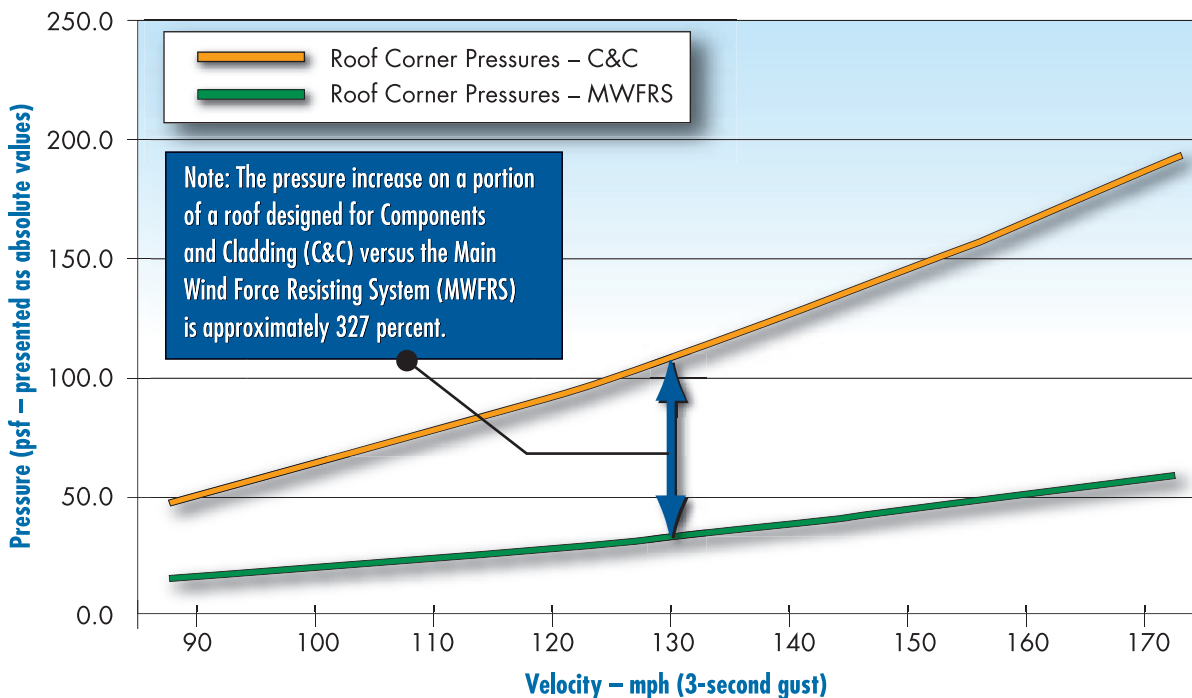
Figure 3-5: Wind pressure as a function of wind speed

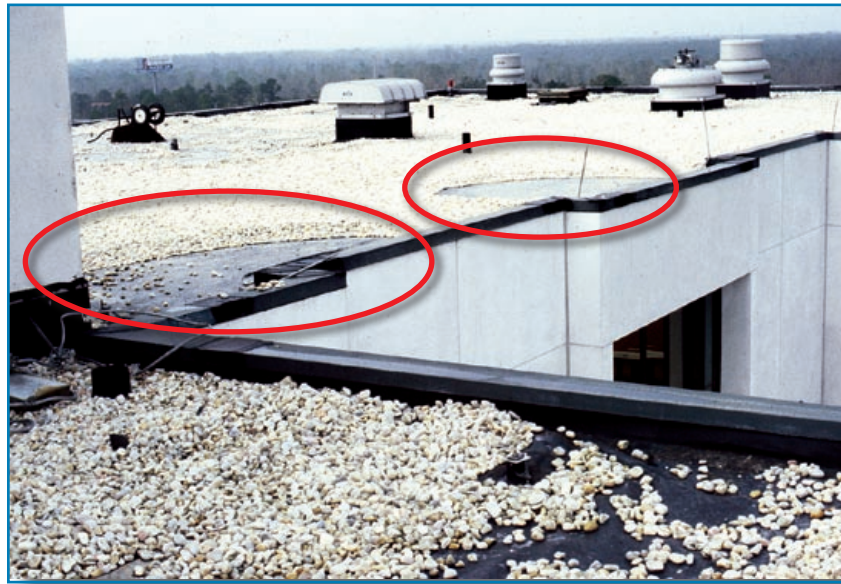
Building irregularities, such as re-entrant corners, bay window projections, a stair tower projecting out from the main wall, dormers, and chimneys can cause localized turbulence. Turbulence causes wind speed-up, which increases the wind loads in the vicinity of the building irregularity, as shown in Figures 3-9 and 3-10. Figure 3-9 shows the aggregate ballast on a hospital's single-ply membrane roof blown away at the re-entrant corner and in the vicinity of the corners of the wall projections at the window bays. The irregular wall surface created turbulence, which led to wind speed-up and loss of aggregate in the turbulent flow areas.

Figure 3-9:
Aggregate blow-off
associated with building
irregularities. Hurricane
Hugo (South Carolina,
1989)

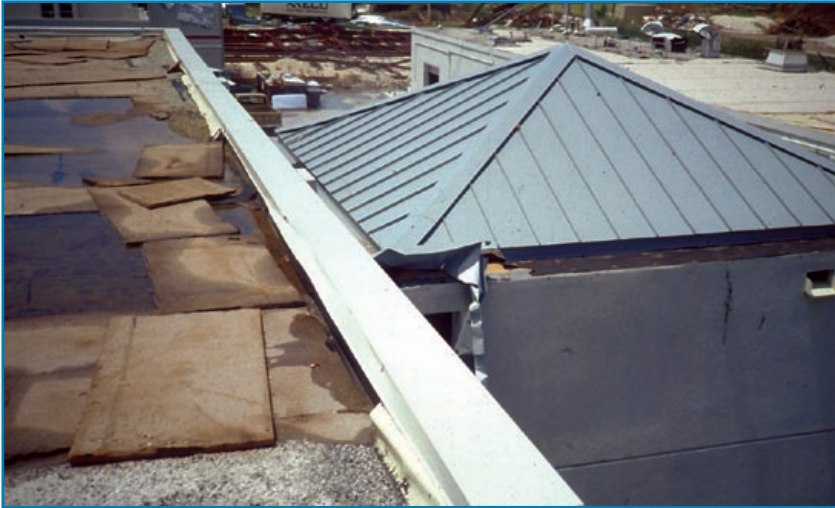
Figure 3-10 shows a stair tower at a hospital that caused turbulence resulting in wind speed-up. The speed-up increased the suction pressure on the base flashing along the parapet behind the stair tower. The built-up roof's base flashing was pulled out from underneath the coping because its attachment was insufficient to resist the suction pressure. The base flashing failure propagated and caused a large area of the roof

membrane to lift and peel. Some of the wall covering on the stair tower was also blown away. Had the stair tower not existed, the built-up roof would likely not have been damaged. To avoid damage in the vicinity of building irregularities, attention needs to be given to the attachment of building elements located in turbulent flow areas.

Figure 3-10:
The irregularity created by the stair tower (covered with a metal roof) caused turbulence resulting in wind speed-up and roof damage. Hurricane Andrew (Florida, 1992)

To avoid the roof membrane damage shown in Figure 3-10, it would be prudent to use corner uplift loads in lieu of perimeter uplift loads in the vicinity of the stair tower, as illustrated in Figure 3-11. Wind load increases due to building irregularities can be identified by wind tunnel studies; however, wind tunnel studies are rarely performed for critical facilities. Therefore, identification of wind load increases due to building irregu-

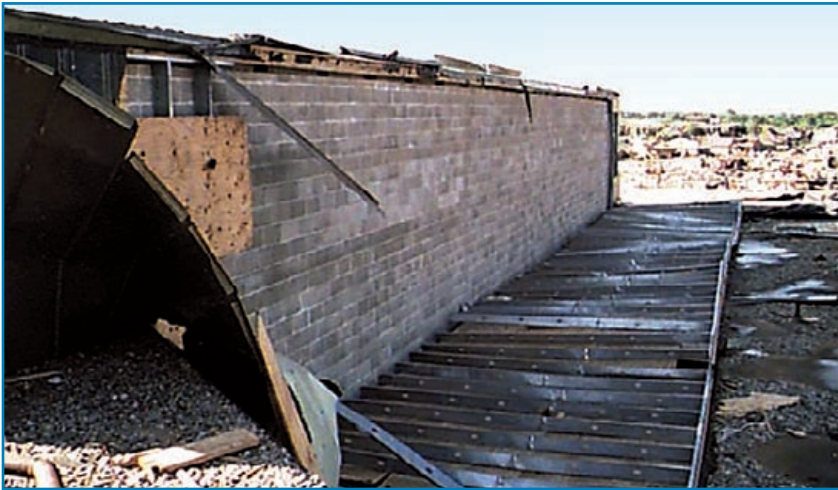
Wall coverings, soffits, and large doors: Exterior wall covering, soffit, and large door damage is common during hurricanes and tornadoes, but is less common during other storms. At the building shown in Figure 3-14, metal wall covering was attached to plywood over metal studs. The CMU wall behind the studs did not appear to be damaged. The building was located on the periphery of a violent tornado.

Figure 3-14:
Collapsed metal stud wall—the wall was blown completely away in another part of the building. (Oklahoma, 1999)

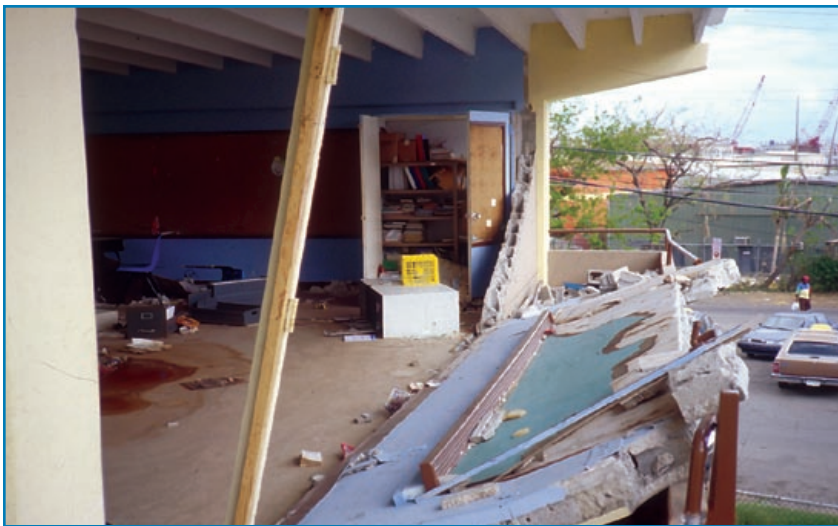
Wall collapse: Collapse of non-load-bearing exterior walls is common during hurricanes and tornadoes, but is less common during other storms (see Figure 3-15).

Figure 3-15:
The unreinforced CMU wall collapsed at a school during Hurricane Marilyn. (U.S. Virgin Islands, 1995)

internal loading for components and cladding in order to avoid collapse. When these types of walls collapse, they represent a severe risk to life because of their great weight (see Figure 3-15).

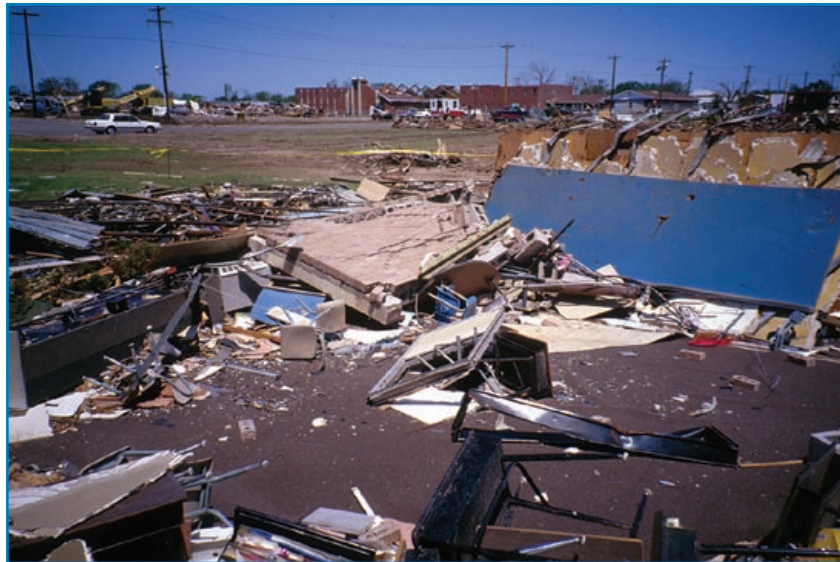
Structural system: Structural damage (e.g., roof deck blow-off, blow-off or collapse of the roof structure, collapse of exterior bearing walls, or collapse of the entire building or major portions thereof) is the principal type of damage that occurs during strong and violent tornadoes (see Figure 3-16).

Figure 3-16:
The school wing was destroyed by a violent tornado. (Oklahoma, 1999)

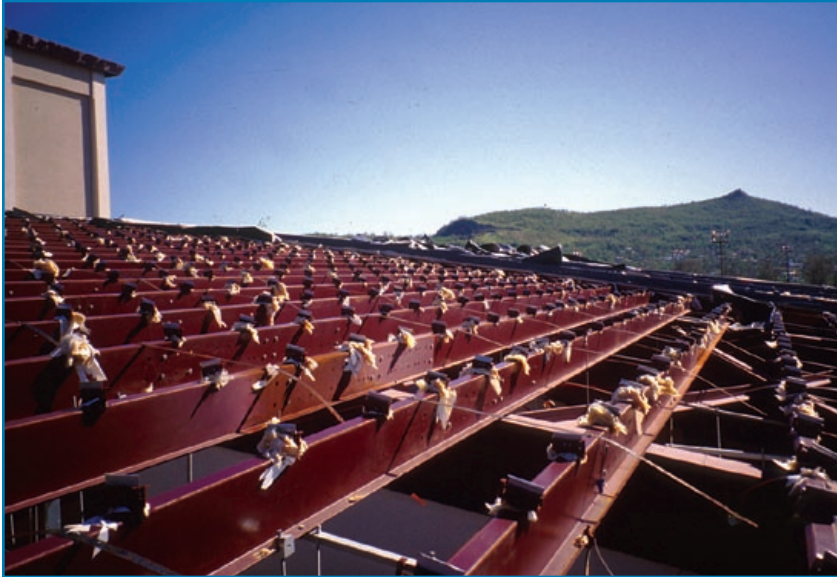
Figure 3-17:
A massive quantity of water entered the building after the roof blew off. Typhoon Paka (Guam, 1997)

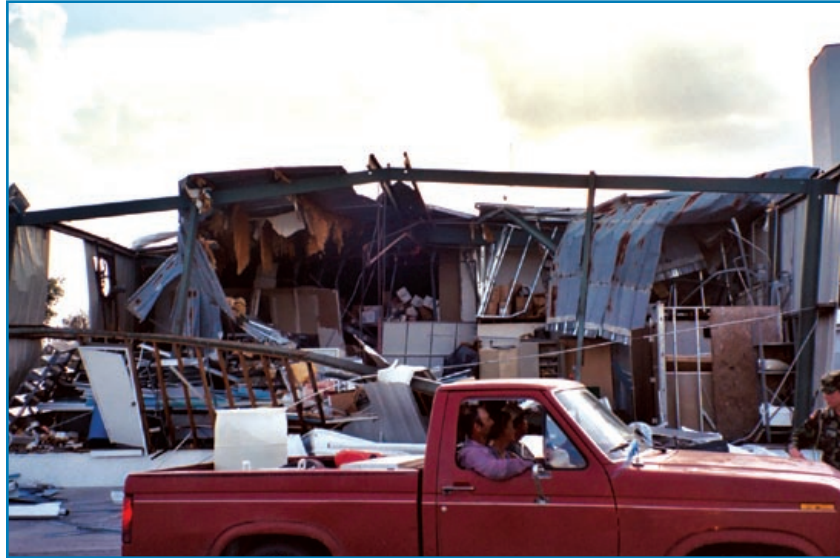
Figure 3-18 contained the hospital's supplies and maintenance shop. With the loss of this building, tents had to be set up to provide supply storage. Almost all of the tools and stock materials for repairs were lost.

Figure 3-18:
A hurricane-damaged,
pre-engineered storage
building adjacent to
a hospital. Hurricane
Charley (Florida, 2004)

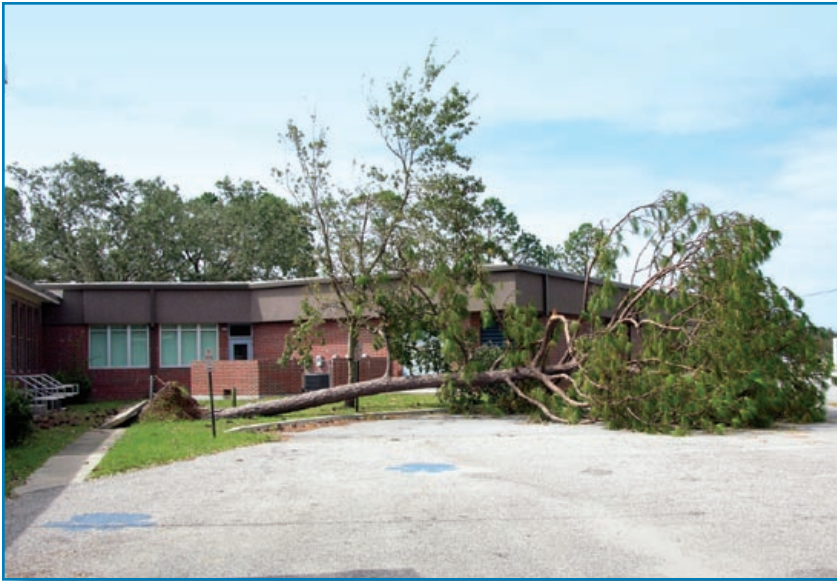
Figure 3-19:
Had this tree fallen in the opposite direction, it would have landed on the school. Hurricane Ivan (Florida, 2004)

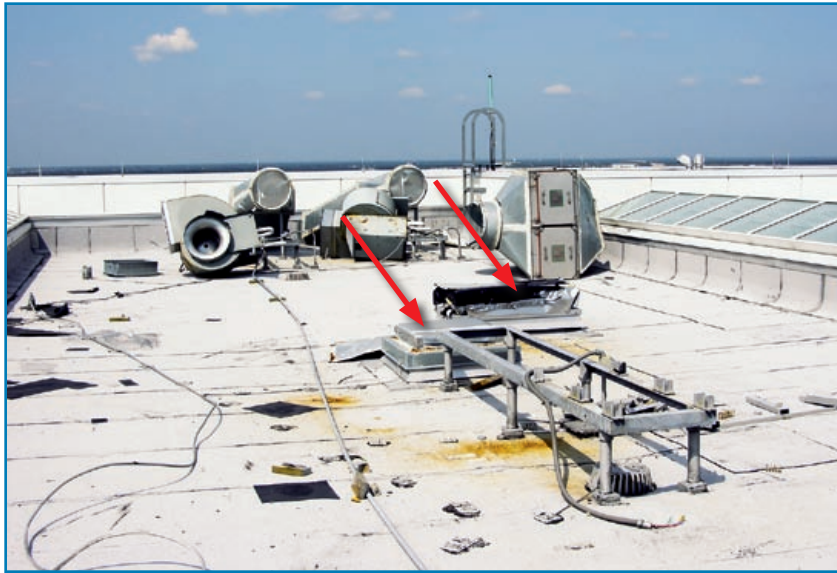
Figure 3-20:
Temporary coverings placed over two large openings in the roof that were left after the ductwork blew away. Hurricane Katrina (Mississippi, 2005)

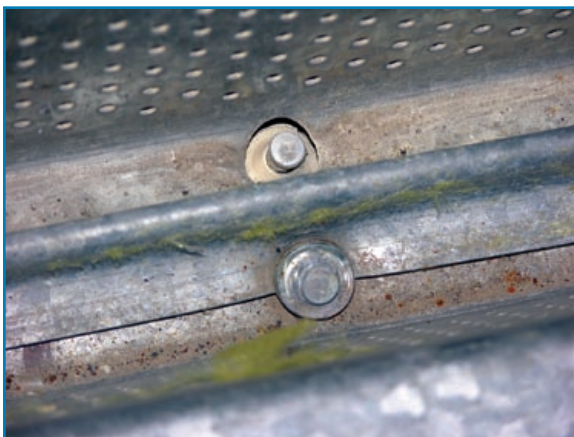
Figure 3-24:
Looking down at a sidelap of a deck attached with powder-driven pins. The washer at the top pin blew through the deck.

- For roof decks, concrete, steel, plywood, or oriented strand board (OSB) is recommended.
- For steel roof decks, it is recommended that a screw attachment be specified, rather than puddle welds or powder-driven pins. Screws are more reliable and much less susceptible to workmanship problems. Figure 3-23 shows decking that was attached with puddle welds. At most of the welds, there was only superficial bonding of the metal deck to the joist, as illustrated by this example. Only a small portion of the deck near the center of the weld area (as delineated by the circle) was well fused to the joist. Figures 3-24 and 3-25 show problems with acoustical decking attached with powder-driven pins. The pin shown on the left of Figure 3-25 is properly seated. However, the pin at the right did not penetrate far enough into the steel joist below.

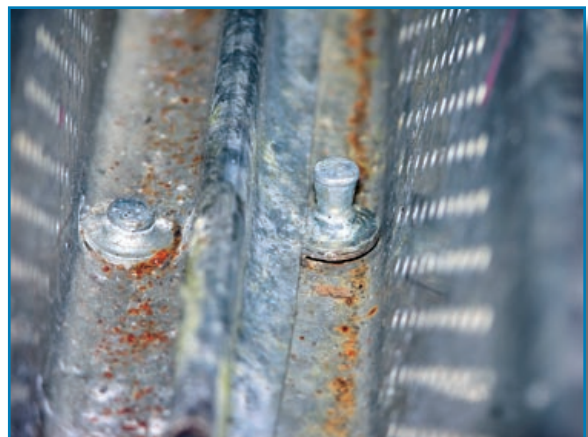
Figure 3-25:
View looking along a sidelap of a deck attached with powder-driven pins. The right pin does not provide adequate uplift and shear resistance.

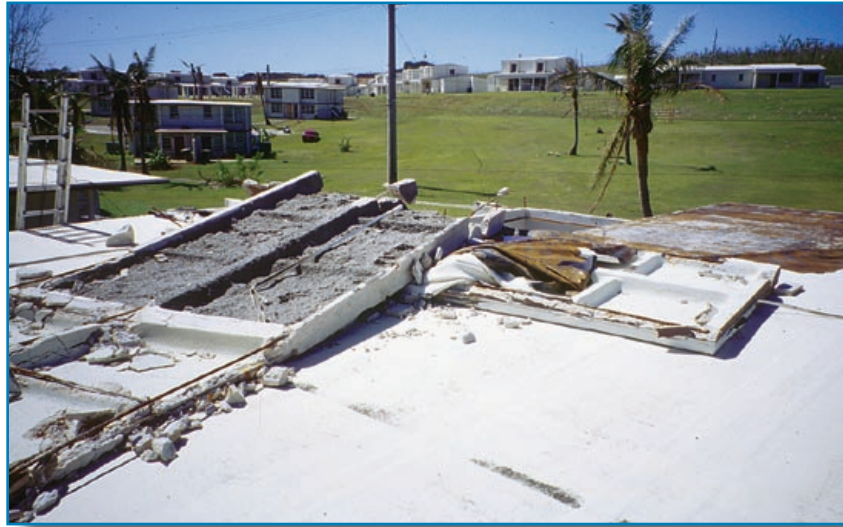
- For precast concrete decks it is recommended that the deck connections be designed to resist the design uplift loads because the deck dead load itself is often insufficient to resist the uplift. The deck in Figure 3-26 had bolts to provide uplift resistance; however, anchor plates and nuts had not been installed. Without the anchor plates, the dead load of the deck was insufficient to resist the wind uplift load.

Figure 3-26:
Portions of this waffled
precast concrete roof deck
were blown off. Typhoon
Paka (Guam, 1997)

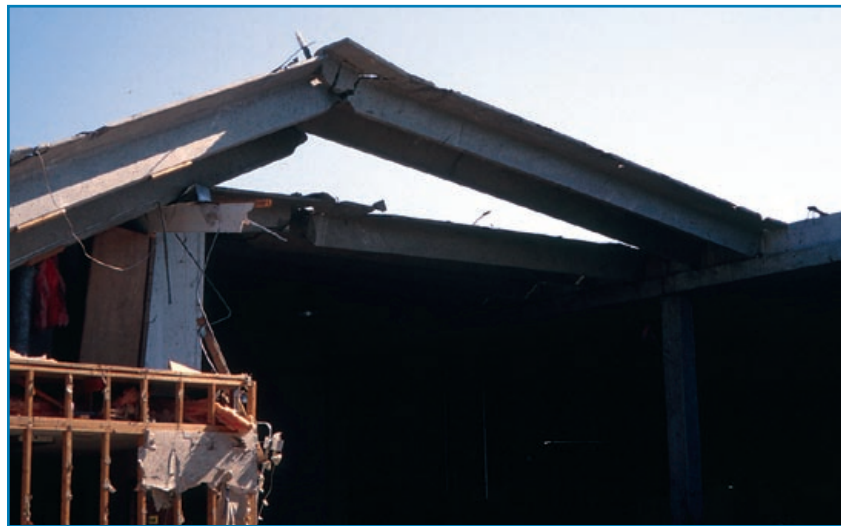
- For precast Tee decks, it is recommended that the reinforcing be designed to accommodate the uplift loads in addition to the gravity loads. Otherwise, large uplift forces can cause member failure due to the Tee's own pre-stress forces after the uplift load exceeds the dead load of the Tee. This type of failure occurred at one of the roof panels shown in Figure 3-27, where a panel lifted because of the combined effects of wind uplift and pre-tension. Also, because the connections between the roof and wall panels provided very little uplift load resistance, several other roof and wall panels collapsed.

Figure 3-27:
Twin-Tee roof panel lifted
as a result of the combined
effects of wind uplift and
pre-tension. Tornado
(Missouri, May 2003)

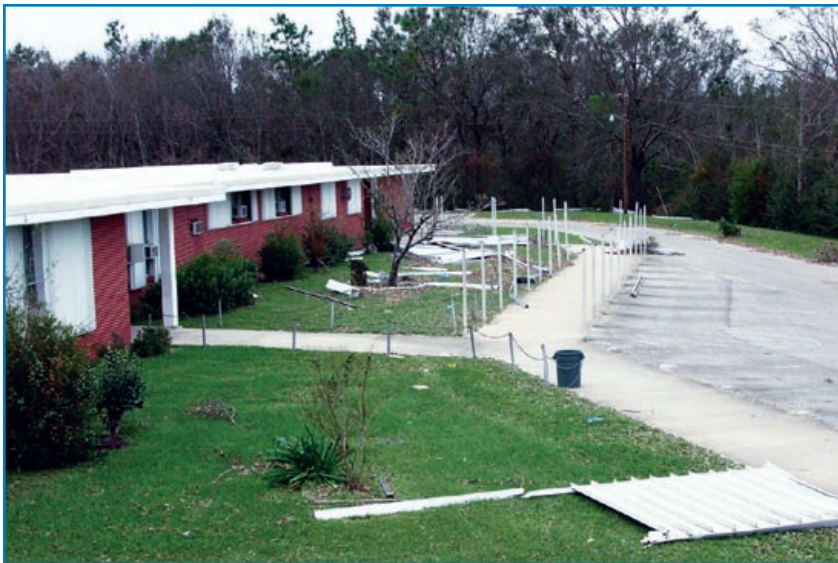
Figure 3-28:
The destroyed walkway canopy in front of a school became wind-borne debris. Hurricane Ivan (Florida, 2004)

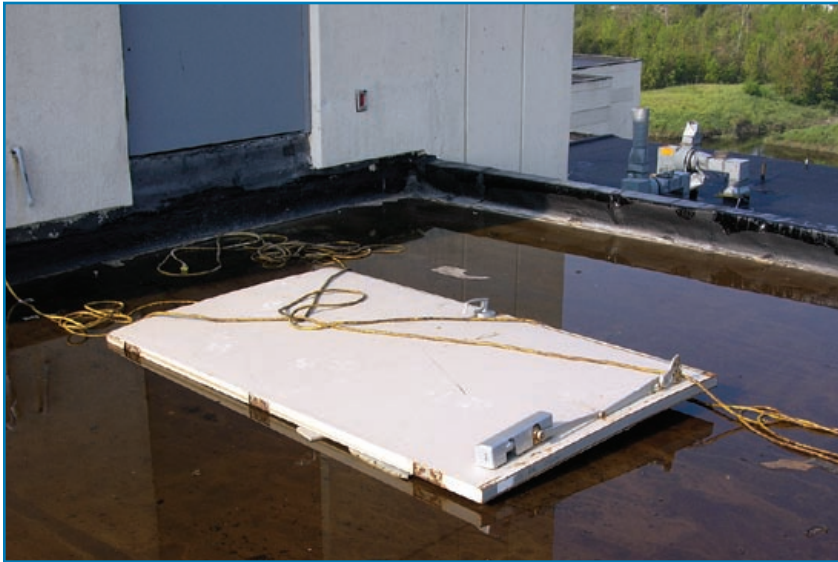
This section addresses primary and secondary egress doors, sectional (garage) doors, and rolling doors. Although blow-off of personnel doors is uncommon, it can cause serious problems (see Figure 3-29). Blown-off doors allow entrance of rain and tumbling doors can damage buildings and cause injuries.

Figure 3-29:
Door on a hospital penthouse blown off its hinges during Hurricane Katrina (Mississippi, 2005)

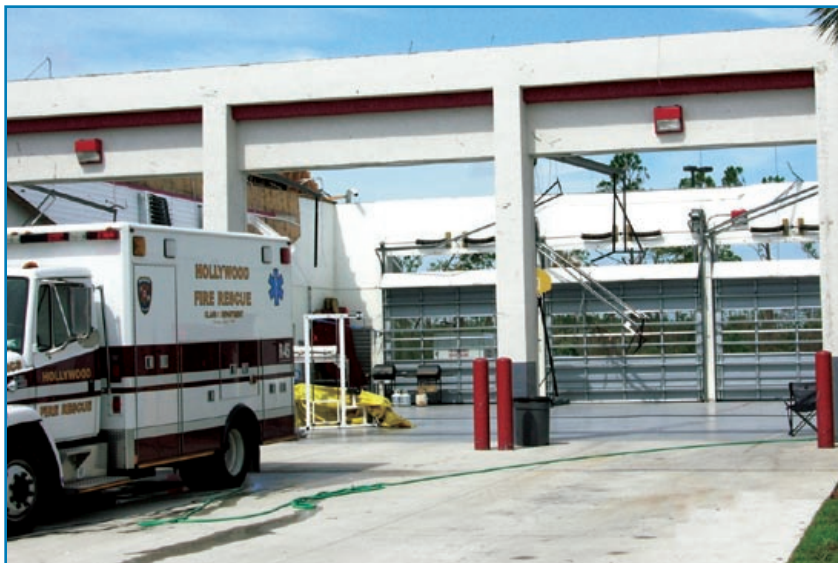
Figure 3-30:
The roof structure over the apparatus bay blew off following the failure of sectional doors. Hurricane Charley (Florida, 2004)

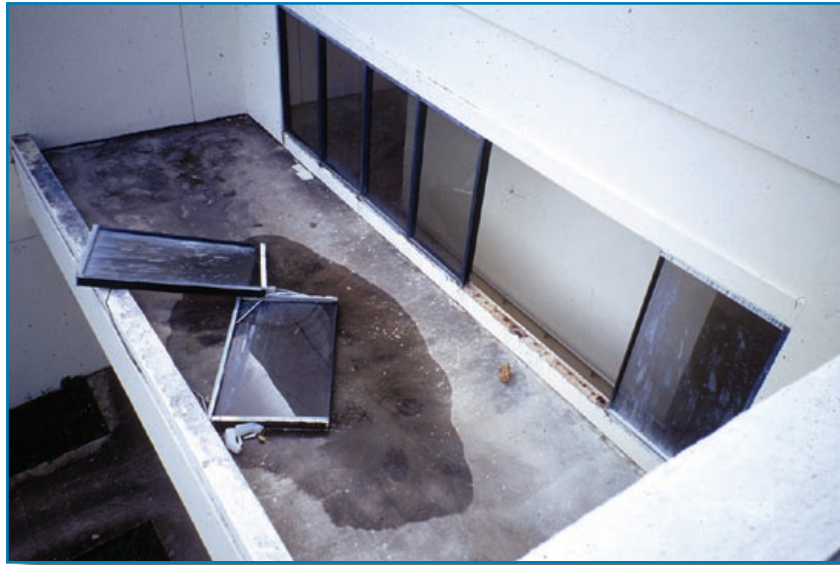
The IBC requires that windows, curtain walls, and skylight assemblies (i.e., the glazing, frame, and frame attachment to the wall or roof) have sufficient strength to resist the positive and negative design wind pressure (see Figure 3-38). Design professionals should specify that these assemblies comply with wind load testing in accordance with ASTM E 1233. It is important to specify an adequate load path and to check its continuity during submittal review.

Figure 3-38:
Two complete windows,
including frames, blew
out as a result of an
inadequate number of
fasteners. Typhoon Paka
(Guam, 1997)

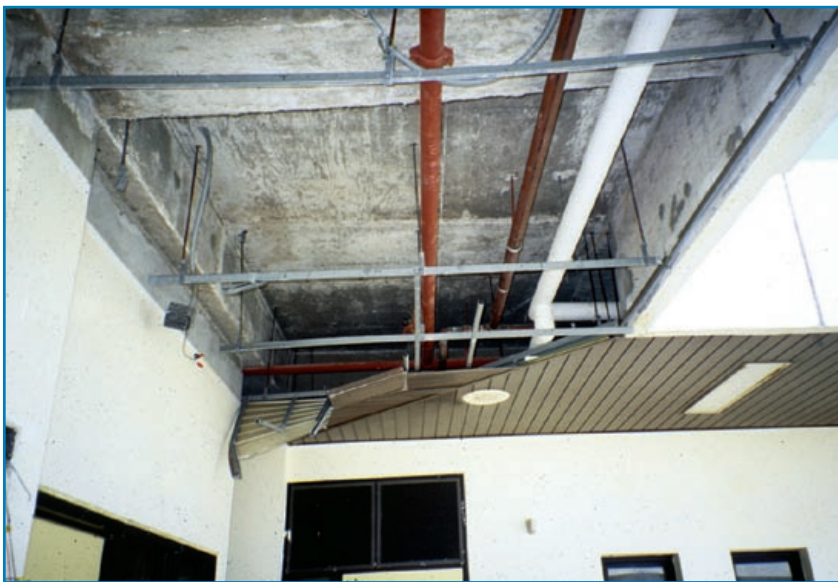
Figure 3-42:
This suspended metal soffit was not designed for upward-acting wind pressure. Typhoon Paka (Guam, 1997)

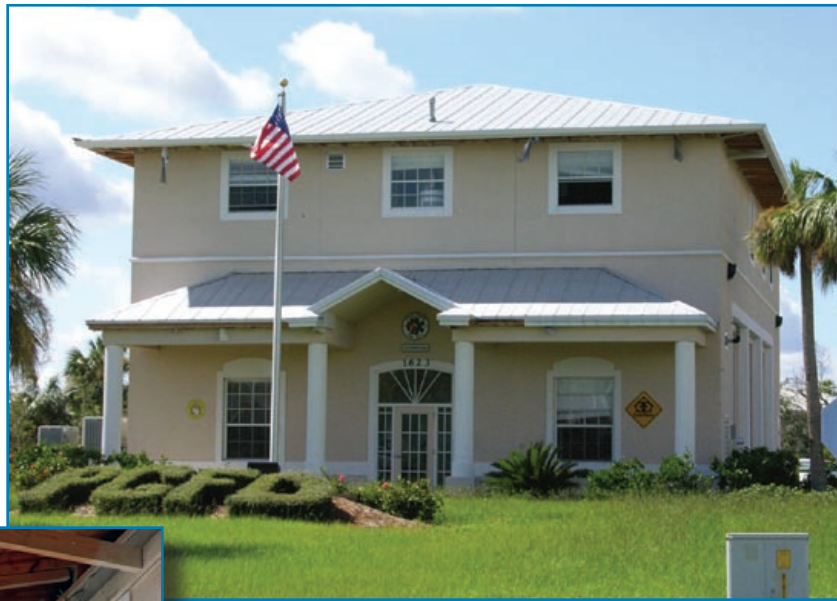
Soffits: Depending on the wind direction, soffits can experience either positive or negative pressure. Besides the cost of repairing the damaged soffits, wind-borne soffit debris can cause property damage and injuries (see Figure 3-42). Failed soffits may also provide a convenient path for wind-driven rain to enter the building. Storm-damage research has shown that water blown into attic spaces after the loss of soffits caused significant damage and the collapse of ceilings. At the relatively new fire station shown in Figure 3-43, essentially all of the perforated aluminum soffit was blown away. Wind-driven water entered the attic and saturated the batt insulation, which caused the ceiling boards to collapse. After the storm, the fire station was evacuated solely because of this damage. Even in instances where soffits remain in place, water can penetrate through soffit vents and cause damage. At this time, there are no known specific test standards or design guidelines to help design wind- and water-resistant soffits and soffit vents.

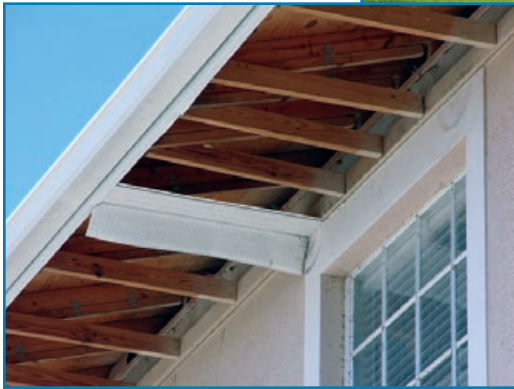
Figure 3-43:
This fire station was
abandoned after
Hurricane Charley
because of soffit failure.
(Florida, 2004)

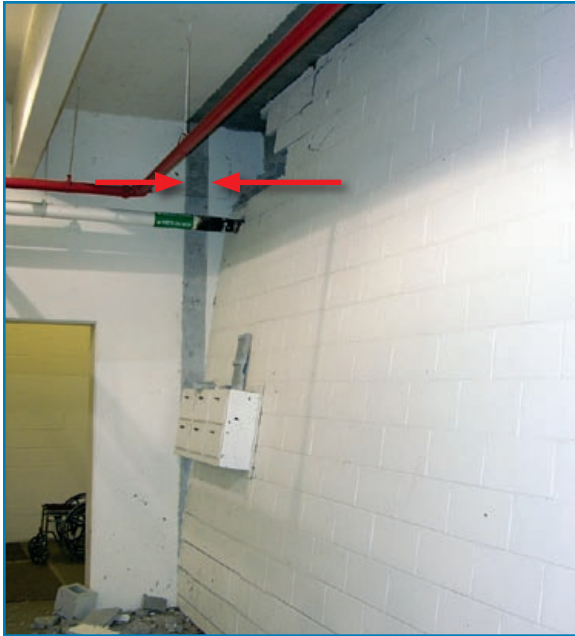
Figure 3-44:
The red arrows show the original location of a CMU wall that nearly collapsed following a rolling door failure. Hurricane Charley (Florida, 2004)

Interior non-load-bearing masonry walls: Special consideration should also be given to interior non-load-bearing masonry walls. Although these walls are not required by building codes to be designed to resist wind loads, if the exterior glazing is broken, or the exterior doors are blown away, the interior walls could be subjected to significant load as the building rapidly becomes fully pressurized. To avoid casualties, it is recommended that interior non-load-bearing masonry walls adjacent to occupied areas be designed to accommodate loads exerted by a design wind event, using the partially enclosed pressure coefficient (see Figure 3-44). By doing so, wall collapse may be prevented if the building envelope is breached. This recommendation is applicable to critical facilities located in areas with a basic wind speed greater than 120

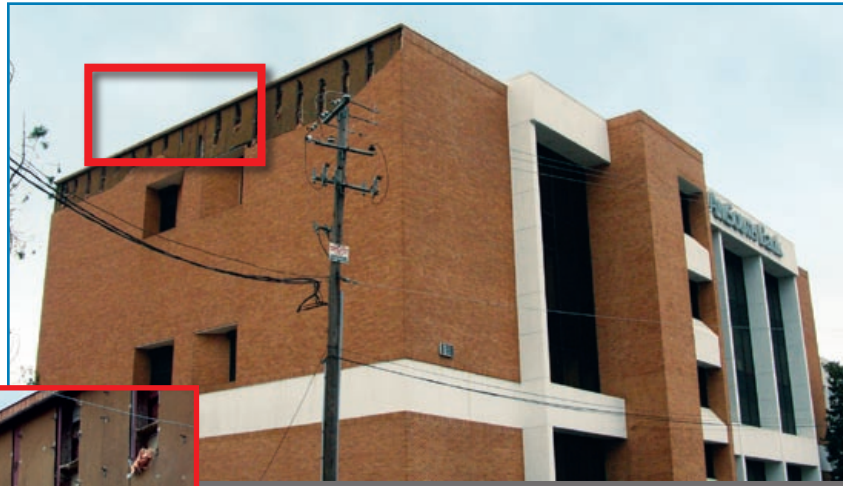
sheathed with plastic foam insulation or wood fiberboard in lieu of wood panels). Pedestrians in the vicinity of damaged walls can also be vulnerable to injury from falling bricks (see Figure 3-45). Common failure modes include tie (anchor) fastener pull-out (see Figure 3-46), failure of masons to embed ties into the mortar (Figure 3-47), poor bonding between ties and mortar, a mortar of poor quality, and tie corrosion.

Figure 3-45:
The brick veneer failure on this building was attributed to tie corrosion. Hurricane Ivan (Florida, 2004)

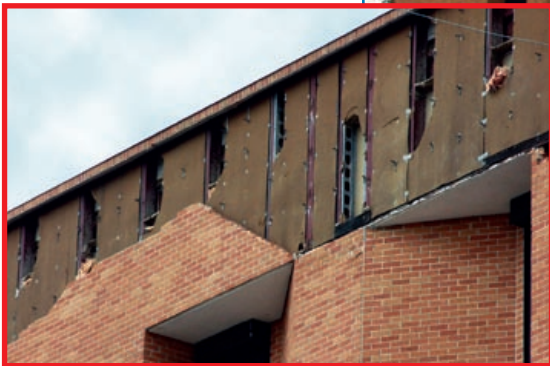
Figure 3-46:
This tie remained embedded in the mortar joint while the smooth-shank nail pulled from the stud.

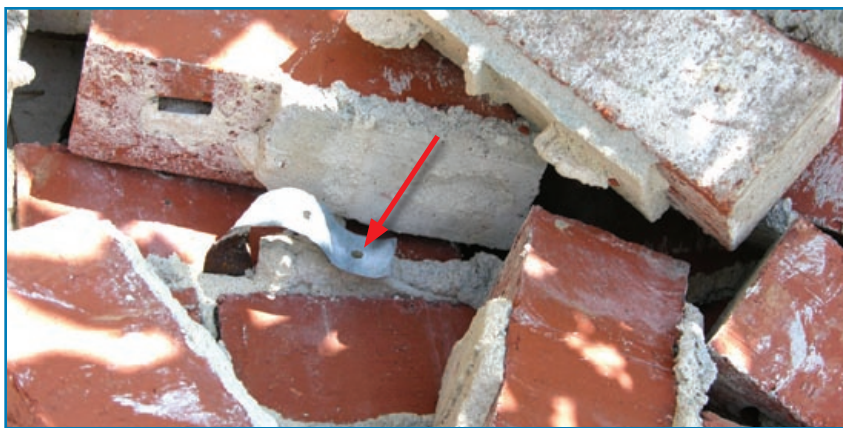
Figure 3-47:
These four ties were never embedded into the mortar joint.

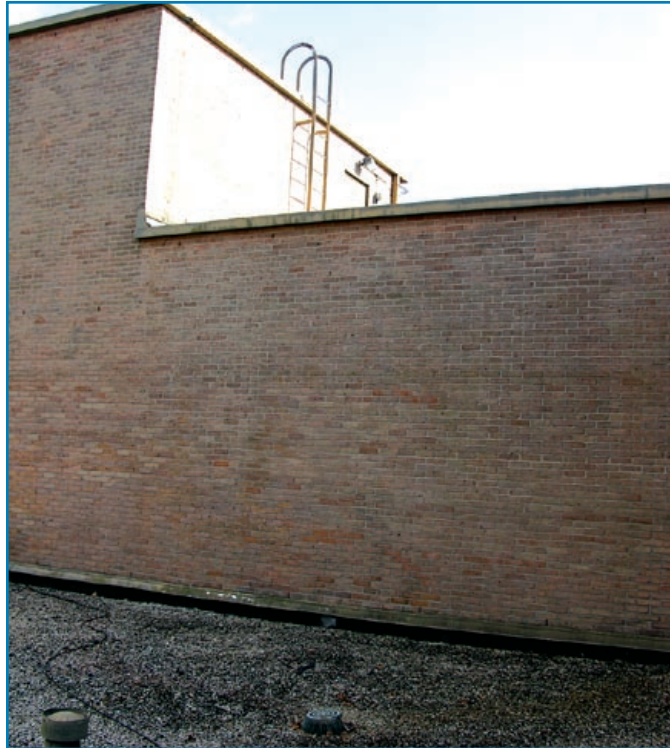
To avoid water leaking into the building, it is important that weep holes be adequately spaced and not be blocked during brick installation, and that through-wall flashings be properly designed and installed. At the hospital shown in Figure 3-52, water leaked into the building along the base of many of the brick veneer walls. When high winds accompany heavy rain, a substantial amount of water can be blown into the wall cavity.

Figure 3-52:
Water leaked inside along
the base of the brick
veneer walls. Hurricane
Katrina (Louisiana, 2005)

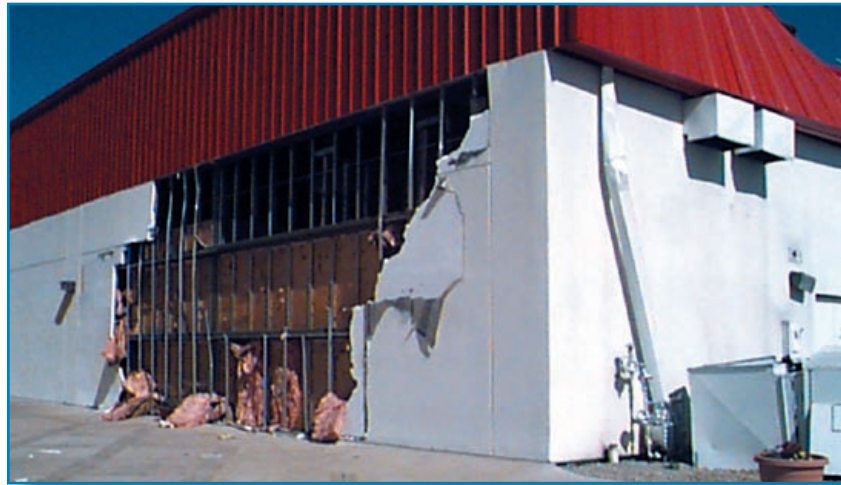
Figure 3-54:
EIFS blow-off at building
corner. In places, metal
fascia was also blown in.
Tornado (Oklahoma, 1999)

EIFS: Figure 3-53 shows typical EIFS assemblies. Figures 3-41, 3-54, and 4-6 show EIFS blow-off. In these cases, the molded expanded polystyrene (MEPS) was attached to gypsum board, which in turn was attached to metal studs. The gypsum board detached from the studs, which is a common EIFS failure. When the gypsum board on the exterior side of the studs is blown away, it is common for gypsum board on the interior side to also be blown off. The opening allows the building to become fully pressurized and allows the entrance of wind-driven rain. Other common types of failure include wall framing failure, separation of the MEPS from its substrate, and separation of the synthetic stucco from the MEPS.

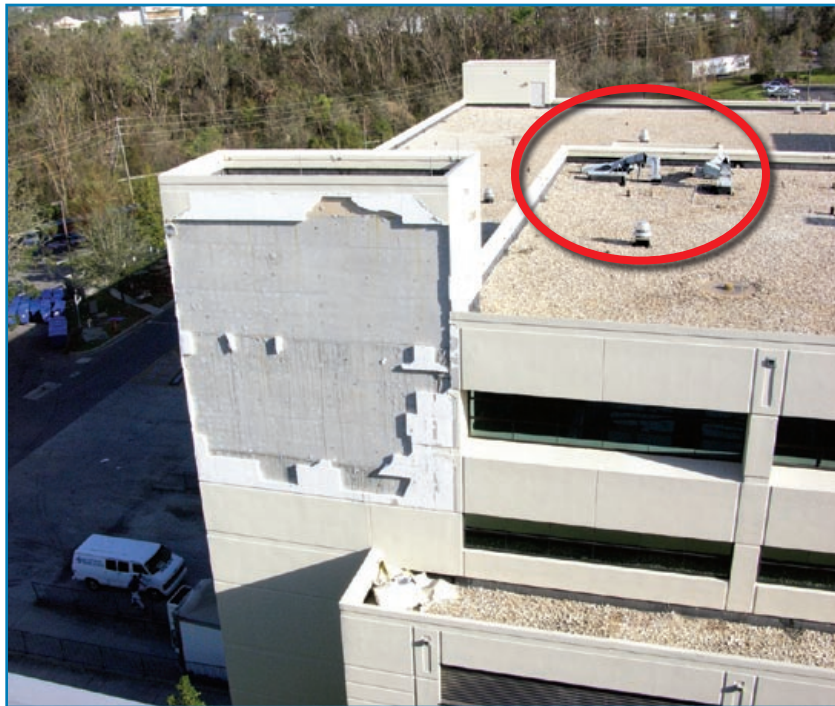
At the hospital shown in Figure 3-55, the EIFS was applied over a concrete wall. The MEPS debonded from the concrete. In general, a concrete substrate prevents wind and water from entering a building, but if the EIFS debonds from the concrete, EIFS debris can break unprotected glazing.

Figure 3-55:
EIFS blown off a cast-in-
place concrete wall. Note
the damaged rooftop
ductwork. Hurricane Ivan
(Florida, 2004)

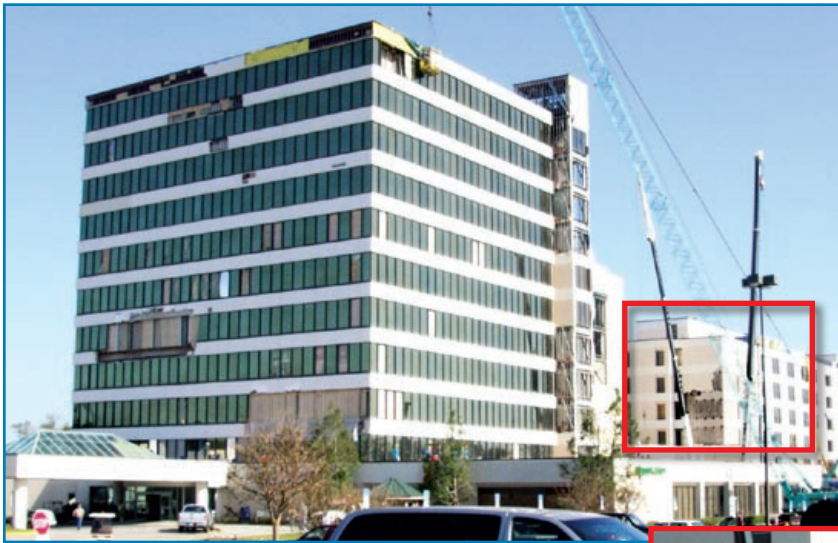
Figure 3-56: EIFS debris blown off the hospital building in the background (red square) broke numerous windows in the MOB in the foreground. Hurricane Ivan (Florida, 2004)

Wind-borne EIFS debris can be devastating to unprotected glazing. At the hospital shown in Figure 3-56, the hospital's original concrete wall panels had been furred with metal hat channels and covered with EIFS. In a large corner area, the EIFS and gypsum board substrate blew off the hat channels and broke a large number of windows in the multi-story connecting walkway

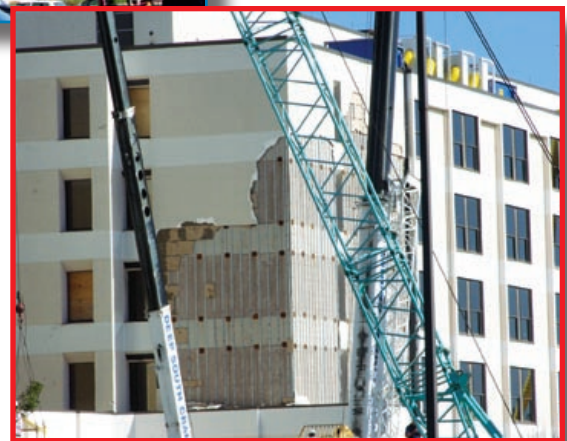
between the hospital and the medical office building (MOB). The EIFS debris also broke a large number of windows in the MOB (see Figure 3-56). Glass shards from the MOB punctured the roof membrane over the dialysis unit. The costly damage resulted in loss of several rooms in the MOB and hampered functioning of the hospital complex.

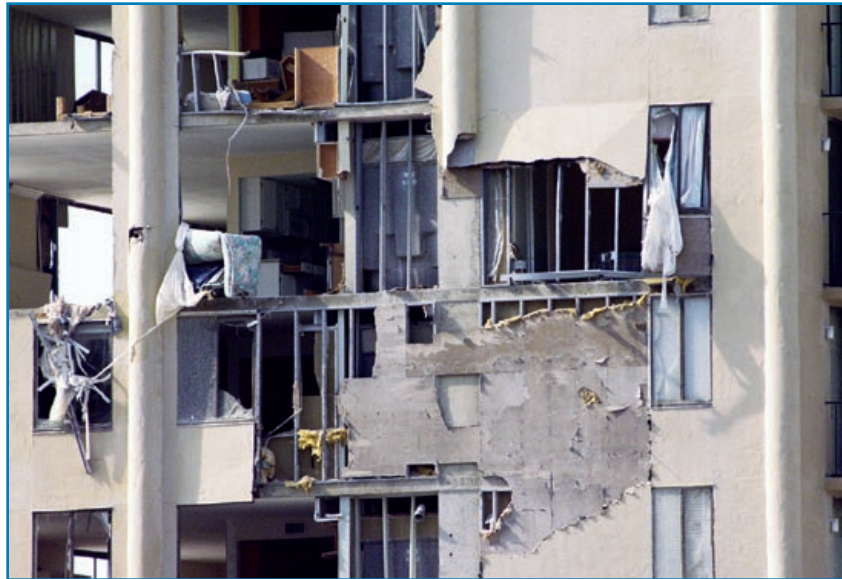
Figure 3-57:
The stucco wall failure was caused by inadequate attachment between the stud tracks and the building's structure. Hurricane Ivan (Florida, 2004)

Stucco: Wind performance of traditional stucco walls is similar to the performance of EIFS, as shown in Figure 3-57. In several areas the metal stud system failed; in other areas the gypsum sheathing blew off the studs; and in other areas, the metal lath blew off the gypsum sheathing. The failure shown in Figure 3-57 illustrates the importance of designing and constructing wall framing (including attachment of stud tracks to the building and attachment of the studs to the tracks) to resist the design wind loads.

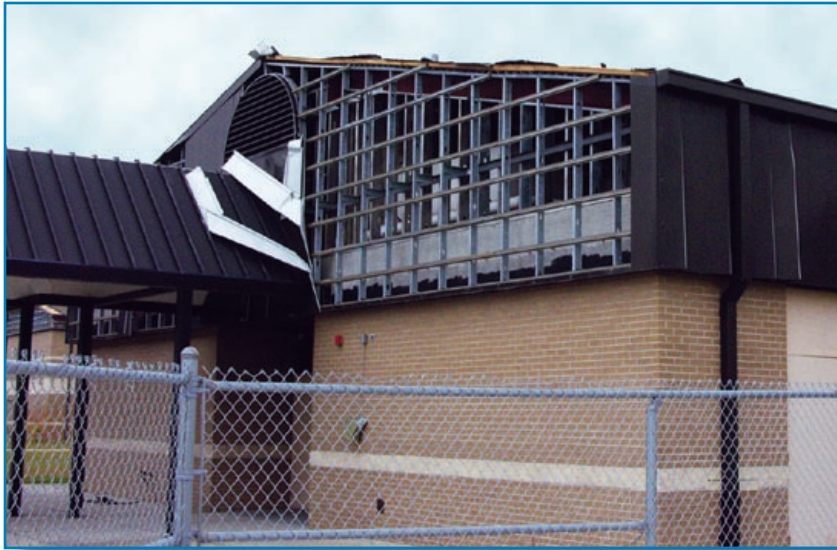
Figure 3-58:
The loss of metal wall panels allowed a substantial amount of wind-driven rain to penetrate this building. Hurricane Ivan (Florida, 2004)

Metal wall panels: Wind performance of metal wall panels is highly variable. Performance depends on the strength of the specified panel (which is a function of material and thickness, panel profile, panel width, and whether the panel is a composite) and the adequacy of the attachment (which can either be by concealed clips or exposed fasteners). Excessive spacing between clips/fasteners is the most common problem. Clip/fastener spacing should be specified, along with the specific type and size of fastener. Figures 3-14 and 3-58 illustrate metal wall panel problems. At the school shown in Figure 3-58 (which was being used as a shelter), the

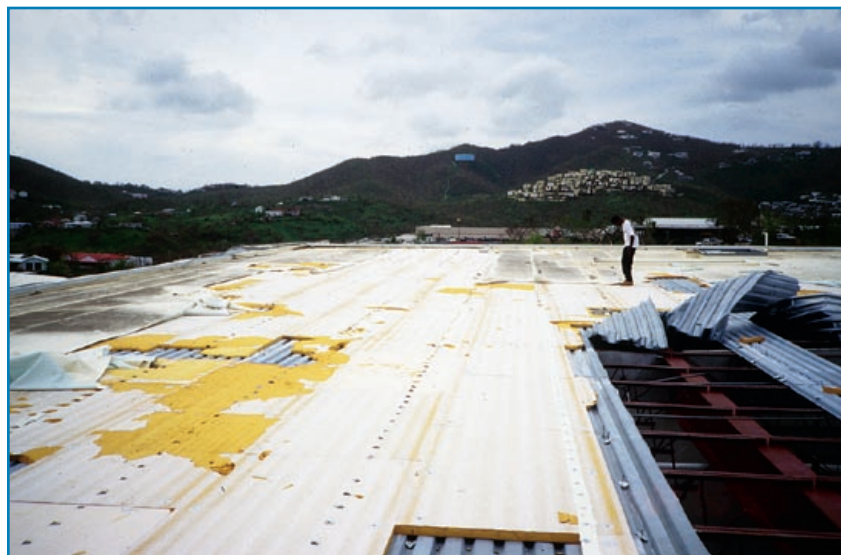
Figure 3-59:
The orientation of the membrane fastener rows led to blow-off of the steel deck. Hurricane Marilyn (U.S. Virgin Islands, 1995)

If a steel deck is selected, it is critical to specify that the membrane fasteners be attached in rows perpendicular to the steel flanges to avoid overstressing the attachment of the deck to the deck support structure. At the school shown in Figure 3-59, the fastener rows of the mechanically attached single-ply membrane ran parallel to the top flange of the steel deck. The deck fasteners were overstressed and a portion of the deck blew off and the membrane progressively tore. At another building, shown in Figure 3-60, the membrane fastener rows also ran parallel to the top flange of the steel deck. When membrane fasteners run parallel to the flange, the flange with membrane fasteners essentially carries all the uplift load because of the deck's inability to transfer any significant load to adjacent flanges. Hence, at the joists shown in Figure 3-60, the deck fasteners on either side of the flange with the membrane fasteners are the only connections to the joist that are carrying substantial uplift load.

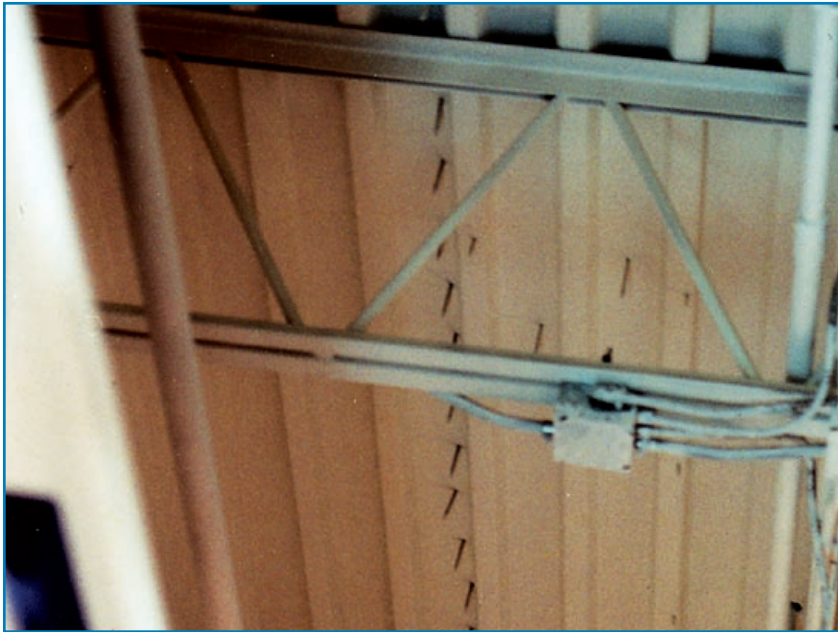
Figure 3-60:
View of the underside of a steel deck showing the mechanically attached single-ply membrane fastener rows running parallel to, instead of across, the top flange of the deck.

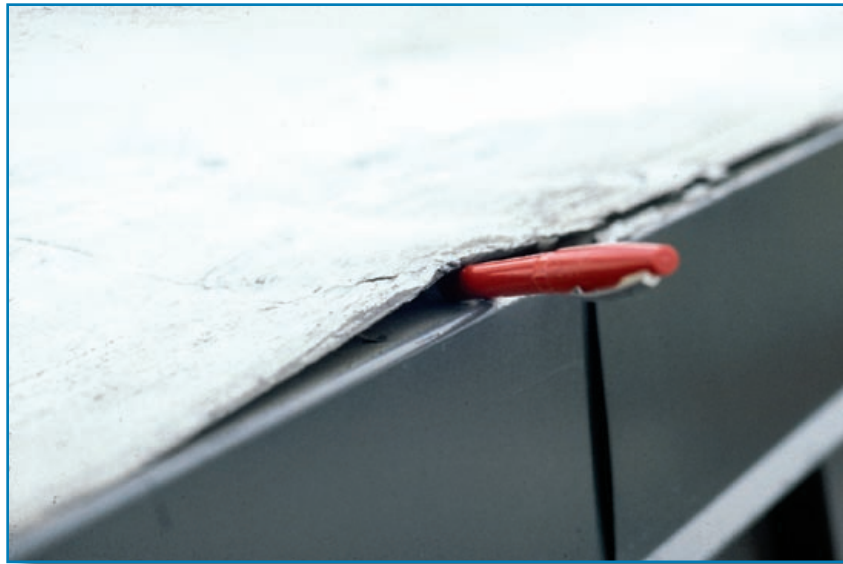
Figure 3-61:
The ink pen shows an opening that the wind can catch, and cause lifting and peeling of the membrane.

Roof membrane blow-off is almost always a result of lifting and peeling of the metal edge flashing or coping, which serves to clamp down the membrane at the roof edge. Therefore, it is important for the design professional to carefully consider the design of metal edge flashings, copings, and the nailers to which they are attached. The metal edge flashing on the modified bitumen membrane roof shown in Figure 3-61 was installed underneath the membrane, rather than on top of it, and then stripped in. In this location, the edge flashing was unable to clamp the membrane down. At one area, the membrane was not sealed to the flashing. An ink pen was inserted into the opening prior to photographing to demonstrate how wind could catch the opening and lift and peel the membrane.

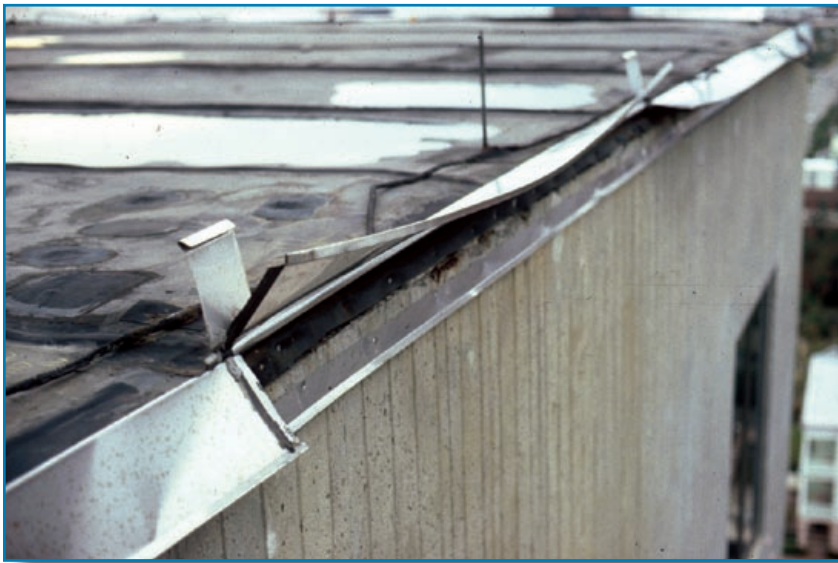
Figure 3-62:
The metal edge flashing disengaged from the continuous cleat and the vertical flange lifted. Hurricane Hugo (South Carolina, 1989)

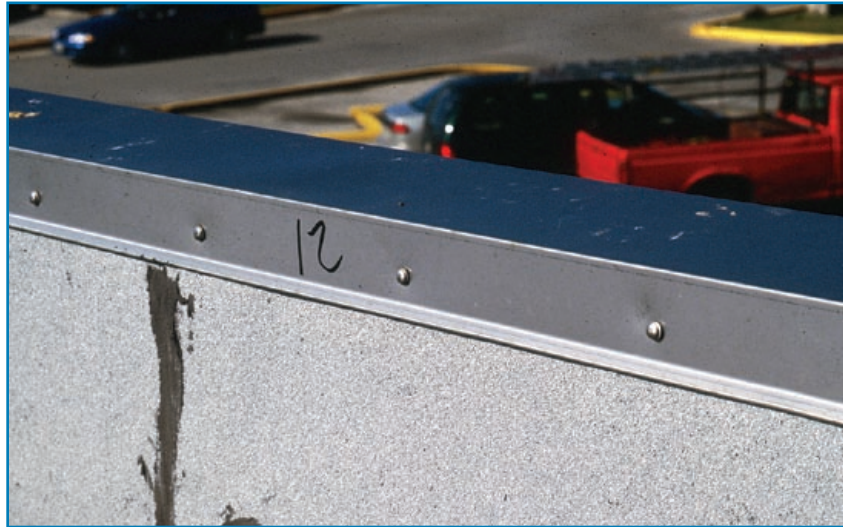
Figure 3-63:
Both vertical faces of the coping were attached with exposed fasteners instead of concealed cleats.
Typhoon Paka (Guam, 1997)

Storm-damage research has revealed that, in lieu of cleat attachment, the use of exposed fasteners to attach the vertical flanges of copings and edge flashings has been found to be a very effective and reliable attachment method. The coping shown in Figure 3-63 was attached with ¼-inch diameter stainless steel concrete spikes at 12 inches on center. When the fastener is placed in wood, #12 stainless steel screws with stainless steel washers are recommended. The fasteners should be more closely spaced in the corner areas (the spacing will depend upon the design wind loads). ANSI/SPRI ES-1 provides guidance on fastener spacing and thickness of the coping and edge flashing.

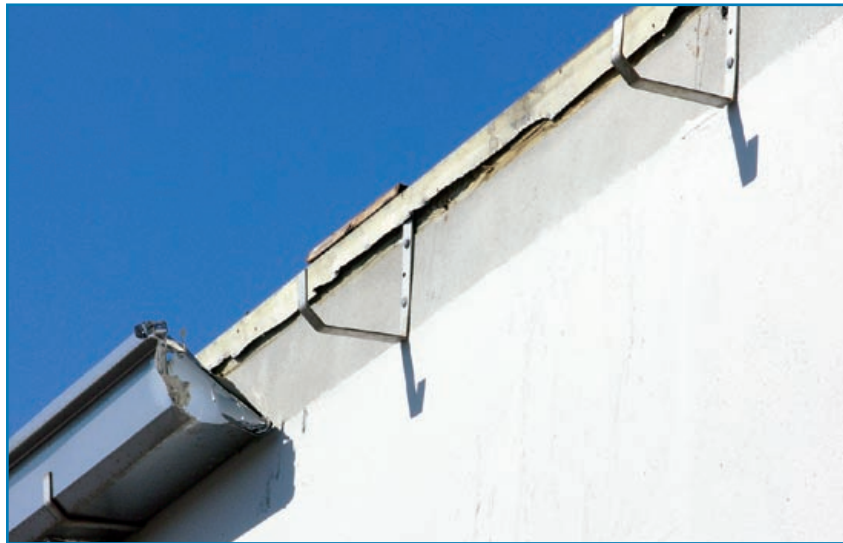
Figure 3-64:
This gutter, supported by a type of bracket that provides no significant uplift resistance, failed when wind lifted it together with the metal edge flashing that lapped into the gutter. Hurricane Francis (Florida, 2004)

Storm-damage research has shown that gutters are seldom constructed to resist wind loads (see Figure 3-64). When a gutter lifts, it typically causes the edge flashing that laps into the gutter to lift as well. Frequently, this results in a progressive lifting and peeling of the roof membrane. The membrane blow-off shown in Figure 3-65 was initiated by gutter uplift. The gutter was similar to that shown in Figure 3-64. The building, housing the county Sheriff's office, suffered water leakage that shut down the county 911 call center, destroyed the crime lab equipment, and caused significant interior water damage.

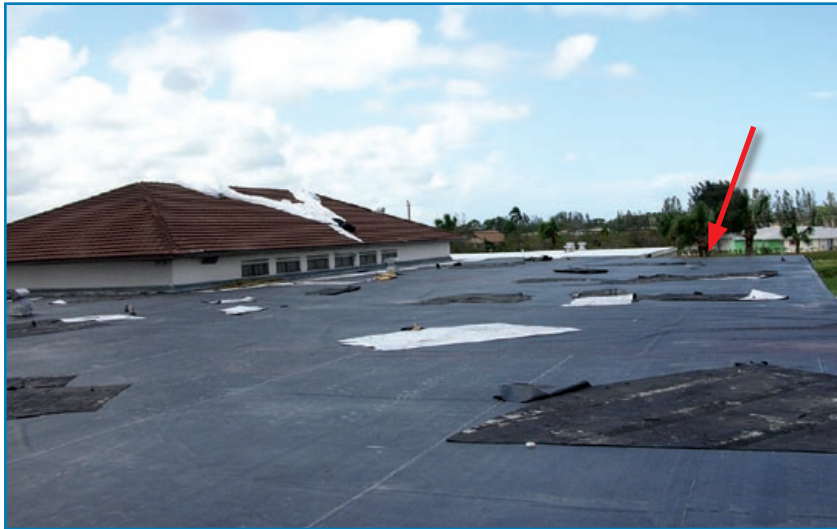
Figure 3-65:
The original modified bitumen membrane was blown away after the gutter lifted in the area shown by the red arrow (the black membrane is a temporary roof). Hurricane Francis (Florida, 2004)
