3.1 GENERAL DESIGN CONSIDERATIONS

3.1.1 NATURE OF HIGH WINDS

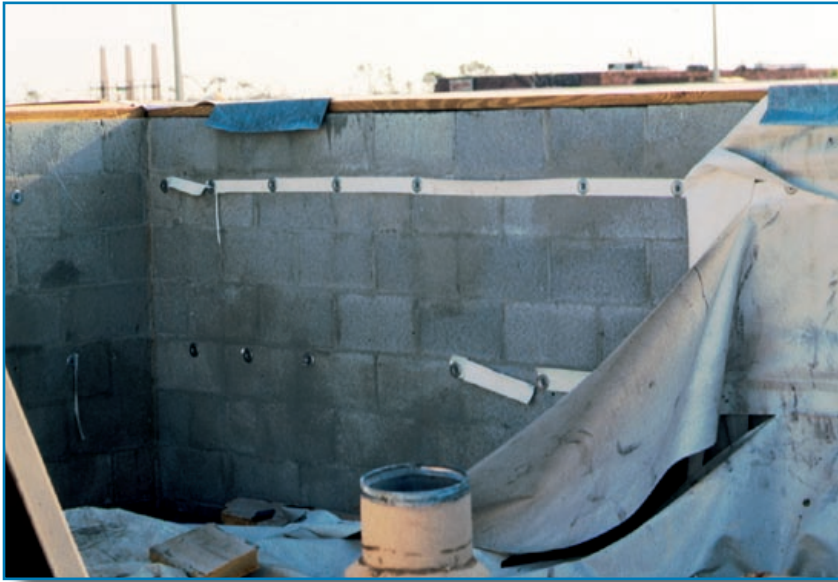
Figure 3-66:
If mechanically attached base flashings have an insufficient number of fasteners, the base flashing can be blown away. Hurricane Andrew (Florida, 1992)

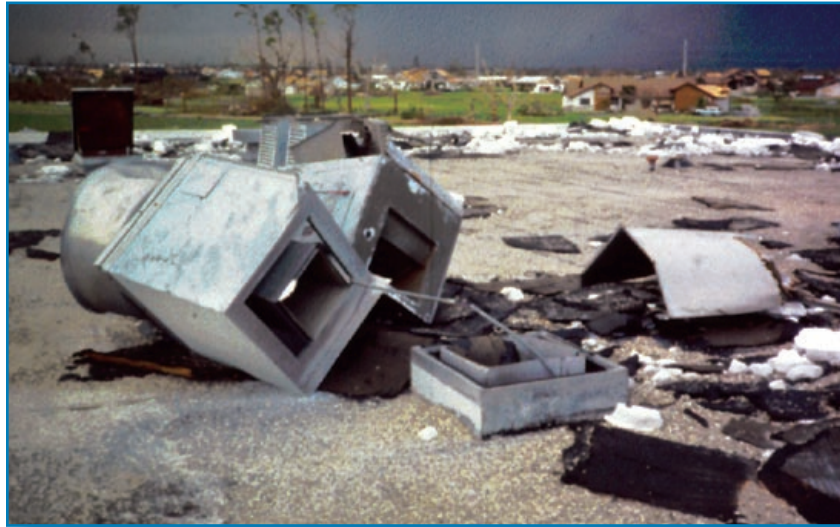
Figure 3-67:
Topped rooftop
mechanical equipment.
Hurricane Andrew
(Florida, 1992)

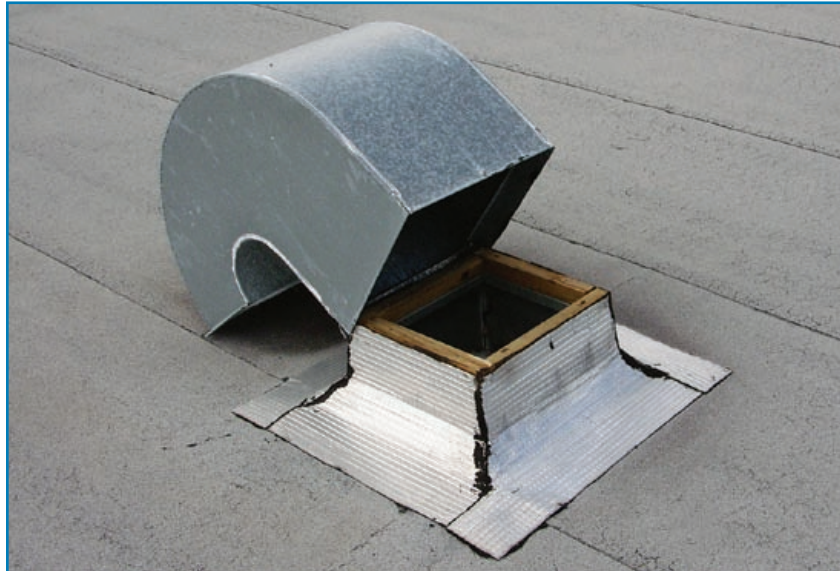
Figure 3-68:
This gooseneck was
attached with only two
small screws. A substantial
amount of water was
able to enter the building
during Hurricane Francis.
(Florida, 2004)

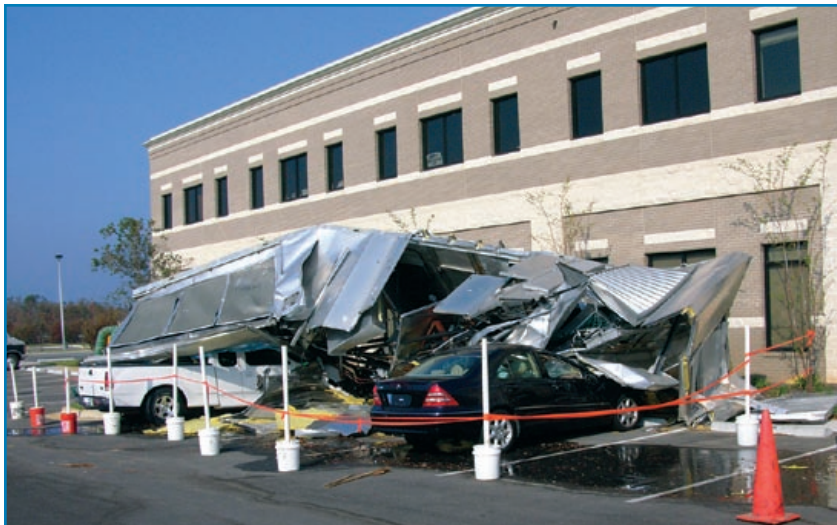
Figure 3-69: Although this 18,000-pound HVAC unit was attached to its curb with 16 straps, it blew off during Hurricane Ivan. (Florida, 2004)

Information on loads on rooftop equipment was first introduced in the 2002 edition of ASCE 7. For guidance on load calculations, see “Calculating Wind Loads and Anchorage Requirements for Rooftop Equipment” (ASHRAE, 2006). A minimum safety factor of 3 is recommended for critical facilities. Loads and resistance should also be calculated for heavy pieces of equipment since the dead load of the equipment is often inadequate to resist the design wind load. The 30’ x 10’ x 8’ 18,000-pound HVAC unit shown in Figure 3-69 was attached to its curb with 16 straps (one screw per strap). Although the wind speeds were estimated to be only 85 to 95 miles per hour (peak gust), the HVAC unit blew off the medical office building.

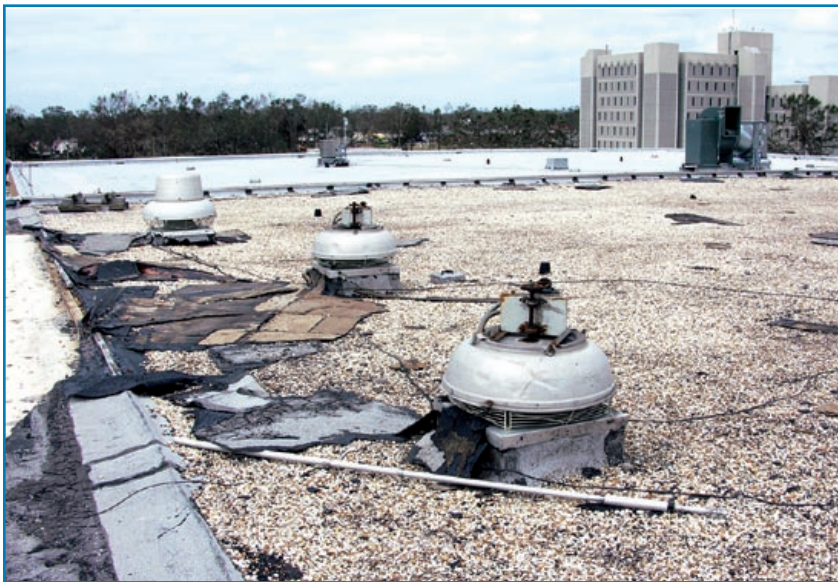
Figure 3-70: Cowlings blew off two of the fans on a police building that housed the county's EOC. Hurricane Ivan (Florida, 2004)

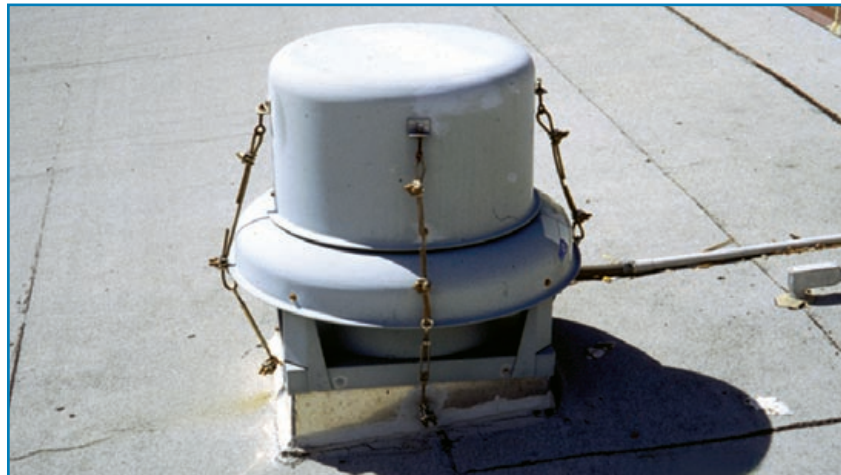
Figure 3-71:
Cables were attached to prevent the cowling from blowing off. Typhoon Paka (Guam, 1997)

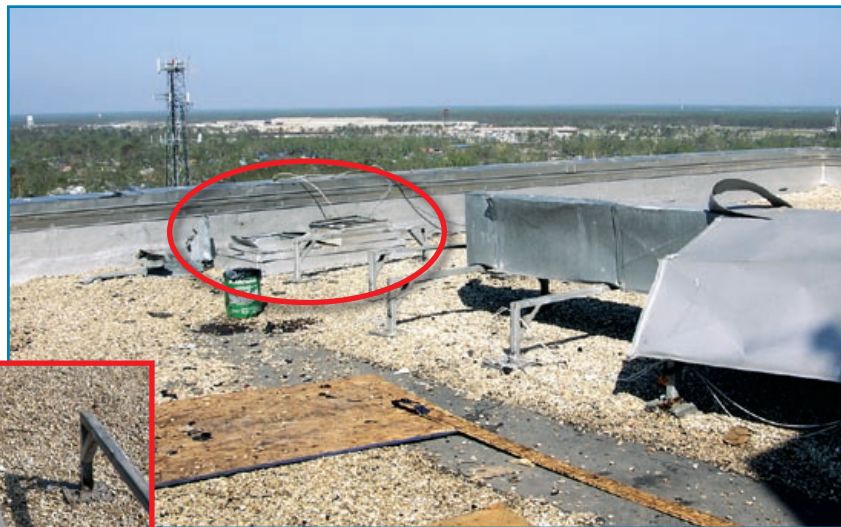
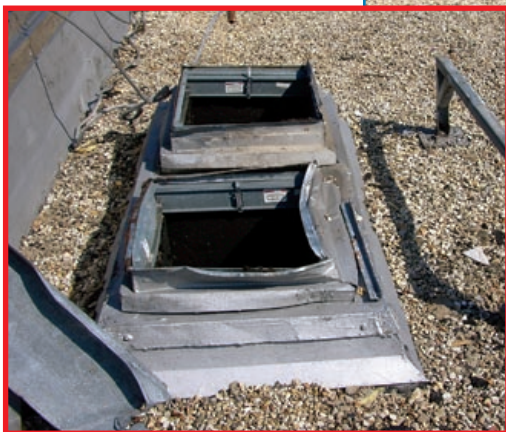
Figure 3-72:
Two large openings remained (circled area and inset to the left) after the ductwork on this roof blew away. Hurricane Katrina (Mississippi, 2005)

Ductwork: To avoid wind and wind-borne debris damage to rooftop ductwork, it is recommended that ductwork not be installed on the roof (see Figure 3-72). If ductwork is installed on the roof, it is recommended that the ducts' gauge and the method of attachment be able to resist the design wind loads.

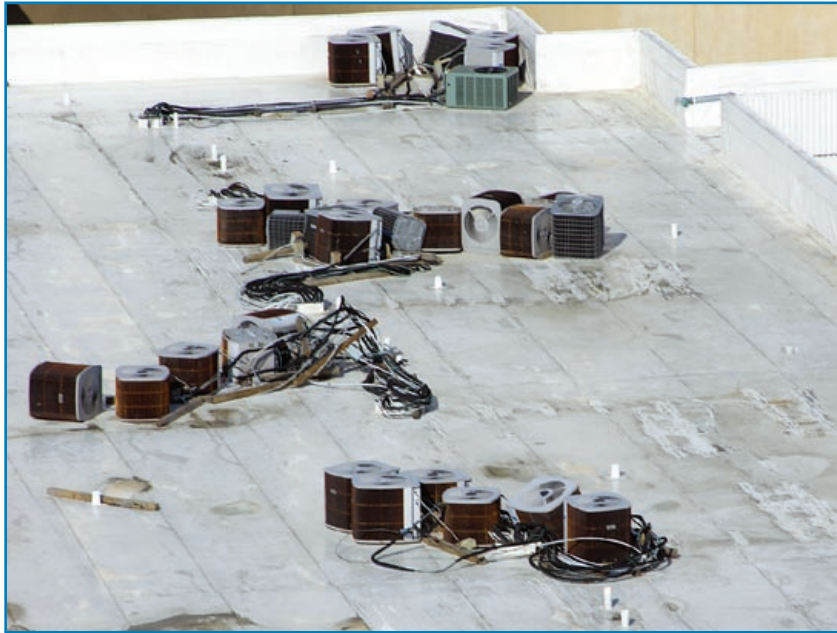
Figure 3-73: Sleeper-mounted condensers displaced by high winds. Hurricane Katrina (Mississippi, 2005)

Condenser attachment: In lieu of placing rooftop-mounted condensers on wood sleepers resting on the roof (see Figure 3-73), it is recommended that condensers be anchored to equipment stands. The attachment of the stand to the roof deck also needs to be designed to resist the design loads. In addition to anchoring the base of the condenser to the stand, two metal straps with two side-by-side #12 screws or bolts with proper end and edge distances at each strap end are recommended when the basic wind speed is greater than 90 mph (see Figure 3-74).

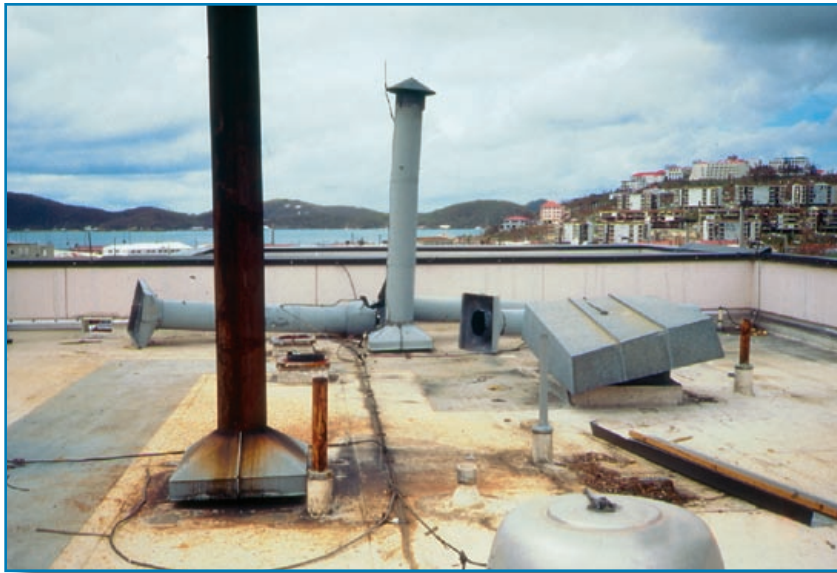
Figure 3-76:
Three of the five stacks that did not have guy-wires were blown down. Hurricane Marilyn (U.S. Virgin Islands, 1995)

Boiler and exhaust stack attachment: To avoid wind damage to boiler and exhaust stacks, wind loads on stacks should be calculated and guy-wires should be designed and constructed to resist the loads. Toppled stacks, as shown at the hospital in Figure 3-76, can allow water to enter the building at the stack penetration, damage the roof membrane, and become wind-borne debris. The designer should advise the building owner that guy-wires should be inspected annually to ensure they are taut.

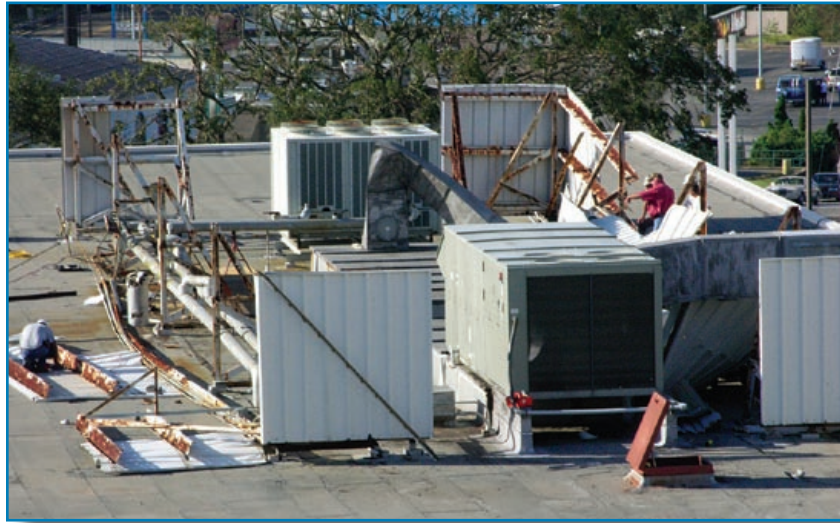
Figure 3-77:
Equipment screen panels,
such as these blown away
at a hospital, can break
glazing, puncture roof
membranes, and cause
injury. Hurricane Ivan
(Florida, 2004)

Equipment screens: Screens around rooftop equipment are frequently blown away (see Figure 3-77). Screens should be designed to resist the wind load derived from ASCE 7. Since the effect of screens on equipment wind loads is unknown, the equipment attachment behind the screens should be designed to resist the design load.

By placing equipment in mechanical penthouses rather than leaving them exposed on the roof, equipment can be shielded from high-wind loads and wind-borne debris. Although screens (such as shown in Figure 3-77) could be designed and constructed to protect equipment from horizontally-flying debris, they are not effective in protecting equipment from missiles that have an angular trajectory. It is therefore recommended that mechanical equipment be placed inside mechanical penthouses. The penthouse itself should be designed and constructed in accordance with the recommendations given in Sections 3.4.2 and 3.4.3.

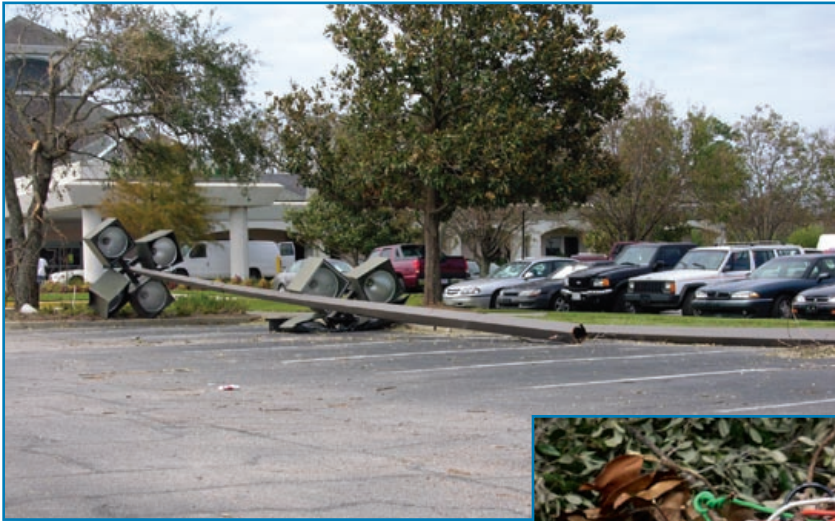
Figure 3-78:
Collapsed hospital light
fixtures caused by severe
corrosion (see inset).
Hurricane Ivan (Florida,
2004)

To avoid corrosion-induced failure (see Figure 3-78), it is recommended that exterior-mounted mechanical, electrical, and communications equipment be made of nonferrous metals, stainless steel, or steel with minimum G-90 hot-dip galvanized coating for the equipment body, stands, anchors, and fasteners. When equipment with enhanced corrosion protection is not available, the designer should advise the building owner that periodic equipment maintenance and inspection is particularly important to avoid advanced corrosion and subsequent equipment damage during a windstorm.

Damage to exterior-mounted electrical equipment is infrequent, mostly because of its small size (e.g., disconnect switches). Exceptions include communication towers, surveillance cameras, electrical service masts, satellite dishes, and lightning protection systems. The damage is typically caused by inadequate mounting as a result of failure to perform wind load calculations and anchorage design. Damage is also sometimes caused by corrosion (see Figure 3-78 and the text box on corrosion in Section 3.3.4.1).

Parapets: For low-sloped roofs, minimum 3-foot high parapets are recommended. With parapets of this height or greater, the uplift load in the corner region is substantially reduced (ASCE 7 permits treating the corner zone as a perimeter zone). Also, a high parapet (as shown in Figures 3-78 and 3-118) may intercept wind-borne debris and keep it from blowing off the roof and damaging other building components or injuring people. To protect base flashings from wind-borne debris damage and subsequent water leakage, it is recommended that metal panels on furring strips be installed over the base flashing (Figure 3-93). Exposed stainless steel screws are recommended for attaching the panels to the furring strips because using exposed fasteners is more reliable than using concealed fasteners or clips (as were used for the failed panels shown in Figure 3-58).

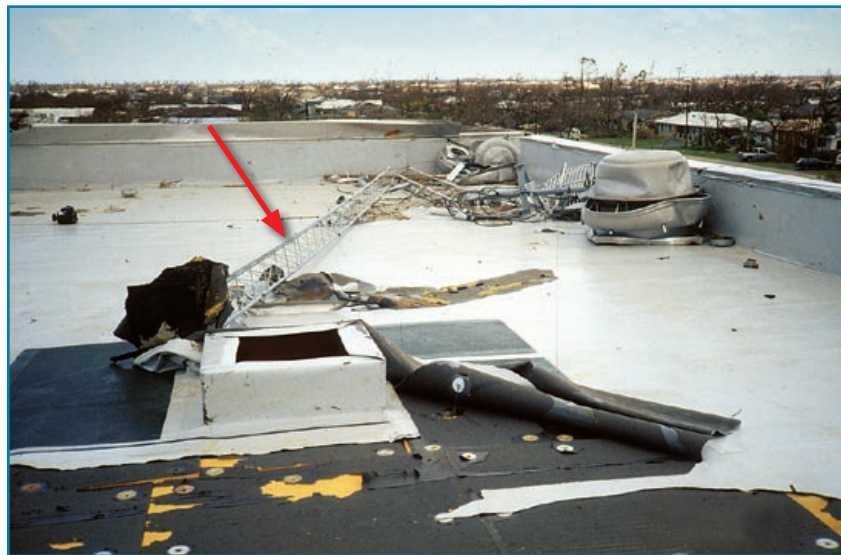
Figure 3-79:
The collapse of the antenna tower caused progressive peeling of the roof membrane. Also note that the exhaust fan blew off the curb, but the high parapet kept it from blowing off the roof. Hurricane Andrew (Florida, 1992)

Collapse of both large and small communication towers at emergency operation centers, fire and police stations, and hospitals is quite common during high-wind events (see Figures 3-79 and 3-80). These failures often result in complete loss of communication capabilities. In addition to the disruption of communications, collapsed towers can puncture roof membranes and allow water leakage into the facilities, unless the roof system incorporated a secondary membrane (as discussed in Section 3.4.3.4). At the tower shown in Figure 3-79 the anchor bolts were pulled out of the deck, which resulted in a progressive peeling of the fully adhered single-ply roof membrane. Tower collapse can also injure or kill people.

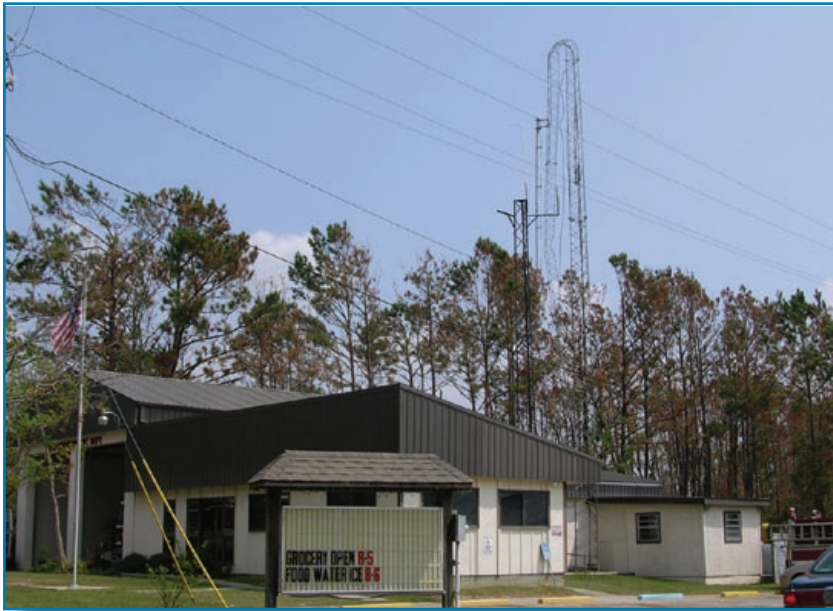
Figure 3-80:
The antenna tower at
this fire station buckled.
Hurricane Katrina
(Mississippi, 2005)

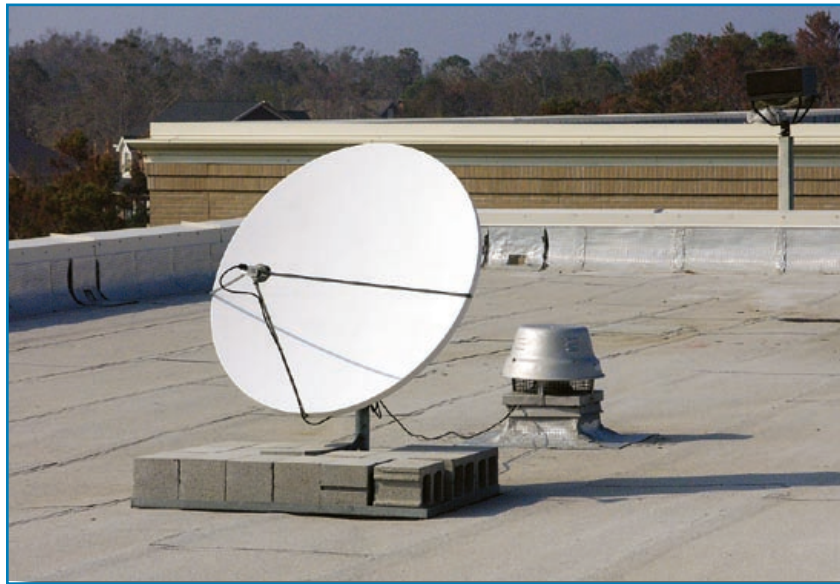
Figure 3-81:
Common anchoring
method for satellite dish.
Hurricane Ivan (Florida,
2004)

Satellite dishes: For the satellite dish shown in Figure 3-81, the dish mast was anchored to a large metal pan that rested on the roof membrane. CMU was placed on the pan to provide overturning resistance. This anchorage method should only be used where calculations demonstrate that it provides sufficient resistance. In this case the wind approached the satellite dish in such a way that it experienced very little wind pressure. In hurricane-prone regions, use of this anchorage method is not recommended (see Figure 3-82).

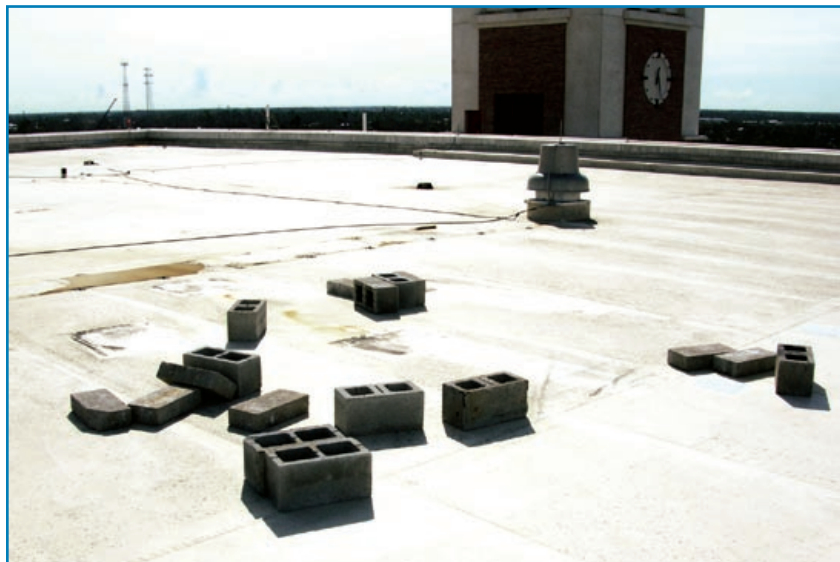
Figure 3-82:
A satellite dish anchored
similarly to that shown
in Figure 3-81 was
blown off of this five-
story building. Hurricane
Charley (Florida, 2004)

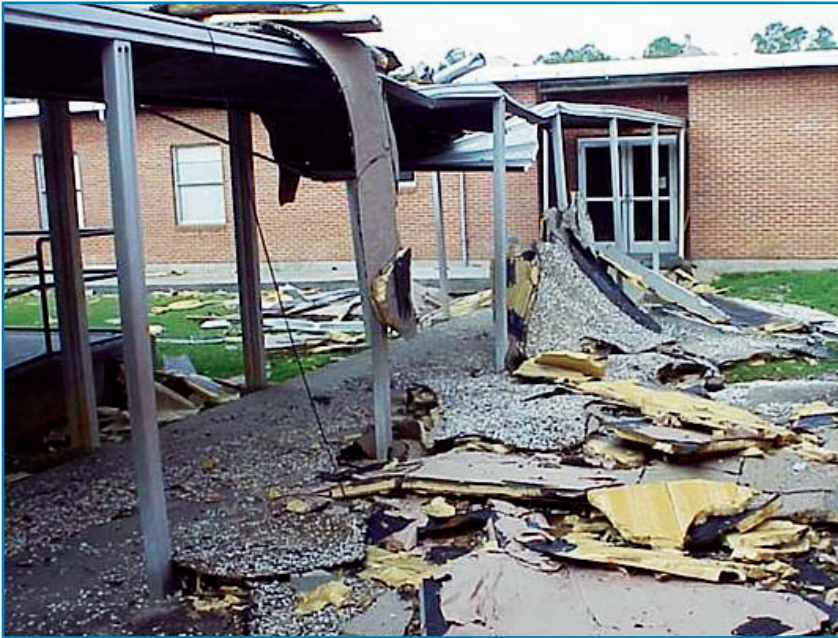
Figure 3-83:
Open walkways do not provide protection from wind-borne debris.
Hurricane Katrina
(Mississippi, 2005)

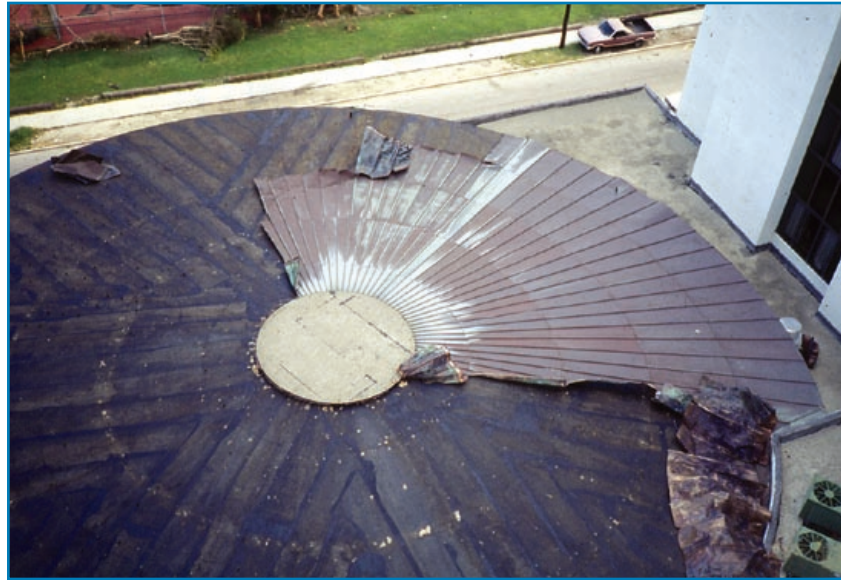
Figure 3-86:
Because this roof system incorporated a secondary membrane, the ICU was not evacuated after the copper roof blew off. Hurricane Andrew (Florida, 1992)

The purpose of the insulation and gypsum roof board is to absorb missile energy. If the primary membrane is punctured or blown off during a storm, the secondary membrane should provide watertight protection unless the roof is hit with missiles of very high momentum that penetrate the insulation and secondary membrane. Figure 3-86 illustrates the merit of

specifying a secondary membrane. The copper roof blew off the hospital's intensive care unit (ICU). Patients and staff were frightened by the loud noise generated by the metal panels as they banged around during the hurricane. Fortunately there was a very robust underlayment (a built-up membrane) that remained in place. Since only minor leakage occurred, the ICU continued to function.

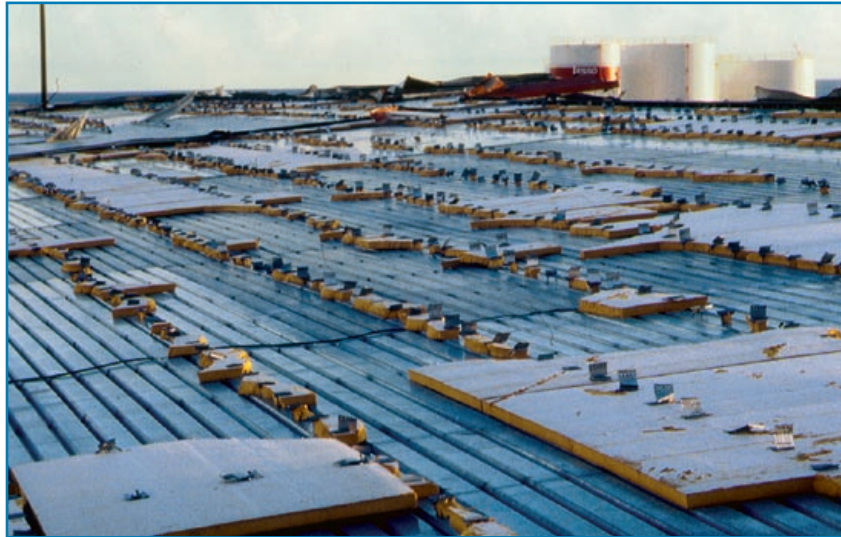
Figure 3-87:
Significant interior water damage and facility interruption occurred after the standing seam roof blew off. Hurricane Marilyn (U.S. Virgin Islands, 1995)

If the metal panels are blown off or punctured during a hurricane, the secondary membrane should provide watertight protection unless the roof is hit with missiles of very high momentum. At the roof shown in Figure 3-87, the structural standing seam panel clips bore on rigid insulation over a steel deck. Had a secondary membrane been installed over the steel deck, the membrane would have likely prevented significant interior water damage and facility disruption.

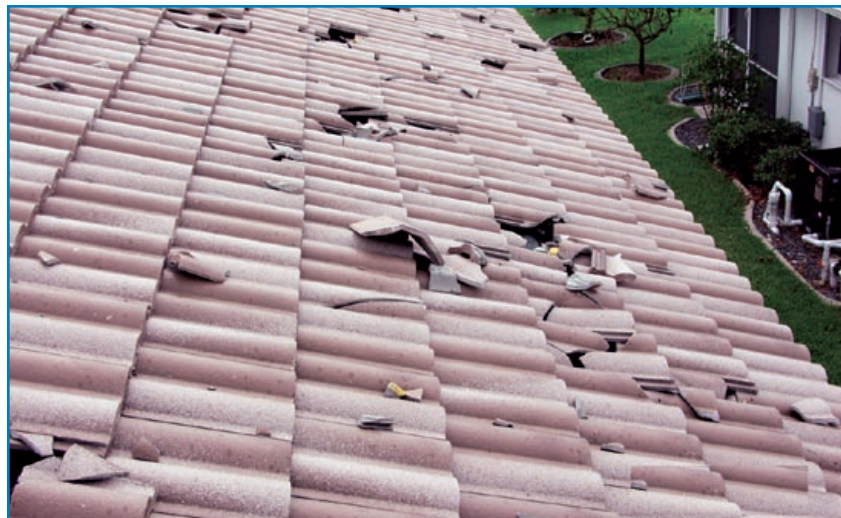
Figure 3-88:
Brittle roof coverings, like slate and tile, can be broken by missiles, and tile debris can break other tiles. Hurricane Charley (Florida, 2004)

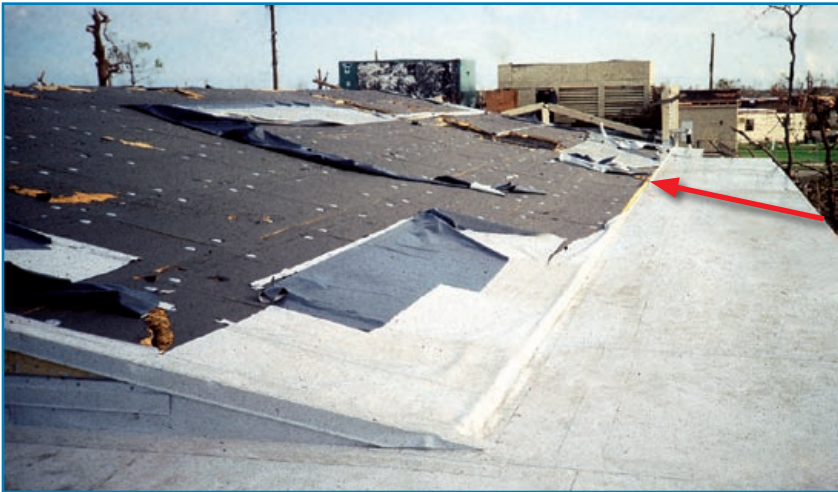
Figure 3-89:
Mechanically attached single-ply membrane progressively tore after being cut by wind-borne debris. Hurricane Andrew (Florida, 1992)

Mechanically attached and air-pressure equalized single-ply membrane systems are susceptible to massive progressive failure after missile impact, and are therefore not recommended for critical facilities in hurricane-prone regions. At the building shown in Figure 3-89, a missile struck the fully adhered low-sloped roof and slid into the steep-sloped reinforced mechanically attached single-ply membrane in the vicinity of the red arrow. A large area of the mechanically attached membrane was blown away as a result of progressive membrane tearing. Fully adhered single-ply membranes are very vulnerable to missiles (see Figure 3-90) and are not recommended unless they are ballasted with pavers.

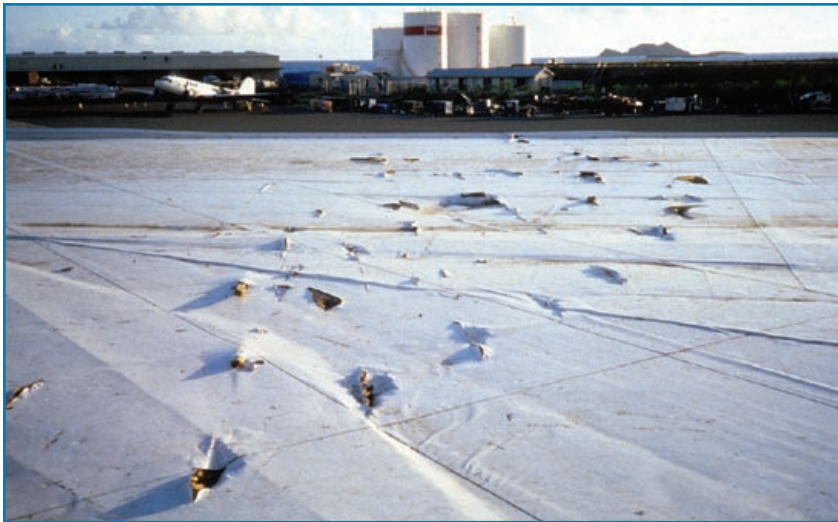
Figure 3-90:
Fully adhered single-ply roof membrane struck by a large number of missiles. Hurricane Marilyn (U.S. Virgin Islands, 1995)

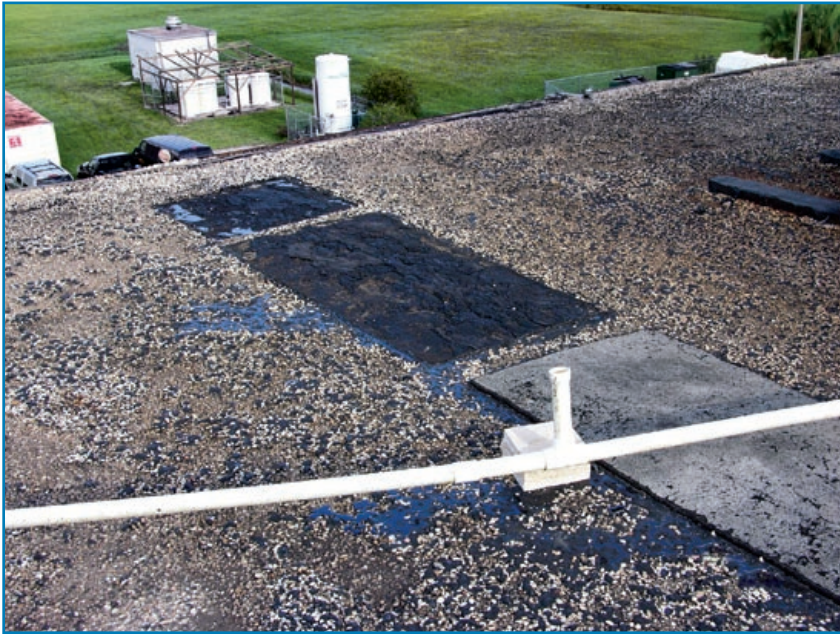
Figure 3-92:
To avoid walkway pad
blow off, as occurred
on this hospital roof,
walkway pads are not
recommended. Hurricane
Charley (Florida, 2004)

Walkway pads: Roof walkway pads are frequently blown off during hurricanes (Figure 3-92). Pad blow-off does not usually damage the roof membrane. However, wind-borne pad debris can damage other building components and injure people. Walkway pads are therefore not recommended in hurricane-prone regions.

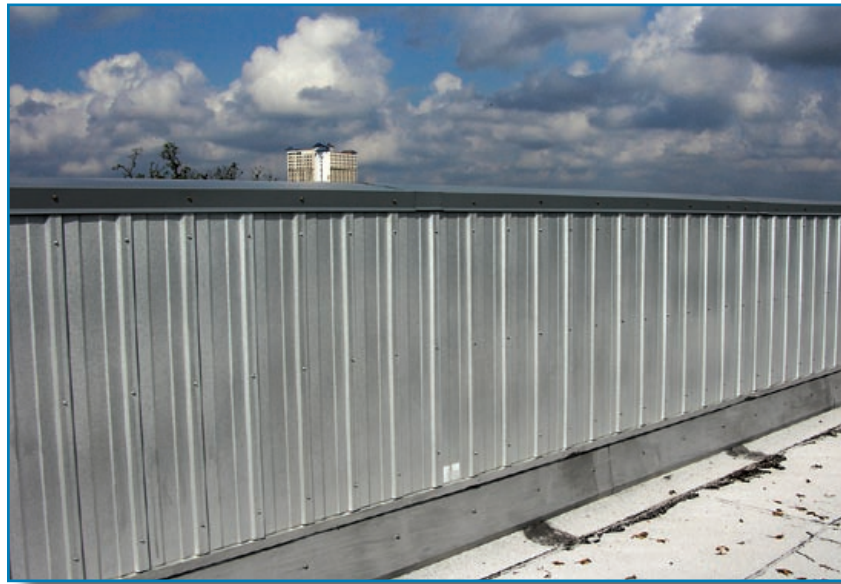
Figure 3-93:
Base flashing protected by
metal panels attached with
exposed screws. Hurricane
Katrina (Mississippi, 2005)

If the roof has a parapet, it is recommended that the inside of the parapet be properly prepared to receive the new base flashing. In many instances, it is prudent to re-skin the parapet with sheathing to provide a suitable substrate. Base flashing should not be applied directly to brick parapets because they have irregular surfaces that inhibit good bonding of the base flashing to the brick (see Figure 3-117). Also, if moisture drives into the wall from the exterior side of the parapet with base flashing attached directly to brick, the base flashing can inhibit drying of the wall. Therefore, rather than totally sealing the parapet with membrane base flashing, the upper portion of the brick can be protected by metal panels (as shown in Figure 3-93), which permit drying of the brick.

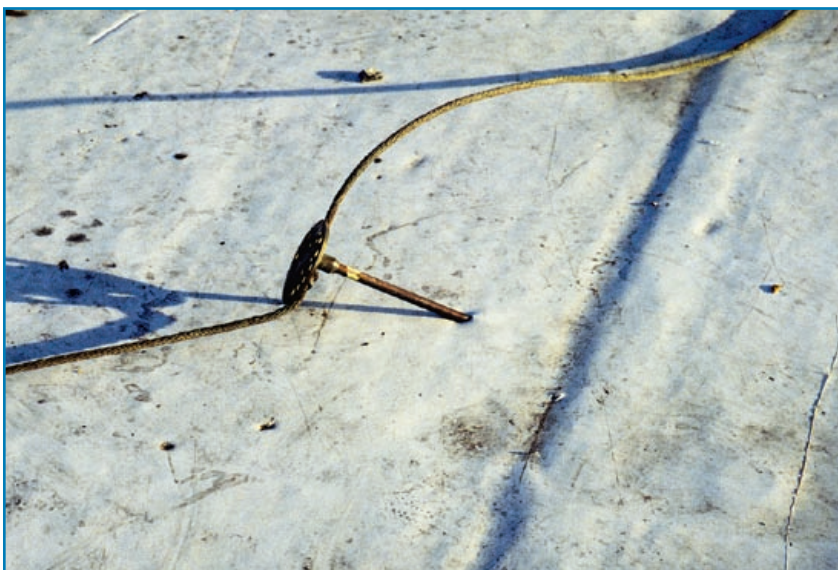
Figure 3-94:
A displaced air terminal
that punctured the
membrane in several
locations. Hurricane
Marilyn (U.S. Virgin
Islands, 1995)

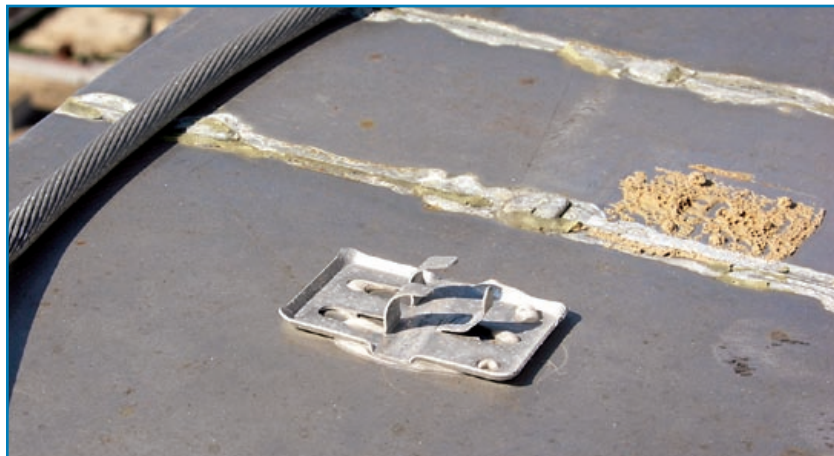
Figure 3-96:
The conductor deformed
the prongs under wind
pressure, and pulled
away from the connector.
Hurricane Katrina
(Mississippi, 2005)

Lightning protection standards such as NFPA 780 and UL 96A provide inadequate guidance for attaching LPS to rooftops in hurricane-prone regions, as are those recommendations typically provided by LPS and roofing material manufacturers. LPS conductors are typically attached to the roof at 3-foot intervals. The conductors are flexible, and when they are exposed to high winds, the conductors exert dynamic loads on the conductor connectors (“clips”). Guidance for calculating the dynamic loads does not exist. LPS conductor connectors typically have prongs to anchor the conductor. When the connector is well-attached to the roof surface, during high winds the conductor frequently bends back the malleable connector prongs (see Figure 3-96). Conductor connectors have also debonded from roof surfaces during high winds. Based on observations after Hurricane Katrina and other hurricanes, it is apparent that pronged conductor connectors typically have not provided reliable attachment.

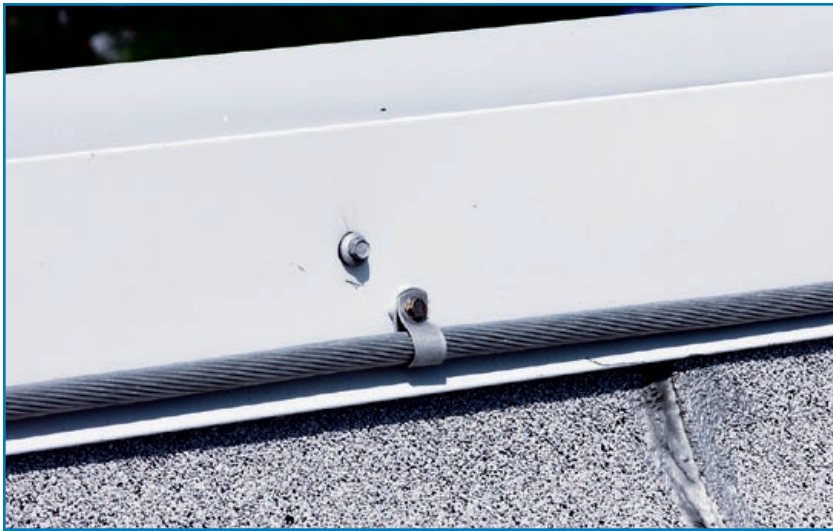
Figure 3-97: This conductor was attached to the coping with a looped connector. Hurricane Katrina (Mississippi, 2005)

Parapet attachment: When the parapet is 12 inches high or greater, it is recommended that the air terminal base plates and conductor connectors be mechanically attached with #12 screws that have minimum 1¼-inch embedment into the inside face of the parapet nailer and are properly sealed for watertight protection. Instead of conductor connectors that have prongs, it is recommended that mechanically attached looped connectors be installed (see Figure 3-97).

Standing seam metal roofs: It is recommended that pre-manufactured, mechanically attached clips that are commonly used to attach various items to roof panels be used. After anchoring the clips to the panel ribs, the air terminal base plates and conductor connectors are anchored to the panel clips. In lieu of conductor connectors that have prongs, it is recommended that mechanically attached looped connectors be installed (see Figure 3-97).

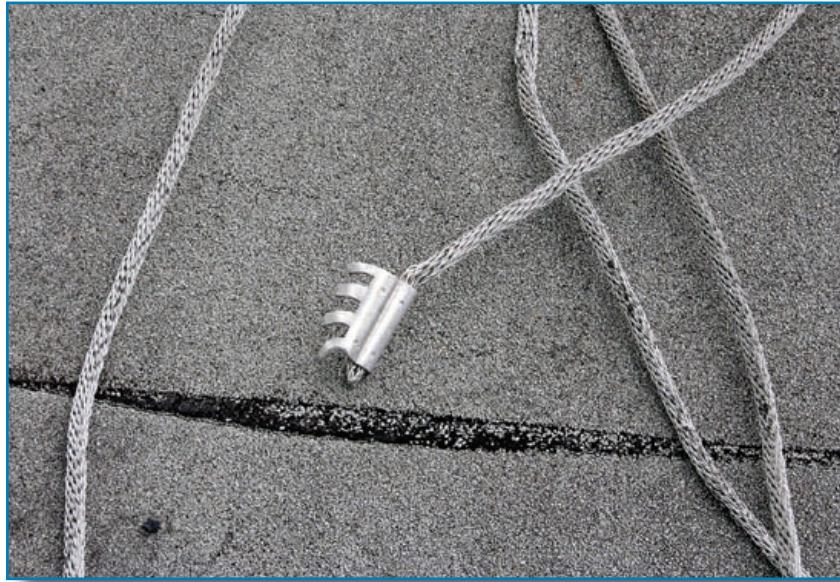
Figure 3-101:
Bolted splice connectors are recommended to prevent free ends of connectors from being whipped around by wind.
Hurricane Katrina
(Mississippi, 2005)

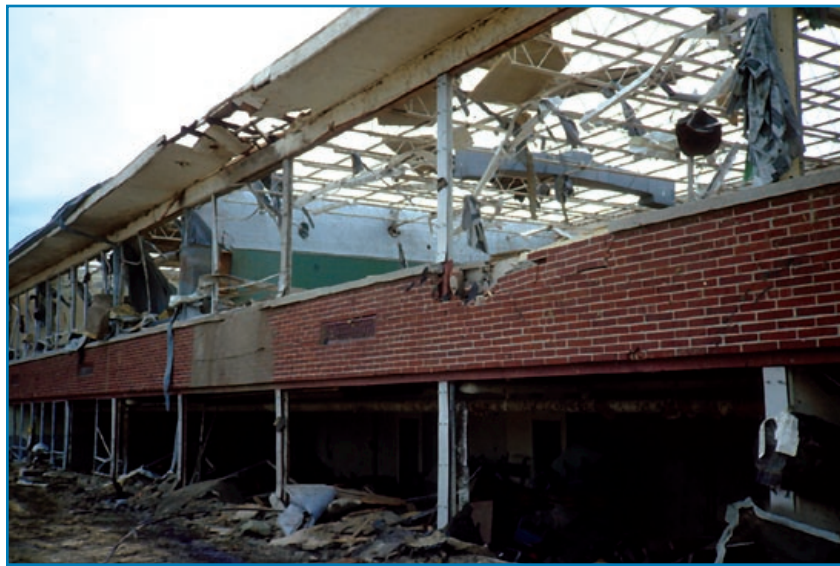
Figure 3-102:
A Northern Illinois school heavily damaged by a strong tornado in 1990

Strong and violent tornadoes may reach wind speeds substantially greater than those recorded in the strongest hurricanes. The wind pressures that these tornadoes can exert on a building are tremendous, and far exceed the minimum pressures derived from building codes. Figure 3-102 shows a classroom wing in a school in Illinois. All of the exterior windows were broken, and virtually all of the cementitious wood-fiber deck panels were blown away. Much of the metal roof decking over the band and chorus area also blew off. The gymnasium collapsed, as did a portion of the multi-purpose room. The school was not in session at the time the tornado struck.

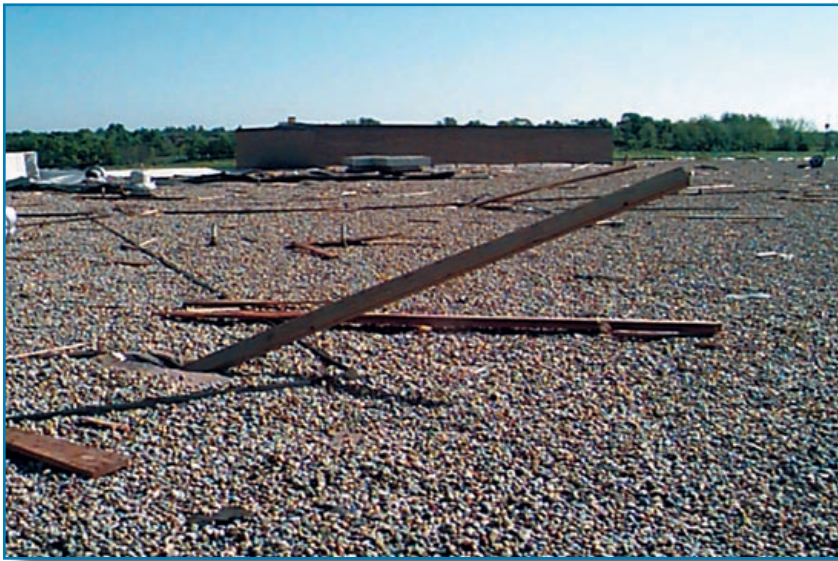
Figure 3-103:
A violent tornado
showered the roof of
this school with missiles.
(Oklahoma, 1999)

Strong and violent tornadoes can generate very powerful missiles. Experience shows that large and heavy objects, including vehicles, can be hurled into buildings at high speeds. The missile sticking out of the roof in the foreground of Figure 3-103 is a double 2-inch by 6-inch wood member. The portion sticking out of the roof is 13 feet long. It penetrated a ballasted ethylene propylene diene monomer (EPDM) membrane, approximately 3 inches of polyisocyanurate roof insulation, and the steel roof deck. The missile lying on the roof just beyond is a 2-inch by 10-inch by 16-foot long wood member.

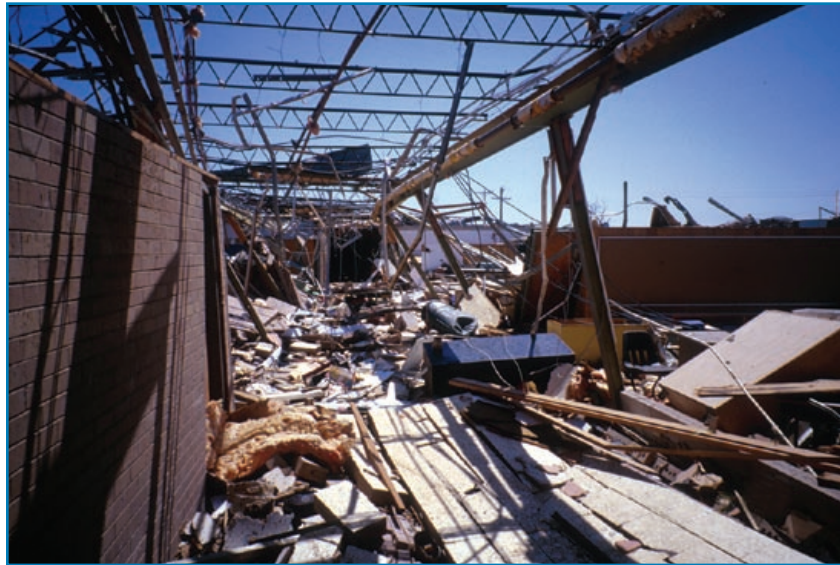
Figure 3-104:
View of school corridor
after passage of a violent
tornado (Oklahoma,
1999)

To minimize casualties in critical facilities, it is very important that the best available refuge areas be identified by a qualified architect or engineer.¹⁴ Once identified, those areas need to be clearly marked so that occupants can reach the refuge areas without delay. Building occupants should not wait for the arrival of a tornado to try to find the best available refuge area in a particular facility; by that time, it will be too late. If refuge areas have not been identified beforehand, occupants will take cover wherever they can, frequently in very dangerous places. Corridors, as shown in Figure 3-104, sometimes provide protection, but they can also be death traps.

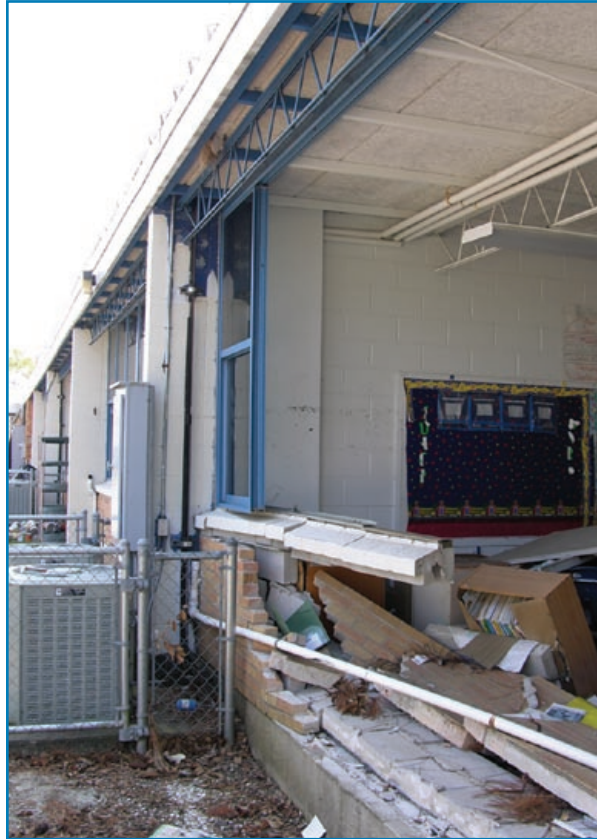
Figure 3-105:
Several walls at this school
collapsed. Windows were
located above a non-
load-bearing masonry
wall. Hurricane Katrina
(Mississippi, 2005)

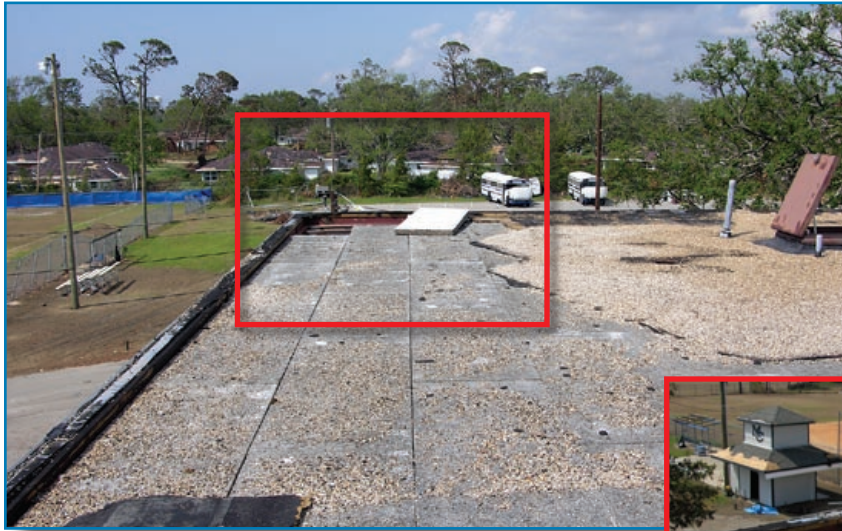
Figure 3-106:
The school's built-up roof
blew off after one of the
cementitious wood-fiber
deck panels detached
from the joists. Hurricane
Katrina (Mississippi, 2005)

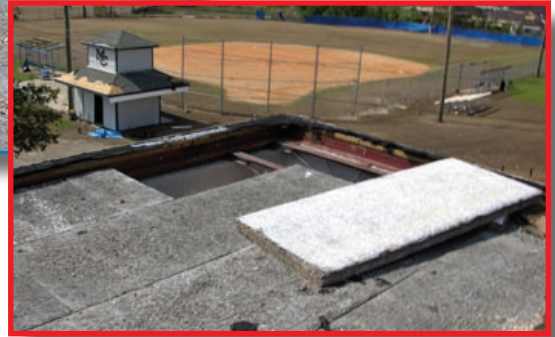
Figure 3-107:
The cementitious wood-
fiber deck panels detached
from the joists along the
overhangs and caused
the school's built-up
membranes to lift and
peel. Hurricane Katrina
(Mississippi, 2005)

As discussed in Section 3.1.4.1, roof decks on many facilities designed prior to the 1982 edition of the SBC and UBC and the 1987 edition of the NBC are very susceptible to failure. Poorly attached decks that are not upgraded are susceptible to blow-off, as shown in Figure 3-106. Decks constructed of cementitious wood-fiber, gypsum, and lightweight insulating concrete over form boards were commonly used on buildings built in the 1950s and 1960s. In that era, these types of decks typically had very limited uplift resistance due to weak connections to the support structure. Steel deck attachment is frequently not adequate because of an inadequate number of welds, or welds of poor quality. Older buildings with overhangs are particularly susceptible to blow-off, as shown in Figure 3-107, because older codes provided inadequate uplift criteria.

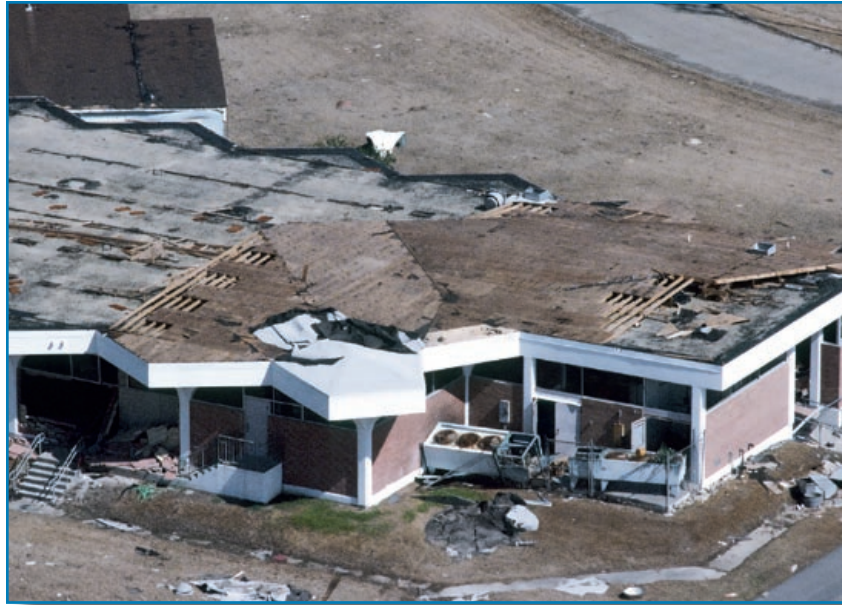
Figure 3-108:
The school's wood superstructure installed as part of a steep-slope conversion blew away because of inadequate attachment. Hurricane Katrina (Louisiana, 2005)

If a low-slope roof is converted to a steep-slope roof, the new support structure should be engineered and constructed to resist the wind loads and avoid the kind of damage shown in Figure 3-108.

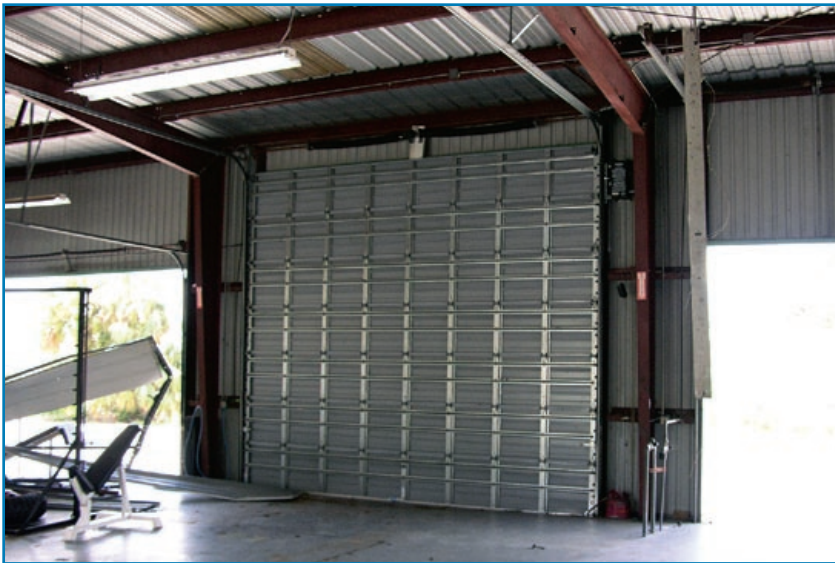
Figure 3-109:
The new door in the center performed very well, but the older doors on either side of it were blown away. Hurricane Charley (Florida, 2004)

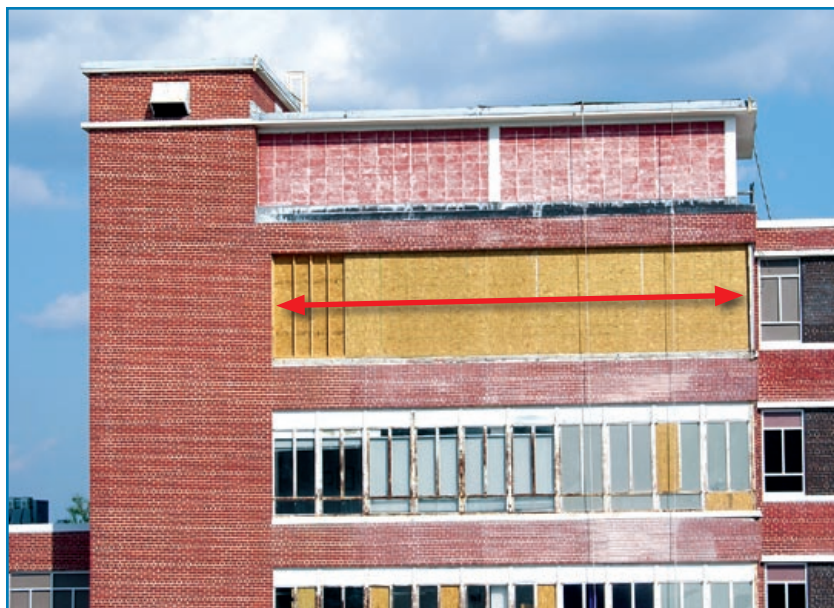
Figure 3-110:
Wind pressure caused
the window frames on
the upper floor to fail (red
arrow). Hurricane Katrina
(Mississippi, 2005)

Windows in older facilities may possess inadequate resistance to wind pressure. Window failures are typically caused by wind-borne debris, however, glazing or window frames may fail as a result of wind pressure (see Figure 3-110). Failure can be caused by inadequate resistance of the glazing, inadequate anchorage of the glazing to the frame, failure of the frame itself, or inadequate attachment of the frame to the wall. For older windows that are too weak to resist the current design pressures, window assembly replacement is recommended. Some older window assemblies have sufficient strength to resist the design pressure, but are inadequate to resist wind-driven rain. If the lack of water resistance is due to worn glazing gaskets or sealants, replacing the gaskets or sealant may be viable. In other situations, replacing the existing assemblies with new, higher-performance assemblies may be necessary.
