3.1 GENERAL DESIGN CONSIDERATIONS

3.1.1 NATURE OF HIGH WINDS

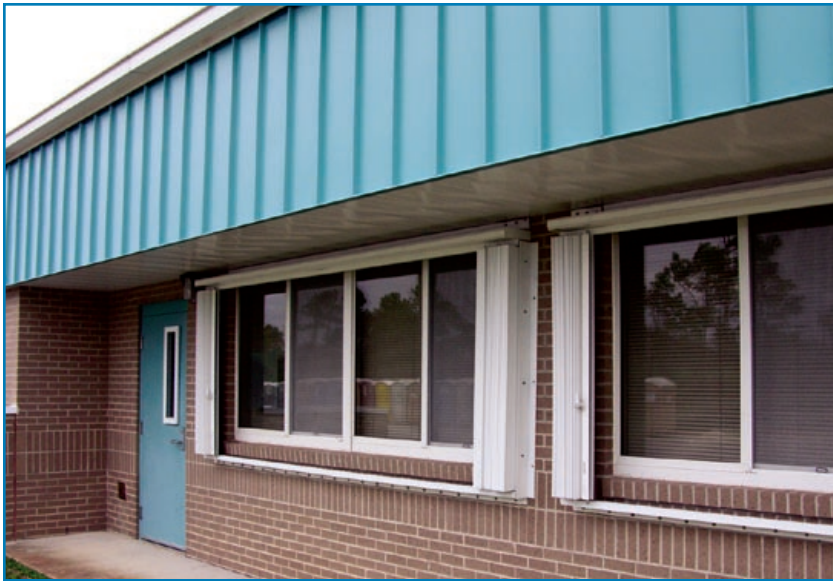
Figure 3-111:
This school has accordion
shutters. Hurricane Ivan
(Florida, 2004)

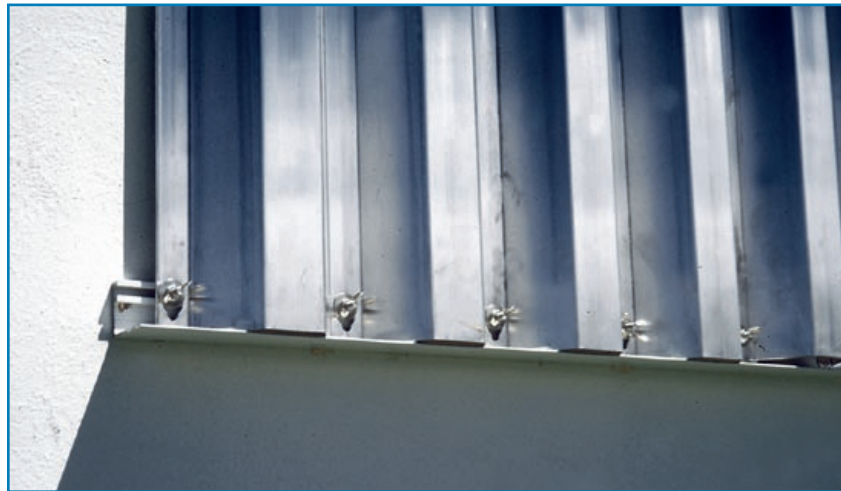
Figure 3-112:
Illustrates a metal panel shutter. Hurricane Georges
(Puerto Rico, 1998)

Shutters are typically a more economical approach for existing facilities. There are a variety of shutter types, all illustrated by Figures 3-111 to 3-113. Accordion shutters are permanently attached to the wall (Figure 3-111). When a hurricane is forecast, the shutters are pulled together and latched into place. Panel shutters (Figure 3-112) are made of metal or polycarbonate. When a hurricane is forecast, the shutters are taken from storage and inserted into metal tracks that are permanently mounted to the wall above and below the window frame. The panels are locked into the frame with wing nuts or clips. Track designs that have permanently mounted studs for the nuts have been shown to be more reliable than track designs using studs that slide into the track. A disadvantage of panel shutters is the need for storage space. Roll-down shutters (Figure 3-113) can be motorized or pulled down manually. Figure 3-113 illustrates the benefits of shuttering. Two of the unprotected window units experienced glass breakage and the third window unit blew in.

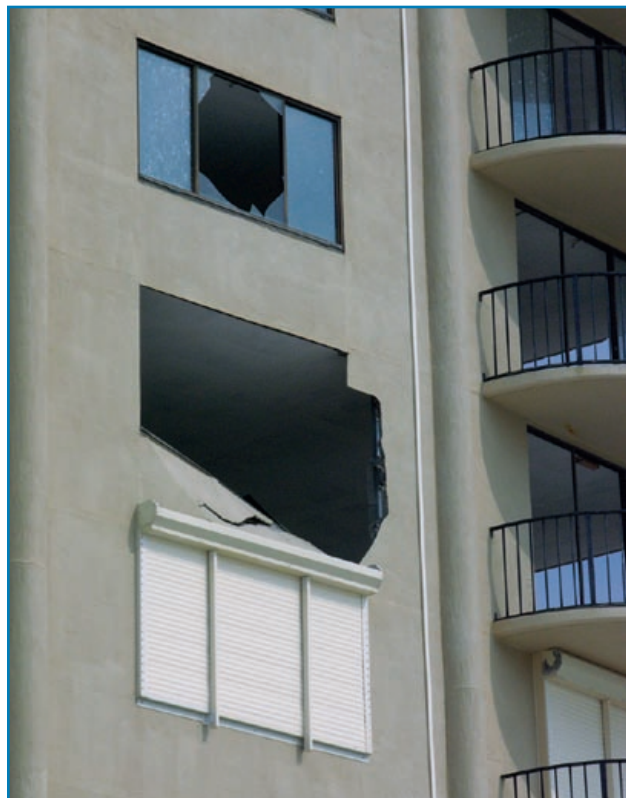
Figure 3-113:
The lower window assembly was protected with a motorized shutter.
Hurricane Ivan (Florida, 2004)

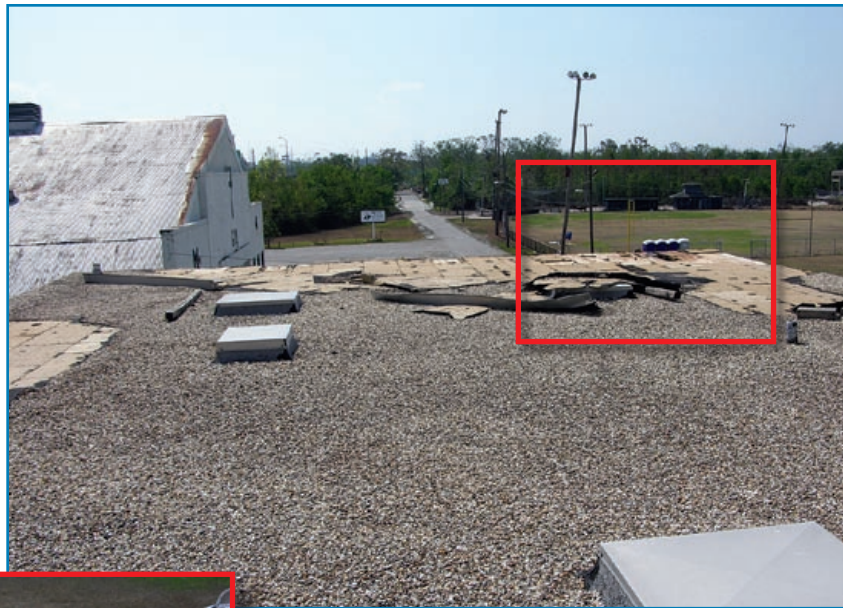
Figure 3-115:
The built-up roof on this school was blown off after a few of the rotted wood planks detached from the joists. Hurricane Katrina (Mississippi, 2005)

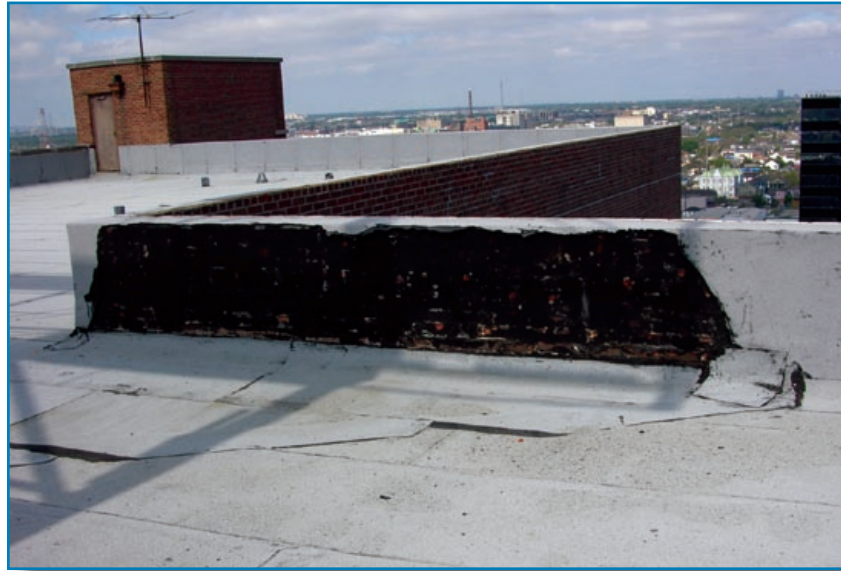
Figure 3-117:
Failed base flashing
adhered directly to the
brick parapet. Hurricane
Katrina (Louisiana, 2005)

If the roof has a parapet, it is recommended that the inside of the parapet be properly prepared to receive the new base flashing. In many instances, it is prudent to re-skin the parapet with sheathing to provide a suitable substrate. Base flashing should not be applied directly to brick parapets because they have irregular surfaces that inhibit good bonding of the base flashing to the brick (see Figure 3-117). Also, if moisture drives into the wall from the exterior side of the parapet with base flashing attached directly to brick, the base flashing can inhibit drying of the wall. Therefore, rather than totally sealing the parapet with membrane base flashing, the upper portion of the brick can be protected by metal panels (as shown in Figure 3-93), which permit drying of the brick.

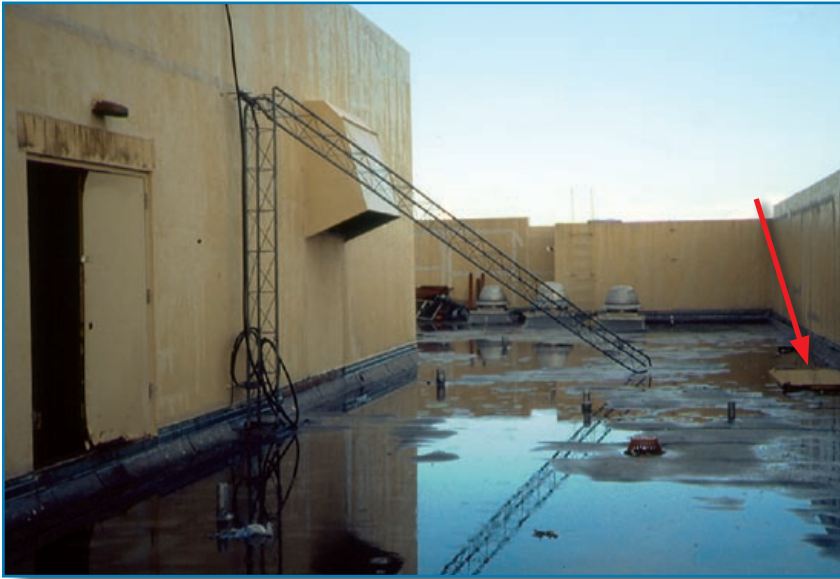
Figure 3-118:
The antenna at this hospital collapsed and was whipped back and forth across the roof membrane. Hurricane Andrew (Florida, 1992)
